**ADDENDUM NO. 1 (DRAFT)**  
**Naperville Riverwalk**  
**Moser Tower Structural Assessment**  
**September 2018**

### CORROSION AND MATERIAL DURABILITY ANALYSIS

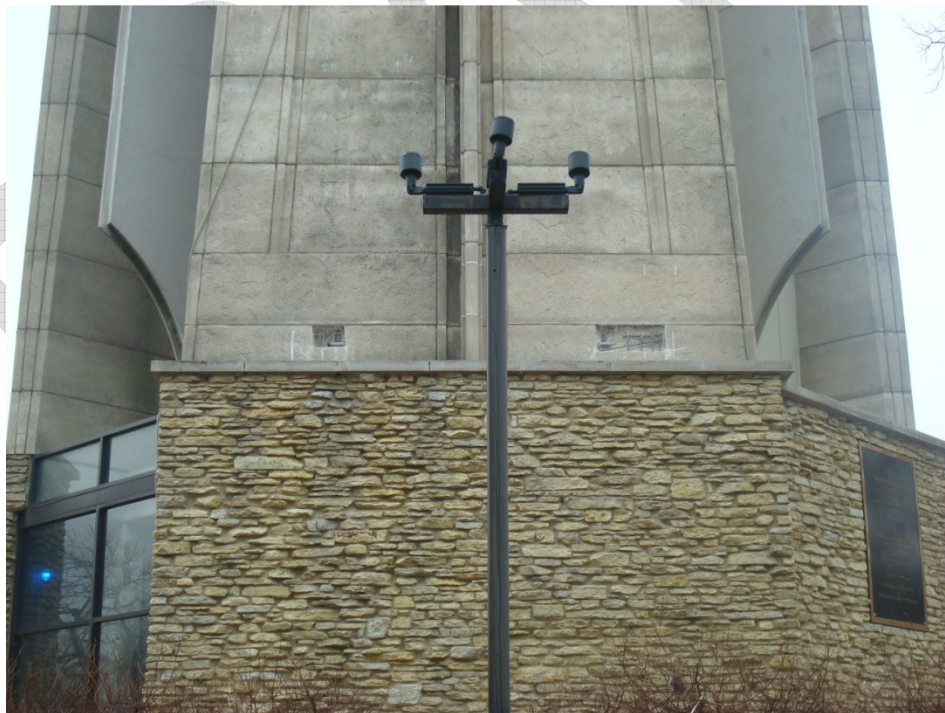
**Photograph #1: Areas of exposed post-tensioned rods at NW corner.**

The selected removal areas were chosen at the bottom of the precast panels immediately above the masonry top cap to provide the most relevant indication of the condition of the post-tensioned strands.

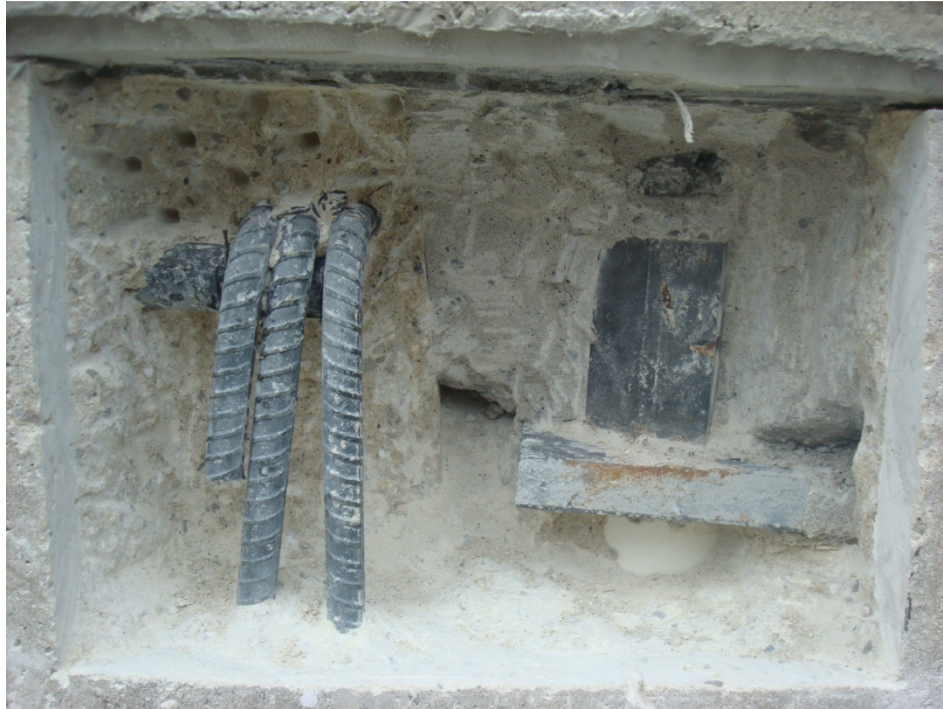
**Photograph #2: Exposed end of PT rod and reinforcement bars at left opening**

As can be clearly seen in Photographs #2, #3, and #4, the post-tensioned rod, reaction plate, and adjacent reinforcement bars are in good condition. There is no sign of corrosion that would cause deterioration of the rods, plates, or bars. These removals also confirmed that the rods have been encased in grouted sleeves, as called out on the precast shop drawings, providing additional protection to these rods from corrosion due to water infiltration.

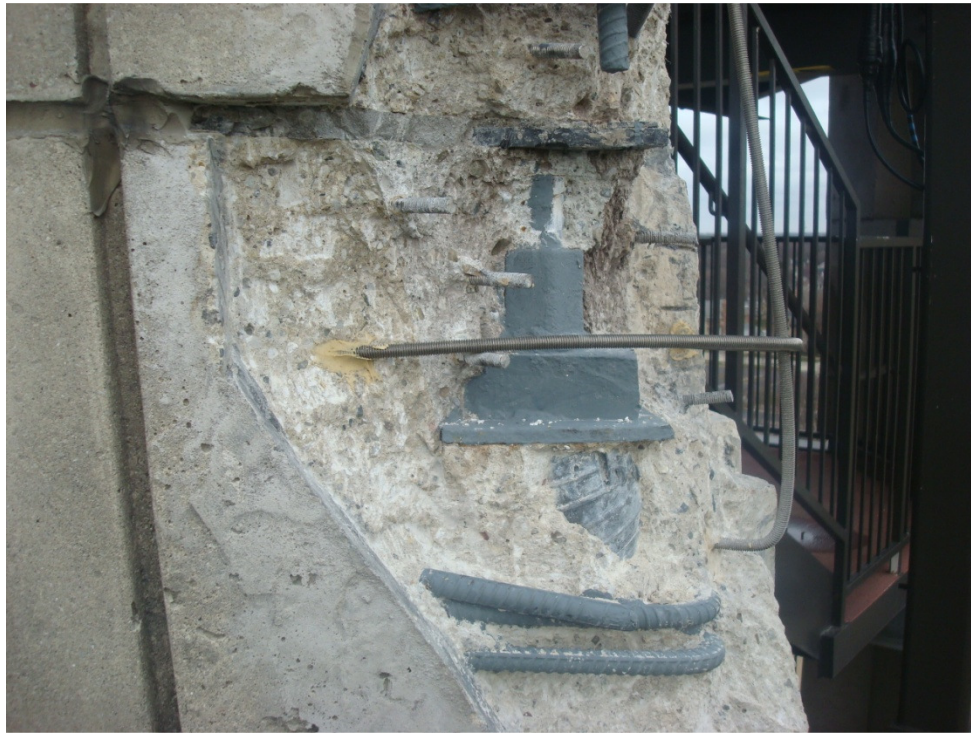
**Photograph #4: Exposed end of PT rod and reinforcement bars at right opening**

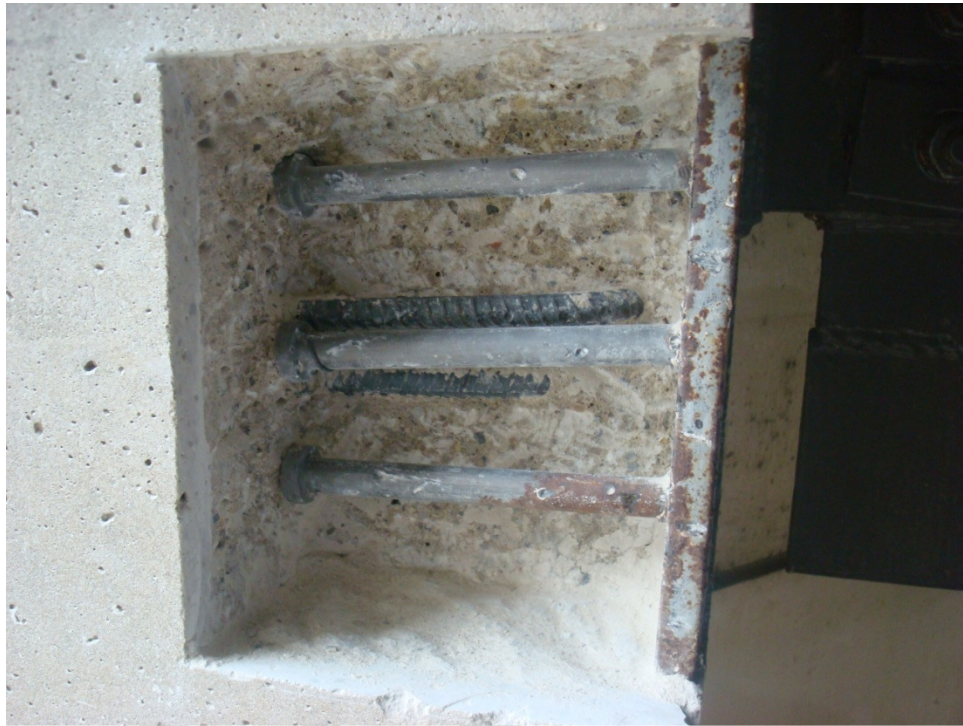
**Photograph #5: Exposed connection plate and embedded studs at northeast side of Elev. 52.5.**

On the right side of Photograph #5 is the steel plate where steel framing connects to the concrete pillars. The condition of the connection is critical to structural stability. The three rods depicted horizontally in Photograph #5 are automatically welded steel studs connected to the steel plate. The studs create shear and bond capacity to the concrete, transferring the vertical and horizontal loads from the steel framing into the concrete pillars. These components were substantially found in good condition.

As can be clearly seen in Photographs #5, #6, and #7, the embedded parts of these connections that are exposed are in good condition. There is evidence of minor surface corrosion on a portion of the embedded steel studs, along with the backside and edges of the plate, but no evidence of significant deterioration of these members. These removals confirm that the installation conforms to the girder support detail C4 shown on C1.1 of the Charles Vincent George drawings.

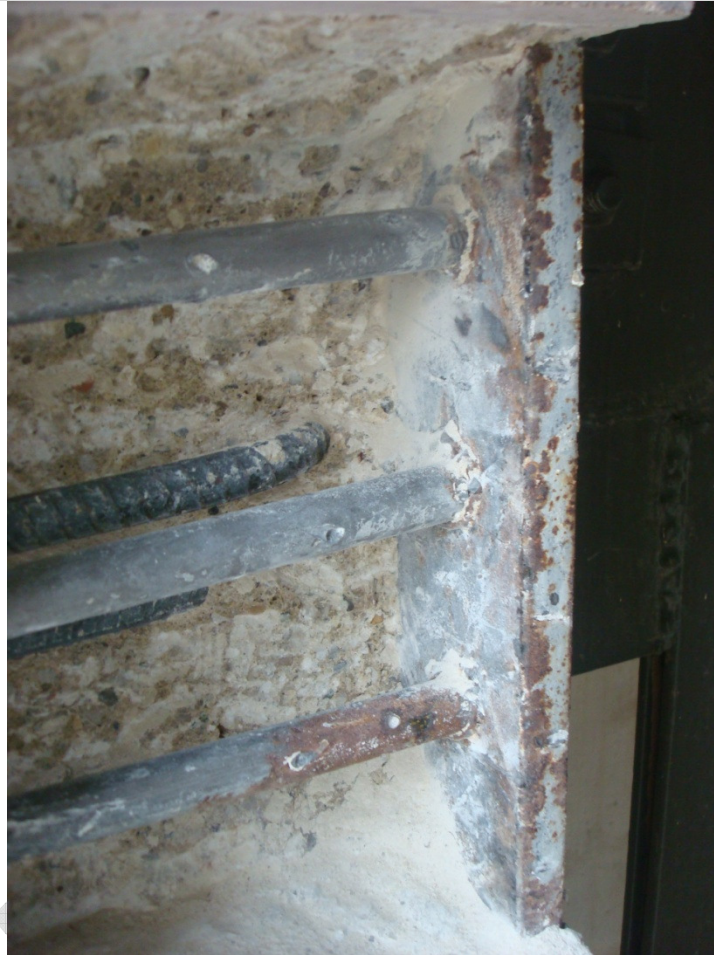
**Photograph #6: Backside of connection plate and embedded studs at northeast side of Elev. 52.5.**

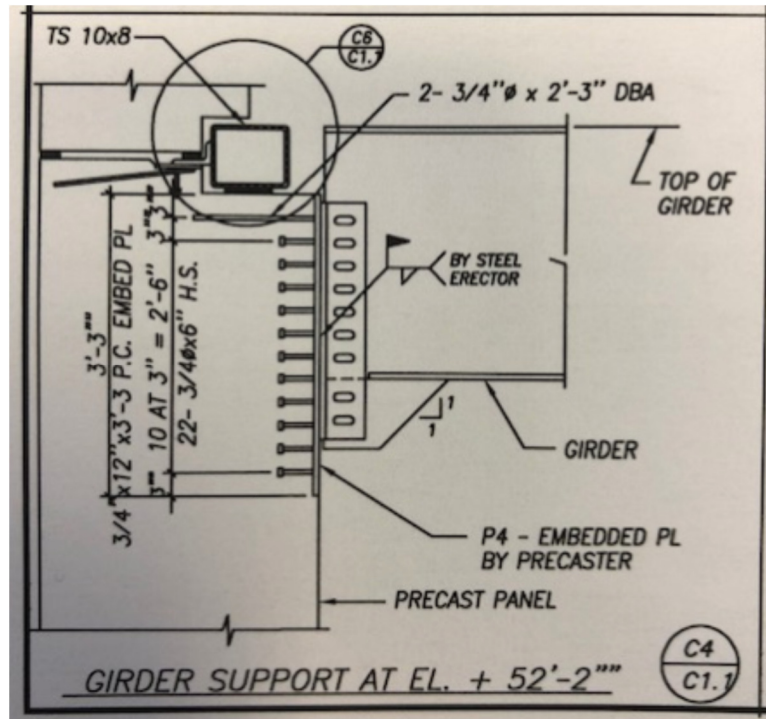
Weather intrusion through concrete cracks and spalled aggregates propagate corrosion on the backside of the connection plate, resulting in corrosion product flow down the face of the concrete. These plates are anchored to the concrete with steel studs, subject to corrosion deterioration. **The weather intrusion and corrosion propagation in these connections must be abated.**

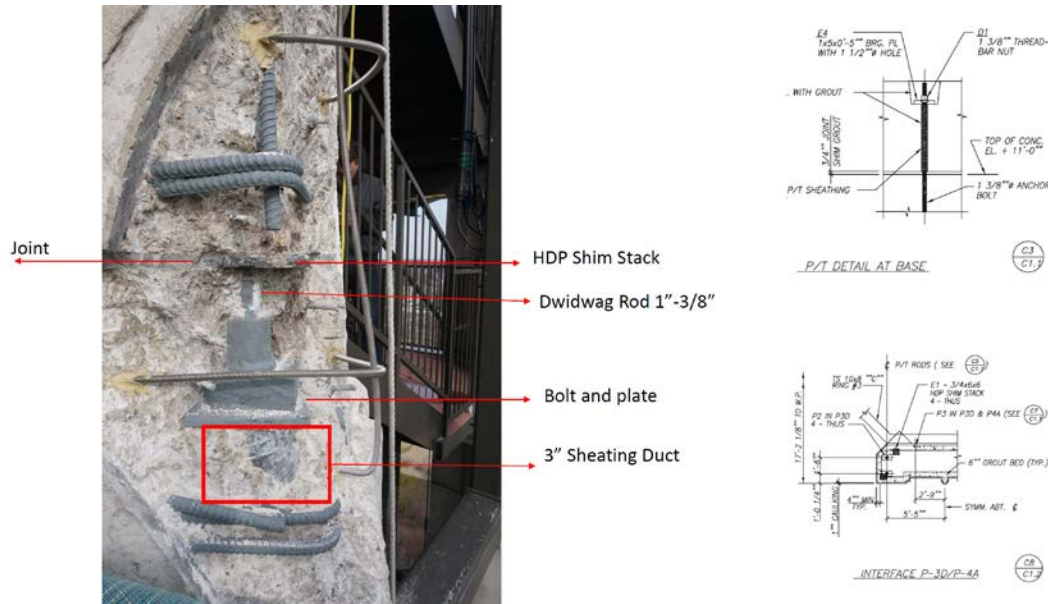
FIGURE 29 FOUND CONDITION AT PROBE OPENING OF POST-TENSIONED ROD DETAIL

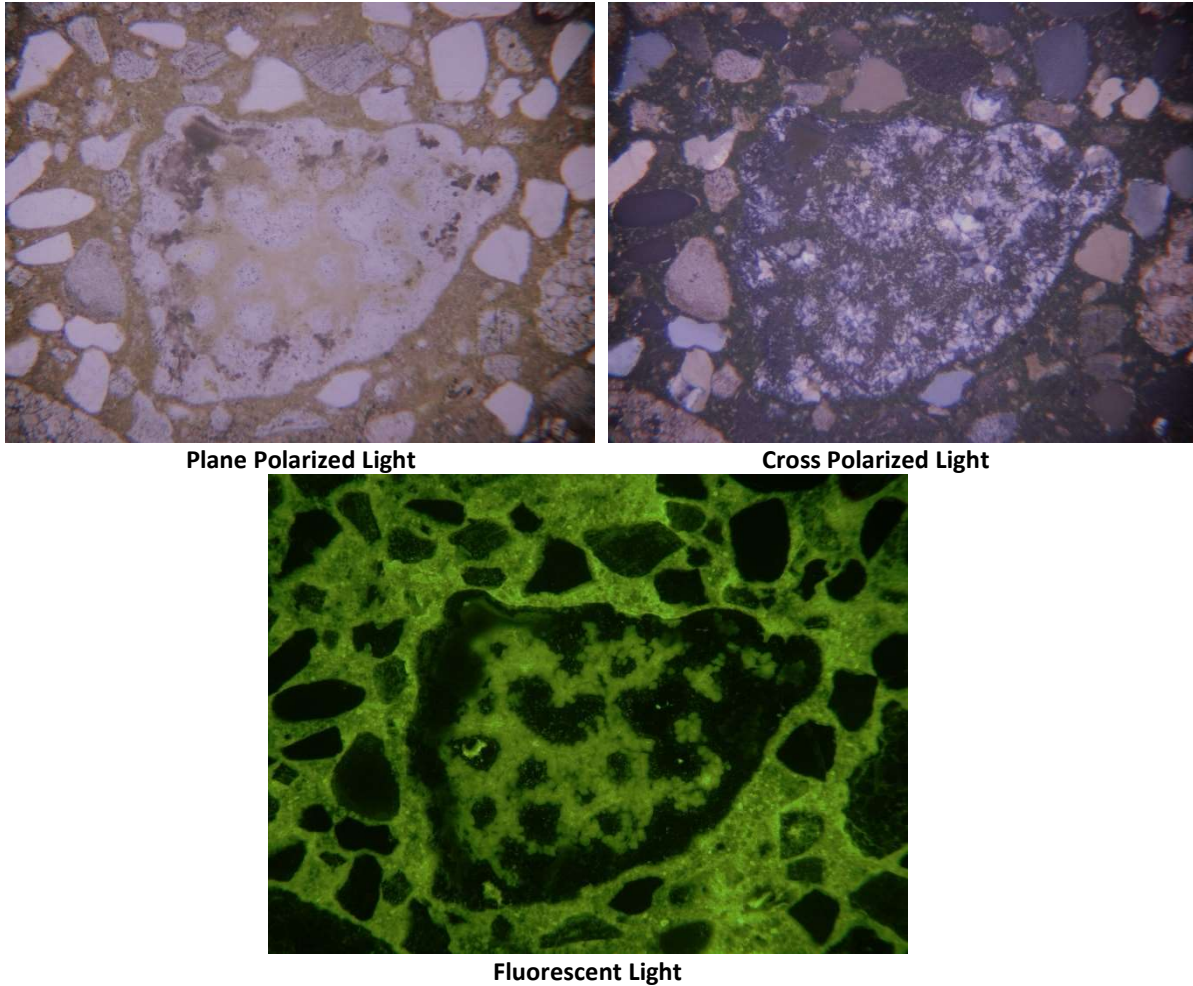
**Figure 8. Fin (3150052). Optical micro-graph in different light modes showing a fine aggregate that is reactive rim, but no cracking in the aggregate or into the paste. Field of view 2.6 mm wide.**

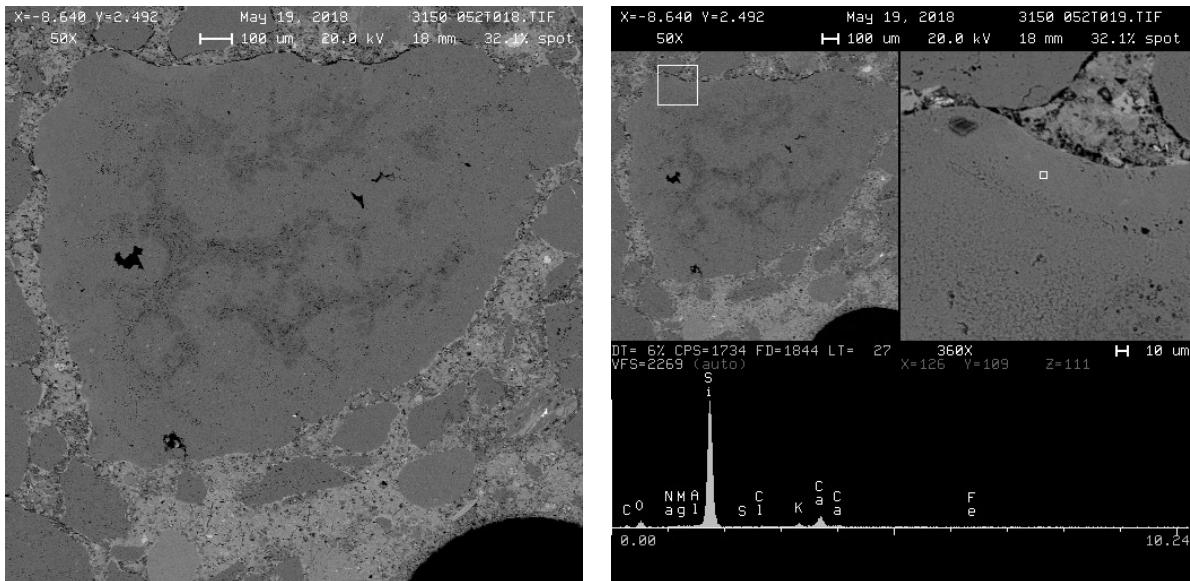
**Figure 9. Fin (3150052). Backscattered electron (BSE) images with EDS spectrum showing the reactive rim on the fine aggregate and the ASR gel with traces of calcium and alkali (K).**

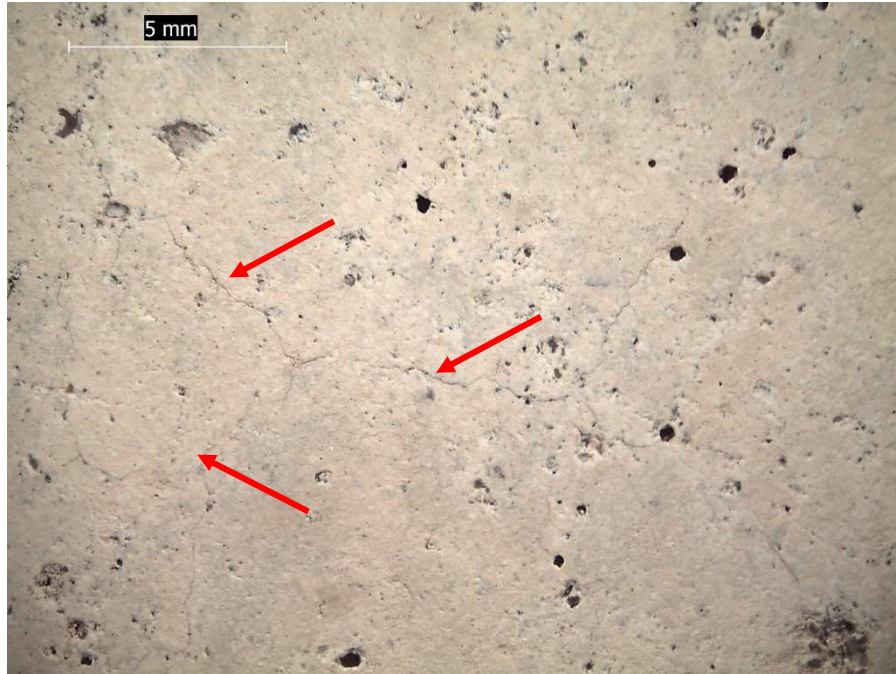
Figure 15. Pre-Cast Panel (3150053). Stereo-optical micrograph showing a minor amount of microcracks in the paint layer.

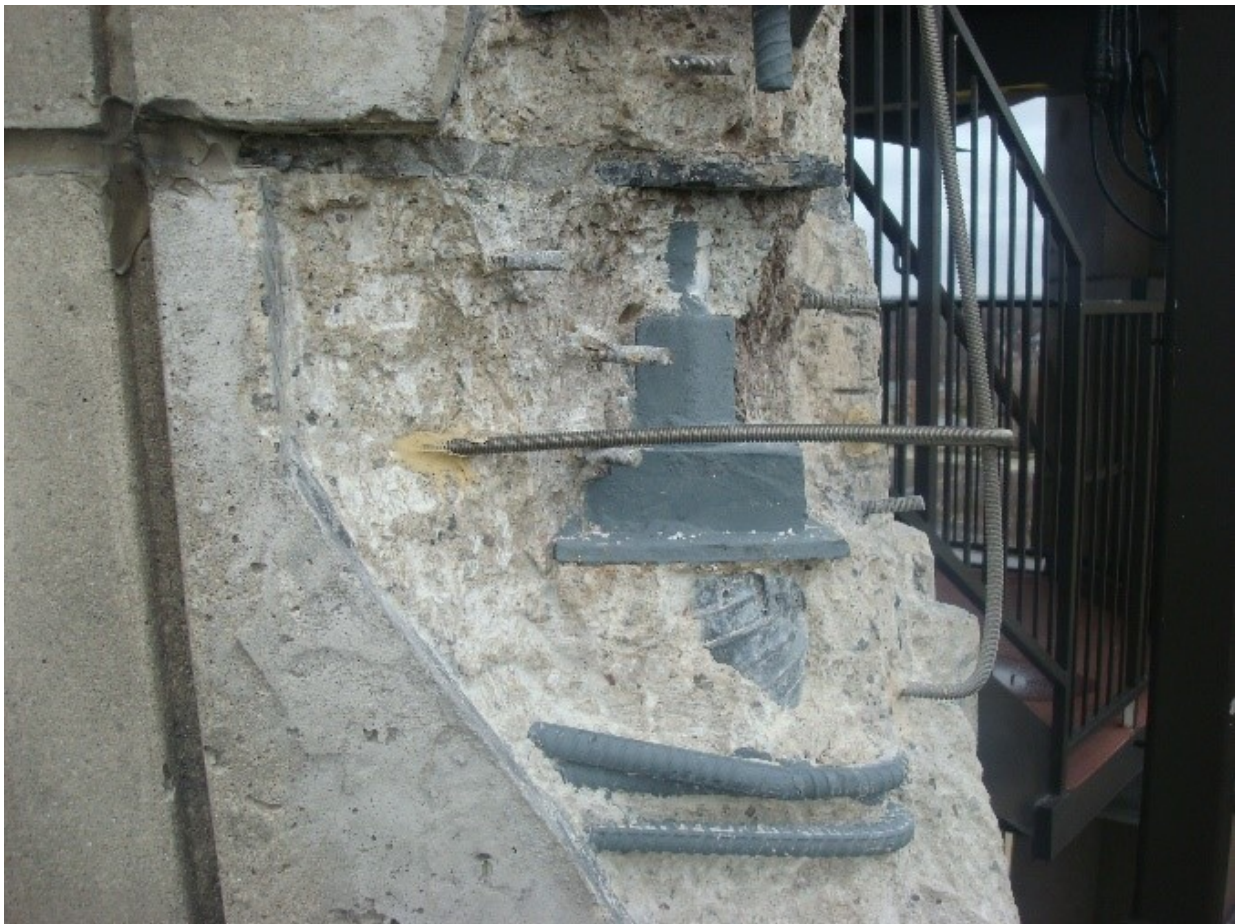
55. A close-up view of failed patch on the SE pier El.116-8" after demolition. The patch that was removed did not have sufficient anchorage to prevent a fall. The exposed concrete cast around the Dywidag post-tensioned hardware is not fully engaged with the steel. The architectural concern for this condition due to its repetition on all sides at this level is that the Dywidag is not sufficiently engaged with the structural reinforcing to prevent repeated failure.

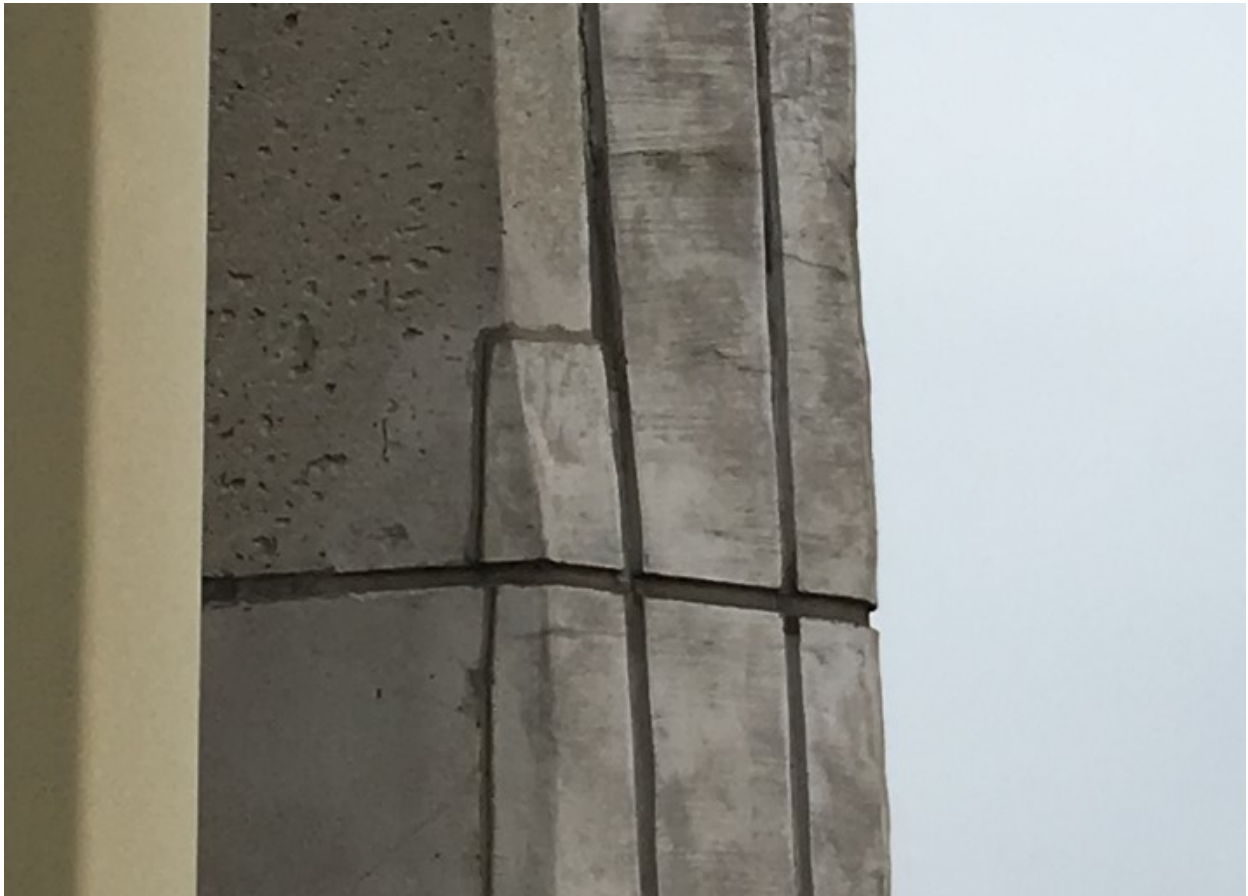
56. A view of previously made patches on the SW pier. At the same 116' elevation as photo 55. This condition is visible on all sides of the structure at this location

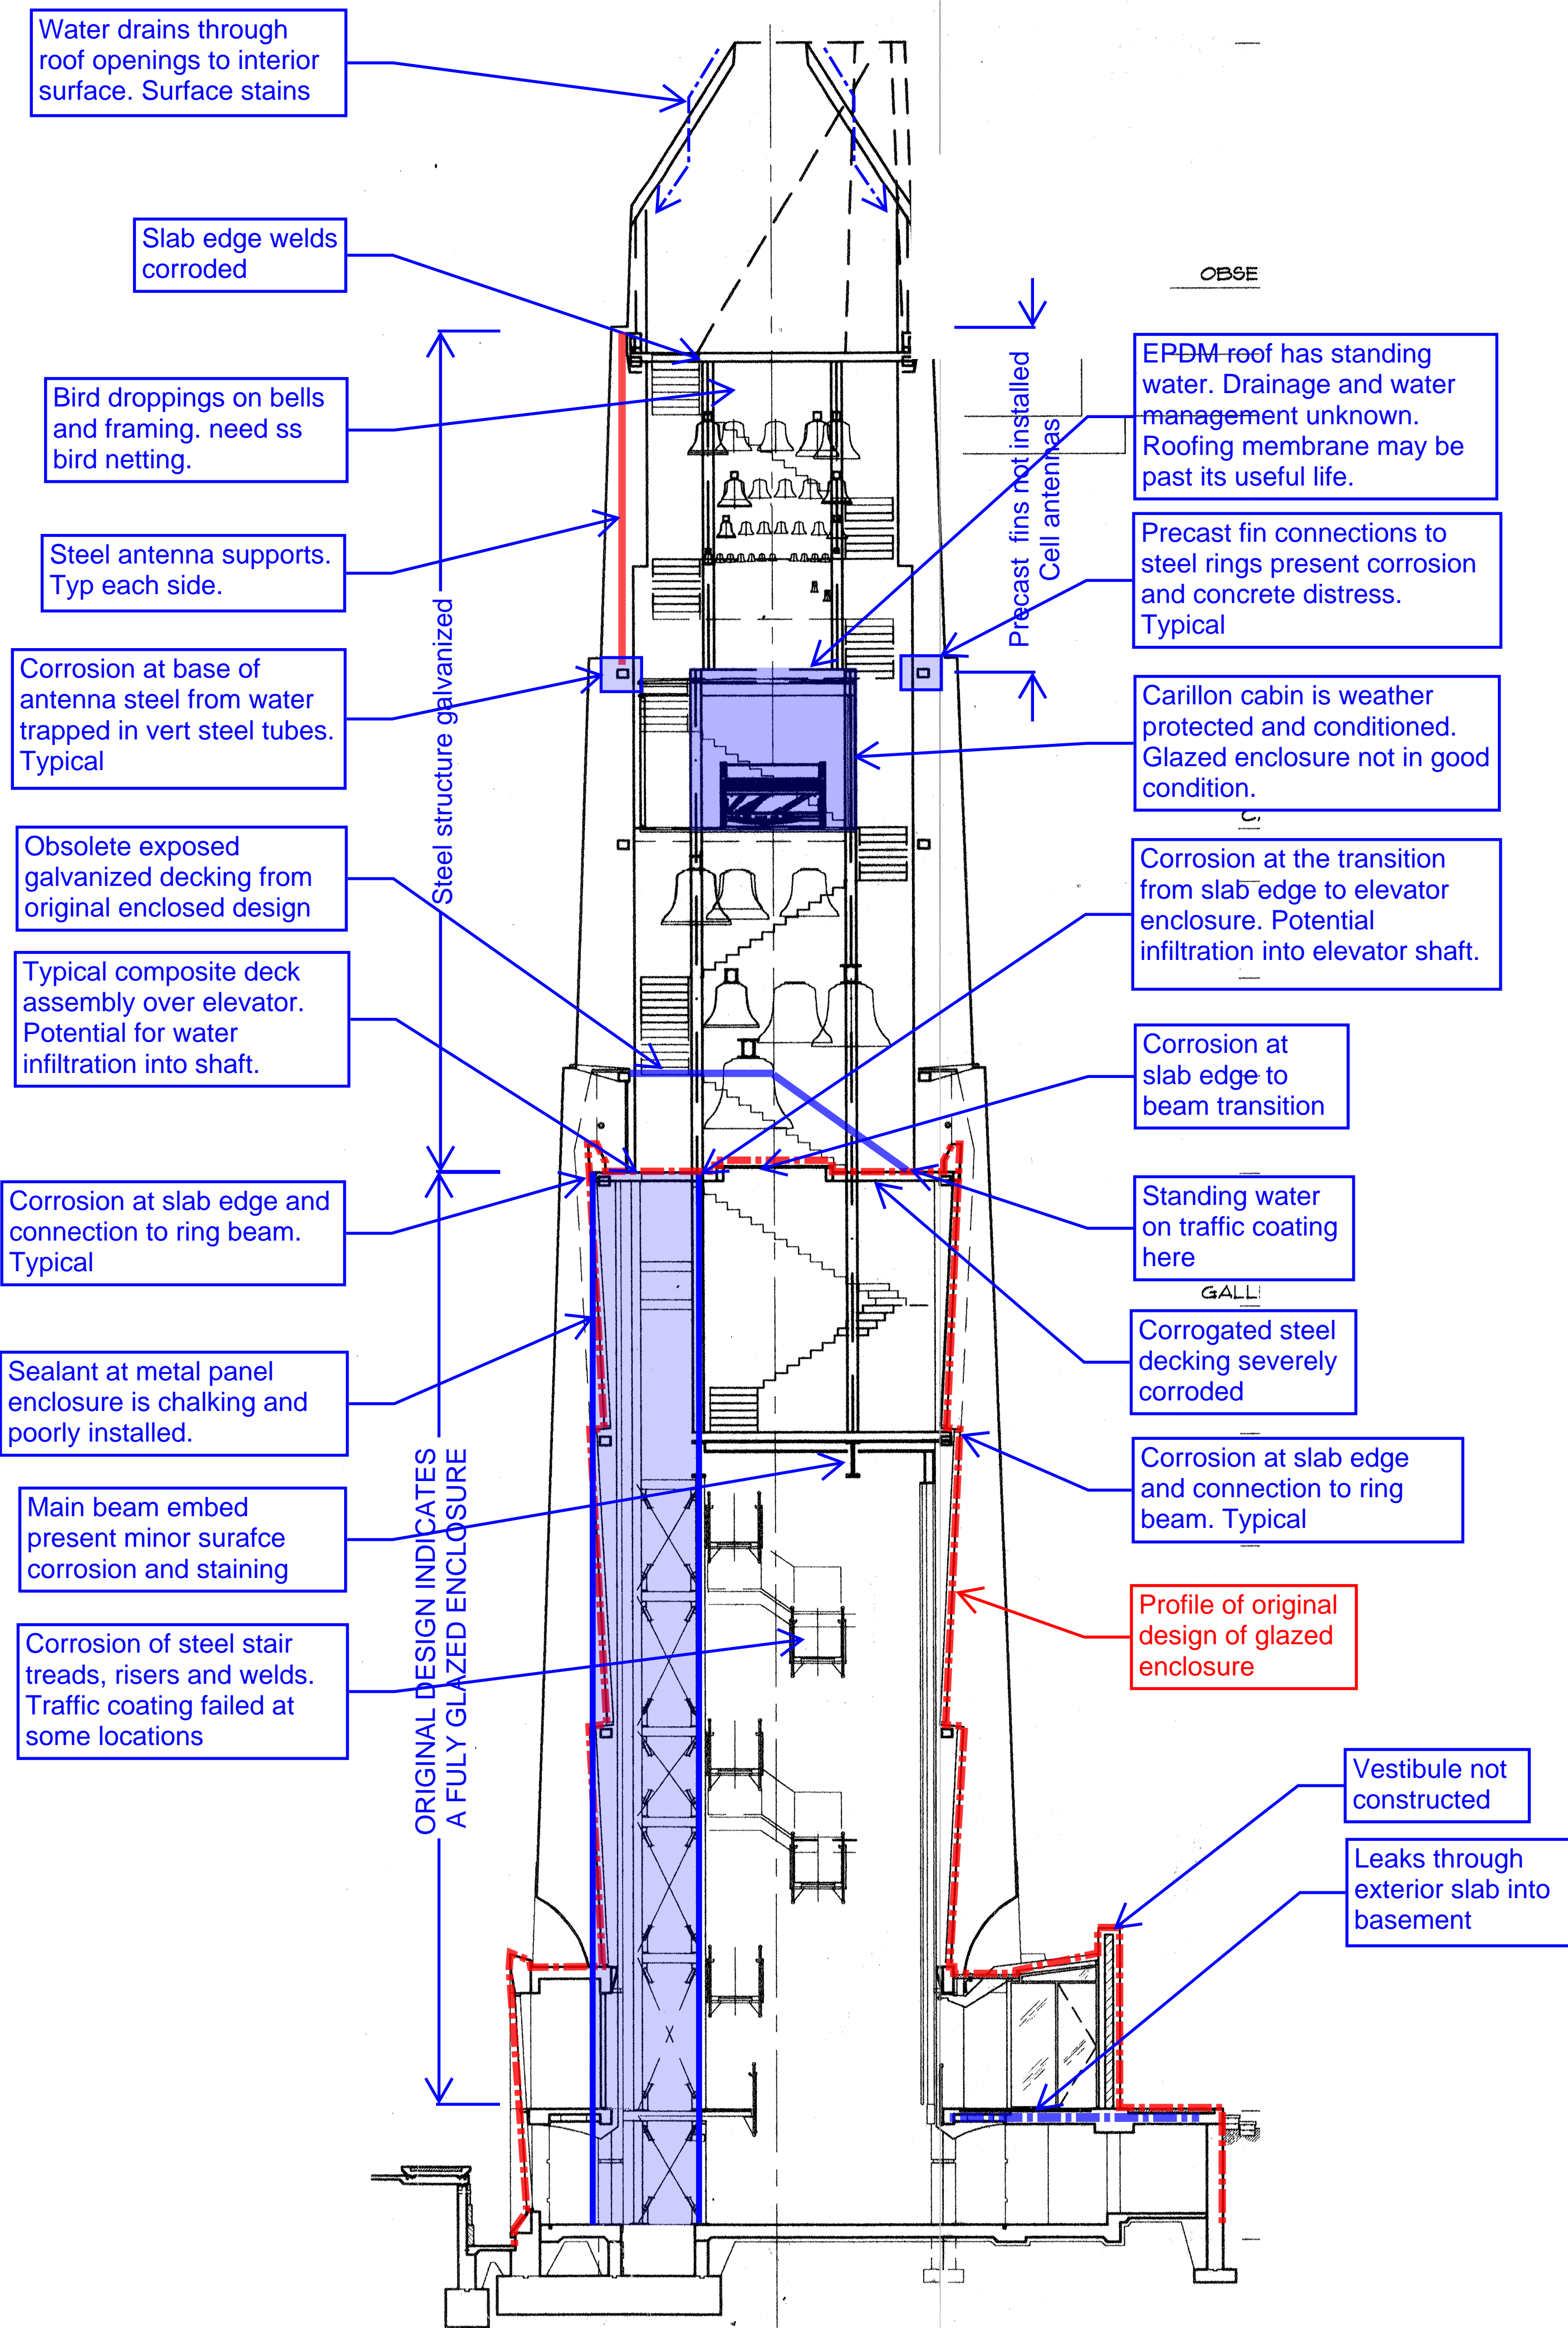
Water drains through roof openings to interior surface. Surface stains
