**ORGANIZATION** RAMSEY HISTORIC CONSULTANTS

**SURVEYAREA** NAPERVILLE SURVEY UPDATE

**City of NAPERVILLE**  
2025 HISTORIC RESOURCES SURVEY UPDATE  
CONTINUATION SHEET

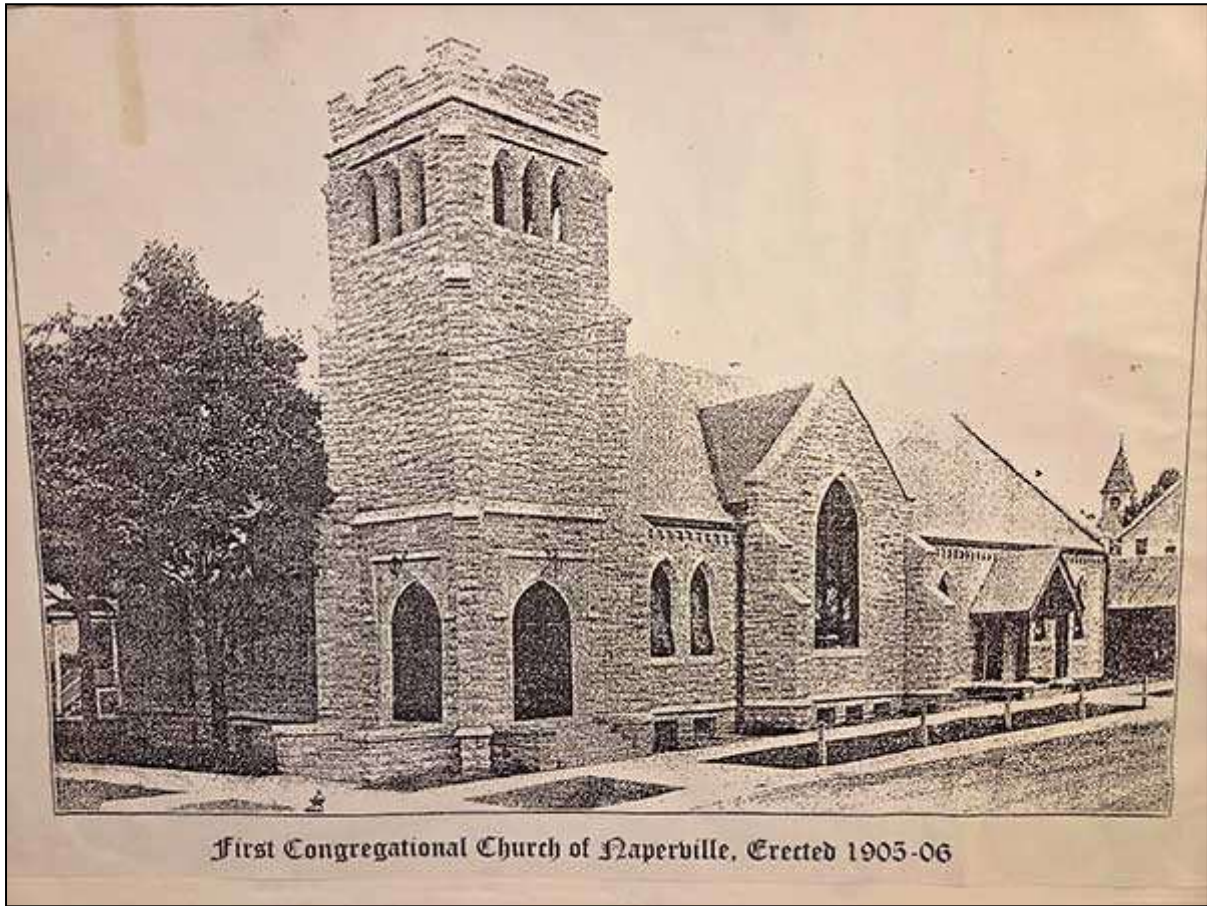
First Congregational Church of Naperville, Erected 1905-06

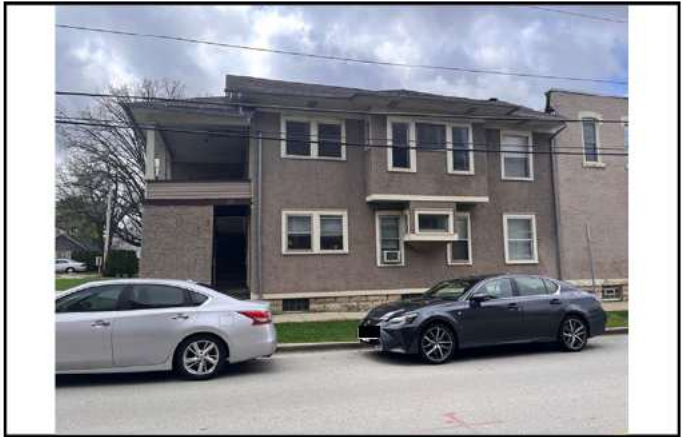
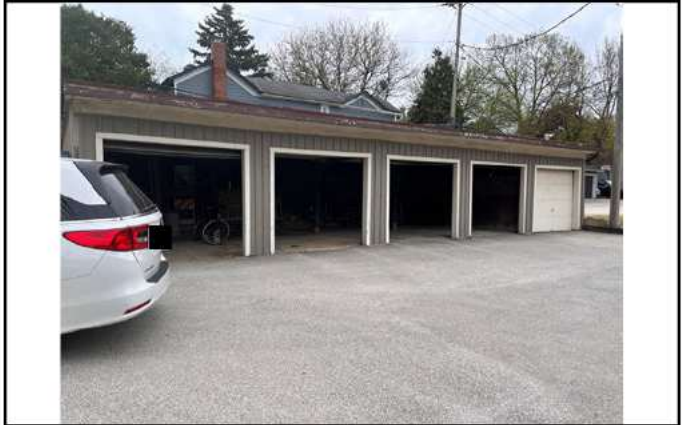
**ALTERATIONS** 1/1 replacement windows in original openings (wood and vinyl); glass block replacement windows in basement; east 2-story porch addition (c. 1950). Post-2007 - no changes.

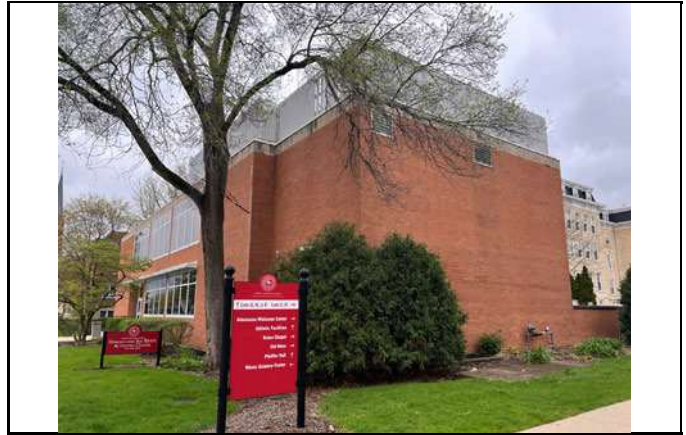
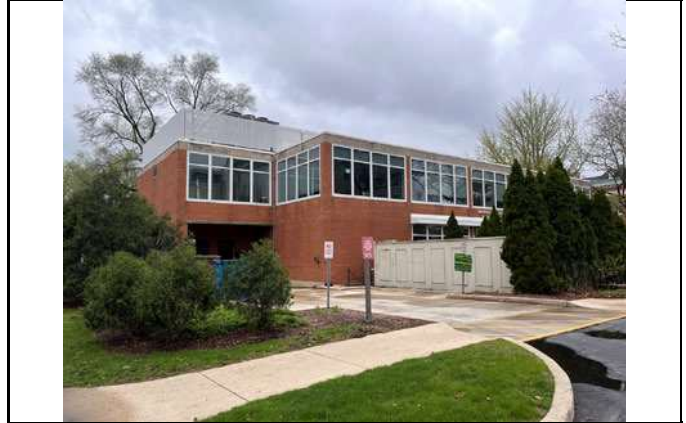
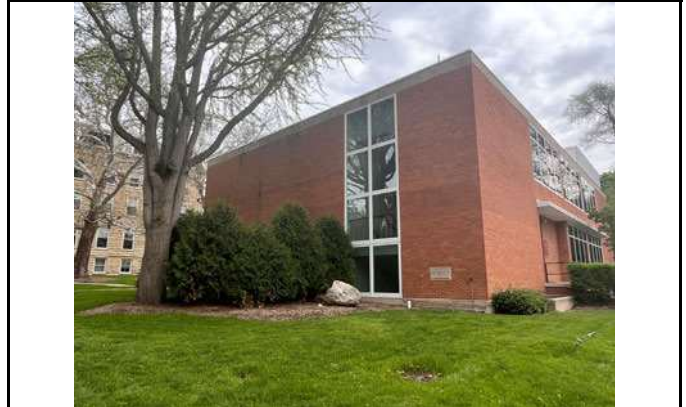
**ALTERATIONS** Post-2007 -- Aluminum replacement windows throughout (simple 2-light configuration that varies from the original multi-light windows); new doors and transom in downsized opening at south entrance; concrete panel east of original entrance clad with brick; metal fencing at roof around rooftop mechanicals.

New doors and transom in downsized opening at south entrance

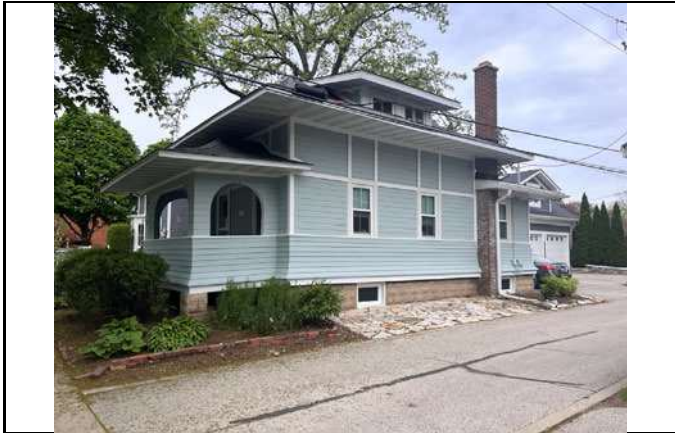
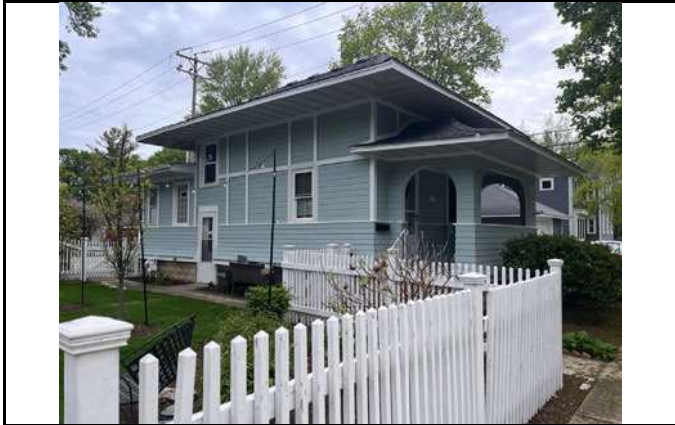
**COA DECISION** COA #23-3801 - In-kind window replacement maintaining grid pattern and use of wood (approved 10/3/2023)

**COA Compliance Notes** From public way, replacement windows appear to be Aluminum-clad--this would still meet the standard for Fast-Track COA approval for window replacement.

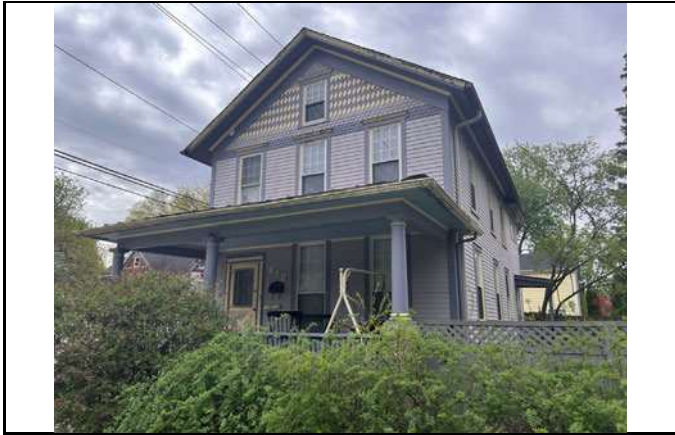
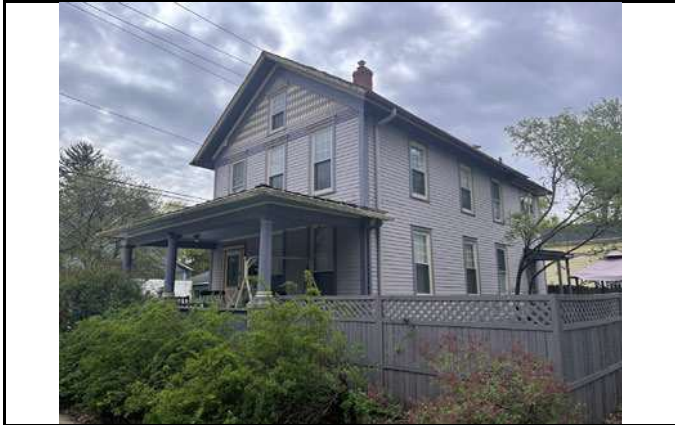
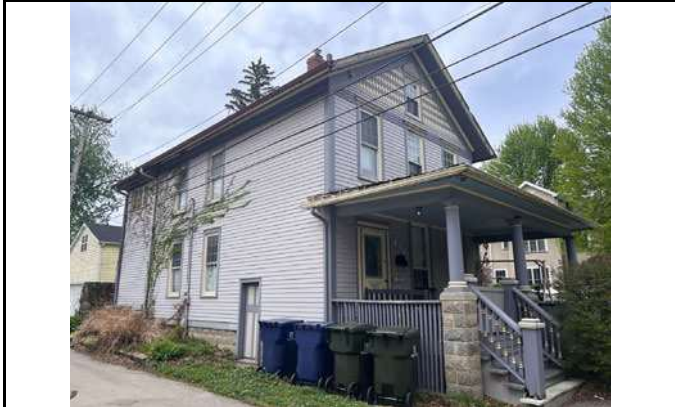
Work Not Requiring COA Replacement windows on on secondary (alley and west) elevations.

9/1 Aluminum/vinyl replacement windows on front façade.

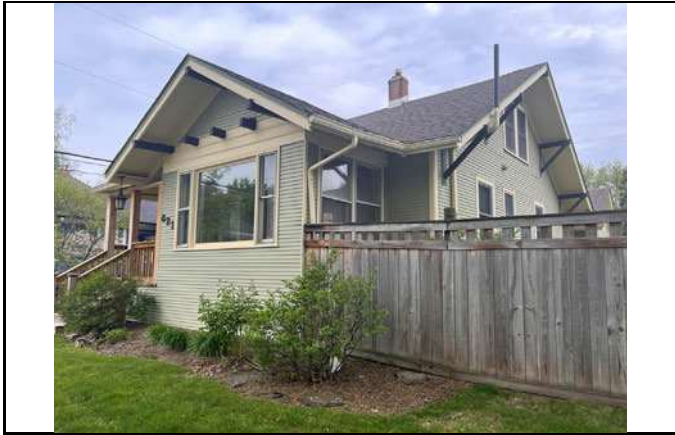
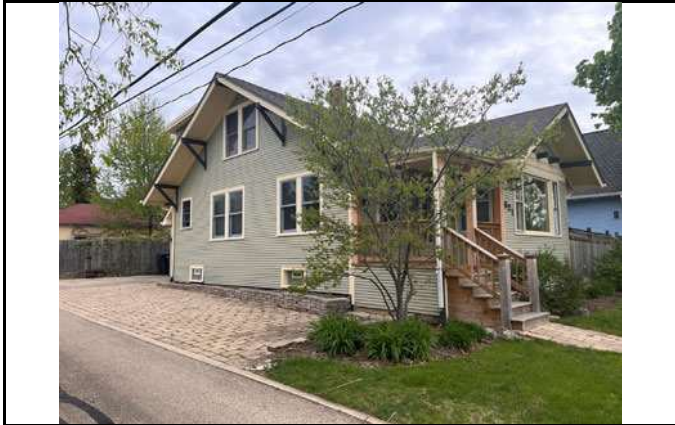
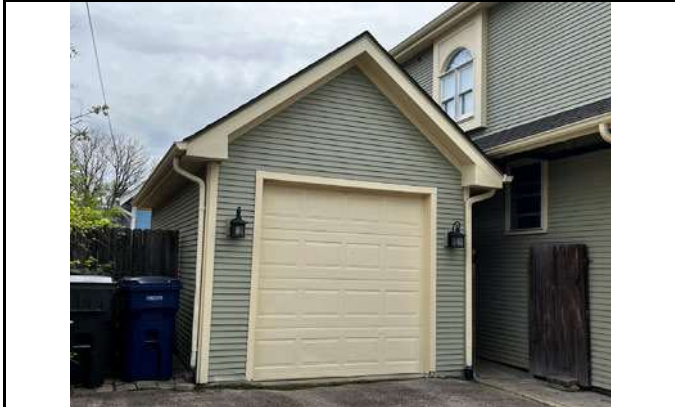
Work Not Requiring COA Exterior repainting

Replacement porch decking, posts, railings, and front steps
