| ORGANIZATION | RAMSEY HISTORIC CONSULTANTS |

| SURVEYAREA | NAPERVILLE SURVEY UPDATE |

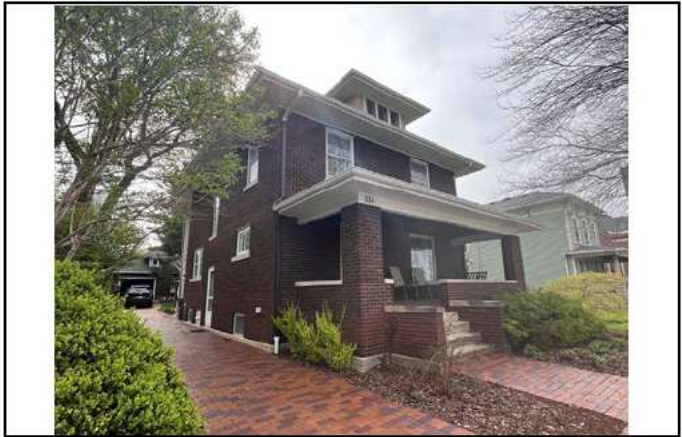
Aluminum siding installed under eaves

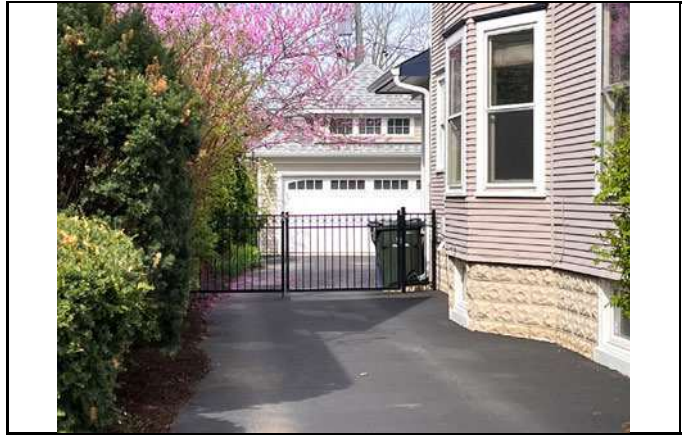
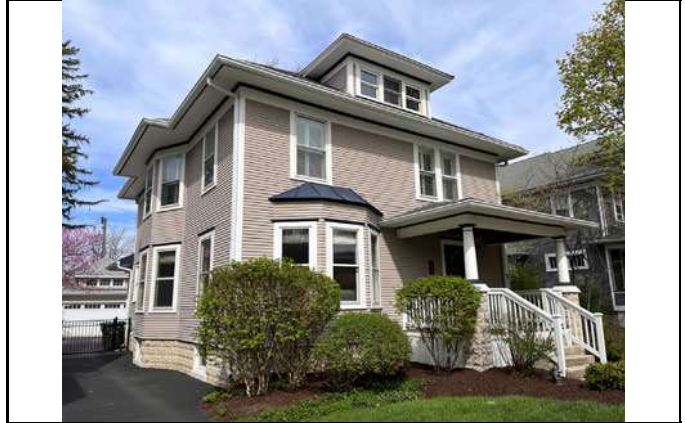
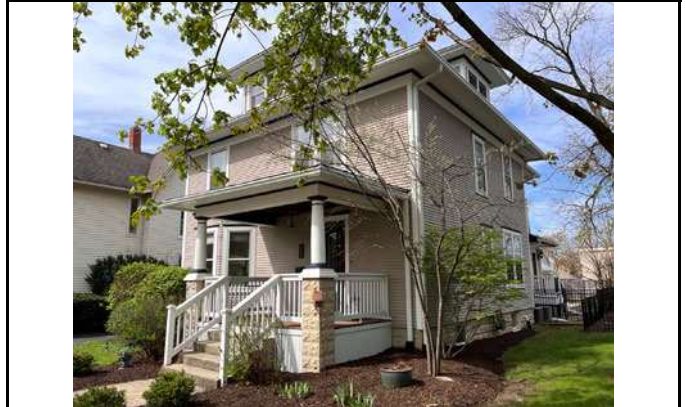
Porch railing replacement (historically compatible)

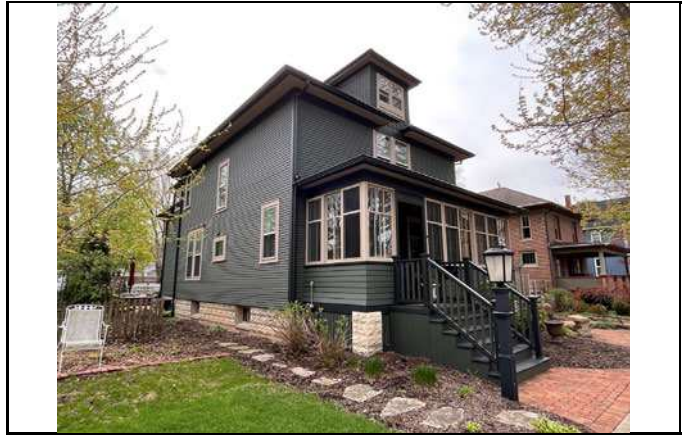
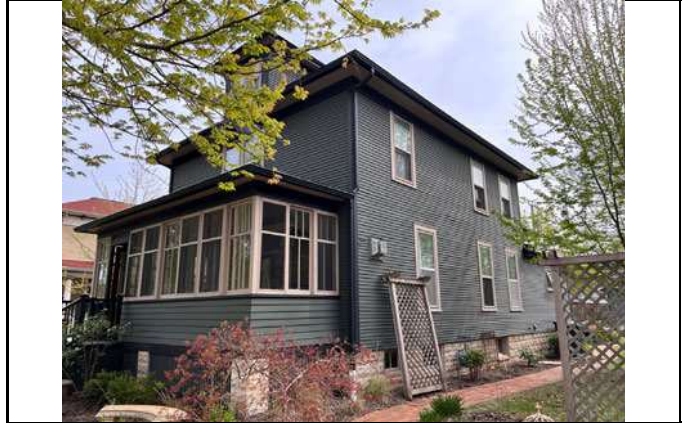
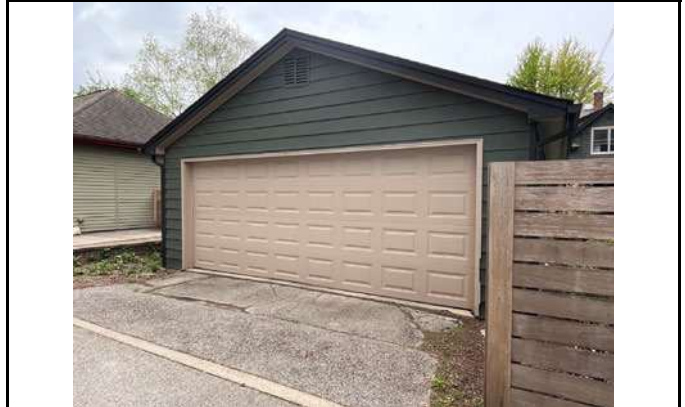
Two windows in front dormer replaced with 1/1 windows in downsized openings.

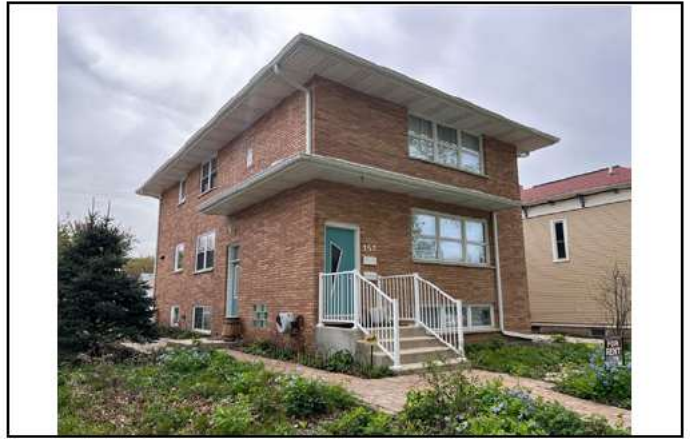
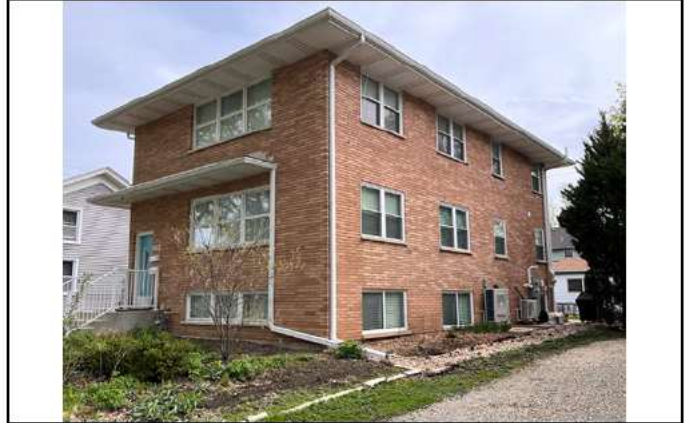
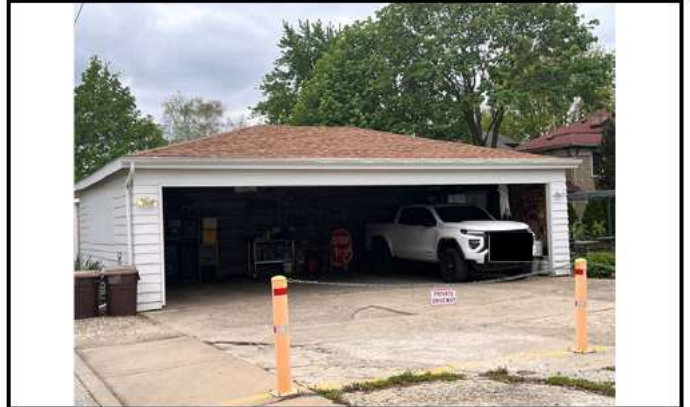
Metal railing at front steps; replacement front door (historically compatible).

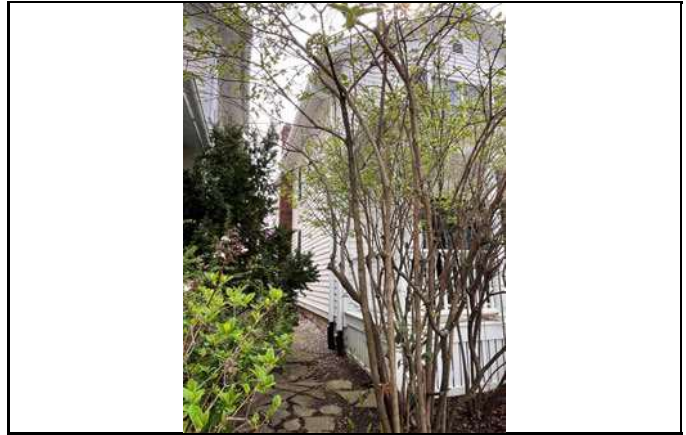
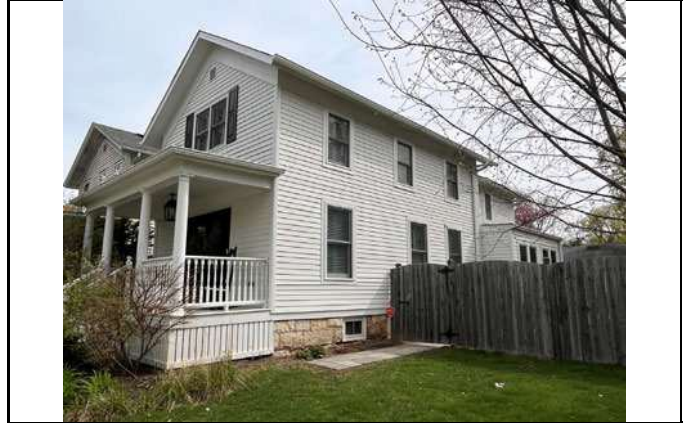
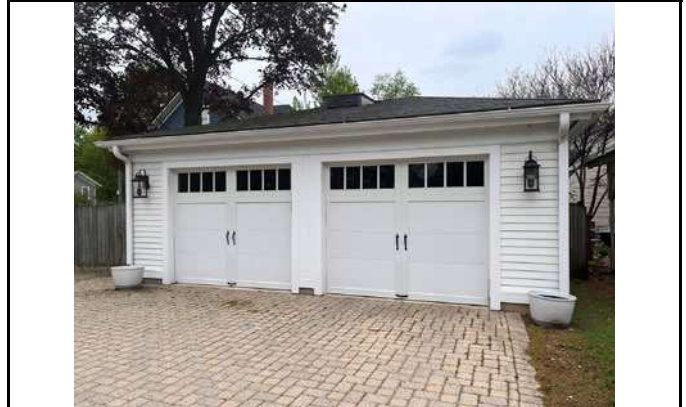
Solid porch knee wall replaced with turned wood railing; front door removed and center window under porch converted to main entrance and fitted with double-leaf door and sidelights; decorative shutters added to 2nd-story window opening on front façade

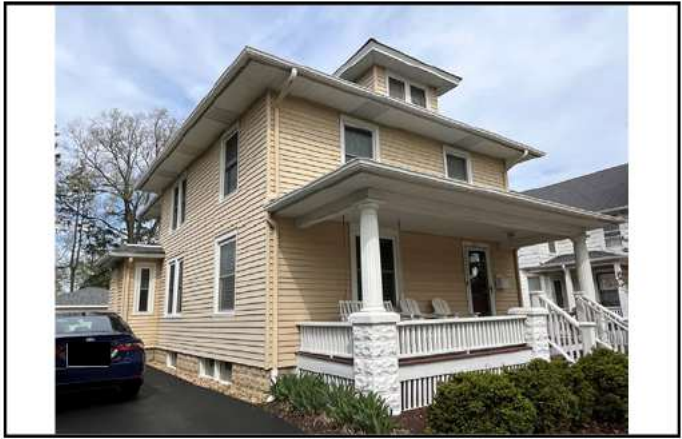
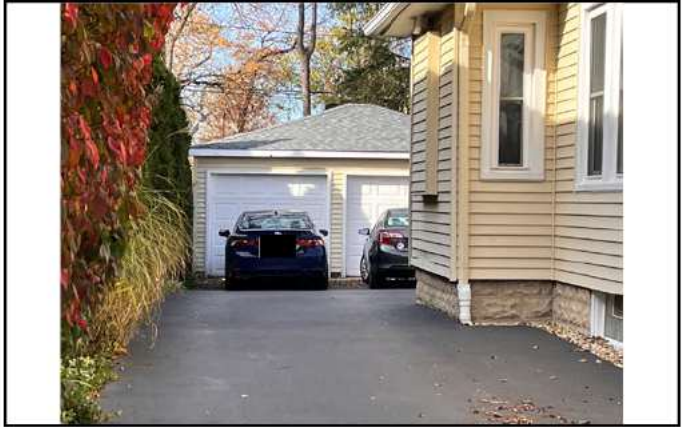
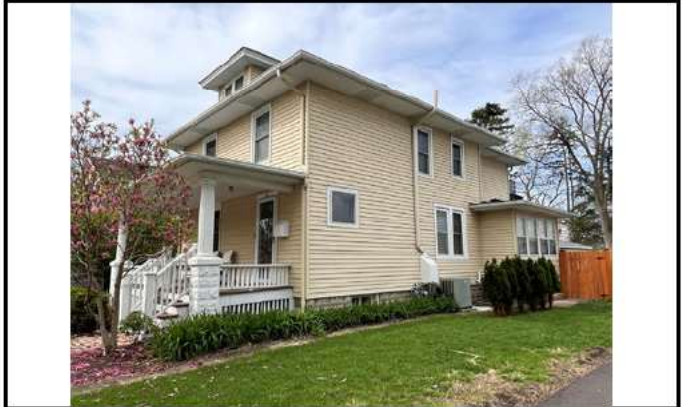
Work Completed Without COA 2nd-story replacement windows in original openings; railing replacement at porch steps

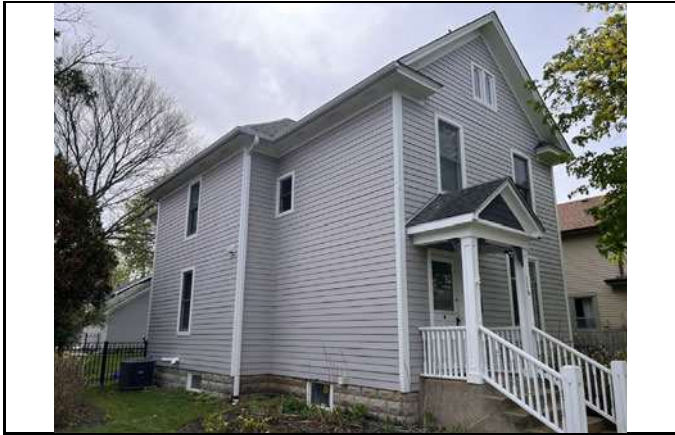
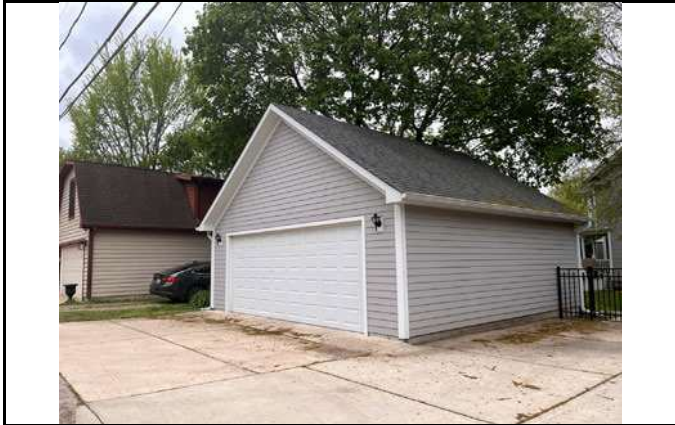
COA Compliance Notes Board width of replacement siding does not match historic wood siding.

Second-story replacement windows and new step railings on front façade
