<b>HISTORIC NAME</b>	Geiger, C. H. House
<b>COMMON NAME</b>	
<b>ARCHITECT</b>	
<b>BUILDER</b>	
<b>ARCHITECT SOURCE</b>	
<b>HISTORIC INFO</b>	Geiger was president of North Central College from 1946-1960. House was featured in Naperville Heritage Housewalk Brochure.
<b>PERMITS</b>	Certificate of Rehabilitation issued January 2007.
<b>LANDSCAPE</b>	Northwest corner of Columbia and Benton; front and south sidewalks; side driveway; similar setbacks; mature trees; rear wood fence
<b>COA DATES</b>	1/4/2017; 5/19/2017
<b>COA DECISION</b>	COA #17-36 - In-kind window and siding replacement (approved 1/5/2017); COA #17-1941 - in-kind replacement of asphalt shingles (approved 5/23/2017)
<b>COA Compliance Notes</b>	COA-approved work does not appear to have been completed.
<b>COA Work Not Completed</b>	
<b>Work Not Requiring COA</b>

<b>PREPARER</b>	Lara Ramsey	<b>SURVEYDATE</b>	11/13/2025
<b>ORGANIZATION</b>	RAMSEY HISTORIC CONSULTANTS	<b>SURVEYAREA</b>	NAPERVILLE SURVEY UPDATE

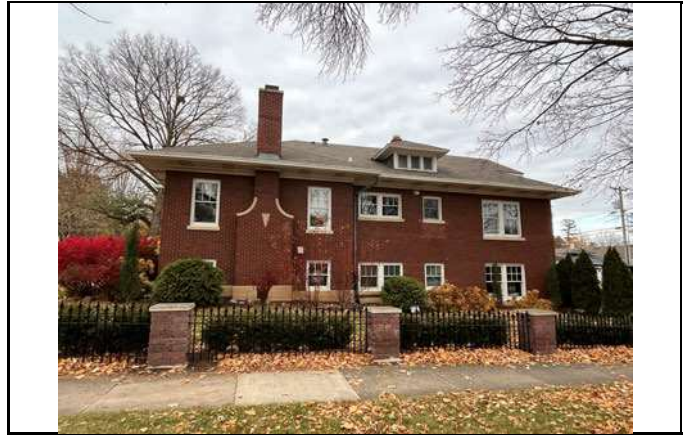
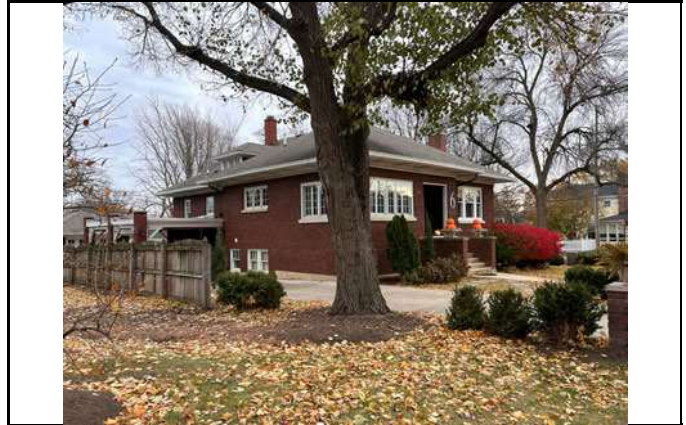
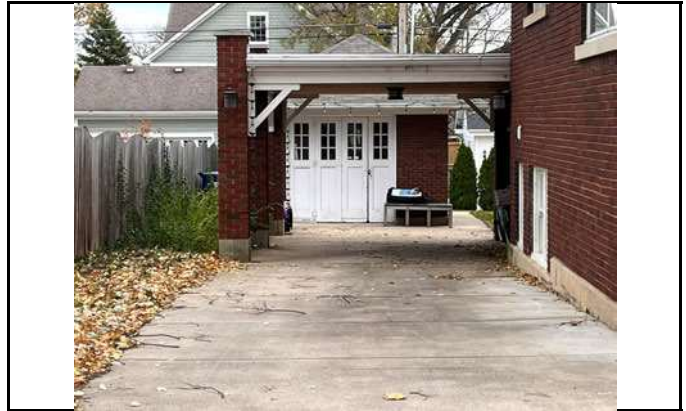
COA Compliance Notes	
COA Work Not Completed	Work approved in COA #22-252 appears to have not been undertaken. Window replacement in south dormer (approved, COA #16-4092) also not undertaken.
Work Not Requiring COA

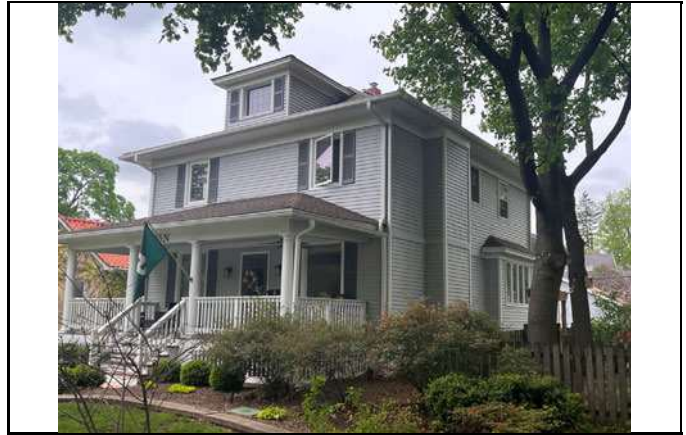
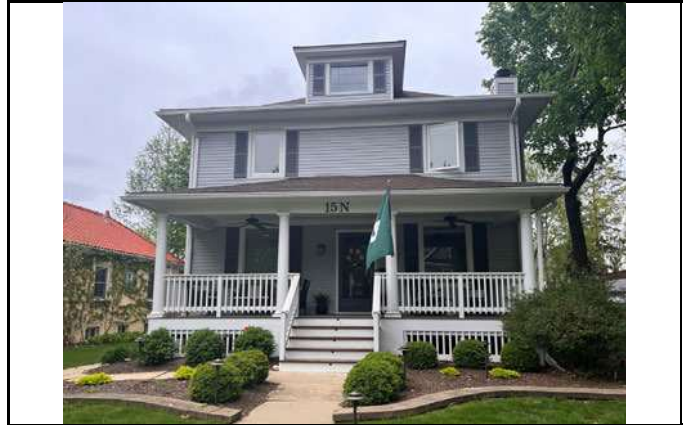
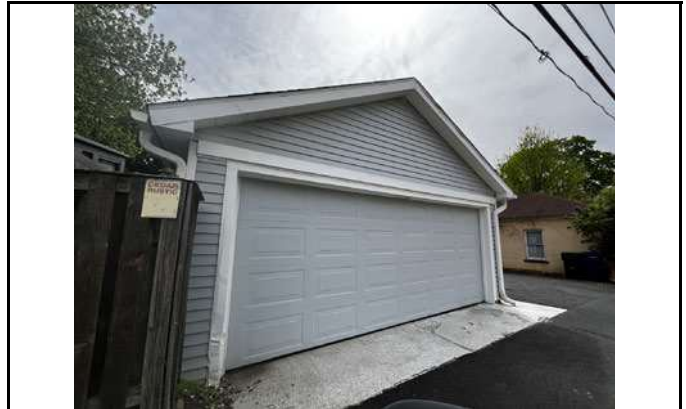
Replacement windows on front façade

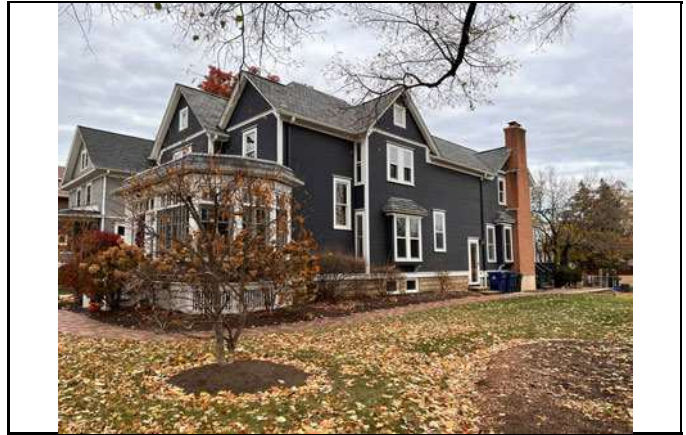
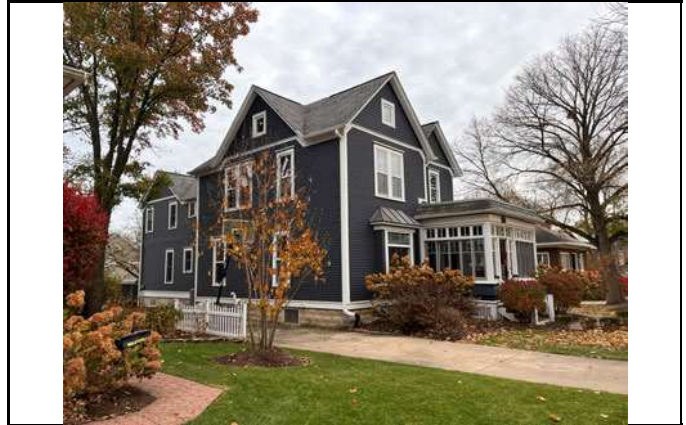
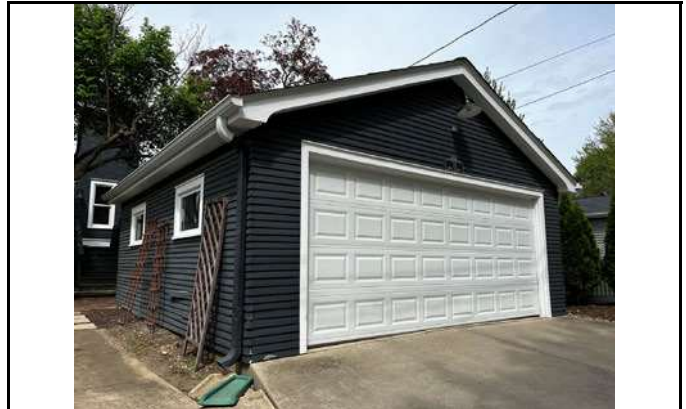
Removal of non-historic awnings from front façade-- may not require COA.

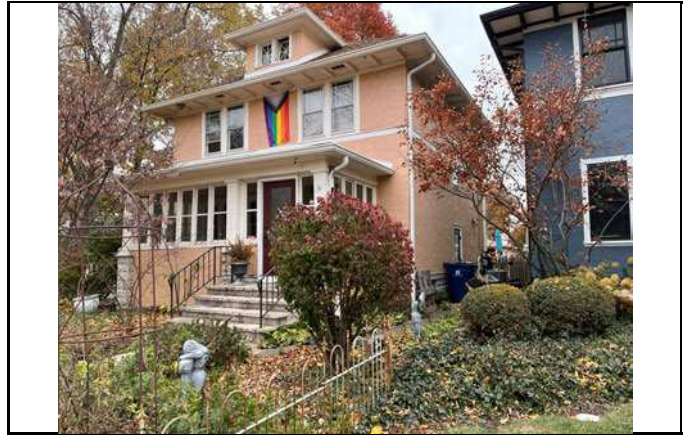
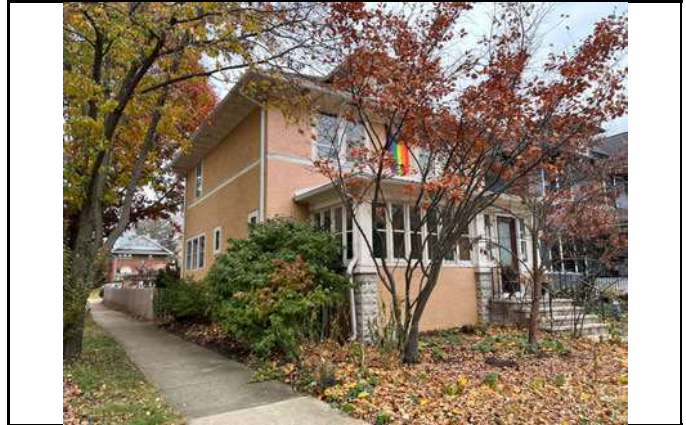
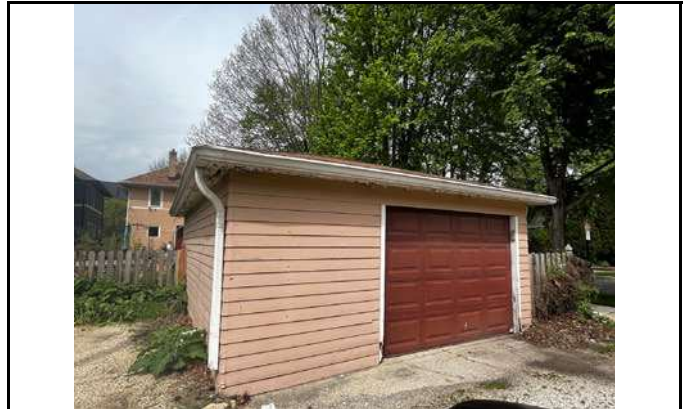
Replacement door to enclosed front porch (may be considered a storm door, which would not require COA)

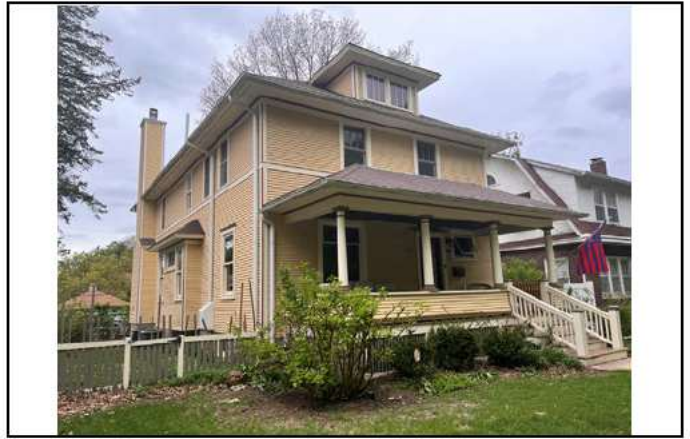
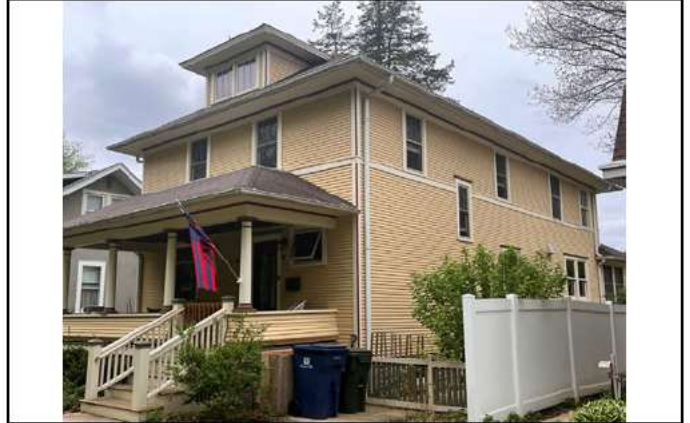
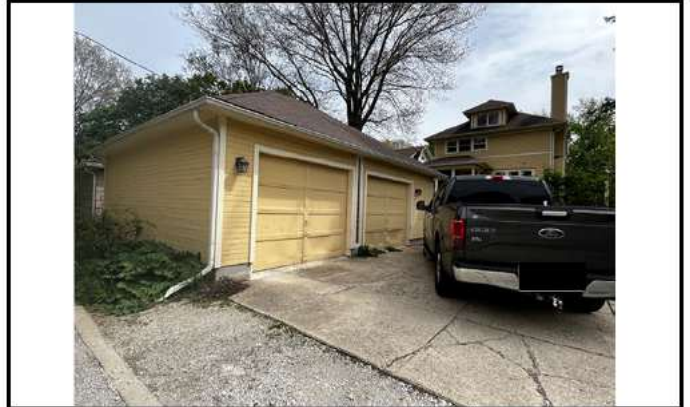
3/1 replacement windows in original openings on front façade (historically compatible type and configuration); wrought iron railings at front steps replaced with painted wood railings

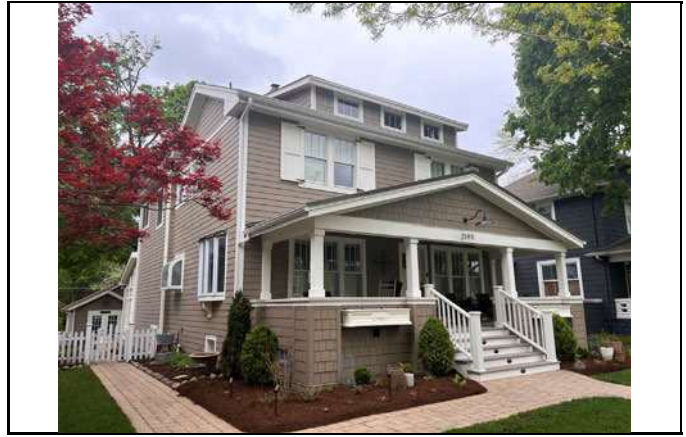
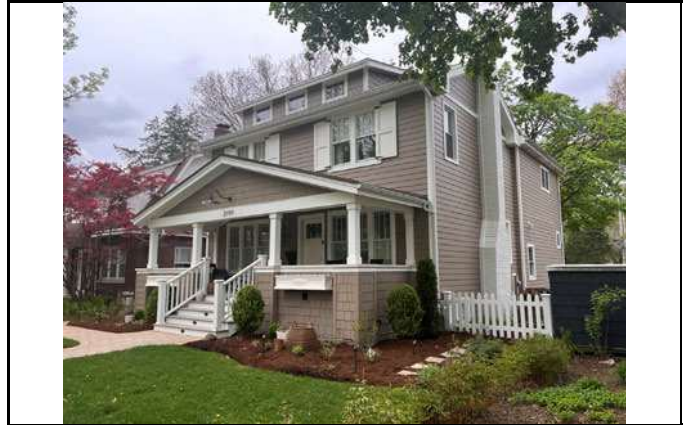
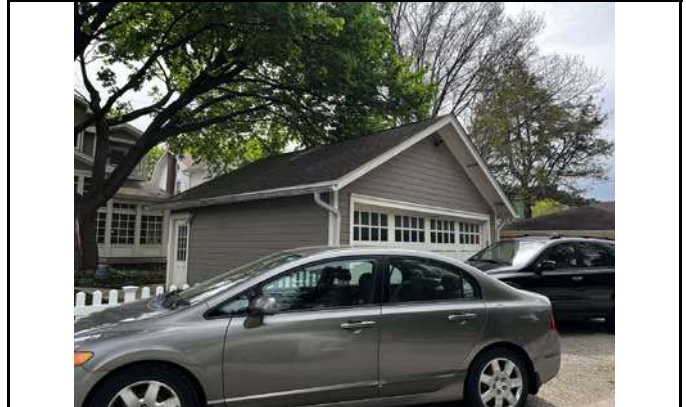
Replacement windows on 2nd story of front façade (historically compatible type and configuration)

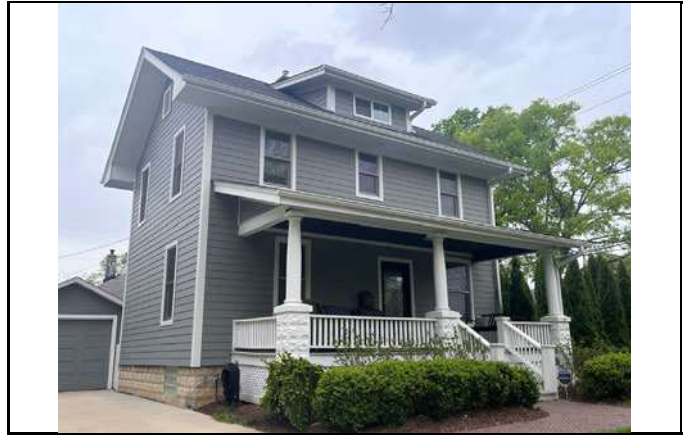
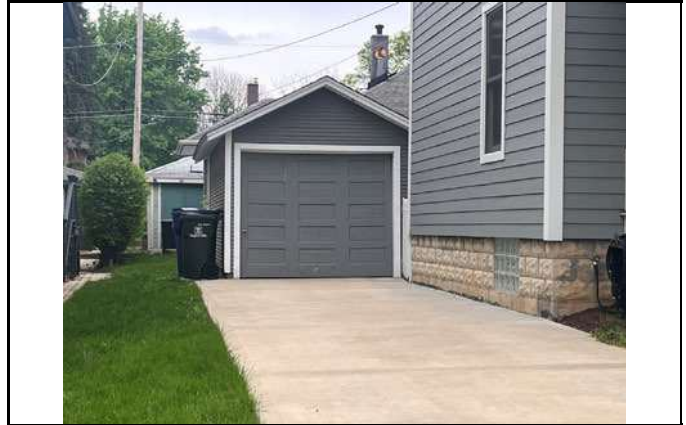
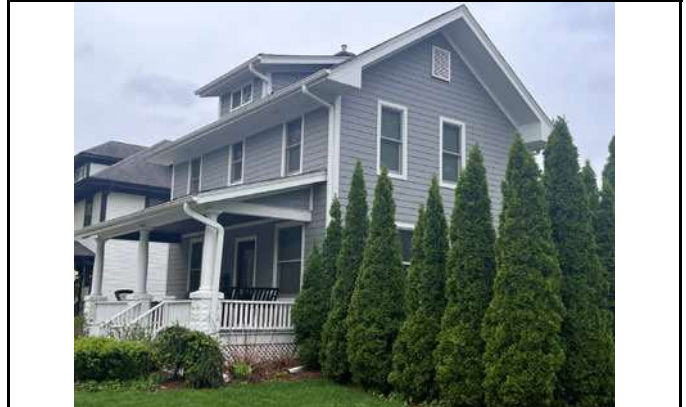
Replacement front door.

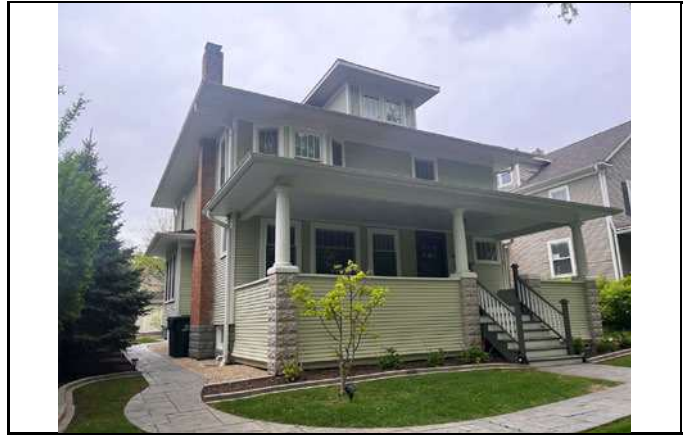
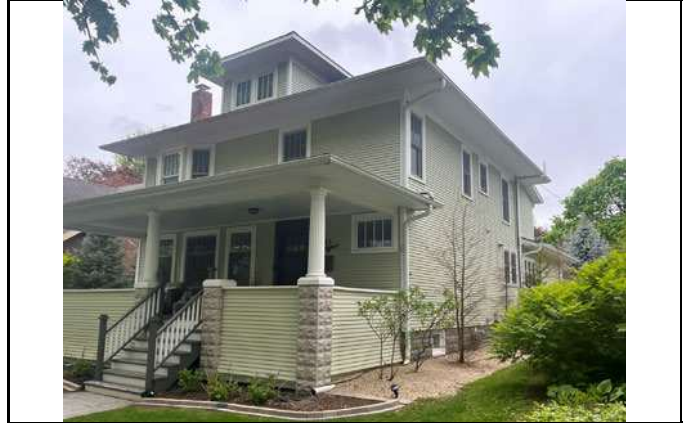
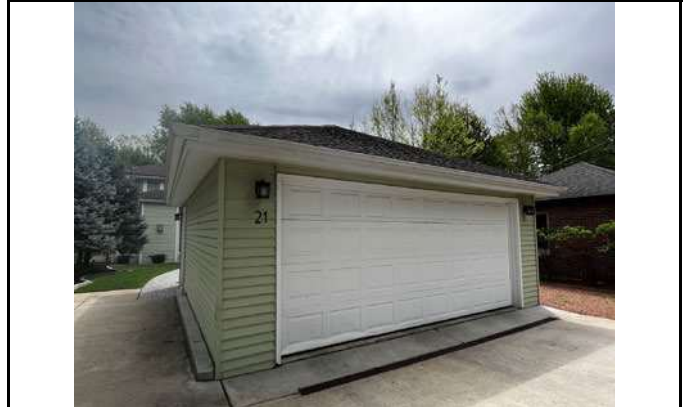
Replacement railings at porch steps.

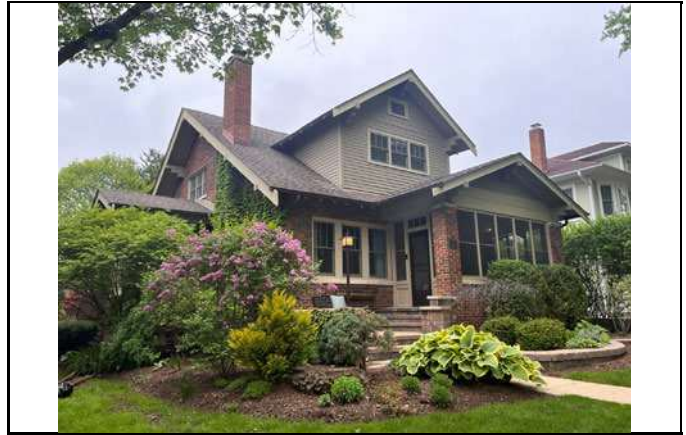
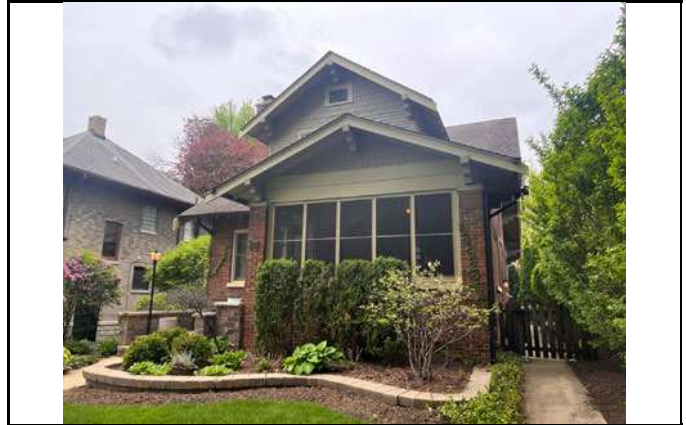
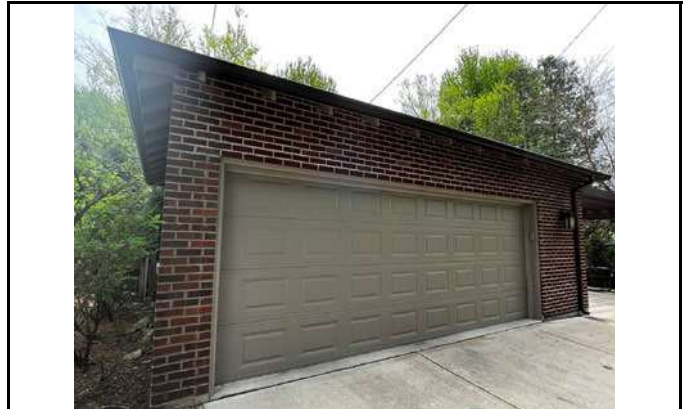
3/1 Aluminum replacement windows on front elevation (do not match original 4/1 configuration, but are historically compatible)

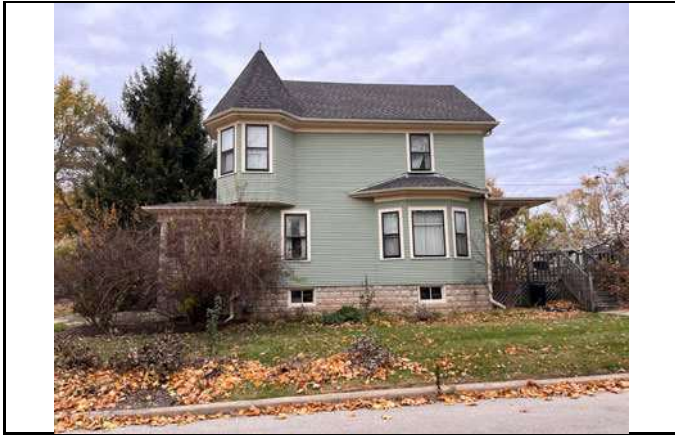
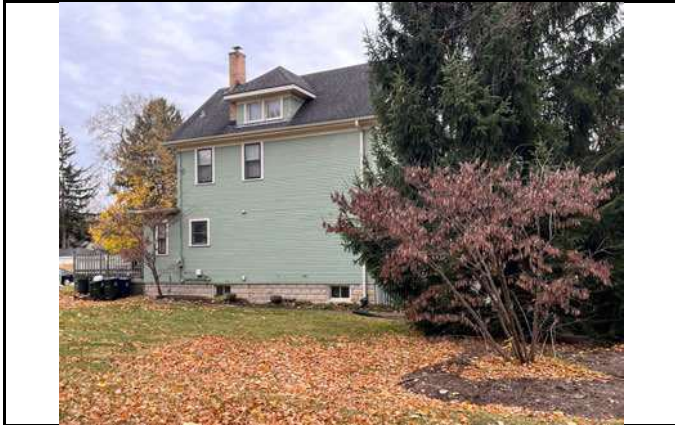
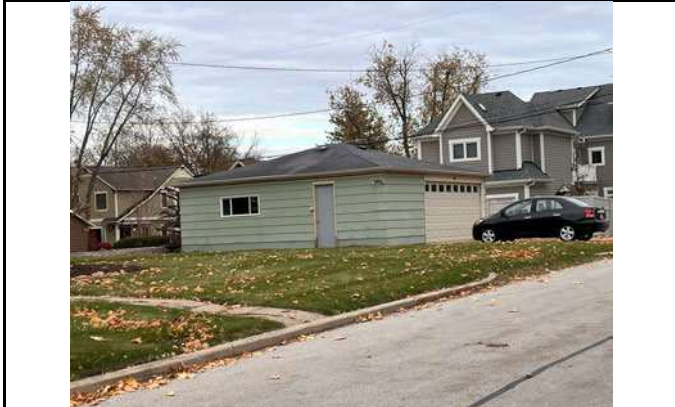
Wood railing replaced with historically compatible new wood railing at front porch.

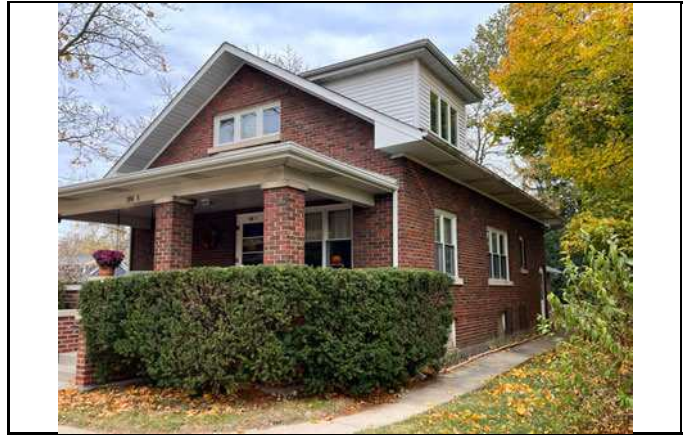
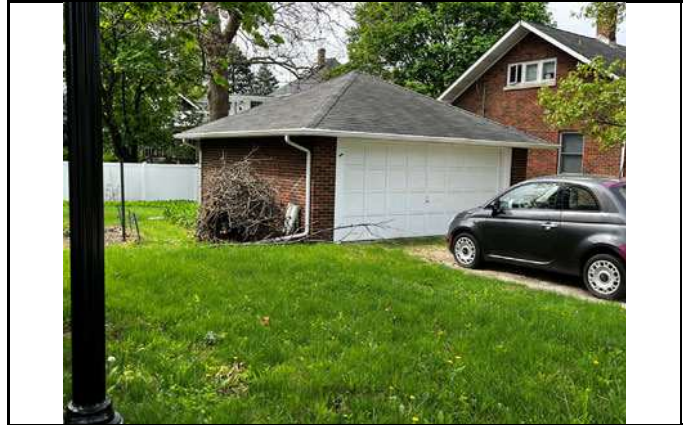
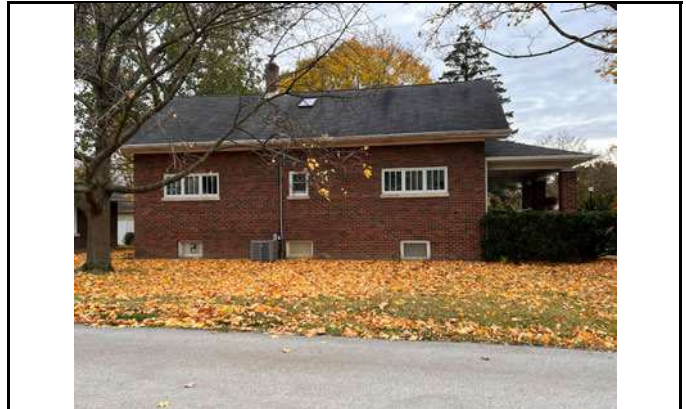
Aluminum replacement windows at east and west ends of north elevation (facing Van Buren Avenue)
