NAPERVILLE SURVEY UPDATE

City of NAPERVILLE

ILLINOIS URBAN ARCHITECTURAL AND HISTORICAL SURVEY CONTINUATION SHEET

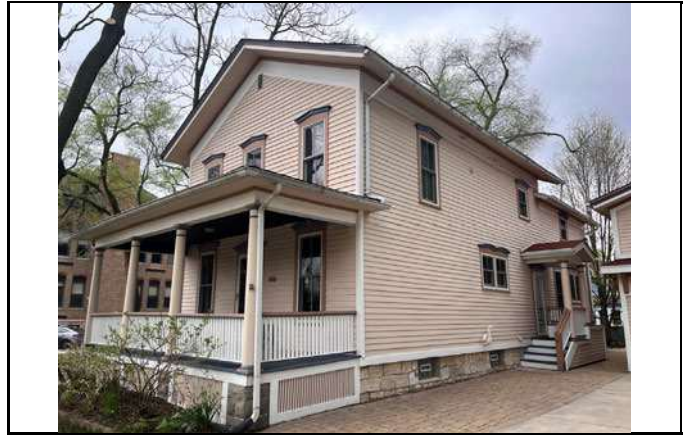
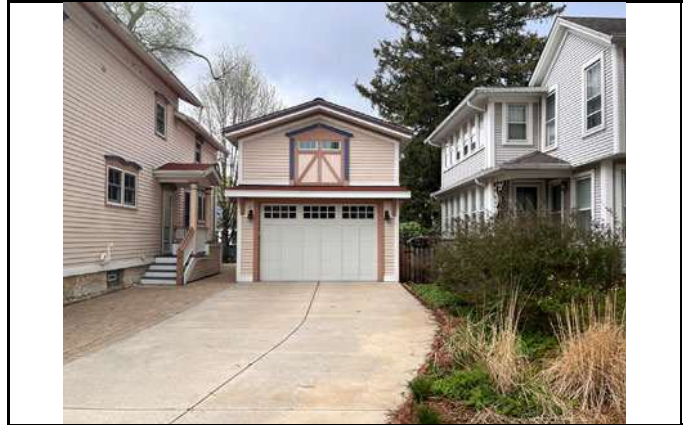
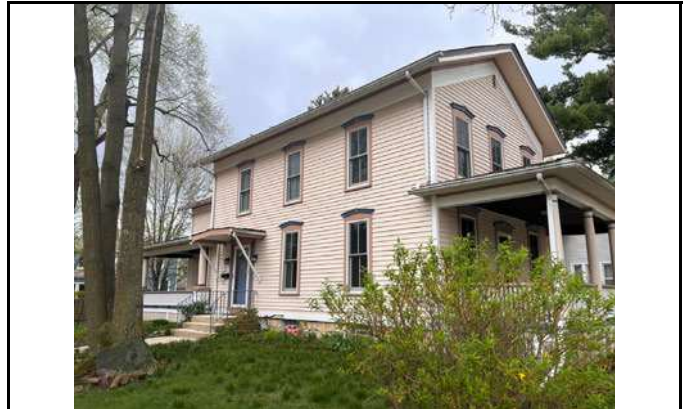
2/2 double-hung replacement windows on front (east) façade and south elevation (facing Franklin Avenue) -- historically compatible type and configuration

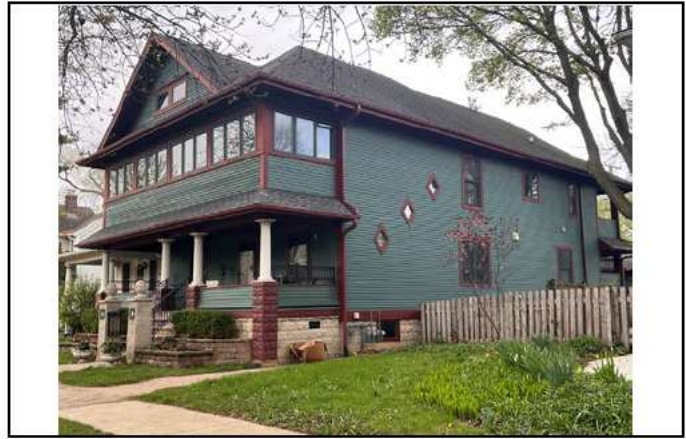
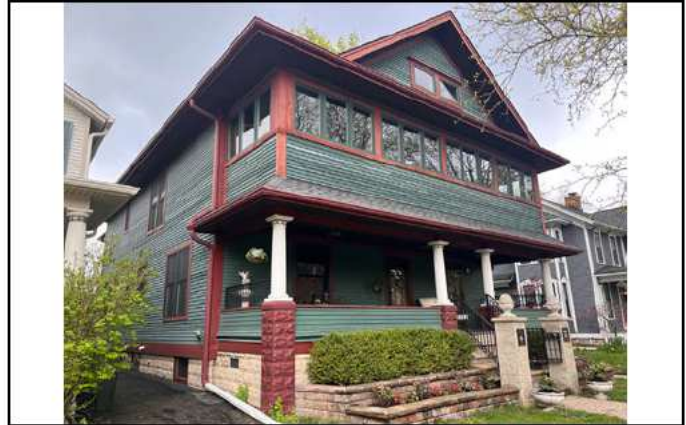
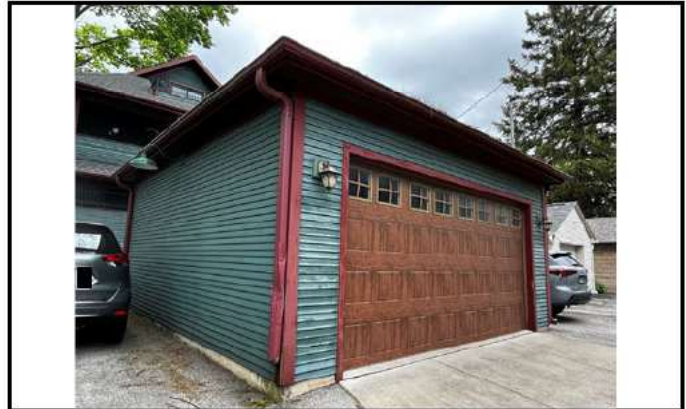
Replacement windows on front façade; north end enclosure of front porch evident in 2007 survey removed; cast-stone steps to front porch; wrought iron railings added above north and south knee walls at front porch.

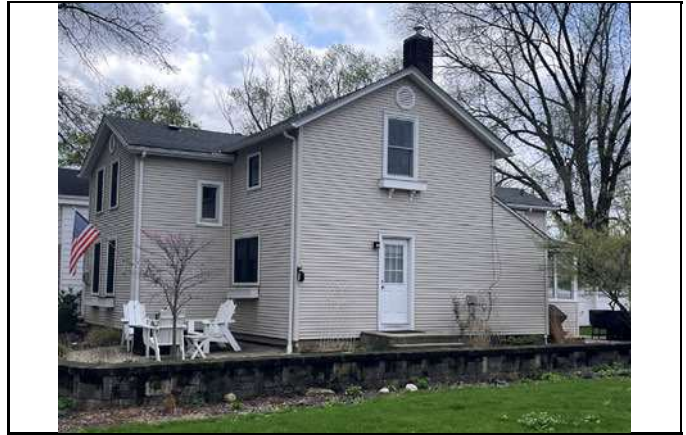
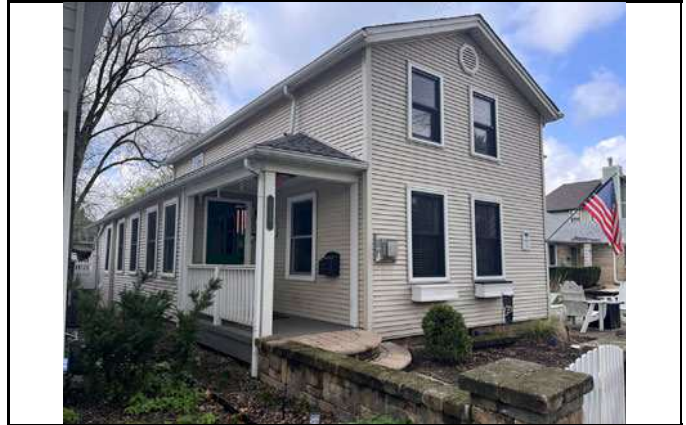
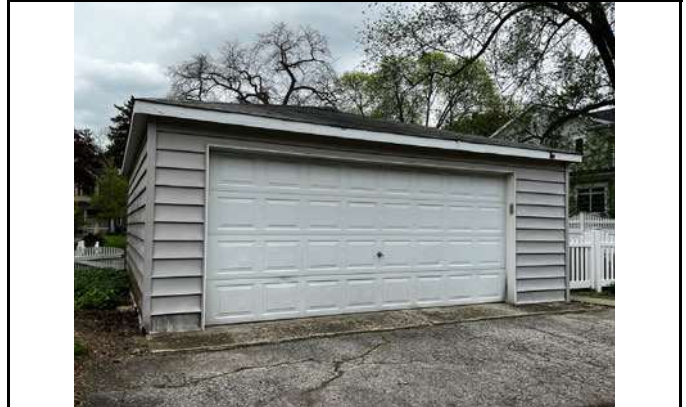
Replacement windows on front façade.

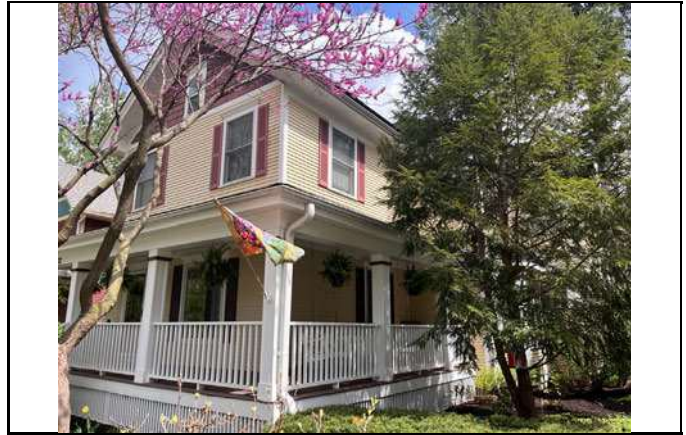
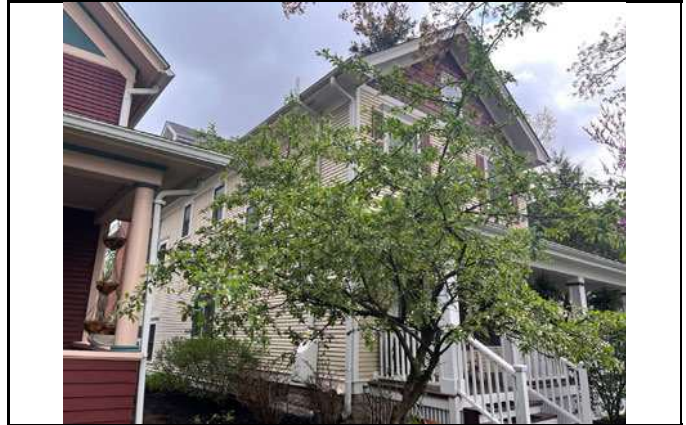
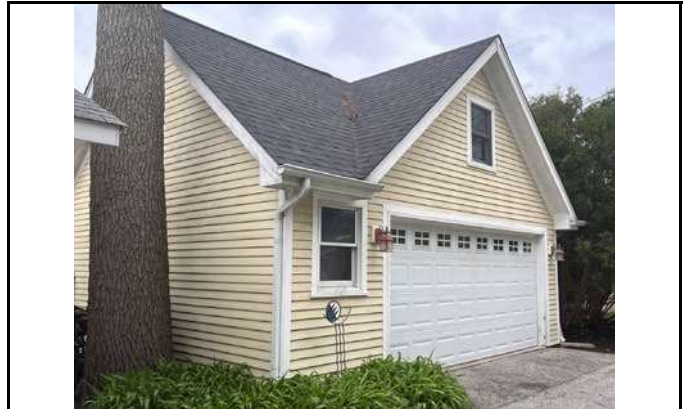
Solar panels on roof--may have been present in 2007 and not noted on survey. 2007 survey photographs do not show slope of roof where panels are located.

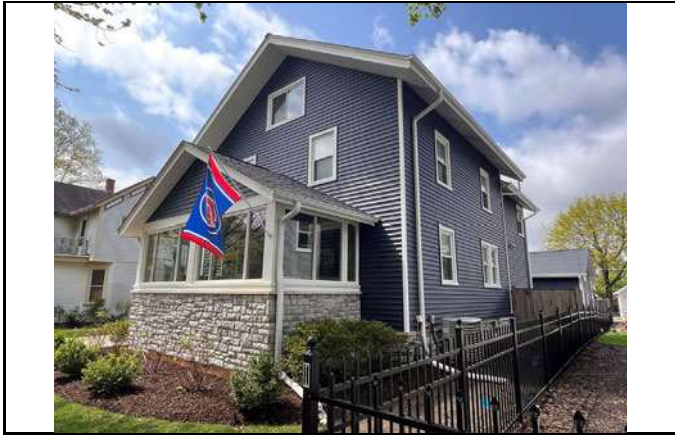
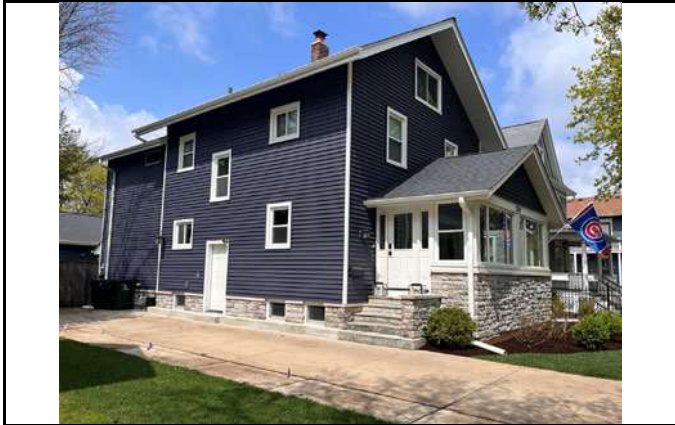
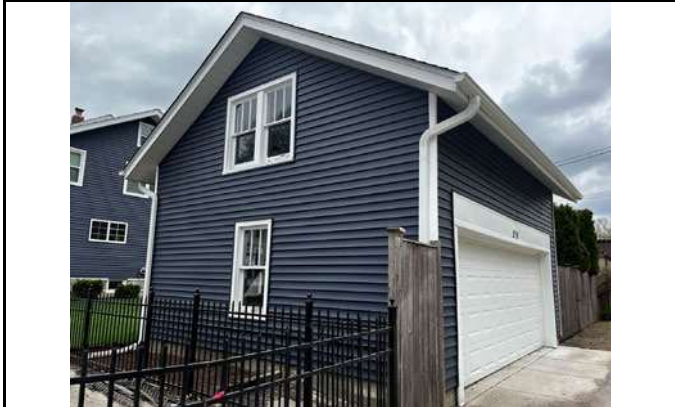
Replacement windows on front façade

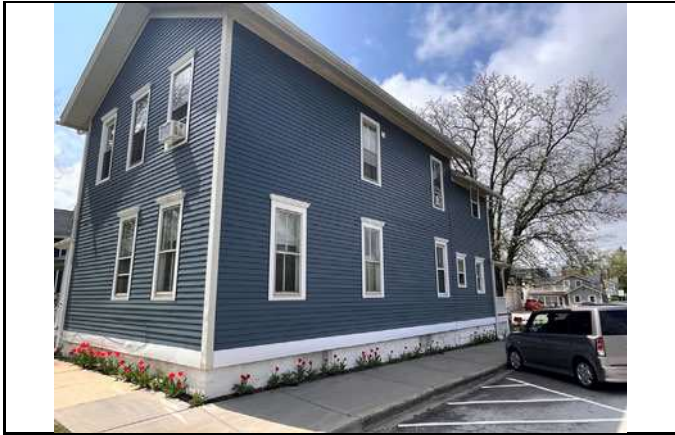
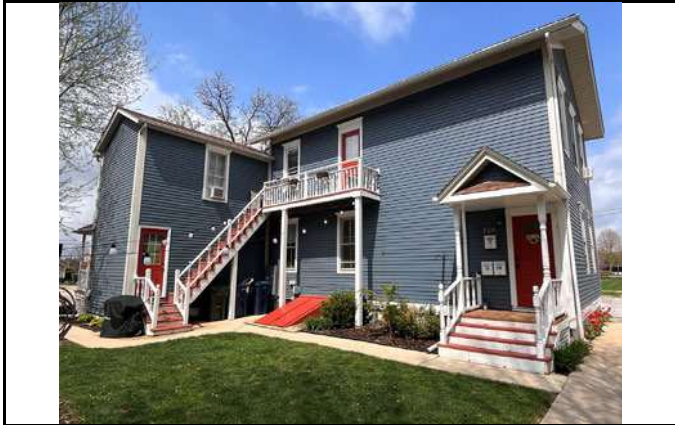
Work Completed Without COA 1/1 replacement windows in select openings on front façade and at west end of north elevation (facing North Avenue) at first story

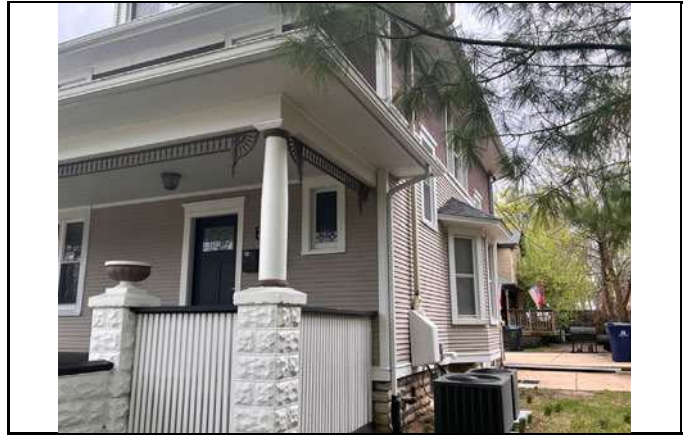
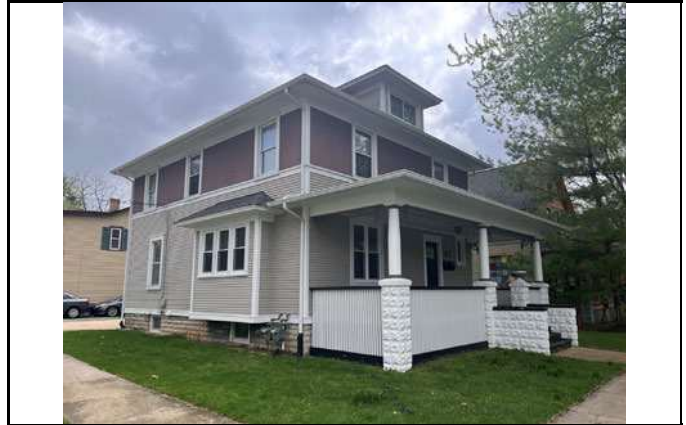
Single window at north end of front façade under porch replaced with paired Aluminum 1/1 double-hung windows.

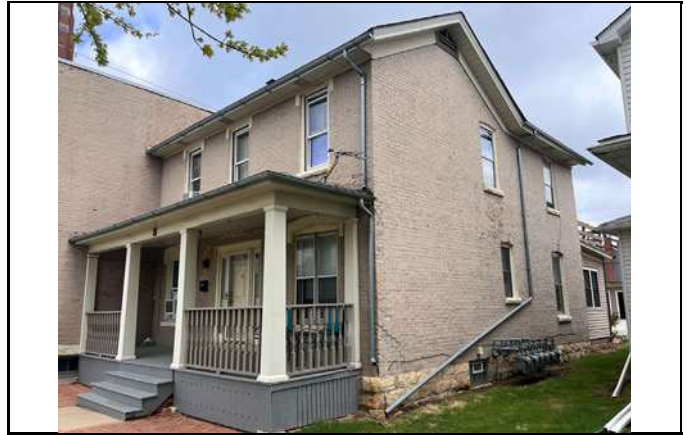
Work Completed Without COA	Paired window at north end of façade under front porch replaced with single 1/1 double-hung window.
-----------------------------------	---

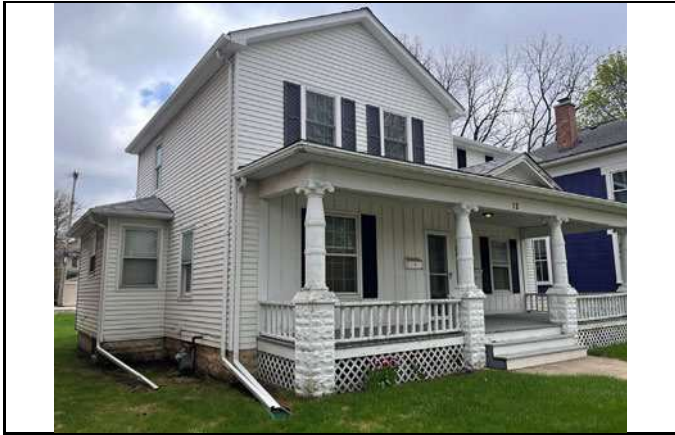
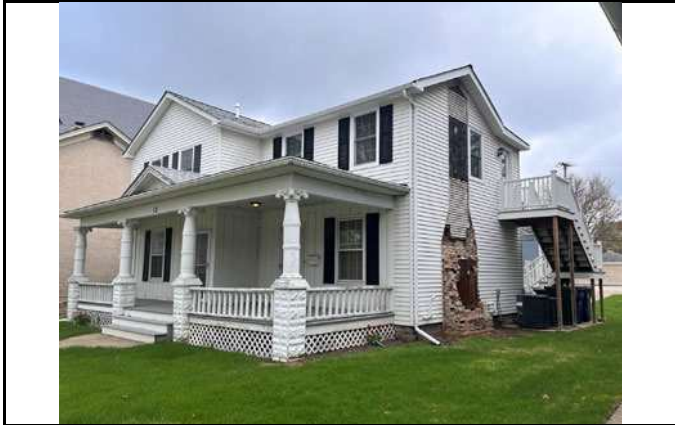
Aluminum/vinyl replacement windows on 2nd story of front façade

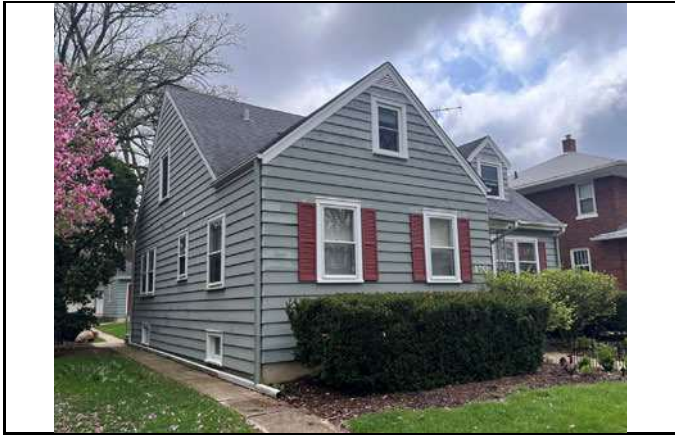
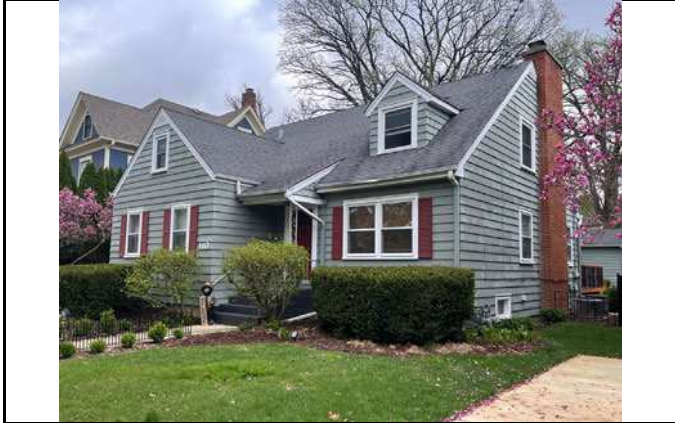
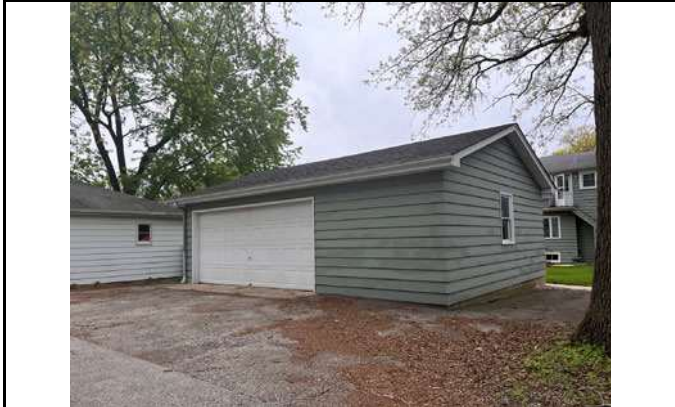
1/1 replacement windows on attic level and in front dormer.
