PREPARER	Lara Ramsey	SURVEYDATE	11/21/2025
ORGANIZATION	RAMSEY HISTORIC CONSULTANTS	SURVEYAREA	NAPERVILLE SURVEY UPDATE

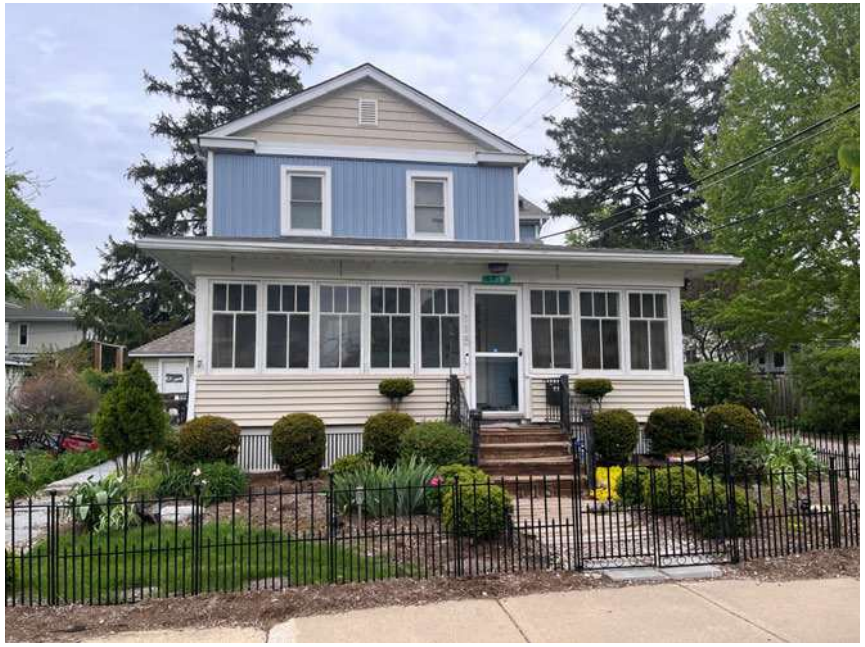
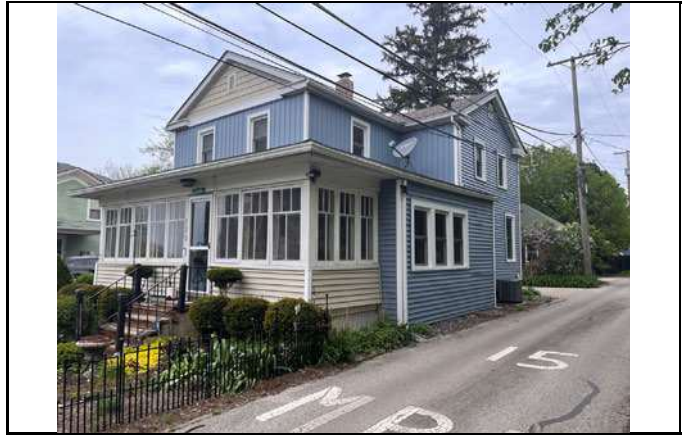
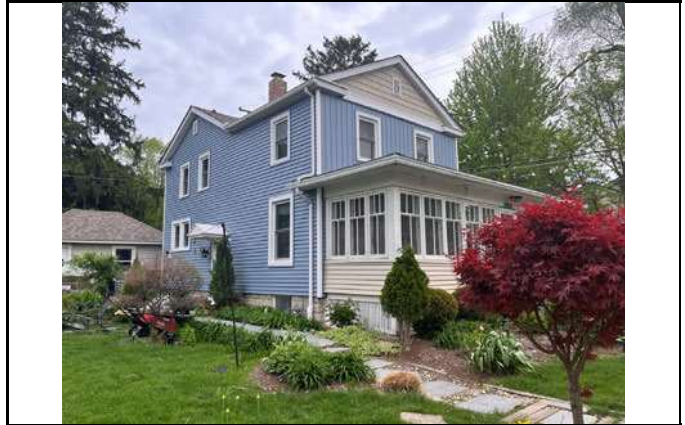
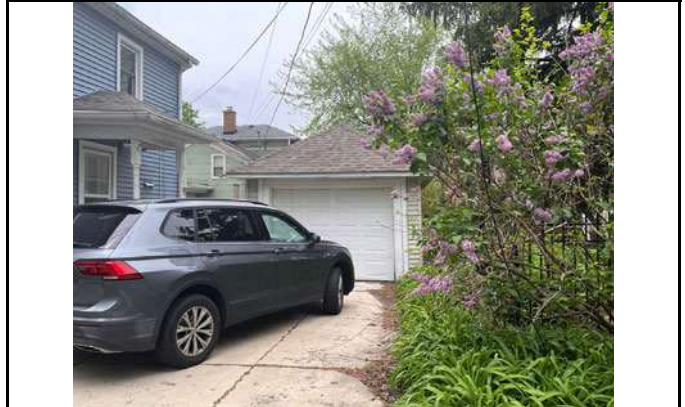
HISTORIC INFO According to owner of Bungalow on Center Street, this house was moved from the site of his house to Franklin when his house was built in the 1920s.

Work Not Requiring COA Replacement siding and windows on east and west secondary elevations.

Vertical replacement siding and replacement windows in original openings on front façade

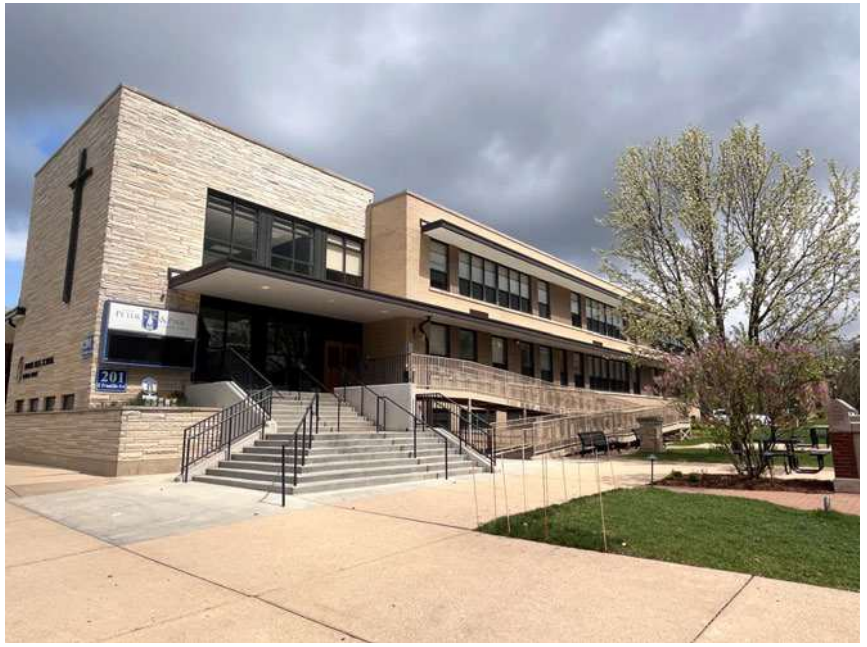
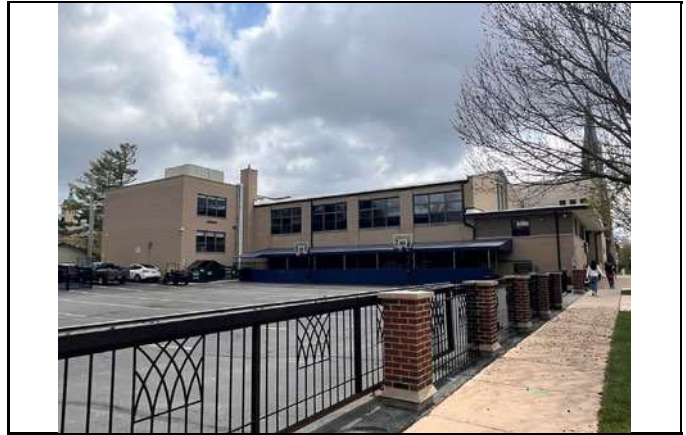
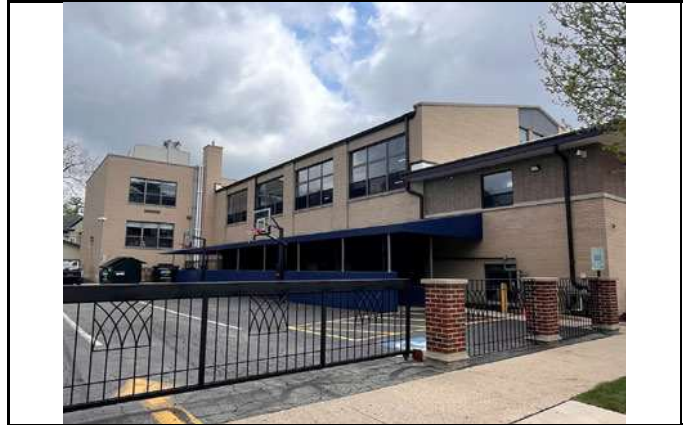
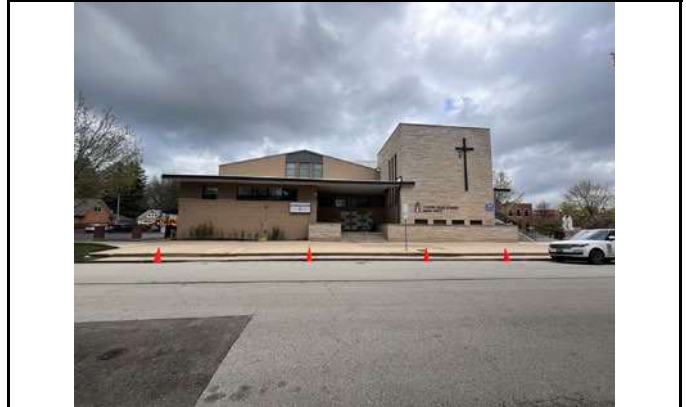
SIGNIFICANT FEATURES Multiple grouped volumes and a variety of exterior materials; prominent southwest corner volume with flat roof and Lannon stone exterior, with metal cross on west elevation and main entrance at south elevation; slightly projecting longer volume extends east from entrance, with ribbon windows along south elevation; cantilevered canopies over main entrance ribbon windows on south elevation; one and two-story volumes at north end of building -- west one-story volume facing Ellsworth contain second entrance deeply recessed under flat roof; 2-story volume features shallow gable roof.

ALTERATIONS Multi-light steel windows on south elevation east of main entrance replaced with 1/1 double-hung Aluminum windows; Post-2007 -- wheelchair ramp along south elevation. New steps at southwest entrance; windows and doors at main entrance replaced with new Aluminum windows that match the original configuration

HISTORIC NAME	Saints Peter and Paul School
COMMON NAME	
ARCHITECT	
BUILDER	
ARCHITECT SOURCE	
HISTORIC INFO	Historic photograph of school is on page 34 of 150 YEARS OF SHARING THE WORD: SS. PETER AND PAUL PARISH.
PERMITS	
LANDSCAPE	Midblock on east side of residential street; front and south sidewalks; south lawn for parish building; parking lot to north
COA DATES	
COA DECISION	
COA Compliance Notes	
COA Work Not Completed	
Work Not Requiring COA	Wheelchair ramp along south elevation, alterations to main entrance at south elevation -- new steps and knee walls, aluminum windows and doors in main entrance opening

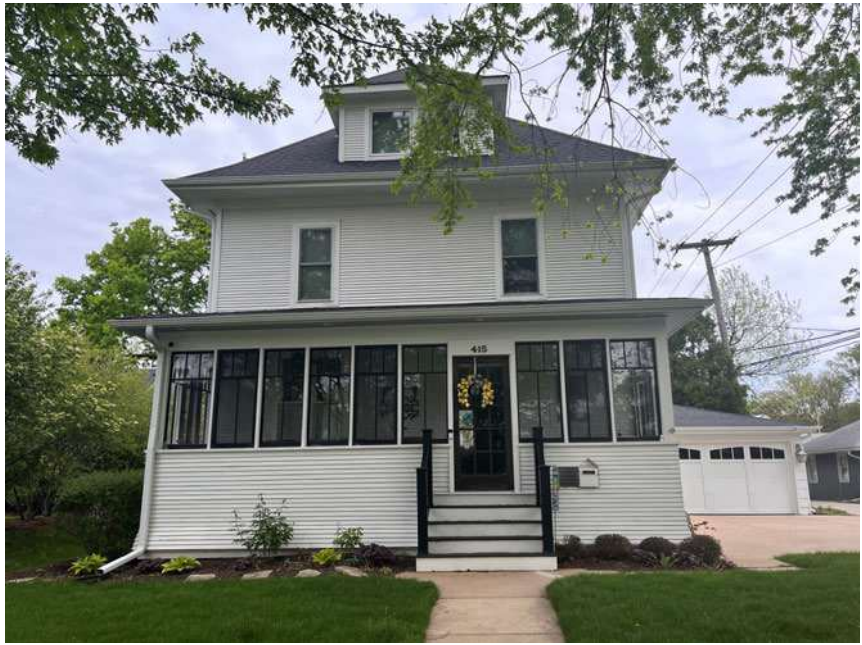
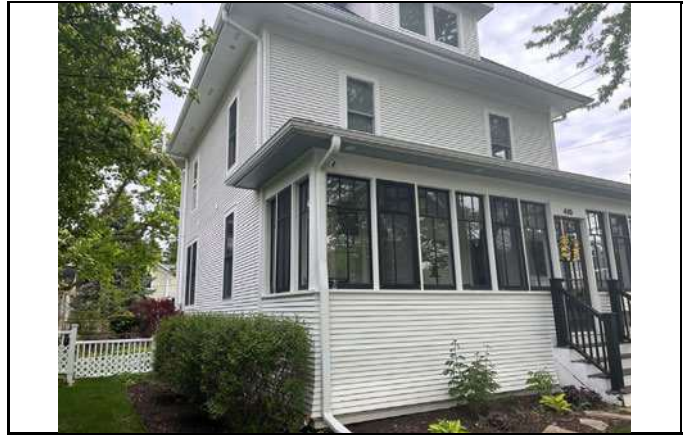
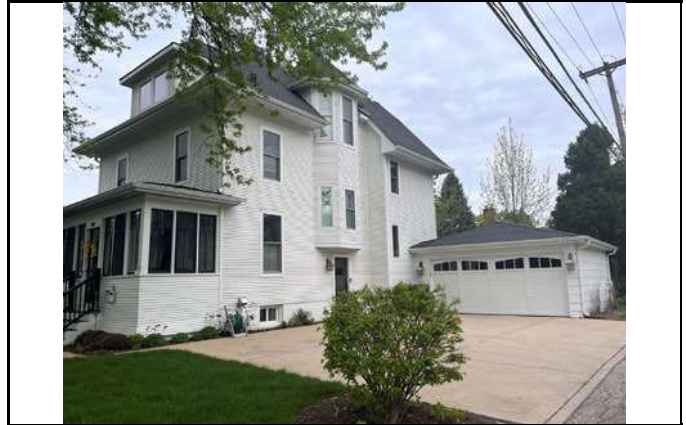
SIGNIFICANT FEATURES Rectangular massing and wood exterior siding; full-width front porch with shallow hipped roof; historic 1/1 wood windows on front elevation above porch and at first and second stories of west elevation at original structure; some historic windows also remain on east elevation; 5-light windows at porch enclosure

ALTERATIONS Replacement front door and steps (not historic); one-story rear addition/connector addition to rear garage (not historic). Post-2007 -- roof rebuilt with steeper pitch and taller front and side dormers; one story east addition at garage; 2nd-story addition over existing northeast addition between house and garage; oriel bay on east elevation extended up to create a two-story bay that pierces the roofline; some 1/1 Aluminum replacement windows in original and altered openings; replacement porch door and replacement door in ground-level east entrance; rear deck.

HISTORIC NAME	
COMMON NAME	
ARCHITECT	
BUILDER	
ARCHITECT SOURCE	
HISTORIC INFO	
PERMITS	
LANDSCAPE	Midblock on north side of residential street; front sidewalk; east side alley; park to west; similar setbacks; mature trees
COA DATES	9/24/2015
COA DECISION	COA #15-1228 - Rebuild and change the pitch of the roof, rebuild the existing dormers, create new window openings on the north, south, and west elevations, replace several existing windows and doors, construct a 2 story addition, and a second story addition (approved by HPC 9/24/2015)
COA Compliance Notes	
COA Work Not Completed	
Work Not Requiring COA

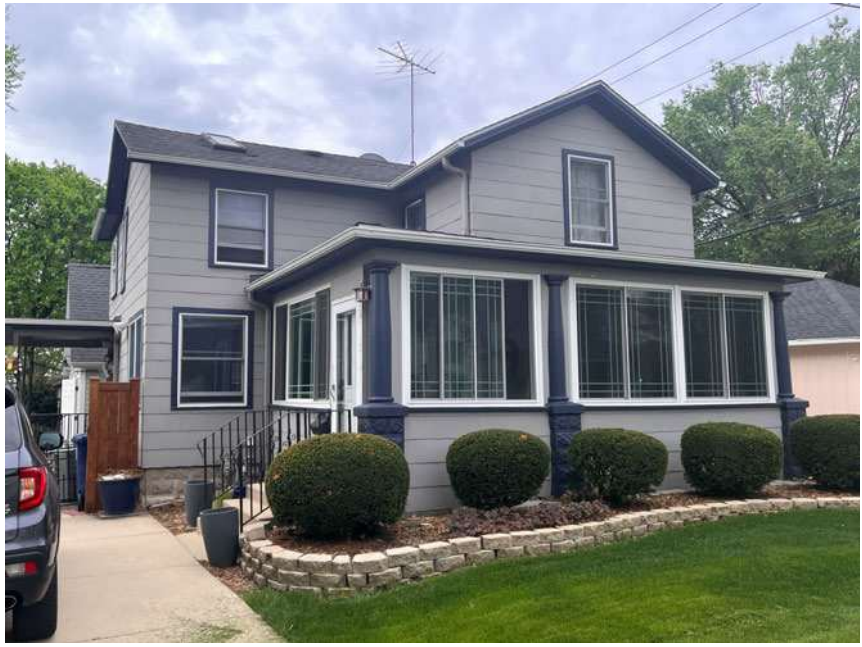
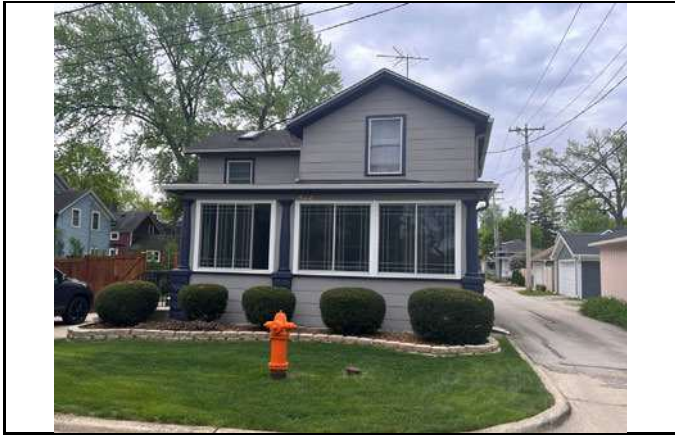
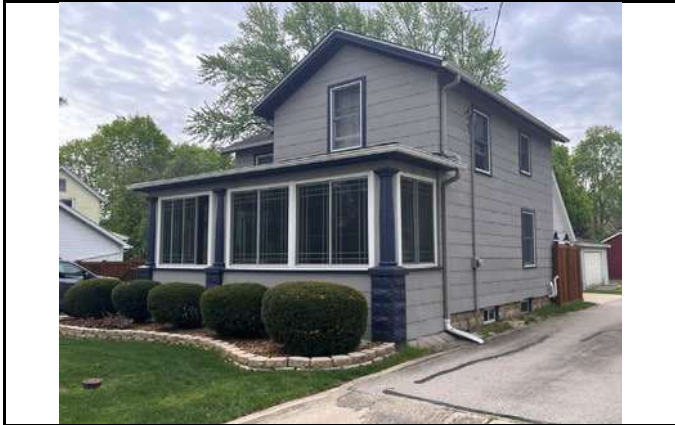
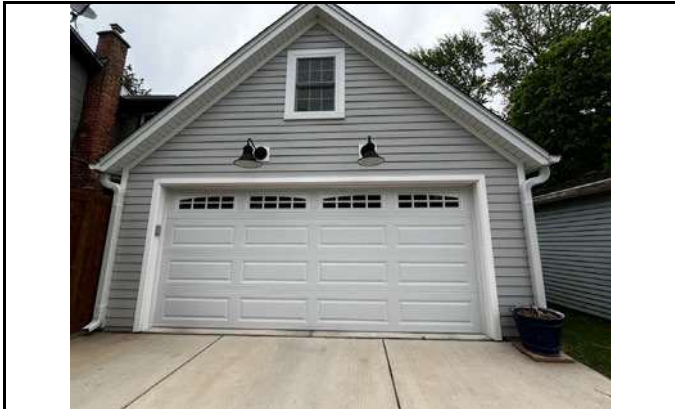
SIGNIFICANT FEATURES Front gable west bay with lower side gable wing -- wing was originally one story and set back from the front façade, but was extended sometime between 1909 and 1921; front porch with hipped roof and classical columns set on concrete block piers (c. 1915, later enclosed).

ALTERATIONS Replacement siding (1950s); front porch extended (c. 1915); 1/1 aluminum or vinyl replacement windows throughout, and in altered opening on wing; 2 story rear addition (post-1954); east side entry porch (post-1954); skylights. Post-2007 -- paired nine-light wood casement windows in porch replaced with aluminum/vinyl multi-light fixed windows; repainted.

HISTORIC INFO Sanborn maps indicate that the two-story east wing is part of an expanded one-story wing that was originally set back along the east elevation of the 2-story west bay. The expansion of the wing and the front porch that bridging the bay and wing were constructed sometime between 1909 and 1921.

Work Not Requiring COA New detached garage; Paired nine-light wood casement storm windows in porch replaced with aluminum/vinyl multi-light fixed windows.

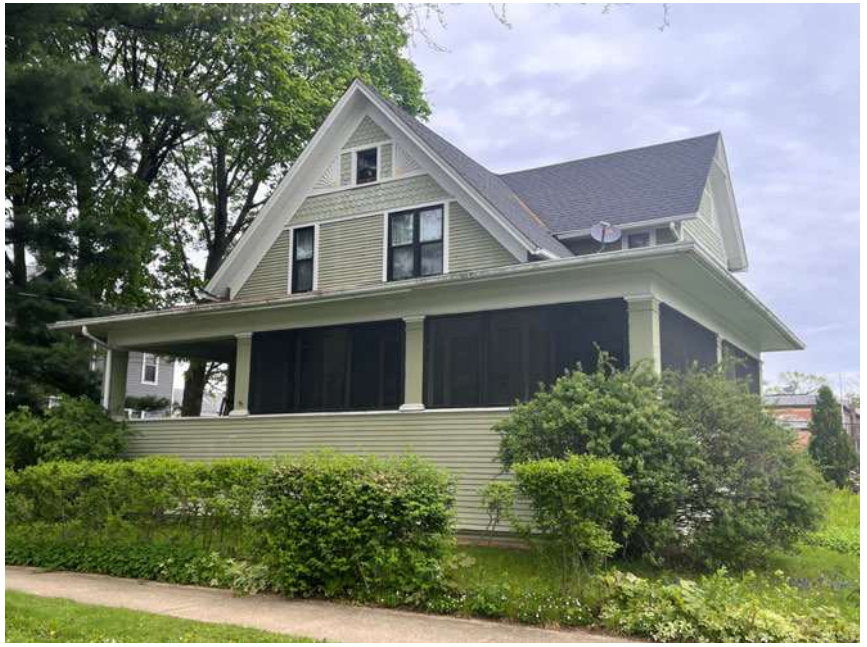
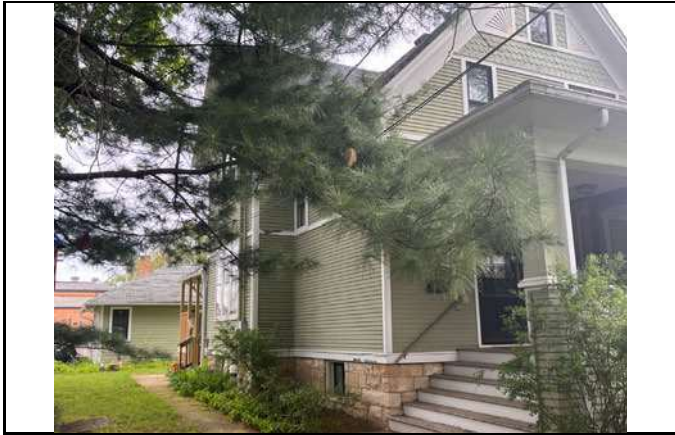
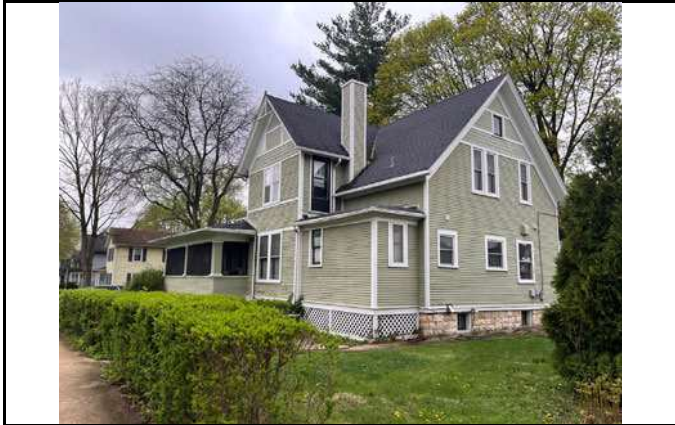
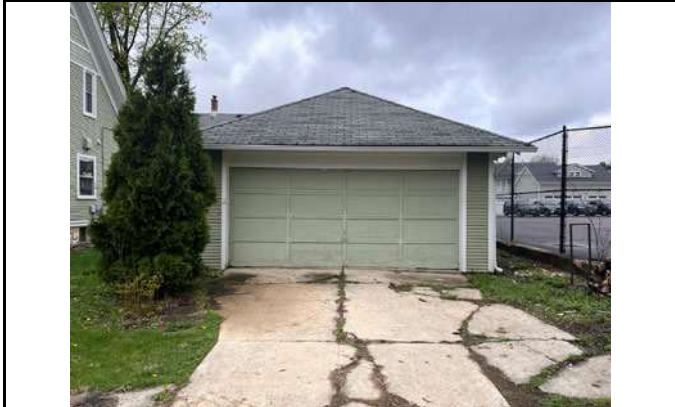
HISTORIC INFO In the 1920s, the house was owned by the Broeker family, who operated a department store on Jefferson Avenue; it was later owned by Henry W. Neyra, who owned Western Frame & Molding. 1909 Sanborn map shows house with full-width front porch. Maps indicate that the porch was extended to the east elevation sometime between 1909 and 1921.

Work Not Requiring COA Replacement elements of entrance porch at north (rear) end of secondary west elevation.
