November 15, 2019

RE: ERA - Moser Tower
Special Structural Analysis of Moser Tower
RRJ 19072

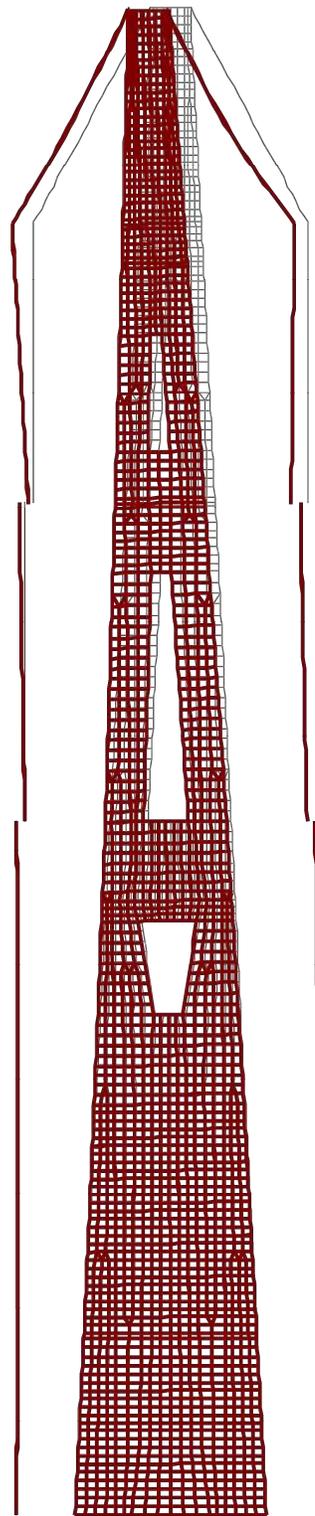
The model results were discussed with DSI staff and revealed no surprises. Low stresses and small top deflection were all well within normal allowable stresses and displacements suggested by industry standards and the building code (Figures 3, 4, and 5). The computed results were as follows:

Top deflection under code prescribed load combination of DL + 0.7WL is 0.43 inch.

Allowable deflection recommendations from ASCE 7-93 is L/600 or 3 inches for the top of the tower.

The significance of these findings is that none of the stress levels are large enough to influence the cracking or spalling observed individually or in combination, indicating that the deterioration at the stressing grout pockets is due to the gypsum contaminated grout and was not affected by any of the stresses due to wind, dead loadings, or post-tensioning forces. Figure 6 provides an isometric view of the grout pocket and post-tensioning, showing the general arrangement and the spall plane. So, once we are certain that the grout does not contain any expansive agents, the repair, if properly designed for anchorage and movement at the joint at Level 116.7, should be expected to provide adequate longevity.

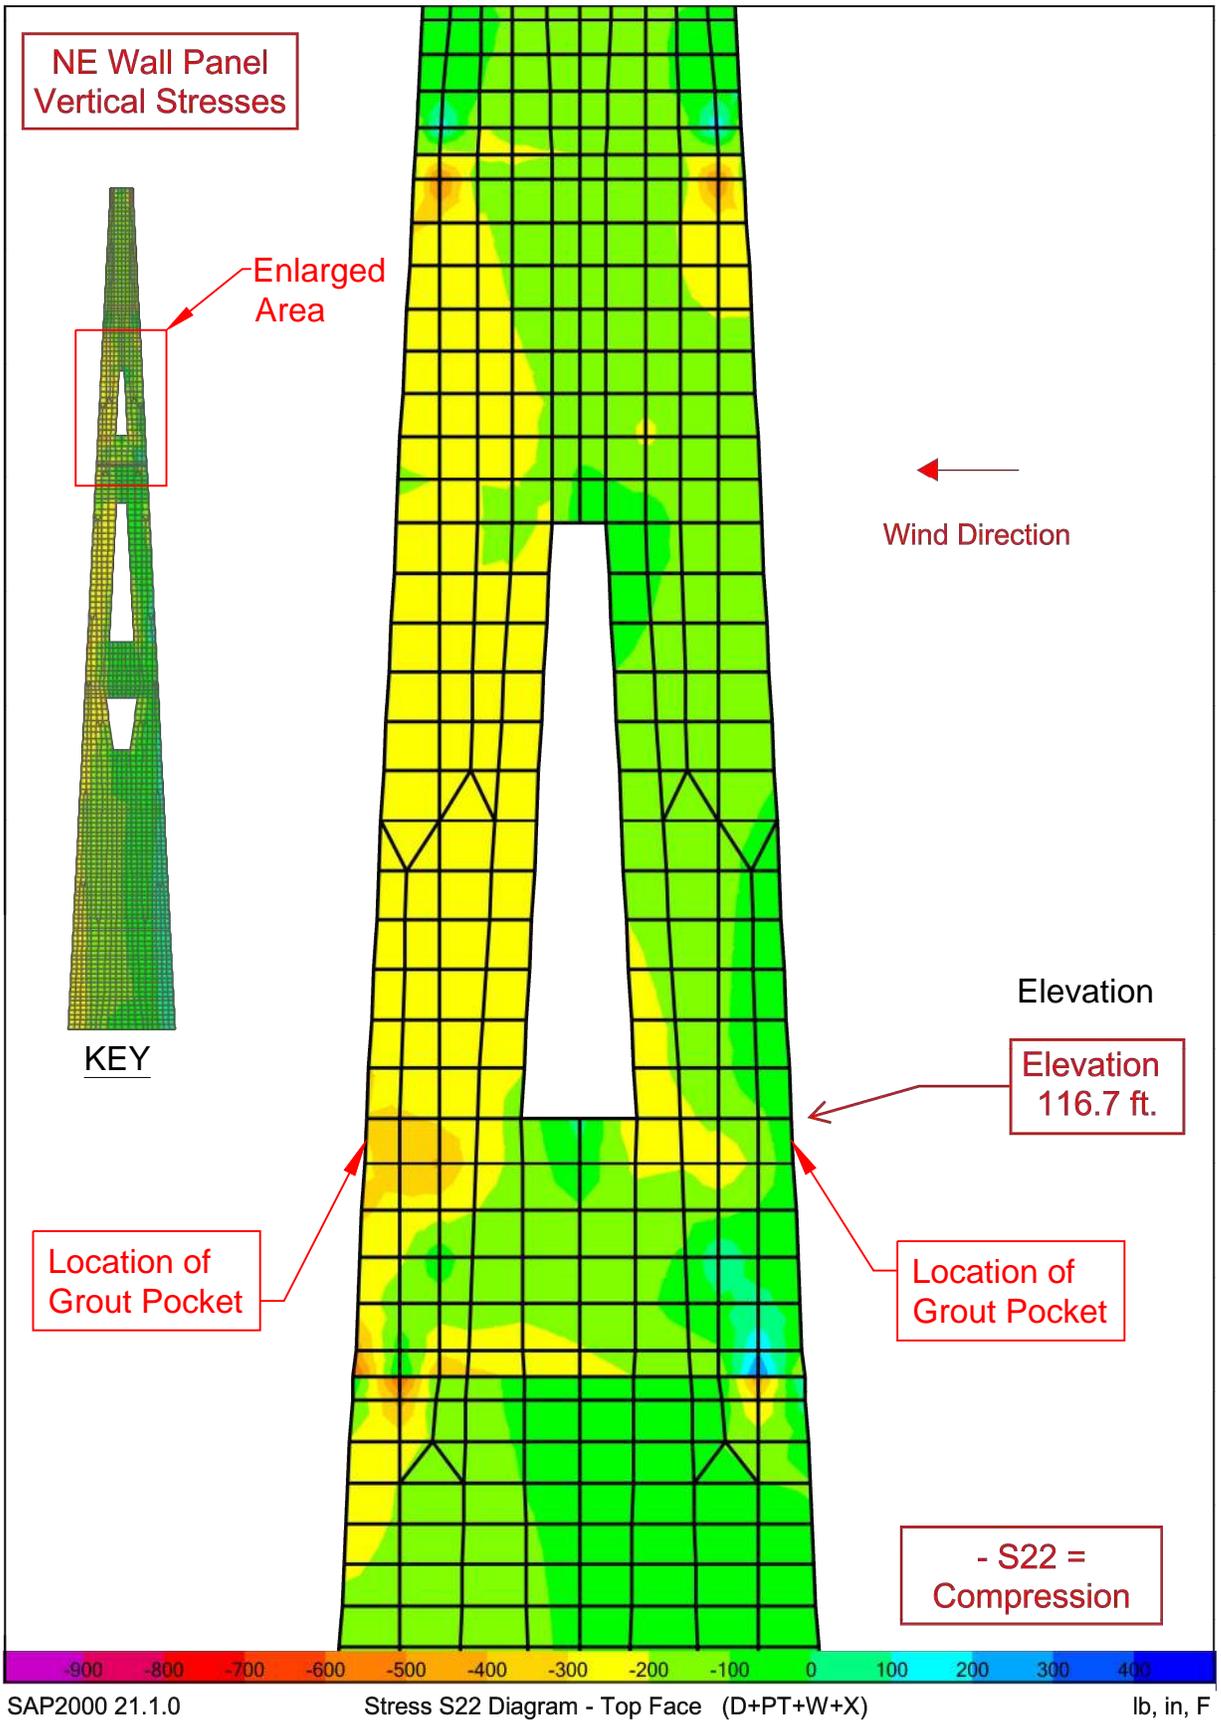
5
FIGURE

Dead Load stresses	47 psi
Wind Load stresses (Compression)	110 psi
Post-Tensioning P/A Compression	150 psi
Load combination 1.2 DL + PT + 1.3 WL	349 psi
Service Load Combination DL + PT + WL	307 psi

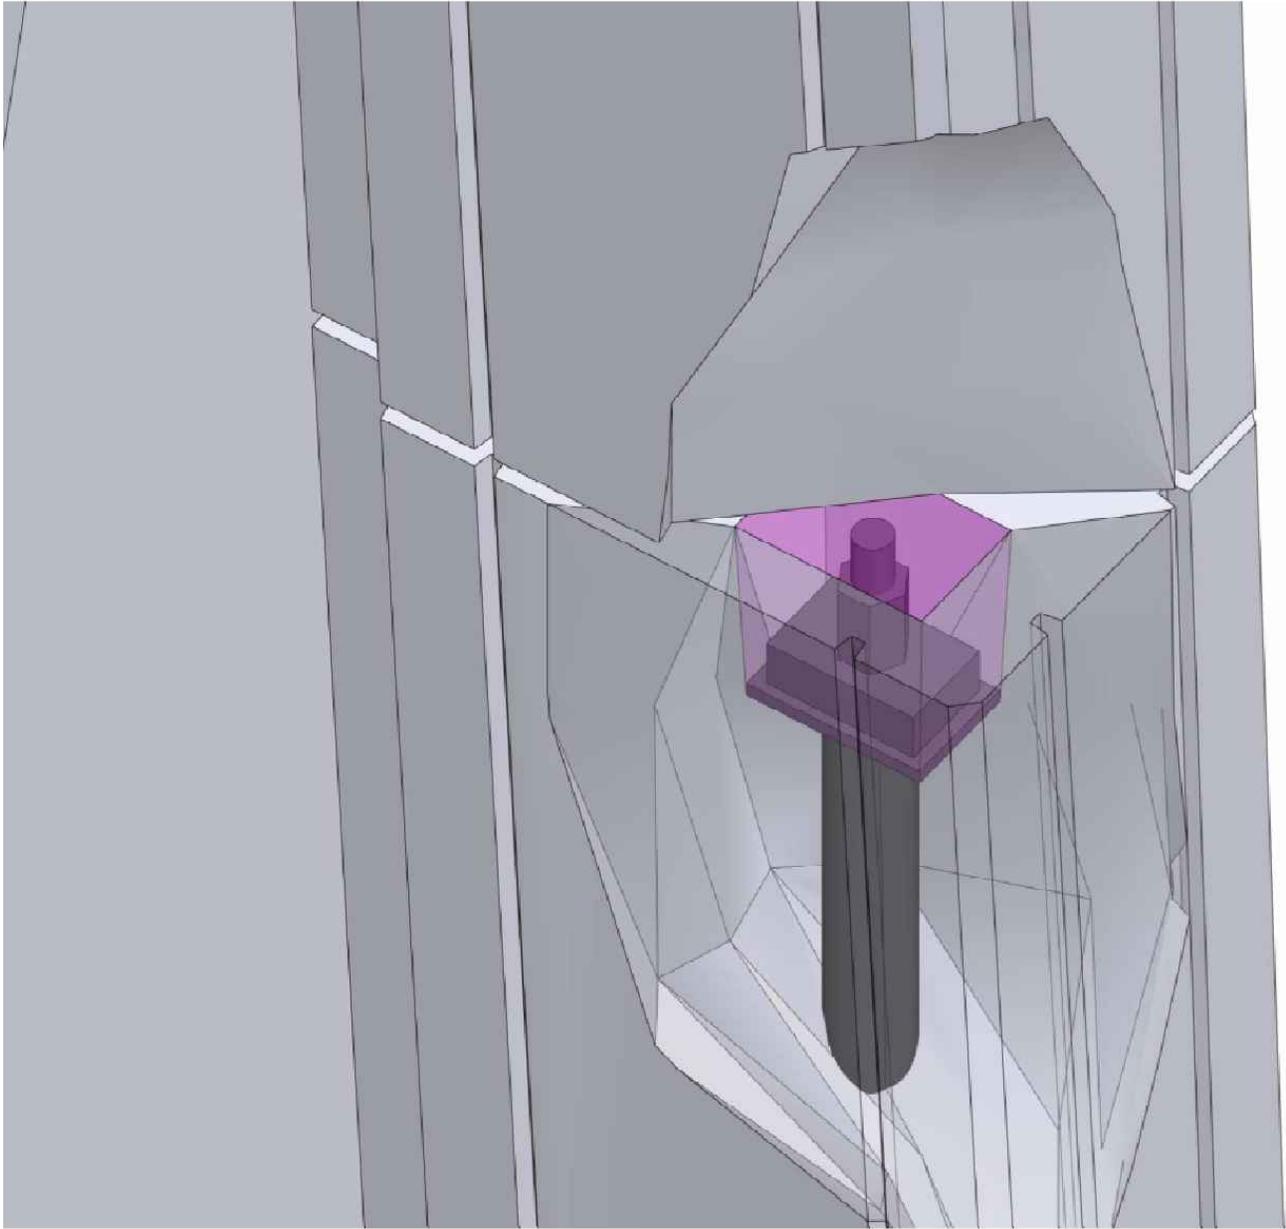
6
FIGURE

Therefore, the result of the RRJ review of available information regarding the Moser Tower concrete distress was that contaminated grout was used in the grout pockets of the south side of the tower at Level 116.7 and likely caused expansion, which burst the precast outer shell of the grout pocket at the post-tensioning anchors above and below the precast joint at Level 116.7. No mention of similar distress was found at grout pockets on the north side at Level 116.7, where it would be expected if the same grout mix containing gypsum were used. Although it is possible that different grout mixes were used in grout pockets, the results are inconclusive regarding the distribution of cracking and spalling because the location of other spalling or significant cracking was not described. This could be because none was found, or it could have been present and not recorded. ESI contended that other grout pocket spalls were observed, but they were not identified. Collins did not report any other grout pocket spalls, and the Brush Architect Report does not identify any other grout pocket spalls. (Fin spalls are described at three locations, but these are not the same as the grout pocket spalling and distress.)

**ISOMETRIC VIEW OF SPALLED GROUT
POCKET AND POST TENSIONING HARDWARE**

Based on the results of the structural analysis and the examination of the collected data on cracking and spalling gathered to date, RRJ recommended additional examination of all eight grout pockets at the 116.7 Level. This inspection should carefully examine the precast concrete for evidence of cracking, indicating a preeminent spall. The rest of the tower should be checked for evidence of cracking at the remaining grout pockets to insure that none have been missed if cracking is present. The area of concrete exposed on the south panels at Level 116.7 at the spall should be carefully examined and probed by DSI to determine that the bearing region and tendon/bars are in good condition, sound, and not corroded. Samples of the grout remaining should be removed and tested to determine if gypsum has been completely removed. Other grout pockets at Level 116.7 should be cored to extract a grout core to be submitted for examination and evaluated for gypsum.
