DOCUMENT REFERENCE RE-E17258-IM-REV 1.0

MOSER TOWER

CORROSION AND MATERIAL DURABILITY ANALYSIS

ECHEM CONSULTANTS LLC 4 JEFFERSON PLAZA SUITE 500 POUGHKEEPSIE, NY 12601

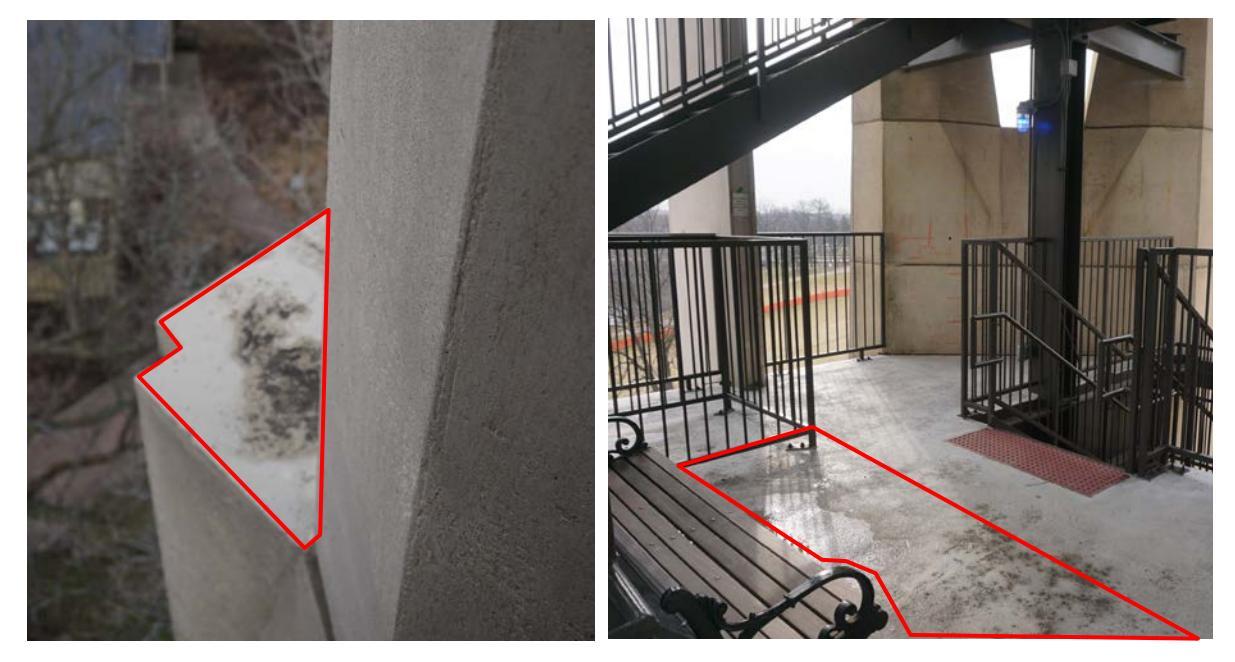
FIGURE 21 STANDING WATER ON TOP OF A PRE-CAST PANEL
[NO PRESENCE OF ANY FLASHING]

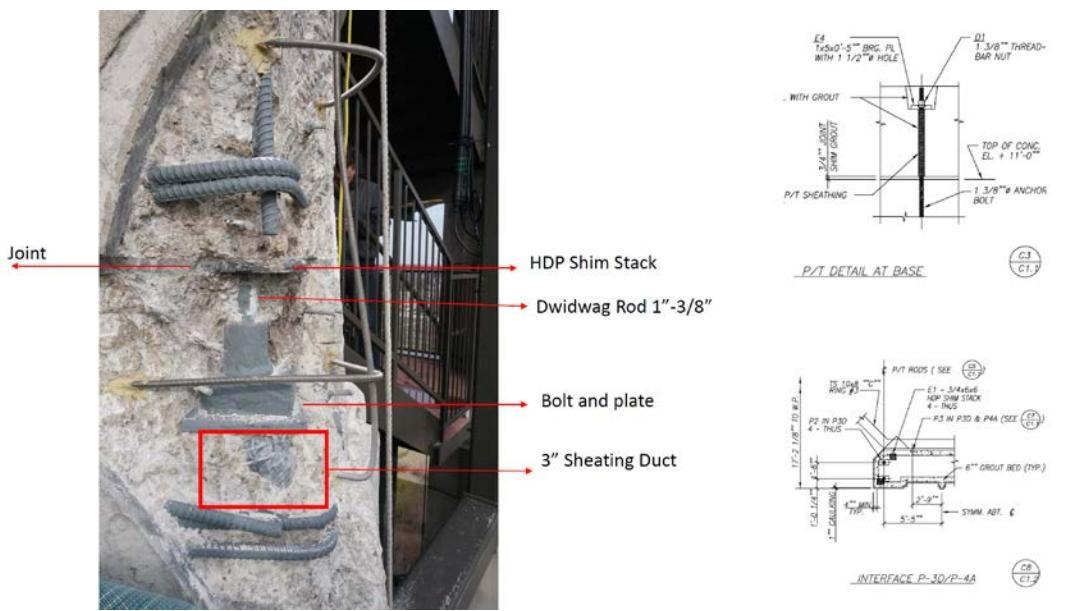
FIGURE 29 FOUND CONDITION AT PROBE OPENING OF POST-TENSIONED ROD DETAIL

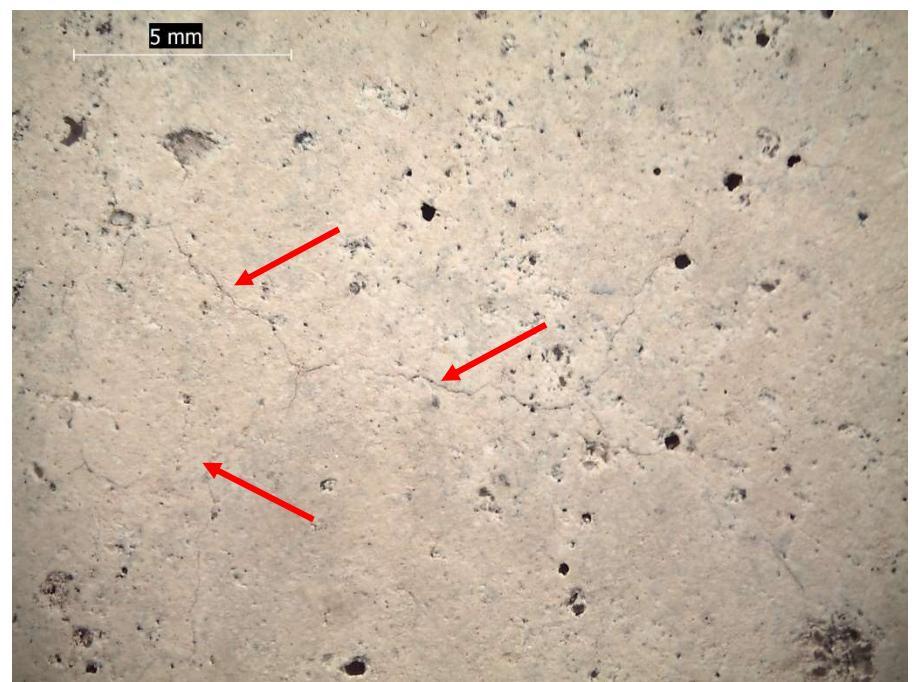
Figure 15. Pre-Cast Panel (3150053). Stereo-optical micrograph showing a minor amount of microcracks in the paint layer.

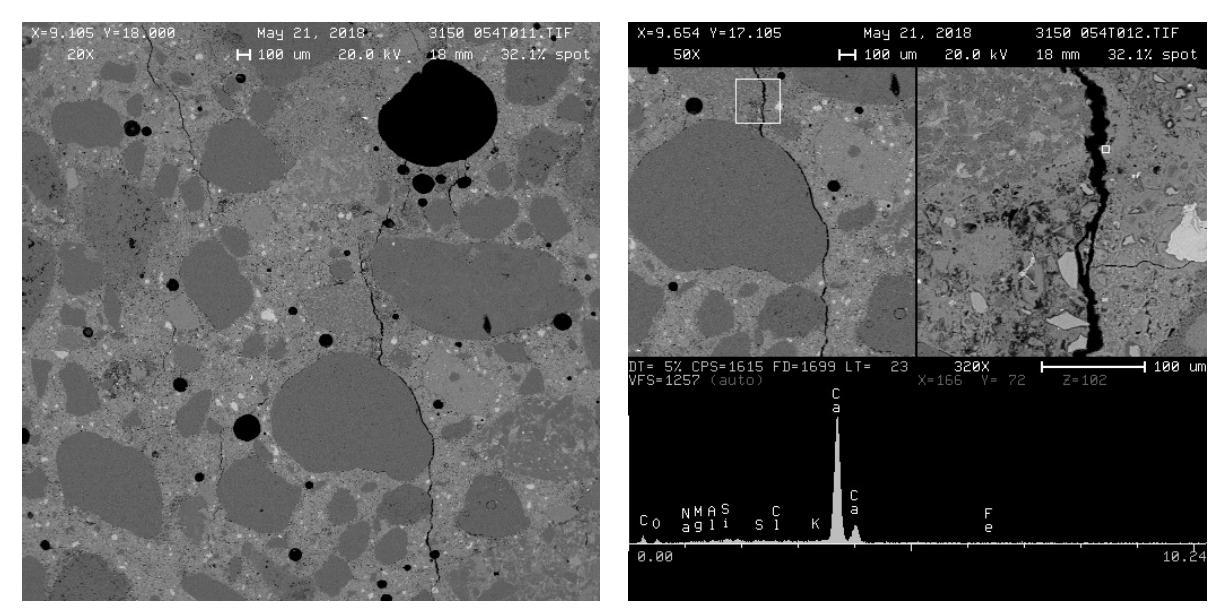
Figure 32. Column (3150054). BSE image of discontinuous microcracks near surface.

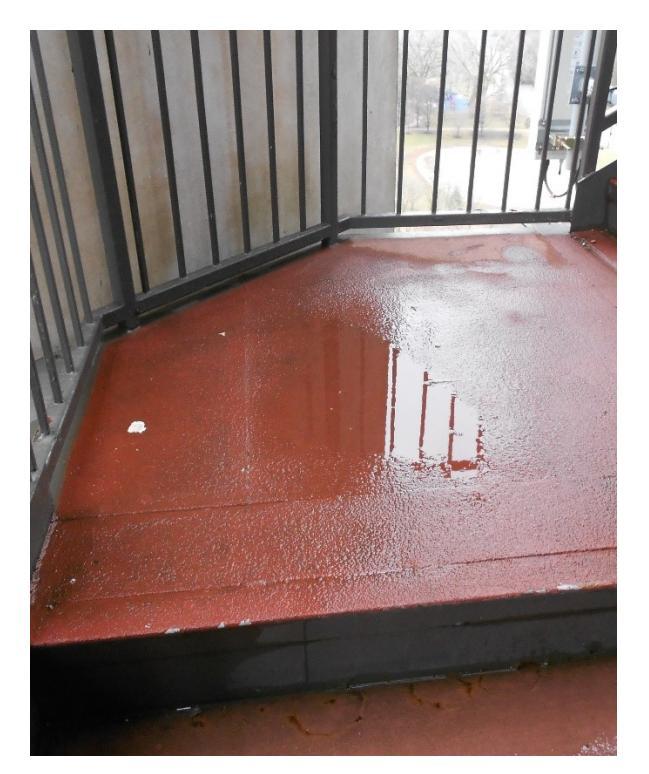
37. Standing water on stair landing.

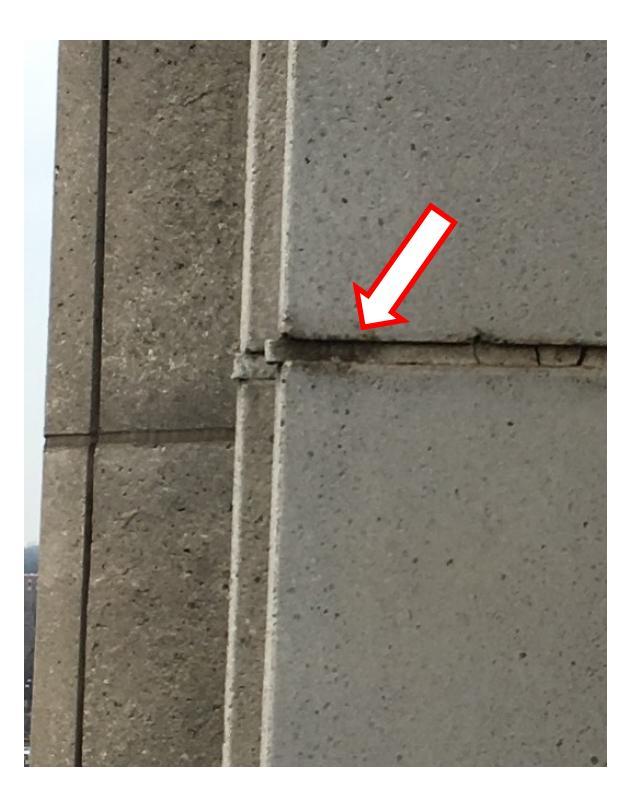
40. A close-up of view of a precast fin joint. Note loose grout in joint.

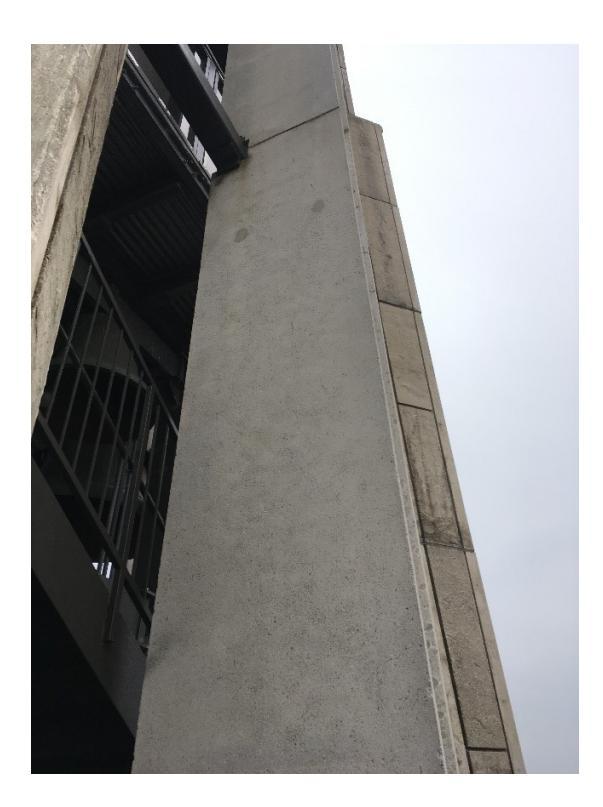
41. A view of a precast fin. Note small lift point patches.

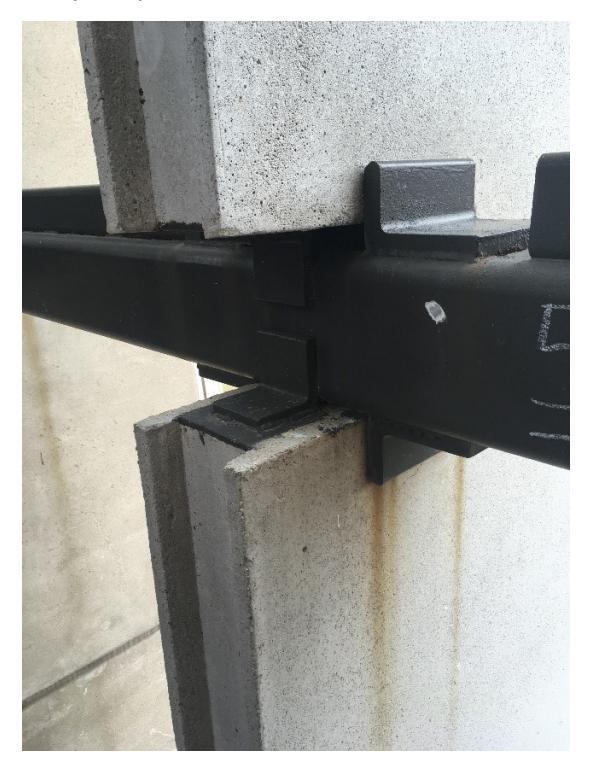
43. A detail view of the precast fin connection. Note corrosion staining.

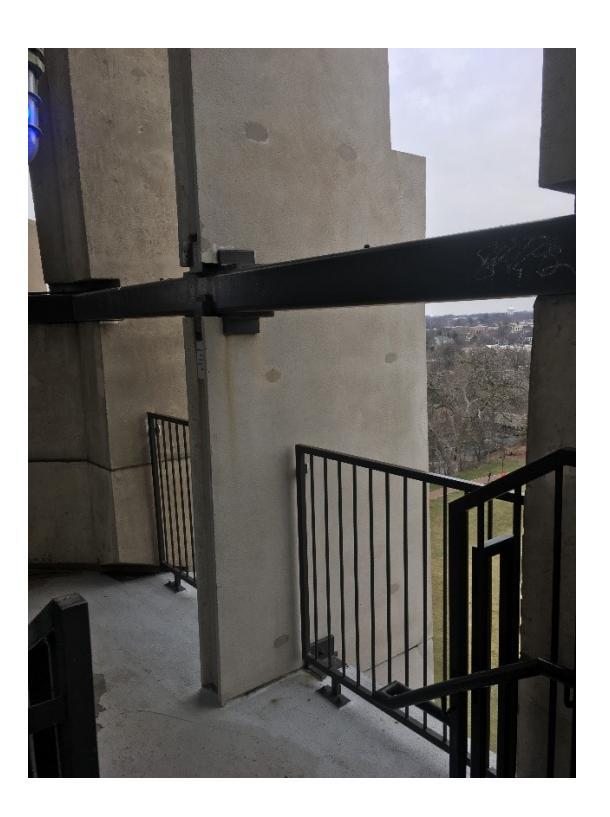
42. A view of a precast fin connection. Note small lift point patches.

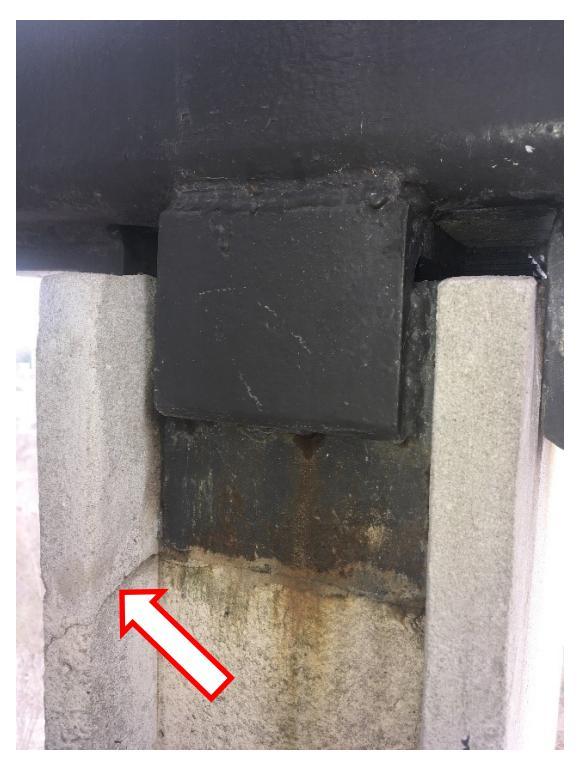
44. A close-up view of the precast fin weld connection. Note concrete crack at corner of. steel embed

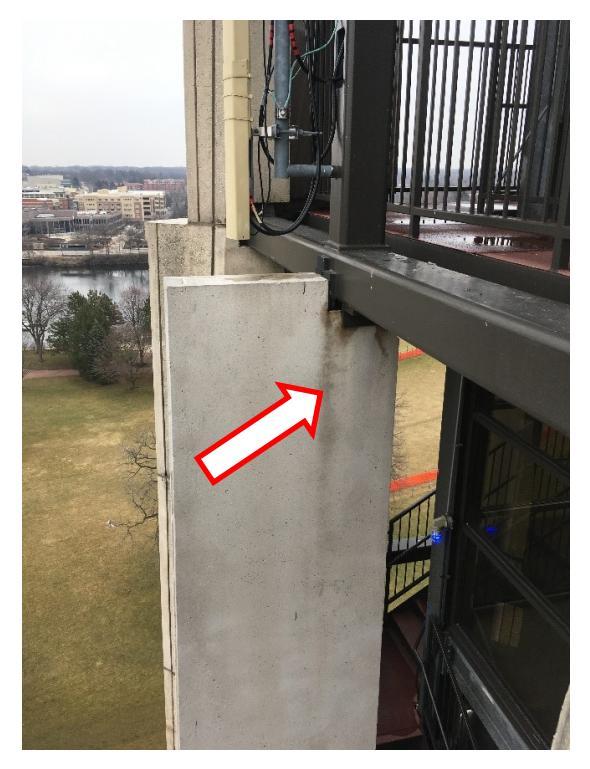
47. A view of the top of a precast fin. Note corrosion a runoff stains.

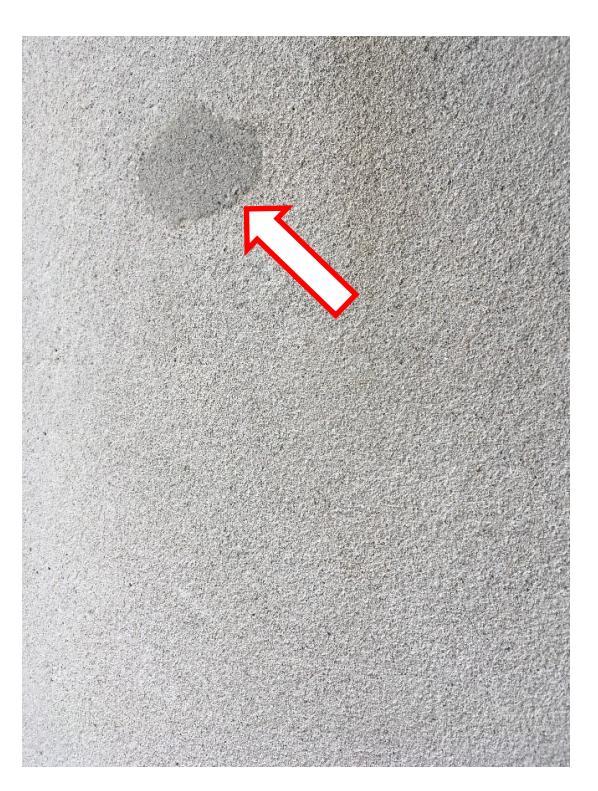
46. close-up of the precast fin showing surface finish. Note typical lift point patch.

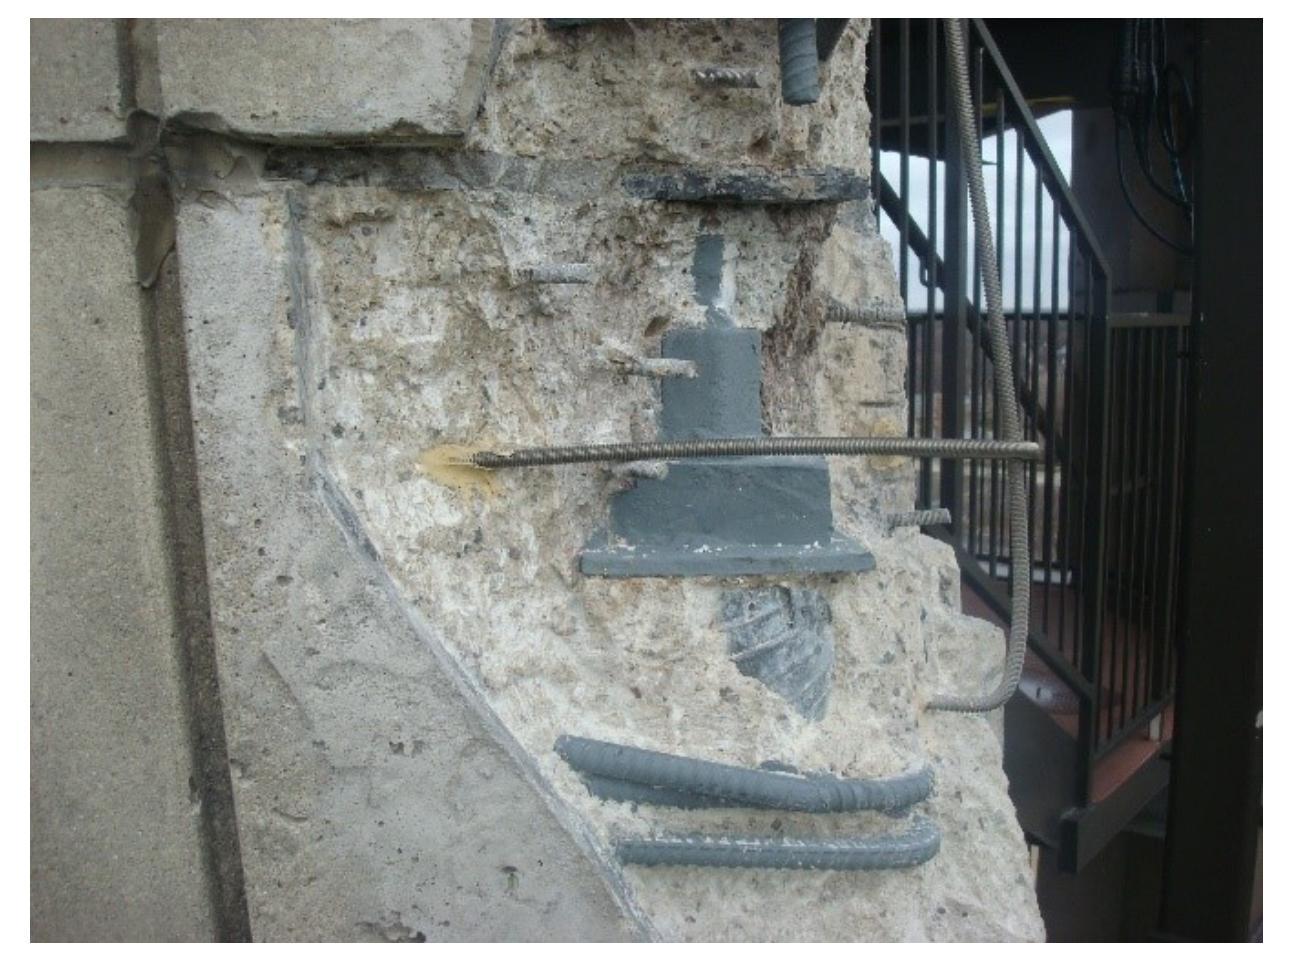
55. A close-up view of failed patch on the SE pier El.116-8" after demolition. The patch that was removed did not have sufficient anchorage to prevent a fall. The exposed concrete cast around the Dywidag post-tensioned hardware is not fully engaged with the steel. The architectural concern for this condition due to its repetition on all sides at this level is that the Dywidag is not sufficiently engaged with the structural reinforcing to prevent repeated failure.

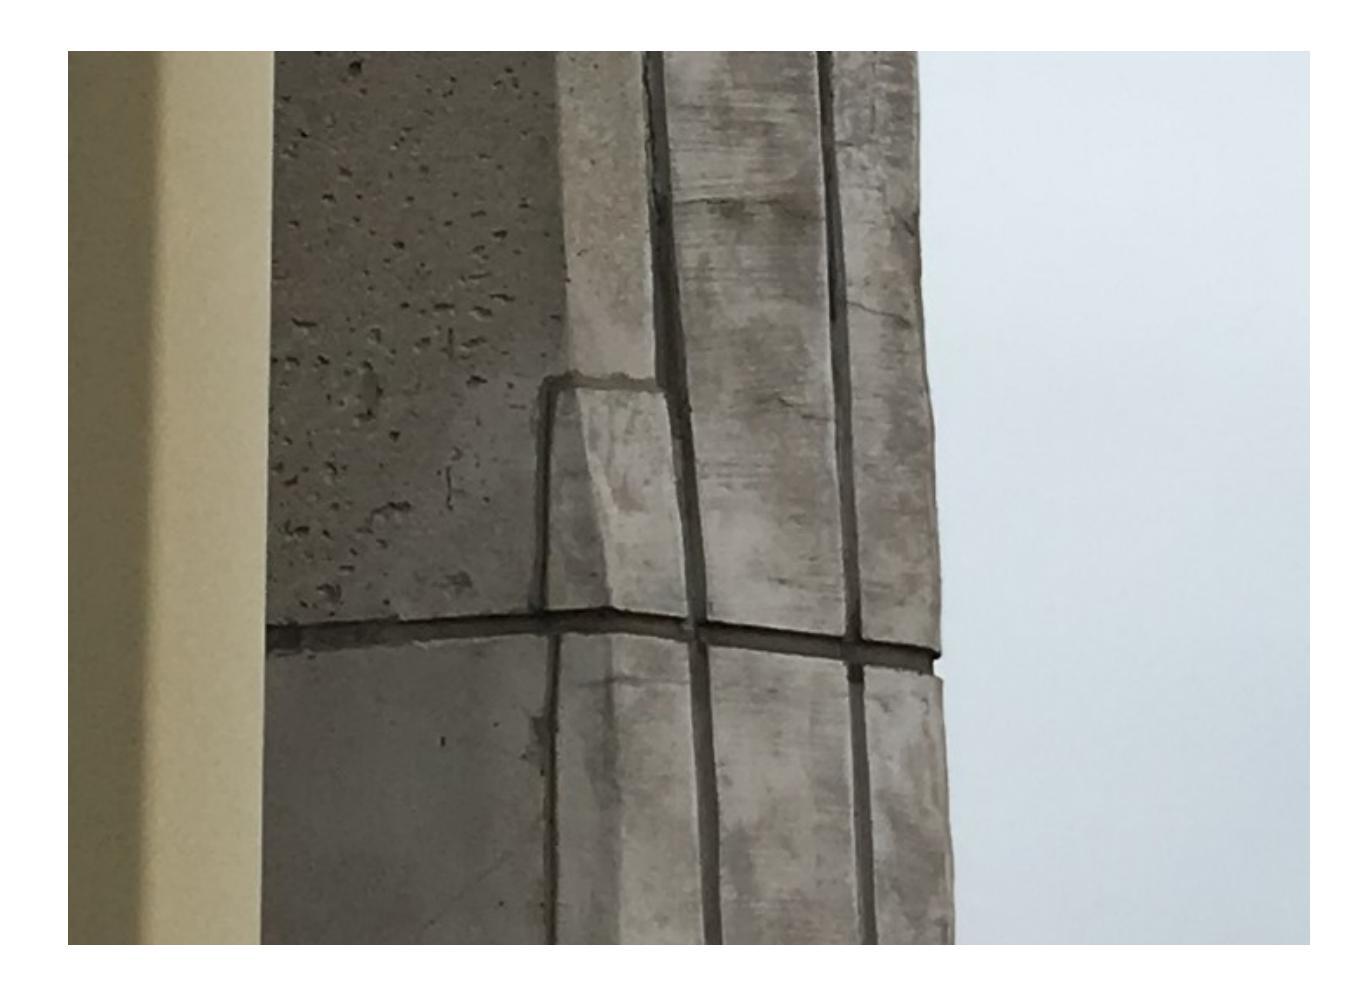
56. A view of previously made patches on the SW pier. At the same 116' elevation as photo 55. This condition is visible on all sides of the structure at this location

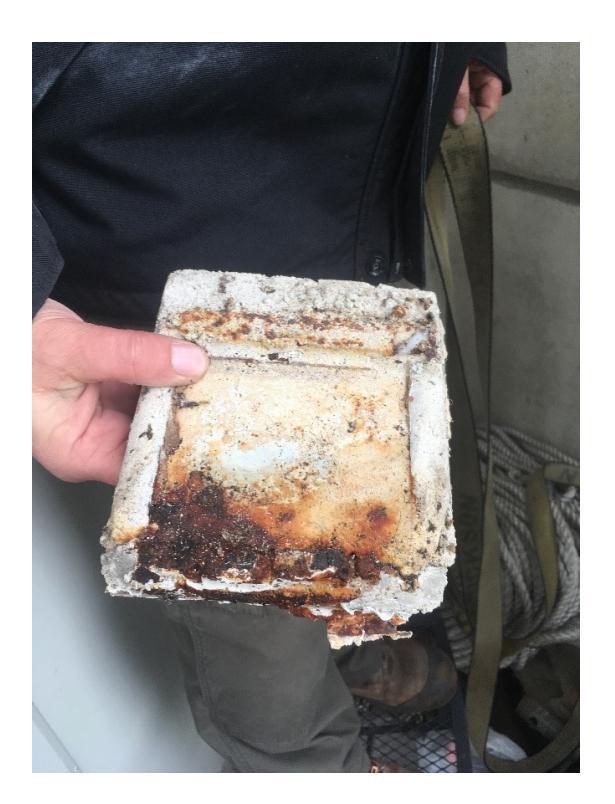
60. A failed embed patch removed during inspection.

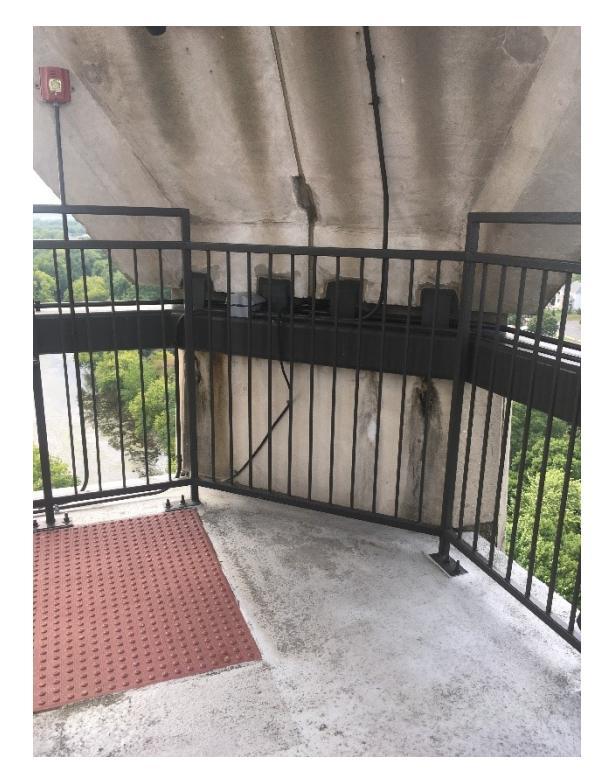
63. A view of the NW pier at the Observation deck. Note corrosion staining below the ring beam.

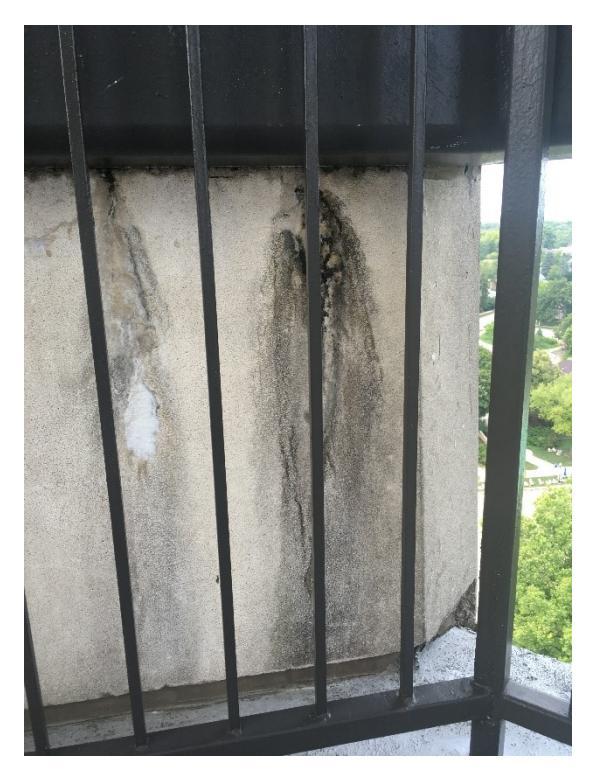
64. A close-up of corrosion and leak patterns at the NW pier below the ring beam.

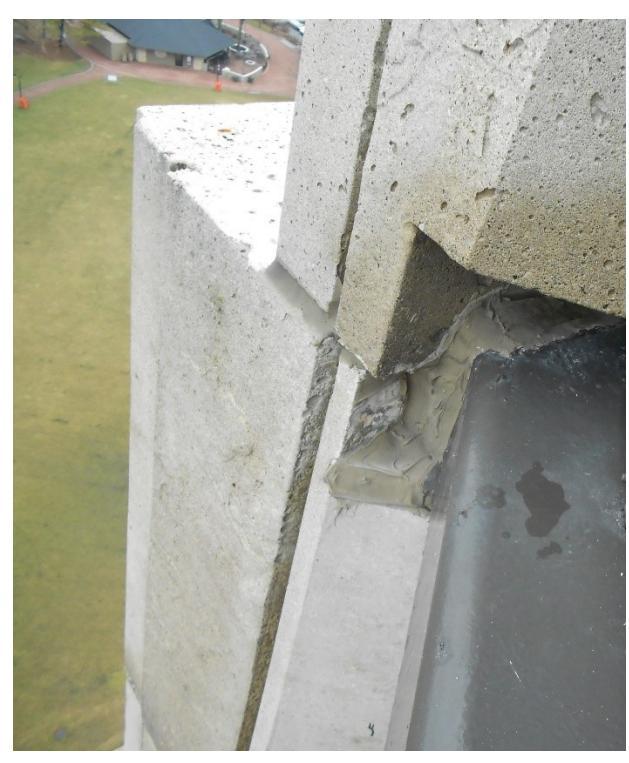
65. A close-up of ledge adjacent to the interior leaks at the Observation deck.

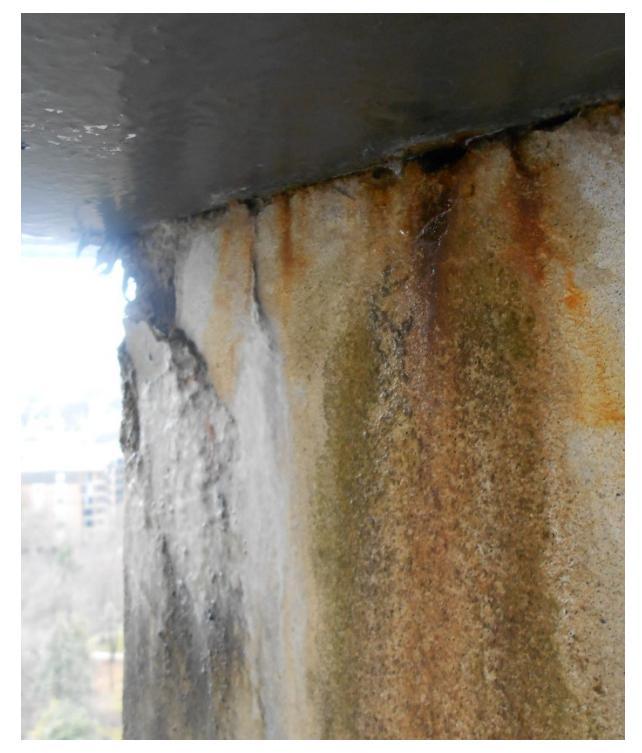
66. A close-up of corrosion and leak patterns at the NW pier below the ring beam.

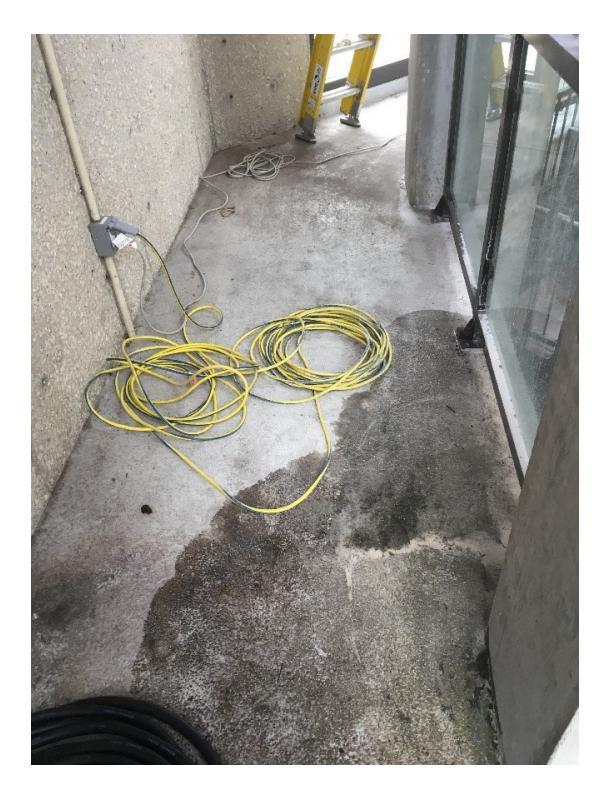
97. A view of the ground floor failed traffic coating with standing water.

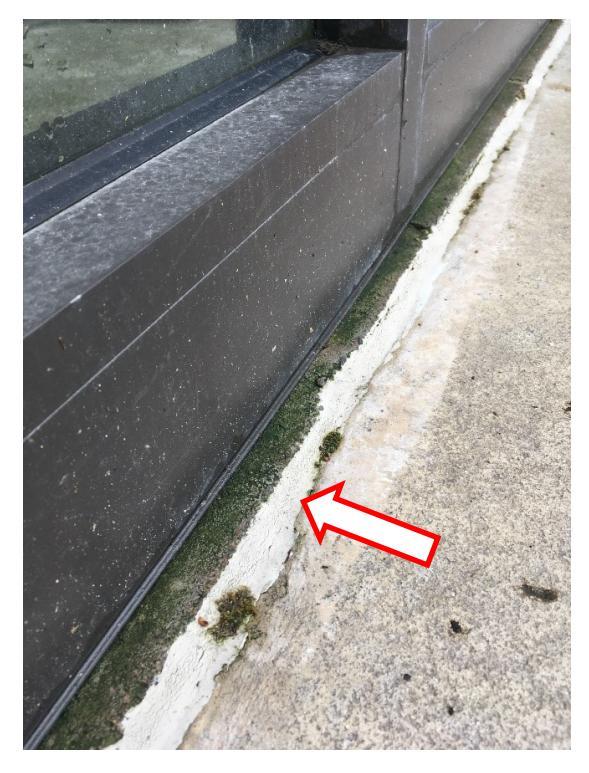
99. A close-up view of the base of glazing walls. Note failed sealant and biological growth.

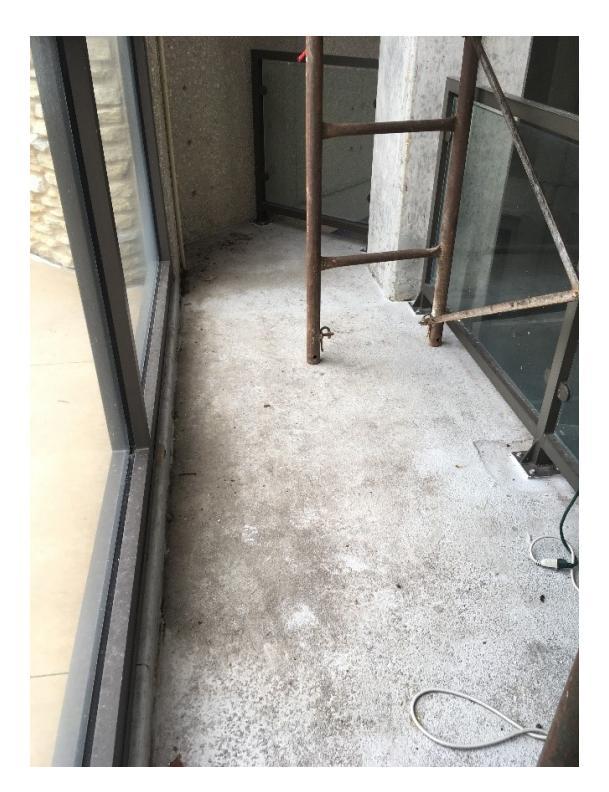
98. A view of the ground floor damaged traffic coating.

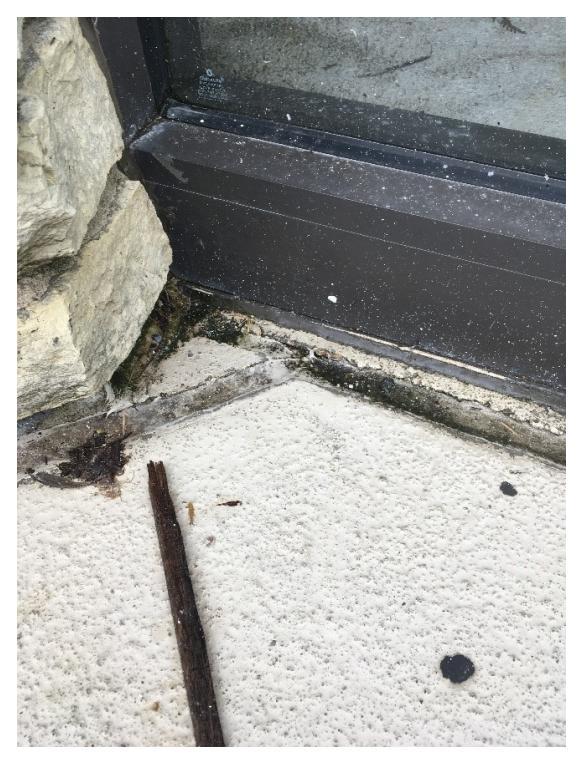
100. A close-up view of the base of glazing walls. Note failed sealant and biological growth.

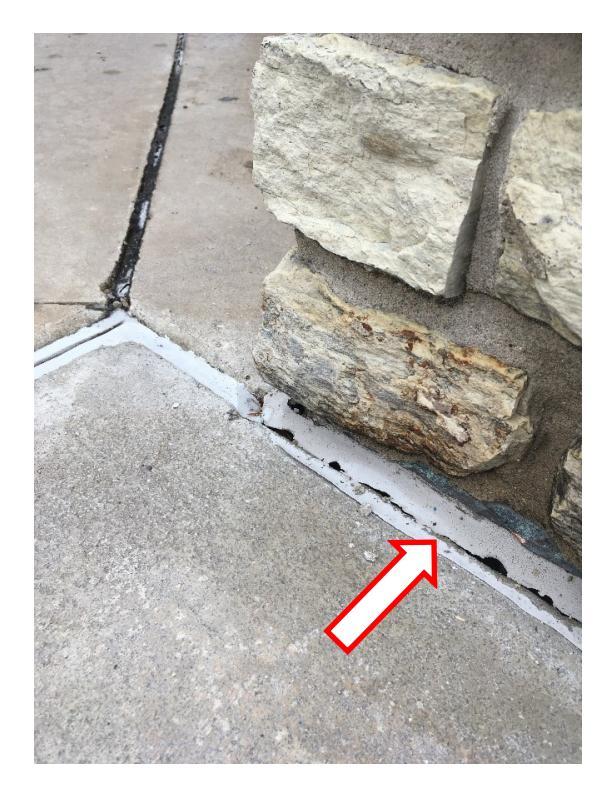
107. A close-up of the failed sealant and flashing at the stone veneer and plaza.

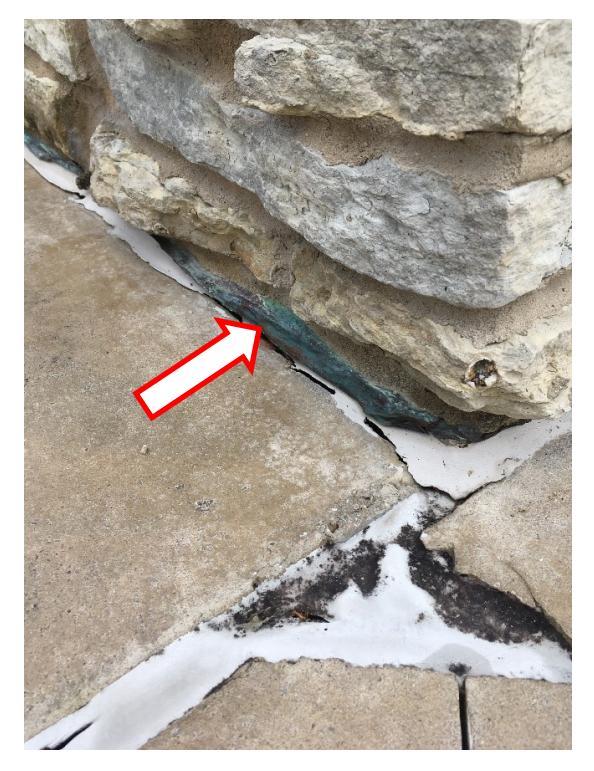
109. A close-up of the failed sealant and damaged flashing at the stone veneer and plaza.

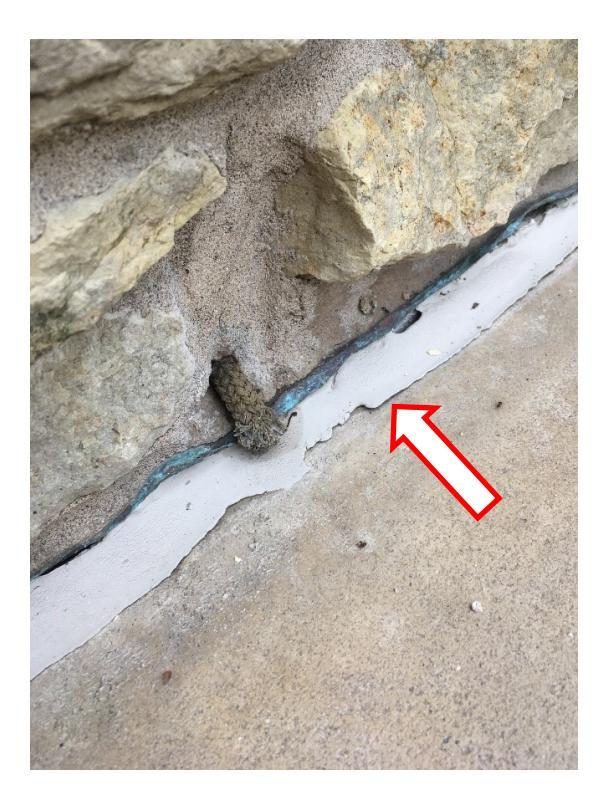
108. A close-up of the failed sealant and damaged flashing at the stone veneer and plaza.

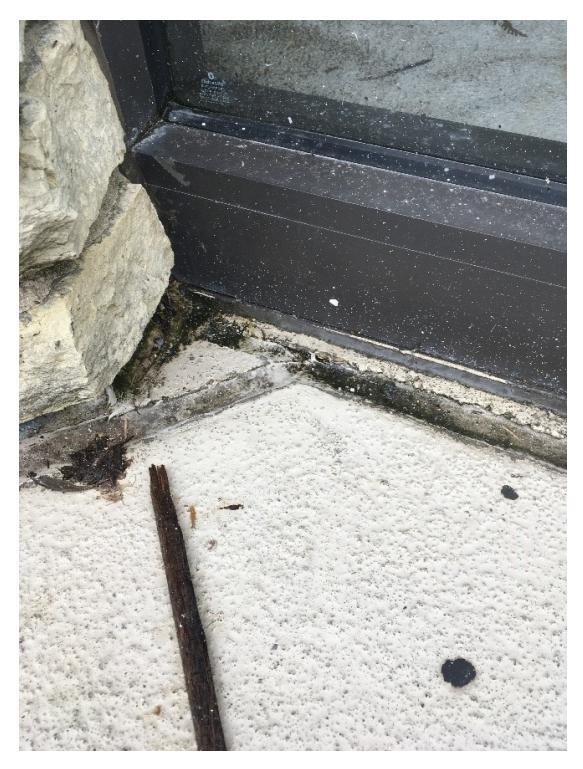
110. A close-up of the failed sealant and flashing at the stone veneer and plaza.

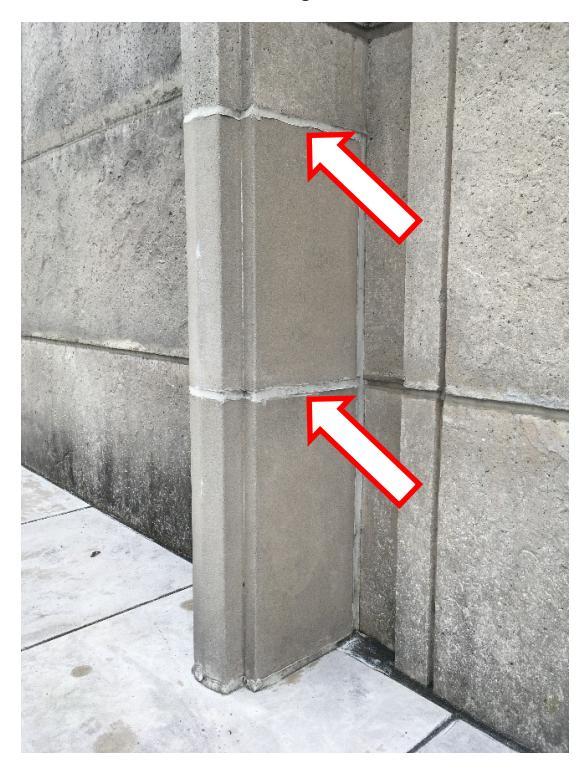
113. A view of a precast fin intersecting the Northwest base coping. Note failed sealant between sections.

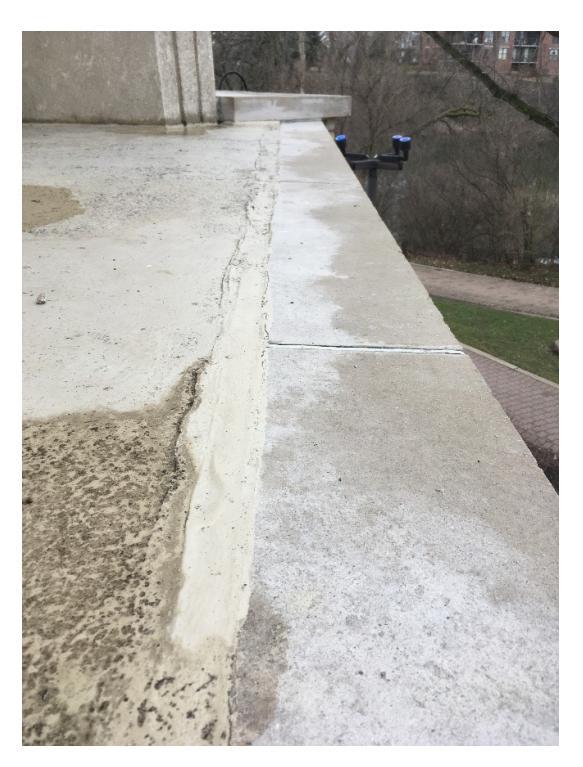
112. A close-up of the failed sealant at the West side of ground floor coping.

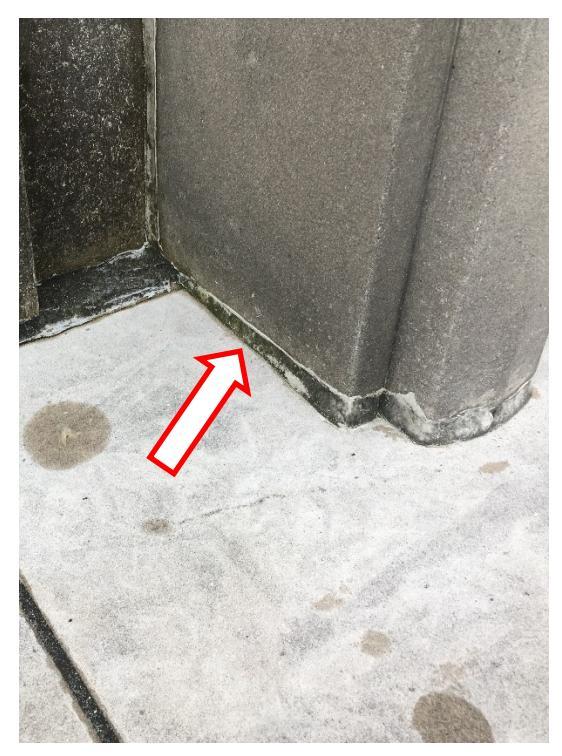
114. A close-up of a precast fin intersecting the Northwest base coping. Note failed sealant.

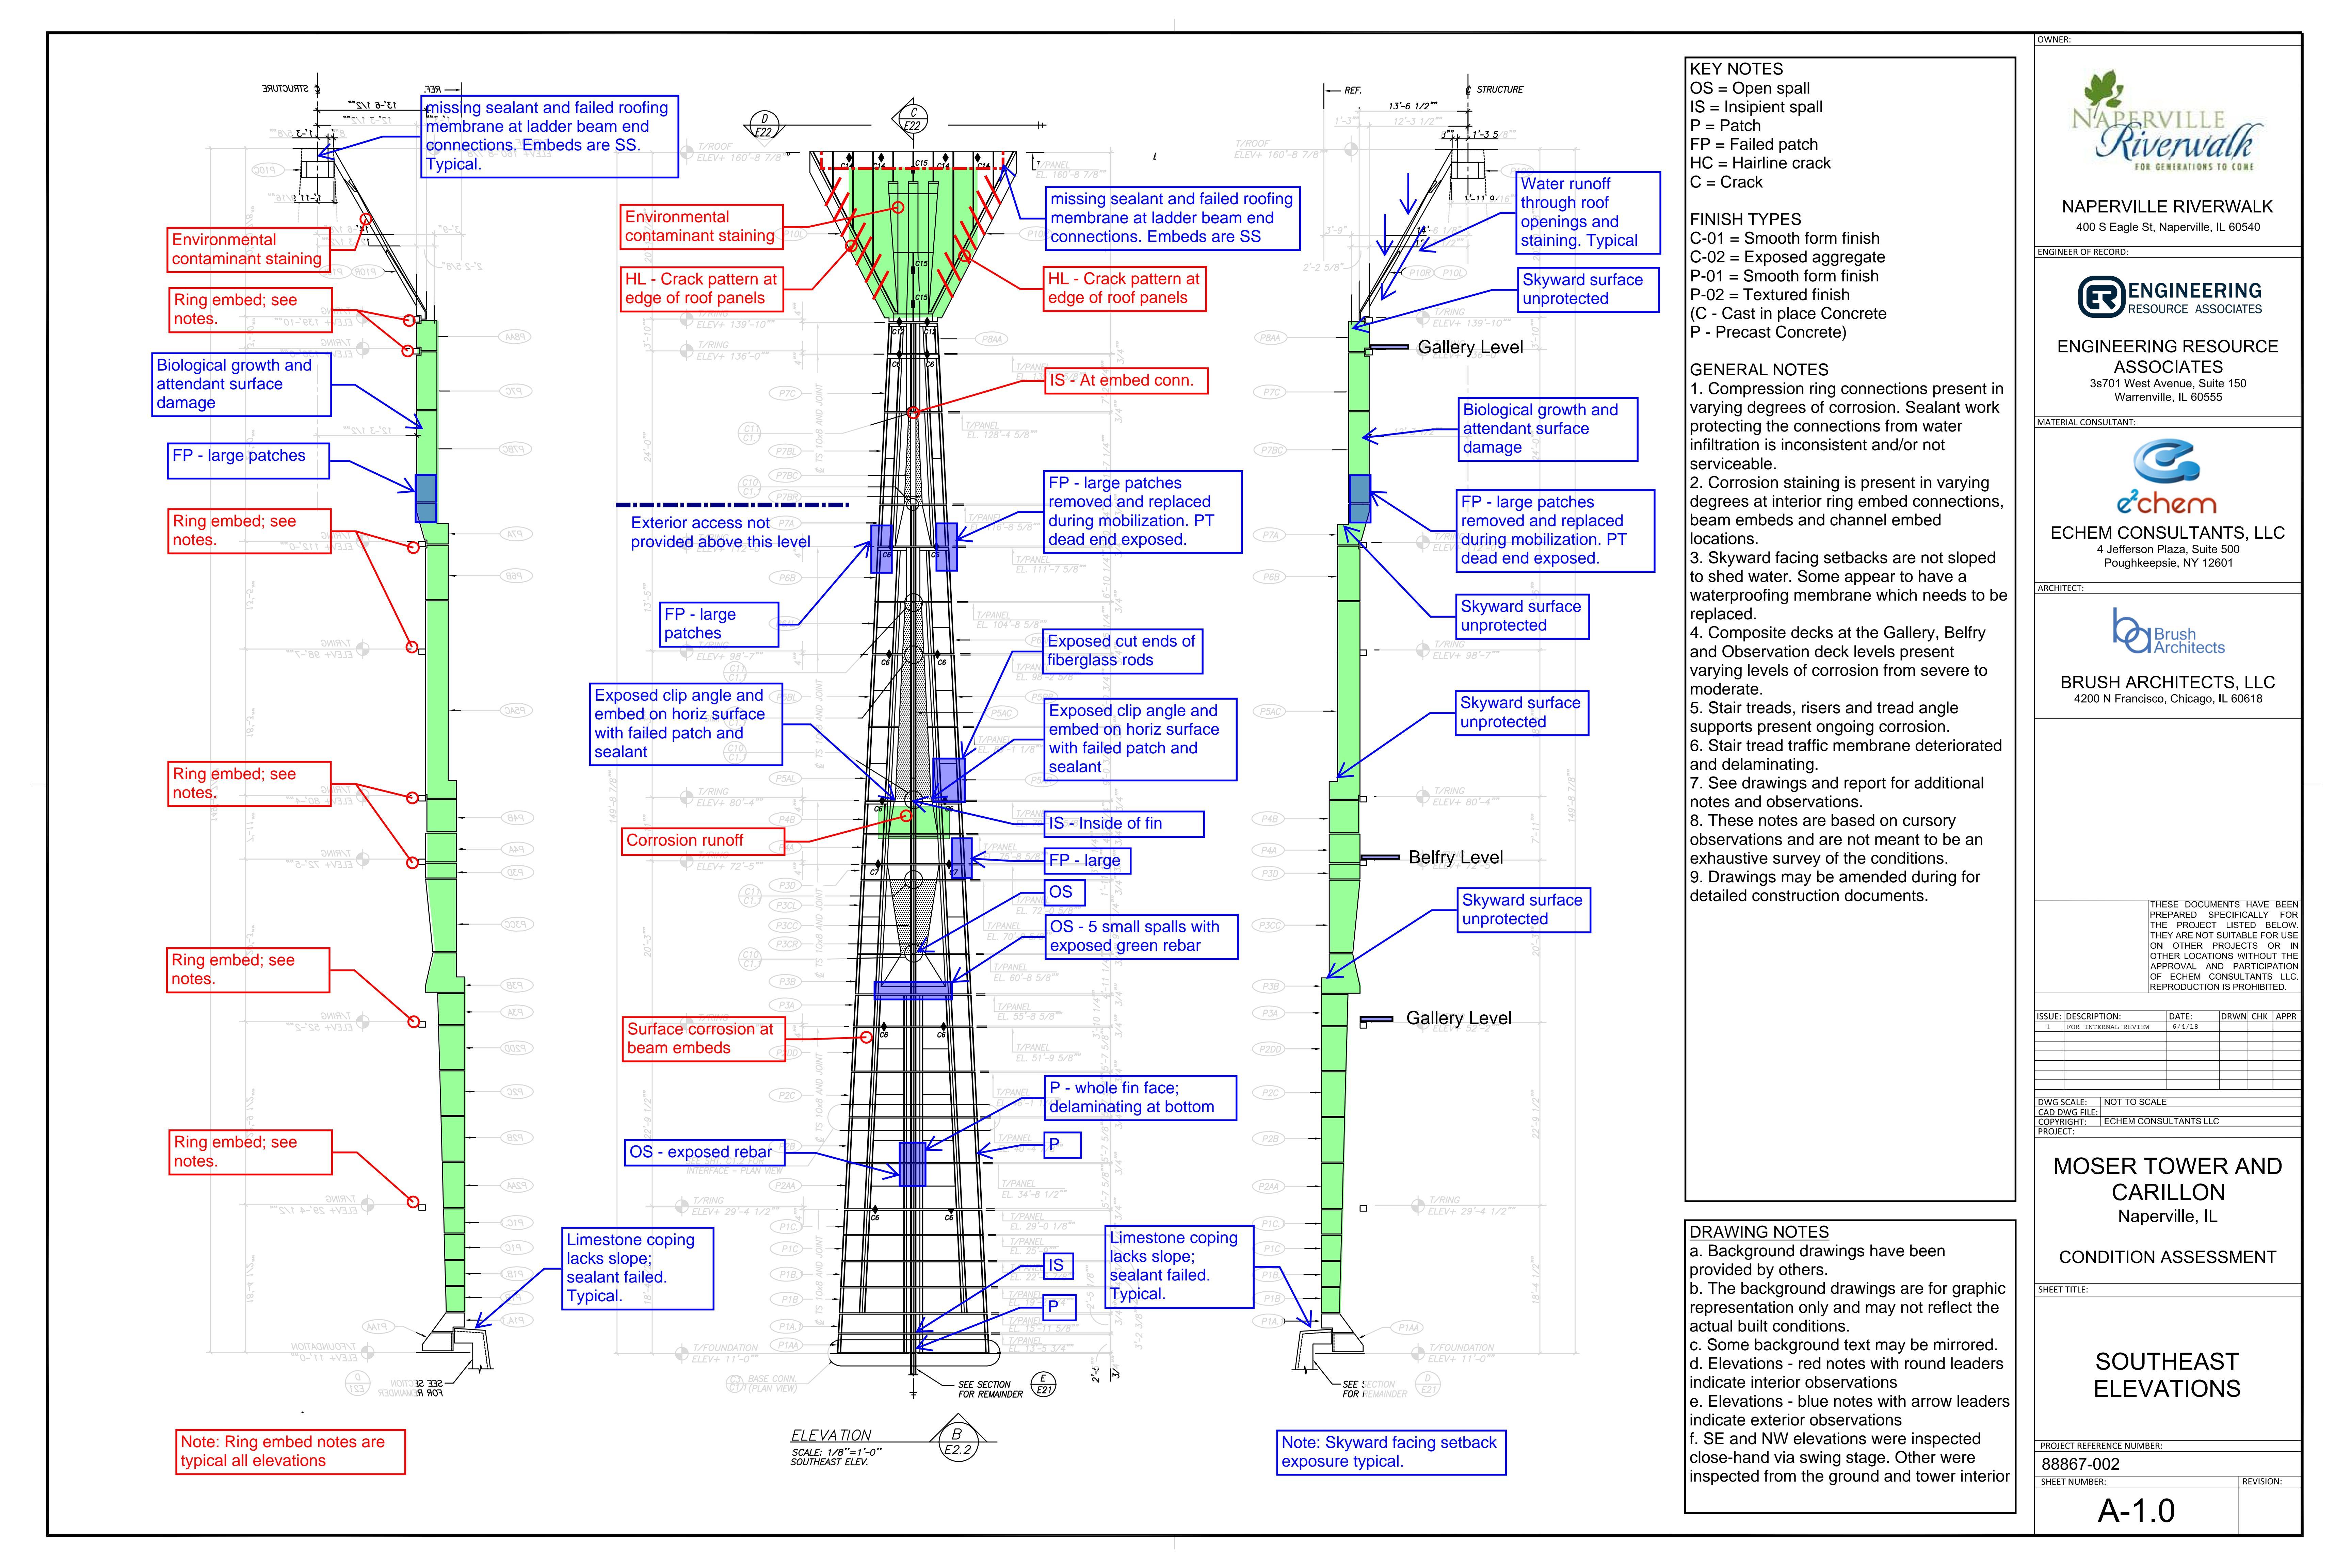
1. Compression ring connections present in	3s701 West Avenue, Suite 150 Warropyillo, II, 60555
varying degrees of corrosion. Sealant work	Warrenvine, iE 00000
protecting the connections from water	MATERIAL CONSULTANT:
infiltration is inconsistent and/or not	
serviceable.
