PREPARER ORGANIZATION GRANACKI HISTORIC CONSULTANTS

SURVEYAREA NAPERVILLE

ILLINOIS URBAN ARCHITECTURAL AND HISTORICAL SURVEY CONTINUATION SHEET

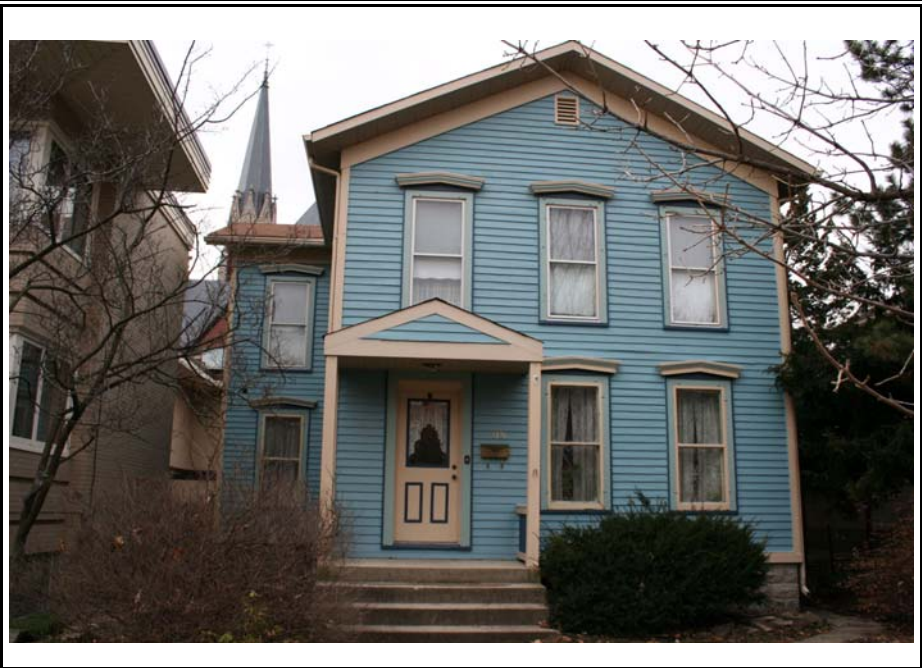
Flared hipped roof with overhanging eaves; front and north side gables w/ deep cornice returns; historic hipped porch w/ rounded columns on concrete block piers (probably an historic alteration); historic leaded glass double and single hung windows; north side three-sided window bay with flared roof and leaded glass upper sashes in windows

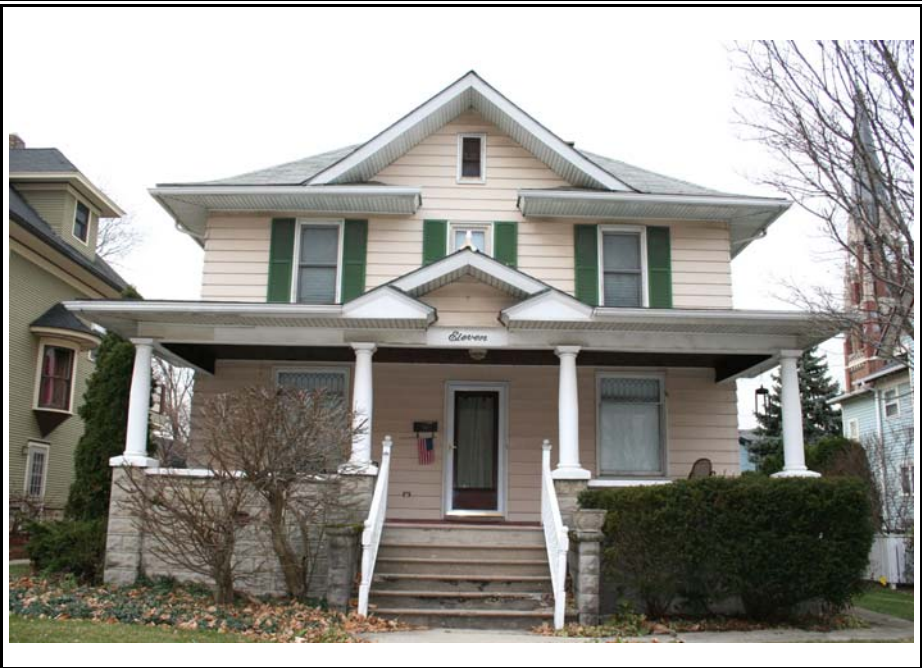
Front porch addition (historic--c. 1910); 1/1 replacement front windows (historic); 2 story front gable north/rear section may be early addition; 4/4 replacement windows on N. side (historic); rear deck add. (not historic); S. covered walkway; 1 story south/rear add. (c. 1950); replacement wood siding and fixed shutters (not historic); Aluminum siding under eaves

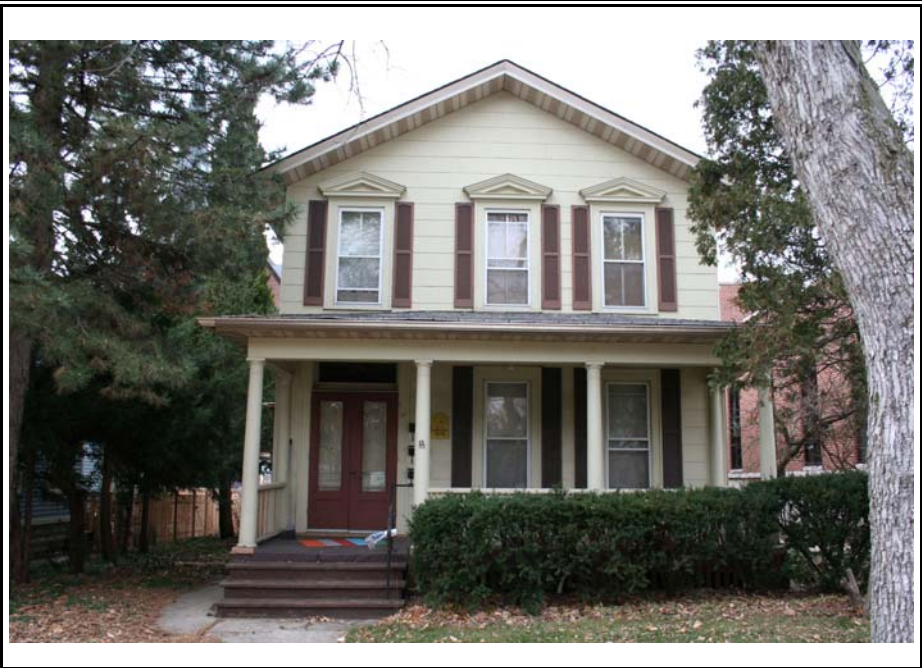
Hipped roof with front gable; 2 story 3-sided front window bay with center leaded glass windows; full front hipped porch w/ classical columns on shingled knee wall; north side rounded oriel bay with conical roof; historic 1/1 wood & leaded glass windows; north and south hipped dormers

House received plaque from the Naperville Heritage Society in 2006. The house was built in 1908 as a parsonage for Second Evangelical Church. The Jaeck family purchased it from the church and later deeded it to their daughter and son-in-law, Minnie & William C. Scherer.

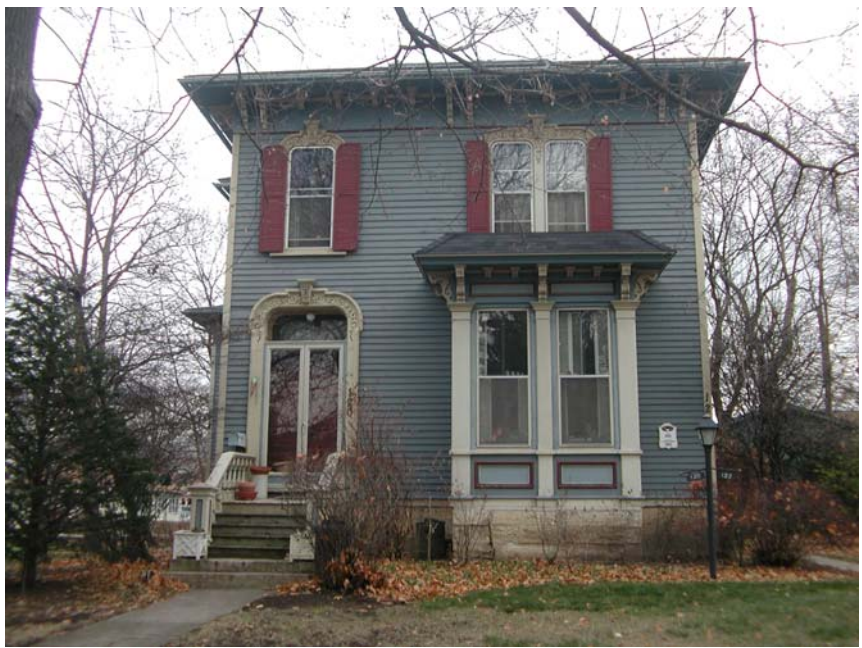
Replacement windows in original openings (not historic); fixed shutters (not historic); replacement siding and shingles (historic); front porch railings & posts replaced, and porch possibly extended; rear/s. porch enclosed (not historic); replacement door in ell; extra door on S. side of gable bay
