City of NAPERVILLE

ILLINOIS URBAN ARCHITECTURAL AND HISTORICAL SURVEY CONTINUATION SHEET

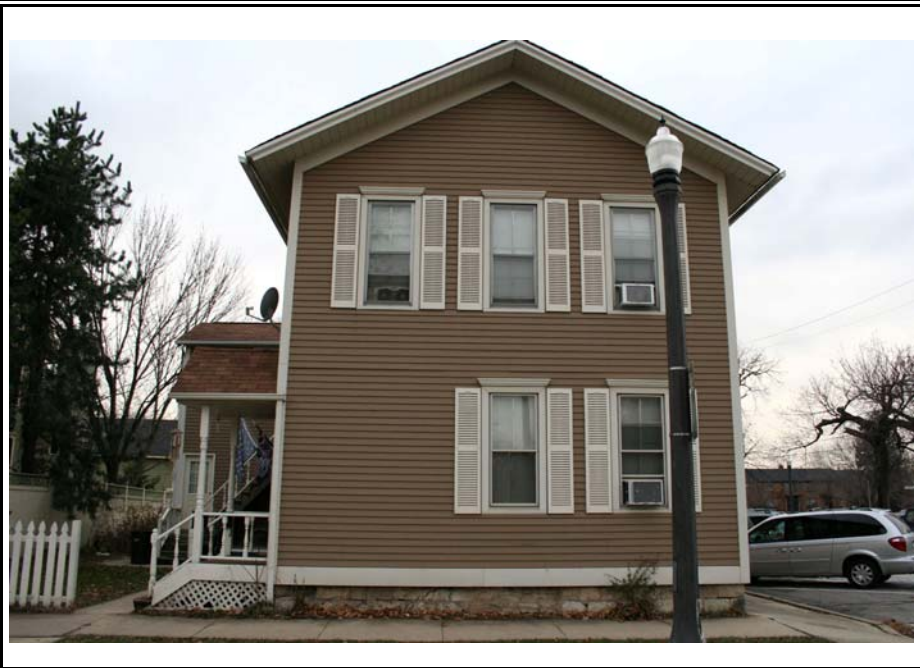
HISTORIC INFO Tax records research by Naperville Heritage Society indicate that house was probably built around 1873.

PERMITS Sanborn maps through 1943 show house with entry at front and no side porch.

LANDSCAPE Southwest corner of Ellsworth and North; front and north sidewalks; south side yard; rear driveway; mature trees

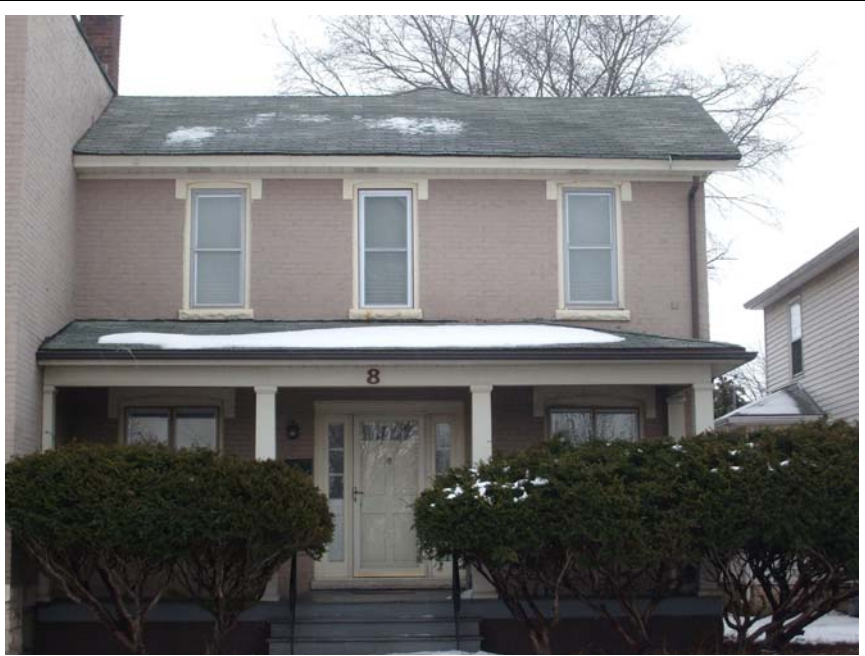
STREET # 12

LANDSCAPE Midblock on east side of residential street; attached to 4-6 S. Ellsworth on N. side; front sidewalk; rear alley; front planting

Replacement front porch (historic--c. 1910); Aluminum and vertical wood siding (not historic); replacement windows in original openings (openings may have been altered on 1st story under porch, historic); north end door under porch added, and replacement door at south end entry (may be historic alteration); fixed shutters (not historic); 2 story rear addition with exterior stair (not historic); chimney addition

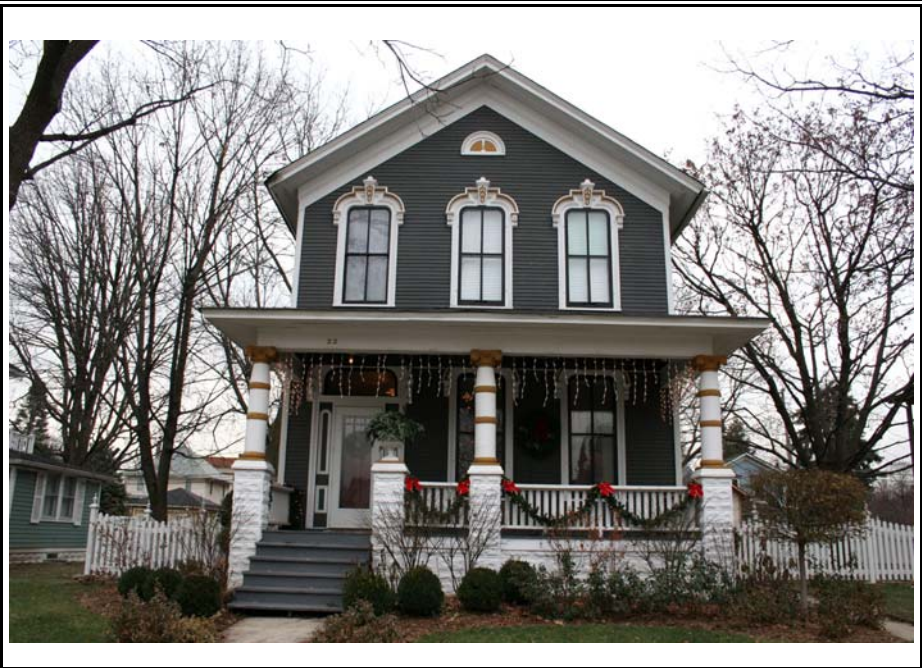
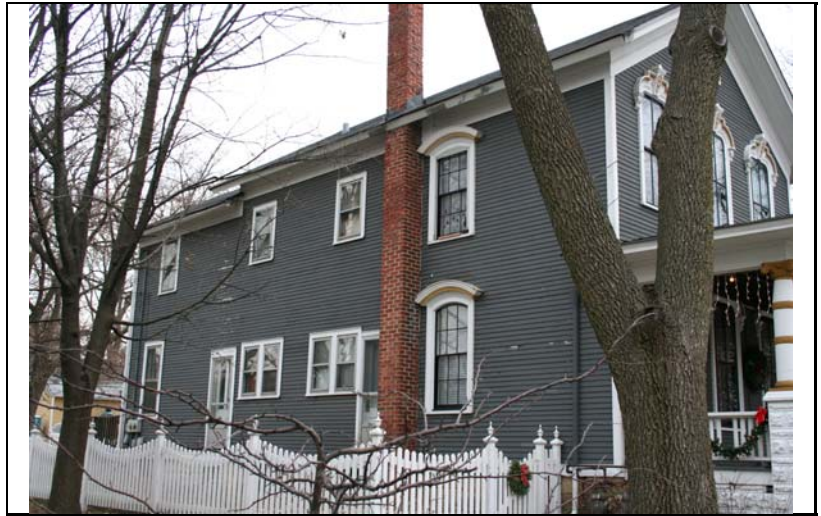
HISTORIC NAME Metz, Adam House

PERMITS Chain of title indicates Metz purchased property from Alvin Scott in 1874 for \$440. Inventory of Metz estate date 1878 makes mention of house.

LANDSCAPE Midblock on east side of residential street; front sidewalk; rear alley; rear and side picket fence; large south side yard; mature trees

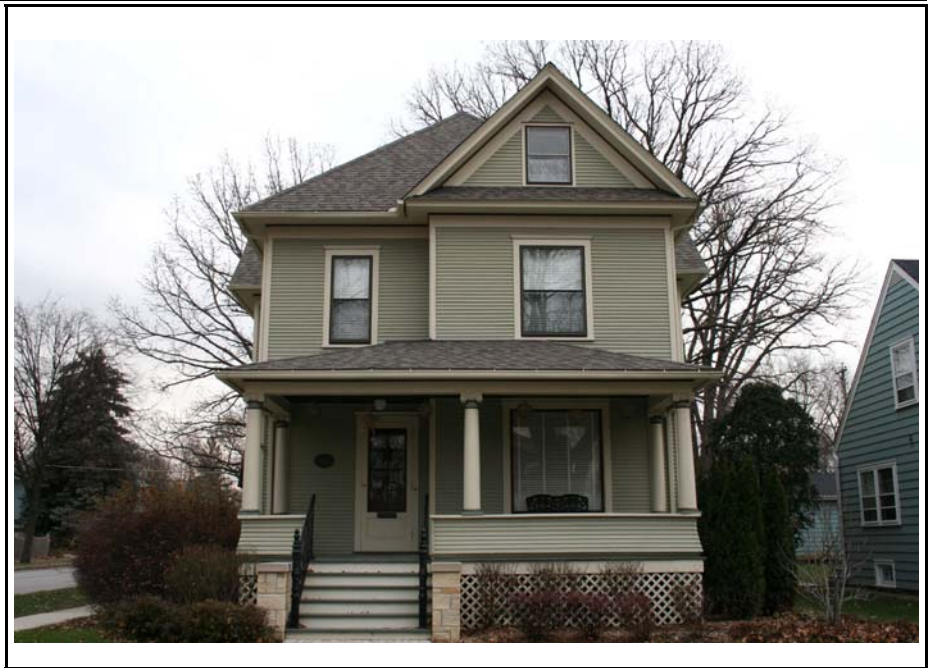
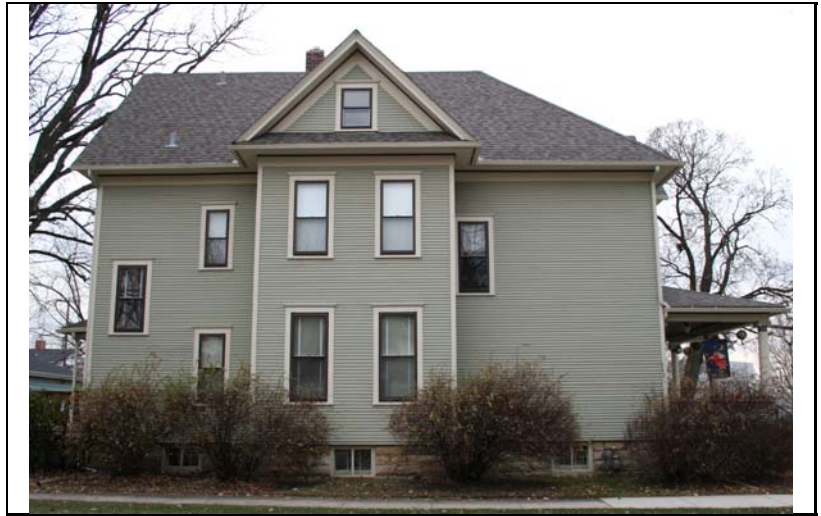
Replacement front door (not historic); front porch add./replacement S. porch (historic--c. 1905); S side door, surround, & canopy/stoop (not historic); glass block in basement windows (not historic); 6/6 replacement windows on N elevation (historic); aluminum canopy & stoop on N entry (not historic)

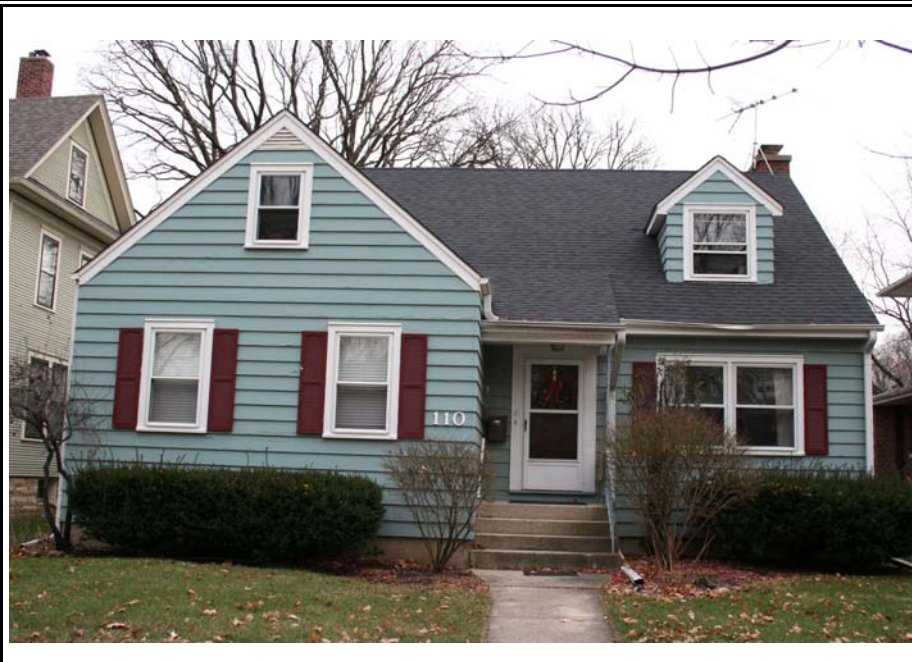
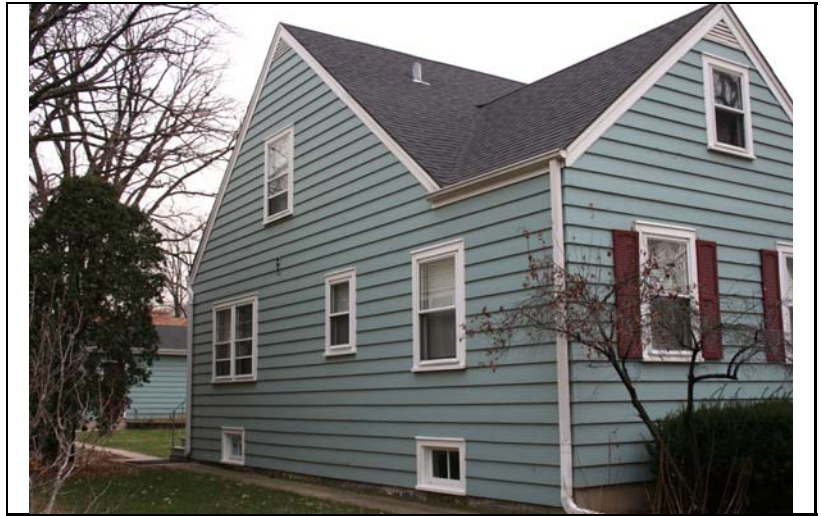
Aluminum siding (not historic); replacement front door/surround/stoop (not historic); 3-sided front window bay (historic); 2 story south/rear addition with entry; replacement windows in original openings (historic); replacement 2nd story window above entry in downsized opening (not historic); 2 & 1 story rear additions

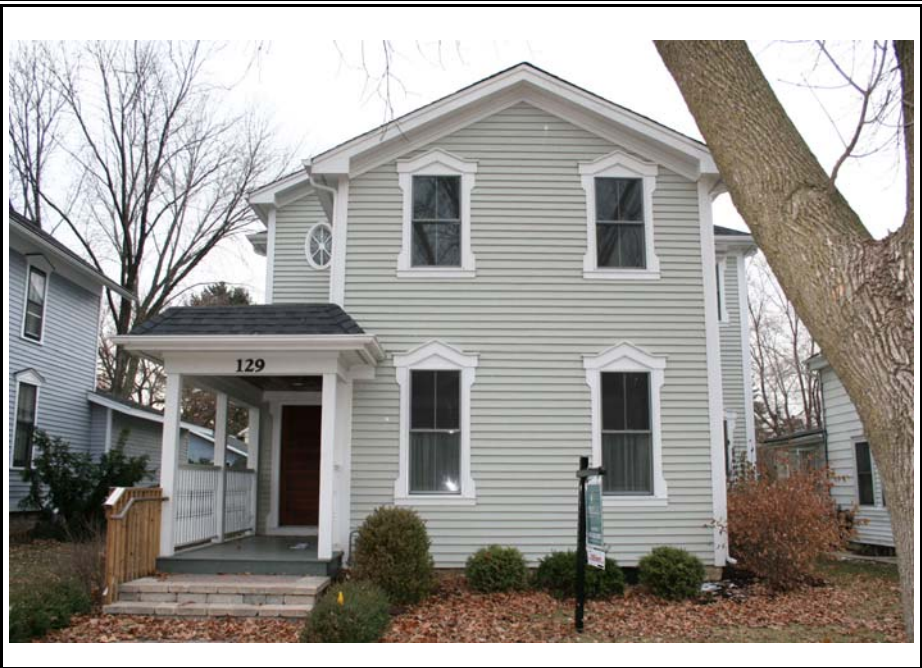
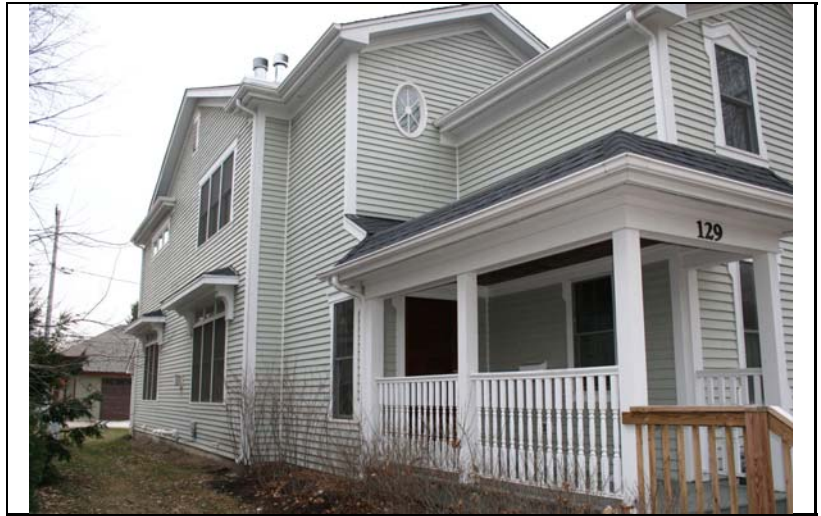
Paired brackets & dentils appear to be later (may be restoration); replacement windows on 2nd story or original structure (not historic); replacement door & transom (not historic); large 2 story S. side addition w/ corner tower (not historic); replacement porch (not historic--ghost lines on original house indicate that there was a full porch); 2 story rear addition (historic); 1 story north bay addition (not historic); segmental arch window on 2nd story north elevation (not historic); chimney (not historic); rear screened porch addition (not historic)

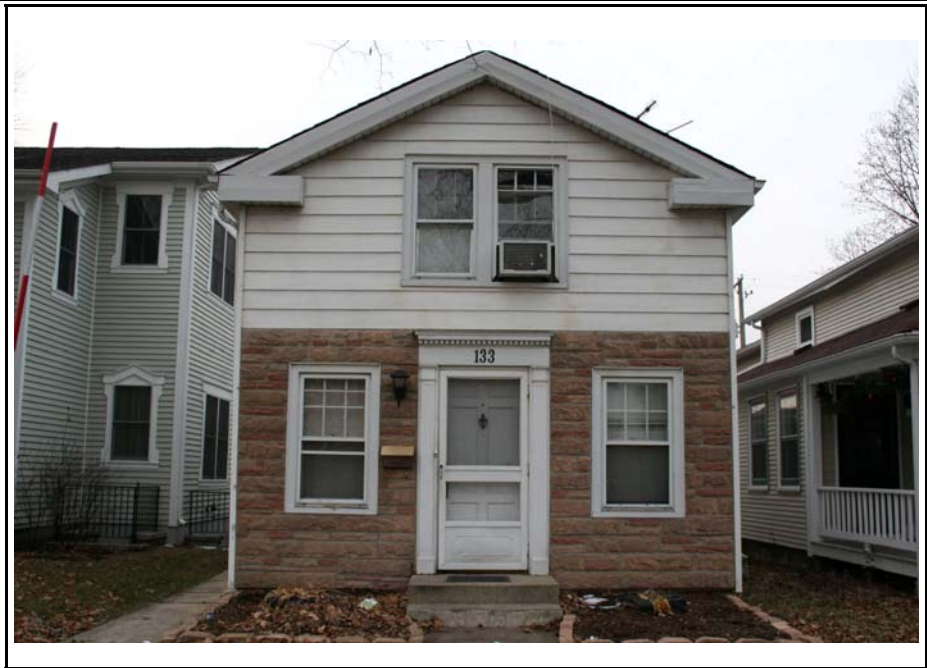
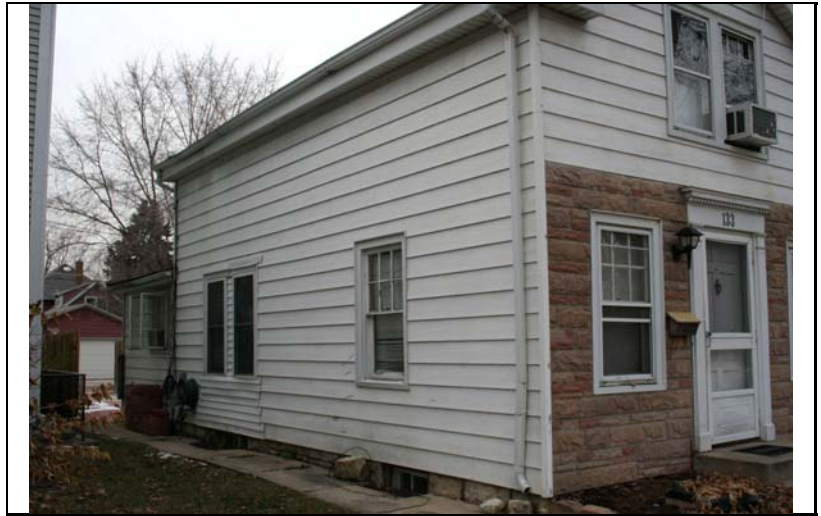
According to Sanborn Maps, house was originally a one-story structure that has been altered and added to over the years: 1 story south side addition is historic, but south porch appears to have been altered (replacement posts, railing, and steps, Aluminum under eaves); second story addition to original house is historic; first story on north addition was added before 1943, with 2nd story added after; aluminum siding; replacement windows in altered openings (not historic--house originally had a full porch and entry on front façade); multiple rear additions; stone steps to north side entry and stone patio at front of house (not historic)

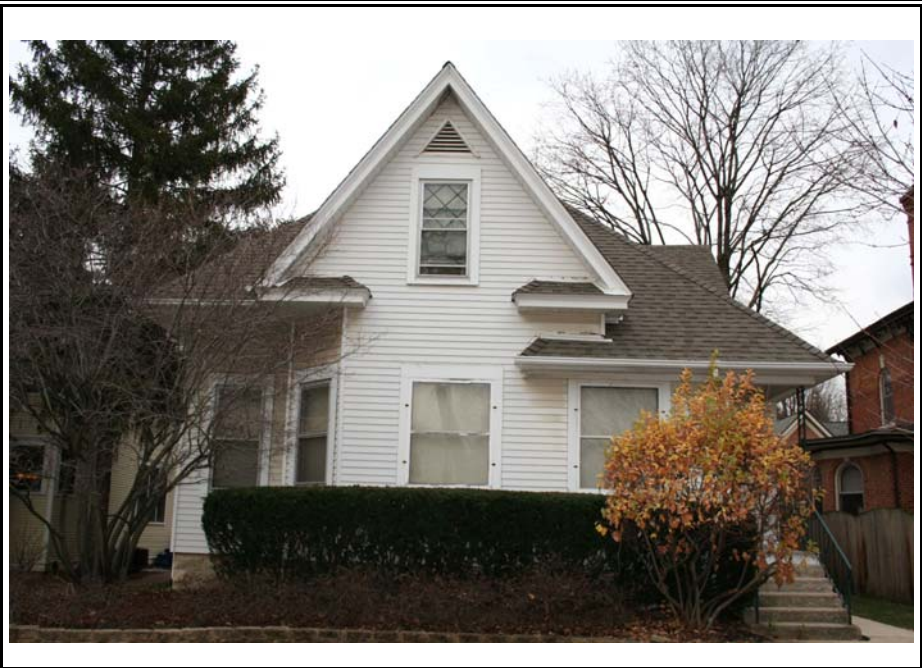
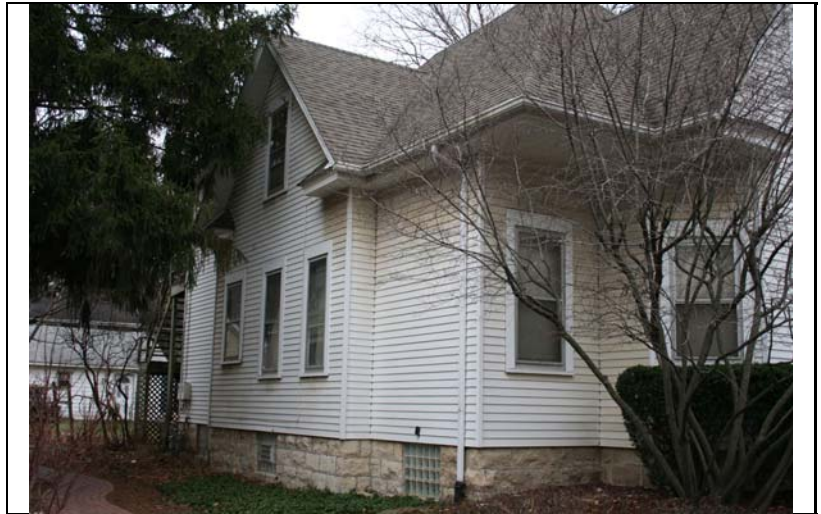
Replacement siding (not historic); replacement windows in original openings (not-historic); replacement door (not historic); replacement supports/railing on porch (not historic); 3-sided 1st story south window bay addition (not historic); large 2 story rear/south addition (not historic); rear porch addition (not historic)

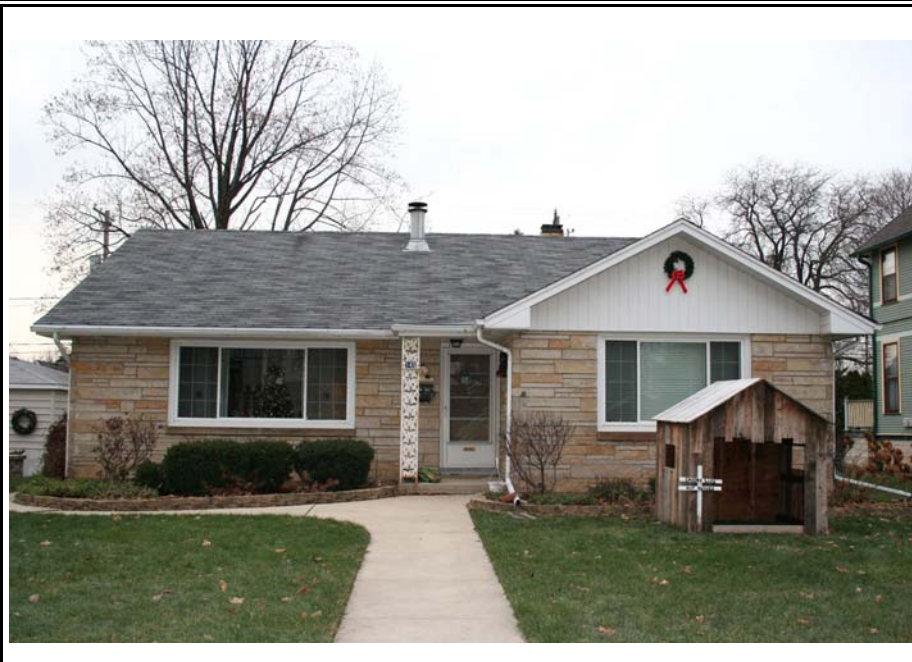
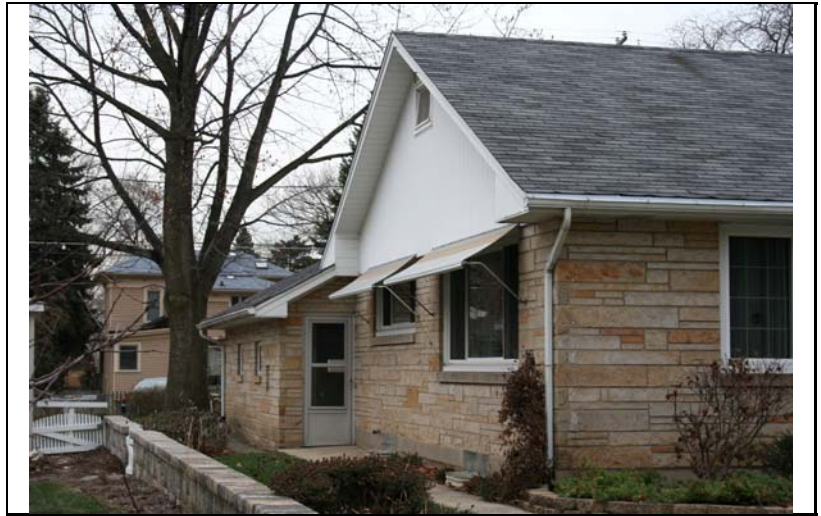
Recent renovation. Appropriate restoration work includes: replacement siding; replacement porch spindles and supports; replacement 1/1 windows; multi-light replacement windows on front bay; north entry porch; 1 story rear addition. Inappropriate alterations include glass block basement windows and a large 2-story addition to the south, including entry and porch, which is difficult to distinguish from the original massing of the home.

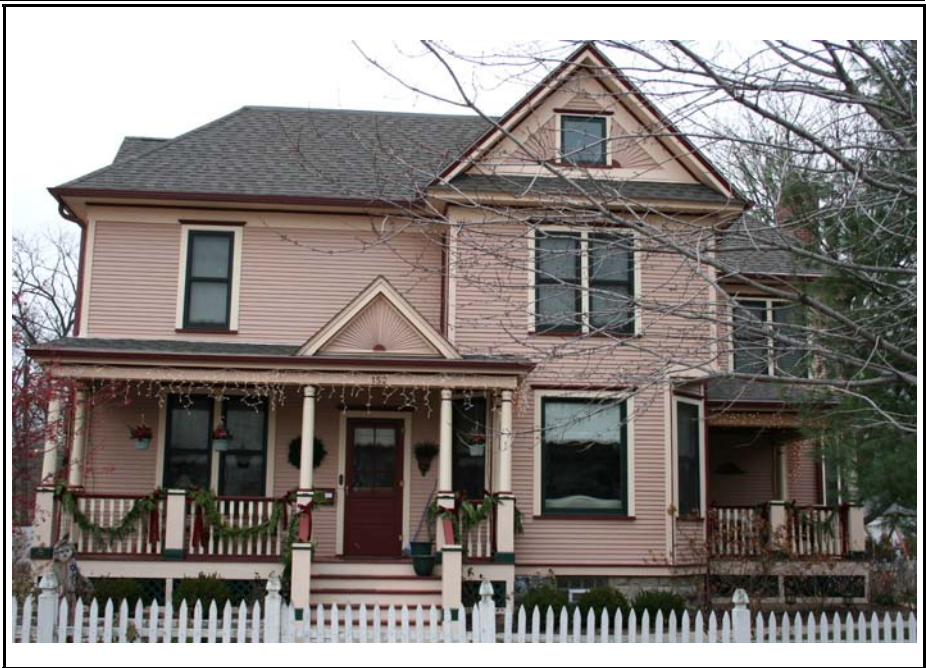
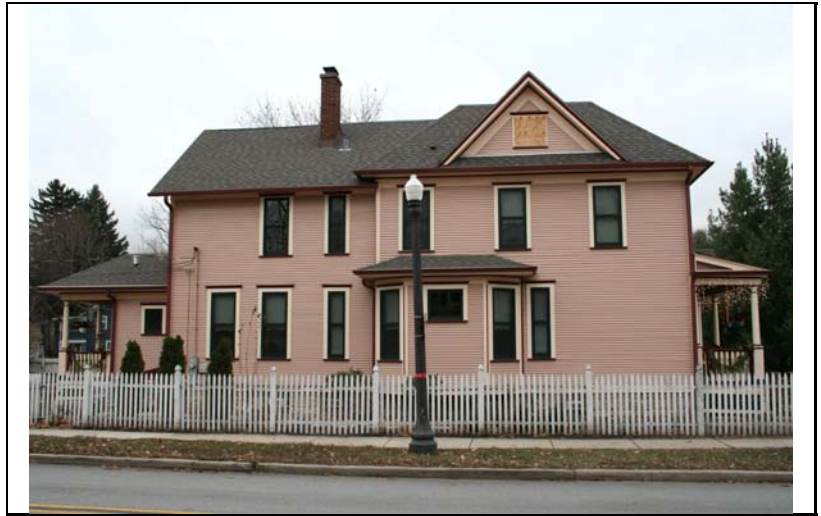
Aluminum siding; fixed shutters (not historic); original front entry replaced with window (historic); north entry & porch (not historic); replacement 6-light casement windows (historic); 2 story north addition (historic); south side porch extended (historic) & enclosed; 1 story rear addition (historic); rear exterior stair (not historic)
