# City of NAPERVILLE

## ILLINOIS URBAN ARCHITECTURAL AND HISTORICAL SURVEY CONTINUATION SHEET

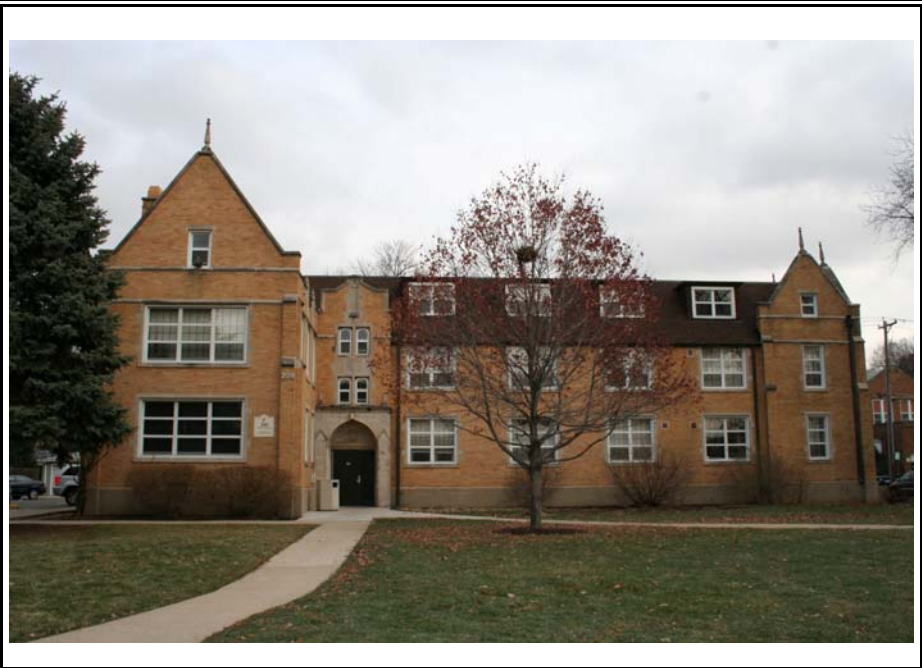
| CONDITION | <input type="text" value="excellent"/> | HISTORIC FUNCTION | <input type="text" value="Education - college"/> |
| INTEGRITY | <input type="text" value="minor alterations"/> | REASON for SIGNIFICANCE | <input type="text" value="Despite window alterations, this English Gothic dormitory remains a significant structure in the district."/> |

| SIGNIFICANT FEATURES | <input type="text" value="L-shaped massing; south and west gables and gable parapet walls; shed dormers; stone gothic entries with recessed rounded arches; crenellated parapet walls; stone quoin window surrounds"/> | | |
| ALTERATIONS | <input type="text" value="replacement windows in original openings (not historic); replacement doors (not historic); glass block replacement windows on north elevation"/> | | |

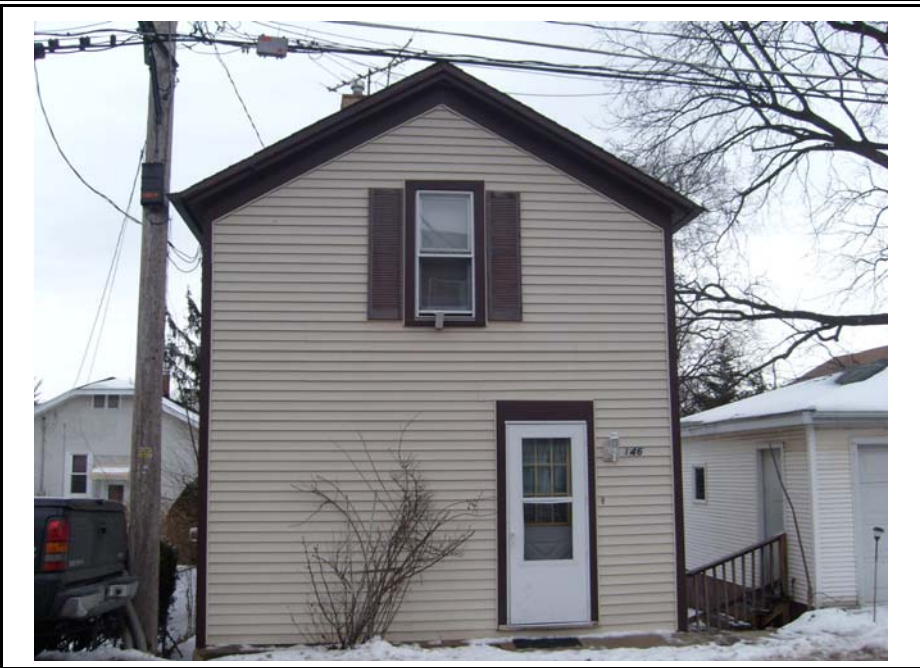
146b N LOOMIS

CATEGORY building CURRENT FUNCTION Domestic - secondary structure  
 CONDITION good HISTORIC FUNCTION Domestic - single dwelling  
 INTEGRITY major alterations and/or addition(s) REASON for SIGNIFICANCE  
 SECONDARY STRUCTURE

ARCHITECTURAL CLASSIFICATION Gable Front PLAN rectangular  
 DETAILS NO OF STORIES 1.5  
 BEGINYEAR c. 1915 ROOF TYPE Front gable  
 OTHER YEAR ROOF MATERIAL Asphalt - shingle  
 DATESOURCE Surveyor FOUNDATION Concrete - block  
 WALL MATERIAL (current) Vinyl PORCH -  
 WALL MATERIAL 2 (current) WINDOW MATERIAL Vinyl  
 WALL MATERIAL (original) Wood WINDOW MATERIAL  
 WALL MATERIAL 2 (original) WINDOW TYPE double hung  
 WINDOW CONFIG 1/1  
 SIGNIFICANT FEATURES Front gable roof and rectangular massing  
 ALTERATIONS Vinyl siding; replacement windows in original openings (not historic); first story window on front façade covered; downsized window on S. side (not historic); replacement front door; fixed shutters (not historic); below grade entry added to N. side

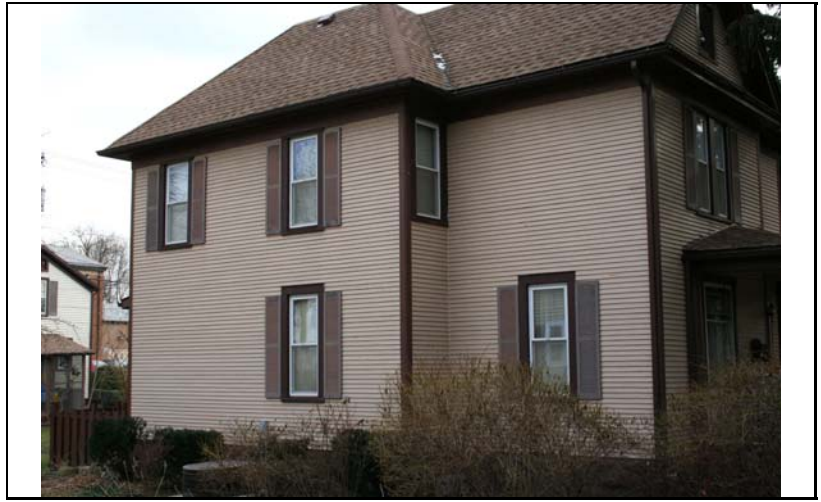
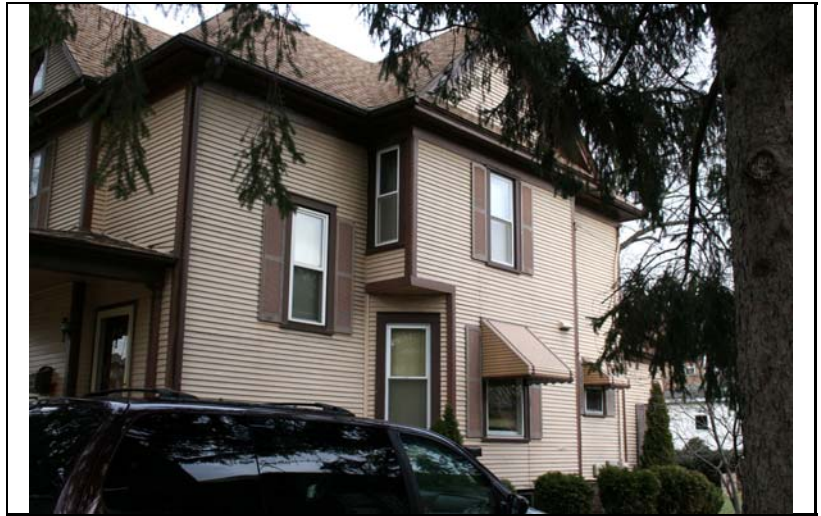
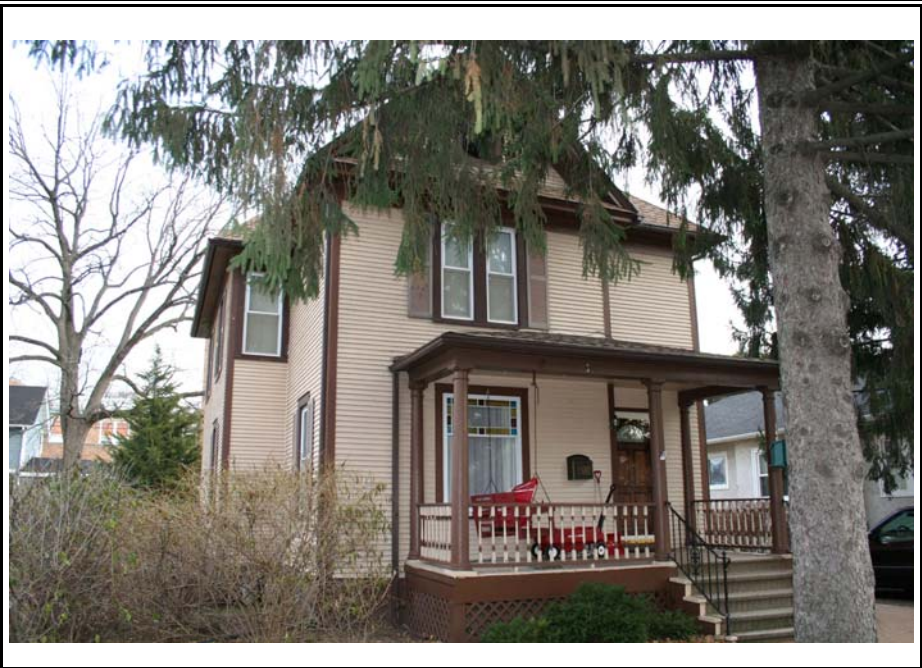
Aluminum siding; fixed shutters (not historic); replacement windows in original openings; 3-part window on front façade 1st story; multi-light wood window linking two first story windows on S. elevation; 2 story rear addition; 3-light & 2/2 windows on N. elevation (historic—1920s); original front entry at north end of front façade converted to window; rear porch addition (1920s)
