City of NAPERVILLE

ILLINOIS URBAN ARCHITECTURAL AND HISTORICAL SURVEY CONTINUATION SHEET

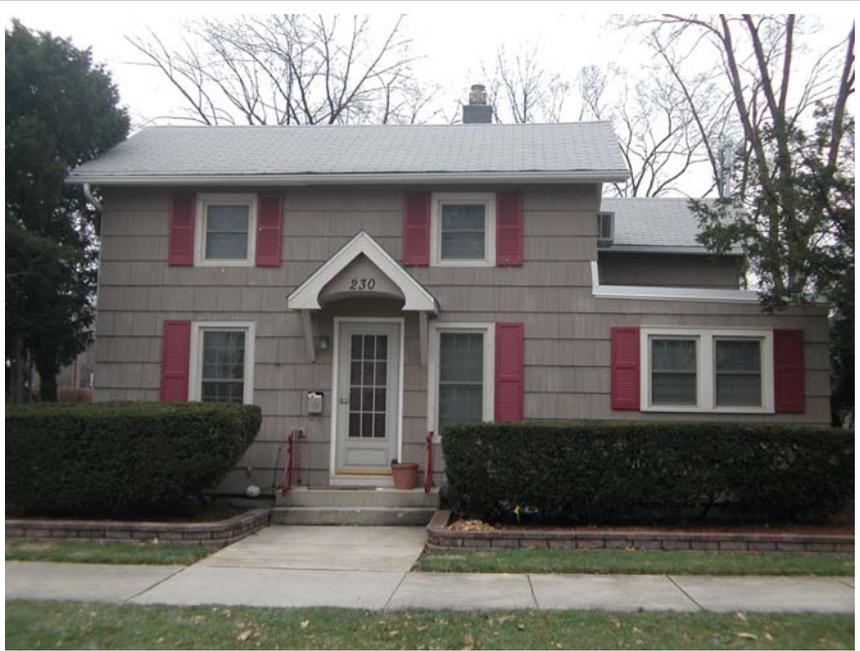
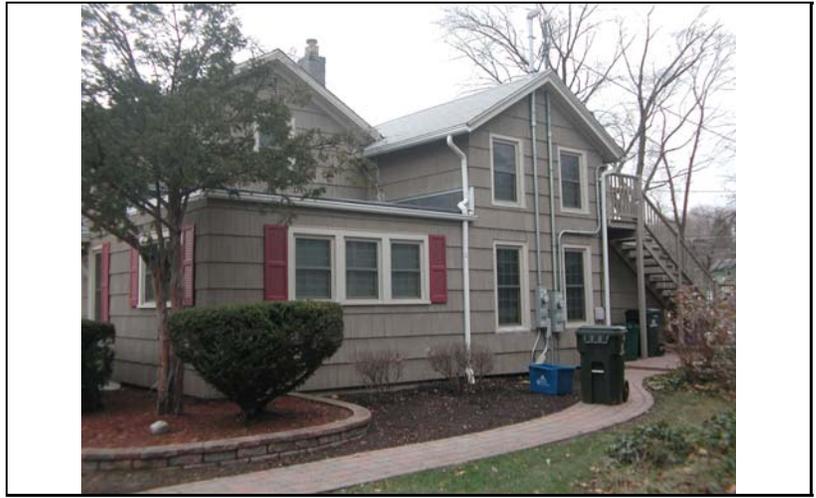
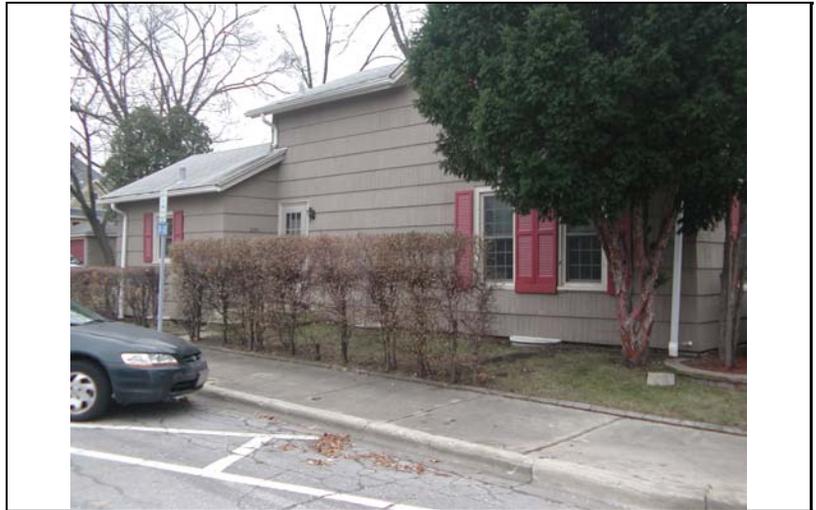
LANDSCAPE Southeast corner of North and Center; front and north sidewalks; rear alley; similar setbacks; mature trees

“This clapboard Italianate house on a limestone foundation was built about 1870. IT contains all of the distinctive characteristics of the style in excellent repair. It has scroll-cut cornices, incised with stars and containing knobbed pendants with the panels between the brackets in the cornice an dentils above. The generous window frames have both feet and shoulders. A segmental cornice, above, has slightly rounded corner boards. On the wing projecting south, on the ground floor, is a polygonal bay. The slightly lower service wing that projects to the east has the original metal roof, although it is now covered with tar. Added sometime in the second decade of the twentieth century was the porch set across the west and south facades. It has cast concrete columns. These are in the Tuscan order with flutes and egg and leaf molding in the echinus, a distinctive form of the order that derived from Renaissance pattern books popular during this period. The use of cast concrete for such an element is an important factor in the development of early twentieth-century building technology.”

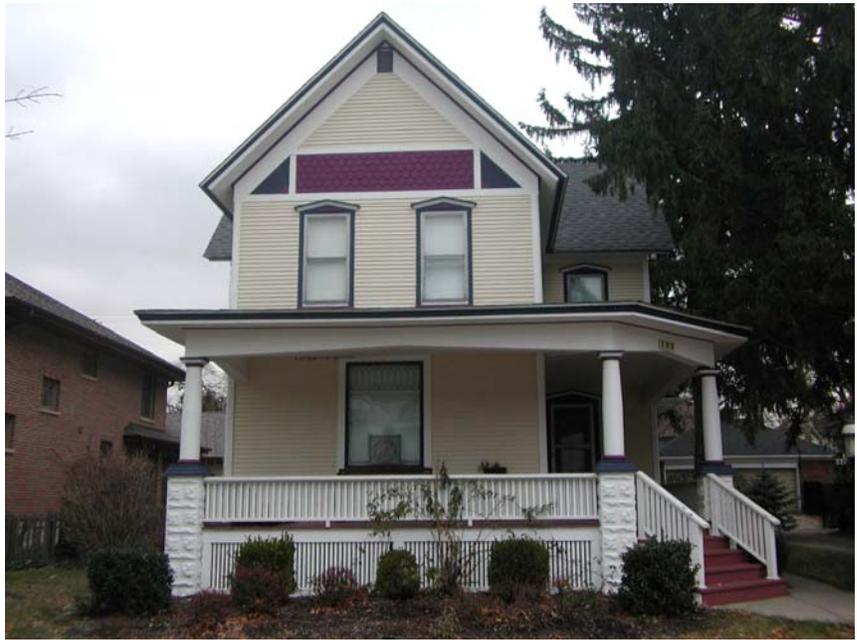
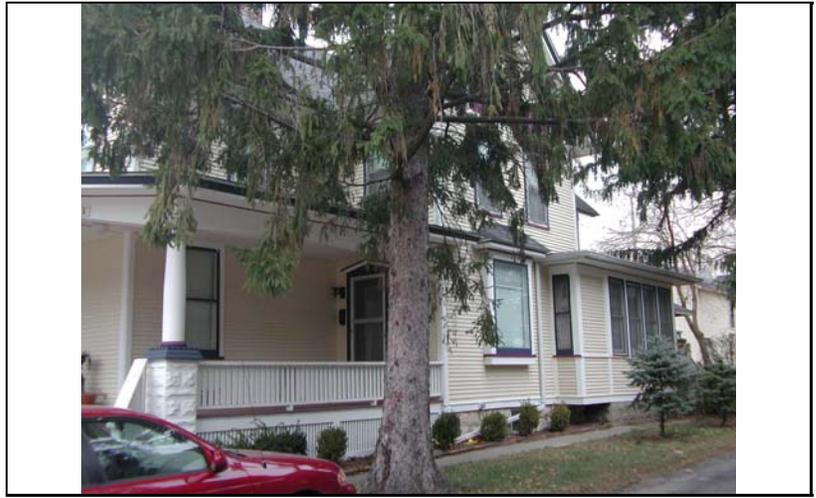
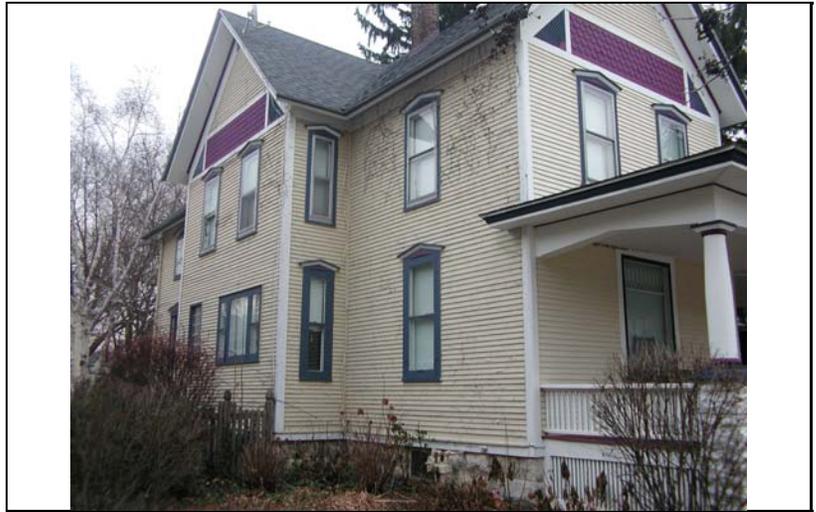
PERMITS 1892-1909 Sanborn maps show house with porch only along S. elevation, with wraparound porch first indicated on 1921 Sanborn.

LANDSCAPE Midblock on east side of residential street; front sidewalk; rear alley; similar setbacks; mature trees

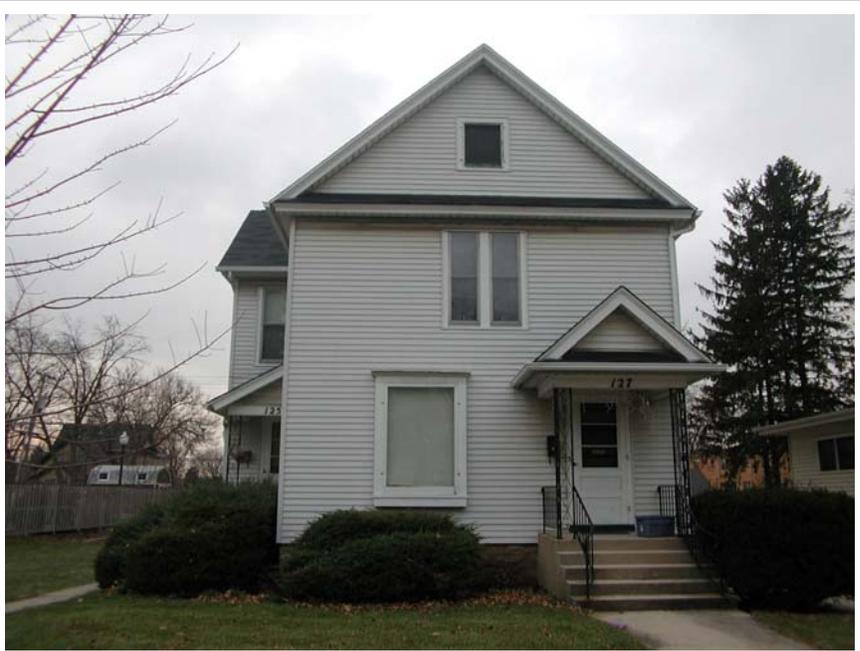
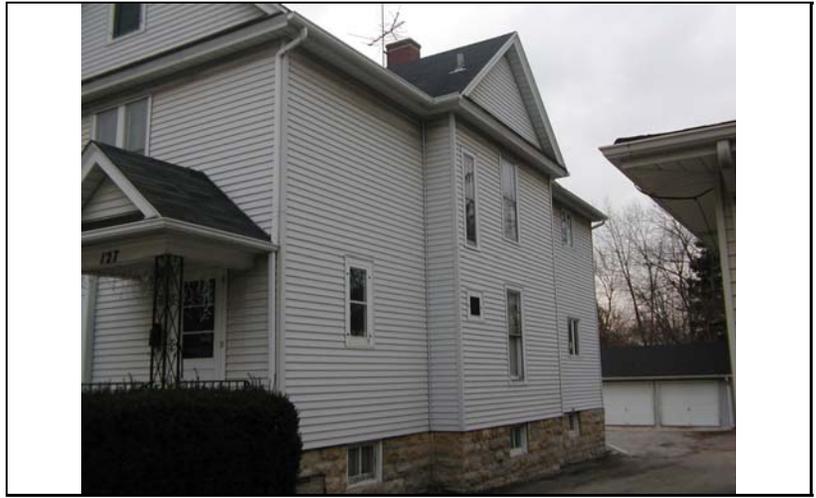
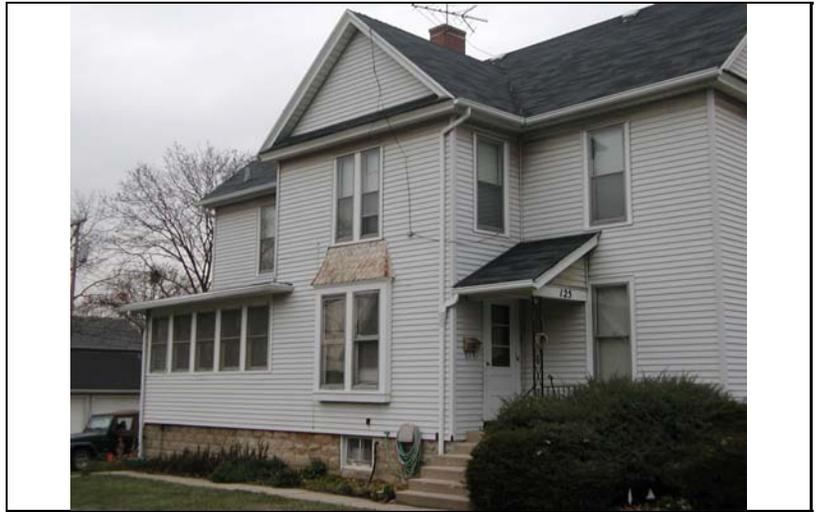
125-127 N CENTER

CATEGORY building CURRENT FUNCTION Domestic - multiple dwelling
 CONDITION good HISTORIC FUNCTION Domestic - single dwelling
 INTEGRITY minor alterations and addition(s) REASON for SIGNIFICANCE
 SECONDARY STRUCTURE Detached garage

ARCHITECTURAL CLASSIFICATION Gabled Ell PLAN L
 DETAILS NO OF STORIES 2.5
 BEGINYEAR c. 1905 ROOF TYPE Front gable
 OTHER YEAR ROOF MATERIAL Asphalt - shingle
 DATESOURCE Surveyor FOUNDATION Stone/Concrete block
 WALL MATERIAL (current) Aluminum PORCH Front/side entry
 WALL MATERIAL 2 (current) WINDOW MATERIAL Wood
 WALL MATERIAL (original) Wood WINDOW MATERIAL
 WALL MATERIAL 2 (original) WINDOW TYPE double hung/fixd
 WINDOW CONFIG 1/1; 1-light
 SIGNIFICANT FEATURES Pedimented front gable with two story side gable ell; historic 1/1 wood windows
 ALTERATIONS Aluminum siding; replacement railings, supports & steps on front & side entry porches (not historic); rear/S. porch enclosed (not historic); replacement front & side doors (not historic); replacement casement windows on rear/N side (not historic)

PERMITS 1909 Sanborns show front & S. side porches in same positions as current. Full front porch was put on between 1910 and 1920, and was removed some time after 1943.

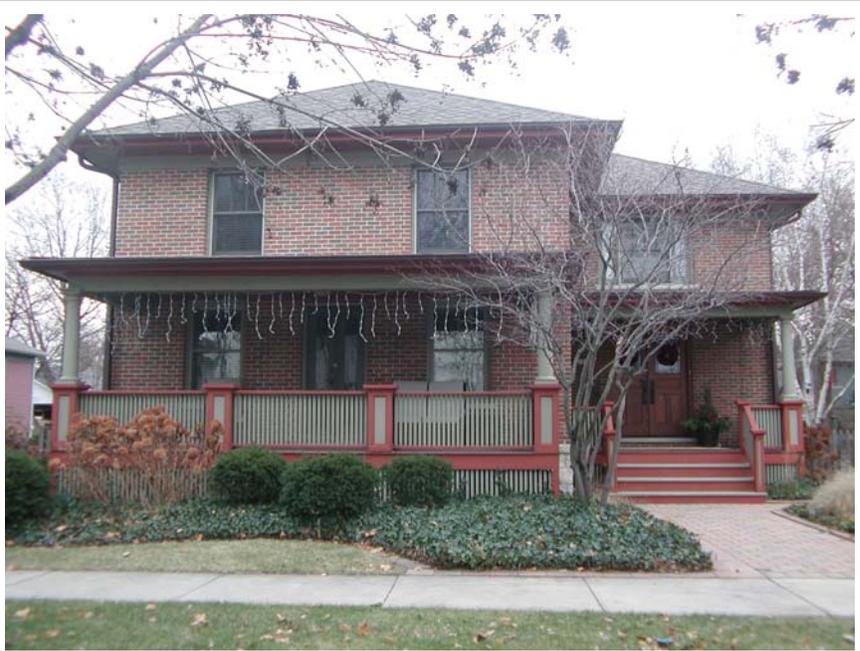
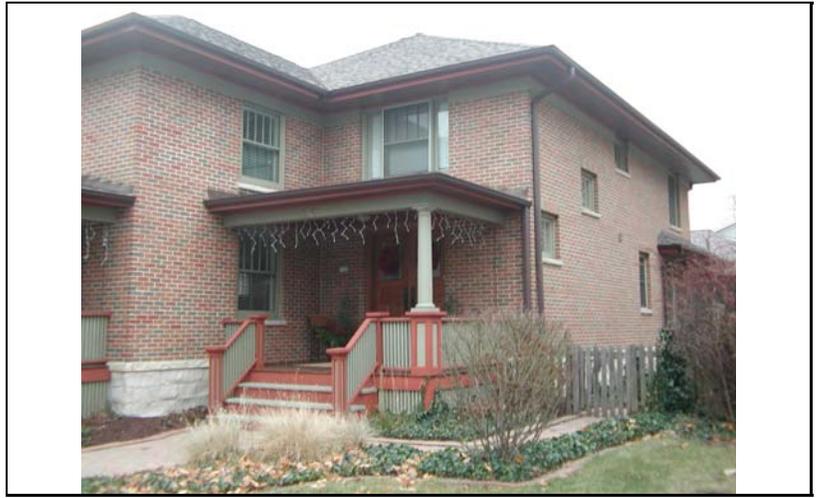
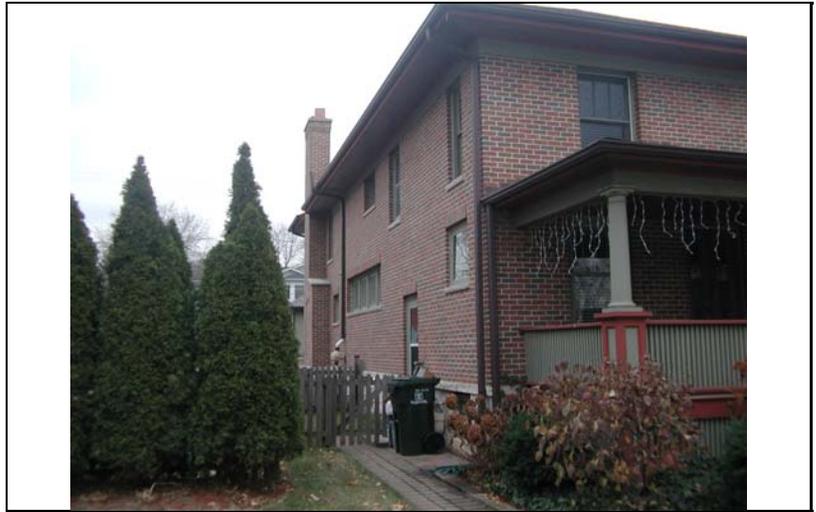
PERMITS Sanborns indicate that house may have dated from c. 1895, and was remodeled between 1909 and 1921.

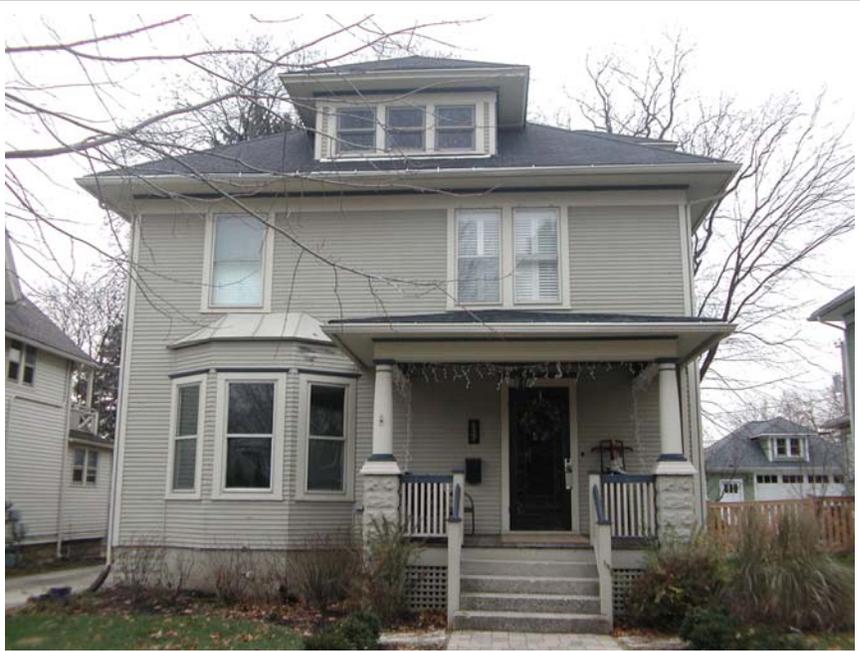
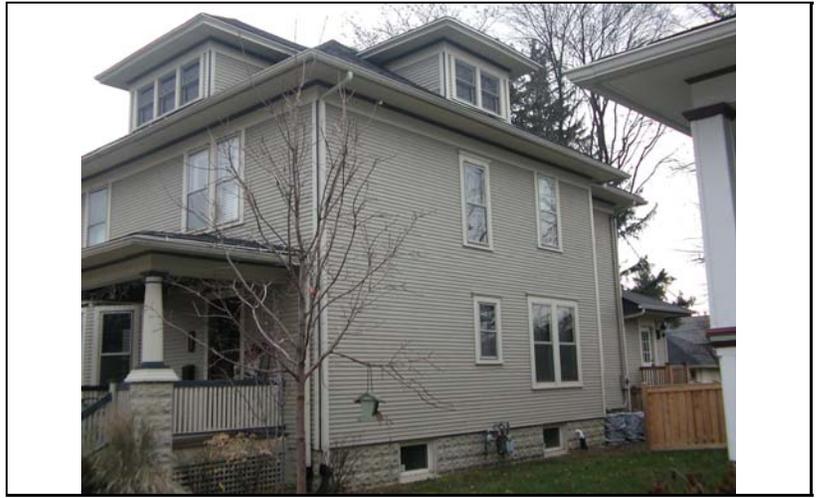
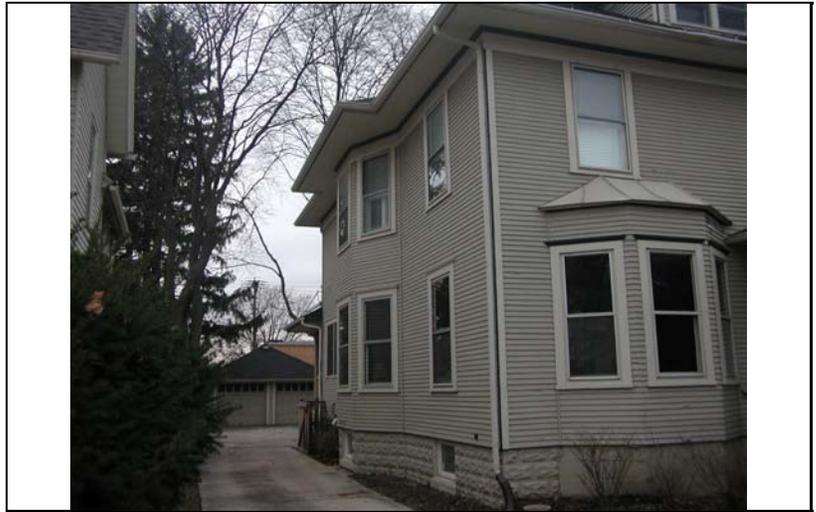
PERMITS 1921, '26, and '43 Sanborn Maps show a full-width front porch on the house.

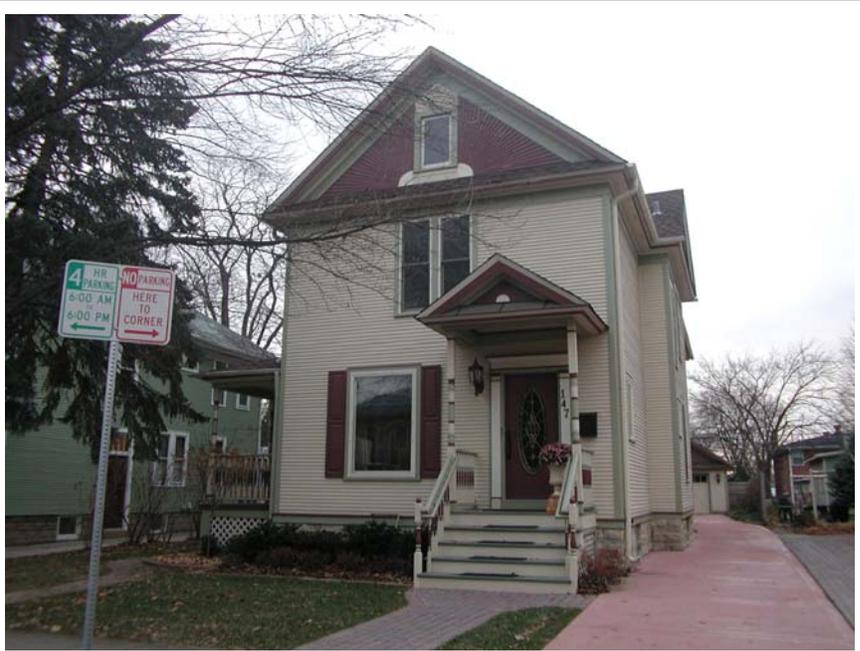
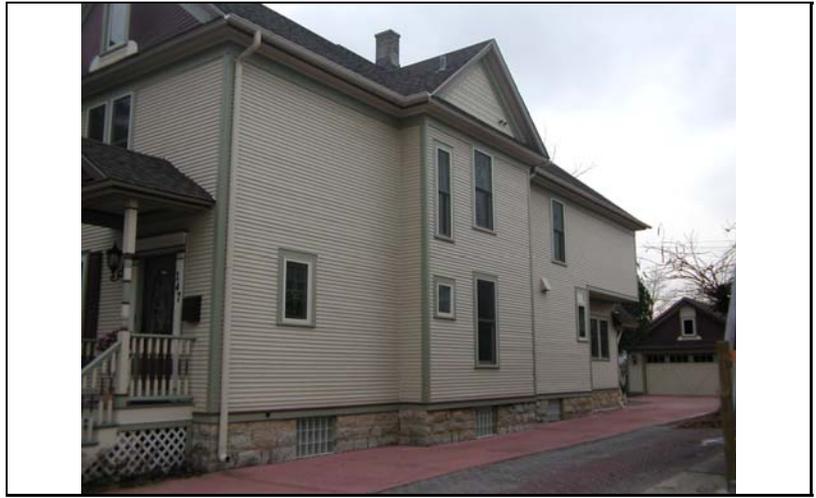
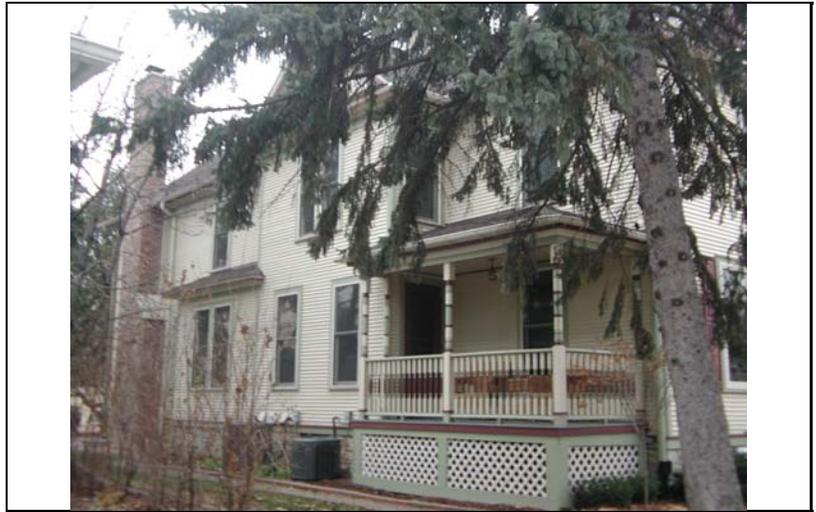
Replacement 1/1 windows in original openings (not historic); fixed window on 1st story façade (not historic); replacement front & S. porches (not historic); replacement siding; replacement front & side doors (not historic); 1-story south add.; 2-story rear add.; glass block basement windows; fixed shutters

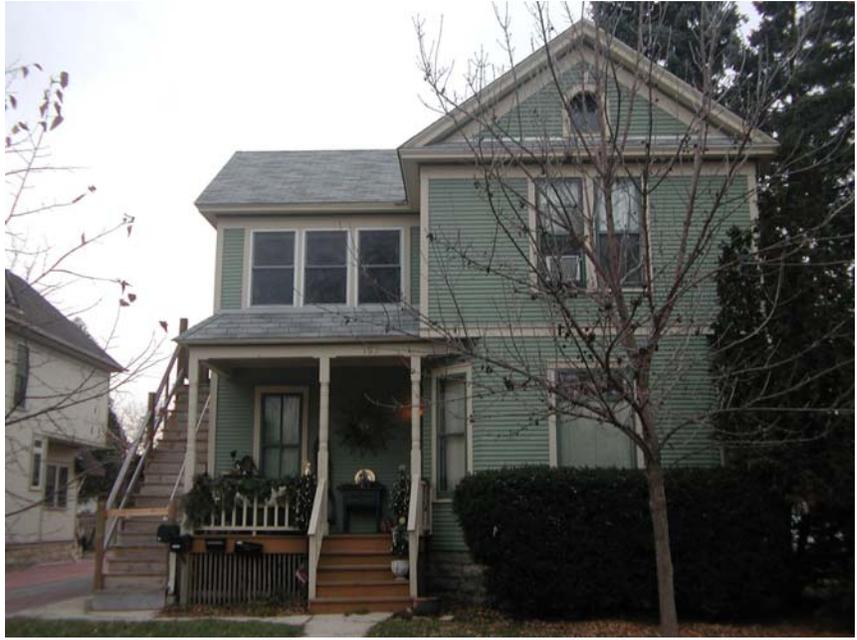
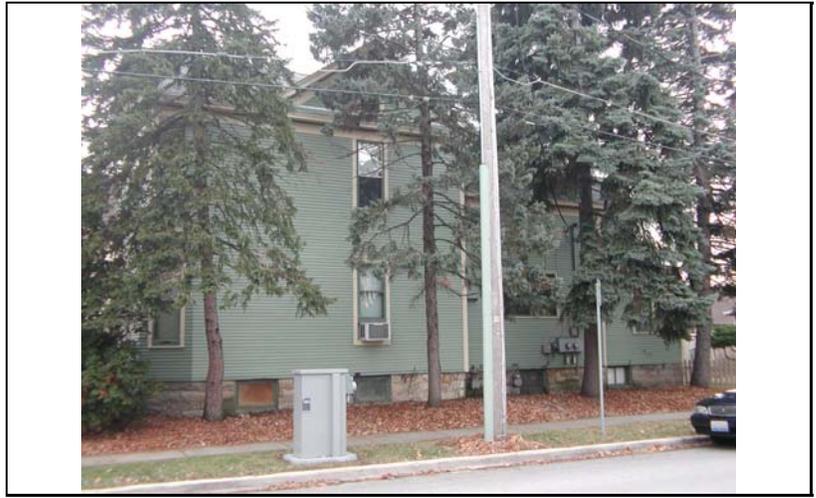
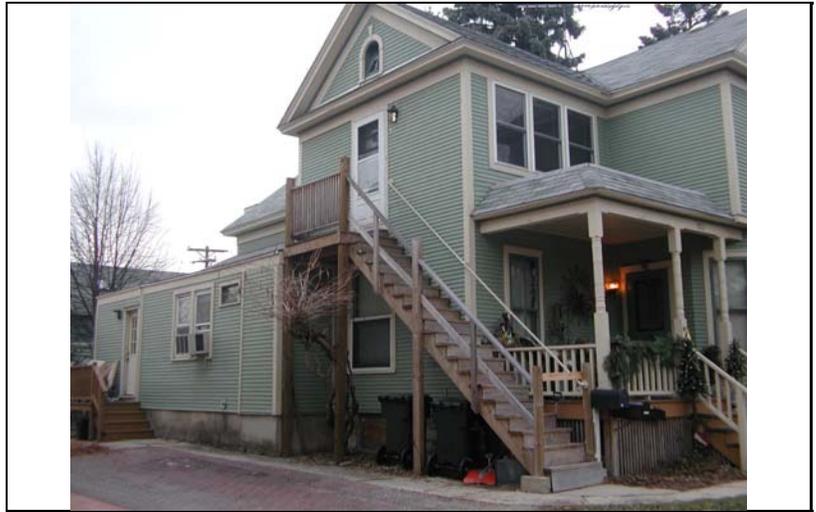
Replacement windows on 2nd story of south bay (not historic); door w/ exterior stair added to south bay (not historic) ; replacement porch (does not appear to be historic); 1 story south addition; two and one-story rear additions (historic); stained glass in front window does not appear to be historic

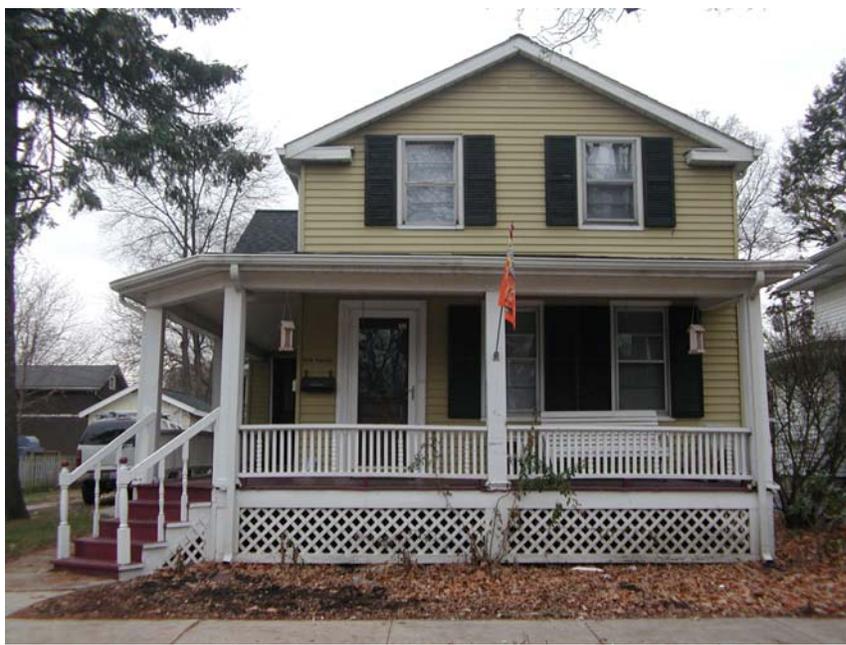
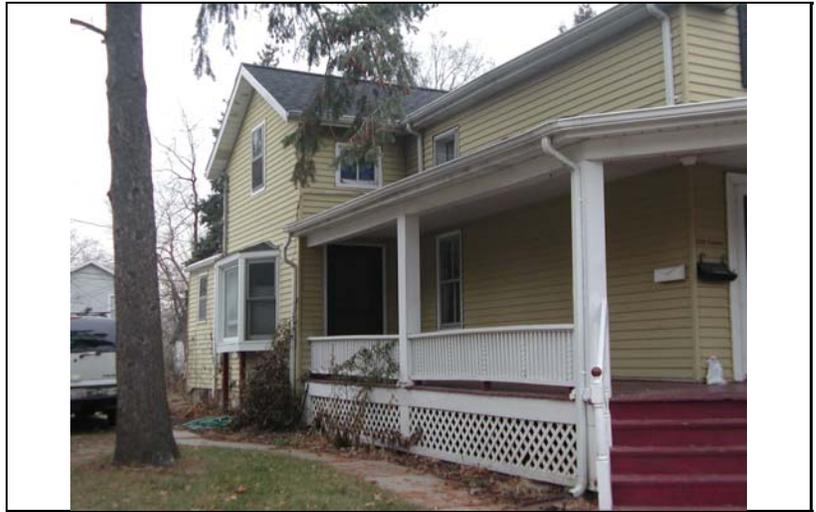
Aluminum siding; wraparound porch (not historic); 3-sided south window bay addition (not historic); early 1 story rear addition; replacement 2/2 horizontal windows in original openings (1950s); fixed shutters (not historic); replacement doors (not historic); rear/north exterior stair add.(not historic)

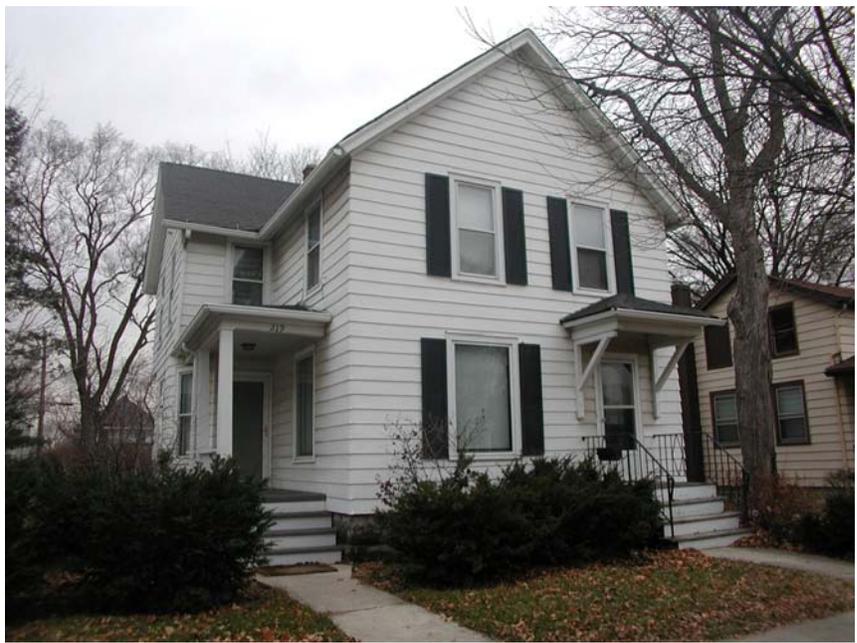
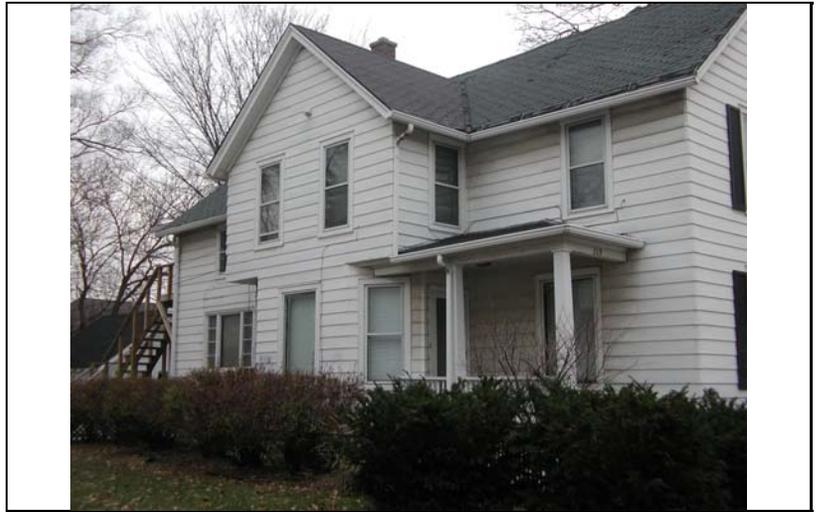
Aluminum siding; replacement front stoop w/ wrought iron railings (not historic); replacement supports and railings on south porch (not historic); fixed shutters (not historic); three-part window on south/rear (not historic); exterior stair addition (not historic); south door is replacement
