Architectural Resources in the Naperville Local Historic District Survey Area Naperville, Illinois A Summary and Inventory

Prepared for the City of Naperville by: Granacki Historic Consultants 1105 West Chicago Avenue, Suite 201 Chicago, IL 60622

2008

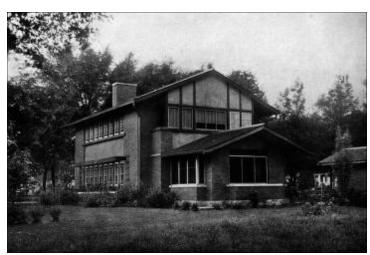
Rollo Giivler House 144 S. Sleight Street

Rollo M. Givler, the owner of an early and important Naperville newspaper named *The Clarion*, also lived in the area. His house at 144 South Sleight was designed in 1915 by Prairie School architect Harry Robinson, who worked in the offices of Frank Lloyd Wright and Walter Burley Griffith.

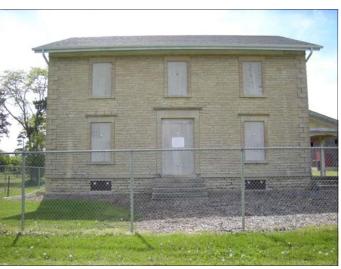
Clow Stone House 11236 S. Book Road

Stone House on Book Road. Constructed in 1868 for Thomas Clow, the house features a handsome stone exterior and simple but fine classical detailing, including window and door sills and corner quoins. The house is a designated local landmark.

The Naperville Local Historic District contains seven Greek Revival style homes. Two (the Clow Stone House at 11236 S. Book Road and 209 East Jefferson) are rated significant, three are rated potentially significant, and two are rating contributing. Of these, the best example is the Clow

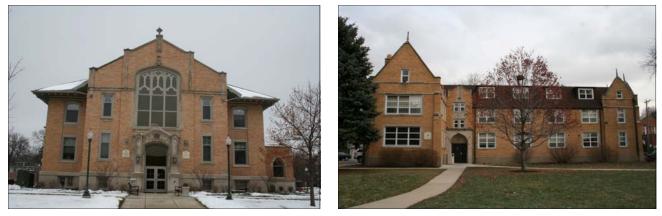
329 School Street

There are three institutional buildings in the Naperville Local Historic District that are designed in the Collegiate Gothic Revival Style, which was popular in the early 20th century.
