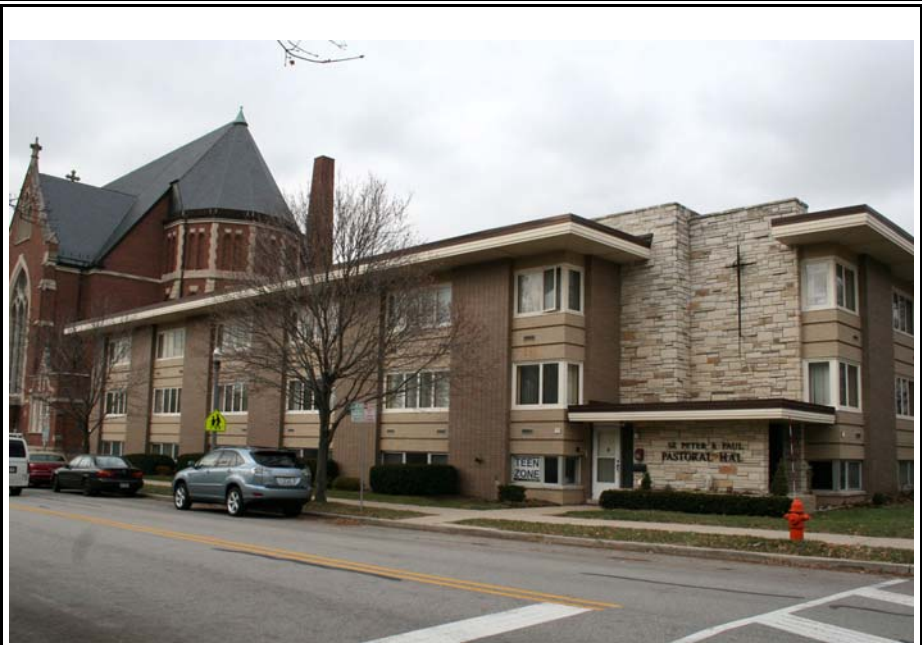
CATEGORY	building	CURRENT FUNCTION	Religion - religious facility
CONDITION	good	HISTORIC FUNCTION	Religion - religious facility
INTEGRITY	minor alterations	REASON for SIGNIFICANCE	
SECONDARY STRUCTURE

ARCHITECTURAL CLASSIFICATION	Late Prairie	PLAN	rectangular
DETAILS		NO OF STORIES	2
BEGINYEAR	1960	ROOF TYPE	Flat
OTHER YEAR		ROOF MATERIAL	Not visible
DATESOURCE	Date panel	FOUNDATION	Concrete - poured
WALL MATERIAL (current)	Stone veneer	PORCH	-
WALL MATERIAL 2 (current)	Brick	WINDOW MATERIAL	Metal
WALL MATERIAL (original)	Stone veneer	WINDOW MATERIAL	
WALL MATERIAL 2 (original)	Brick	WINDOW TYPE	casement
		WINDOW CONFIG	1-light
SIGNIFICANT FEATURES	Flat roofline with overhangs, ribbon windows separated by horizontal banding		
ALTERATIONS

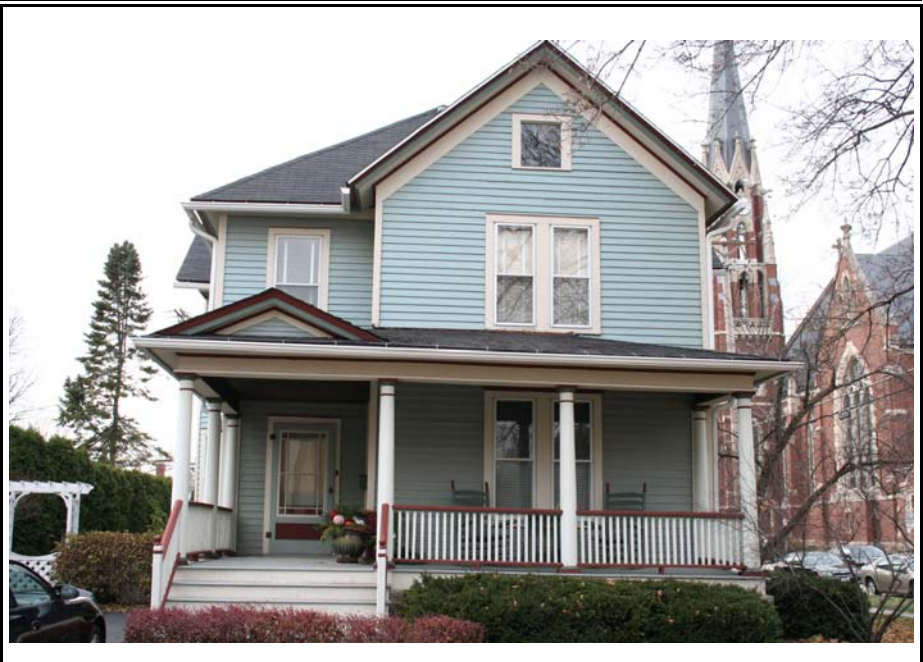
CATEGORY	building	CURRENT FUNCTION	Domestic - single dwelling
CONDITION	excellent	HISTORIC FUNCTION	Domestic - single dwelling
INTEGRITY	minor alterations and addition(s)	REASON for SIGNIFICANCE	Fine, intact example of early 20th century Queen Anne - Free Classic.
SECONDARY STRUCTURE

ARCHITECTURAL CLASSIFICATION	Queen Anne - Free Classic	PLAN	irregular
DETAILS		NO OF STORIES	2.5
BEGINYEAR	c. 1900	ROOF TYPE	Gable on hip
OTHER YEAR		ROOF MATERIAL	Asphalt - shingle
DATESOURCE	surveyor	FOUNDATION	Concrete - block
WALL MATERIAL (current)	Wood	PORCH	Full front
WALL MATERIAL 2 (current)		WINDOW MATERIAL	Wood
WALL MATERIAL (original)	Wood	WINDOW MATERIAL	aluminum
WALL MATERIAL 2 (original)		WINDOW TYPE	double hung/fixed
		WINDOW CONFIG	1/1; 1-light
SIGNIFICANT FEATURES	Hipped roof with front, north and south side gabled bays; front porch with classical columns and pediment over porch entry; recessed south end entry; historic 1/1 single and double hung windows		
ALTERATIONS	Two story rear addition (may have originally been historic one story addition with 2nd story added later); north/rear entry porch; replacement gable windows in original openings (not historic)

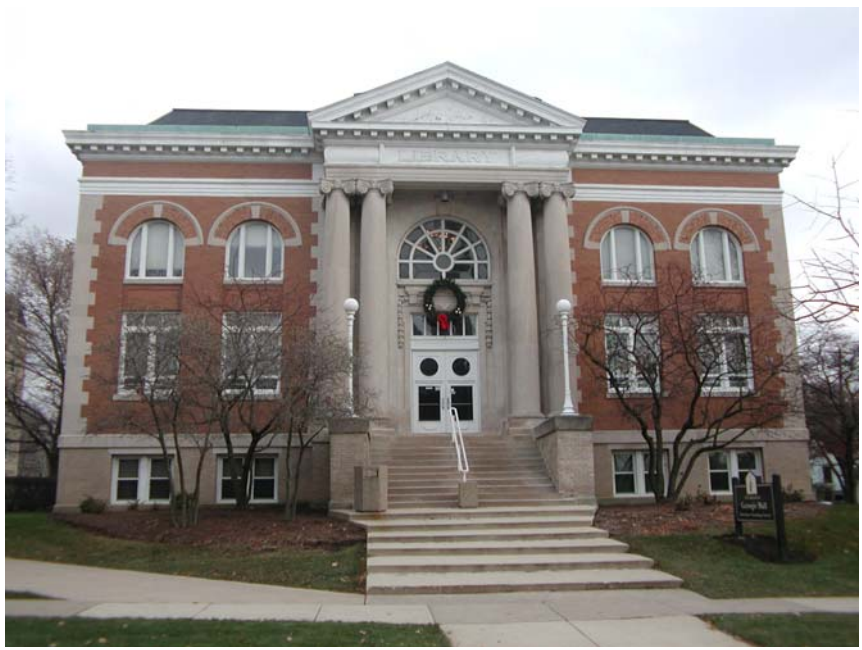
CATEGORY	building	CURRENT FUNCTION	Education - college
CONDITION	good	HISTORIC FUNCTION	Education - library
INTEGRITY	minor alterations	REASON for SIGNIFICANCE	The pedimented front portico with massive paired Ionic columns distinguishes this Classical Revival structure. The building is one of only a handful of Carnegie Libraries constructed on college campuses.
SECONDARY STRUCTURE

ARCHITECTURAL CLASSIFICATION	Classical Revival	PLAN	Rectangular
DETAILS		NO OF STORIES	3
BEGINYEAR	1908	ROOF TYPE	Hipped
OTHER YEAR		ROOF MATERIAL	Not visible
DATESOURCE	NCC	FOUNDATION	Concrete - poured
WALL MATERIAL (current)	Brick	PORCH	Front portico
WALL MATERIAL 2 (current)	Stone	WINDOW MATERIAL	Aluminum/Wood
WALL MATERIAL (original)	Brick	WINDOW MATERIAL	Beveled glass
WALL MATERIAL 2 (original)	Stone	WINDOW TYPE	Casement/double hung/fix
		WINDOW CONFIG	1-light; multi-light
SIGNIFICANT FEATURES	Hipped roof w/ modillion cornice; center full height portico w/ massive paired stone Ionic columns and triangular pediment; stone entry w/ garland and round arch multi-light transom--SEE CONTINUATION SHEET		
ALTERATIONS	Building rehabbed in 1980s--replacement windows in original openings (configurations may be different--not historic); replacement front doors and transom

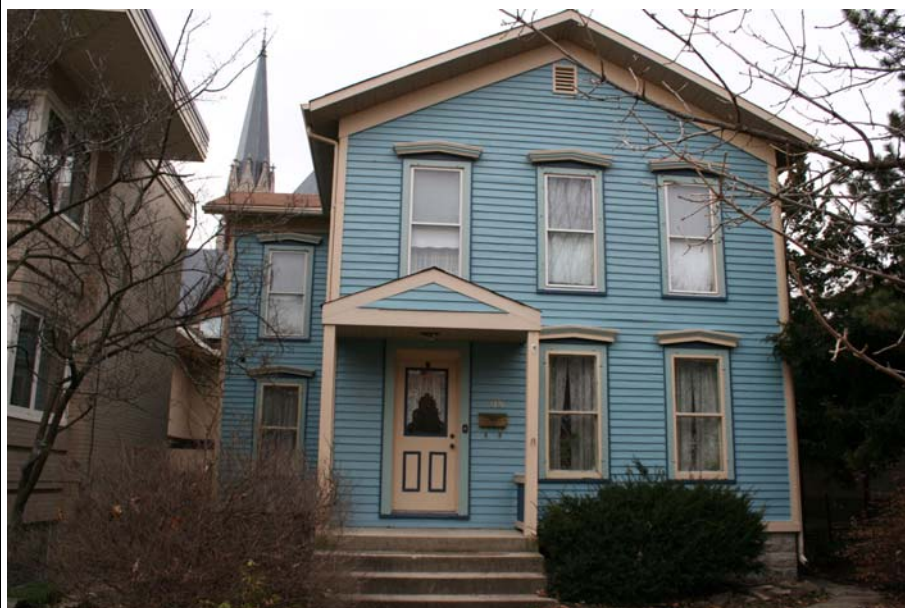
CATEGORY	building	CURRENT FUNCTION	Domestic - single dwelling
CONDITION	good	HISTORIC FUNCTION	Domestic - single dwelling
INTEGRITY	minor alterations and addition(s)	REASON for SIGNIFICANCE	This handsome Italianate remains notable as an intact local example of the style, despite several historic additions, including a 1905 front porch, replacement windows, and rear addition .
SECONDARY STRUCTURE

ARCHITECTURAL CLASSIFICATION	Gabled Ell	PLAN	L
DETAILS	Italianate	NO OF STORIES	2
BEGINYEAR	c. 1875	ROOF TYPE	Front gable
OTHER YEAR		ROOF MATERIAL	Asphalt - shingle
DATESOURCE	Surveyor	FOUNDATION	Concrete - block
WALL MATERIAL (current)	Wood	PORCH	Front entry
WALL MATERIAL 2 (current)		WINDOW MATERIAL	Wood
WALL MATERIAL (original)	Wood	WINDOW MATERIAL	
WALL MATERIAL 2 (original)		WINDOW TYPE	double hung
		WINDOW CONFIG	1/1
SIGNIFICANT FEATURES	Front gable bay with side (south) gabled ell; historic (not original---c. 1900) 1/1 wood windows with pediment lintels; south end entry; historic siding		
ALTERATIONS	Front porch addition (not historic); replacement front door and surround (not historic); 2 story rear addition

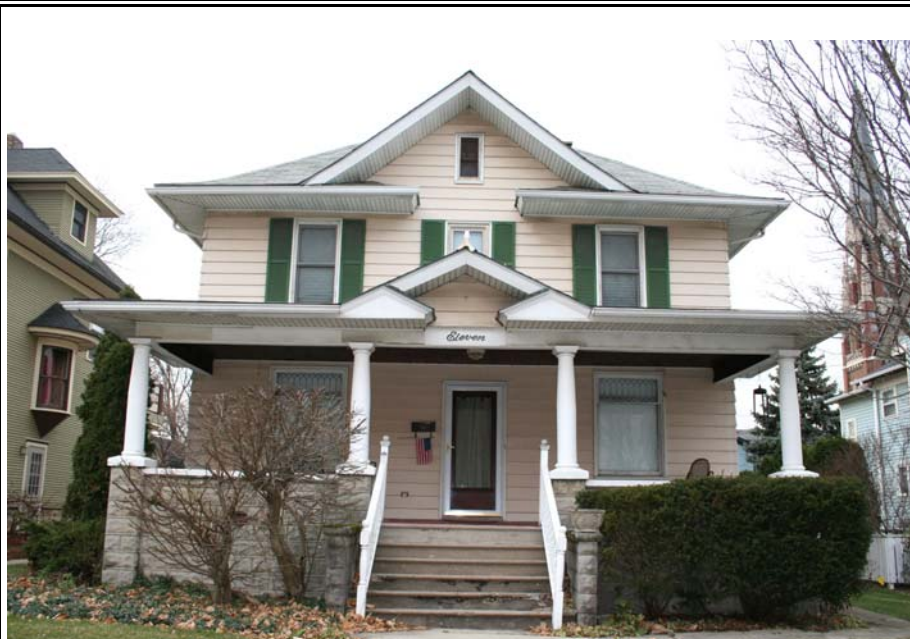
CATEGORY	building	CURRENT FUNCTION	Domestic - single dwelling
CONDITION	good	HISTORIC FUNCTION	Domestic - single dwelling
INTEGRITY	minor alterations	REASON for SIGNIFICANCE	Unusual example of the style, with center gable and deep cornice returns on front elevation.
SECONDARY STRUCTURE	Detached garage

ARCHITECTURAL CLASSIFICATION	Colonial Revival	PLAN	rectangular
DETAILS		NO OF STORIES	2.5
BEGINYEAR	c. 1915	ROOF TYPE	Hipped
OTHER YEAR		ROOF MATERIAL	Asphalt - shingle
DATESOURCE	Surveyor	FOUNDATION	Concrete - block
WALL MATERIAL (current)	Aluminum	PORCH	Full front
WALL MATERIAL 2 (current)		WINDOW MATERIAL	Wood/Aluminum
WALL MATERIAL (original)	Wood	WINDOW MATERIAL	leaded glass
WALL MATERIAL 2 (original)		WINDOW TYPE	Single & Double hung
		WINDOW CONFIG	1/1; LG/1; 8/8
SIGNIFICANT FEATURES	Flared hipped roof with overhanging eaves; front and north side gables w/ deep cornice returns; historic hipped porch w/ rounded columns on concrete block piers (probably an historic alteration)--SEE CONTINUATION SHEET		
ALTERATIONS	Aluminum siding (not historic); replacement 1/1 windows in original openings (not historic); fixed shutters (not historic); 1 story rear addition; 8/8 wood windows on south elevation (historic)

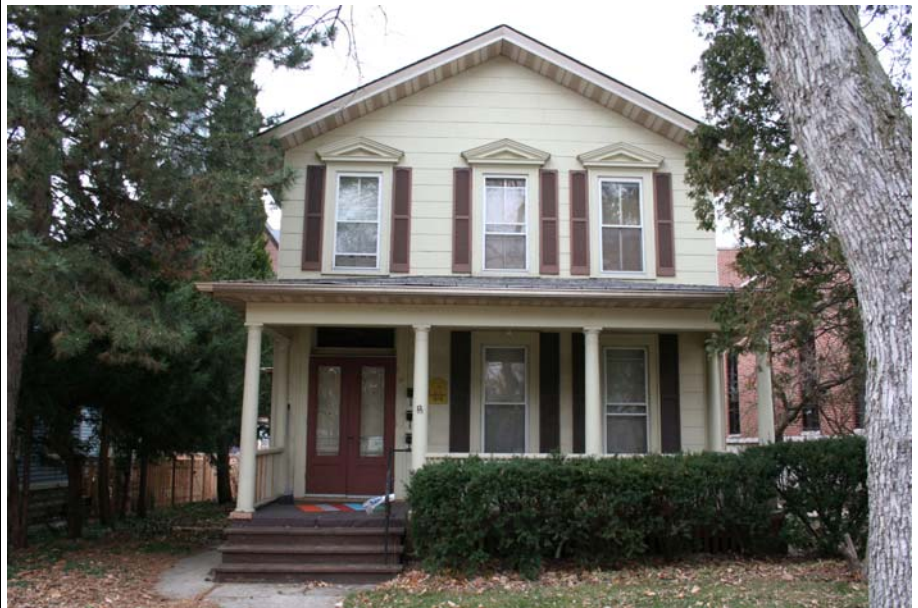
CATEGORY	building	CURRENT FUNCTION	Domestic - multiple dwelling
CONDITION	good	HISTORIC FUNCTION	Domestic - single dwelling
INTEGRITY	minor alterations	REASON for SIGNIFICANCE	Solid, simple example of the style, with an historic porch addition.
SECONDARY STRUCTURE	Barn

ARCHITECTURAL CLASSIFICATION	Italianate	PLAN	rectangular
DETAILS		NO OF STORIES	2
BEGINYEAR	1876	ROOF TYPE	Front gable
OTHER YEAR		ROOF MATERIAL	Asphalt - shingle
DATESOURCE	Plaque	FOUNDATION	Parged/stone
WALL MATERIAL (current)	Asbestos shingle	PORCH	Full front
WALL MATERIAL 2 (current)		WINDOW MATERIAL	Wood
WALL MATERIAL (original)	Wood	WINDOW MATERIAL	
WALL MATERIAL 2 (original)		WINDOW TYPE	double hung
		WINDOW CONFIG	2/2 vert.; 1/1; 4/4
SIGNIFICANT FEATURES	Front gable roof; original 2/2 wood windows w/ triangular pediments over 2nd story windows; original entry doors w/ flattened arch panels and transom		
ALTERATIONS	Front porch addition (historic--c. 1905); 1/1 replacement front windows (historic); 2 story front gable north/rear section may be early addition; 4/4 replacement windows on N. side; rear deck add.; S. covered walkway--SEE CONTINUATION SHEET

Front porch addition (historic--c. 1910); 1/1 replacement front windows (historic); 2 story front gable north/rear section may be early addition; 4/4 replacement windows on N. side (historic); rear deck add. (not historic); S. covered walkway; 1 story south/rear add. (c .1950); replacement wood siding and fixed shutters (not historic); Aluminum siding under eaves

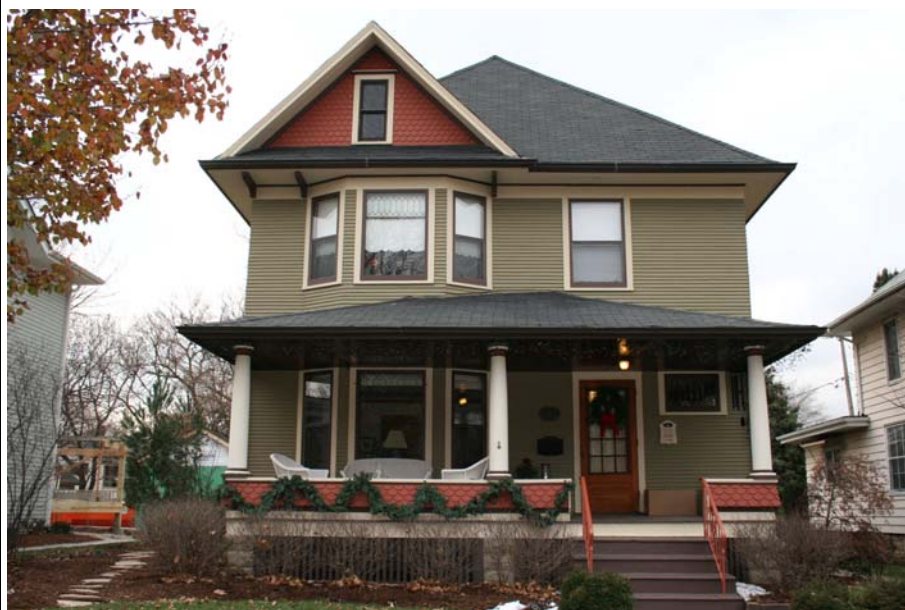
CATEGORY	building	CURRENT FUNCTION	Domestic - single dwelling
CONDITION	excellent	HISTORIC FUNCTION	Religion - church-related residence
INTEGRITY	minor alterations	REASON for SIGNIFICANCE	Handsome Queen Anne with historic leaded glass windows and porch with classical columns.
SECONDARY STRUCTURE	Detached garage

ARCHITECTURAL CLASSIFICATION	Queen Anne - Free Classic	PLAN	Rectangular
DETAILS		NO OF STORIES	2.5
BEGINYEAR	c. 1908	ROOF TYPE	Gable on hip
OTHER YEAR		ROOF MATERIAL	Asphalt - shingle
DATESOURCE	Plaque	FOUNDATION	Concrete - block
WALL MATERIAL (current)	Wood	PORCH	Full front
WALL MATERIAL 2 (current)	Wood - shingle	WINDOW MATERIAL	Wood
WALL MATERIAL (original)	Wood	WINDOW MATERIAL	Leaded glass
WALL MATERIAL 2 (original)	Wood - shingle	WINDOW TYPE	Fixed/double hung
		WINDOW CONFIG	1/1; 1-light
SIGNIFICANT FEATURES	Hipped roof w/ front gable; 2 story 3-sided front window bay w/ center leaded glass windows; full front hipped porch w/ classical columns on shingled knee walls; north side rounded oriel bay w/ conical roof--SEE CONTINUATION SHEET		
ALTERATIONS	Replacement dormer windows (not historic); 1 story rear addition; wrought iron railings at front steps (not historic); replacement window in gable (not historic)

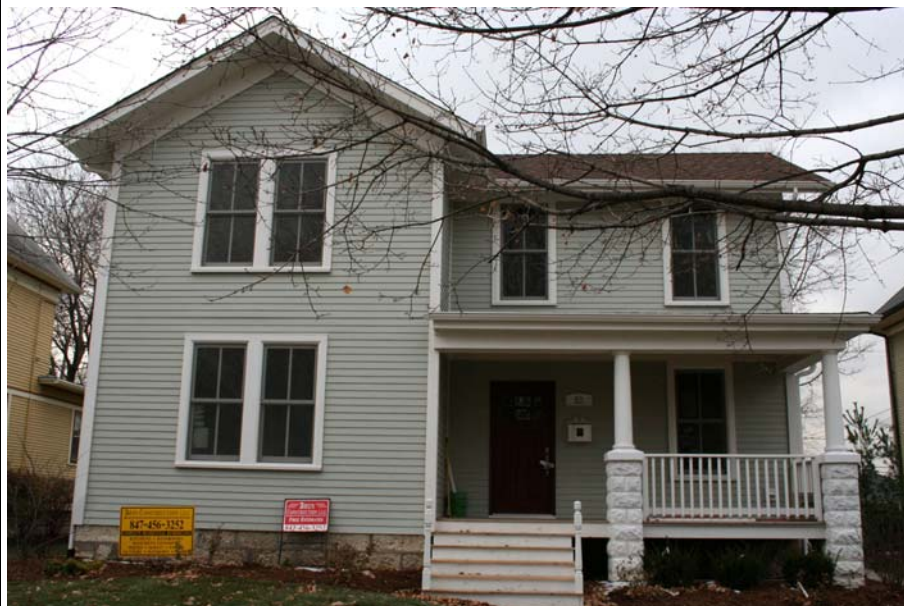
CATEGORY	building	CURRENT FUNCTION	Domestic - single dwelling
CONDITION	excellent	HISTORIC FUNCTION	Domestic - single dwelling
INTEGRITY	minor alterations and addition(s)	REASON for SIGNIFICANCE	
SECONDARY STRUCTURE	Detached garage

ARCHITECTURAL CLASSIFICATION	L-Form with 2-story Wing	PLAN	L
DETAILS		NO OF STORIES	2
BEGINYEAR	c. 1880	ROOF TYPE	Cross gable
OTHER YEAR		ROOF MATERIAL	Asphalt - shingle
DATESOURCE	Surveyor	FOUNDATION	Stone
WALL MATERIAL (current)	Wood	PORCH	front
WALL MATERIAL 2 (current)		WINDOW MATERIAL	Vinyl
WALL MATERIAL (original)	Wood	WINDOW MATERIAL	Glass block
WALL MATERIAL 2 (original)		WINDOW TYPE	double hung/fixed
		WINDOW CONFIG	2/2 vertical
SIGNIFICANT FEATURES	Front gable bay with north side gable intersecting wing		
ALTERATIONS	2/2 replacement windows in altered openings (not historic); replacement siding (historically appropriate); replacement front porch (historic); replacement door (not historic); 2 story rear addition(historic); glass block windows in basement

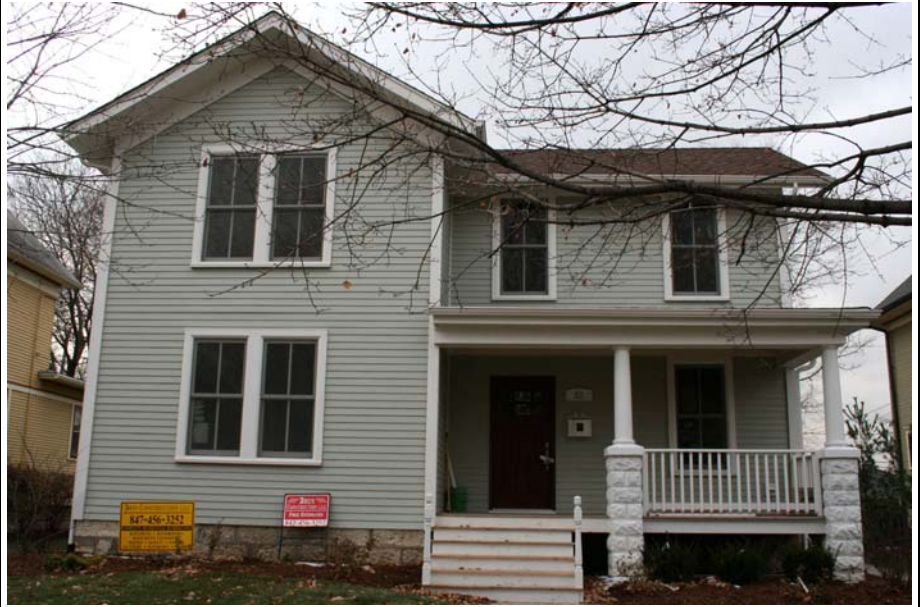
CATEGORY	building	CURRENT FUNCTION	Domestic - single dwelling
CONDITION	excellent	HISTORIC FUNCTION	Domestic - single dwelling
INTEGRITY	minor alterations and addition(s)	REASON for SIGNIFICANCE	
SECONDARY STRUCTURE	Detached garage

ARCHITECTURAL CLASSIFICATION	L-Form with 2-story Wing	PLAN	L
DETAILS		NO OF STORIES	2
BEGINYEAR	c. 1880	ROOF TYPE	Cross gable
OTHER YEAR		ROOF MATERIAL	Asphalt - shingle
DATESOURCE	Surveyor	FOUNDATION	Stone
WALL MATERIAL (current)	Wood	PORCH	front
WALL MATERIAL 2 (current)		WINDOW MATERIAL	Vinyl
WALL MATERIAL (original)	Wood	WINDOW MATERIAL	Glass block
WALL MATERIAL 2 (original)		WINDOW TYPE	double hung/fixed
		WINDOW CONFIG	2/2 vertical
SIGNIFICANT FEATURES	Front gable bay with north side gable intersecting wing		
ALTERATIONS	2/2 replacement windows in altered openings (not historic); replacement siding (historically appropriate); replacement front porch (historic); replacement door (not historic); 2 story rear addition(historic); glass block windows in basement

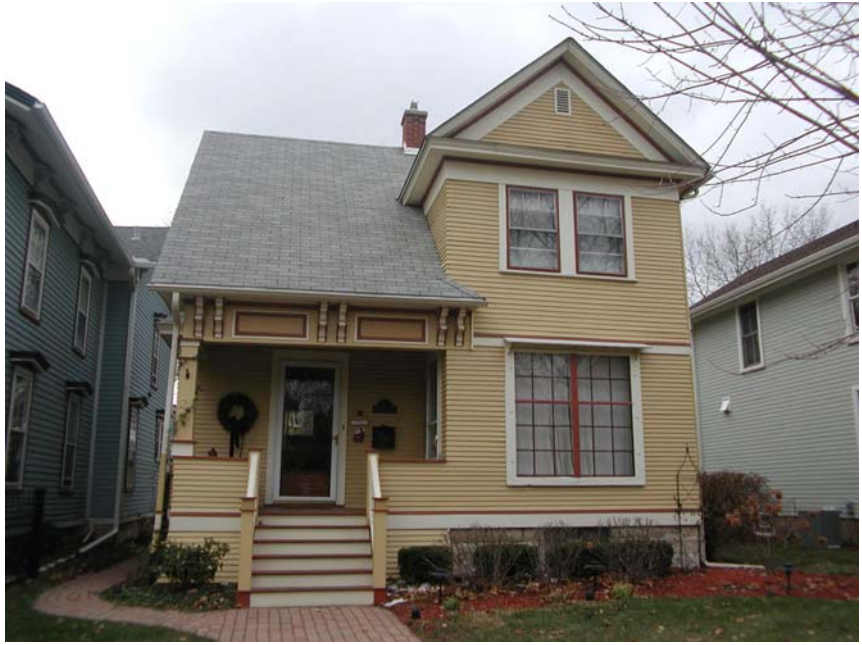
CATEGORY	building	CURRENT FUNCTION	Domestic - single dwelling
CONDITION	good	HISTORIC FUNCTION	Domestic - single dwelling
INTEGRITY	minor alterations and addition(s)	REASON for SIGNIFICANCE	
SECONDARY STRUCTURE	Carriage House

ARCHITECTURAL CLASSIFICATION	Queen Anne	PLAN	L
DETAILS		NO OF STORIES	2
BEGINYEAR	c. 1905	ROOF TYPE	Multi-gable
OTHER YEAR		ROOF MATERIAL	Asphalt - shingle
DATESOURCE	Surveyor	FOUNDATION	Stone
WALL MATERIAL (current)	Wood	PORCH	Front entry
WALL MATERIAL 2 (current)		WINDOW MATERIAL	Wood
WALL MATERIAL (original)	Wood	WINDOW MATERIAL	Glass Block/Aluminum
WALL MATERIAL 2 (original)		WINDOW TYPE	double hung/fixed
		WINDOW CONFIG	3/1; multi-light; 1/1
SIGNIFICANT FEATURES	Side gable roof w/ cornice returns; front 2 story bay w/ pent front gable; inset front entry porch w/ paneled frieze, paired brackets, & square classical columns on solid knee wall; historic 1/1 wood double hung windows; S. square window bay w/ hip roof		
ALTERATIONS	1 story rear addition; replacement 3/1 windows in original openings (historic); replacement multi-light windows in altered openings on first floor (historic); Panels & brackets are new/salvaged, not appropriate

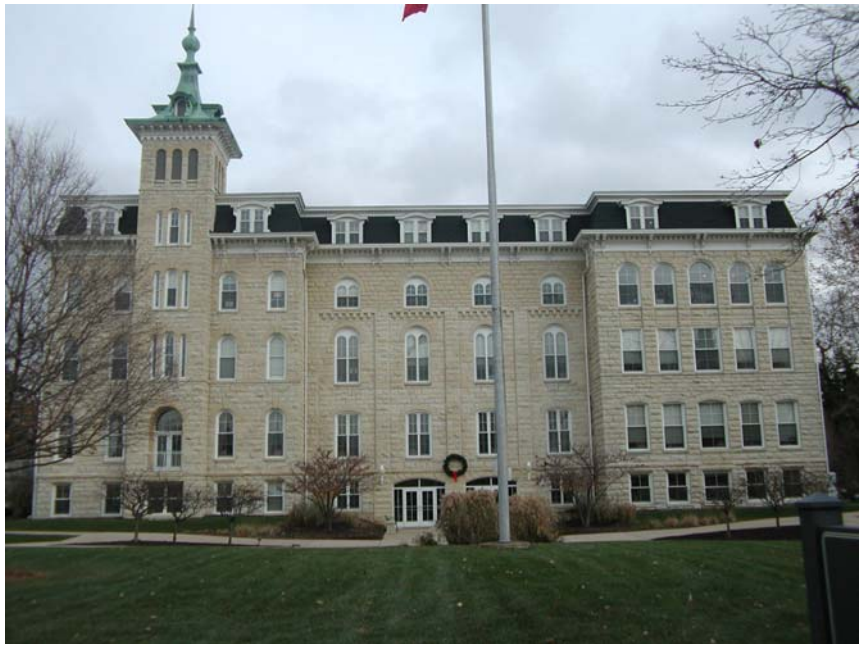
CATEGORY	building	CURRENT FUNCTION	Education - college
CONDITION	excellent	HISTORIC FUNCTION	Education - college
INTEGRITY	minor alterations	REASON for SIGNIFICANCE	Impressive Second Empire stone building is architecturally significant and historically significant as North Central College's first building in Naperville. Vinyl windows have somewhat lessened its integrity.
SECONDARY STRUCTURE

ARCHITECTURAL CLASSIFICATION	Second Empire	PLAN	rectangular
DETAILS		NO OF STORIES	5
BEGINYEAR	1871	ROOF TYPE	Mansard
OTHER YEAR		ROOF MATERIAL	Asphalt - shingle
DATESOURCE	NCC	FOUNDATION	Stone
WALL MATERIAL (current)	Stone	PORCH	-
WALL MATERIAL 2 (current)		WINDOW MATERIAL	Vinyl
WALL MATERIAL (original)	Stone	WINDOW MATERIAL	
WALL MATERIAL 2 (original)		WINDOW TYPE	double hung
		WINDOW CONFIG	4/4; 1/1
SIGNIFICANT FEATURES	North section is original building, middle section is either original or very early addition, south section is historic (c. 1890) addition; mansard roof with modillion cornice and paired scrolled brackets--SEE CONTINUATION SHEET		
ALTERATIONS	Original raised front entry was in center of north section—steps to entry have been removed, and entry has been closed with balcony; entry on south (c. 1890) addition was also raised---SEE CONTINUATION SHEET Removal of portion of window for air supply (admin. approval COA# 17-179)

North section is original building, middle section is either original or very early addition (but has been recently altered and added to), south section is historic (c. 1890) addition; mansard roof with modillion cornice and paired scrolled brackets on original, north section; projecting square bay in center of original building (north section) with copper pinnacle on roof; rusticated limestone exterior; round arch and segmental arch window openings; flat arch lintels on first story, flanged segmental arch dormers

Original raised front entry was in center of north section—steps to entry have been removed, and entry has been closed with balcony; entry on south (c. 1890) addition was also raised, but has been filled in with ground level window (not historic); top two stories (including mansard roof) of center section are addition from 1998 renovation; south section originally had hipped roof—mansard is an historic alteration; vinyl replacement windows in original openings; replacement entry doors in middle section (probably in altered openings); below grade entry doors on east elevation; elevated patio addition to north elevation

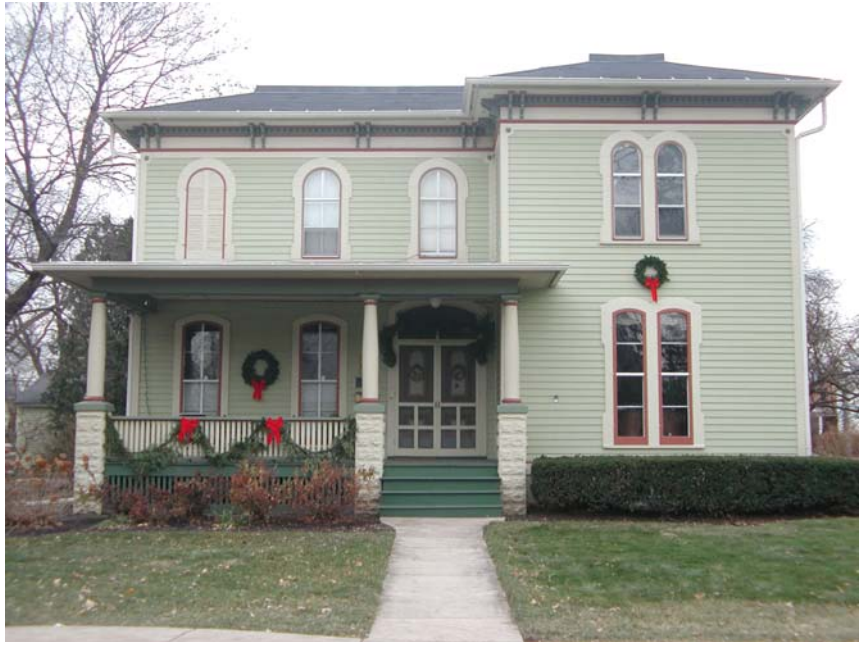
CATEGORY	building	CURRENT FUNCTION	Domestic - multiple dwelling
CONDITION	excellent	HISTORIC FUNCTION	Domestic - single dwelling
INTEGRITY	minor alterations and addition(s)	REASON for SIGNIFICANCE	This impressive 1870 Italianate residence was home to Reverend Heidner, professor of German languages at North Central College.
SECONDARY STRUCTURE	Detached garage shed (NC)

ARCHITECTURAL CLASSIFICATION	Italianate	PLAN	irregular
DETAILS		NO OF STORIES	2
BEGINYEAR	1870	ROOF TYPE	Hipped
OTHER YEAR		ROOF MATERIAL	Asphalt - shingle
DATESOURCE	Plaque	FOUNDATION	Stone
WALL MATERIAL (current)	Wood	PORCH	Front/side
WALL MATERIAL 2 (current)		WINDOW MATERIAL	Wood
WALL MATERIAL (original)	Wood	WINDOW MATERIAL	
WALL MATERIAL 2 (original)		WINDOW TYPE	Double & single hung
		WINDOW CONFIG	4/4; 2/2 vert; 1/2; 2/2
SIGNIFICANT FEATURES	Hipped roof w/ paired brackets & modillions; 3-sided S. window bay; paired front doors w/ segmental arch transom; round arch window openings on 2nd story, segmental arch openings on 1st story; historic 4/4 & 2/2 vertical 2nd story windows		
ALTERATIONS	2/2 horizontal windows are historic replacement; 1/2 windows are non historic; replacement siding; replacement columns & concrete block piers on front porch (historic); rear N. & S. Porch is historic, but have replacement columns & brackets

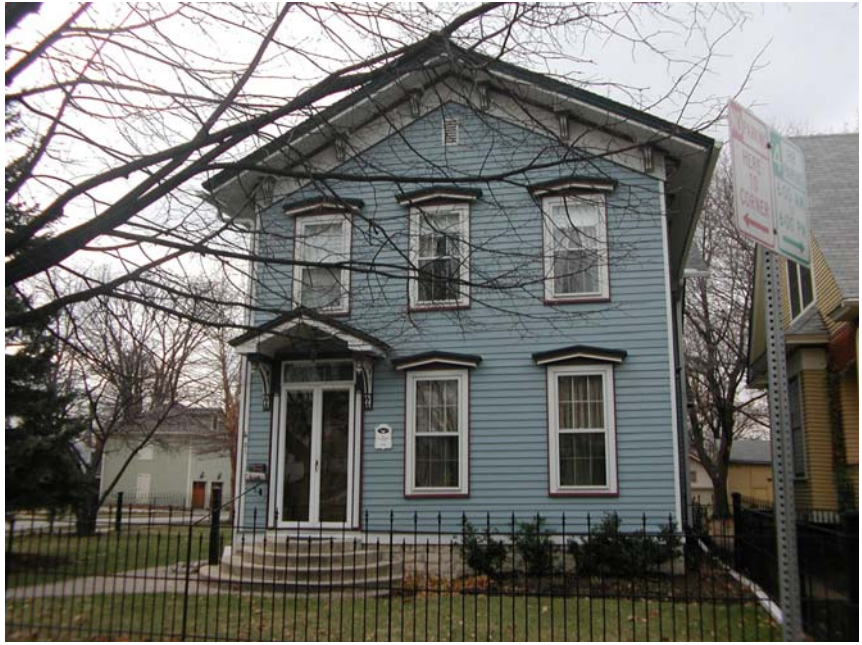
CATEGORY	building	CURRENT FUNCTION	Domestic - single dwelling
CONDITION	excellent	HISTORIC FUNCTION	Domestic - single dwelling
INTEGRITY	minor alterations and addition(s)	REASON for SIGNIFICANCE	Even with alterations, this remains a solid example of a mid-1870s Italianate residence.
SECONDARY STRUCTURE	Detached garage

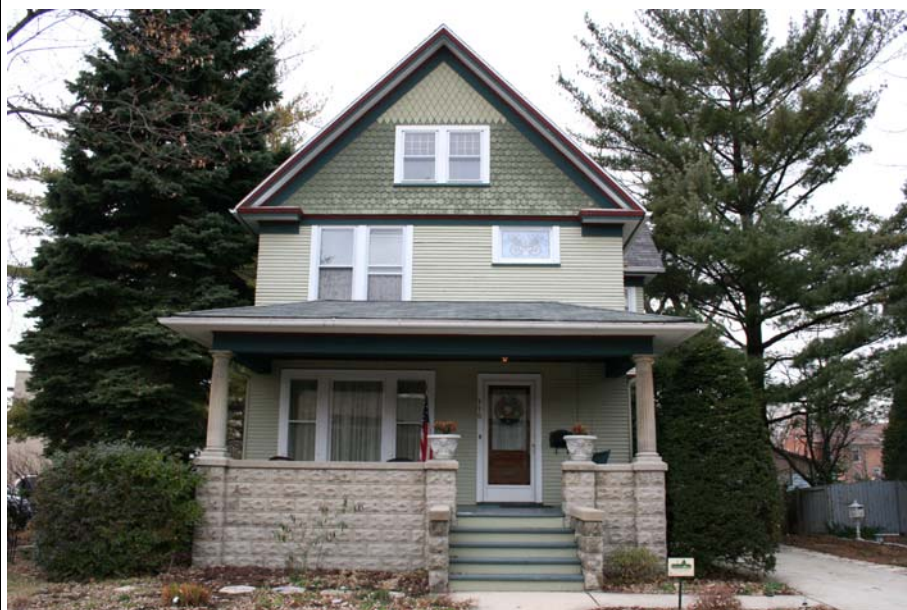
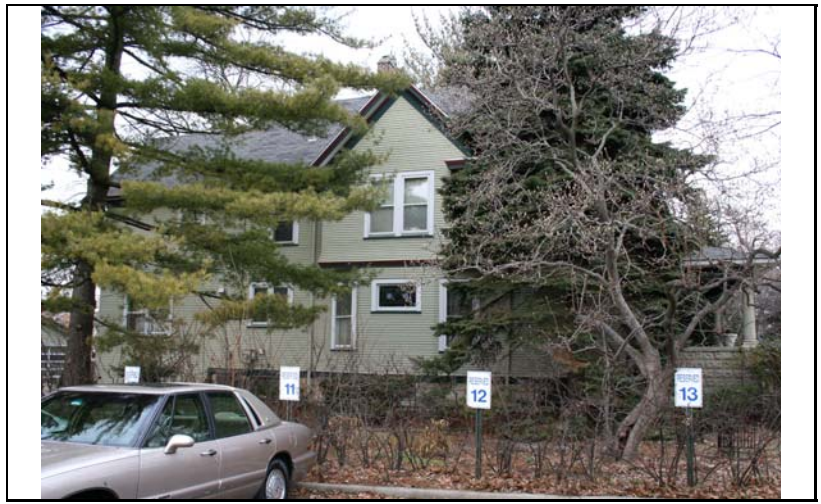
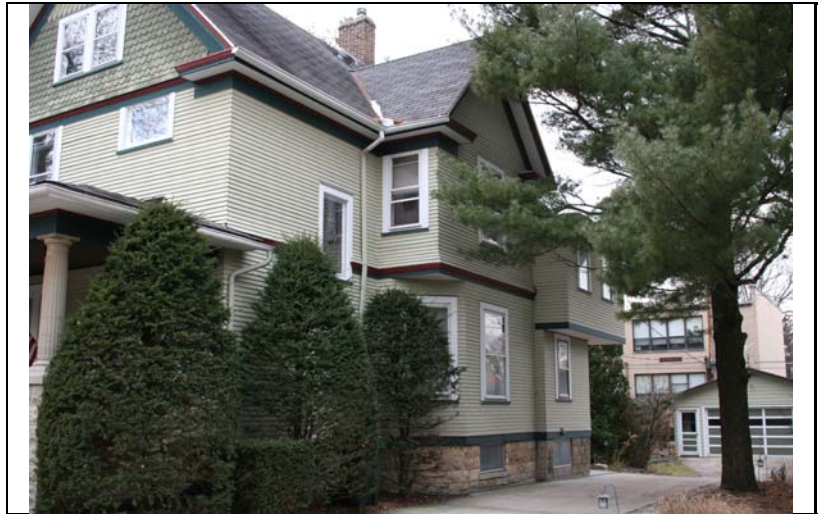
115 N BRAINARD

CATEGORY	building	CURRENT FUNCTION	Domestic - single dwelling
CONDITION	excellent	HISTORIC FUNCTION	Domestic - single dwelling
INTEGRITY	minor alterations and addition(s)	REASON for SIGNIFICANCE	Fine late-19th century Queen Anne with historic concrete block front porch.
SECONDARY STRUCTURE	Detached garage

ARCHITECTURAL CLASSIFICATION	Queen Anne	PLAN	irregular
DETAILS		NO OF STORIES	2.5
BEGINYEAR	c. 1895	ROOF TYPE	Front gable
OTHER YEAR		ROOF MATERIAL	Asphalt - shingle
DATESOURCE	surveyor	FOUNDATION	Stone
WALL MATERIAL (current)	Wood	PORCH	Full front
WALL MATERIAL 2 (current)	Wood - shingle	WINDOW MATERIAL	Wood
WALL MATERIAL (original)	Wood	WINDOW MATERIAL	Stained glass
WALL MATERIAL 2 (original)	Wood - shingle	WINDOW TYPE	double hung/fixed
		WINDOW CONFIG	1/1; 12/1; 1-light
SIGNIFICANT FEATURES	Front gable roof w/ cornice returns and wood shingles under gable; side gable north and south side bays w/ 1st story cutaway corners; historic wood door; 1/1 historic wood windows		
ALTERATIONS	Replacement front porch (c. 1910); stained glass window above porch (may be salvaged window); 2 story rear/north addition (1910s)

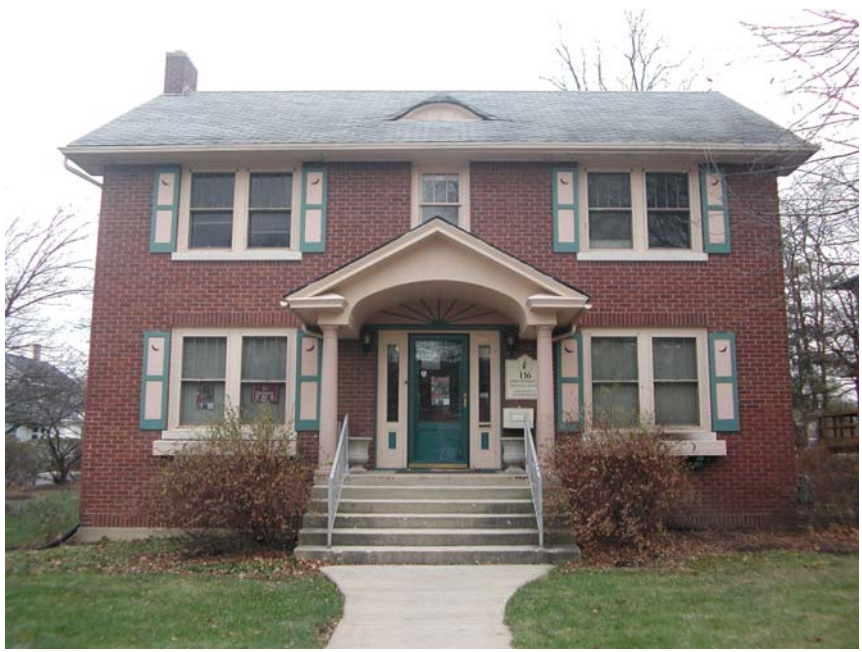
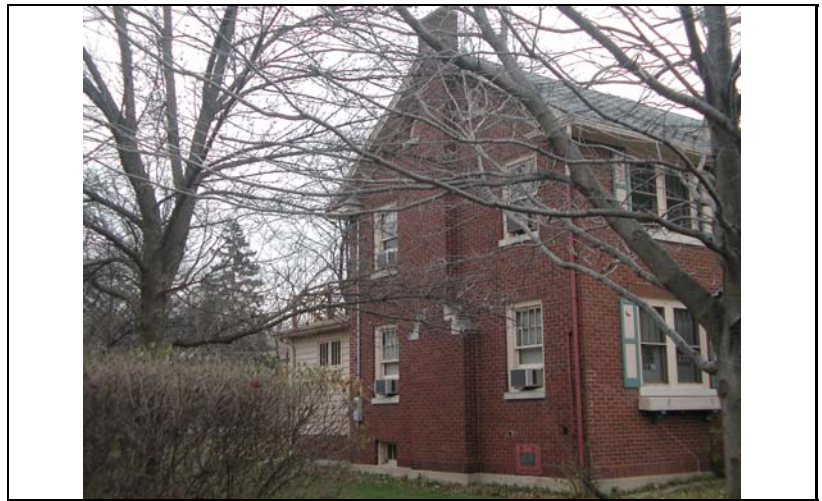
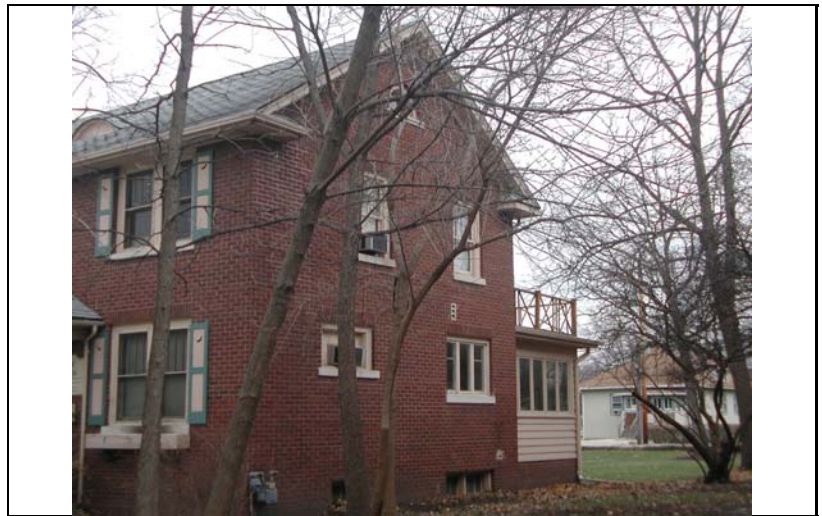
CATEGORY	building	CURRENT FUNCTION	Education - college
CONDITION	good	HISTORIC FUNCTION	Domestic - single dwelling
INTEGRITY	minor alterations	REASON for SIGNIFICANCE	Intact and nicely detailed 1920s Colonial Revival with many original features.
SECONDARY STRUCTURE

ARCHITECTURAL CLASSIFICATION	Colonial Revival	PLAN	rectangular
DETAILS		NO OF STORIES	2
BEGINYEAR	c. 1925	ROOF TYPE	Side gable
OTHER YEAR		ROOF MATERIAL	Asphalt - shingle
DATESOURCE	Surveyor	FOUNDATION	Concrete - poured
WALL MATERIAL (current)	Brick	PORCH	Front entry
WALL MATERIAL 2 (current)		WINDOW MATERIAL	Wood
WALL MATERIAL (original)	Brick	WINDOW MATERIAL	
WALL MATERIAL 2 (original)		WINDOW TYPE	double hung
		WINDOW CONFIG	4/1; 3/1
SIGNIFICANT FEATURES	Side gable roof with north end chimney and cornice returns; center eyebrow window; symmetrical front façade; center entry with single sidelights; historic 4/1 and 3/1 wood windows		
ALTERATIONS	Front porch with concrete stoop and wrought iron railings (post-1943); 1 story rear addition (may have originally been rear porch that was enclosed); wood exterior stair addition

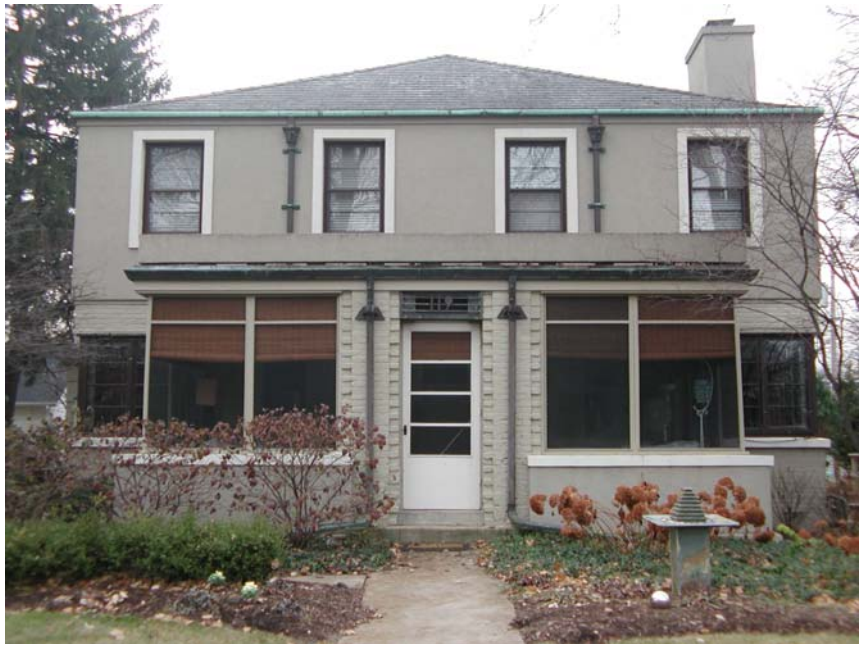
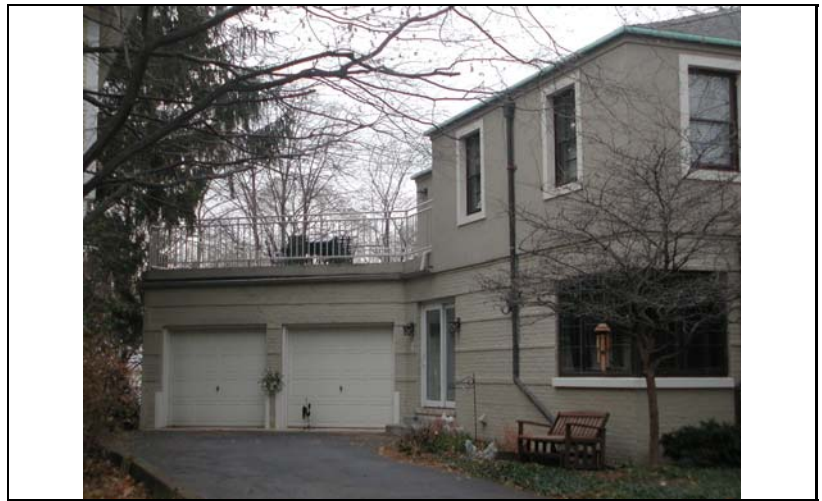
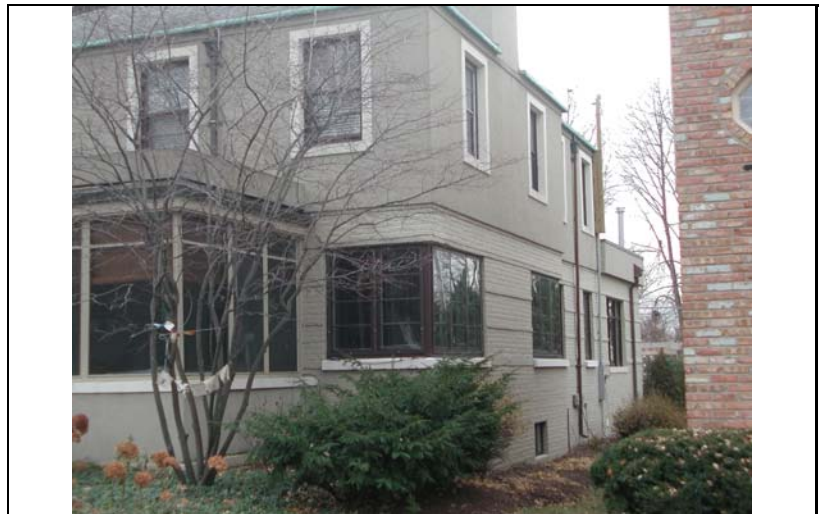
CATEGORY	building	CURRENT FUNCTION	Domestic - single dwelling
CONDITION	good	HISTORIC FUNCTION	Domestic - single dwelling
INTEGRITY	minor alterations	REASON for SIGNIFICANCE	Sole example of Art Modern style in the district, with very few alterations.
SECONDARY STRUCTURE

ARCHITECTURAL CLASSIFICATION	Art Moderne	PLAN	irregular
DETAILS		NO OF STORIES	2
BEGINYEAR	c. 1940	ROOF TYPE	Hipped
OTHER YEAR		ROOF MATERIAL	Asphalt - shingle
DATESOURCE	Surveyor	FOUNDATION	Not visible
WALL MATERIAL (current)	Brick	PORCH	Front
WALL MATERIAL 2 (current)	Stucco	WINDOW MATERIAL	Wood
WALL MATERIAL (original)	Brick	WINDOW MATERIAL	
WALL MATERIAL 2 (original)	Stucco	WINDOW TYPE	double hung/casement
		WINDOW CONFIG	2/2 horizontal; 4-light
SIGNIFICANT FEATURES	Brick first story with horizontal stringcourses and 4-light corner casement windows; centered screened front porch with brick around porch entry; 2/2 horizontal wood windows in 2nd story		
ALTERATIONS	rear addition

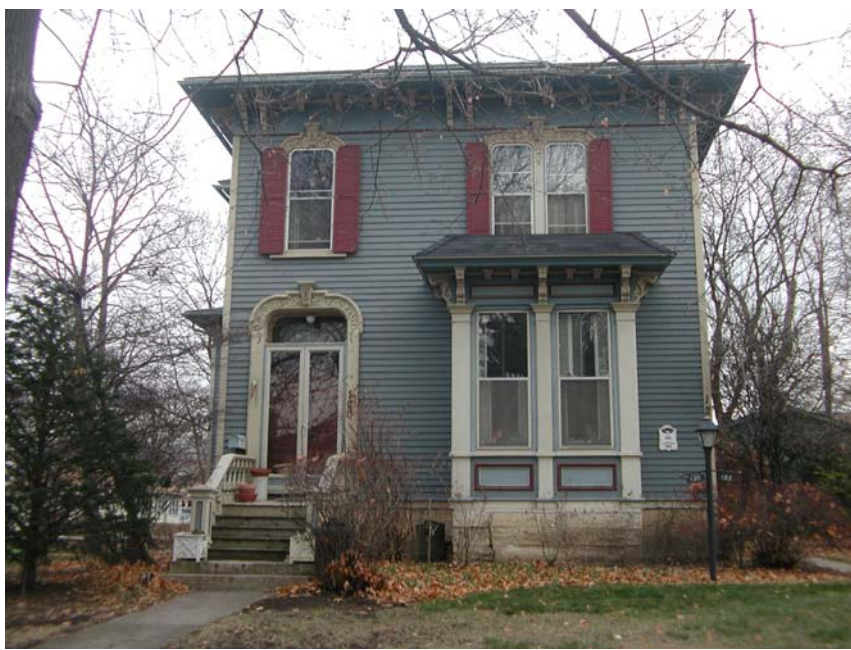
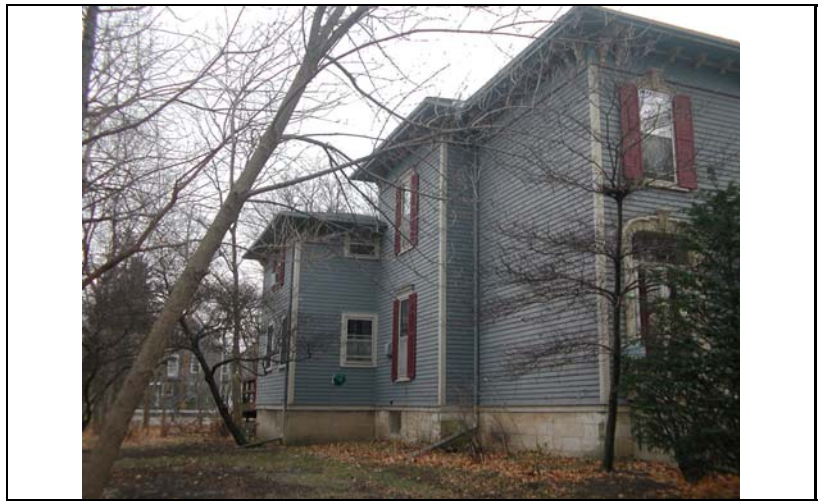
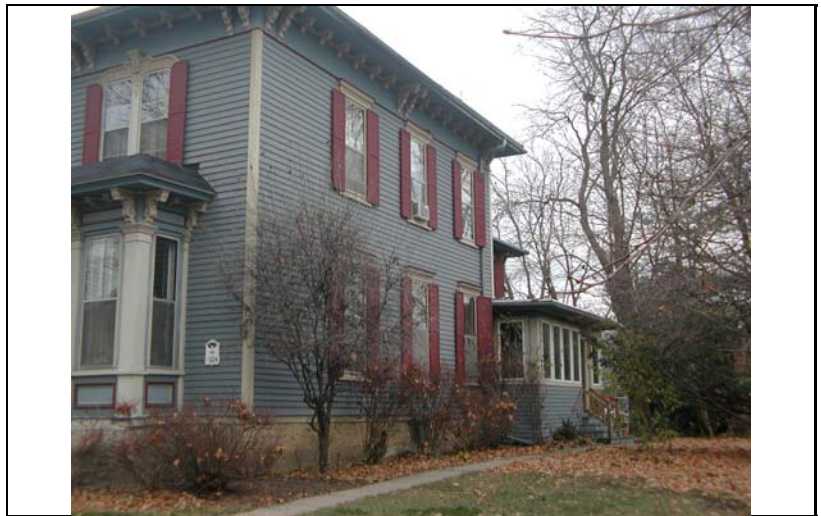
120-122 S BRAINARD

Hipped roof with larger paired brackets interspersed with smaller single brackets; front façade w/ elaborate incised wood door and windows surrounds w/ center keystones; simpler classical lintels on side windows; historic 2/2 vertical wood windows with flattened arches on upper sash; 1st story front window bay with scrolled brackets and piers; historic double wood front door

CATEGORY	building	CURRENT FUNCTION	Domestic - multiple dwelling
CONDITION	excellent	HISTORIC FUNCTION	Domestic - single dwelling
INTEGRITY	minor alterations and addition(s)	REASON for SIGNIFICANCE	The elaborate incised window and door hoods are the distinguishing feature of this 1870s Italianate.
SECONDARY STRUCTURE	Barn/d. garage

ARCHITECTURAL CLASSIFICATION	Italianate	PLAN	irregular
DETAILS		NO OF STORIES	2
BEGINYEAR	1874	ROOF TYPE	Hipped
OTHER YEAR	1881	ROOF MATERIAL	Asphalt - shingle
DATESOURCE	NR Nomination/Plaque	FOUNDATION	Stone/concrete block
WALL MATERIAL (current)	Wood	PORCH	-
WALL MATERIAL 2 (current)		WINDOW MATERIAL	Wood
WALL MATERIAL (original)	Wood	WINDOW MATERIAL	
WALL MATERIAL 2 (original)		WINDOW TYPE	double hung/casement
		WINDOW CONFIG	2/2 vert.; 6/6; 1-light
SIGNIFICANT FEATURES	Hipped roof with larger paired brackets interspersed with smaller single brackets; front façade w/ elaborate incised wood door and windows surrounds w/ center keystones; simpler classical lintels on side windows--SEE CONTINUATION SHEET		
ALTERATIONS	Replacement front entry steps (not historic); 1 story south (rear) porch extended and enclosed (not historic); replacement wood siding (historically appropriate); fixed shutters (not historic); 2 story rear/north addition; rear deck addition Roof replacement (admin. approval COA#12-2035)

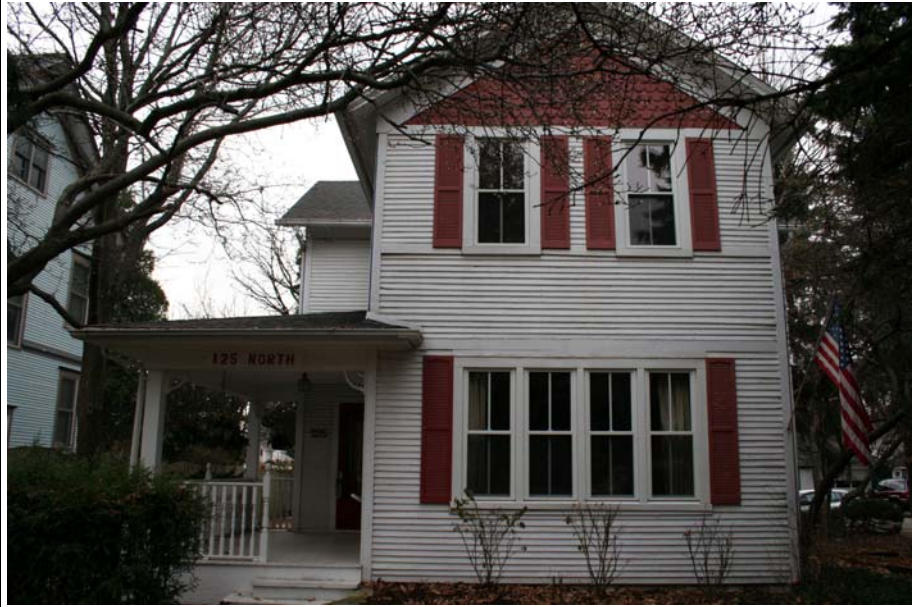
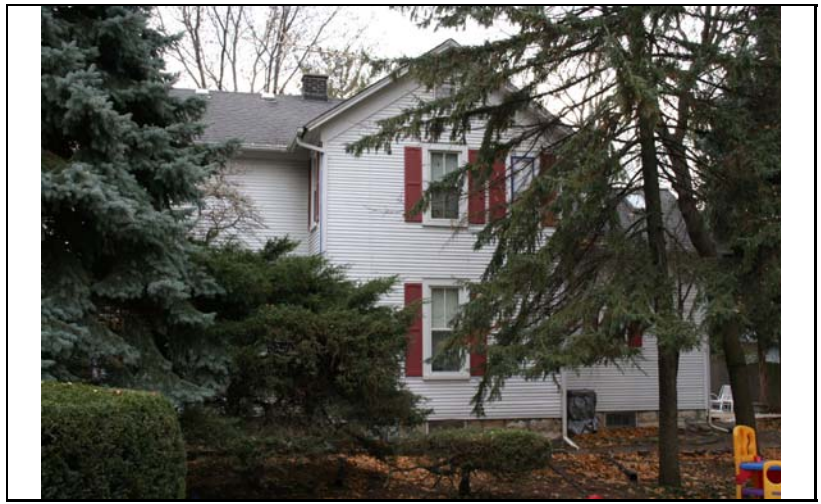
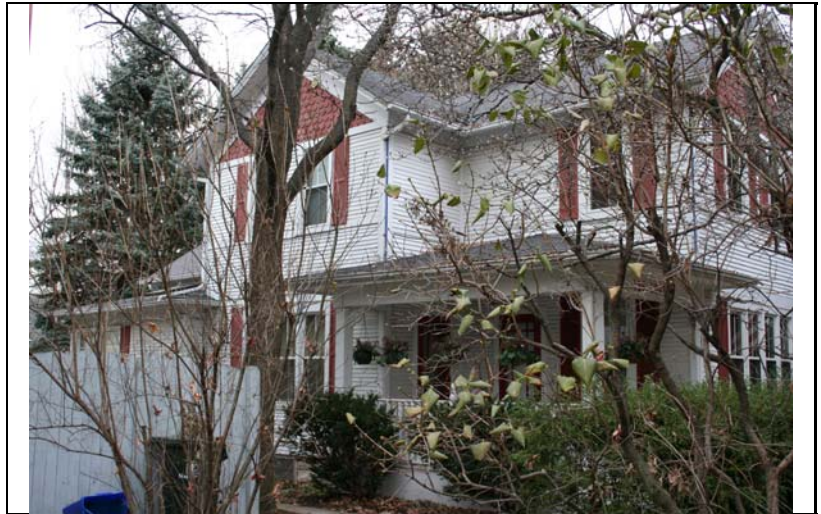
Replacement windows in original openings (not historic); fixed shutters (not historic); replacement siding and shingles (historic); front porch railings & posts replaced, and porch possibly extended; rear/s. porch enclosed (not historic); replacement door in ell; extra door on S. side of gable bay

CATEGORY	building	CURRENT FUNCTION	Domestic - single dwelling
CONDITION	good	HISTORIC FUNCTION	Domestic - single dwelling
INTEGRITY	minor alterations	REASON for SIGNIFICANCE	
SECONDARY STRUCTURE	Detached garage Shed (C)

ARCHITECTURAL CLASSIFICATION	Gabled Ell	PLAN	L
DETAILS		NO OF STORIES	2
BEGINYEAR	c. 1885	ROOF TYPE	Front gable
OTHER YEAR		ROOF MATERIAL	Asphalt - shingle
DATESOURCE	Surveyor	FOUNDATION	Stone
WALL MATERIAL (current)	Wood	PORCH	Front entry
WALL MATERIAL 2 (current)	Wood - shingle	WINDOW MATERIAL	Aluminum
WALL MATERIAL (original)	Wood	WINDOW MATERIAL	
WALL MATERIAL 2 (original)	Wood - shingle	WINDOW TYPE	double hung
		WINDOW CONFIG	2/2 vertical; 6/1
SIGNIFICANT FEATURES	Front gable bay with side gable ell		
ALTERATIONS	Replacement windows in original openings (not historic); fixed shutters (not historic); replacement siding and shingles (historic); front porch railings & posts replaced--SEE CONTINUATION SHEET

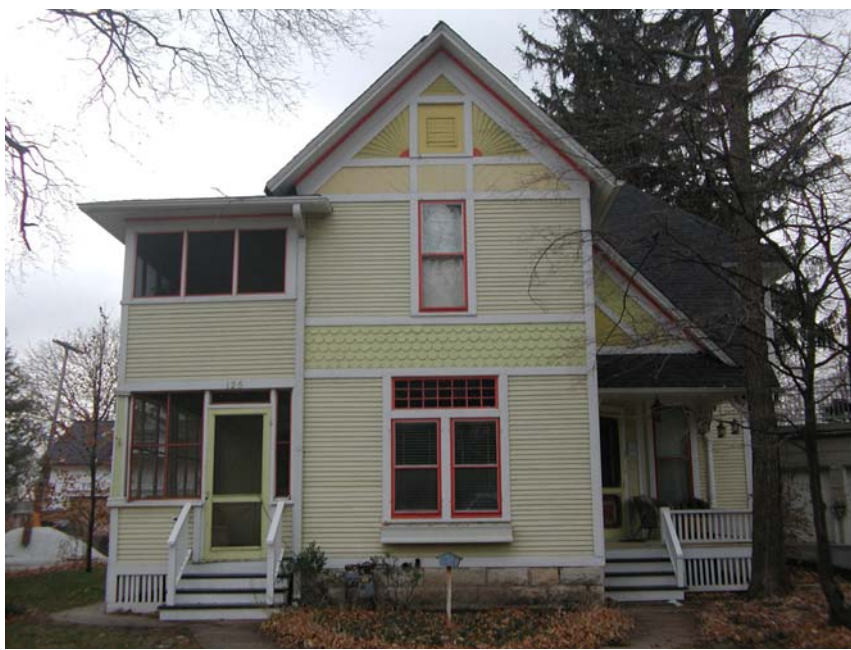
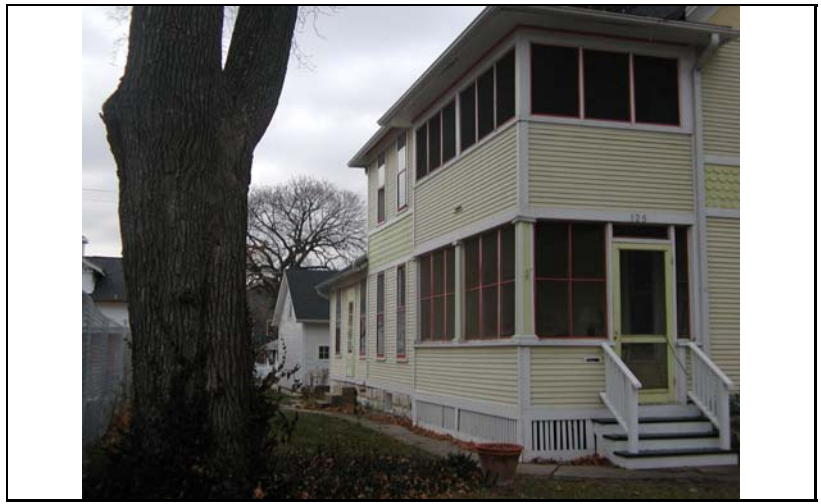
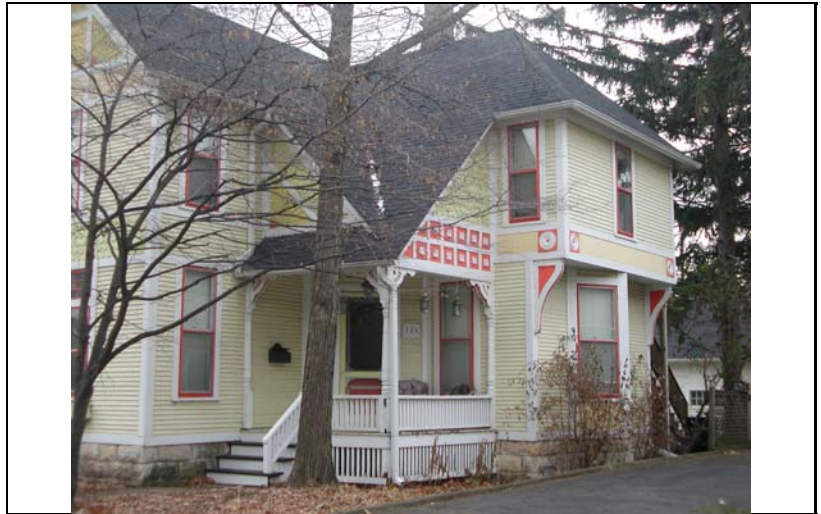
125 S BRAINARD

CATEGORY	building	CURRENT FUNCTION	Domestic - single dwelling
CONDITION	good	HISTORIC FUNCTION	Domestic - single dwelling
INTEGRITY	minor alterations and addition(s)	REASON for SIGNIFICANCE	
SECONDARY STRUCTURE	Detached garage

ARCHITECTURAL CLASSIFICATION	Queen Anne	PLAN	irregular
DETAILS		NO OF STORIES	2
BEGINYEAR	c. 1890	ROOF TYPE	Combination
OTHER YEAR		ROOF MATERIAL	Asphalt - shingle
DATESOURCE	Surveyor	FOUNDATION	Stone
WALL MATERIAL (current)	Wood	PORCH	Front entry/side
WALL MATERIAL 2 (current)	Wood - shingle	WINDOW MATERIAL	Wood
WALL MATERIAL (original)	Wood	WINDOW MATERIAL	
WALL MATERIAL 2 (original)	Wood - shingle	WINDOW TYPE	double hung/fixed
		WINDOW CONFIG	1/1; multi-light
SIGNIFICANT FEATURES	Irregular massing with front gabled bay, 2-story square hipped-roof bay on south elevation, and 2-story hipped roof bay with overhanging 2nd story and 1st story triangular window bay on north elevation; decorative shingling on front gable bay		
ALTERATIONS	historic S. side porch addition enclosed and 2nd story added; replacement wood windows in original openings (historic); rear 2 story deck addition
