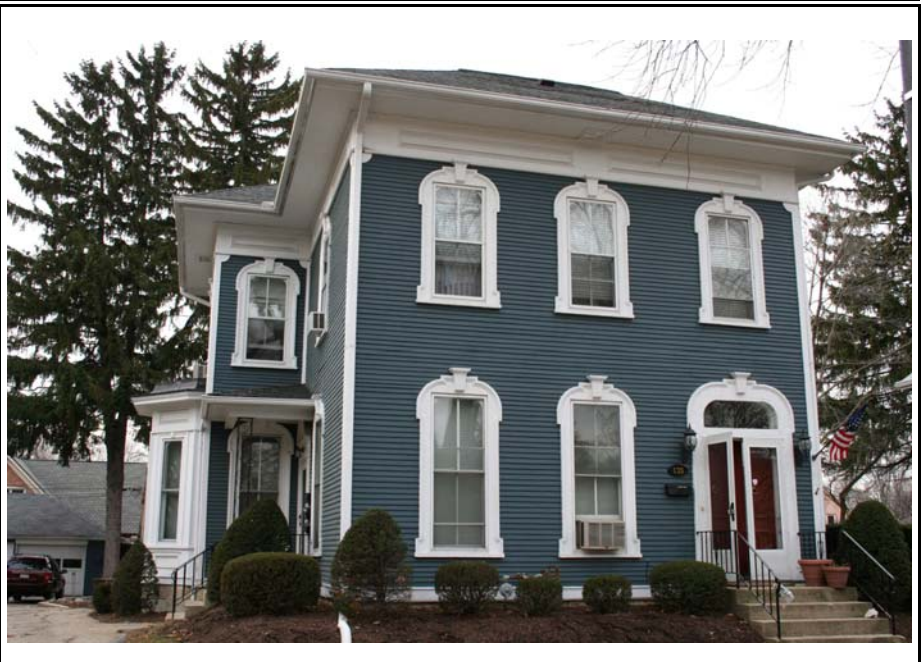
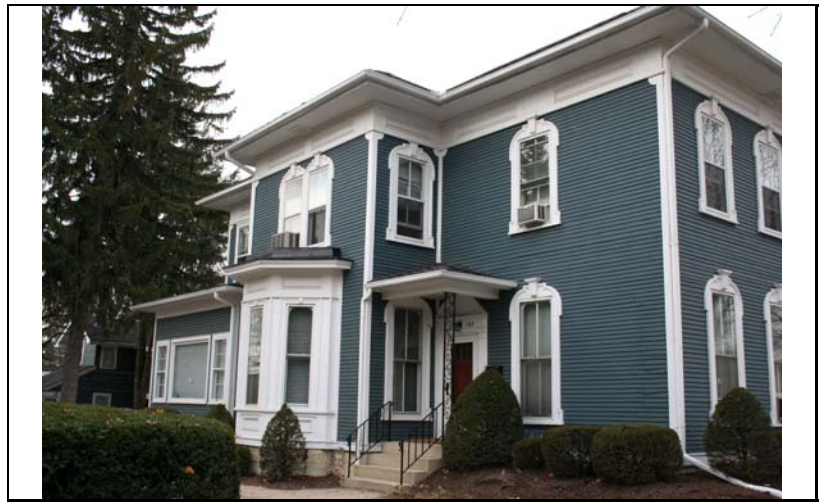
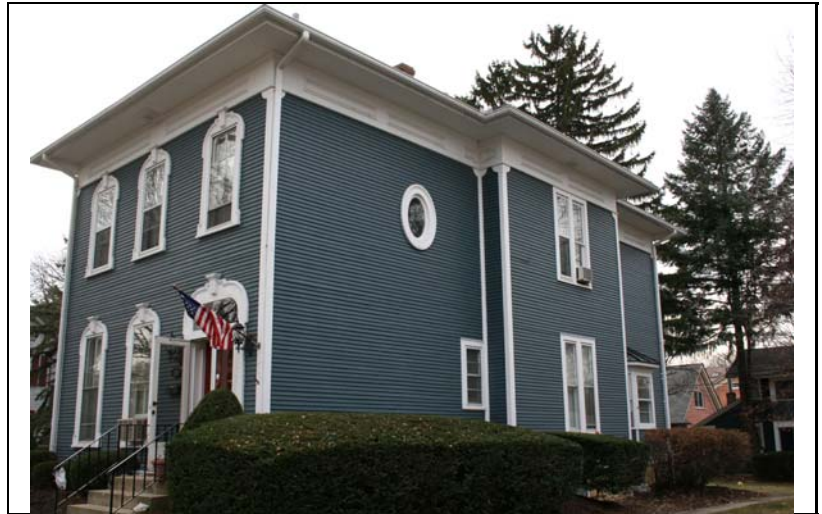
135 N BRAINARD

“...this is a good example of a cubic, Italianate building from the 1870s. Especially notable are the window surrounds which have feet and shoulders and nice incising in the upper parts and the keystone.”

CATEGORY	building	CURRENT FUNCTION	Domestic - single dwelling
CONDITION	excellent	HISTORIC FUNCTION	Domestic - single dwelling
INTEGRITY	minor alterations	REASON for SIGNIFICANCE	Despite alterations, this Italianate house remains an outstanding example within the local historic district.
SECONDARY STRUCTURE	Guest house D. garage/shed

ARCHITECTURAL CLASSIFICATION	Italianate	PLAN	Rectangular
DETAILS		NO OF STORIES	2
BEGINYEAR	c. 1873	ROOF TYPE	Hipped
OTHER YEAR		ROOF MATERIAL	Asphalt - shingle
DATESOURCE	NHS Brochure (East)	FOUNDATION	Stone
WALL MATERIAL (current)	Wood	PORCH	-
WALL MATERIAL 2 (current)		WINDOW MATERIAL	Wood
WALL MATERIAL (original)	Wood	WINDOW MATERIAL	
WALL MATERIAL 2 (original)		WINDOW TYPE	double hung/fixed
		WINDOW CONFIG	round; 2/2 v.; 2/2 horiz.
SIGNIFICANT FEATURES	Hipped roof with paneled frieze; historic 2/2 flattened arch wood windows on front façade with elaborate incised wood surrounds & center keystones; double entry doors with flattened arch transom---SEE CONTINUATION SHEET		
ALTERATIONS	1/1 replacement window on north elevation; south/rear 1 story addition; north/rear window bay addition; south side entry addition (historic) with non-historic wrought iron railings and concrete steps on entry porch; replacement front steps

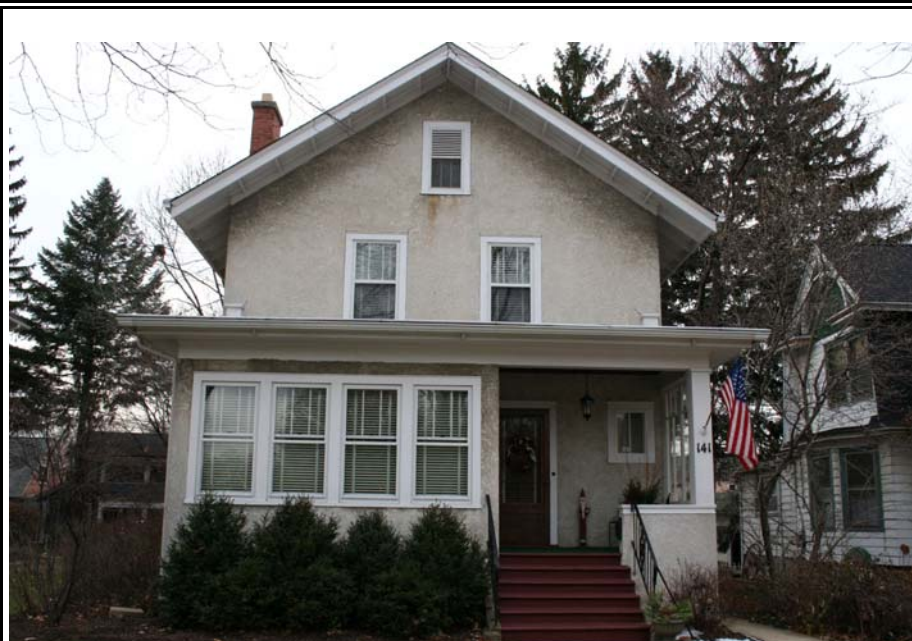
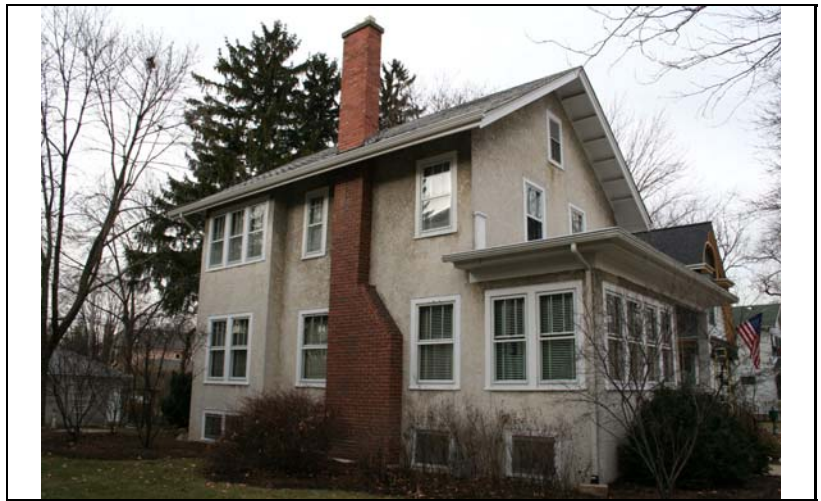
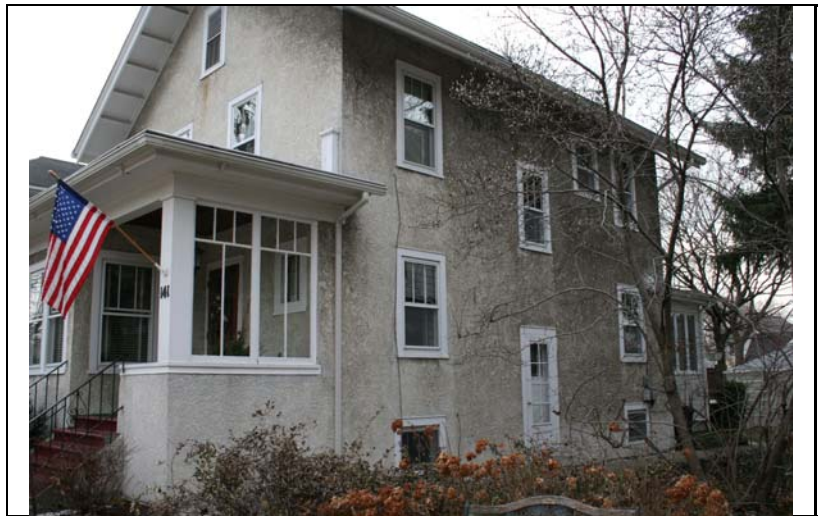
141 N BRAINARD

CATEGORY	building	CURRENT FUNCTION	Domestic - single dwelling
CONDITION	good	HISTORIC FUNCTION	Domestic - single dwelling
INTEGRITY	Minor alterations	REASON for SIGNIFICANCE	
SECONDARY STRUCTURE	Detached garage

ARCHITECTURAL CLASSIFICATION	Craftsman	PLAN	rectangular
DETAILS		NO OF STORIES	2.5
BEGINYEAR	1919	ROOF TYPE	Front gable
OTHER YEAR		ROOF MATERIAL	Asphalt - shingle
DATESOURCE	Owner	FOUNDATION	Parged
WALL MATERIAL (current)	Stucco	PORCH	Full front-enclosed
WALL MATERIAL 2 (current)		WINDOW MATERIAL	Wood
WALL MATERIAL (original)	Stucco	WINDOW MATERIAL	
WALL MATERIAL 2 (original)		WINDOW TYPE	Double hung/casement/sto
		WINDOW CONFIG	3/1; 2-light; 5-light
SIGNIFICANT FEATURES	Front gable roof with exposed rafter tails; hipped front bay with sun porch and entry porch with square wood columns on stucco knee wall; historic 1/1 wood double hung windows and casement window beside door		
ALTERATIONS	Rear enclosed porch addition (c. 1970); railing removed from roof of porch structure, and porch roof slanted (1980s)

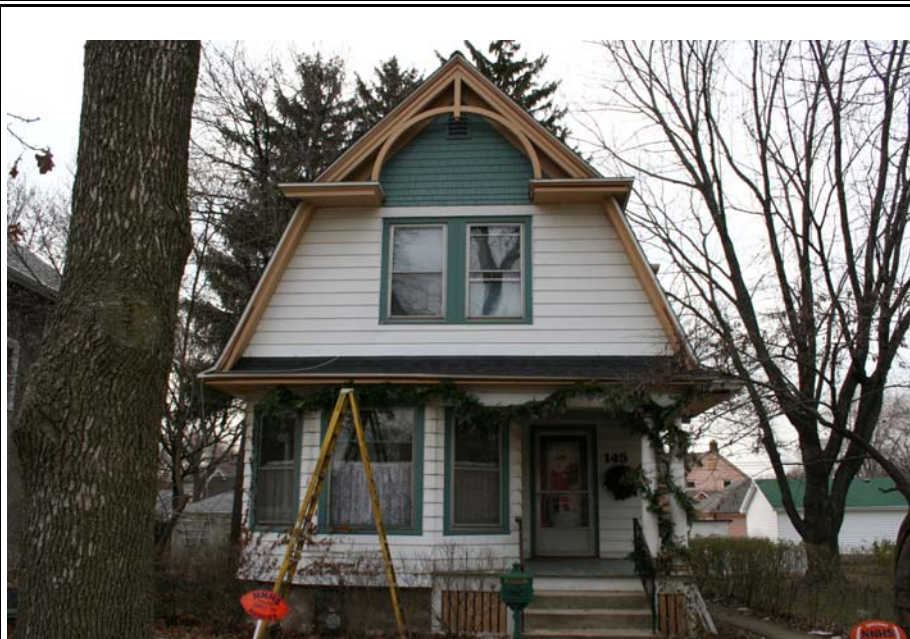
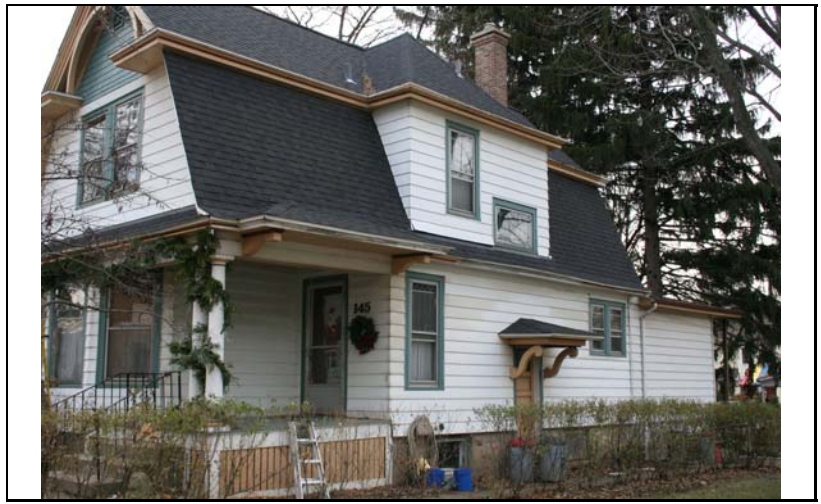
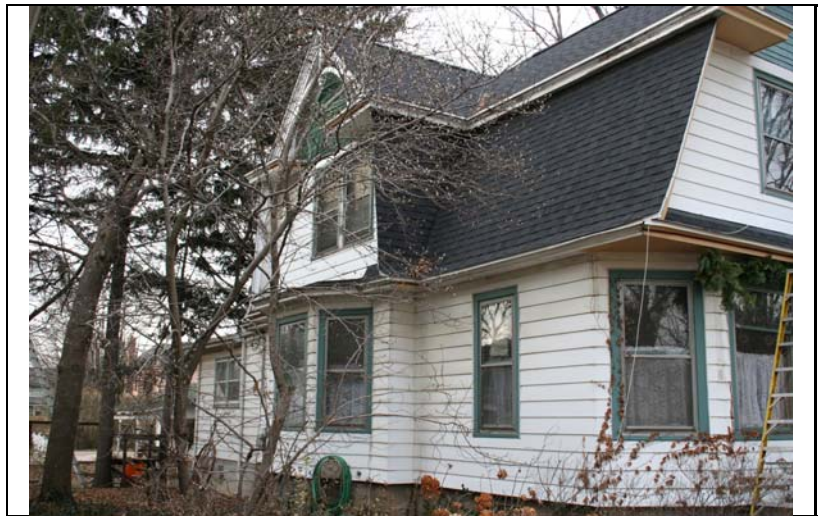
145 N BRAINARD

CATEGORY	building	CURRENT FUNCTION	Domestic - single dwelling
CONDITION	good	HISTORIC FUNCTION	Domestic - single dwelling
INTEGRITY	minor alterations and addition(s)	REASON for SIGNIFICANCE	The unusual gambrel roof with rounded arch detail distinguishes this early 1900s Shingle Style residence.
SECONDARY STRUCTURE	Detached garage

ARCHITECTURAL CLASSIFICATION	Shingle Style	PLAN	Rectangular
DETAILS		NO OF STORIES	2
BEGINYEAR	1904	ROOF TYPE	Gambrel
OTHER YEAR		ROOF MATERIAL	Asphalt - shingle
DATESOURCE	Surveyor	FOUNDATION	Parged (stone)
WALL MATERIAL (current)	Aluminum	PORCH	Front entry
WALL MATERIAL 2 (current)	Wood - shingle	WINDOW MATERIAL	Wood
WALL MATERIAL (original)	Wood	WINDOW MATERIAL	Leaded Glass
WALL MATERIAL 2 (original)	Wood - shingle	WINDOW TYPE	Double/single hung;fixed
		WINDOW CONFIG	1/1; leaded/1; multi-light

ALTERATIONS Aluminum siding; wrought iron railing and replacement steps to porch; 1 story rear addition (1981)

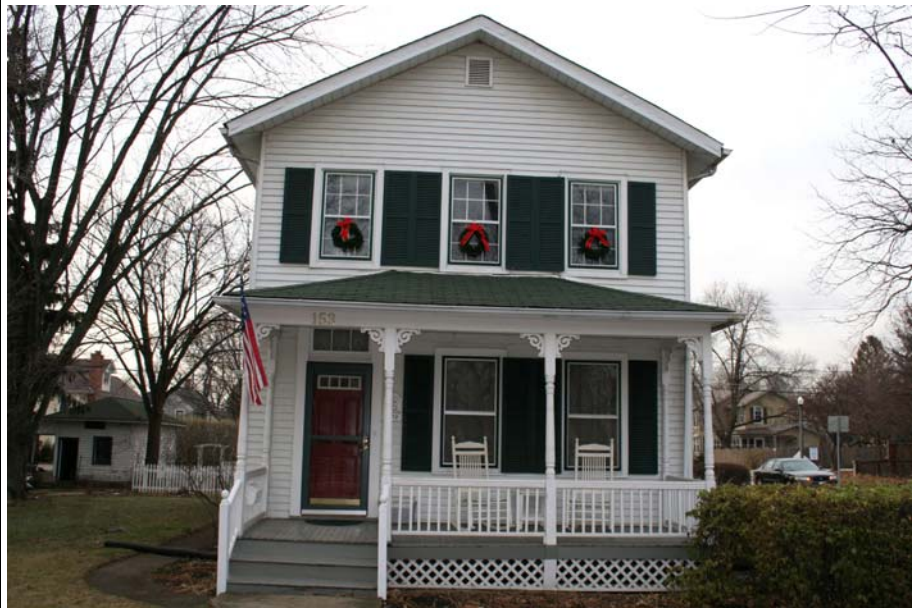
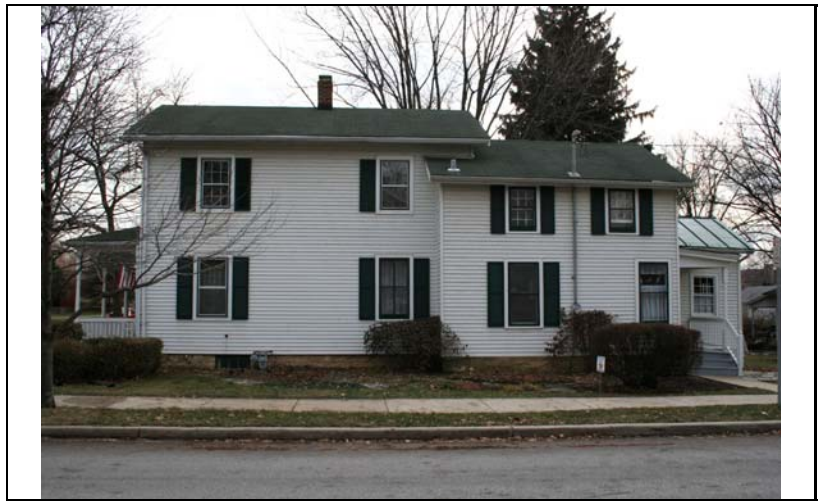
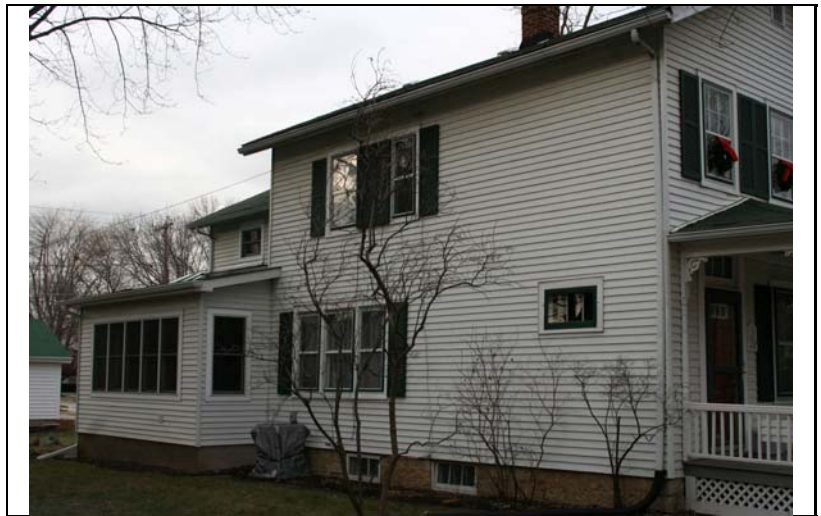
153 N BRAINARD

CATEGORY	building	CURRENT FUNCTION	Domestic - single dwelling
CONDITION	good	HISTORIC FUNCTION	Domestic - single dwelling
INTEGRITY	minor alterations	REASON for SIGNIFICANCE	
SECONDARY STRUCTURE	Detached garage Shed (C)

ARCHITECTURAL CLASSIFICATION	Gable Front	PLAN	irregular
DETAILS		NO OF STORIES	2
BEGINYEAR	1872	ROOF TYPE	Front gable
OTHER YEAR		ROOF MATERIAL	Asphalt - shingle
DATESOURCE	Plaque	FOUNDATION	Stone
WALL MATERIAL (current)	Aluminum	PORCH	Full front
WALL MATERIAL 2 (current)		WINDOW MATERIAL	Wood
WALL MATERIAL (original)	Wood	WINDOW MATERIAL	
WALL MATERIAL 2 (original)		WINDOW TYPE	Double hung/awning
		WINDOW CONFIG	6/6; 1/1; 3-light
SIGNIFICANT FEATURES	Front gable roof; historic fenestration on front façade; transom over front entry; 1/1 wood windows appear historic, but not original; lower gabled rear/north bay		
ALTERATIONS	6/6 replacement windows downsized in openings (historic); replacement front door; full front porch addition (c. 1905-- railings & supports later); 1 story south/rear addition (historic); aluminum siding; fixed shutters; 1 story rear addition (historic)

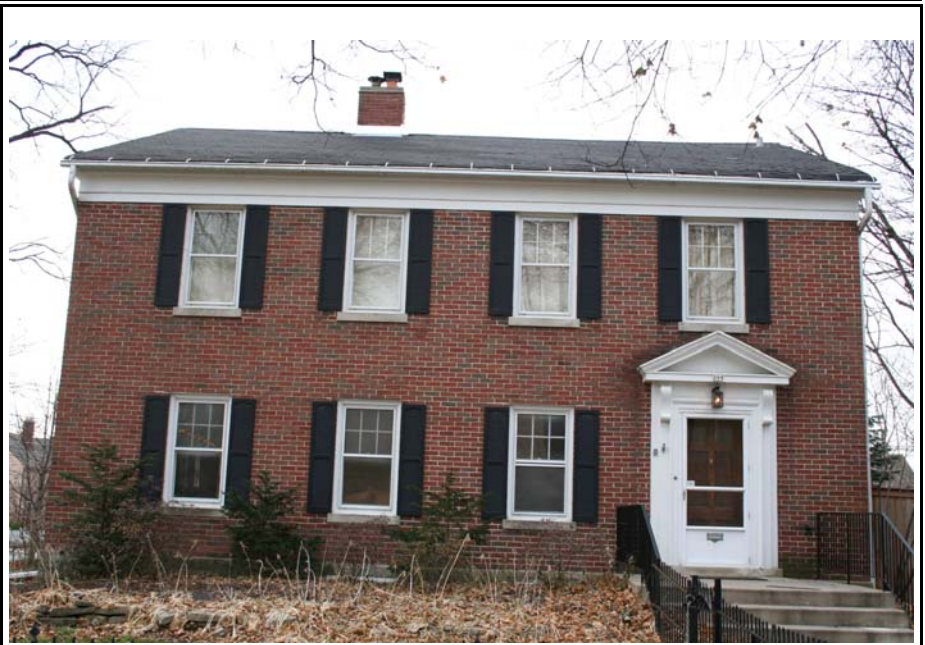
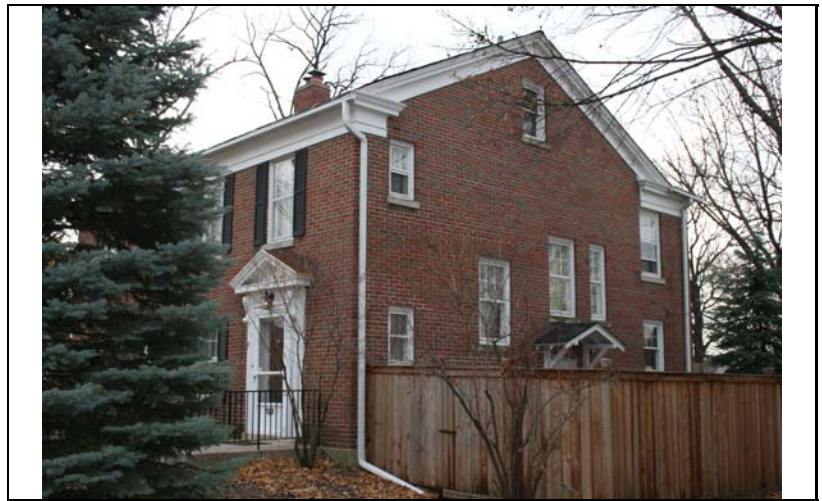
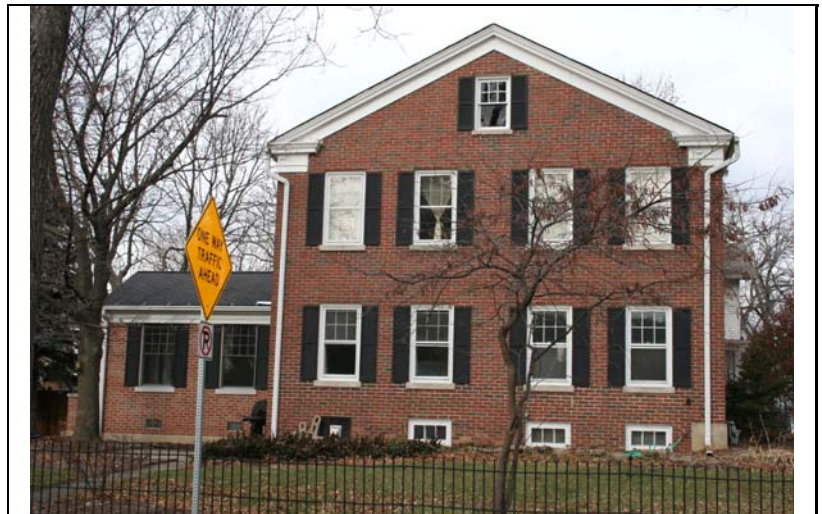
209 N BRAINARD

CATEGORY	building	CURRENT FUNCTION	Domestic - single dwelling
CONDITION	excellent	HISTORIC FUNCTION	Domestic - single dwelling
INTEGRITY	minor alterations and addition(s)	REASON for SIGNIFICANCE	Excellent example of Colonial Revival residence in the historic district. Simple, yet stately, example. Listed on Illinois Historic Structures Survey.
SECONDARY STRUCTURE	Detached garage

ARCHITECTURAL CLASSIFICATION	Colonial Revival	PLAN	Rectangular
DETAILS		NO OF STORIES	2
BEGINYEAR	c. 1925	ROOF TYPE	Side gable
OTHER YEAR		ROOF MATERIAL	Asphalt - shingle
DATESOURCE	Surveyor	FOUNDATION	Concrete - poured
WALL MATERIAL (current)	Brick	PORCH	-
WALL MATERIAL 2 (current)		WINDOW MATERIAL	Wood
WALL MATERIAL (original)	Brick	WINDOW MATERIAL	
WALL MATERIAL 2 (original)		WINDOW TYPE	Double hung/awning
		WINDOW CONFIG	6/1; 3-light

ALTERATIONS Replacement front steps and railing (not historic); 1 story rear addition

ARCHITECTURAL CLASSIFICATION	Colonial Revival	PLAN	Rectangular
DETAILS		NO OF STORIES	2
BEGINYEAR	c. 1925	ROOF TYPE	Side gable
OTHER YEAR		ROOF MATERIAL	Asphalt - shingle
DATESOURCE	Surveyor	FOUNDATION	Concrete - poured
WALL MATERIAL (current)	Brick	PORCH	-
WALL MATERIAL 2 (current)		WINDOW MATERIAL	Wood
WALL MATERIAL (original)	Brick	WINDOW MATERIAL	
WALL MATERIAL 2 (original)		WINDOW TYPE	Double hung/awning
		WINDOW CONFIG	6/1; 3-light
SIGNIFICANT FEATURES	Side gable roof with cornice returns; symmetrical front façade; front entry with classical surround and carved brackets; historic 6/1 wood double hung windows		
ALTERATIONS	Replacement front steps and railing (not historic); 1 story rear addition Window replacement (admin. approved. COA#10-2893) Window replacement (admin. approved COA# 11-3735)

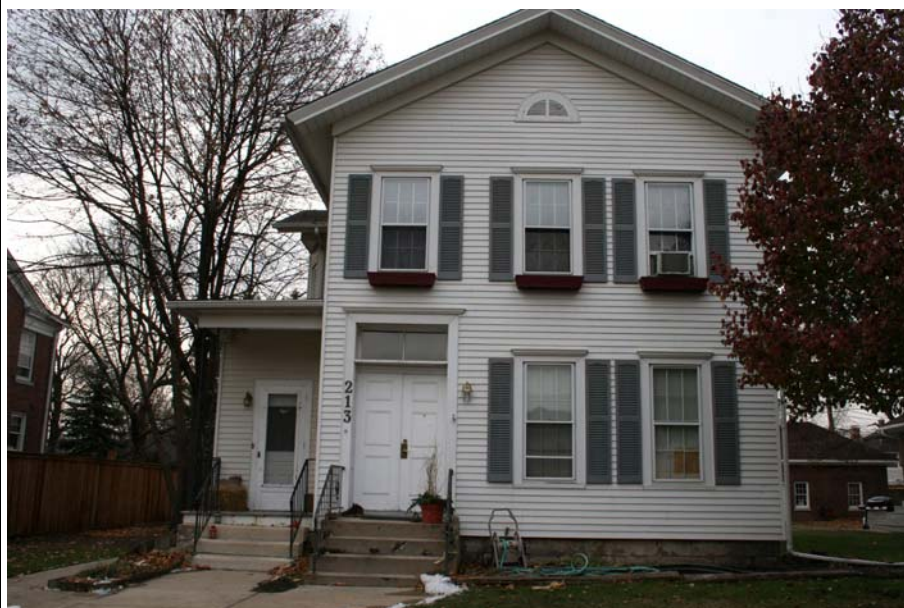
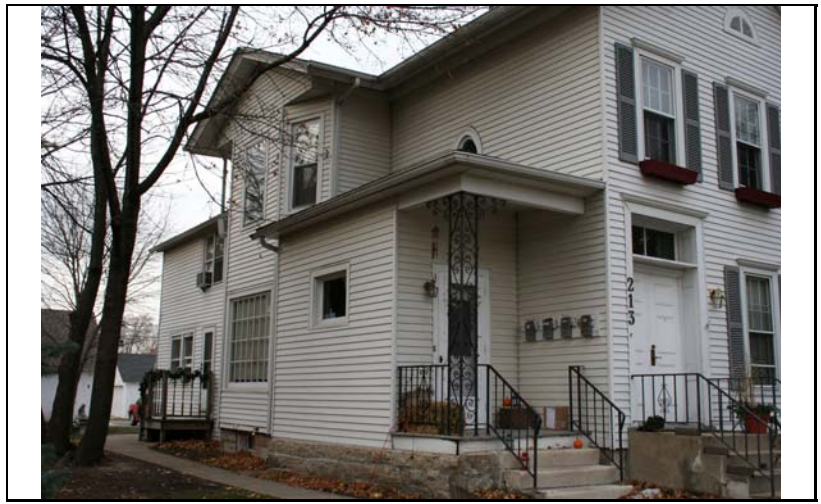
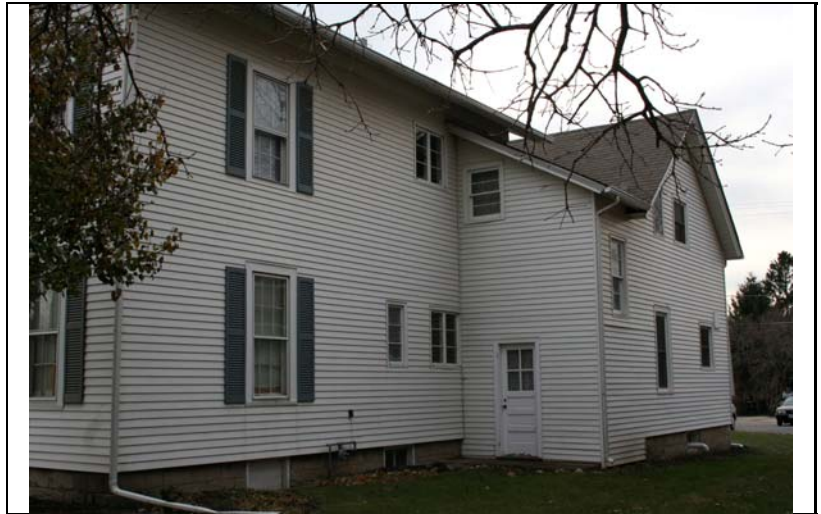
213 N BRAINARD

CATEGORY	building	CURRENT FUNCTION	Domestic - multiple dwelling
CONDITION	good	HISTORIC FUNCTION	Domestic - single dwelling
INTEGRITY	minor alterations and addition(s)	REASON for SIGNIFICANCE	Although altered, this 1870s Greek Revival residence retains its historic character, and is one of only a handful of this style in the district. List on IHSS (HD).
SECONDARY STRUCTURE	Detached garage

ARCHITECTURAL CLASSIFICATION	Greek Revival	PLAN	irregular
DETAILS		NO OF STORIES	2
BEGINYEAR	c. 1870	ROOF TYPE	Front gable
OTHER YEAR		ROOF MATERIAL	Asphalt - shingle
DATESOURCE	Surveyor	FOUNDATION	Stone
WALL MATERIAL (current)	Aluminum	PORCH	Front entry
WALL MATERIAL 2 (current)		WINDOW MATERIAL	Wood
WALL MATERIAL (original)	Wood	WINDOW MATERIAL	
WALL MATERIAL 2 (original)		WINDOW TYPE	double hung/fixed
		WINDOW CONFIG	6/6; multi-light; 1/1
SIGNIFICANT FEATURES	Front gable bay with 2 story south side gabled bay; historic 6/6 wood windows (probably not original); recessed front entry with transom and double wood paneled doors; rounded south window		
ALTERATIONS	Aluminum siding (not historic); fixed shutters (not historic); 2 story rear/north side shed addition (not historic); S. entry add.(historic--porch is later); 1/1 & multi-light replacement windows in original openings (historic); rear add. w/ deck Replacement of siding & window trim (admin. approved COA#15-4313)

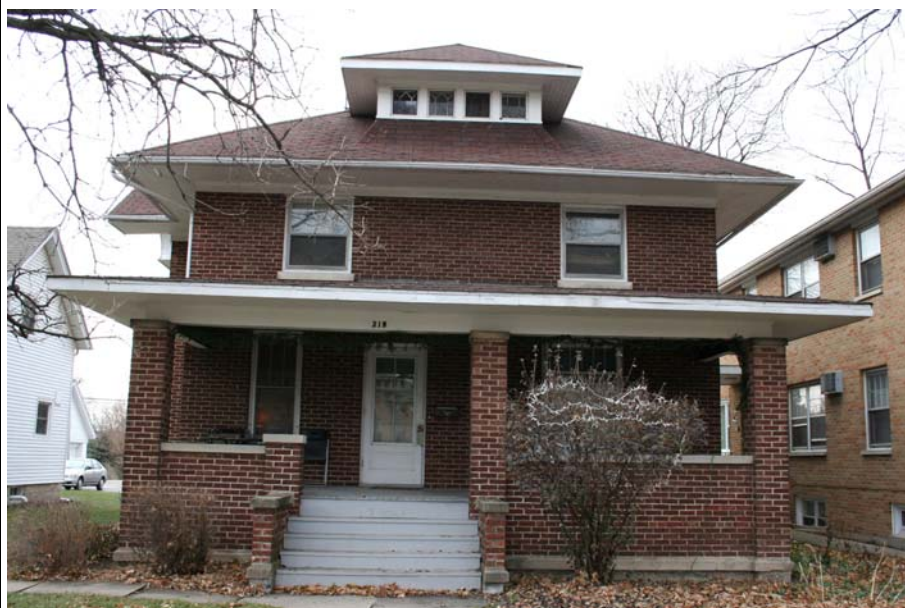
CATEGORY	building	CURRENT FUNCTION	Domestic - multiple dwelling
CONDITION	good	HISTORIC FUNCTION	Domestic - single dwelling
INTEGRITY	minor alterations	REASON for SIGNIFICANCE	Fine, brick-clad example of American Foursquare type.
SECONDARY STRUCTURE	Detached garage

ARCHITECTURAL CLASSIFICATION	American Foursquare	PLAN	rectangular
DETAILS	Prairie	NO OF STORIES	2.5
BEGINYEAR	c. 1915	ROOF TYPE	Hipped
OTHER YEAR		ROOF MATERIAL	Asphalt - shingle
DATESOURCE	Surveyor	FOUNDATION	Concrete - poured
WALL MATERIAL (current)	Brick	PORCH	Full front
WALL MATERIAL 2 (current)		WINDOW MATERIAL	Wood
WALL MATERIAL (original)	Brick	WINDOW MATERIAL	
WALL MATERIAL 2 (original)		WINDOW TYPE	Double/single hung/awnin
		WINDOW CONFIG	3/1; 1/1; 6/1; multi-light
SIGNIFICANT FEATURES	Hipped roof with overhanging eaves and front central hipped dormer; full front hipped roof porch with square brick columns on brick knee walls; historic double hung and single hung wood windows; 2 story south bay with gable roof		
ALTERATIONS	Second story addition to rear porch (historic); door added to first story south bay (appears historic)

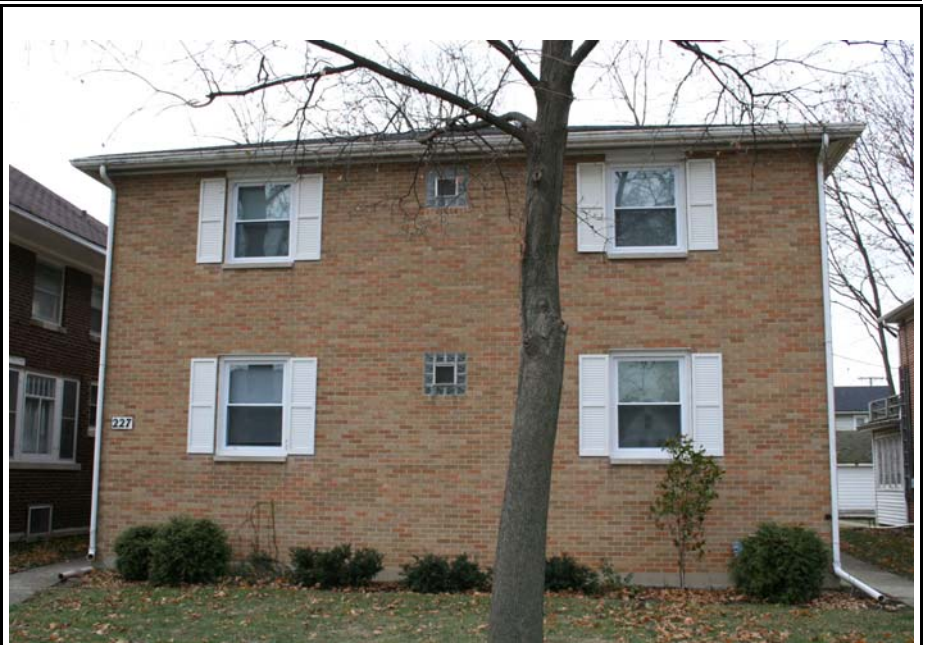
227 N BRAINARD

CATEGORY	building	CURRENT FUNCTION	Domestic - multiple dwelling
CONDITION	excellent	HISTORIC FUNCTION	Domestic - single dwelling
INTEGRITY	minor alterations	REASON for SIGNIFICANCE	
SECONDARY STRUCTURE

ARCHITECTURAL CLASSIFICATION	Duplex	PLAN	Rectangular
DETAILS		NO OF STORIES	2
BEGINYEAR	c. 1955	ROOF TYPE	Hipped
OTHER YEAR		ROOF MATERIAL	Asphalt - shingle
DATESOURCE	Surveyor	FOUNDATION	Concrete - poured
WALL MATERIAL (current)	Brick	PORCH	Side entry
WALL MATERIAL 2 (current)		WINDOW MATERIAL	Vinyl/wood
WALL MATERIAL (original)	Brick	WINDOW MATERIAL	Glass block
WALL MATERIAL 2 (original)		WINDOW TYPE	double hung/fixed
		WINDOW CONFIG	1/1
SIGNIFICANT FEATURES	Hipped roof; north and south entries with cantilevered canopies; historic 6/1 wood windows		
ALTERATIONS	1/1 vinyl replacement windows in original openings; fixed shutters; glass block replacement windows in original openings

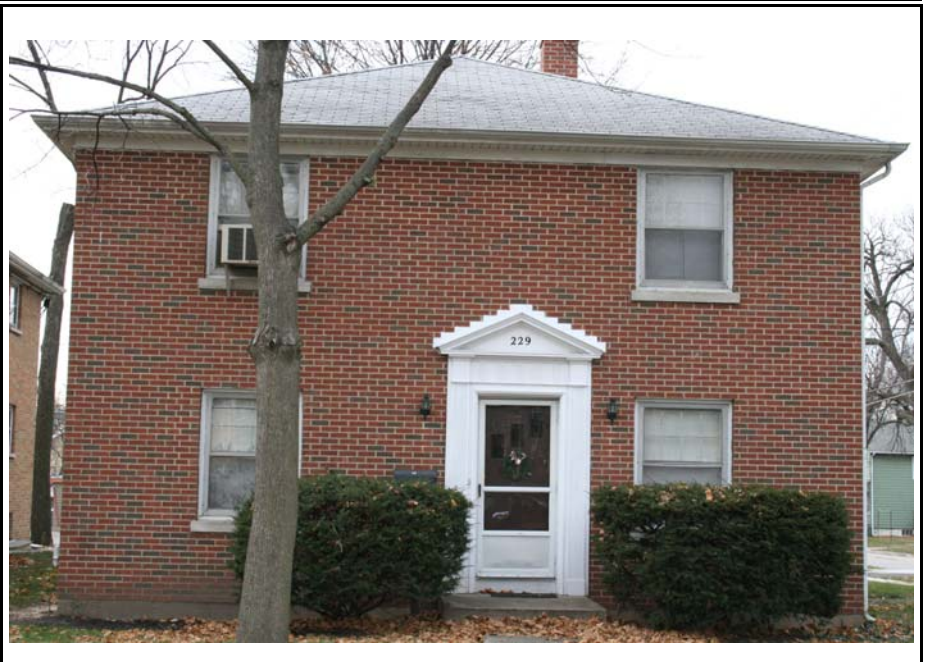
CATEGORY	building	CURRENT FUNCTION	Domestic - multiple dwelling
CONDITION	excellent	HISTORIC FUNCTION	Domestic - single dwelling
INTEGRITY	minor alterations	REASON for SIGNIFICANCE	
SECONDARY STRUCTURE	Detached garage

ARCHITECTURAL CLASSIFICATION	Colonial Revival	PLAN	rectangular
DETAILS		NO OF STORIES	2
BEGINYEAR	c. 1950	ROOF TYPE	Hipped
OTHER YEAR		ROOF MATERIAL	Asphalt - shingle
DATESOURCE	Surveyor	FOUNDATION	Concrete - poured
WALL MATERIAL (current)	Brick	PORCH	-
WALL MATERIAL 2 (current)		WINDOW MATERIAL	Wood
WALL MATERIAL (original)	Brick	WINDOW MATERIAL	
WALL MATERIAL 2 (original)		WINDOW TYPE	double hung
		WINDOW CONFIG	6/1
SIGNIFICANT FEATURES	Hipped roof; classical entry surround; historic 6/1 double hung wood windows		
ALTERATIONS	Aluminum awning over north side entry (not historic)
