STREET #	225
DIRECTION	N
STREET	COLUMBIA
SUFFIX	ST
PIN	0818205001
LOCAL SIGNIFICANCE RATING	C
POTENTIAL IND NR? (Y or N)	N
Contributing to a NR DISTRICT?	C
Contributing secondary structure?	C
Listed on existing SURVEY?	Local District; NR District

ILLINOIS URBAN ARCHITECTURAL AND HISTORICAL SURVEY CONTINUATION SHEET

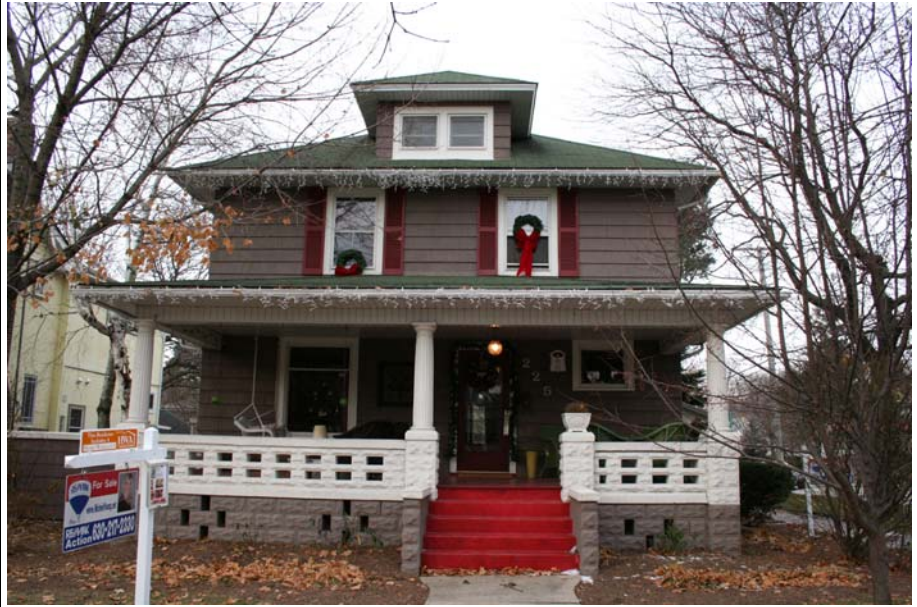
CATEGORY	building	CURRENT FUNCTION	Domestic - single dwelling
CONDITION	excellent	HISTORIC FUNCTION	Domestic - single dwelling
INTEGRITY	minor alterations and addition(s)	REASON for SIGNIFICANCE	
SECONDARY STRUCTURE	Detached garage

ARCHITECTURAL CLASSIFICATION	American Foursquare	PLAN	rectangular
DETAILS		NO OF STORIES	2.5
BEGINYEAR	1915	ROOF TYPE	Hipped
OTHER YEAR		ROOF MATERIAL	Asphalt - shingle
DATESOURCE	Plaque	FOUNDATION	Concrete - block
WALL MATERIAL (current)	Wood - shingle	PORCH	Full front
WALL MATERIAL 2 (current)		WINDOW MATERIAL	Wood
WALL MATERIAL (original)	Wood	WINDOW MATERIAL	Leaded glass
WALL MATERIAL 2 (original)		WINDOW TYPE	Double & single hung; fixe
		WINDOW CONFIG	1/1;multi/1; 1 & 2-light
SIGNIFICANT FEATURES	Hipped roof with front hipped dormer; full hipped porch with round fluted columns on rusticated concrete block piers/knee wall; shed canopy with curving knee brackets on north side entry; historic 1/1 and leaded glass windows; historic door		
ALTERATIONS	Aluminum siding under eaves and porch; fixed shutters (not historic); south patio addition (not historic); replacement siding (not historic) Roof replacement (admin. approved COA#12-0682)

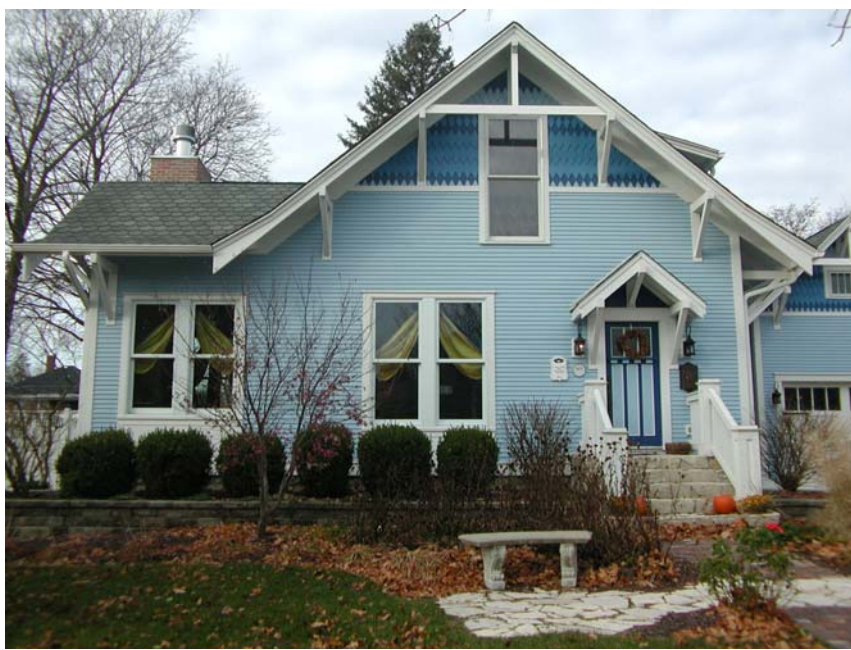
House recently renovated (received Illinois property tax assessment freeze)--large 1.5 story rear addition; replacement siding and shingles; replacement knee brackets and bracing; replacement windows in original openings (window under front gable was probably added when the attic was built out, before the latest renovation); replacement front stoop and entry canopy; north dormer addition

CATEGORY	building	CURRENT FUNCTION	Domestic - single dwelling
CONDITION	excellent	HISTORIC FUNCTION	Domestic - single dwelling
INTEGRITY	major alterations and/or addition(s)	REASON for SIGNIFICANCE	
SECONDARY STRUCTURE	Detached garage

ARCHITECTURAL CLASSIFICATION	Craftsman Bungalow	PLAN	irregular
DETAILS		NO OF STORIES	1.5
BEGINYEAR	1915	ROOF TYPE	Multi-gable
OTHER YEAR		ROOF MATERIAL	Asphalt - shingle
DATESOURCE	Plaque	FOUNDATION	Concrete - block
WALL MATERIAL (current)	Wood	PORCH	-
WALL MATERIAL 2 (current)	Wood - shingle	WINDOW MATERIAL	Aluminum clad
WALL MATERIAL (original)	Wood	WINDOW MATERIAL	
WALL MATERIAL 2 (original)	Wood - shingle	WINDOW TYPE	Double hung/casement/aw
		WINDOW CONFIG	1/1; 1-light; 3-light
SIGNIFICANT FEATURES	Original multi-gabled roof line; historic window openings(except under front gable) on original house; original front entry opening		
ALTERATIONS	House recently renovated--large 1.5 story rear addition; replacement siding and shingles; replacement knee brackets and bracing; replacement windows in original openings--SEE CONTINUATION SHEET

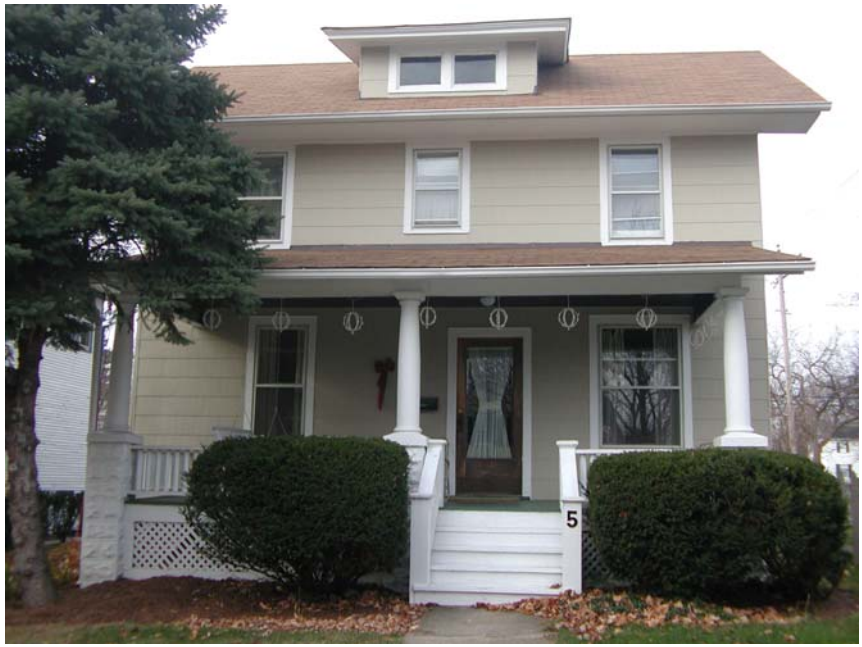
CATEGORY	building	CURRENT FUNCTION	Domestic - single dwelling
CONDITION	good	HISTORIC FUNCTION	Domestic - single dwelling
INTEGRITY	minor alterations and addition(s)	REASON for SIGNIFICANCE	Good example of Craftsman style in the district.
SECONDARY STRUCTURE	Detached garage

ARCHITECTURAL CLASSIFICATION	Craftsman	PLAN	rectangular
DETAILS	Colonial Revival	NO OF STORIES	2.5
BEGINYEAR	1908	ROOF TYPE	Side gable
OTHER YEAR		ROOF MATERIAL	Asphalt - shingle
DATESOURCE	Owner	FOUNDATION	Concrete - block
WALL MATERIAL (current)	Wood - shingle	PORCH	Full front
WALL MATERIAL 2 (current)		WINDOW MATERIAL	wood
WALL MATERIAL (original)	Wood	WINDOW MATERIAL	
WALL MATERIAL 2 (original)		WINDOW TYPE	Double hung/awning
		WINDOW CONFIG	1/1; 1-light
SIGNIFICANT FEATURES	Side gable roof with overhanging eaves; full width shed roof front porch with round columns on concrete block piers; front shed dormer; historic 1/1 and 1-light wood windows		
ALTERATIONS	Replacement siding; one story rear addition (may have originally been porch that was enclosed) In kind window & siding replacement (admin. approved COA#13-36) In kind replacement of asphalt shingles (admin. approved COA#17-1941) in kind replacement of porch columns (admin. approved COA#19-1373)

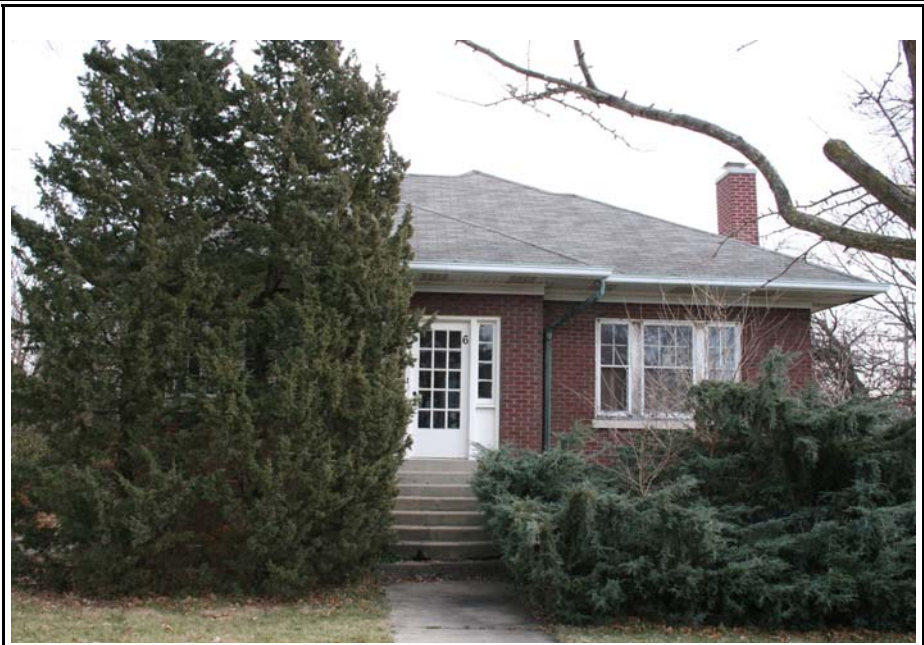
CATEGORY	<input type="text" value="building"/>	CURRENT FUNCTION	<input type="text" value="Domestic - single dwelling"/>
CONDITION	<input type="text" value="good"/>	HISTORIC FUNCTION	<input type="text" value="Domestic - single dwelling"/>
INTEGRITY	<input type="text" value="minor alterations"/>	REASON for SIGNIFICANCE	<input type="text" value="Excellent, nearly unaltered example of a 1920s brick bungalow."/>
SECONDARY STRUCTURE	<input type="text" value="Detached garage"/>

ARCHITECTURAL CLASSIFICATION	<input type="text" value="Bungalow"/>	PLAN	<input type="text" value="rectangular"/>
DETAILS	<input type="text"/>	NO OF STORIES	<input type="text" value="1.5"/>
BEGINYEAR	<input type="text" value="c. 1925"/>	ROOF TYPE	<input type="text" value="Hipped"/>
OTHER YEAR	<input type="text"/>	ROOF MATERIAL	<input type="text" value="Asphalt - shingle"/>
DATESOURCE	<input type="text" value="Surveyor"/>	FOUNDATION	<input type="text" value="Concrete"/>
WALL MATERIAL (current)	<input type="text" value="Brick"/>	PORCH	<input type="text" value="-"/>
WALL MATERIAL 2 (current)	<input type="text"/>	WINDOW MATERIAL	<input type="text" value="Wood"/>
WALL MATERIAL (original)	<input type="text" value="Brick"/>	WINDOW MATERIAL	<input type="text"/>
WALL MATERIAL 2 (original)	<input type="text"/>	WINDOW TYPE	<input type="text" value="Double hung/casement/jal"/>
		WINDOW CONFIG	<input type="text" value="6/1; 3/1; 4/1; 8 & 6-light"/>

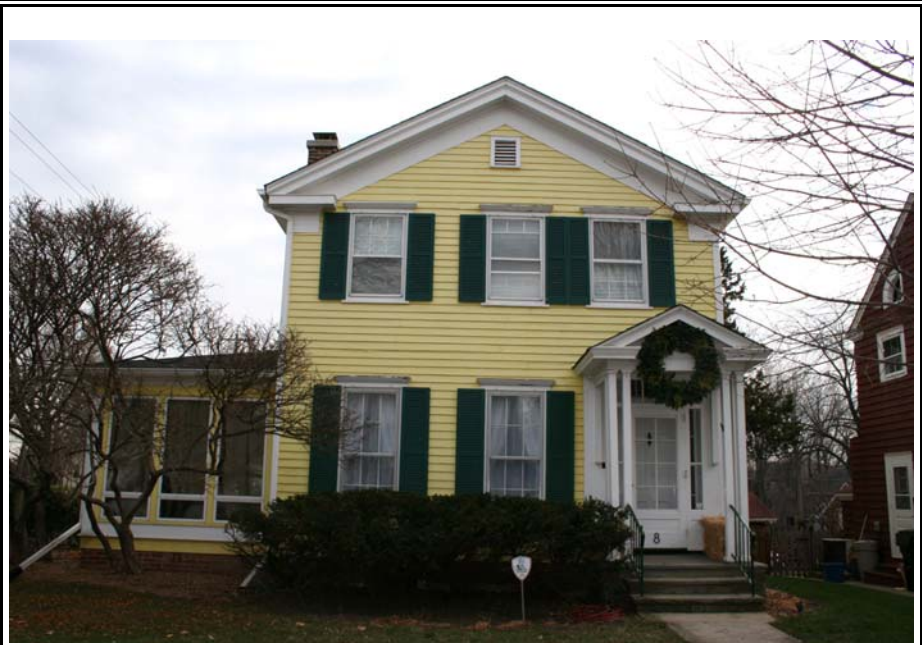
CATEGORY	building	CURRENT FUNCTION	Domestic - single dwelling
CONDITION	good	HISTORIC FUNCTION	Domestic - single dwelling
INTEGRITY	minor alterations and addition(s)	REASON for SIGNIFICANCE	Despite alterations, this remains a great 1860s example of the Greek Revival style.
SECONDARY STRUCTURE	Detached garage

ARCHITECTURAL CLASSIFICATION	Greek Revival	PLAN	rectangular
DETAILS		NO OF STORIES	2
BEGINYEAR	c. 1865	ROOF TYPE	Front gable
OTHER YEAR		ROOF MATERIAL	Asphalt - shingle
DATESOURCE	Surveyor	FOUNDATION	Brick
WALL MATERIAL (current)	Wood	PORCH	Front entry
WALL MATERIAL 2 (current)		WINDOW MATERIAL	Wood
WALL MATERIAL (original)	Wood	WINDOW MATERIAL	Vinyl
WALL MATERIAL 2 (original)		WINDOW TYPE	double hung/fixed/awning
		WINDOW CONFIG	6/6; 1-light
SIGNIFICANT FEATURES	Front gable with cornice returns; historic 6/6 wood windows; front gable entry porch roof with cornice returns; multi-light sidelights and transom at entry; classical lintels on windows		
ALTERATIONS	One story north sun porch addition (not historic); fixed shutters; replacement columns and base on porch (not historic); first story window bay addition (south side, historic); two story rear addition; replacement brick foundation Replace escape window (admin. approved COA#11-4104)

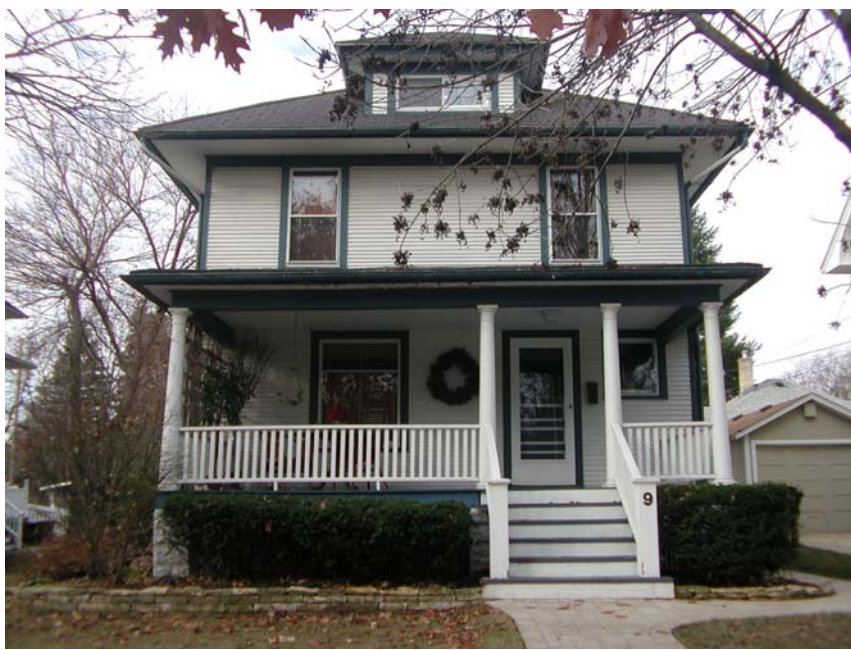
CATEGORY	building	CURRENT FUNCTION	Domestic - single dwelling
CONDITION	excellent	HISTORIC FUNCTION	Domestic - single dwelling
INTEGRITY	minor alterations	REASON for SIGNIFICANCE	Typical example of the American Foursquare type in the district.
SECONDARY STRUCTURE	Detached garage

ARCHITECTURAL CLASSIFICATION	American Foursquare	PLAN	rectangular
DETAILS		NO OF STORIES	2.5
BEGINYEAR	c. 1910	ROOF TYPE	Hipped
OTHER YEAR		ROOF MATERIAL	Asphalt - shingle
DATESOURCE	Surveyor/Title Research	FOUNDATION	Concrete - block
WALL MATERIAL (current)	Wood	PORCH	Full front
WALL MATERIAL 2 (current)		WINDOW MATERIAL	Wood
WALL MATERIAL (original)	Wood	WINDOW MATERIAL	
WALL MATERIAL 2 (original)		WINDOW TYPE	Double hung/fixed/sliding
		WINDOW CONFIG	1/1; 1-light; 1-1
SIGNIFICANT FEATURES	Hipped roof with front and side hipped dormers; full front porch with round columns and square railings; historic 1/1 and 1-light windows		
ALTERATIONS	Replacement dormer windows (not historic)

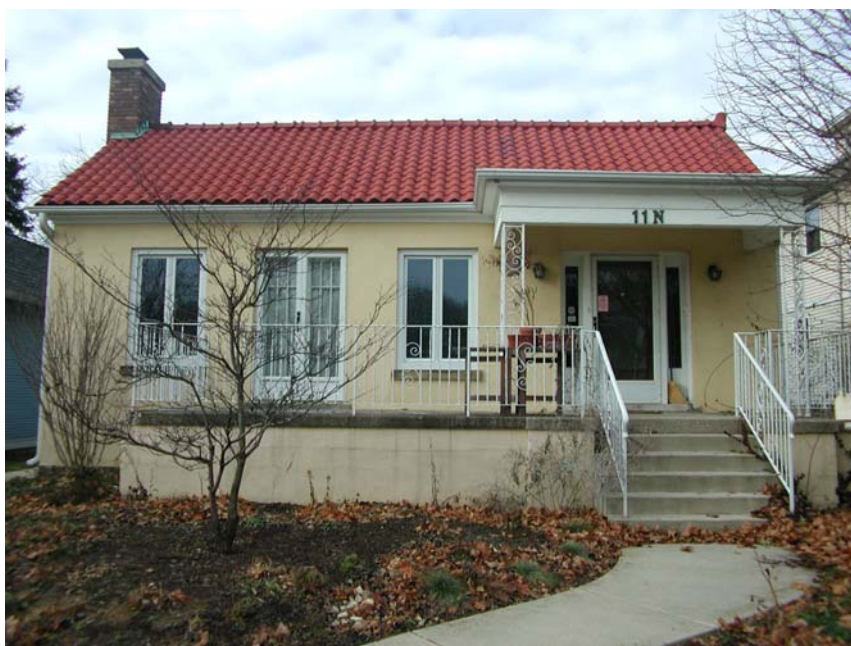
CATEGORY	building	CURRENT FUNCTION	Domestic - single dwelling
CONDITION	excellent	HISTORIC FUNCTION	Domestic - single dwelling
INTEGRITY	minor alterations	REASON for SIGNIFICANCE	
SECONDARY STRUCTURE	Detached garage

ARCHITECTURAL CLASSIFICATION	Mediterranean Revival	PLAN	Rectangular
DETAILS		NO OF STORIES	1
BEGINYEAR	c. 1930	ROOF TYPE	Side gable
OTHER YEAR		ROOF MATERIAL	Ceramic Tile
DATESOURCE	Surveyor	FOUNDATION	Brick
WALL MATERIAL (current)	Stucco	PORCH	Front
WALL MATERIAL 2 (current)		WINDOW MATERIAL	Aluminum
WALL MATERIAL (original)	Stucco	WINDOW MATERIAL	
WALL MATERIAL 2 (original)		WINDOW TYPE	Casement/double hung
		WINDOW CONFIG	1-light; 1/1
SIGNIFICANT FEATURES	Side gable roof with ceramic tile; front patio with flat-roof porch over entry; French doors to south of main entry; south end chimney		
ALTERATIONS	Replacement windows in original openings; raised terrace addition south of front porch; wrought iron railing on porch

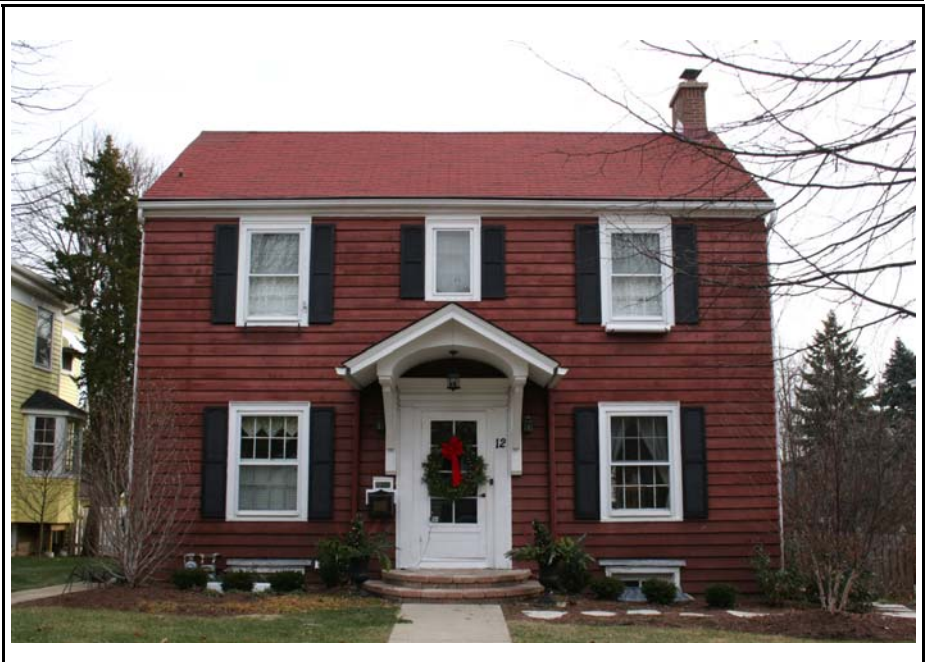
CATEGORY	building	CURRENT FUNCTION	Domestic - single dwelling
CONDITION	excellent	HISTORIC FUNCTION	Domestic - single dwelling
INTEGRITY	minor alterations and addition(s)	REASON for SIGNIFICANCE	
SECONDARY STRUCTURE	Detached garage

ARCHITECTURAL CLASSIFICATION	Colonial Revival	PLAN	rectangular
DETAILS		NO OF STORIES	2
BEGINYEAR	1923	ROOF TYPE	Side gable
OTHER YEAR		ROOF MATERIAL	Asphalt - shingle
DATESOURCE	Naperville Heritage Society	FOUNDATION	concrete
WALL MATERIAL (current)	Wood	PORCH	Canopy
WALL MATERIAL 2 (current)		WINDOW MATERIAL	Wood
WALL MATERIAL (original)	Stucco	WINDOW MATERIAL	
WALL MATERIAL 2 (original)		WINDOW TYPE	double hung/casement
		WINDOW CONFIG	8/8; 6/6; multi-light
SIGNIFICANT FEATURES	Side gable roof with cornice returns; historic 8/8 and 6/6 double hung windows and quarter round windows under side gables		
ALTERATIONS	Wood siding (1952); fixed shutters; 2 story rear addition (historic); rear deck addition; replacement front door & surround (1952); gabled front entry canopy addition (1993)

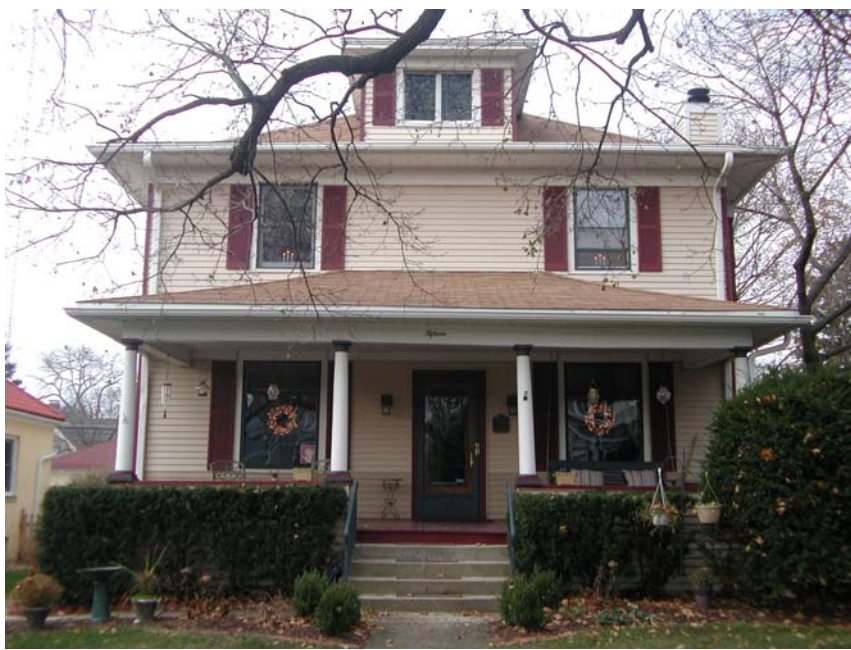
CATEGORY	building	CURRENT FUNCTION	Domestic - single dwelling
CONDITION	excellent	HISTORIC FUNCTION	Domestic - single dwelling
INTEGRITY	minor alterations and addition(s)	REASON for SIGNIFICANCE	
SECONDARY STRUCTURE	Detached garage

ARCHITECTURAL CLASSIFICATION	American Foursquare	PLAN	rectangular
DETAILS		NO OF STORIES	2.5
BEGINYEAR	c. 1910	ROOF TYPE	Hipped
OTHER YEAR		ROOF MATERIAL	Asphalt - shingle
DATESOURCE	surveyor	FOUNDATION	Parged
WALL MATERIAL (current)	Aluminum	PORCH	Full front
WALL MATERIAL 2 (current)		WINDOW MATERIAL	Wood/Vinyl
WALL MATERIAL (original)	Wood	WINDOW MATERIAL	Leaded glass
WALL MATERIAL 2 (original)		WINDOW TYPE	Double & Single hung/cas
		WINDOW CONFIG	1/1; multi/1; multi-light
SIGNIFICANT FEATURES	Hipped roof with front and south hipped dormers; full hipped front porch with round columns on solid knee wall; historic 1/1 first story windows with leaded glass upper sash; historic multi-light casement windows in front dormer		
ALTERATIONS	Replacement 1/1 double hung windows in original openings (not historic); Aluminum siding; 1 story rear addition; rear enclosed porch addition; fixed shutters; wrought iron railings at steps Addition to front porch style (HPC approved COA#19-487)

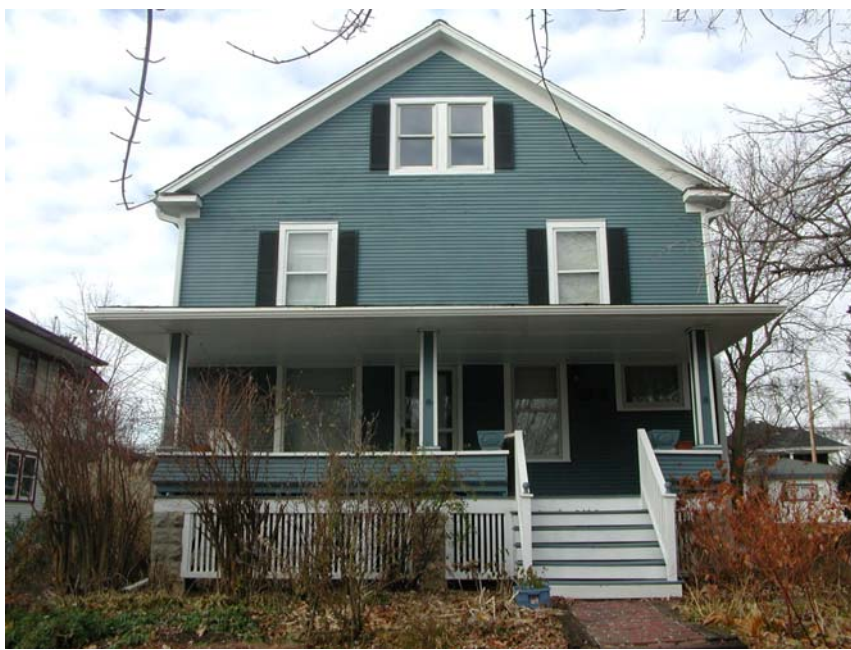
CATEGORY	building	CURRENT FUNCTION	Domestic - single dwelling
CONDITION	good	HISTORIC FUNCTION	Domestic - single dwelling
INTEGRITY	minor alterations and addition(s)	REASON for SIGNIFICANCE	
SECONDARY STRUCTURE	Detached garage

ARCHITECTURAL CLASSIFICATION	Gable Front	PLAN	rectangular
DETAILS		NO OF STORIES	2.5
BEGINYEAR	c. 1910-15	ROOF TYPE	Front gable
OTHER YEAR		ROOF MATERIAL	Asphalt - shingle
DATESOURCE	Surveyor	FOUNDATION	Concrete - block
WALL MATERIAL (current)	Wood	PORCH	Full front
WALL MATERIAL 2 (current)		WINDOW MATERIAL	Wood
WALL MATERIAL (original)	Wood	WINDOW MATERIAL	
WALL MATERIAL 2 (original)		WINDOW TYPE	double hung/fixed
		WINDOW CONFIG	1/1; 1-light
SIGNIFICANT FEATURES	Front gable roof with cornice returns; north and south gable dormers; full front porch with square columns on solid knee wall; historic 1/1 and 1-light wood windows		
ALTERATIONS	Replacement windows under front gable (not historic); window and door openings appear to have been altered under front porch (not historic)

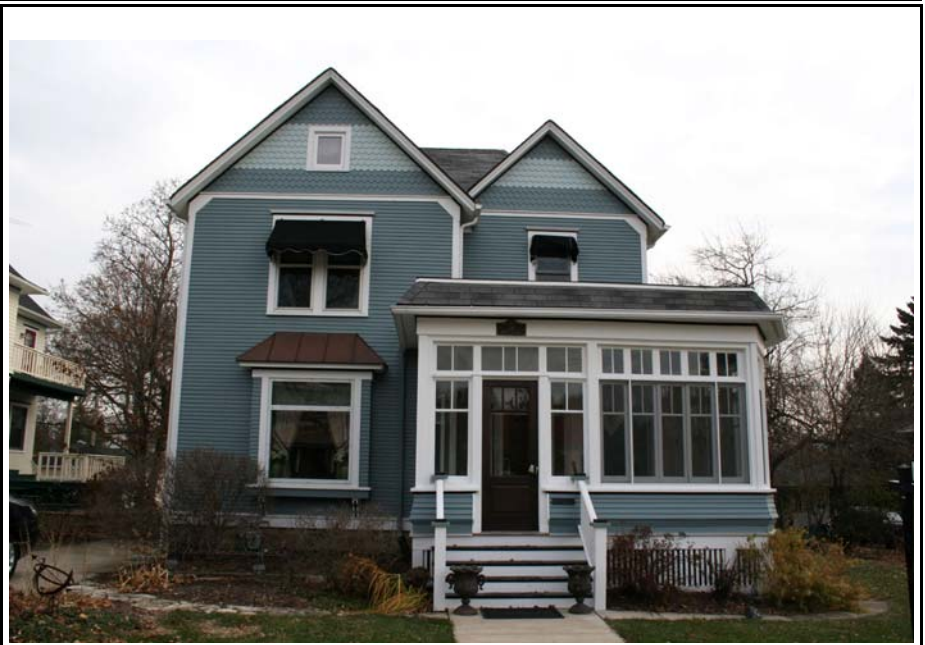
CATEGORY	building	CURRENT FUNCTION	Domestic - single dwelling
CONDITION	excellent	HISTORIC FUNCTION	Domestic - single dwelling
INTEGRITY	minor alterations and addition(s)	REASON for SIGNIFICANCE	Good example of the style, with minor alterations.
SECONDARY STRUCTURE	Detached garage

ARCHITECTURAL CLASSIFICATION	Queen Anne	PLAN	irregular
DETAILS		NO OF STORIES	2.5
BEGINYEAR	c. 1905	ROOF TYPE	Multi-gable
OTHER YEAR		ROOF MATERIAL	Asphalt - shingle
DATESOURCE	surveyor	FOUNDATION	Stone
WALL MATERIAL (current)	Wood	PORCH	Front
WALL MATERIAL 2 (current)	Wood - shingle	WINDOW MATERIAL	Wood
WALL MATERIAL (original)	Wood	WINDOW MATERIAL	
WALL MATERIAL 2 (original)	Wood - shingle	WINDOW TYPE	Double hung/fixed/caseme
		WINDOW CONFIG	1/1; 1-light; multi-light
SIGNIFICANT FEATURES	North front gable bay with north side gable; front oriel window		
ALTERATIONS	Replacement windows in original openings (historic); front porch addition (historic--later enclosed, w/ replacement front steps); awnings (not historic); 2 story rear addition; rear deck addition (not historic) In kind replacement of roof shingles (admin. approved COA#15-2811)

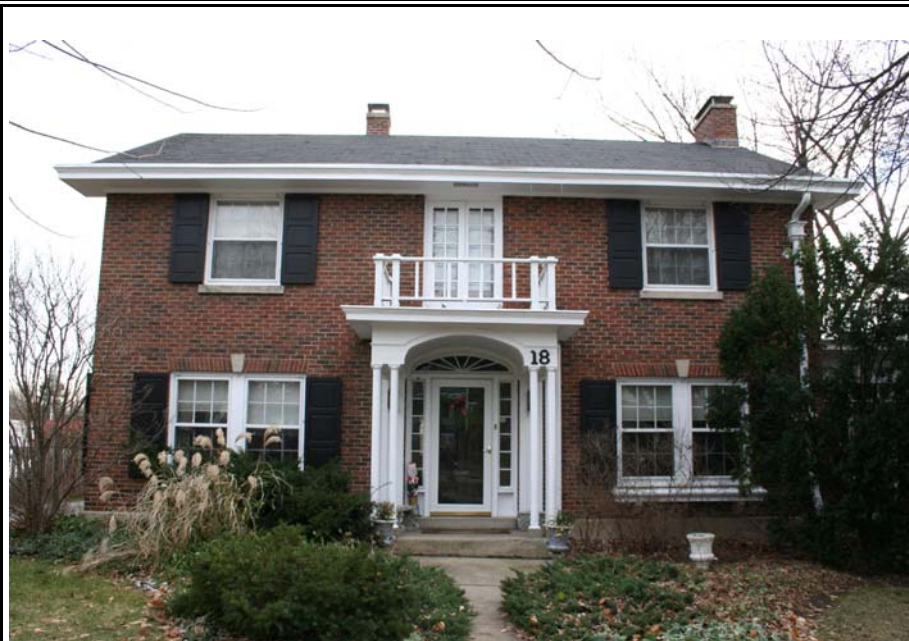
CATEGORY	building	CURRENT FUNCTION	Domestic - single dwelling
CONDITION	good	HISTORIC FUNCTION	Domestic - single dwelling
INTEGRITY	minor alterations and addition(s)	REASON for SIGNIFICANCE	Well-preserved example of 1920s Colonial Revival residential architecture, with handsome front entry porch.
SECONDARY STRUCTURE	Detached garage

ARCHITECTURAL CLASSIFICATION	Colonial Revival	PLAN	rectangular
DETAILS		NO OF STORIES	2
BEGINYEAR	c. 1925	ROOF TYPE	Side gable
OTHER YEAR		ROOF MATERIAL	Asphalt - shingle
DATESOURCE	surveyor	FOUNDATION	Concrete
WALL MATERIAL (current)	Brick	PORCH	Front entry
WALL MATERIAL 2 (current)		WINDOW MATERIAL	Wood
WALL MATERIAL (original)	Brick	WINDOW MATERIAL	
WALL MATERIAL 2 (original)		WINDOW TYPE	double hung/awning/fixed
		WINDOW CONFIG	8/8; 6/6; 1-light
SIGNIFICANT FEATURES	Side gable roof with cornice returns; center entry; barrel arch front entry porch with grouped round columns; historic double hung windows and quarter round windows; south side sun porch; side lights and fanlight at front entry		
ALTERATIONS	First story replacement window in downsized opening on north elevation (not historic); 1 & 2 story rear additions

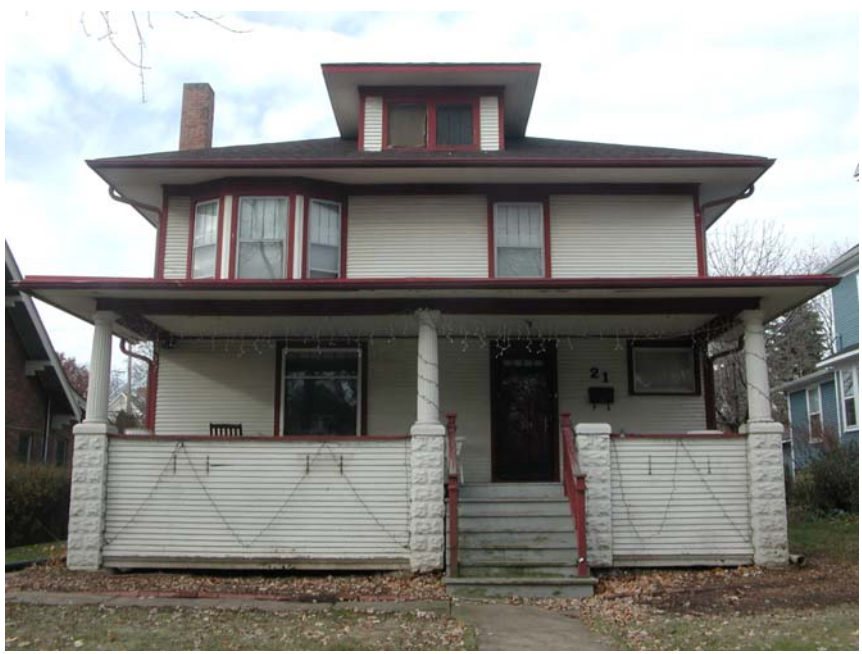
CATEGORY	building	CURRENT FUNCTION	Domestic - single dwelling
CONDITION	good	HISTORIC FUNCTION	Domestic - single dwelling
INTEGRITY	minor alterations and addition(s)	REASON for SIGNIFICANCE	Typical example of American Foursquare type in the district.
SECONDARY STRUCTURE	Detached garage

ARCHITECTURAL CLASSIFICATION	American Foursquare	PLAN	rectangular
DETAILS		NO OF STORIES	2.5
BEGINYEAR	c. 1910	ROOF TYPE	Hipped
OTHER YEAR		ROOF MATERIAL	Asphalt - shingle
DATESOURCE	Surveyor	FOUNDATION	Concrete - block
WALL MATERIAL (current)	Wood	PORCH	Full front
WALL MATERIAL 2 (current)		WINDOW MATERIAL	Wood
WALL MATERIAL (original)	Wood	WINDOW MATERIAL	
WALL MATERIAL 2 (original)		WINDOW TYPE	Double & Single Hung/fixe
		WINDOW CONFIG	3/1; 4/1; 6/1; 4 & 3-light
SIGNIFICANT FEATURES	Hipped roof with overhanging eaves and front hipped dormer; full front porch with classical columns on concrete block piers; 2nd story 3-sided front window bay; historic wood windows; historic wood front door		
ALTERATIONS	Railing at front steps is replacement (not historic); one-story rear additions and second story addition (not historic) Window replacement (admin. approved COA#10-0148)

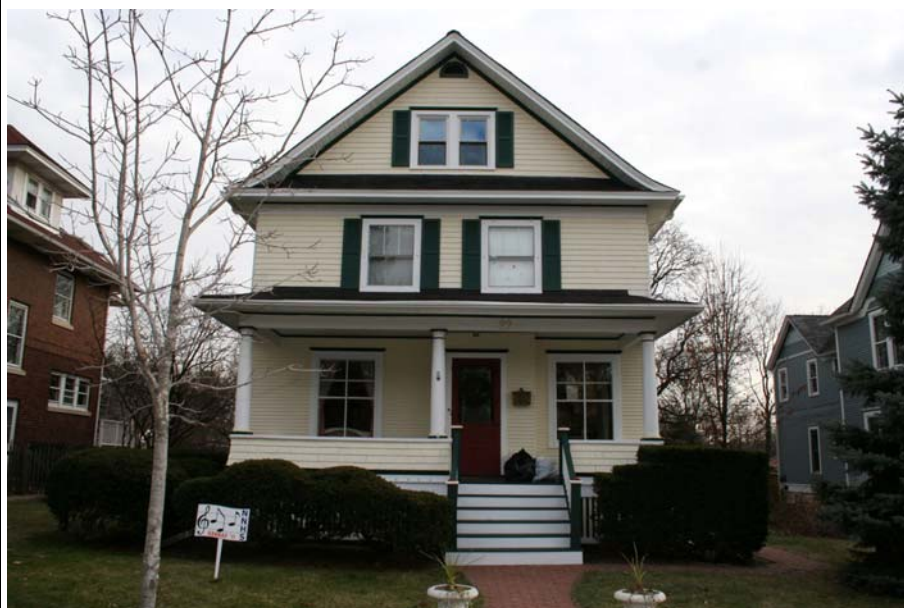
CATEGORY	building	CURRENT FUNCTION	Domestic - single dwelling
CONDITION	excellent	HISTORIC FUNCTION	Domestic - single dwelling
INTEGRITY	minor alterations	REASON for SIGNIFICANCE	Handsome Queen Anne-Free Classic residence with flared, pent gable roof and full width front porch.
SECONDARY STRUCTURE	Detached garage

ARCHITECTURAL CLASSIFICATION	Queen Anne - Free Classic	PLAN	Rectangular
DETAILS		NO OF STORIES	2.5
BEGINYEAR	1910	ROOF TYPE	Front gable
OTHER YEAR		ROOF MATERIAL	Asphalt - shingle
DATESOURCE	Owner	FOUNDATION	Concrete - block
WALL MATERIAL (current)	Wood	PORCH	Full front
WALL MATERIAL 2 (current)	Wood - shingle	WINDOW MATERIAL	Wood/leaded glass
WALL MATERIAL (original)	Wood	WINDOW MATERIAL	Glass block
WALL MATERIAL 2 (original)	Wood - shingle	WINDOW TYPE	double hung/fixed
		WINDOW CONFIG	1/1; 1-light; multi-light
SIGNIFICANT FEATURES	Pent front gable roof with flared eaves; full front porch with round columns on wood shingle knee walls; shingled 2nd story & gable walls; oriel square window bay w/ flared hip roof on N. side; historic wood windows; rounded S. oriel bay w/ conical roof		
ALTERATIONS	Front entry bay is a possible addition (historic); 2 story rear addition (1994); replacement windows in dormers and under front gable (not historic); rear/south porch and deck addition (not historic); fixed shutters (not historic)

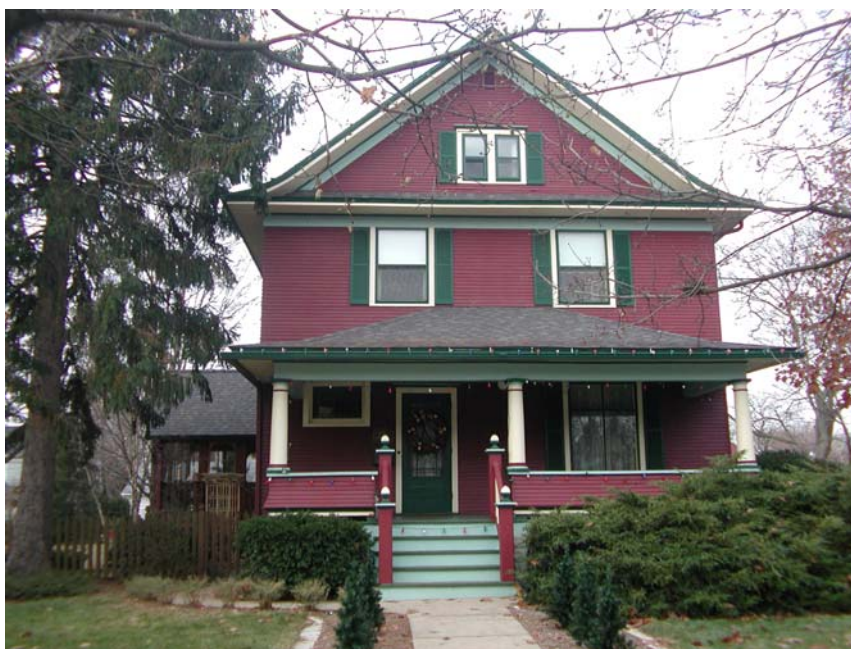
CATEGORY	building	CURRENT FUNCTION	Domestic - single dwelling
CONDITION	excellent	HISTORIC FUNCTION	Domestic - single dwelling
INTEGRITY	minor alterations and addition(s)	REASON for SIGNIFICANCE	Fine example of early 20th-century Queen Anne-Free Classic, with flared, pent gable roof and hipped porch with classical columns.
SECONDARY STRUCTURE	Detached garage

ARCHITECTURAL CLASSIFICATION	Queen Anne - Free Classic	PLAN	rectangular
DETAILS		NO OF STORIES	2.5
BEGINYEAR	c. 1905	ROOF TYPE	Front gable
OTHER YEAR		ROOF MATERIAL	Asphalt - shingle
DATESOURCE	Surveyor	FOUNDATION	Parged
WALL MATERIAL (current)	Wood	PORCH	Full front
WALL MATERIAL 2 (current)		WINDOW MATERIAL	Wood
WALL MATERIAL (original)	Wood	WINDOW MATERIAL	Leaded glass
WALL MATERIAL 2 (original)		WINDOW TYPE	Double & single hung/fixed
		WINDOW CONFIG	1/1; multi/1; multi-light
SIGNIFICANT FEATURES	Flared front gable roof with pent enclosure; front hipped porch with flared eaves, wood frieze, and round columns on solid knee walls; north side square oriel bay; historic wood and leaded glass windows; north hipped dormer		
ALTERATIONS	Replacement railings at steps (not historic); two story rear addition; 1 story south/rear addition (not historic)

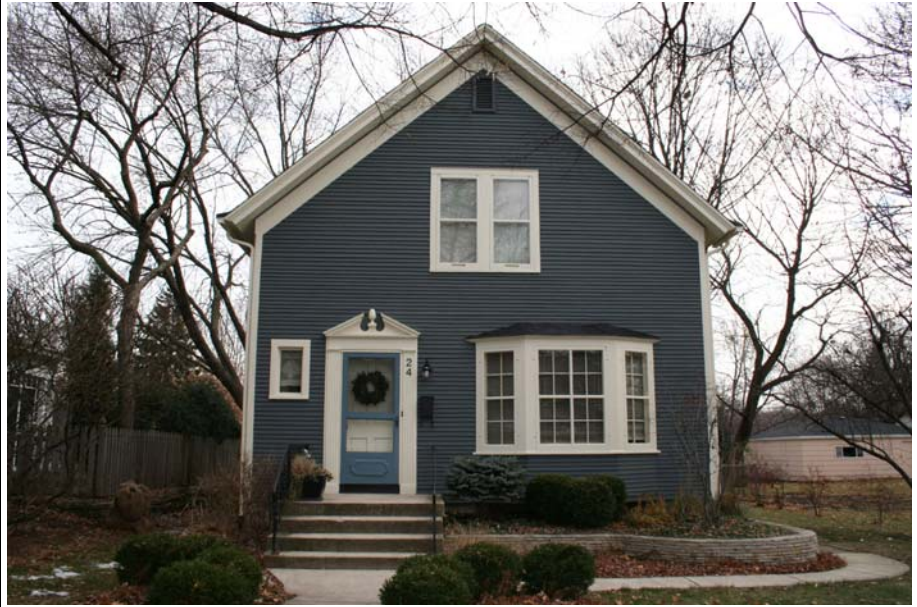
CATEGORY	building	CURRENT FUNCTION	Domestic - single dwelling
CONDITION	excellent	HISTORIC FUNCTION	Domestic - single dwelling
INTEGRITY	minor alterations and addition(s)	REASON for SIGNIFICANCE	
SECONDARY STRUCTURE	Detached garage

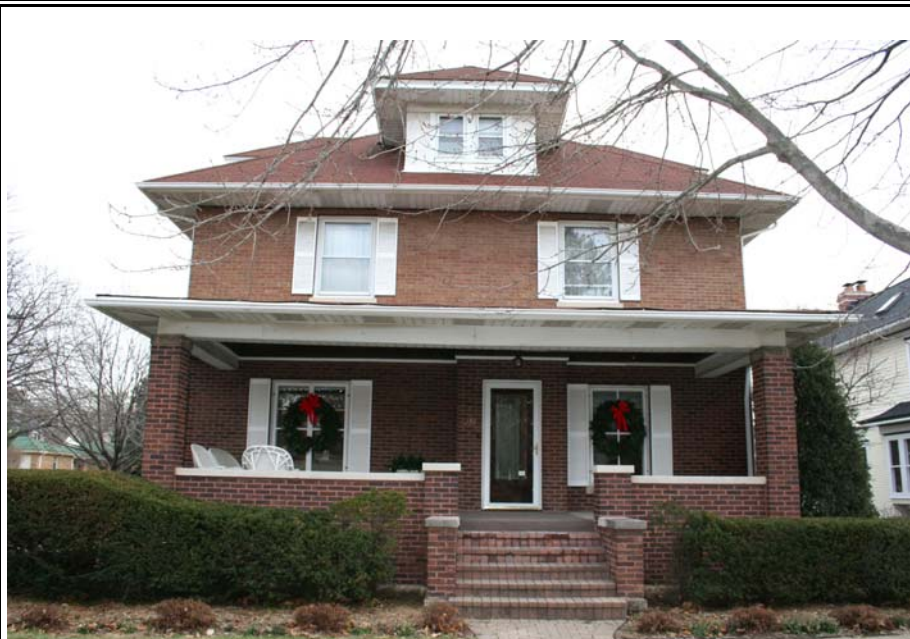
STREET #	26
DIRECTION	N
STREET	COLUMBIA
SUFFIX	ST
PIN	0818404001
LOCAL SIGNIFICANCE RATING	C
POTENTIAL IND NR? (Y or N)	N
Contributing to a NR DISTRICT?	C
Contributing secondary structure?	C
Listed on existing SURVEY?	Local District; NR District

CATEGORY	building	CURRENT FUNCTION	Domestic - single dwelling
CONDITION	good	HISTORIC FUNCTION	Domestic - single dwelling
INTEGRITY	minor alterations and addition(s)	REASON for SIGNIFICANCE	
SECONDARY STRUCTURE	Detached garage

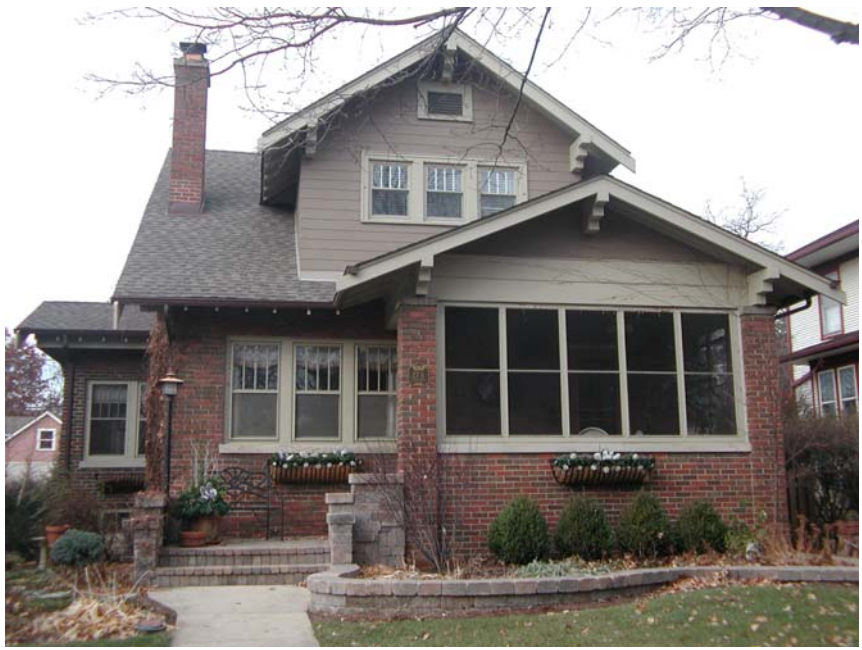
STREET #	27
DIRECTION	S
STREET	COLUMBIA
SUFFIX	ST
PIN	0818407006
LOCAL SIGNIFICANCE RATING	S
POTENTIAL IND NR? (Y or N)	N
Contributing to a NR DISTRICT?	C
Contributing secondary structure?	C
Listed on existing SURVEY?	Local District; NR District

CATEGORY	building	CURRENT FUNCTION	Domestic - single dwelling
CONDITION	excellent	HISTORIC FUNCTION	Domestic - single dwelling
INTEGRITY	minor alterations and addition(s)	REASON for SIGNIFICANCE	Fine Craftsman Bungalow with distinctive stepped brackets under gables.
SECONDARY STRUCTURE	Detached garage

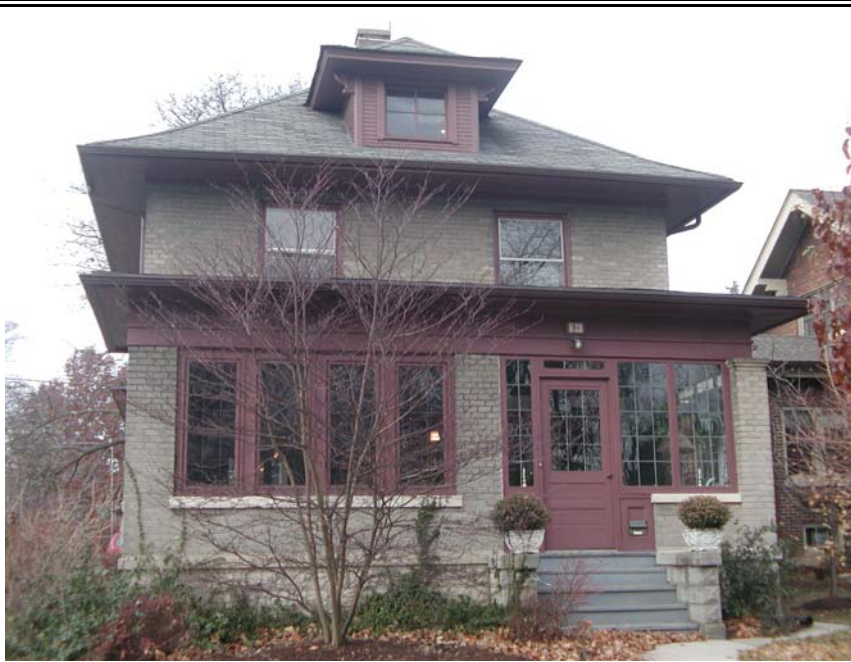
STREET #	31
DIRECTION	S
STREET	COLUMBIA
SUFFIX	ST
PIN	0818407007
LOCAL SIGNIFICANCE RATING	C
POTENTIAL IND NR? (Y or N)	N
Contributing to a NR DISTRICT?	C
Contributing secondary structure?	C
Listed on existing SURVEY?	Local District; NR District

CATEGORY	building	CURRENT FUNCTION	Domestic - single dwelling
CONDITION	excellent	HISTORIC FUNCTION	Domestic - single dwelling
INTEGRITY	minor alterations	REASON for SIGNIFICANCE	
SECONDARY STRUCTURE	Detached garage

ARCHITECTURAL CLASSIFICATION	American Foursquare	PLAN	Rectangular
DETAILS		NO OF STORIES	2.5
BEGINYEAR	c. 1915	ROOF TYPE	Hipped
OTHER YEAR		ROOF MATERIAL	Asphalt - shingle
DATESOURCE	Surveyor	FOUNDATION	Concrete - block
WALL MATERIAL (current)	Brick	PORCH	Full front
WALL MATERIAL 2 (current)	Wood	WINDOW MATERIAL	Wood
WALL MATERIAL (original)	Brick	WINDOW MATERIAL	Aluminum/leaded glass
WALL MATERIAL 2 (original)	Wood	WINDOW TYPE	Double hung/fixed/caseme
		WINDOW CONFIG	3/1; 1/1; 4-light; 10-light
SIGNIFICANT FEATURES	Flared hipped roof with overhanging eaves; front hipped dormer with scrolled brackets; front porch with brick columns and knee walls (appears that south end of porch is historic sun porch); historic 3/1 wood windows; square south side window bay		
ALTERATIONS	North end of porch enclosed w/ multi-light windows and door (not historic); replacement dormer window (not historic); replacement windows on south side bay (not historic) Roof replacement (admin. approved COA#09-2589)

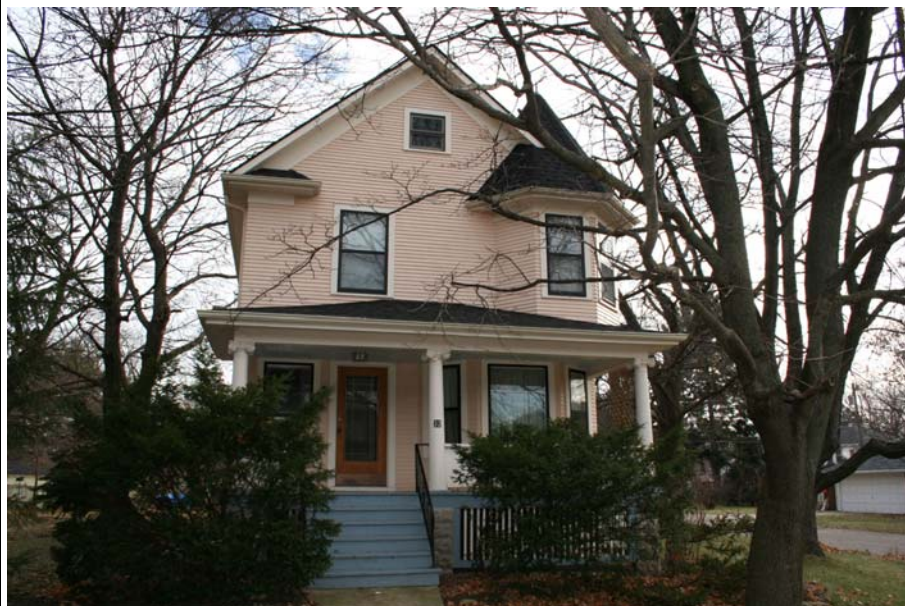
STREET #	32
DIRECTION	S
STREET	COLUMBIA
SUFFIX	ST
PIN	0818408005
LOCAL SIGNIFICANCE RATING	S
POTENTIAL IND NR? (Y or N)	N
Contributing to a NR DISTRICT?	C
Contributing secondary structure?	NC
Listed on existing SURVEY?	Local District; NR District

CATEGORY	building	CURRENT FUNCTION	Domestic - single dwelling
CONDITION	good	HISTORIC FUNCTION	Domestic - single dwelling
INTEGRITY	minor alterations and addition(s)	REASON for SIGNIFICANCE	Excellent example of an early 20th century Queen Anne-Free Classic residence, with polygonal corner turret and Ionic columns on porch.
SECONDARY STRUCTURE	Detached garage

ARCHITECTURAL CLASSIFICATION	Queen Anne - Free Classic	PLAN	rectangular
DETAILS		NO OF STORIES	2.5
BEGINYEAR	c. 1915	ROOF TYPE	Front gable
OTHER YEAR		ROOF MATERIAL	Asphalt - shingle
DATESOURCE	Surveyor	FOUNDATION	Concrete - block
WALL MATERIAL (current)	Wood	PORCH	Full front
WALL MATERIAL 2 (current)		WINDOW MATERIAL	Wood
WALL MATERIAL (original)	Wood	WINDOW MATERIAL	leaded glass
WALL MATERIAL 2 (original)		WINDOW TYPE	double hung/fixed
		WINDOW CONFIG	1/1; 1-light; multi-light
SIGNIFICANT FEATURES	Front gable with cornice returns; 2nd story polygonal corner bay with conical roof; full front porch w/ round Ionic columns; historic 1/1 and leaded glass windows; 3-sided 1st story S. window bay; hipped N. side dormer		
ALTERATIONS	Solid porch railing on front of porch, missing railings on sides (not historic); replacement windows in dormer and under gable (not historic); rear deck addition (not historic)

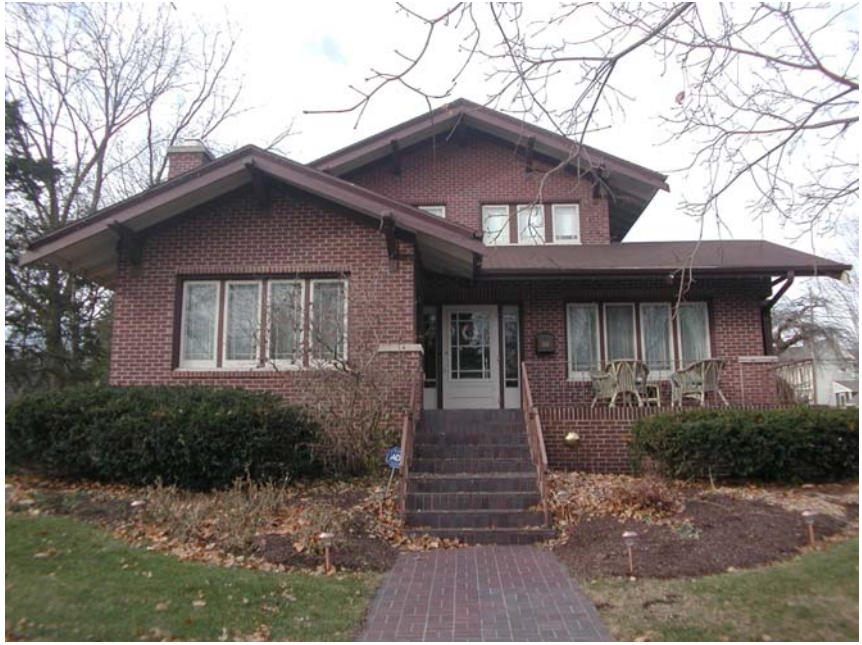
STREET #	105
DIRECTION	S
STREET	COLUMBIA
SUFFIX	ST
PIN	0818409010
LOCAL SIGNIFICANCE RATING	S
POTENTIAL IND NR? (Y or N)	N
Contributing to a NR DISTRICT?	C
Contributing secondary structure?	C
Listed on existing SURVEY?	Local District; NR District

CATEGORY	building	CURRENT FUNCTION	Domestic - single dwelling
CONDITION	excellent	HISTORIC FUNCTION	Domestic - single dwelling
INTEGRITY	minor alterations	REASON for SIGNIFICANCE	Well-preserved example of the Craftsman style, with broad overhanging eaves and decorative L-brackets.
SECONDARY STRUCTURE	Detached garage

ARCHITECTURAL CLASSIFICATION	Craftsman	PLAN	irregular
DETAILS		NO OF STORIES	1.5
BEGINYEAR	c. 1925	ROOF TYPE	Multi-gable
OTHER YEAR		ROOF MATERIAL	Asphalt - shingle
DATESOURCE	Surveyor	FOUNDATION	Not visible
WALL MATERIAL (current)	Brick	PORCH	Front deck
WALL MATERIAL 2 (current)		WINDOW MATERIAL	Wood
WALL MATERIAL (original)	Brick	WINDOW MATERIAL	
WALL MATERIAL 2 (original)		WINDOW TYPE	Casement/double hung
		WINDOW CONFIG	9-light; 6/6
SIGNIFICANT FEATURES	Recessed 2nd story; multi-gable roof with overhanging eaves, knee brackets, and exposed rafter tails; historic multi-pane front door with sidelights; broad south wall chimney; historic 6-light and 6/6 wood windows; N. entry porch; battered brick chimney		
ALTERATIONS	wrought iron railings on front patio

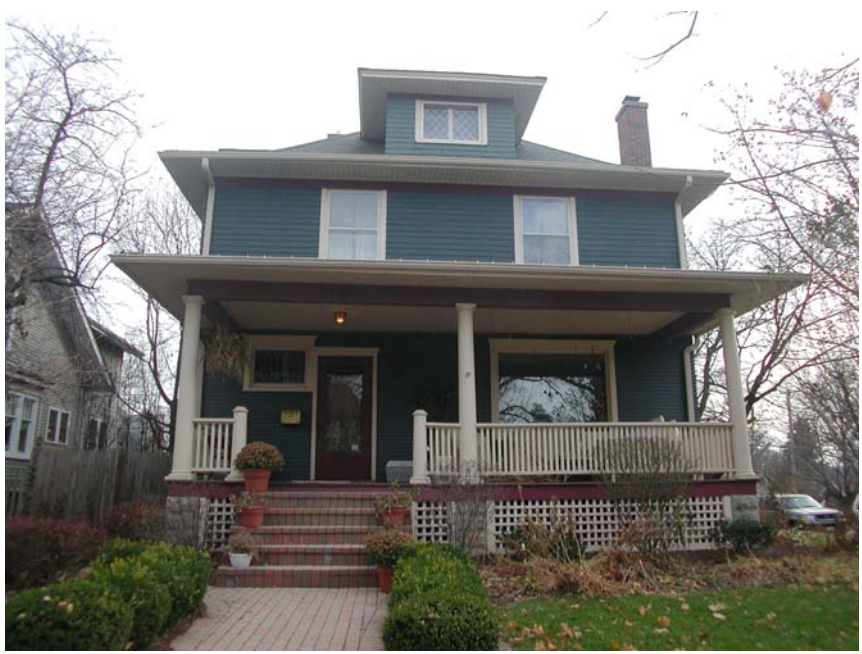
STREET #	106
DIRECTION	N
STREET	COLUMBIA
SUFFIX	ST
PIN	0818400011
LOCAL SIGNIFICANCE RATING	S
POTENTIAL IND NR? (Y or N)	N
Contributing to a NR DISTRICT?	C
Contributing secondary structure?	NC
Listed on existing SURVEY?	Local District; NR District

CATEGORY	building	CURRENT FUNCTION	Domestic - single dwelling
CONDITION	excellent	HISTORIC FUNCTION	Domestic - single dwelling
INTEGRITY	minor alterations and addition(s)	REASON for SIGNIFICANCE	An intact example of the style, with an appropriately-placed rear addition.
SECONDARY STRUCTURE	Detached garage

ARCHITECTURAL CLASSIFICATION	Queen Anne - Free Classic	PLAN	rectangular
DETAILS		NO OF STORIES	2.5
BEGINYEAR	c. 1905	ROOF TYPE	Hipped
OTHER YEAR		ROOF MATERIAL	Asphalt - shingle
DATESOURCE	Surveyor	FOUNDATION	Concrete - block
WALL MATERIAL (current)	Wood	PORCH	Full front
WALL MATERIAL 2 (current)	Wood - shingle	WINDOW MATERIAL	wood
WALL MATERIAL (original)	Wood	WINDOW MATERIAL	leaded glass
WALL MATERIAL 2 (original)	Wood - shingle	WINDOW TYPE	double hung/casement/fixe
		WINDOW CONFIG	1/1; multi-light
SIGNIFICANT FEATURES	Flared hipped roof with overhanging eaves; front & side hipped dormers; full front porch with hipped roof, rounded columns & square railings; wood shingle 2nd story (slight flare at 2nd story break); historic wood windows; 3-sided, 2-story south bay		
ALTERATIONS	Replacement front steps (not historic); large 2 story rear addition, with 2nd south bay and rear porch (not historic)

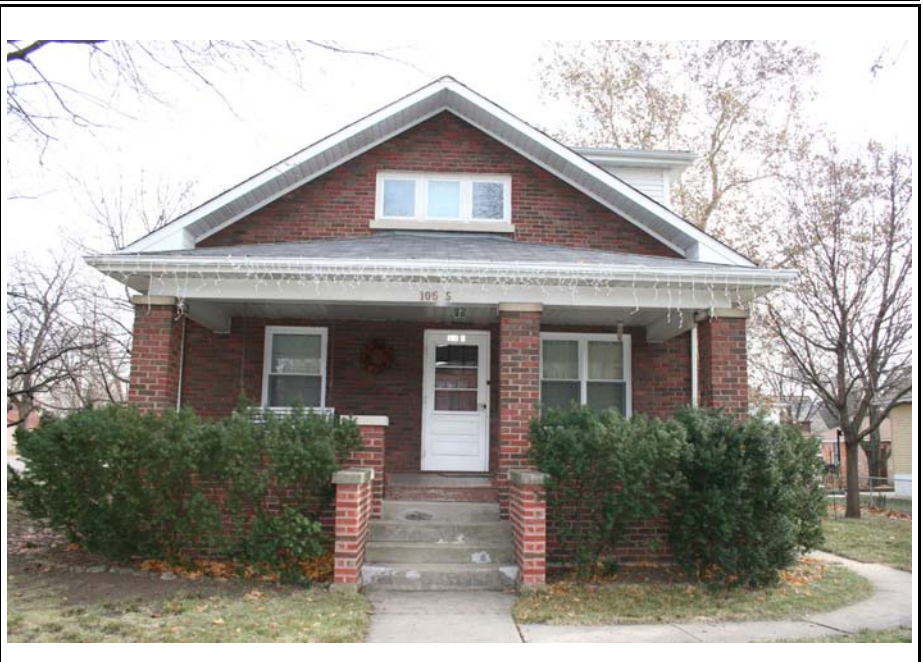
STREET #	106
DIRECTION	S
STREET	COLUMBIA
SUFFIX	ST
PIN	0818410011
LOCAL SIGNIFICANCE RATING	C
POTENTIAL IND NR? (Y or N)	N
Contributing to a NR DISTRICT?	C
Contributing secondary structure?	C
Listed on existing SURVEY?	Local District; NR District

CATEGORY	building	CURRENT FUNCTION	Domestic - single dwelling
CONDITION	excellent	HISTORIC FUNCTION	Domestic - single dwelling
INTEGRITY	minor alterations and addition(s)	REASON for SIGNIFICANCE	
SECONDARY STRUCTURE	Detached garage

ARCHITECTURAL CLASSIFICATION	Bungalow	PLAN	rectangular
DETAILS		NO OF STORIES	1.5
BEGINYEAR	1935	ROOF TYPE	Front gable
OTHER YEAR		ROOF MATERIAL	Asphalt - shingle
DATESOURCE	Owner	FOUNDATION	concrete
WALL MATERIAL (current)	Brick	PORCH	Full front
WALL MATERIAL 2 (current)	Wood	WINDOW MATERIAL	wood
WALL MATERIAL (original)	Brick	WINDOW MATERIAL	Vinyl
WALL MATERIAL 2 (original)		WINDOW TYPE	double hung/casement
		WINDOW CONFIG	6/6; 3/1; 1-light
SIGNIFICANT FEATURES	Front gable with cornice returns; hipped front porch with square brick columns on brick knee walls; historic 3/1 and 6/6 wood windows		
ALTERATIONS	South side dormer addition (not historic); replacement 2nd story windows; Aluminum under eaves Steps repair (admin. approved COA#09-3056)

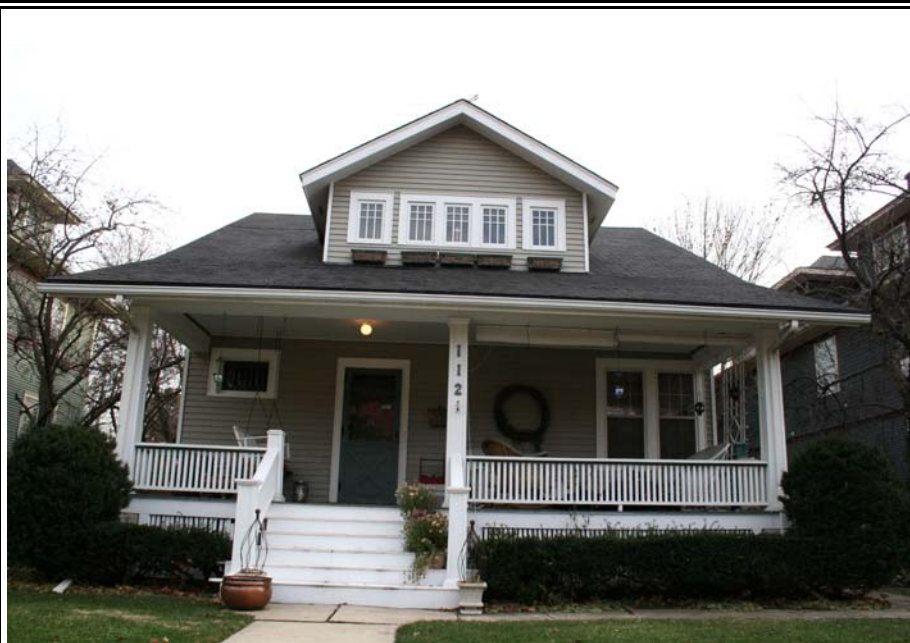
STREET #	112
DIRECTION	N
STREET	COLUMBIA
SUFFIX	ST
PIN	0818400010
LOCAL SIGNIFICANCE RATING	PS
POTENTIAL IND NR? (Y or N)	N
Contributing to a NR DISTRICT?	C
Contributing secondary structure?	NC
Listed on existing SURVEY?	Local District; NR District

CATEGORY	building	CURRENT FUNCTION	Domestic - single dwelling
CONDITION	excellent	HISTORIC FUNCTION	Domestic - single dwelling
INTEGRITY	minor alterations and addition(s)	REASON for SIGNIFICANCE	Notable example of the Bungalow type, with few alterations.
SECONDARY STRUCTURE	Detached garage

ARCHITECTURAL CLASSIFICATION	Bungalow	PLAN	rectangular
DETAILS		NO OF STORIES	1.5
BEGINYEAR	c. 1910	ROOF TYPE	Side gable
OTHER YEAR		ROOF MATERIAL	Asphalt - shingle
DATESOURCE	Surveyor	FOUNDATION	Concrete - block
WALL MATERIAL (current)	Wood	PORCH	Full front
WALL MATERIAL 2 (current)		WINDOW MATERIAL	wood/leaded glass
WALL MATERIAL (original)	Wood	WINDOW MATERIAL	Aluminum clad
WALL MATERIAL 2 (original)		WINDOW TYPE	Double hung/casement/fix
		WINDOW CONFIG	3/1; 6/6; 6/1; 1/1; 9-light
SIGNIFICANT FEATURES	Broad side gable roof with large front gable dormer; full width inset front porch with square columns and railings; historic 6/6, 1/1, 6/1, 3/1 & leaded glass windows on first story		
ALTERATIONS	2 story rear addition (not historic); replacement windows in original openings on 2nd story (not historic)

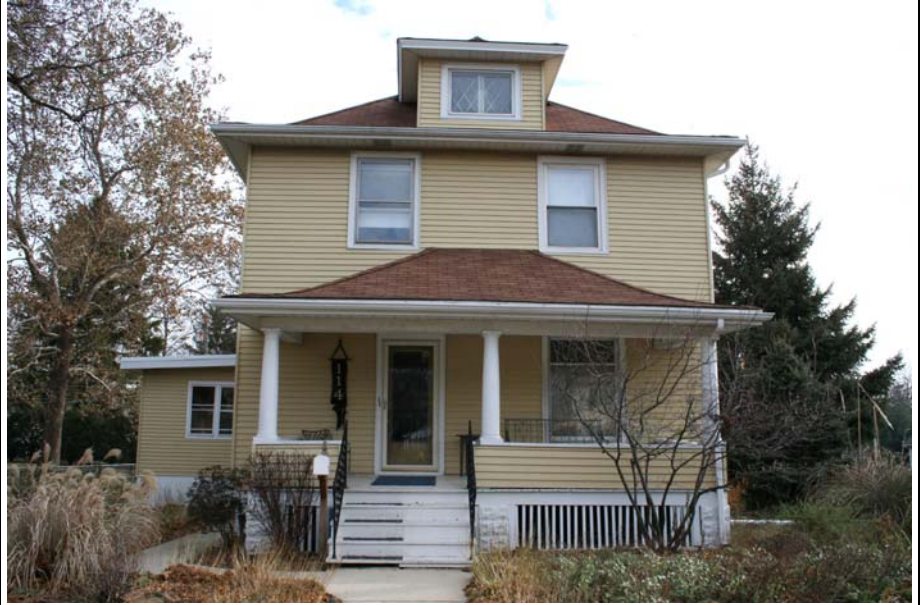
STREET #	114
DIRECTION	S
STREET	COLUMBIA
SUFFIX	ST
PIN	0818410010
LOCAL SIGNIFICANCE RATING	PS
POTENTIAL IND NR? (Y or N)	N
Contributing to a NR DISTRICT?	C
Contributing secondary structure?	NC
Listed on existing SURVEY?	Local District; NR District

CATEGORY	building	CURRENT FUNCTION	Domestic - single dwelling
CONDITION	good	HISTORIC FUNCTION	Domestic - single dwelling
INTEGRITY	minor alterations and addition(s)	REASON for SIGNIFICANCE	Typical, early example of the American Foursquare type in the district.
SECONDARY STRUCTURE	Detached garage D. garage (C)

ARCHITECTURAL CLASSIFICATION	American Foursquare	PLAN	rectangular
DETAILS		NO OF STORIES	2.5
BEGINYEAR	c. 1905	ROOF TYPE	Hipped
OTHER YEAR		ROOF MATERIAL	Asphalt - shingle
DATESOURCE	surveyor	FOUNDATION	Stucco
WALL MATERIAL (current)	Aluminum	PORCH	Full front
WALL MATERIAL 2 (current)		WINDOW MATERIAL	Wood
WALL MATERIAL (original)	Wood	WINDOW MATERIAL	Leaded glass
WALL MATERIAL 2 (original)		WINDOW TYPE	double hung/fixed
		WINDOW CONFIG	1/1; 1-light; multi-light
SIGNIFICANT FEATURES	Steeply pitched flared hipped roof with front hipped dormer; hipped (flared) front porch with round columns on solid knee wall; historic wood and leaded glass windows		
ALTERATIONS	Two story rear addition (historic); 1 story north side addition (not historic); Aluminum siding Demolition of existing front porch & construction of new wrap around porch on the west and south facades of home (HPC approved COA#13-2992)
