STREET #	225
DIRECTION	N
STREET	COLUMBIA
SUFFIX	ST
PIN	0818205001
LOCAL SIGNIFICANCE RATING	C
POTENTIAL IND NR? (Y or N)	N
Contributing to a NR DISTRICT?	C
Contributing secondary structure?	C
Listed on existing SURVEY?	Local District; NR District

ILLINOIS URBAN ARCHITECTURAL AND HISTORICAL SURVEY CONTINUATION SHEET

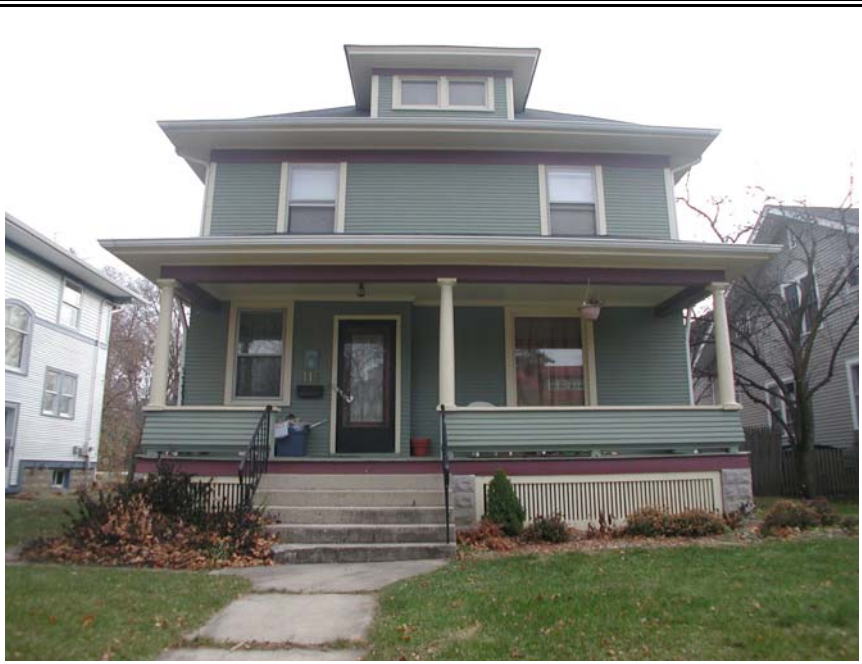
STREET #	116
DIRECTION	N
STREET	COLUMBIA
SUFFIX	ST
PIN	0818400009
LOCAL SIGNIFICANCE RATING	PS
POTENTIAL IND NR? (Y or N)	N
Contributing to a NR DISTRICT?	C
Contributing secondary structure?	C
Listed on existing SURVEY?	Local District; NR District

CATEGORY	building	CURRENT FUNCTION	Domestic - single dwelling
CONDITION	excellent	HISTORIC FUNCTION	Domestic - single dwelling
INTEGRITY	minor alterations	REASON for SIGNIFICANCE	Handsome example of American Foursquare type, with few alterations.
SECONDARY STRUCTURE	Detached garage Shed (C)

ARCHITECTURAL CLASSIFICATION	American Foursquare	PLAN	rectangular
DETAILS		NO OF STORIES	2.5
BEGINYEAR	c. 1910	ROOF TYPE	Hipped
OTHER YEAR		ROOF MATERIAL	Asphalt - shingle
DATESOURCE	Surveyor	FOUNDATION	Concrete - block
WALL MATERIAL (current)	Wood	PORCH	Full front
WALL MATERIAL 2 (current)		WINDOW MATERIAL	wood
WALL MATERIAL (original)	Wood	WINDOW MATERIAL	
WALL MATERIAL 2 (original)		WINDOW TYPE	double hung/fixed
		WINDOW CONFIG	1/1; 1-light; multi-light
SIGNIFICANT FEATURES	Hipped roof with overhanging eaves; front and side hipped dormers; full hipped front porch with round columns on solid knee walls; historic double hung & fixed wood windows; historic front door		
ALTERATIONS	Replacement front steps (not historic); 1 story rear addition

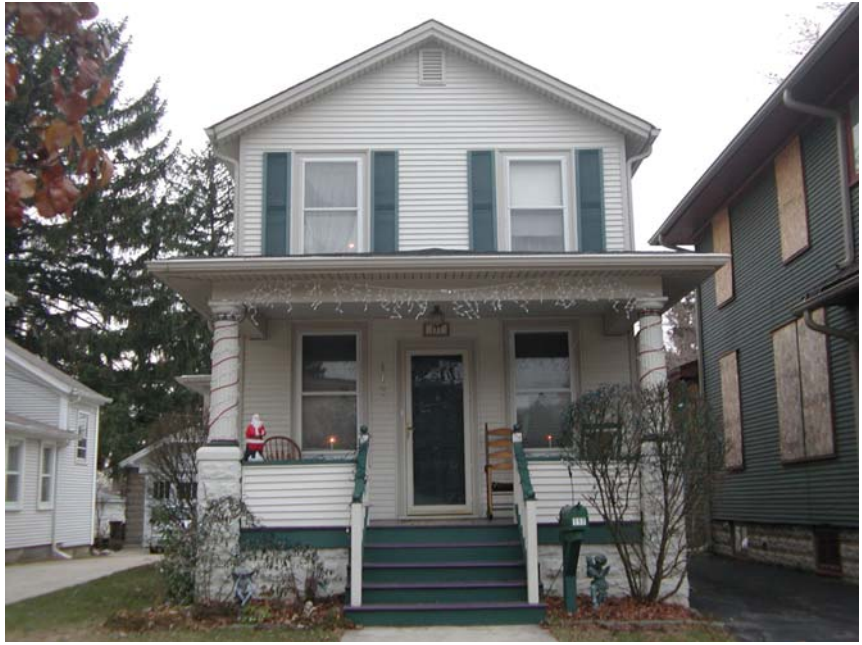
STREET #	117
DIRECTION	N
STREET	ELLSWORTH
SUFFIX	ST
PIN	0818301013
LOCAL SIGNIFICANCE RATING	C
POTENTIAL IND NR? (Y or N)	N
Contributing to a NR DISTRICT?	C
Contributing secondary structure?	C
Listed on existing SURVEY?	Local District; NR District

CATEGORY	building	CURRENT FUNCTION	Domestic - single dwelling
CONDITION	excellent	HISTORIC FUNCTION	Domestic - single dwelling
INTEGRITY	minor alterations	REASON for SIGNIFICANCE	
SECONDARY STRUCTURE	detached garage

ARCHITECTURAL CLASSIFICATION	Gable Front	PLAN	Rectangular
DETAILS		NO OF STORIES	2
BEGINYEAR	c. 1870	ROOF TYPE	Front gable
OTHER YEAR		ROOF MATERIAL	Asphalt - shingle
DATESOURCE	surveyor	FOUNDATION	Concrete block
WALL MATERIAL (current)	Aluminum	PORCH	Full front
WALL MATERIAL 2 (current)		WINDOW MATERIAL	Wood
WALL MATERIAL (original)	Wood	WINDOW MATERIAL	
WALL MATERIAL 2 (original)		WINDOW TYPE	double hung
		WINDOW CONFIG	1/1
SIGNIFICANT FEATURES	Front gable roof; historic 1/1 wood windows; rear/south side 2 story bay		
ALTERATIONS	Front porch (historic); rear/south side entry porch (not historic); Aluminum siding; fixed shutters (not historic); replacement front door (not historic)

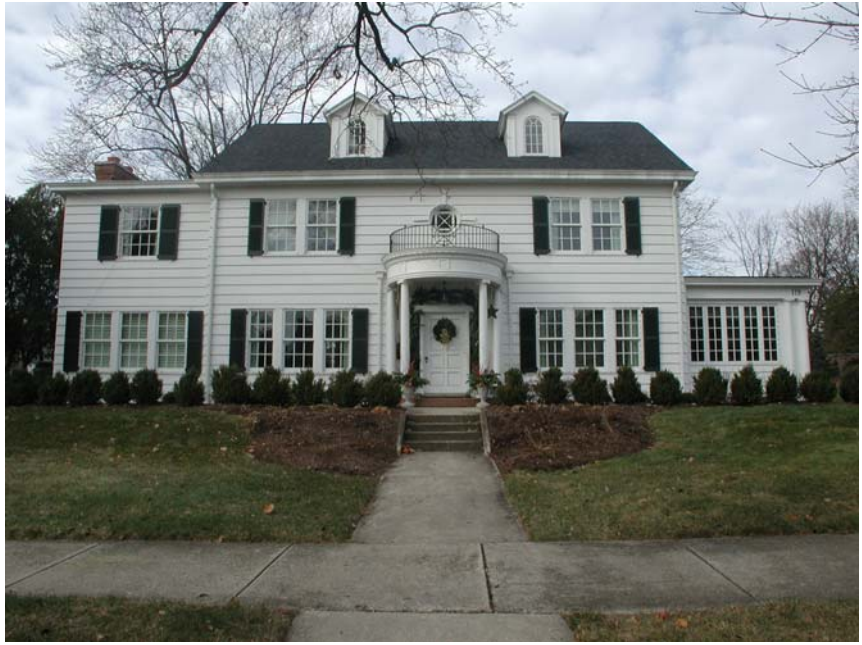
STREET #	119
DIRECTION	S
STREET	COLUMBIA
SUFFIX	ST
PIN	0818409008
LOCAL SIGNIFICANCE RATING	S
POTENTIAL IND NR? (Y or N)	N
Contributing to a NR DISTRICT?	C
Contributing secondary structure?	C
Listed on existing SURVEY?	Local District; NR District

CATEGORY	building	CURRENT FUNCTION	Domestic - single dwelling
CONDITION	excellent	HISTORIC FUNCTION	Domestic - single dwelling
INTEGRITY	minor alterations and addition(s)	REASON for SIGNIFICANCE	Stately Colonial Revival residence with rounded front portico.
SECONDARY STRUCTURE	Detached garage

ARCHITECTURAL CLASSIFICATION	Colonial Revival	PLAN	rectangular
DETAILS		NO OF STORIES	2.5
BEGINYEAR	c. 1920	ROOF TYPE	Side gable
OTHER YEAR		ROOF MATERIAL	Asphalt - shingle
DATESOURCE	Surveyor	FOUNDATION	Not visible
WALL MATERIAL (current)	Wood	PORCH	Front entry
WALL MATERIAL 2 (current)		WINDOW MATERIAL	Aluminum clad
WALL MATERIAL (original)	Wood	WINDOW MATERIAL	
WALL MATERIAL 2 (original)		WINDOW TYPE	double hung/casement
		WINDOW CONFIG	8/8; 6/6; 6-light; 10-light
SIGNIFICANT FEATURES	Side gable roof with cornice returns; center rounded entry portico with Ionic columns; front entry with leaded glass fanlight and sidelights; gabled front dormers; 1 story north sun porch		
ALTERATIONS	Replacement windows in original openings (not historic); one story rear addition to sun porch (not historic)

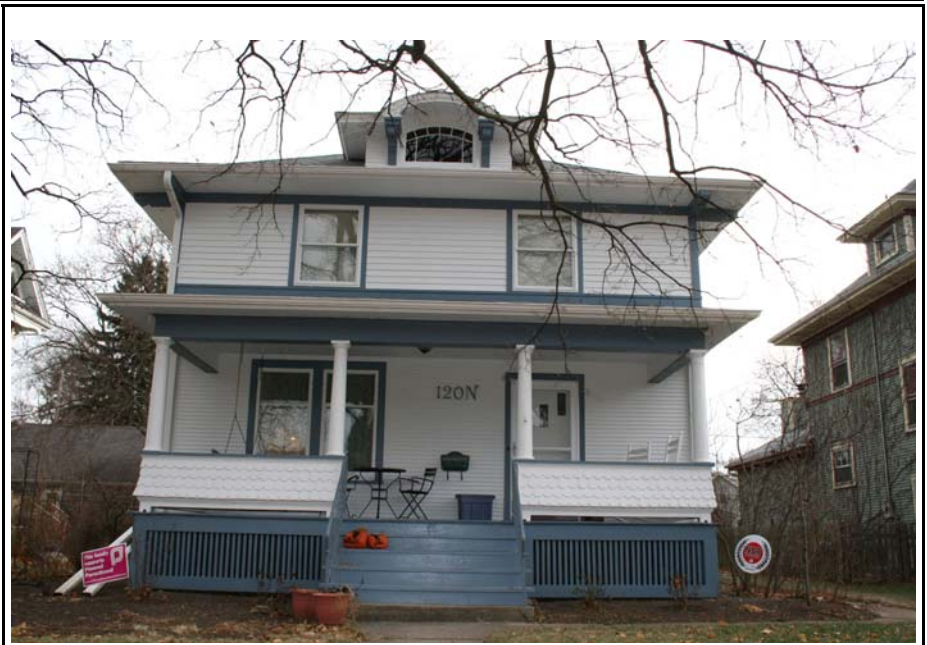
STREET #	120
DIRECTION	N
STREET	COLUMBIA
SUFFIX	ST
PIN	0818400008
LOCAL SIGNIFICANCE RATING	S
POTENTIAL IND NR? (Y or N)	N
Contributing to a NR DISTRICT?	C
Contributing secondary structure?	C
Listed on existing SURVEY?	Local District; NR District

CATEGORY	building	CURRENT FUNCTION	Domestic - single dwelling
CONDITION	good	HISTORIC FUNCTION	Domestic - single dwelling
INTEGRITY	minor alterations	REASON for SIGNIFICANCE	Fine, well-preserved example of American Foursquare, with handsome detailing at the porch and on the front dormer.
SECONDARY STRUCTURE	Detached garage Shed (C)

ARCHITECTURAL CLASSIFICATION	American Foursquare	PLAN	rectangular
DETAILS		NO OF STORIES	2.5
BEGINYEAR	c. 1910	ROOF TYPE	Hipped
OTHER YEAR		ROOF MATERIAL	Asphalt - shingle
DATESOURCE	Surveyor	FOUNDATION	Stone
WALL MATERIAL (current)	Wood	PORCH	Full front
WALL MATERIAL 2 (current)	Wood - shingle	WINDOW MATERIAL	Wood
WALL MATERIAL (original)	Wood	WINDOW MATERIAL	
WALL MATERIAL 2 (original)	Wood - shingle	WINDOW TYPE	Double & Single hung
		WINDOW CONFIG	1/1; multi/1
SIGNIFICANT FEATURES	Hipped roof with overhanging eaves; corner rafters; hipped front dormer with segmental arch window opening and scrolled brackets; full front porch with shed roof, rounded columns on shingled knee walls; historic wood windows		
ALTERATIONS	Dormer window boarded up Window replacement (admin. approved COA#11-2071) keep south dormer (constructed without COA) with modifications (HPC approved COA#13-1360)

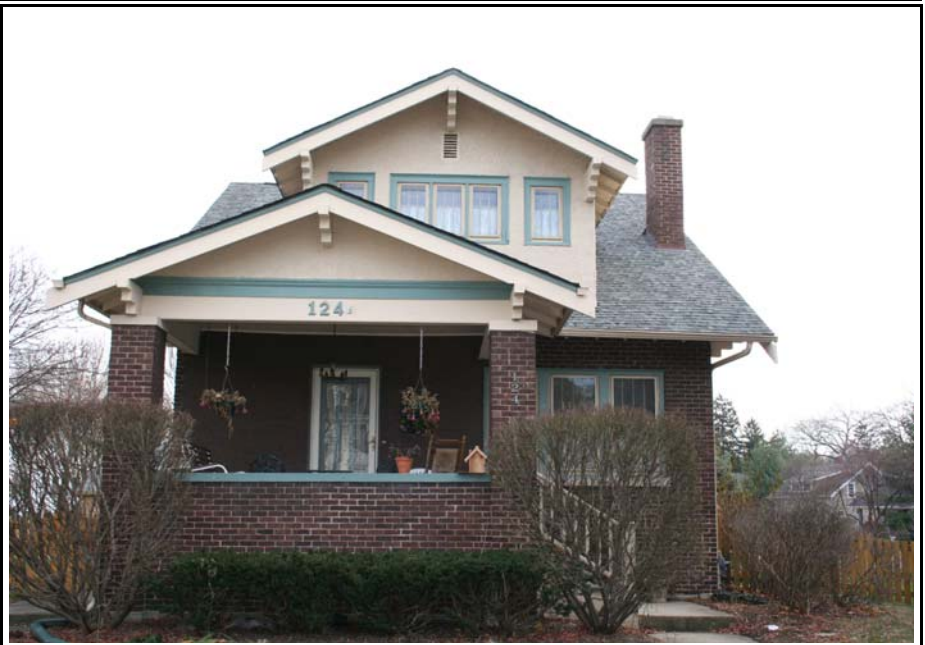
STREET #	124
DIRECTION	S
STREET	COLUMBIA
SUFFIX	ST
PIN	0818410005
LOCAL SIGNIFICANCE RATING	S
POTENTIAL IND NR? (Y or N)	N
Contributing to a NR DISTRICT?	C
Contributing secondary structure?	C
Listed on existing SURVEY?	Local District; NR District

CATEGORY	building	CURRENT FUNCTION	Domestic - single dwelling
CONDITION	excellent	HISTORIC FUNCTION	Domestic - single dwelling
INTEGRITY	not altered	REASON for SIGNIFICANCE	Fine, unaltered example of Craftsman Bungalow with distinctive stepped brackets.
SECONDARY STRUCTURE	Detached garage

ARCHITECTURAL CLASSIFICATION	Craftsman Bungalow	PLAN	rectangular
DETAILS		NO OF STORIES	1.5
BEGINYEAR	c. 1925	ROOF TYPE	Side gable
OTHER YEAR		ROOF MATERIAL	Asphalt - shingle
DATESOURCE	Surveyor	FOUNDATION	concrete
WALL MATERIAL (current)	Brick	PORCH	Front
WALL MATERIAL 2 (current)	stucco	WINDOW MATERIAL	Wood
WALL MATERIAL (original)	Brick	WINDOW MATERIAL	
WALL MATERIAL 2 (original)	Stucco	WINDOW TYPE	Casement/double hung
		WINDOW CONFIG	9-light; 4-light
SIGNIFICANT FEATURES	Broad side gable roof w/ stepped brackets; front gable stucco dormer w/ stepped brackets; 9-light wood casement windows; historic double hung wood windows; front gable porch w/ square brick columns on solid knee walls; historic wood door		
ALTERATIONS

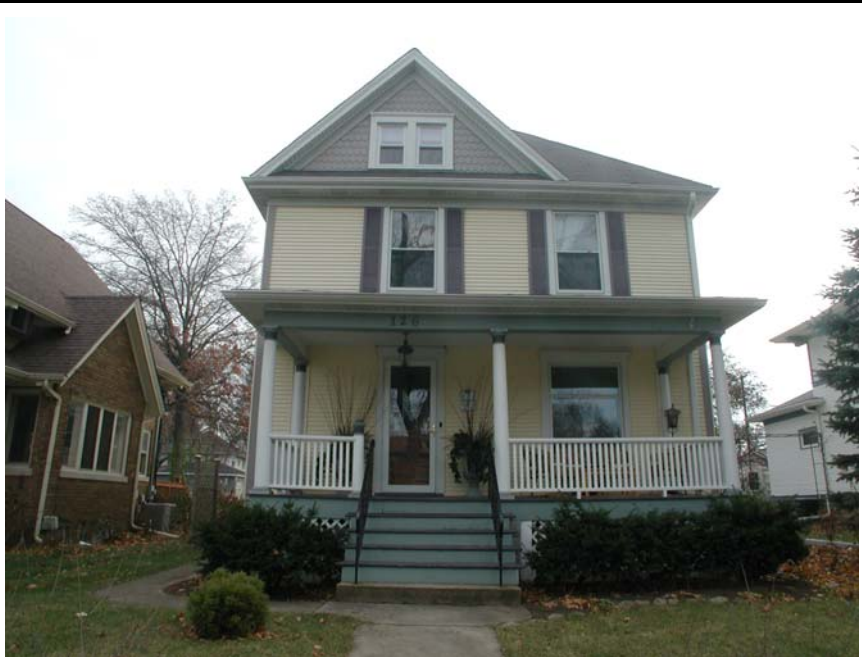
STREET #	126
DIRECTION	N
STREET	COLUMBIA
SUFFIX	ST
PIN	0818400007
LOCAL SIGNIFICANCE RATING	C
POTENTIAL IND NR? (Y or N)	N
Contributing to a NR DISTRICT?	C
Contributing secondary structure?	NC
Listed on existing SURVEY?	Local District; NR District

CATEGORY	building	CURRENT FUNCTION	Domestic - single dwelling
CONDITION	excellent	HISTORIC FUNCTION	Domestic - single dwelling
INTEGRITY	minor alterations and addition(s)	REASON for SIGNIFICANCE	
SECONDARY STRUCTURE	Detached garage

ARCHITECTURAL CLASSIFICATION	American Foursquare	PLAN	Rectangular
DETAILS	Queen Anne - Free Classic	NO OF STORIES	2.5
BEGINYEAR	1907	ROOF TYPE	Hipped
OTHER YEAR		ROOF MATERIAL	Asphalt - shingle
DATESOURCE	Plaque	FOUNDATION	Stone
WALL MATERIAL (current)	Wood	PORCH	Full front
WALL MATERIAL 2 (current)		WINDOW MATERIAL	Wood/stained glass
WALL MATERIAL (original)	Wood	WINDOW MATERIAL	Aluminum clad
WALL MATERIAL 2 (original)		WINDOW TYPE	double hung/fixed
		WINDOW CONFIG	1/1; 1-light
SIGNIFICANT FEATURES	Full front porch with hipped roof and rounded columns; historic 1/1 windows; two stained glass transoms over 1st story single light windows; south full height 3-sided bay with cutaway corners		
ALTERATIONS	Gabled dormer additions (front and north--not historic); gable over south bay filled with windows (not historic); fixed shutters at 2nd story of front façade (not historic); 1 story rear addition (not historic); vinyl under eaves In kind replacement of front porch (admin. approved COA#15-2384)

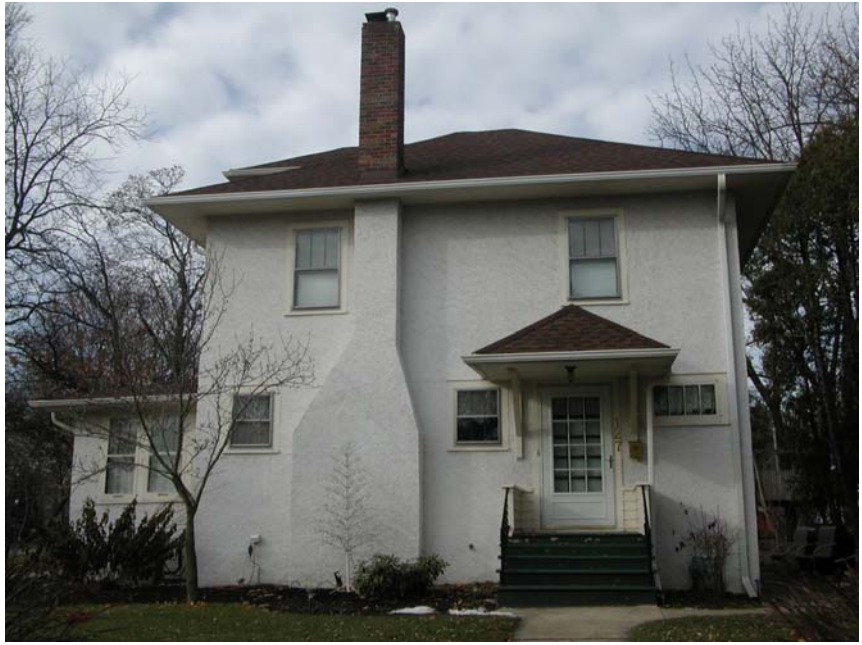
STREET #	127
DIRECTION	S
STREET	COLUMBIA
SUFFIX	ST
PIN	0818409004
LOCAL SIGNIFICANCE RATING	C
POTENTIAL IND NR? (Y or N)	N
Contributing to a NR DISTRICT?	C
Contributing secondary structure?	C
Listed on existing SURVEY?	Local District; NR District

CATEGORY	building	CURRENT FUNCTION	Domestic - single dwelling
CONDITION	good	HISTORIC FUNCTION	Domestic - single dwelling
INTEGRITY	minor alterations	REASON for SIGNIFICANCE	
SECONDARY STRUCTURE	Detached garage

ARCHITECTURAL CLASSIFICATION	Prairie	PLAN	rectangular
DETAILS		NO OF STORIES	2.5
BEGINYEAR	c. 1915	ROOF TYPE	Hipped
OTHER YEAR		ROOF MATERIAL	Asphalt - shingle
DATESOURCE	Surveyor	FOUNDATION	Stucco
WALL MATERIAL (current)	Stucco	PORCH	Front entry canopy
WALL MATERIAL 2 (current)		WINDOW MATERIAL	Wood
WALL MATERIAL (original)	Stucco	WINDOW MATERIAL	
WALL MATERIAL 2 (original)		WINDOW TYPE	Double hung/awning
		WINDOW CONFIG	3/1; 6/1; 4-light
SIGNIFICANT FEATURES	Broad hipped roof with overhanging eaves; south side hipped dormer; hipped front entry canopy with large brackets; historic 3/1 wood windows & 4-light awning windows; 1-story south sun porch		
ALTERATIONS	One story rear addition (historic); replacement porch stoop, railings, walls (not historic)

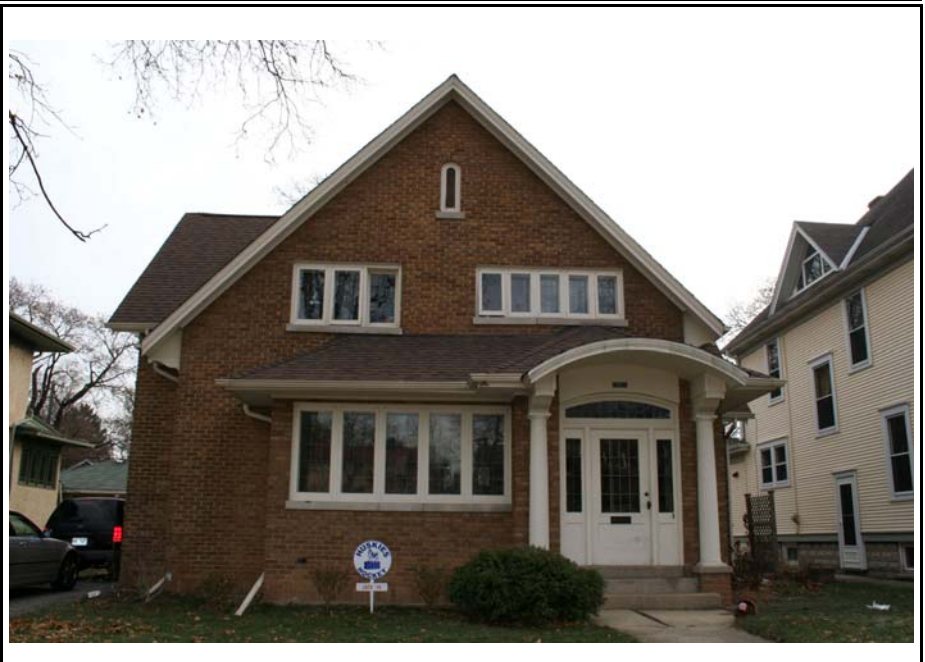
STREET #	130
DIRECTION	N
STREET	COLUMBIA
SUFFIX	ST
PIN	0818400006
LOCAL SIGNIFICANCE RATING	C
POTENTIAL IND NR? (Y or N)	N
Contributing to a NR DISTRICT?	C
Contributing secondary structure?	C
Listed on existing SURVEY?	Local District; NR District

CATEGORY	building	CURRENT FUNCTION	Domestic - single dwelling
CONDITION	excellent	HISTORIC FUNCTION	Domestic - single dwelling
INTEGRITY	addition(s)	REASON for SIGNIFICANCE	
SECONDARY STRUCTURE	Detached garage

ARCHITECTURAL CLASSIFICATION	Tudor Revival	PLAN	Rectangular
DETAILS	Craftsman	NO OF STORIES	1.5
BEGINYEAR	c. 1925	ROOF TYPE	Front gable
OTHER YEAR		ROOF MATERIAL	Asphalt - shingle
DATESOURCE	Surveyor	FOUNDATION	Concrete
WALL MATERIAL (current)	Brick	PORCH	Front entry
WALL MATERIAL 2 (current)		WINDOW MATERIAL	Wood
WALL MATERIAL (original)	Brick	WINDOW MATERIAL	metal
WALL MATERIAL 2 (original)		WINDOW TYPE	Casement/double hung
		WINDOW CONFIG	Multi-light; 6/6
SIGNIFICANT FEATURES	Steep front gable bay with north side gable bay; projecting front entry and window bay; classical segmental arch entry canopy with fluted engaged columns; segmental arch leaded glass transom---SEE CONTINUATION SHEET		
ALTERATIONS	One story rear addition; rear porch addition

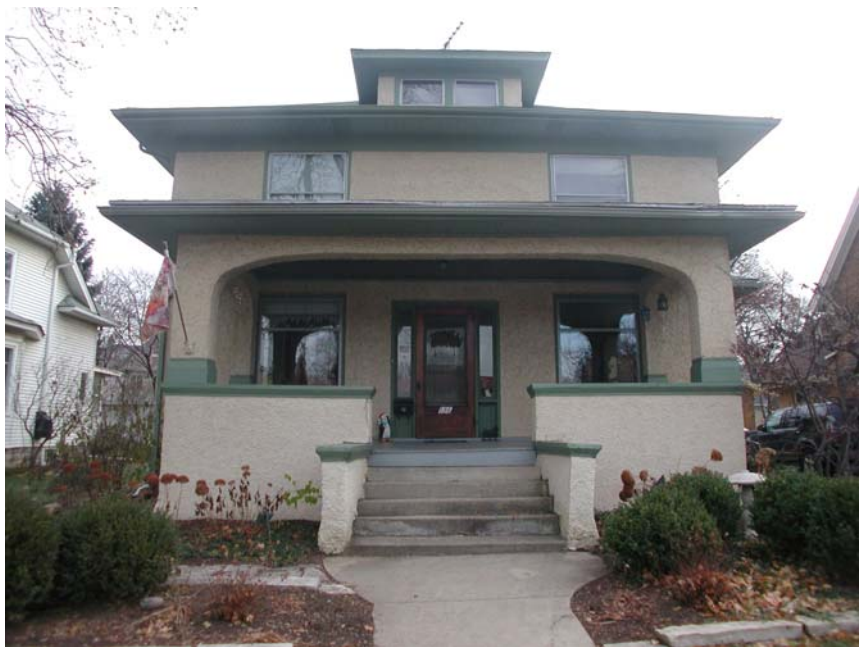
STREET #	136
DIRECTION	N
STREET	COLUMBIA
SUFFIX	ST
PIN	0818400005
LOCAL SIGNIFICANCE RATING	S
POTENTIAL IND NR? (Y or N)	N
Contributing to a NR DISTRICT?	C
Contributing secondary structure?	C
Listed on existing SURVEY?	Local District; NR District

CATEGORY	building	CURRENT FUNCTION	Domestic - single dwelling
CONDITION	good	HISTORIC FUNCTION	Domestic - single dwelling
INTEGRITY	minor alterations	REASON for SIGNIFICANCE	Excellent stucco example of the American Foursquare type with Prairie detailing
SECONDARY STRUCTURE	Detached garage

ARCHITECTURAL CLASSIFICATION	American Foursquare	PLAN	rectangular
DETAILS	Prairie	NO OF STORIES	2.5
BEGINYEAR	c. 1920	ROOF TYPE	Hipped
OTHER YEAR		ROOF MATERIAL	Asphalt - shingle
DATESOURCE	surveyor	FOUNDATION	Concrete - block
WALL MATERIAL (current)	Stucco	PORCH	Front
WALL MATERIAL 2 (current)		WINDOW MATERIAL	wood
WALL MATERIAL (original)	Stucco	WINDOW MATERIAL	
WALL MATERIAL 2 (original)		WINDOW TYPE	double hung/casement
		WINDOW CONFIG	1/1; 1-light; multi-light
SIGNIFICANT FEATURES	Hipped roof with overhanging eaves and front hipped dormer; hipped front porch with square stucco columns on solid knee wall; square south window bay; historic wood windows; front door with sidelights		
ALTERATIONS	glass block replacement windows on 2nd story of north elevation

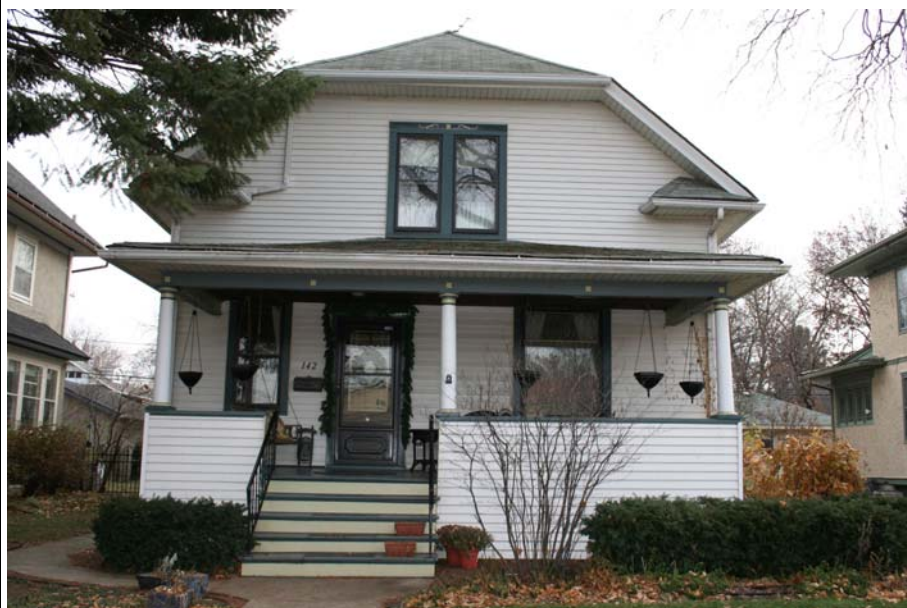
STREET #	142
DIRECTION	N
STREET	COLUMBIA
SUFFIX	ST
PIN	0818400004
LOCAL SIGNIFICANCE RATING	C
POTENTIAL IND NR? (Y or N)	N
Contributing to a NR DISTRICT?	C
Contributing secondary structure?	C
Listed on existing SURVEY?	Local District; NR District

CATEGORY	building	CURRENT FUNCTION	Domestic - single dwelling
CONDITION	good	HISTORIC FUNCTION	Domestic - single dwelling
INTEGRITY	minor alterations and addition(s)	REASON for SIGNIFICANCE	
SECONDARY STRUCTURE	Detached garage

ARCHITECTURAL CLASSIFICATION	Craftsman	PLAN	rectangular
DETAILS		NO OF STORIES	1.5
BEGINYEAR	c. 1910	ROOF TYPE	Jerkinhead
OTHER YEAR		ROOF MATERIAL	Asphalt - shingle
DATESOURCE	Surveyor	FOUNDATION	Stone
WALL MATERIAL (current)	Aluminum	PORCH	Full front
WALL MATERIAL 2 (current)		WINDOW MATERIAL	Wood/vinyl
WALL MATERIAL (original)	Wood	WINDOW MATERIAL	leaded glass
WALL MATERIAL 2 (original)		WINDOW TYPE	double hung/fixed
		WINDOW CONFIG	1/1; multi-light
SIGNIFICANT FEATURES	Front jerkinhead roof with large cornice returns; north and south jerkinhead gables; full front porch with hipped roof, round columns on solid knee wall; historic 1/1 and leaded glass windows		
ALTERATIONS	Aluminum siding; screen door at front entry; replacement multi-light vinyl windows on north elevation Replacement of aluminum siding with fiber cement siding & replacement of windows with aluminum clad windows (admin. approved COA#16-2362) Change in porch style (HPC approved COA#16-2823)

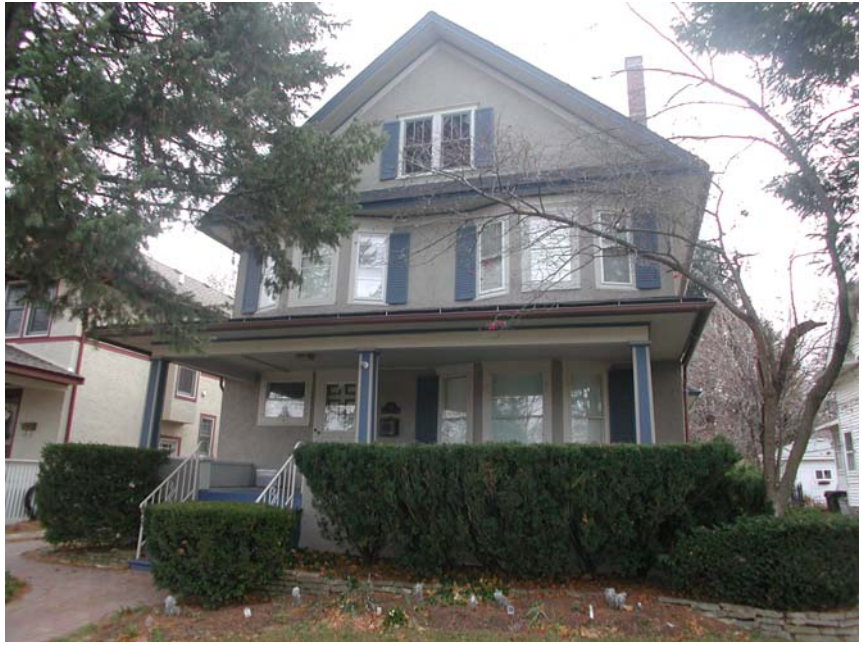
STREET #	146
DIRECTION	N
STREET	COLUMBIA
SUFFIX	ST
PIN	0818400003
LOCAL SIGNIFICANCE RATING	S
POTENTIAL IND NR? (Y or N)	N
Contributing to a NR DISTRICT?	C
Contributing secondary structure?	C
Listed on existing SURVEY?	Local District; NR District

CATEGORY	building	CURRENT FUNCTION	Domestic - single dwelling
CONDITION	excellent	HISTORIC FUNCTION	Domestic - single dwelling
INTEGRITY	minor alterations	REASON for SIGNIFICANCE	The multiple rounded front window bays are the distinguishing features of this 1910s Craftsman house.
SECONDARY STRUCTURE	Detached garage

ARCHITECTURAL CLASSIFICATION	Craftsman	PLAN	Rectangular
DETAILS		NO OF STORIES	2.5
BEGINYEAR	c. 1915	ROOF TYPE	Front gable
OTHER YEAR		ROOF MATERIAL	Asphalt - shingle
DATESOURCE	Surveyor	FOUNDATION	
WALL MATERIAL (current)	Stucco	PORCH	Full front
WALL MATERIAL 2 (current)		WINDOW MATERIAL	Wood
WALL MATERIAL (original)	Stucco	WINDOW MATERIAL	Leaded glass
WALL MATERIAL 2 (original)		WINDOW TYPE	double hung/fixed
		WINDOW CONFIG	1/1; 3/1; multi-light
SIGNIFICANT FEATURES	Pent front gable w/ overhanging eaves; rounded 1st & 2nd story front window bays; full front porch w/ shed roof, stucco knee walls, & square wood columns; historic 1/1 & 3/1 wood windows; leaded glass windows left (N) of front door; S. square window bay		
ALTERATIONS	3/1 replacement windows under front gable (not historic); wrought iron railings at front steps; dormer addition on north side Repair damaged roof, soffit & fascia (admin. approved COA#12-2903)

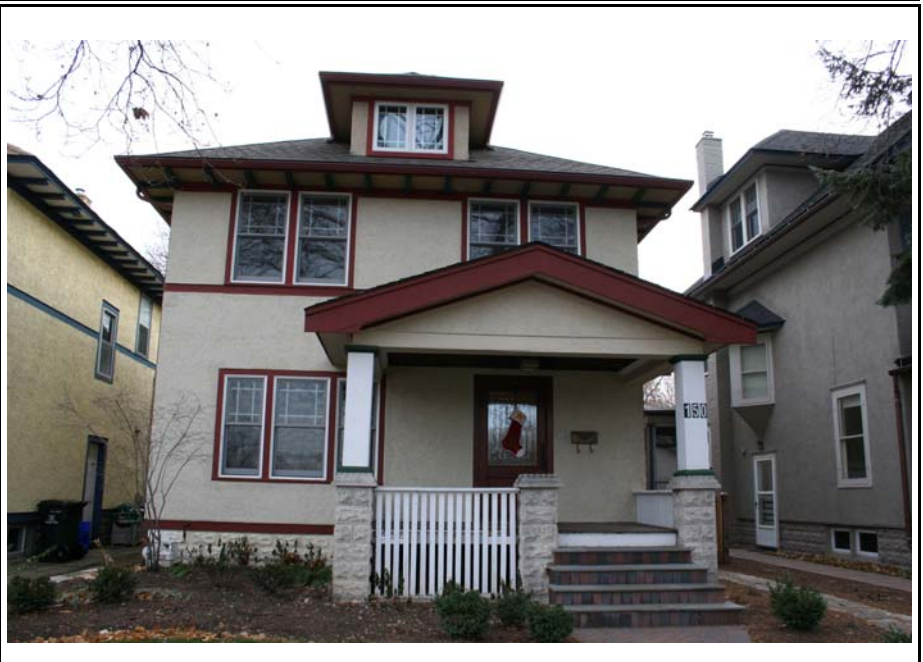
STREET #	150
DIRECTION	N
STREET	COLUMBIA
SUFFIX	ST
PIN	0818400002
LOCAL SIGNIFICANCE RATING	C
POTENTIAL IND NR? (Y or N)	N
Contributing to a NR DISTRICT?	C
Contributing secondary structure?	C
Listed on existing SURVEY?	Local District; NR District

CATEGORY	building	CURRENT FUNCTION	Domestic - single dwelling
CONDITION	good	HISTORIC FUNCTION	Domestic - single dwelling
INTEGRITY	minor alterations and addition(s)	REASON for SIGNIFICANCE	
SECONDARY STRUCTURE	Detached garage

ARCHITECTURAL CLASSIFICATION	American Foursquare	PLAN	Rectangular
DETAILS	Craftsman	NO OF STORIES	2.5
BEGINYEAR	c. 1910	ROOF TYPE	Hipped
OTHER YEAR		ROOF MATERIAL	Asphalt - shingle
DATESOURCE	Surveyor	FOUNDATION	Concrete - block
WALL MATERIAL (current)	Stucco	PORCH	Front
WALL MATERIAL 2 (current)		WINDOW MATERIAL	Wood
WALL MATERIAL (original)	Stucco	WINDOW MATERIAL	Vinyl
WALL MATERIAL 2 (original)		WINDOW TYPE	double hung/casement
		WINDOW CONFIG	Multi/1; multi-light
SIGNIFICANT FEATURES	Hipped roof with overhanging eaves and exposed rafter tails; front gable porch with square wood columns on concrete block piers; front hipped dormer		
ALTERATIONS	Replacement windows in original openings (not historic); replacement front door (not historic); two story rear addition; replacement railing and steps on front porch (not historic) Add railing for front porch steps (admin. approved COA#11-4105)

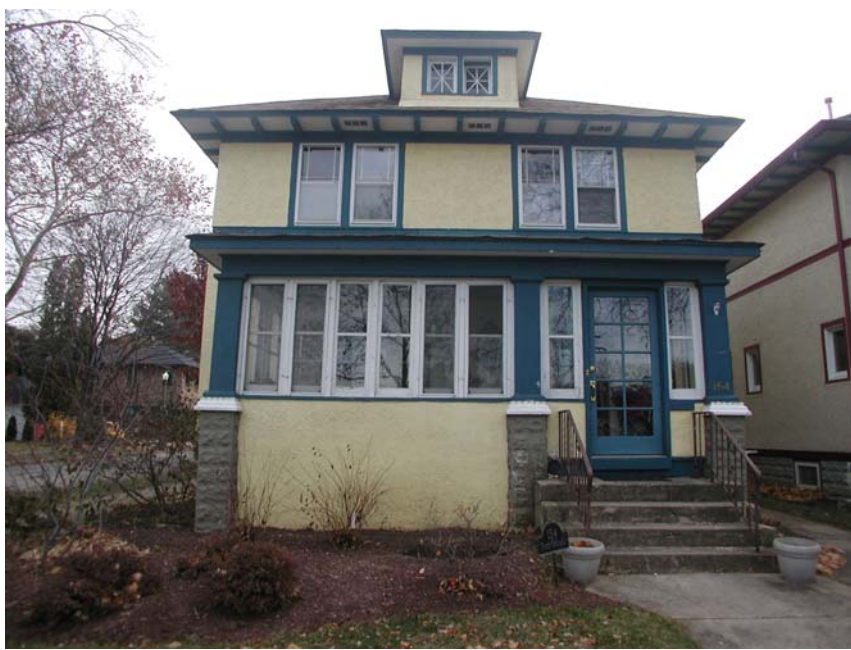
STREET #	154
DIRECTION	N
STREET	COLUMBIA
SUFFIX	ST
PIN	0818400001
LOCAL SIGNIFICANCE RATING	C
POTENTIAL IND NR? (Y or N)	N
Contributing to a NR DISTRICT?	C
Contributing secondary structure?	C
Listed on existing SURVEY?	Local District; NR District

CATEGORY	building	CURRENT FUNCTION	Domestic - single dwelling
CONDITION	good	HISTORIC FUNCTION	Domestic - single dwelling
INTEGRITY	minor alterations	REASON for SIGNIFICANCE	
SECONDARY STRUCTURE	Detached garage

ARCHITECTURAL CLASSIFICATION	American Foursquare	PLAN	Rectangular
DETAILS		NO OF STORIES	2.5
BEGINYEAR	c. 1910	ROOF TYPE	Hipped
OTHER YEAR		ROOF MATERIAL	Asphalt - shingle
DATESOURCE	Surveyor	FOUNDATION	Concrete - block
WALL MATERIAL (current)	Stucco	PORCH	Full front
WALL MATERIAL 2 (current)		WINDOW MATERIAL	Wood
WALL MATERIAL (original)	Stucco	WINDOW MATERIAL	
WALL MATERIAL 2 (original)		WINDOW TYPE	double hung/fixed
		WINDOW CONFIG	Multilight/1; multi-light
SIGNIFICANT FEATURES	Hipped roof with overhanging eaves and exposed rafter tails; front hipped dormer; front hipped porch with concrete block piers; historic double hung and fixed/casement windows		
ALTERATIONS	Front porch enclosed (historic alteration) In kind replacement of asphalt shingles (admin. approved COA#17-4813)

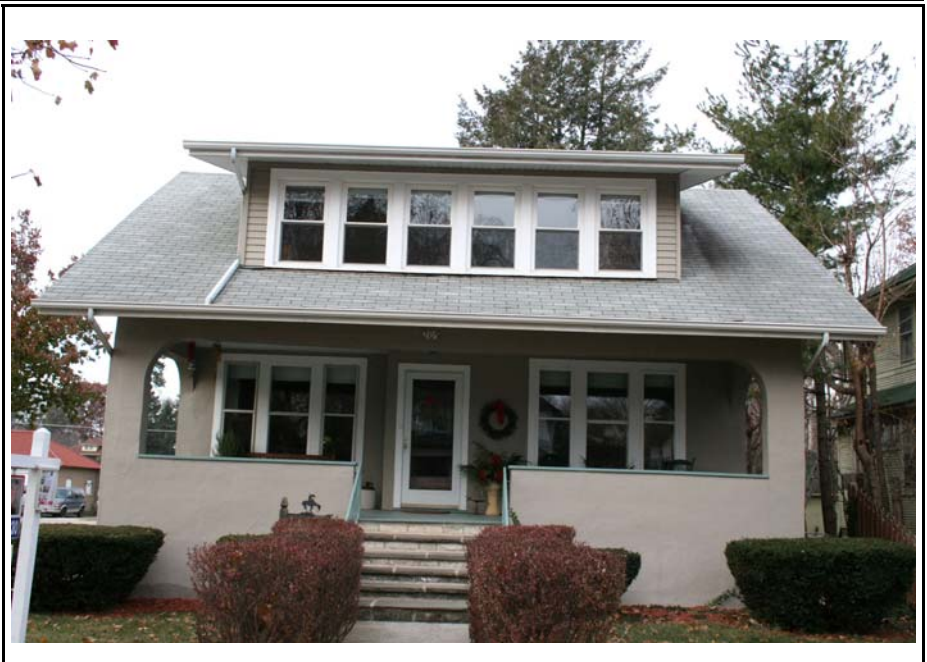
STREET #	205
DIRECTION	N
STREET	COLUMBIA
SUFFIX	ST
PIN	0818205005
LOCAL SIGNIFICANCE RATING	C
POTENTIAL IND NR? (Y or N)	N
Contributing to a NR DISTRICT?	C
Contributing secondary structure?	NC
Listed on existing SURVEY?	Local District; NR District

CATEGORY	building	CURRENT FUNCTION	Domestic - single dwelling
CONDITION	excellent	HISTORIC FUNCTION	Domestic - single dwelling
INTEGRITY	minor alterations	REASON for SIGNIFICANCE	
SECONDARY STRUCTURE	Detached garage

ARCHITECTURAL CLASSIFICATION	Bungalow	PLAN	rectangular
DETAILS		NO OF STORIES	1.5
BEGINYEAR	c. 1925	ROOF TYPE	Side gable
OTHER YEAR		ROOF MATERIAL	Asphalt - shingle
DATESOURCE	Surveyor	FOUNDATION	Parged
WALL MATERIAL (current)	Stucco	PORCH	Full front
WALL MATERIAL 2 (current)	Aluminum	WINDOW MATERIAL	Wood
WALL MATERIAL (original)	Stucco	WINDOW MATERIAL	Vinyl
WALL MATERIAL 2 (original)		WINDOW TYPE	double hung/casement
		WINDOW CONFIG	1/1; 1-light
SIGNIFICANT FEATURES	Side gable roof with overhanging eaves; inset front porch w/ square columns on solid knee walls (rounded corners at porch openings); historic 3-part front window; 1/1 historic first floor windows		
ALTERATIONS	Enlarged front dormer with Aluminum siding and replacement windows (not historic); replacement 2nd story side windows (not historic); green house window on south elevation (not historic) Demolition of existing staircase, awning & bracket, new building addition including enclosed porch on rear side of home (HPC approved COA#11-1157)

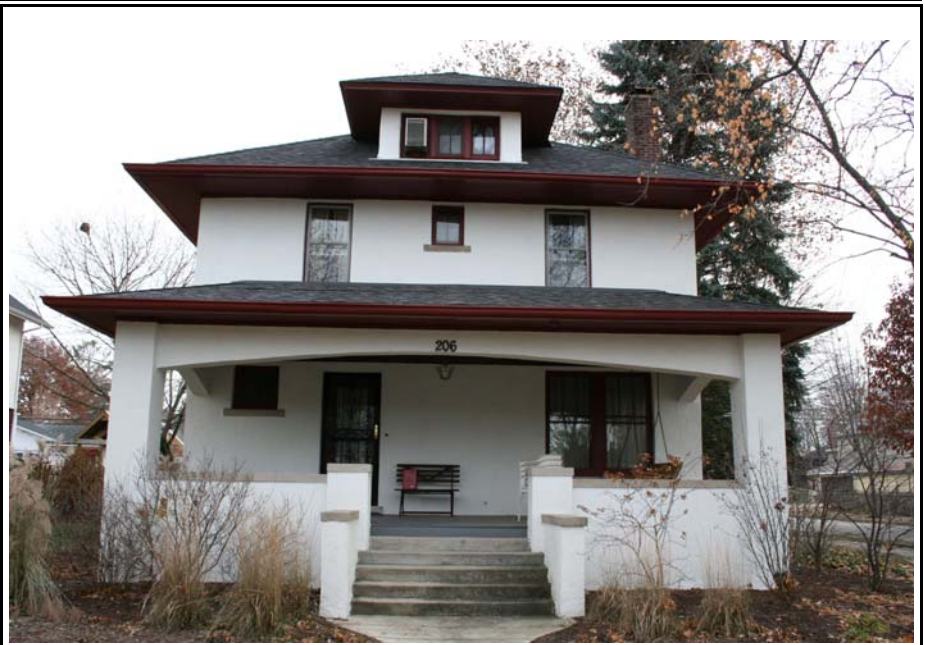
STREET #	206
DIRECTION	N
STREET	COLUMBIA
SUFFIX	ST
PIN	0818209004
LOCAL SIGNIFICANCE RATING	PS
POTENTIAL IND NR? (Y or N)	N
Contributing to a NR DISTRICT?	C
Contributing secondary structure?	C
Listed on existing SURVEY?	Local District; NR District

CATEGORY	building	CURRENT FUNCTION	Domestic - single dwelling
CONDITION	good	HISTORIC FUNCTION	Domestic - single dwelling
INTEGRITY	addition(s)	REASON for SIGNIFICANCE	Notable stucco example of American Foursquare, with broad full-front porch and flared hipped roof.
SECONDARY STRUCTURE	Detached garage

ARCHITECTURAL CLASSIFICATION	American Foursquare	PLAN	rectangular
DETAILS	Prairie	NO OF STORIES	2.5
BEGINYEAR	c. 1910	ROOF TYPE	Hipped
OTHER YEAR		ROOF MATERIAL	Asphalt - shingle
DATESOURCE	Surveyor	FOUNDATION	Parged
WALL MATERIAL (current)	Stucco	PORCH	Full front
WALL MATERIAL 2 (current)		WINDOW MATERIAL	Wood
WALL MATERIAL (original)	Stucco	WINDOW MATERIAL	
WALL MATERIAL 2 (original)		WINDOW TYPE	double hung/casement
		WINDOW CONFIG	3/1; 2-light
SIGNIFICANT FEATURES	Broad hipped roof with overhanging eaves; front hipped dormer; full width front porch with hipped roof, square stucco columns on solid knee walls, and curved frieze; historic 3/1 and 2-light wood windows		
ALTERATIONS	1 story rear addition

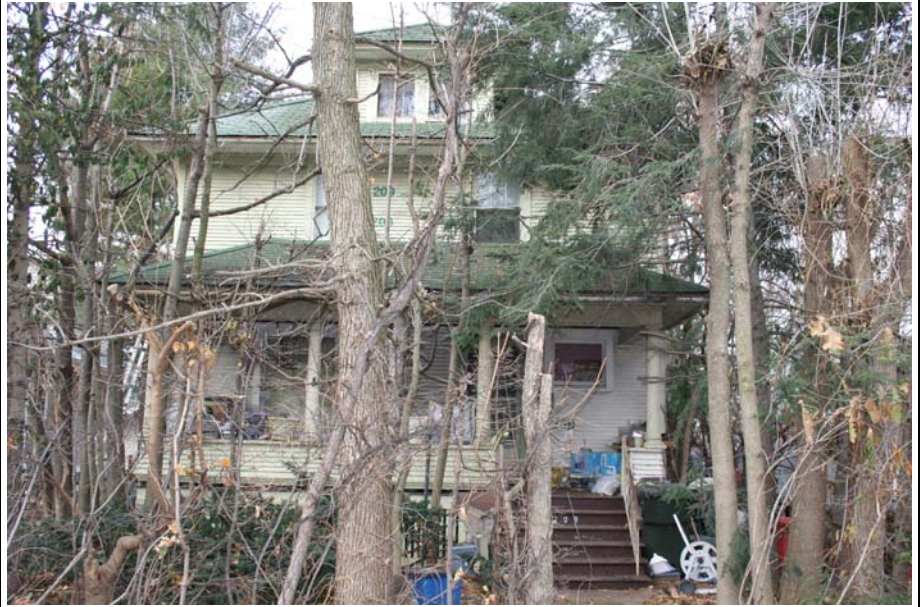
STREET #	209
DIRECTION	N
STREET	COLUMBIA
SUFFIX	ST
PIN	0818205004
LOCAL SIGNIFICANCE RATING	S
POTENTIAL IND NR? (Y or N)	N
Contributing to a NR DISTRICT?	C
Contributing secondary structure?	C
Listed on existing SURVEY?	Local District; NR District

CATEGORY	building	CURRENT FUNCTION	Domestic - single dwelling
CONDITION	Good/Fair	HISTORIC FUNCTION	Domestic - single dwelling
INTEGRITY	not altered	REASON for SIGNIFICANCE	A solid, unaltered example of the American Foursquare type.
SECONDARY STRUCTURE	Detached garage

ARCHITECTURAL CLASSIFICATION	American Foursquare	PLAN	Rectangular
DETAILS		NO OF STORIES	2.5
BEGINYEAR	c. 1905	ROOF TYPE	Hipped
OTHER YEAR		ROOF MATERIAL	Asphalt - shingle
DATESOURCE	surveyor	FOUNDATION	Concrete - block
WALL MATERIAL (current)	Wood	PORCH	Full front
WALL MATERIAL 2 (current)		WINDOW MATERIAL	Wood
WALL MATERIAL (original)	Wood	WINDOW MATERIAL	Leaded glass
WALL MATERIAL 2 (original)		WINDOW TYPE	Double & single hung/case
		WINDOW CONFIG	3/1; multi/1; 3 & 1-light
SIGNIFICANT FEATURES	Hipped roof with front hipped dormer; full front hipped roof porch with round columns on solid knee wall; historic 3/1, leaded glass and 3-light windows; first story south square window bay		
ALTERATIONS

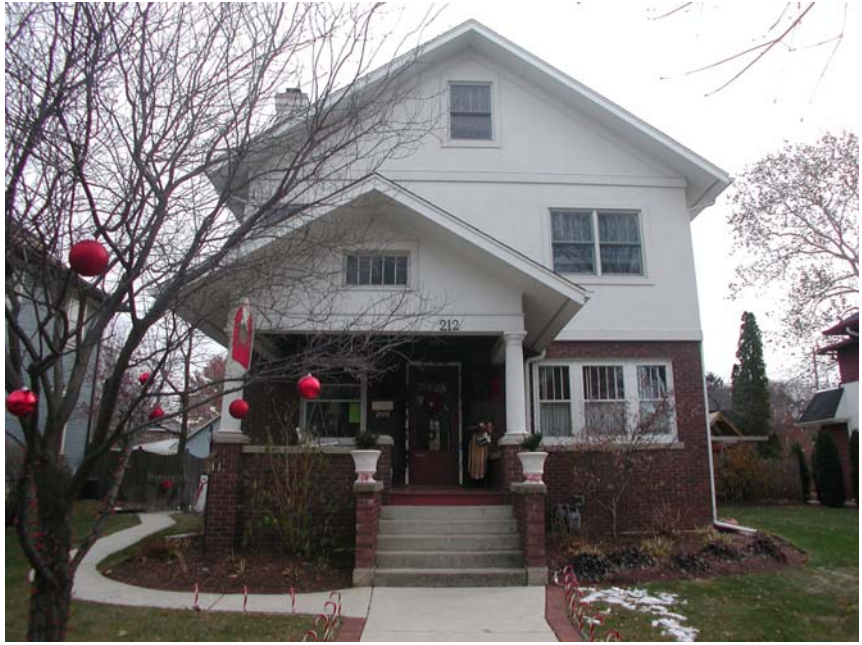
STREET #	212
DIRECTION	N
STREET	COLUMBIA
SUFFIX	ST
PIN	0818209003
LOCAL SIGNIFICANCE RATING	NC
POTENTIAL IND NR? (Y or N)	N
Contributing to a NR DISTRICT?	NC
Contributing secondary structure?	NC
Listed on existing SURVEY?	Local District; NR District

CATEGORY	building	CURRENT FUNCTION	Domestic - single dwelling
CONDITION	good	HISTORIC FUNCTION	Domestic - single dwelling
INTEGRITY	major alterations and/or addition(s)	REASON for SIGNIFICANCE	
SECONDARY STRUCTURE	Detached garage

ARCHITECTURAL CLASSIFICATION	Bungalow (altered)	PLAN	rectangular
DETAILS		NO OF STORIES	2
BEGINYEAR	c. 1925	ROOF TYPE	Front gable
OTHER YEAR		ROOF MATERIAL	Asphalt - shingle
DATESOURCE	Surveyor	FOUNDATION	Concrete
WALL MATERIAL (current)	Brick	PORCH	Front entry
WALL MATERIAL 2 (current)	Stucco	WINDOW MATERIAL	Wood
WALL MATERIAL (original)	Brick	WINDOW MATERIAL	Vinyl
WALL MATERIAL 2 (original)		WINDOW TYPE	double hung/casement
		WINDOW CONFIG	4/1; 5/1; multi-light
SIGNIFICANT FEATURES	Brick 1st story of house, with brick base for front porch; historic wood windows		
ALTERATIONS	Original house obscured by 2nd story addition; front porch roof may also be replacement

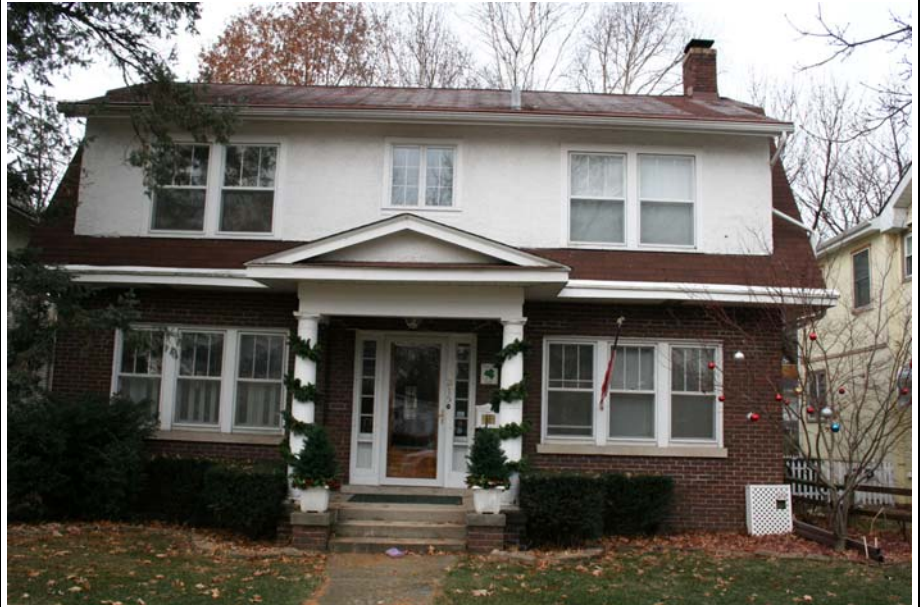
STREET #	215
DIRECTION	N
STREET	COLUMBIA
SUFFIX	ST
PIN	0818205003
LOCAL SIGNIFICANCE RATING	C
POTENTIAL IND NR? (Y or N)	N
Contributing to a NR DISTRICT?	C
Contributing secondary structure?	NC
Listed on existing SURVEY?	Local District; NR District

CATEGORY	building	CURRENT FUNCTION	Domestic - single dwelling
CONDITION	good	HISTORIC FUNCTION	Domestic - single dwelling
INTEGRITY	minor alterations	REASON for SIGNIFICANCE	
SECONDARY STRUCTURE	Detached garage

ARCHITECTURAL CLASSIFICATION	Dutch Colonial Revival	PLAN	rectangular
DETAILS		NO OF STORIES	2
BEGINYEAR	c. 1924	ROOF TYPE	Gambrel
OTHER YEAR		ROOF MATERIAL	Asphalt - shingle
DATESOURCE	Owner	FOUNDATION	Concrete
WALL MATERIAL (current)	Brick	PORCH	Front entry
WALL MATERIAL 2 (current)	Stucco	WINDOW MATERIAL	Wood
WALL MATERIAL (original)	Brick	WINDOW MATERIAL	vinyl
WALL MATERIAL 2 (original)	Stucco	WINDOW TYPE	double hung/casement
		WINDOW CONFIG	3/1; 6-light
SIGNIFICANT FEATURES	Side gambrel roof with full-width shed dormer; center entry with 5-light sidelights; pedimented front entry porch with round columns; historic 3/1 wood double hung windows		
ALTERATIONS	Replacement 2nd floor casement windows above front entry (not historic); one story rear addition (1985); 2nd story rear addition (not historic); rear deck (not historic)

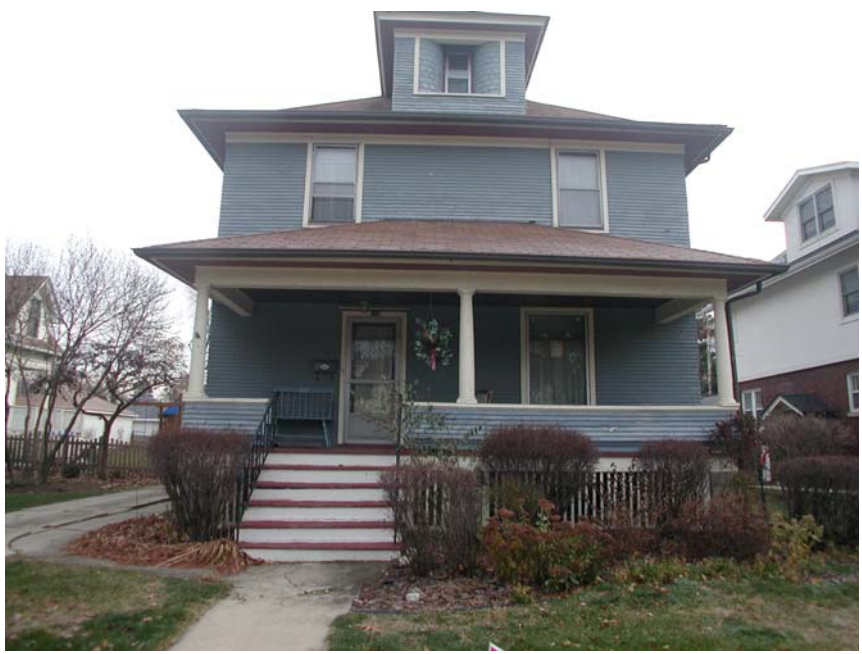
STREET #	218
DIRECTION	N
STREET	COLUMBIA
SUFFIX	ST
PIN	0818209002
LOCAL SIGNIFICANCE RATING	S
POTENTIAL IND NR? (Y or N)	N
Contributing to a NR DISTRICT?	C
Contributing secondary structure?	C
Listed on existing SURVEY?	Local District; NR District

CATEGORY	building	CURRENT FUNCTION	Domestic - single dwelling
CONDITION	good	HISTORIC FUNCTION	Domestic - single dwelling
INTEGRITY	minor alterations	REASON for SIGNIFICANCE	The unique hipped dormer on this classically detailed American Foursquare features rounded, shingled walls curving into the single centered window.
SECONDARY STRUCTURE	Detached garage

ARCHITECTURAL CLASSIFICATION	American Foursquare	PLAN	rectangular
DETAILS	Colonial Revival	NO OF STORIES	2.5
BEGINYEAR	c. 1905	ROOF TYPE	Hipped
OTHER YEAR		ROOF MATERIAL	Asphalt - shingle
DATESOURCE	Surveyor	FOUNDATION	Concrete - block
WALL MATERIAL (current)	Wood	PORCH	Full front
WALL MATERIAL 2 (current)		WINDOW MATERIAL	wood
WALL MATERIAL (original)	Wood	WINDOW MATERIAL	leaded glass
WALL MATERIAL 2 (original)		WINDOW TYPE	double hung/fixed
		WINDOW CONFIG	1/1; diamond
SIGNIFICANT FEATURES	Flared hipped roof with overhanging eaves; hipped dormer with curving, shingled walls around single window; full width front porch with hipped roof and classical columns on solid knee wall; historic 1/1 wood windows;leaded glass window under porch		
ALTERATIONS	Deck addition on roof of rear 1 story bay (not historic); wrought iron railings at front steps (not historic) Addition of 2 dormers, shutters & brackets, repairs of foundation base & vertical lattice, replacement of stairs & railing system, replace three windows, put in wood siding & asphalt shingles, alteration of front doors (HPC approve COA#18-56)

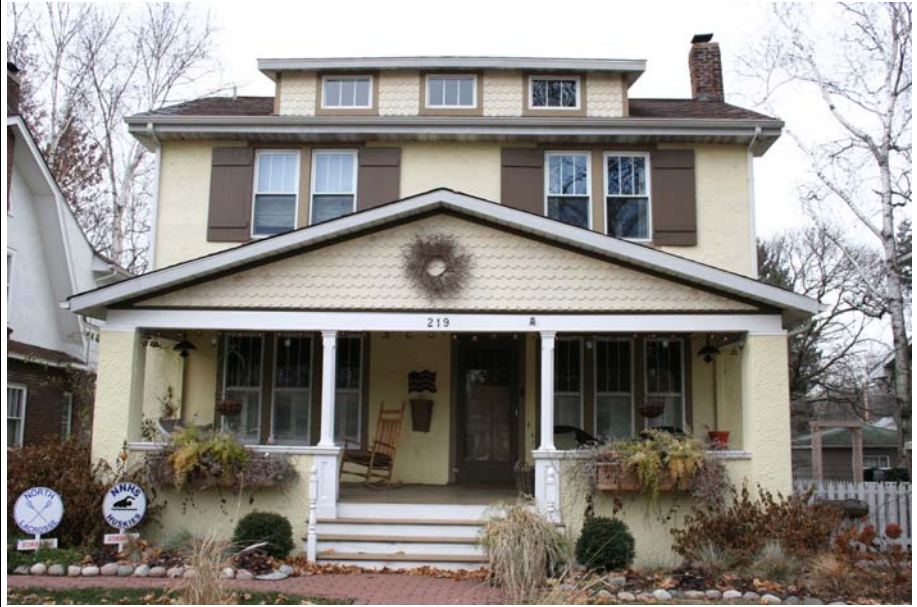
STREET #	219
DIRECTION	N
STREET	COLUMBIA
SUFFIX	ST
PIN	0818205002
LOCAL SIGNIFICANCE RATING	C
POTENTIAL IND NR? (Y or N)	N
Contributing to a NR DISTRICT?	C
Contributing secondary structure?	C
Listed on existing SURVEY?	Local District; NR District

CATEGORY	building	CURRENT FUNCTION	Domestic - single dwelling
CONDITION	good	HISTORIC FUNCTION	Domestic - single dwelling
INTEGRITY	minor alterations and addition(s)	REASON for SIGNIFICANCE	
SECONDARY STRUCTURE	Detached garage

ARCHITECTURAL CLASSIFICATION	Craftsman	PLAN	rectangular
DETAILS		NO OF STORIES	2.5
BEGINYEAR	c. 1920	ROOF TYPE	Side gable
OTHER YEAR		ROOF MATERIAL	Asphalt - shingle
DATESOURCE	Surveyor	FOUNDATION	Parged
WALL MATERIAL (current)	Stucco	PORCH	Full front
WALL MATERIAL 2 (current)	Wood - shingle/Aluminum	WINDOW MATERIAL	aluminum
WALL MATERIAL (original)	Stucco	WINDOW MATERIAL	Wood
WALL MATERIAL 2 (original)		WINDOW TYPE	Double hung/casement/aw
		WINDOW CONFIG	3/1; 3-light; 1-light
SIGNIFICANT FEATURES	Side gable roof; historic 3/1 wood windows under porch		
ALTERATIONS	Replacement front porch; Aluminum siding under eaves; wood shingles under gables and on dormers; stucco cladding; front dormer enlarged with replacement windows; replacement windows in original openings; window bay addition (south)--SEE CONTINUATION SHEET

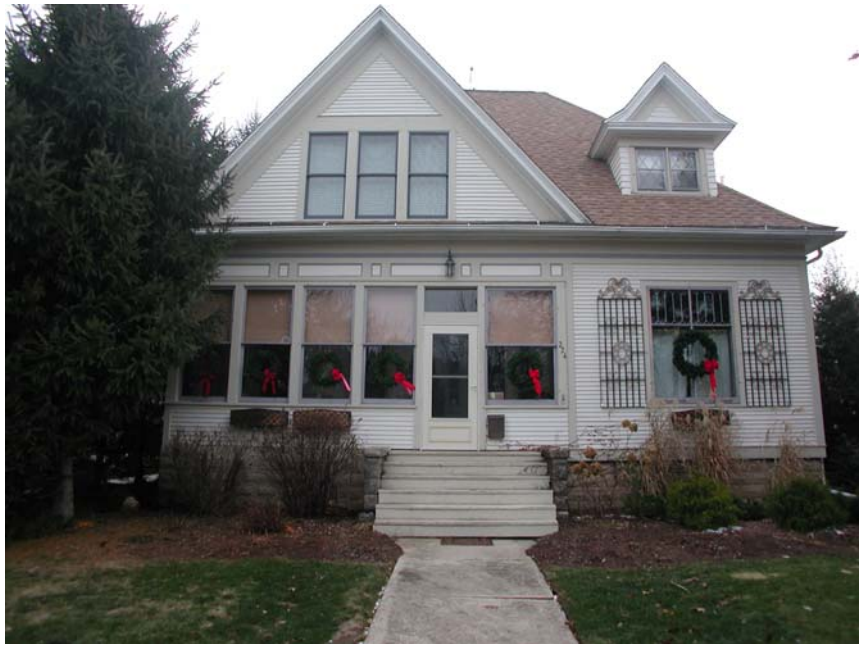
STREET #	224
DIRECTION	N
STREET	COLUMBIA
SUFFIX	ST
PIN	0818209011
LOCAL SIGNIFICANCE RATING	PS
POTENTIAL IND NR? (Y or N)	N
Contributing to a NR DISTRICT?	C
Contributing secondary structure?	C
Listed on existing SURVEY?	Local District; NR District

CATEGORY	building	CURRENT FUNCTION	Domestic - single dwelling
CONDITION	excellent	HISTORIC FUNCTION	Domestic - single dwelling
INTEGRITY	minor alterations and addition(s)	REASON for SIGNIFICANCE	Good example of early 20th century Queen Anne-Free Classic.
SECONDARY STRUCTURE	Detached garage

ARCHITECTURAL CLASSIFICATION	Queen Anne - Free Classic	PLAN	rectangular
DETAILS		NO OF STORIES	1.5
BEGINYEAR	c. 1910	ROOF TYPE	Combination
OTHER YEAR		ROOF MATERIAL	Asphalt - shingle
DATESOURCE	Surveyor	FOUNDATION	Concrete - block
WALL MATERIAL (current)	Wood	PORCH	Front (enclosed)
WALL MATERIAL 2 (current)		WINDOW MATERIAL	wood
WALL MATERIAL (original)	Wood	WINDOW MATERIAL	Vinyl/leaded glass
WALL MATERIAL 2 (original)		WINDOW TYPE	double hung/fixed
		WINDOW CONFIG	1/1; diamond
SIGNIFICANT FEATURES	Flared hipped roof with front and north side gables; front dormer with pent gable; inset front/corner porch (enclosed); historic 1/1 wood windows on 1st story; leaded glass window on front façade, diamond pane window in front dormer		
ALTERATIONS	Replacement windows under gables (not historic); front porch enclosed (not historic); south and north side dormer additions; north side deck addition (not historic)
