STREET #	529				1
DIRECTION	Е				学
STREET	CHICAGO				10
SUFFIX	AV		The second second	A STATE OF THE STA	
PIN	0818322016				
LOCAL SIGNIFICANCE RATING POTENTIAL IND NR? (Y or N)  Contributing to a NR DISTRICT? Contributing secon	NC NC dary structure	? -			
Listed on existing SURVEY?	Local District;	NR District			
			GENERAL INFO	<u>ORMATION</u>	
<b>CATEGORY</b> bu	ıilding		CURRENT FUNCTION	ON Domestic - single dwell	ling
<b>CONDITION</b> ex	cellent		HISTORIC FUNCTION	ON Domestic - single dwell	ling
INTEGRITY major alterations and/or addition(s)  REASON for SIGNFICANCE					
SECONDARY STRUCTURE					
			ARCHITECTURA	L DESCRIPTION	_
ARCHITECTURA CLASSIFICATION		itional (altered)		PLAN	irregular
DETAILS		, ,		NO OF STORIES	2
BEGINYEAR	c. 1900			ROOF TYPE	Combination
OTHER YEAR	c. 2000			ROOF MATERIAL	Asphalt - shingle
DATESOURCE	Surveyor			FOUNDATION	Not visible
WALL MATERIA		Wood		PORCH	Wrap around
WALL MATERIA		Wood - shingle		WINDOW MATERIA	AL Aluminum

# ILLINOIS URBAN ARCHITECTURAL AND HISTORICAL SURVEY CONTINUATION SHEET

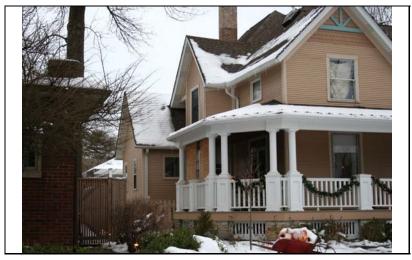
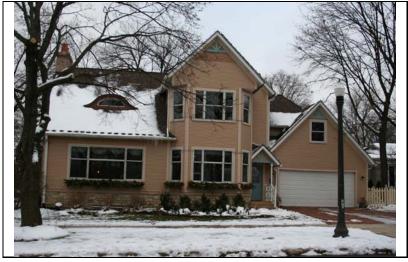
WALL MATERIA		Wood		WINDOW MATERIA	
WALL MATERIA	_			WINDOW TYPE	Double hung/fixed/caseme
				WINDOW CONFIG	1/1; 1-light
SIGNIFICANT FEATURES	Possible that fr	ont gable bay and	d west side two story three-	sided bay are part of origina	I structure
t		replacement wind		east side addition; 2 story e story west side addition; 2	entry addition and polygonal story east/rear bay addition;

<u>HISTORIC INFORMATION</u>
HISTORIC NAME
COMMON NAME
COST
ARCHITECT
ARCHITECT2
BUILDER
ARCHITECT SOURCE
HISTORIC INFO
PERMITS
LANDSCAPE Northwest corner of Chicago and
Wright; front and east sidewalks; rear driveway; rear picket fence;
similar setbacks; mature trees
COA DATE
COA
DECISION
PREPARER Lara Ramsey
PREPARER ORGANIZATION GRANACKI HISTORIC CONSULTANTS
SURVEYDATE 11/28/2007
SURVEYAREA NAPERVILLE
529 E CHICAGO

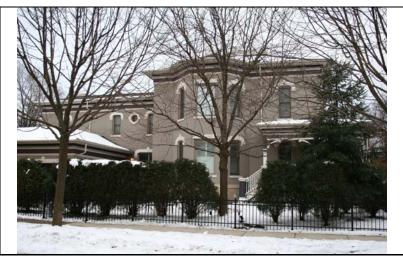
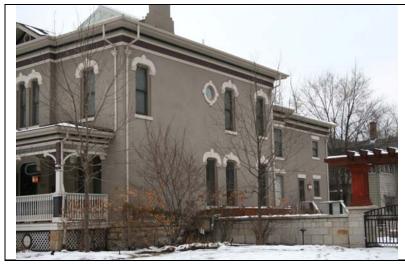
WALL MATERIA		Stucco		WINDOW MATERI	AL Aluminum clad
WALL MATERIA				WINDOW MATERI	AL
WALL MATERIA		Brick		WINDOW TYPE	double hung
WALL MATERIA	AL 2 (original)			WINDOW CONFIG	1/1
		th center front peo	diment; historic window ope	nings; segmental arch linte	s with center keystones; two-
	skylights; repla	acement door and	cco cladding; front wrap aro transom; 2 story rear additi t (admin. approval COA#13	on; rear garage addition	ndows in original openings;

HISTO	DRIC INFORMATION
HISTORIC NAME	Reuss, George House
COMMON NAME	
COST	
ARCHITECT	
ARCHITECT2	
BUILDER	
ARCHITECT SOURCE	
INFO NAF cont Nap Reu	PERVILLE HOMECOMING. See inuation sheet. According to erville Heritage Society brochure, ss was a banker and clothing ufacturer. See continuation sheet.
PERMITS	
Ch rea	ortheast corner of Loomis and icago; front and west sidewalks; ar driveway; wrought iron fence; ature trees
COA DATE	
COA DECISION	
PREPARER	Lara Ramsey
PREPARER ORGANIZATION	GRANACKI HISTORIC CONSULTANTS
SURVEYDATE	11/28/2007
SURVEYAREA	NAPERVILLE

According to article in *The Naperville Sun* (2/6/1998), the house had been converted to a six-flat before the renovation back to single family in 1998.

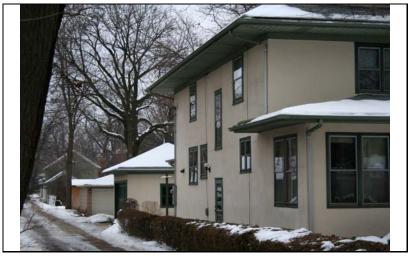
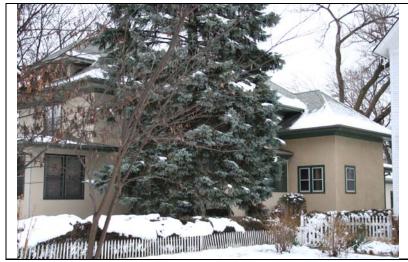
WALL MATERIA	AL (current)	Stucco		PORCH	Full front enclosed	
WALL MATERIA	AL 2 (current)			WINDOW MATERIA		
WALL MATERIA	AL (original)	Stucco		WINDOW MATERIA	AL	
WALL MATERIA				WINDOW TYPE	double hung/awning	
	,			WINDOW CONFIG	1/1; diamond	
			eaves; front hipped do tory east bay; historic 1		nt windows; hipped full front	
ALTERATIONS	2 story rear/ea	st side addition (not his	storic); Aluminum sidin	g under eaves

11151	ORIC INFORMATION
HISTORIC NAME	
COMMON NAME	
COST	
ARCHITECT	
ARCHITECT2	
BUILDER	
ARCHITECT SOURCE	
HISTORIC INFO	
PERMITS	
st	idblock on north side of residential reet; front sidewalk; west side ley; similar setbacks; mature trees
COA DATE	
COA DECISION	
PREPARER	Lara Ramsey
PREPARER ORGANIZATION	GRANACKI HISTORIC
SURVEYDATE	11/28/2007
SURVEYAREA	NAPERVILLE
423 E CH	ICAGO

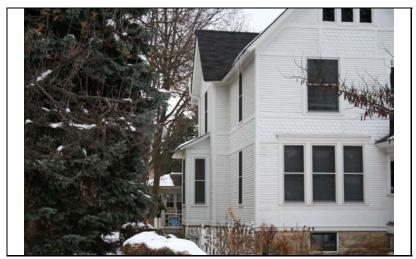
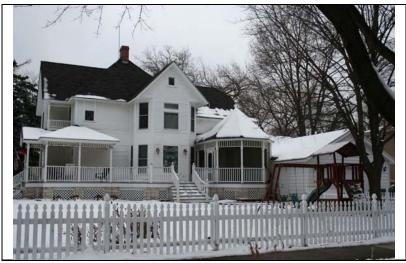
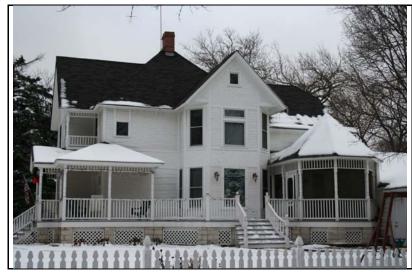
WALL MATERIA	AL (current)	Wood				PORCH WINDOW MATERIA	
WALL MATERIA	AL 2 (current)	Wood - shingle				WINDOW MATERIA	
WALL MATERIA	AL (original)	Wood				WINDOW MATERIA	double hung/fixed
WALL MATERIA	AL 2 (original)	Wood - shingle				WINDOW THE WINDOW CONFIG	1/1; 1-light
CICNIEICANT	Hippod roof wi	th 2 stary front go	blo b	ov: polygopal post side	2 2 01	tory gable bay; 2nd story	
SIGNIFICANT FEATURES	пірреа тоог мі	in 2 Story front gai	ible b	ay, polygorial east slut	<i>3</i>	ory gable bay, 2nd Story	mont poten
ALTERATIONS				c); east side deck addi nings (historic); rear ga		screened rear addition a	at northeast corner;

11151	JAIC IN ORWATION
HISTORIC NAME	
COMMON NAME	
COST	
ARCHITECT	
ARCHITECT2	
BUILDER	
ARCHITECT SOURCE	
HISTORIC INFO	
Sle rea	orthwest corner of Chicago and eight; front and east sidewalks; ar driveway; wood picket fence; milar setbacks; mature trees
COA DATE	
COA DECISION	
PREPARER	Lara Ramsey
PREPARER ORGANIZATION	GRANACKI HISTORIC CONSULTANTS
SURVEYDATE	11/28/2007
SURVEYAREA	NAPERVILLE
JUNILIAMEA

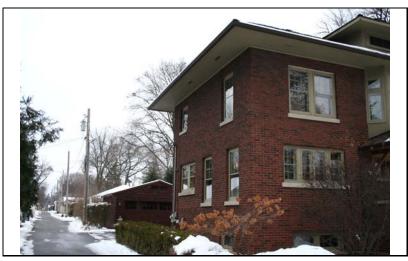
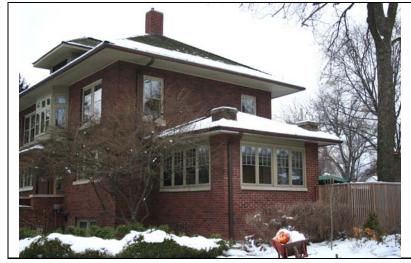
WALL MATERIA		Brick		WINDOW MATERIA	AL		
WALL MATERIA	_	Stucco		WINDOW TYPE	Double hung/casement/aw		
	\ <b>\ \ \</b>			WINDOW CONFIG	6/1; multi-light		
FEATURES	hipped canopy			rindows; center entry with 9-ld window bay; historic double	light sidelights and wood door; e hung, casement, and		
ALTERATIONS

HISTORIC INFORMATION
HISTORIC NAME
COMMON NAME
COST
ARCHITECT
ARCHITECT2
BUILDER
ARCHITECT SOURCE
HISTORIC INFO
PERMITS
LANDSCAPE Midblock on north side of residential street; front sidewalks; west alley; rear wood fence; similar setbacks; mature trees
COA DATE
COA DECISION
PREPARER Lara Ramsey
PREPARER GRANACKI HISTORIC CONSULTANTS
SURVEYDATE 11/28/2007
SURVEYAREA NAPERVILLE
523 E CHICAGO
