STREET #	229
DIRECTION	N
STREET	ELLSWORTH
SUFFIX	ST
PIN	0818129007
LOCAL SIGNIFICANCE RATING	C
POTENTIAL IND NR? (Y or N)	N
Contributing to a NR DISTRICT?	C
Contributing secondary structure?	C
Listed on existing SURVEY?	Local District; NR District

COA DATE	
COA DECISION	
PREPARER	Lara Ramsey
PREPARER ORGANIZATION	GRANACKI HISTORIC CONSULTANTS
SURVEYDATE	11/16/2007
SURVEYAREA	NAPERVILLE

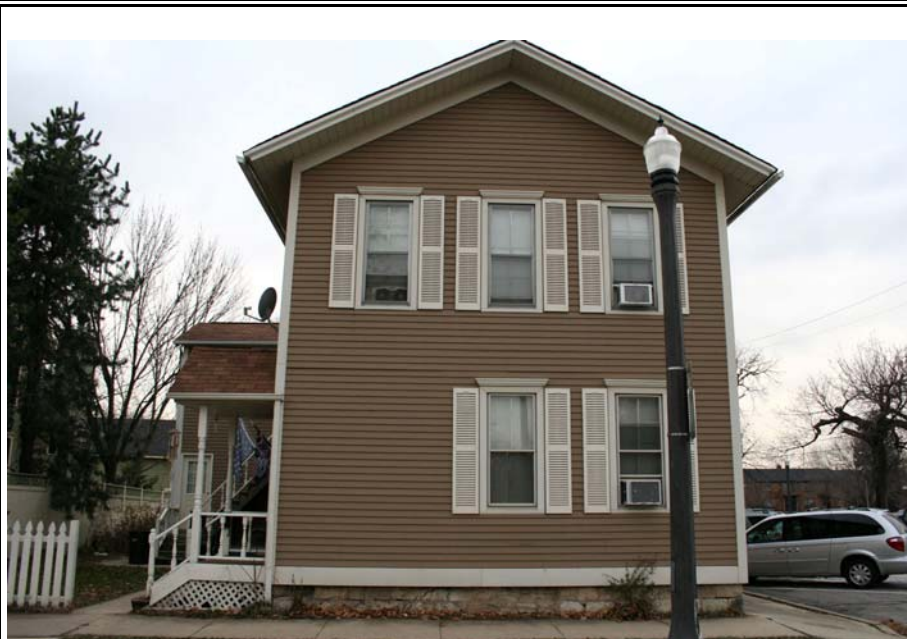
229 N ELLSWORTH

CATEGORY	building	CURRENT FUNCTION	Domestic - multiple dwelling
CONDITION	good	HISTORIC FUNCTION	Domestic - single dwelling
INTEGRITY	major alterations and/or addition(s)	REASON for SIGNIFICANCE	
SECONDARY STRUCTURE	Detached garage

ARCHITECTURAL CLASSIFICATION	Gable Front	PLAN	rectangular
DETAILS		NO OF STORIES	2
BEGINYEAR	1873	ROOF TYPE	Front gable
OTHER YEAR		ROOF MATERIAL	Asphalt - shingle
DATESOURCE	surveyor/tax records	FOUNDATION	Stone
WALL MATERIAL (current)	Aluminum	PORCH	Side
WALL MATERIAL 2 (current)		WINDOW MATERIAL	Wood
WALL MATERIAL (original)	Wood	WINDOW MATERIAL	
WALL MATERIAL 2 (original)		WINDOW TYPE	double hung
		WINDOW CONFIG	2/2 vertical
SIGNIFICANT FEATURES	Front gable roof and rectangular massing; 2/2 vertical wood windows (lintels covered with aluminum, but are historic); frieze board		
ALTERATIONS	Appears that front entry was covered up, & new side entry & porch built (post 1943); 2 story rear add. (historic); south add. (post 1943); exterior stair w/ 2nd story S. window converted to door (not historic); aluminum siding; fixed shutters In kind replacement of asphalt shingles (admin. approved COA#17-4764)

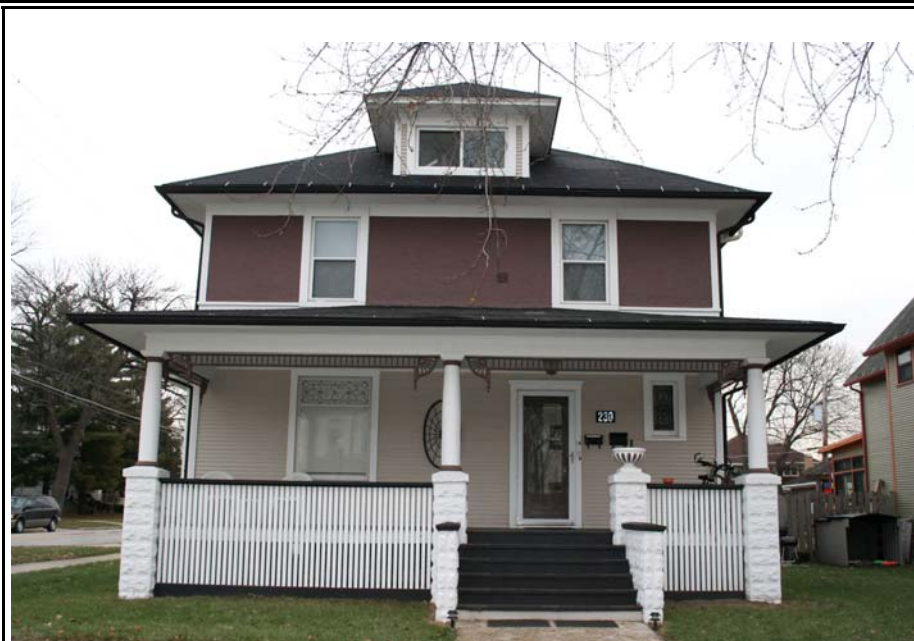
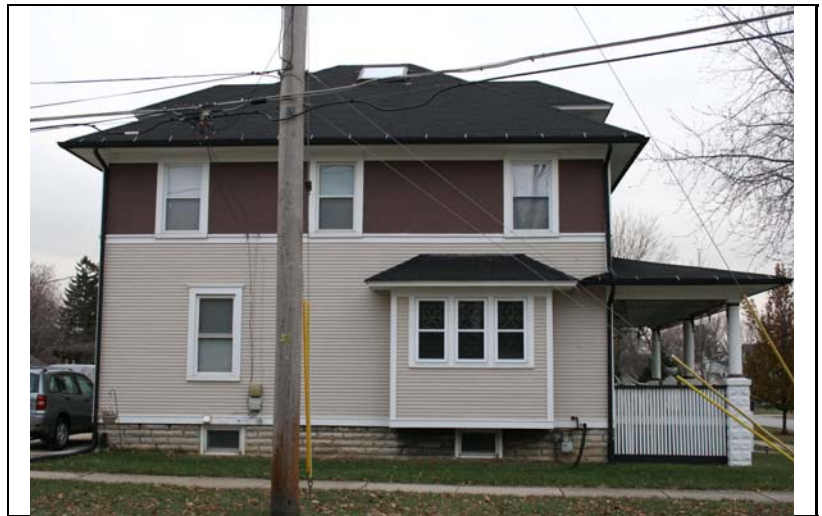
230 N ELLSWORTH

CATEGORY	building	CURRENT FUNCTION	Domestic - multiple dwelling
CONDITION	excellent	HISTORIC FUNCTION	Domestic - single dwelling
INTEGRITY	minor alterations	REASON for SIGNIFICANCE	
SECONDARY STRUCTURE

ARCHITECTURAL CLASSIFICATION	American Foursquare	PLAN	rectangular
DETAILS		NO OF STORIES	2.5
BEGINYEAR	c. 1915	ROOF TYPE	Hipped
OTHER YEAR		ROOF MATERIAL	Asphalt - shingle
DATESOURCE	Surveyor	FOUNDATION	Concrete - block
WALL MATERIAL (current)	Wood	PORCH	Full front
WALL MATERIAL 2 (current)	Stucco	WINDOW MATERIAL	Wood/vinyl
WALL MATERIAL (original)	Wood	WINDOW MATERIAL	beveled glass
WALL MATERIAL 2 (original)	Stucco	WINDOW TYPE	Double hung/casement/fix
		WINDOW CONFIG	1/1; 1-light
SIGNIFICANT FEATURES	Hipped roof with overhanging eaves and front hipped dormer; full front porch with round columns on concrete block piers; 1st story north square window bay w/ beveled glass casement windows; beveled glass windows under porch; 3-sided S. window bay		
ALTERATIONS	1/1 replacement windows in original openings (not historic); replacement railing and added frieze on porch In kind shingle replacement (admin. approved COA#16-4595)

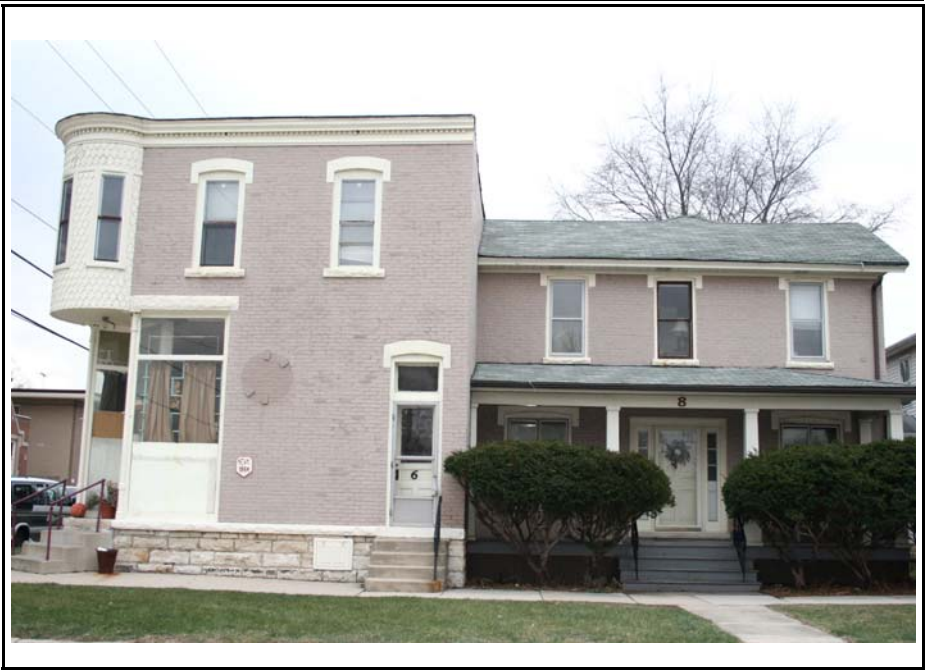
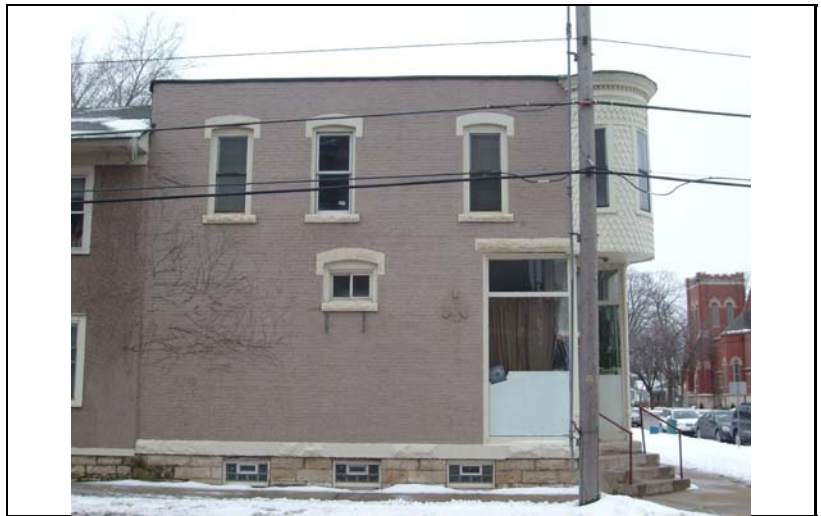
4-6 S ELLSWORTH

CATEGORY	building	CURRENT FUNCTION	Domestic - multiple dwelling
CONDITION	good	HISTORIC FUNCTION	Commerce/Trade
INTEGRITY	minor alterations	REASON for SIGNIFICANCE	The only commercial block in the historic district, this 19th-century building still retains much of its historic character.
SECONDARY STRUCTURE

ARCHITECTURAL CLASSIFICATION	Two Part Commercial Block	PLAN	rectangular
DETAILS		NO OF STORIES	2
BEGINYEAR	c. 1880	ROOF TYPE	Flat
OTHER YEAR		ROOF MATERIAL	Not visible
DATESOURCE	Surveyor	FOUNDATION	Stone
WALL MATERIAL (current)	Brick	PORCH	-
WALL MATERIAL 2 (current)	Stucco	WINDOW MATERIAL	Wood
WALL MATERIAL (original)	Brick	WINDOW MATERIAL	Vinyl
WALL MATERIAL 2 (original)	wood shingle	WINDOW TYPE	Storefront/double hung
		WINDOW CONFIG	1-light; 1/1
SIGNIFICANT FEATURES	Dentil cornice; northwest corner entry w/ 2nd story rounded turret with wood shingles; cast iron columns at entry; stone segmental arch label molds on window openings w/ rough stone sills		
ALTERATIONS	Brick painted; original conical roof atop round northwest corner tower removed; display windows and storefront door are replacement, but may be historic; concrete steps and railing; replacement upper windows in original openings

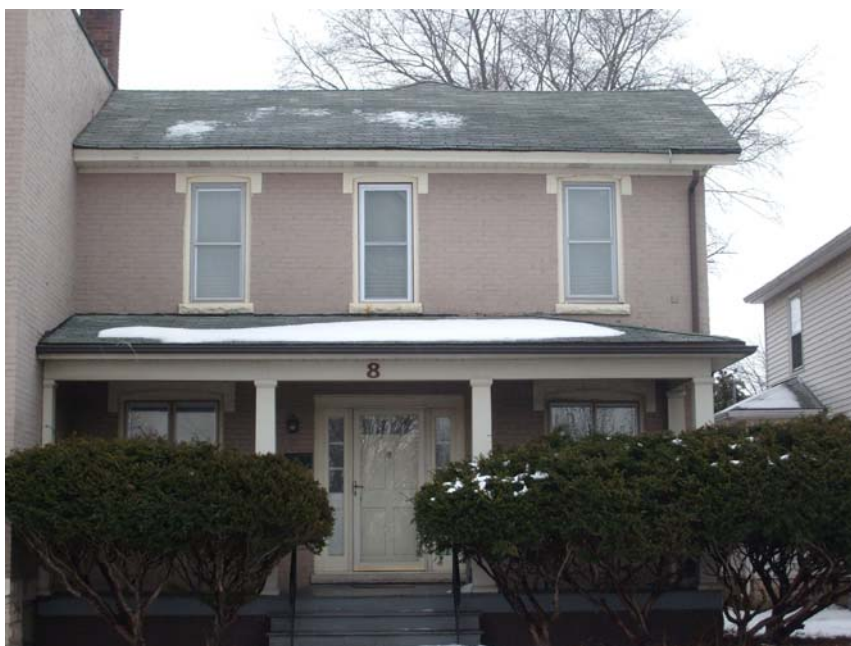
CATEGORY	building	CURRENT FUNCTION	Domestic - single dwelling
CONDITION	good	HISTORIC FUNCTION	Domestic - single dwelling
INTEGRITY	minor alterations and addition(s)	REASON for SIGNIFICANCE	Rare, early example of the I-House in the district, with only minor alterations.
SECONDARY STRUCTURE	Detached garage

ARCHITECTURAL CLASSIFICATION	I-House	PLAN	rectangular
DETAILS		NO OF STORIES	2
BEGINYEAR	c. 1870	ROOF TYPE	Side gable
OTHER YEAR		ROOF MATERIAL	Asphalt - shingle
DATESOURCE	Surveyor	FOUNDATION	Stone
WALL MATERIAL (current)	Brick	PORCH	Full front
WALL MATERIAL 2 (current)		WINDOW MATERIAL	Wood
WALL MATERIAL (original)	Brick	WINDOW MATERIAL	
WALL MATERIAL 2 (original)		WINDOW TYPE	double hung
		WINDOW CONFIG	1/1
SIGNIFICANT FEATURES	Side gable roof and rectangular massing; segmental arch window openings with stone label molds on front façade and brick lintels on side; with rusticated stone sills		
ALTERATIONS	Aluminum siding under eaves (not historic); painted brick exterior; replacement windows in original openings (historic); front entry door and sidelights (historic); replacement front porch (historic); 1 story rear addition (historic)

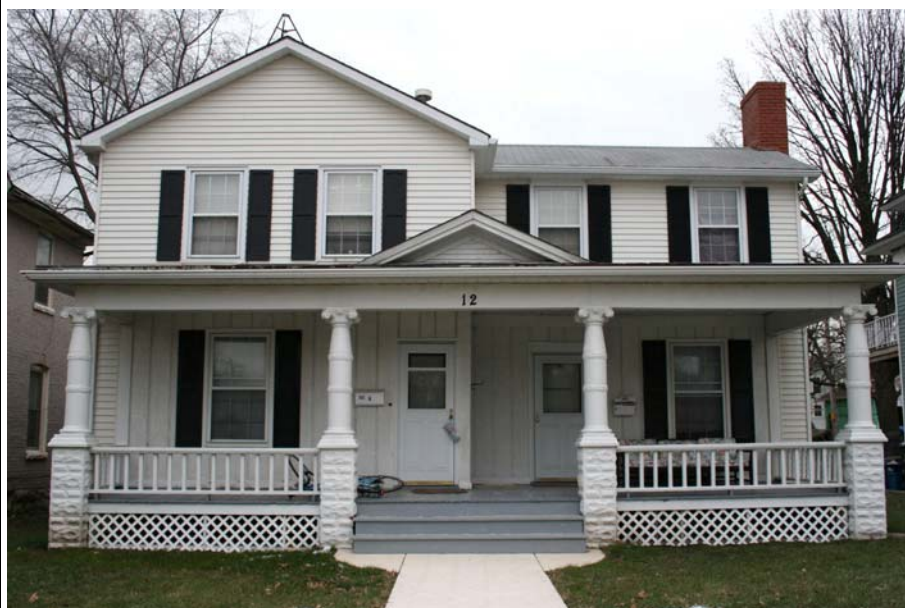
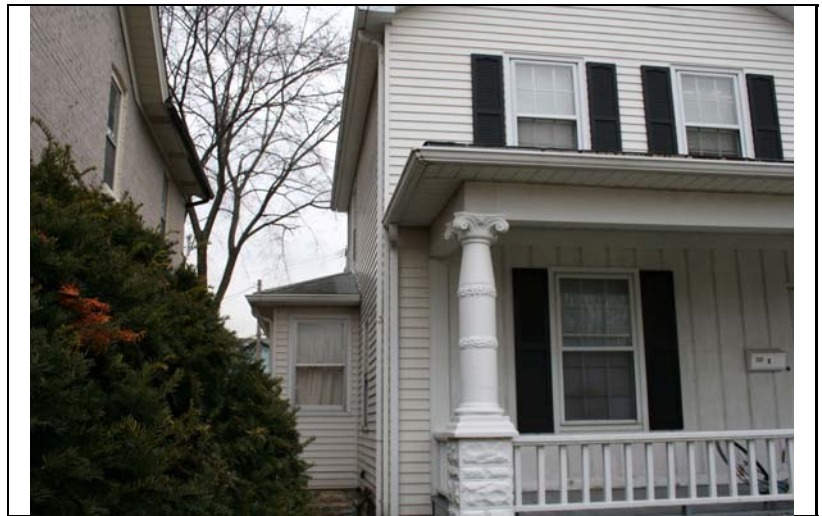
12 S ELLSWORTH

CATEGORY	building	CURRENT FUNCTION	Domestic - multiple dwelling
CONDITION	good	HISTORIC FUNCTION	Domestic - multiple dwelling
INTEGRITY	minor alterations and addition(s)	REASON for SIGNIFICANCE	
SECONDARY STRUCTURE

ARCHITECTURAL CLASSIFICATION	L-Form	PLAN	L
DETAILS	Greek Revival	NO OF STORIES	2
BEGINYEAR	c. 1865	ROOF TYPE	Multi-gable
OTHER YEAR		ROOF MATERIAL	Asphalt - shingle
DATESOURCE	surveyor	FOUNDATION	Concrete - block
WALL MATERIAL (current)	Aluminum	PORCH	Full front
WALL MATERIAL 2 (current)	wood - vertical board	WINDOW MATERIAL	wood
WALL MATERIAL (original)	Wood	WINDOW MATERIAL	
WALL MATERIAL 2 (original)		WINDOW TYPE	double hung
		WINDOW CONFIG	6/6; 6/9

SIGNIFICANT FEATURES Two story front gable bay with intersecting south side gable wing; historic replacement front porch

ALTERATIONS Replacement front porch (historic--c. 1910); Aluminum and vertical wood siding; replacement windows in original openings (may have been altered on 1st story under porch); north end door under porch added--SEE CONTINUATION SHEET

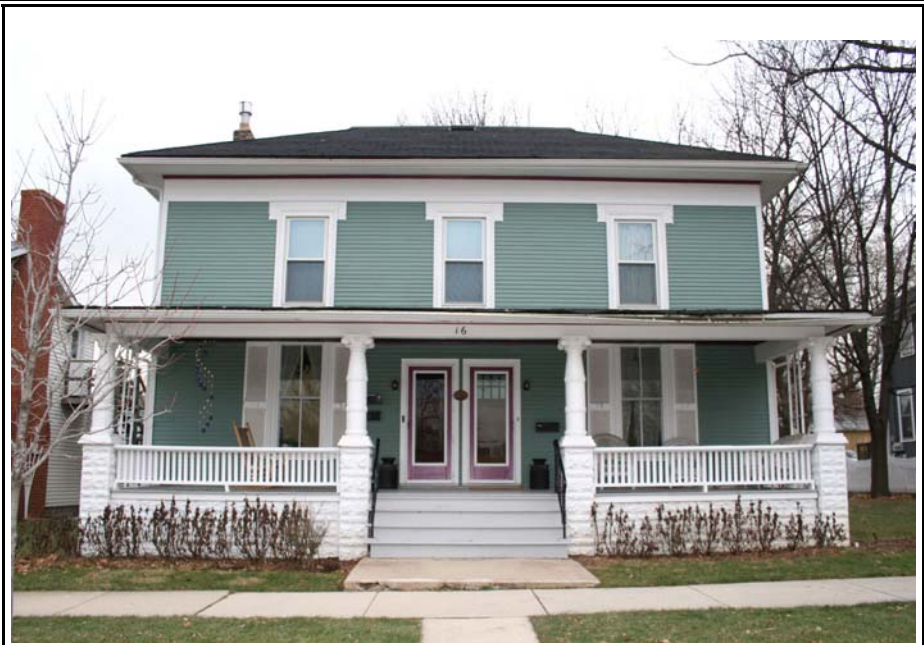
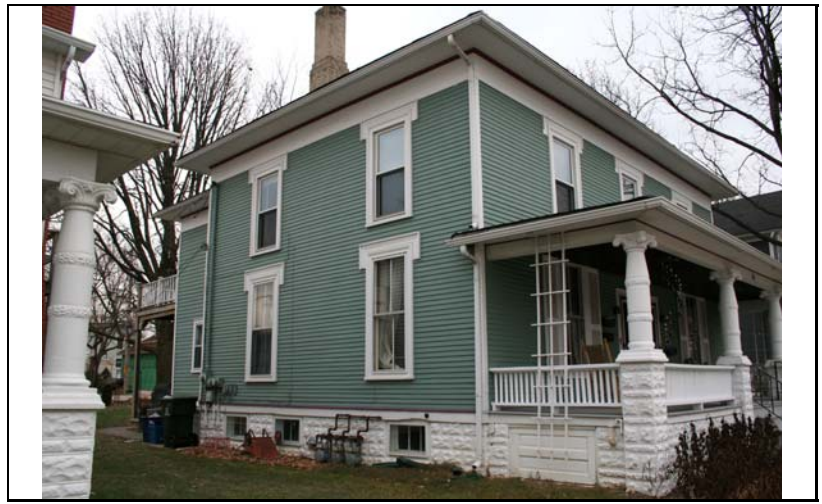
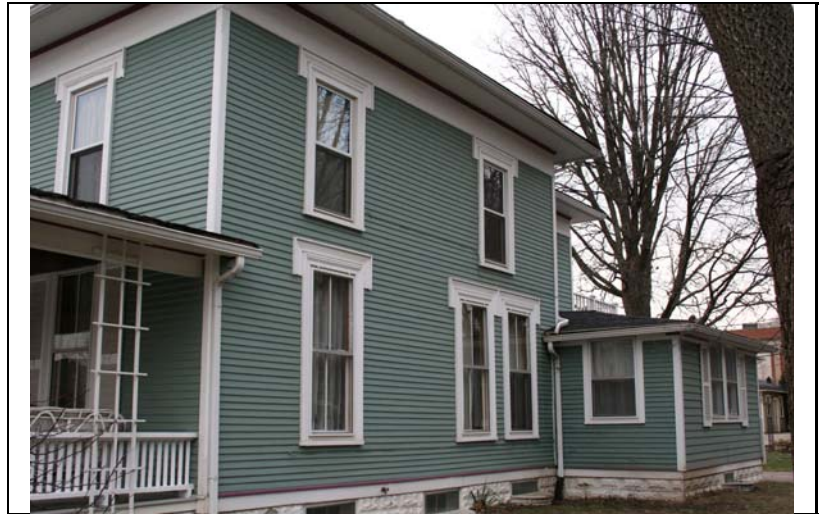
CATEGORY	building	CURRENT FUNCTION	Domestic - multiple dwelling
CONDITION	excellent	HISTORIC FUNCTION	Domestic - multiple dwelling
INTEGRITY	minor alterations and addition(s)	REASON for SIGNIFICANCE	Excellent example of Italianate residential architecture in the district. Front porch is historic, and dates from the 1910s.
SECONDARY STRUCTURE

ARCHITECTURAL CLASSIFICATION	Duplex-Italianate	PLAN	rectangular
DETAILS		NO OF STORIES	2
BEGINYEAR	c. 1870	ROOF TYPE	Hipped
OTHER YEAR		ROOF MATERIAL	Asphalt - shingle
DATESOURCE	Surveyor	FOUNDATION	Concrete - block
WALL MATERIAL (current)	Wood	PORCH	Full front
WALL MATERIAL 2 (current)		WINDOW MATERIAL	wood
WALL MATERIAL (original)	Wood	WINDOW MATERIAL	vinyl
WALL MATERIAL 2 (original)		WINDOW TYPE	double hung
		WINDOW CONFIG	1/1; 2/2 vert.
SIGNIFICANT FEATURES	Shallow mansard roof; historic 2/2 vertical wood windows on 1st story; label molds on all window openings; wide wood frieze under eaves; historic replacement front porch		
ALTERATIONS	Replacement front porch (historic); vinyl replacement windows in original openings on 2nd story (not historic); 2 story rear addition w/ 2nd story deck (not historic); replacement front doors; fixed shutters; 1 story rear/south addition (historic)

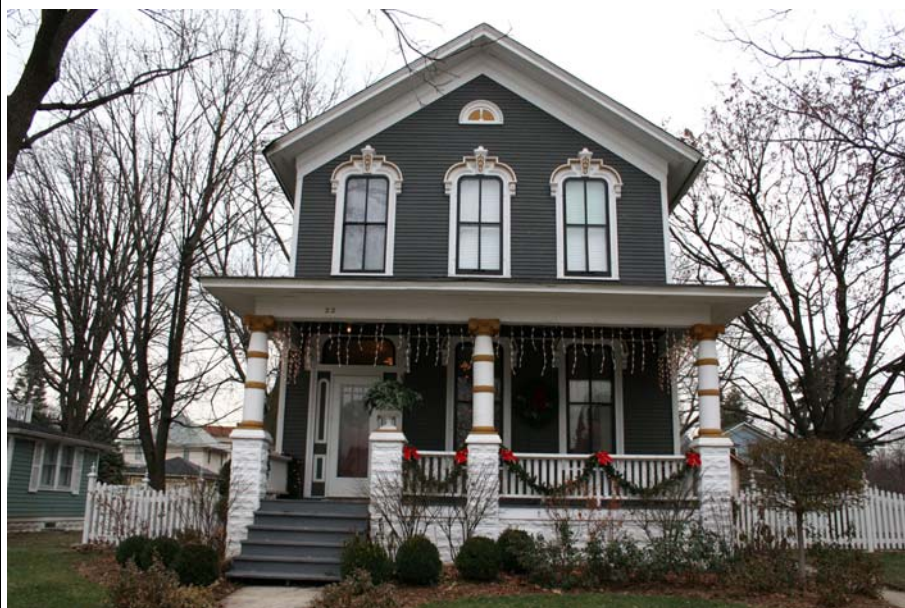
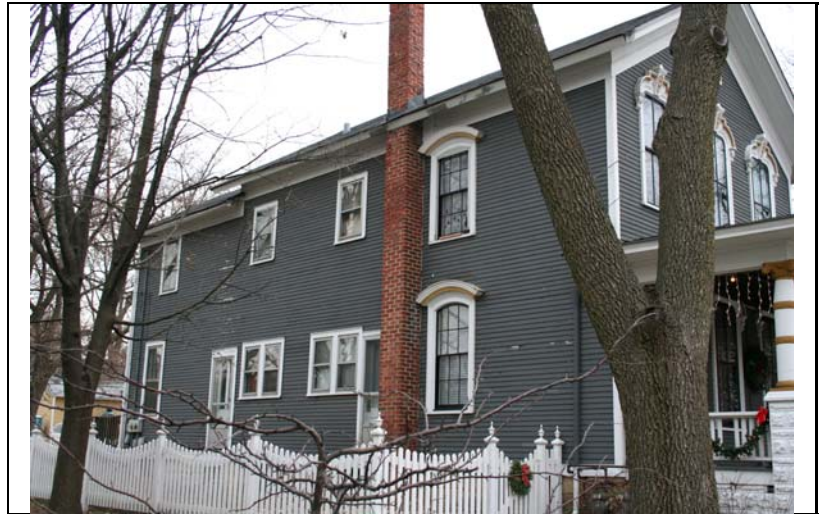
CATEGORY	<input type="text" value="building"/>	CURRENT FUNCTION	<input type="text" value="Domestic - single dwelling"/>
CONDITION	<input type="text" value="excellent"/>	HISTORIC FUNCTION	<input type="text" value="Domestic - single dwelling"/>
INTEGRITY	<input type="text" value="minor alterations and addition(s)"/>	REASON for SIGNIFICANCE	<input type="text" value="Handsome Italianate with exuberant detailing at windows and entry. Listed on IHSS (P)."/>
SECONDARY STRUCTURE	<input type="text" value="Detached garage"/>

ARCHITECTURAL CLASSIFICATION	<input type="text" value="Italianate"/>	PLAN	<input type="text" value="rectangular"/>
DETAILS	<input type="text"/>	NO OF STORIES	<input type="text" value="2"/>
BEGINYEAR	<input type="text" value="c. 1875"/>	ROOF TYPE	<input type="text" value="Front gable"/>
OTHER YEAR	<input type="text"/>	ROOF MATERIAL	<input type="text" value="Asphalt - shingle"/>
DATESOURCE	<input type="text" value="Surveyor/Chain of Title"/>	FOUNDATION	<input type="text" value="Stone/concrete block"/>
WALL MATERIAL (current)	<input type="text" value="Wood"/>	PORCH	<input type="text"/>
WALL MATERIAL 2 (current)	<input type="text"/>	WINDOW MATERIAL	<input type="text" value="Wood"/>
WALL MATERIAL (original)	<input type="text" value="Wood"/>	WINDOW MATERIAL	<input type="text"/>
WALL MATERIAL 2 (original)	<input type="text"/>	WINDOW TYPE	<input type="text" value="double hung"/>
		WINDOW CONFIG	<input type="text" value="2/2; 6/6; 1/1"/>

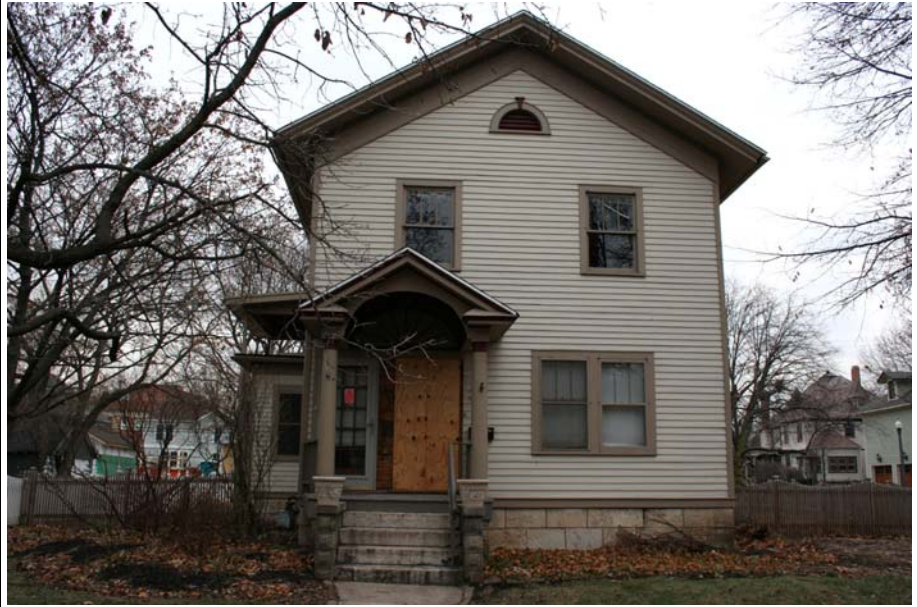
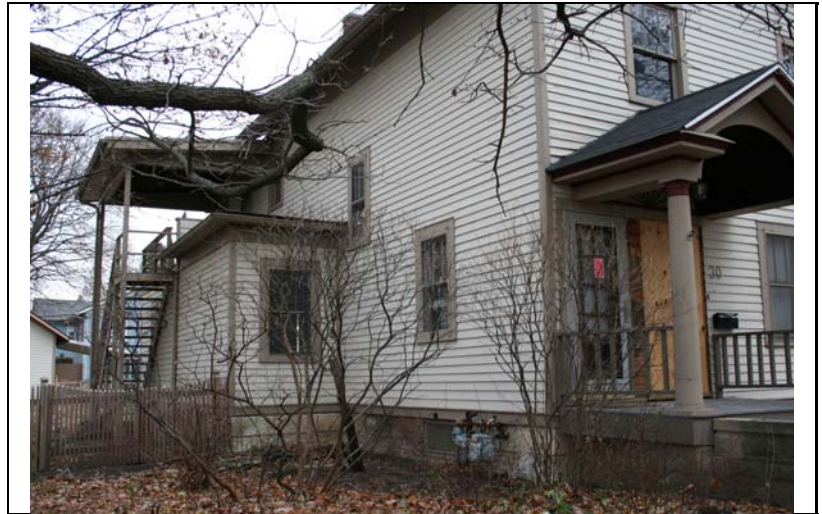
CATEGORY	building	CURRENT FUNCTION	Domestic - multiple dwelling
CONDITION	good	HISTORIC FUNCTION	Domestic - single dwelling
INTEGRITY	major alterations and/or addition(s)	REASON for SIGNIFICANCE	
SECONDARY STRUCTURE	Shed

ARCHITECTURAL CLASSIFICATION	Greek Revival	PLAN	rectangular
DETAILS		NO OF STORIES	2
BEGINYEAR	c. 1865	ROOF TYPE	Front gable
OTHER YEAR		ROOF MATERIAL	Asphalt - shingle
DATESOURCE	Surveyor	FOUNDATION	Stone
WALL MATERIAL (current)	Wood	PORCH	Front entry
WALL MATERIAL 2 (current)		WINDOW MATERIAL	Wood
WALL MATERIAL (original)	Wood	WINDOW MATERIAL	
WALL MATERIAL 2 (original)		WINDOW TYPE	double hung
		WINDOW CONFIG	3/1; 6/6

ALTERATIONS	Replacement 3/1 wood windows (in altered openings on 1st story façade--1920s); two story rear addition (c. 1940); two story NE corner addition with 2nd story porch; replacement front porch (historic); single front entry door replaced with two doors Addition of 2 upper story windows, modifications to screen porch to windows (admin. approved COA#15-3111) Demolition of existing construction (HPC approved COA#11-2993) Modifications to site plan and building elevations improved (HPC approved COA#13-3320) Construction of new residence (HPC approved COA#15-314)
-------------	--

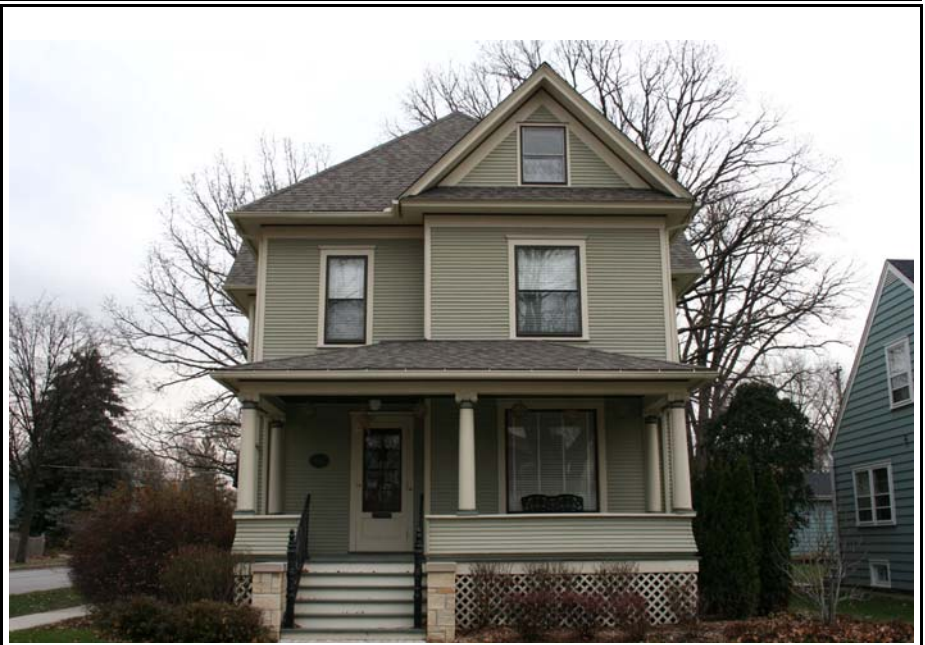
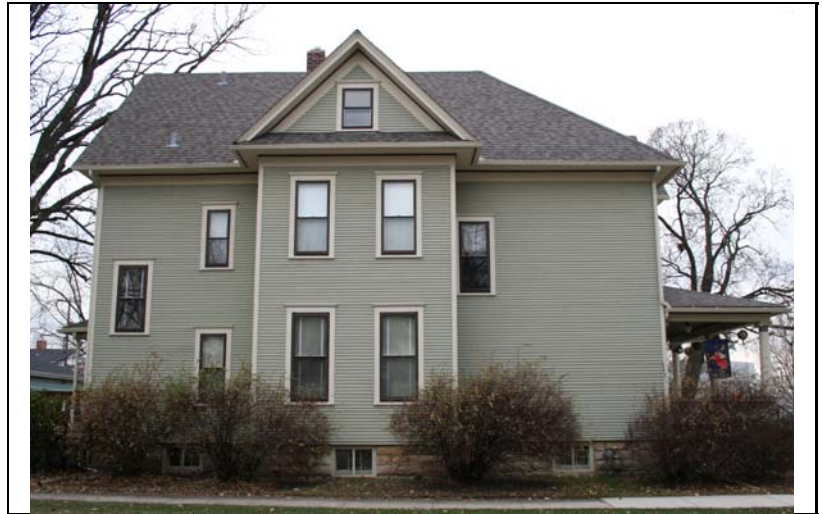
CATEGORY	building	CURRENT FUNCTION	Domestic - single dwelling
CONDITION	excellent	HISTORIC FUNCTION	Domestic - single dwelling
INTEGRITY	major alterations and/or addition(s)	REASON for SIGNIFICANCE	Quintessential example of Free Classic Queen Anne from around the turn of the 20th century.
SECONDARY STRUCTURE	Barn

ARCHITECTURAL CLASSIFICATION	Queen Anne - Free Classic	PLAN	irregular
DETAILS		NO OF STORIES	2.5
BEGINYEAR	c. 1905	ROOF TYPE	Hipped
OTHER YEAR		ROOF MATERIAL	Asphalt - shingle
DATESOURCE	Surveyor	FOUNDATION	Stone
WALL MATERIAL (current)	Wood	PORCH	Full front
WALL MATERIAL 2 (current)		WINDOW MATERIAL	Wood
WALL MATERIAL (original)	Wood	WINDOW MATERIAL	
WALL MATERIAL 2 (original)		WINDOW TYPE	double hung/fixed
		WINDOW CONFIG	1/1; 1-light
SIGNIFICANT FEATURES	Hipped main roof; front & south 2-story pent gable bays; full front porch with Ionic columns on wood knee wall; historic 1/1 wood windows		
ALTERATIONS	Fixed front window is replacement (possibly historic); replacement porch steps (not historic); rear deck addition (not historic)

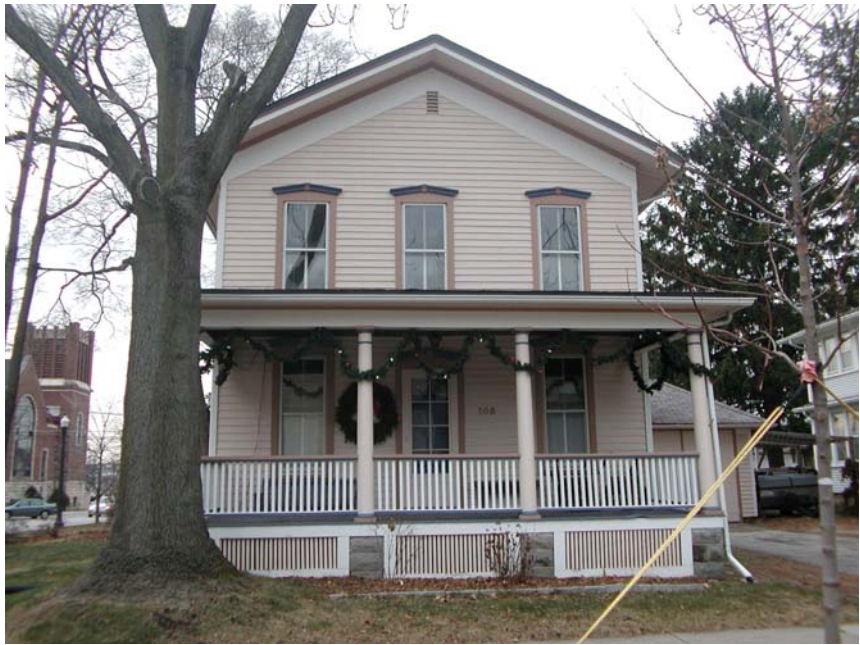
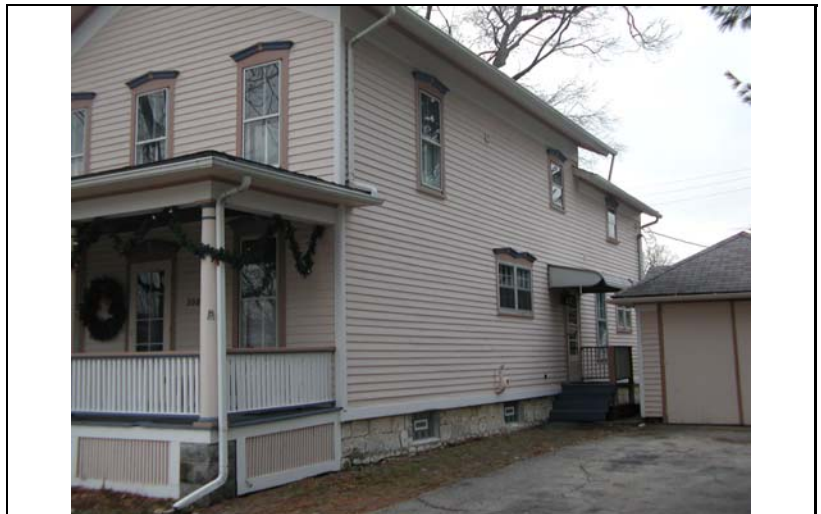
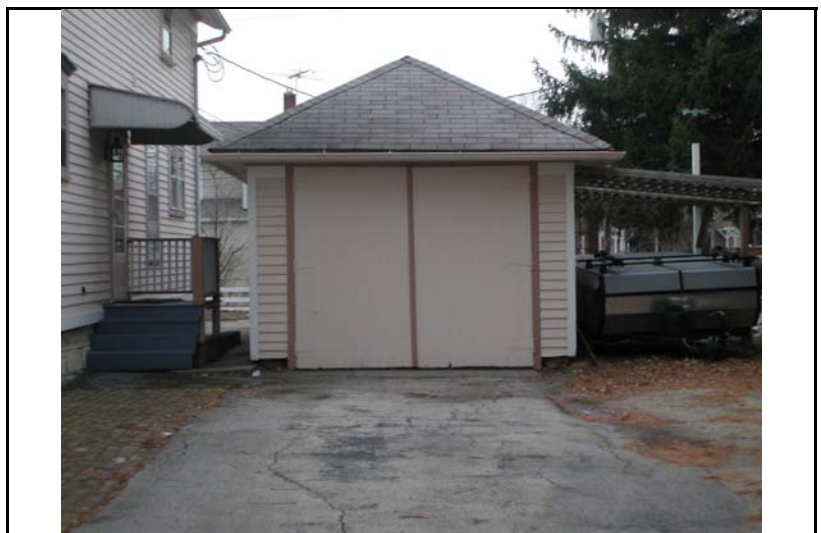
105 N ELLSWORTH

CATEGORY	building	CURRENT FUNCTION	Domestic - single dwelling
CONDITION	good	HISTORIC FUNCTION	Domestic - single dwelling
INTEGRITY	minor alterations and addition(s)	REASON for SIGNIFICANCE	Fine, simple iteration of the Italianate style within the district.
SECONDARY STRUCTURE	detached garage

ARCHITECTURAL CLASSIFICATION	Italianate	PLAN	rectangular
DETAILS		NO OF STORIES	2
BEGINYEAR	1874	ROOF TYPE	Front gable
OTHER YEAR		ROOF MATERIAL	Asphalt - shingle
DATESOURCE	Plaque	FOUNDATION	Stone
WALL MATERIAL (current)	Wood	PORCH	full front/side
WALL MATERIAL 2 (current)		WINDOW MATERIAL	Wood
WALL MATERIAL (original)	Wood	WINDOW MATERIAL	
WALL MATERIAL 2 (original)		WINDOW TYPE	double hung
		WINDOW CONFIG	2/2 vert.; 6/6
SIGNIFICANT FEATURES	Front gable roof with wood frieze; historic 2/2 wood windows with pedimented lintels		
ALTERATIONS	Replacement front door (not historic); front porch add./replacement S. porch (historic--c. 1905); S side door, surround, & canopy/stoop (not historic); glass block in basement windows (not historic)--SEE CONTINUATION SHEET Replacement of side entry porch (admin. approved COA#12-3641)

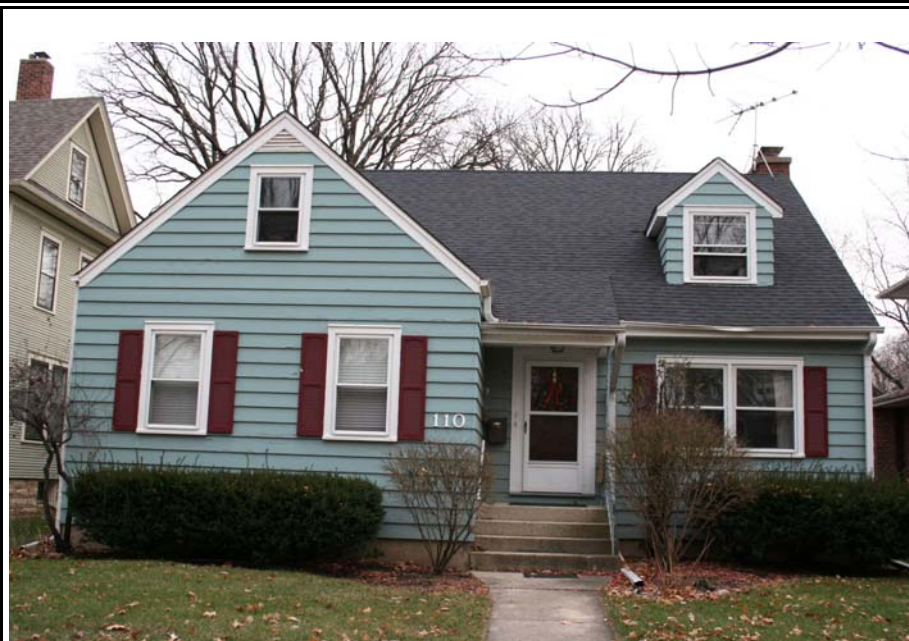
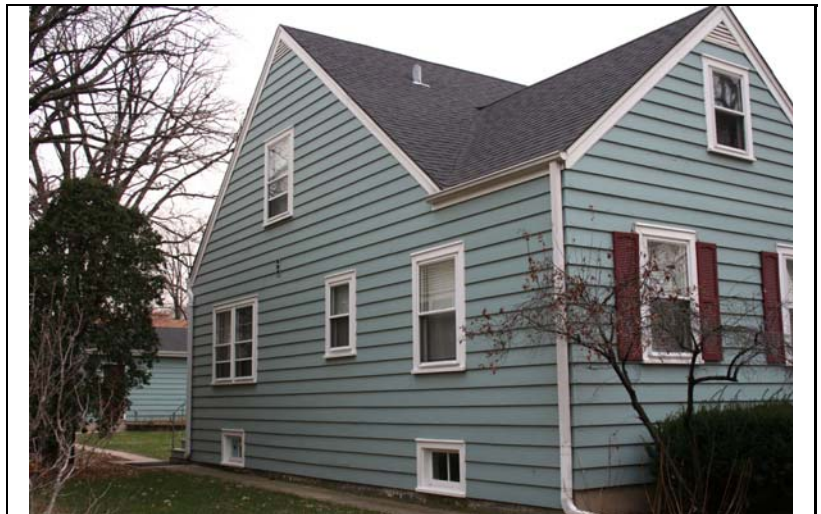
110 S ELLSWORTH

CATEGORY	building	CURRENT FUNCTION	Domestic - single dwelling
CONDITION	good	HISTORIC FUNCTION	Domestic - single dwelling
INTEGRITY	minor alterations	REASON for SIGNIFICANCE	
SECONDARY STRUCTURE	Detached garage

ARCHITECTURAL CLASSIFICATION	Minimal Traditional	PLAN	rectangular
DETAILS		NO OF STORIES	1.5
BEGINYEAR	c.1950	ROOF TYPE	Side gable
OTHER YEAR		ROOF MATERIAL	Asphalt - shingle
DATESOURCE	surveyor	FOUNDATION	Concrete
WALL MATERIAL (current)	Wood	PORCH	Front entry
WALL MATERIAL 2 (current)		WINDOW MATERIAL	Wood
WALL MATERIAL (original)	Wood	WINDOW MATERIAL	
WALL MATERIAL 2 (original)		WINDOW TYPE	double hung
		WINDOW CONFIG	1/1
SIGNIFICANT FEATURES	Side gable roof with front gable bay and dormer; front entry porch (altered)		
ALTERATIONS	Wrought iron railings on front porch (may be original); fixed shutters; Aluminum under eaves

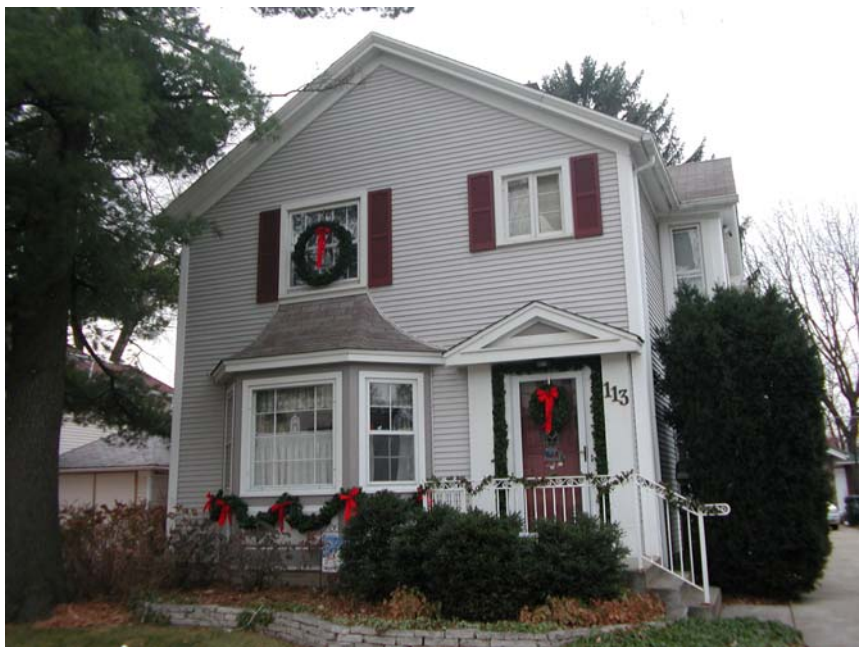
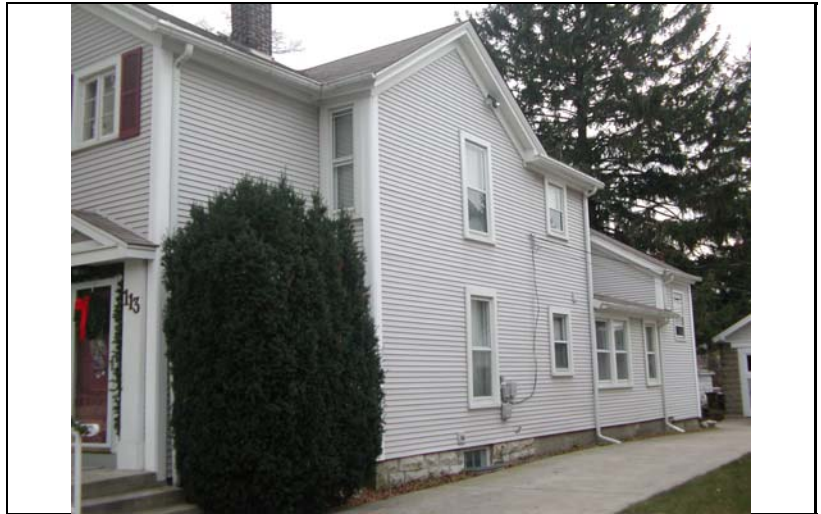
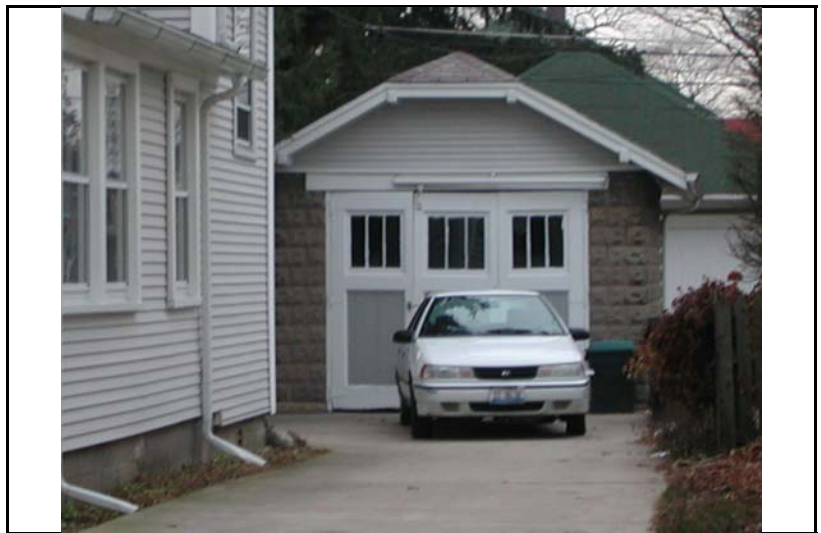
113 N ELLSWORTH

CATEGORY	building	CURRENT FUNCTION	Domestic - single dwelling
CONDITION	good	HISTORIC FUNCTION	Domestic - single dwelling
INTEGRITY	minor alterations and addition(s)	REASON for SIGNIFICANCE	
SECONDARY STRUCTURE	detached garage

ARCHITECTURAL CLASSIFICATION	Gable Front	PLAN	irregular
DETAILS		NO OF STORIES	2
BEGINYEAR	c. 1900	ROOF TYPE	Front gable
OTHER YEAR		ROOF MATERIAL	Asphalt - shingle
DATESOURCE	Surveyor	FOUNDATION	Stone
WALL MATERIAL (current)	Aluminum	PORCH	side entry
WALL MATERIAL 2 (current)		WINDOW MATERIAL	Wood
WALL MATERIAL (original)	Wood	WINDOW MATERIAL	
WALL MATERIAL 2 (original)		WINDOW TYPE	double hung/fixed/caseme
		WINDOW CONFIG	4/4; 1/1; multi/1; 3-light
SIGNIFICANT FEATURES	Front gable with south side gable bay (1st story cutaway corners on south bay); concrete block one-car detached garage		
ALTERATIONS	Aluminum siding (not historic); replacement front door/surround/stoop (not historic); 3-sided front window bay (historic); 2 story south/rear addition with entry; replacement windows in original openings (historic)--SEE CONTINUATION SHEET

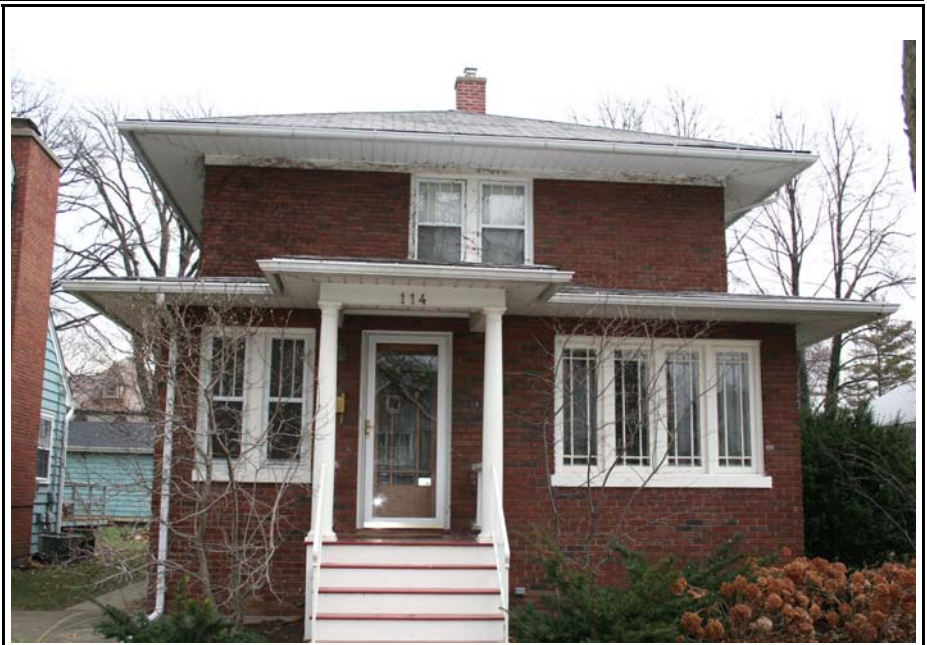
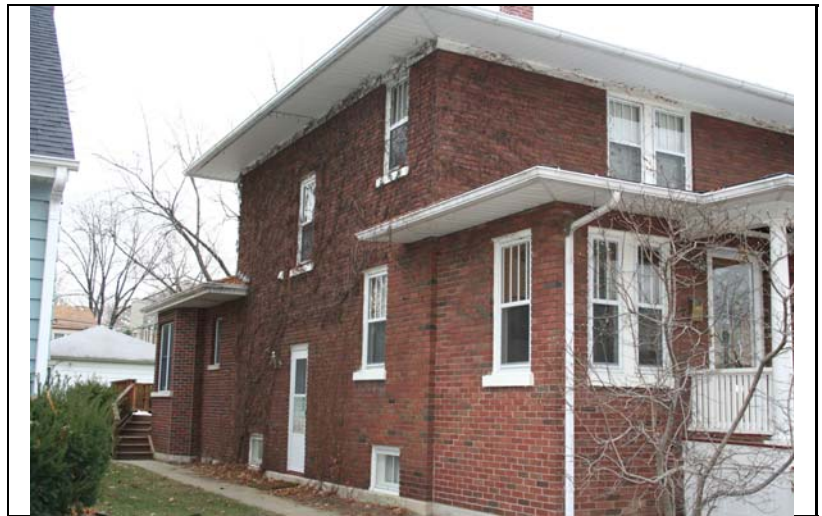
CATEGORY	building	CURRENT FUNCTION	Domestic - single dwelling
CONDITION	excellent	HISTORIC FUNCTION	Domestic - single dwelling
INTEGRITY	minor alterations and addition(s)	REASON for SIGNIFICANCE	
SECONDARY STRUCTURE	Detached garage

ARCHITECTURAL CLASSIFICATION	American Foursquare	PLAN	Rectangular
DETAILS	Prairie	NO OF STORIES	2.5
BEGINYEAR	c. 1925	ROOF TYPE	Hipped
OTHER YEAR		ROOF MATERIAL	Asphalt - shingle
DATESOURCE	Surveyor	FOUNDATION	Concrete
WALL MATERIAL (current)	Brick	PORCH	Front entry
WALL MATERIAL 2 (current)		WINDOW MATERIAL	Wood
WALL MATERIAL (original)	Brick	WINDOW MATERIAL	
WALL MATERIAL 2 (original)		WINDOW TYPE	Double hung/casement/aw
		WINDOW CONFIG	4/1; 3-light; 9-light geo.
SIGNIFICANT FEATURES	Hipped roof with overhanging eaves; 1 story front bay w/ 9-light geometric wood windows on south end of facade; historic wood windows		
ALTERATIONS	Aluminum under eaves; front entry porch at north end of front facade enclosed, center entry porch added (post 1943); replacement front steps and railing (not historic); rear deck addition (not historic)

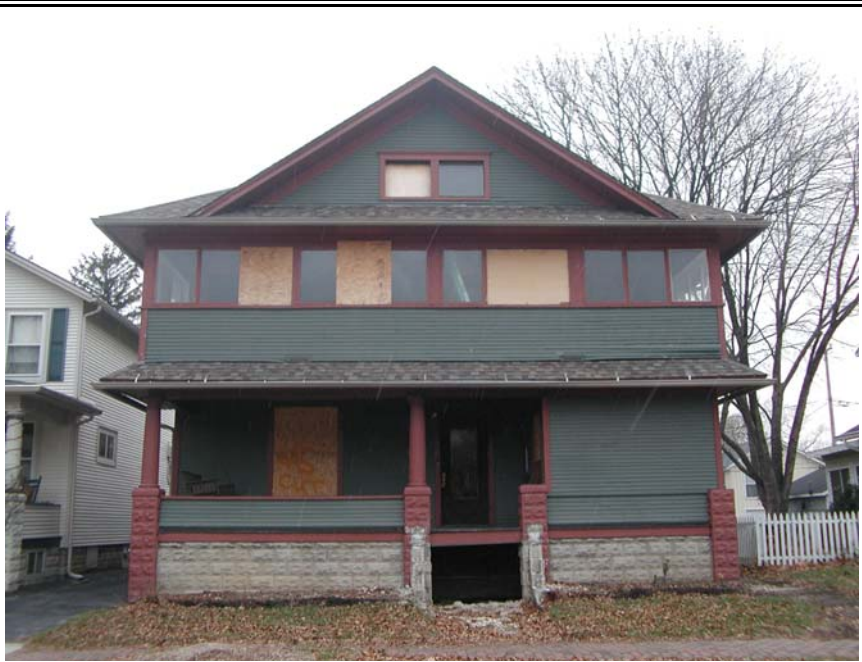
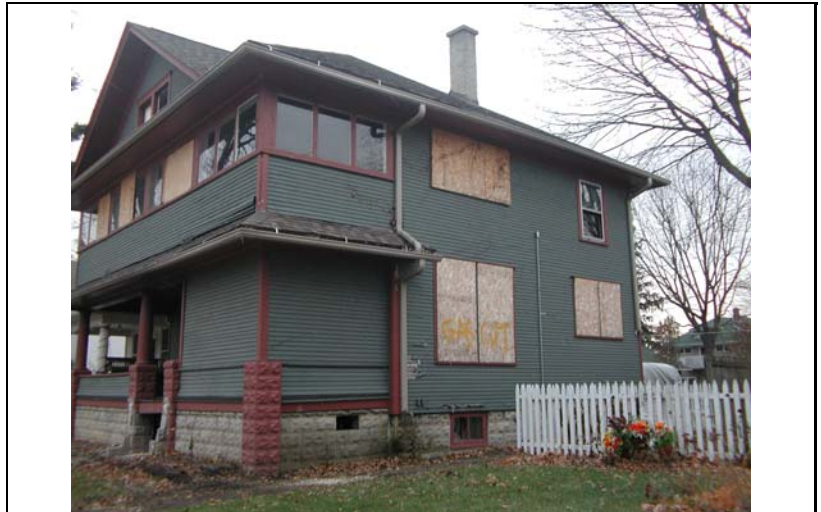
119 N ELLSWORTH

CATEGORY	building	CURRENT FUNCTION	Vacant/Not in Use
CONDITION	Good/fair	HISTORIC FUNCTION	Domestic - single dwelling
INTEGRITY	minor alterations	REASON for SIGNIFICANCE	Despite alterations, this Craftsman house remains an excellent example of the style in the district.
SECONDARY STRUCTURE

ARCHITECTURAL CLASSIFICATION	Craftsman	PLAN	Rectangular
DETAILS		NO OF STORIES	2.5
BEGINYEAR	c. 1915	ROOF TYPE	Gable on hip
OTHER YEAR		ROOF MATERIAL	Asphalt - shingle
DATESOURCE	Surveyor	FOUNDATION	Concrete - block
WALL MATERIAL (current)	Wood	PORCH	Front
WALL MATERIAL 2 (current)		WINDOW MATERIAL	Wood
WALL MATERIAL (original)	Wood	WINDOW MATERIAL	
WALL MATERIAL 2 (original)		WINDOW TYPE	double hung/casement
		WINDOW CONFIG	1/1; 1-light

ALTERATIONS Front porch enclosed on north end; most windows are boarded up; steps to front porch missing
 Replacement of door with window in kind replacement matching existing window (admin. approved COA#18-3335)
 Remove window & replace with door, door existed prior to 2018 (admin. approved COA#19-1196)

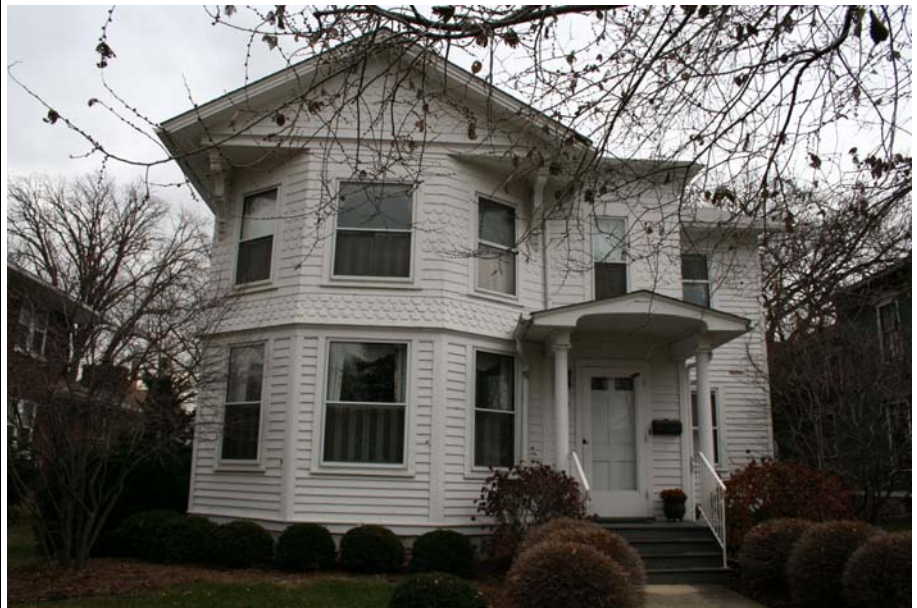
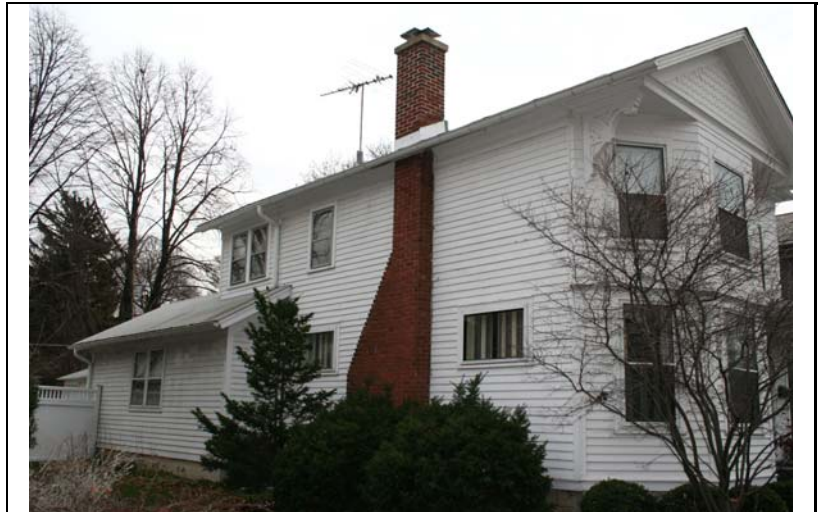
120 S ELLSWORTH

CATEGORY	building	CURRENT FUNCTION	Domestic - single dwelling
CONDITION	good	HISTORIC FUNCTION	Domestic - single dwelling
INTEGRITY	minor alterations and addition(s)	REASON for SIGNIFICANCE	Even with the front porch addition and rear additions, this house remains significant local example of the Queen Anne style.
SECONDARY STRUCTURE	Detached garage

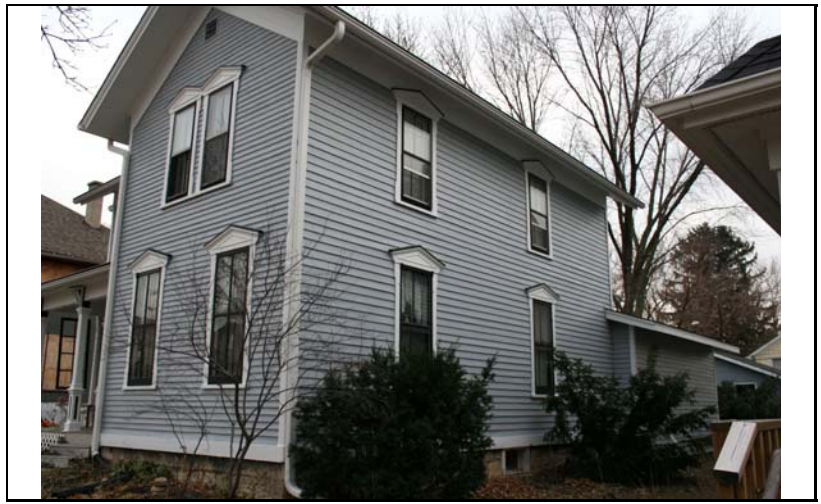
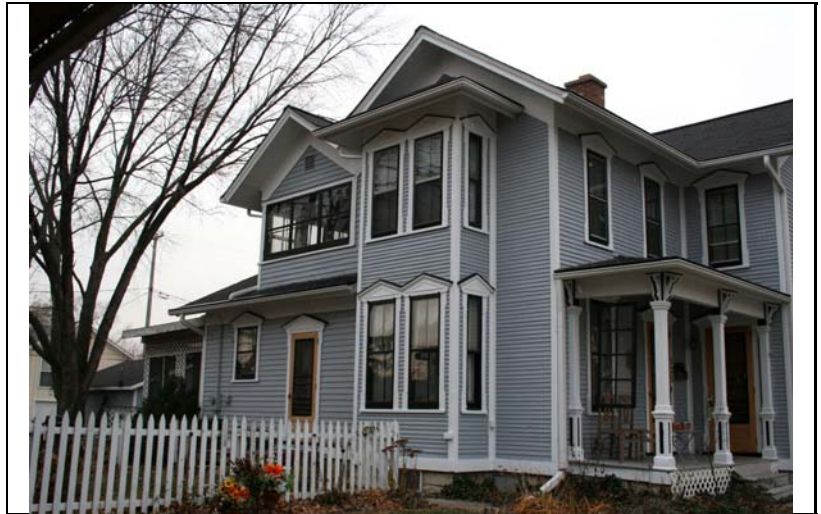
125 N ELLSWORTH

CATEGORY	building	CURRENT FUNCTION	Domestic - single dwelling
CONDITION	excellent	HISTORIC FUNCTION	Domestic - single dwelling
INTEGRITY	minor alterations and addition(s)	REASON for SIGNIFICANCE	Fine local example of the Italianate style, featuring elegant window surrounds topped with triangular pediments. Listed on IHSS (P).
SECONDARY STRUCTURE	detached garage

Front gable roof with wide wood frieze; south polygonal window bay with segmental arch windows, narrow round arch wood panels, carved brackets, and paneled frieze; 2/2 wood windows with flanged pediment lintels; recessed entry with paneled sides & transoms; historic double wood doors (altered)

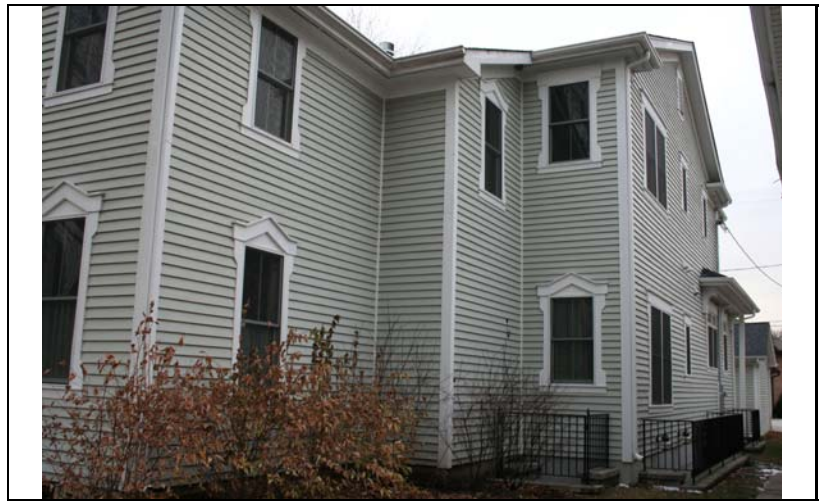
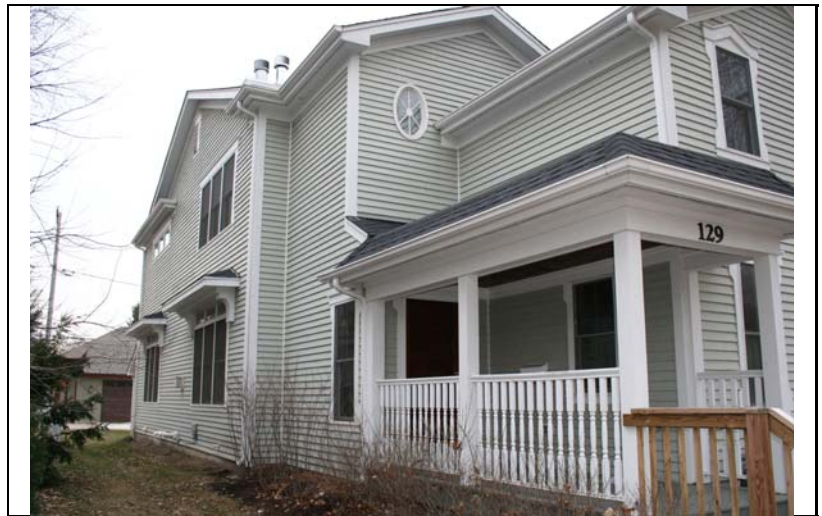
129 N ELLSWORTH

CATEGORY	building	CURRENT FUNCTION	Domestic - single dwelling
CONDITION	excellent	HISTORIC FUNCTION	Domestic - single dwelling
INTEGRITY	major alterations and/or addition(s)	REASON for SIGNIFICANCE	
SECONDARY STRUCTURE	detached garage

Paired brackets & dentils appear to be later (may be restoration); replacement windows on 2nd story or original structure (not historic); replacement door & transom (not historic); large 2 story S. side addition w/ corner tower (not historic); replacement porch (not historic--ghost lines on original house indicate that there was a full porch); 2 story rear addition (historic); 1 story north bay addition (not historic); segmental arch window on 2nd story north elevation (not historic); chimney (not historic); rear screened porch addition (not historic)
