STREET #	229
DIRECTION	N
STREET	ELLSWORTH
SUFFIX	ST
PIN	0818129007
LOCAL SIGNIFICANCE RATING	C
POTENTIAL IND NR? (Y or N)	N
Contributing to a NR DISTRICT?	C
Contributing secondary structure?	C
Listed on existing SURVEY?	Local District; NR District

COA DATE	
COA DECISION	
PREPARER	Lara Ramsey
PREPARER ORGANIZATION	GRANACKI HISTORIC CONSULTANTS
SURVEYDATE	11/16/2007
SURVEYAREA	NAPERVILLE

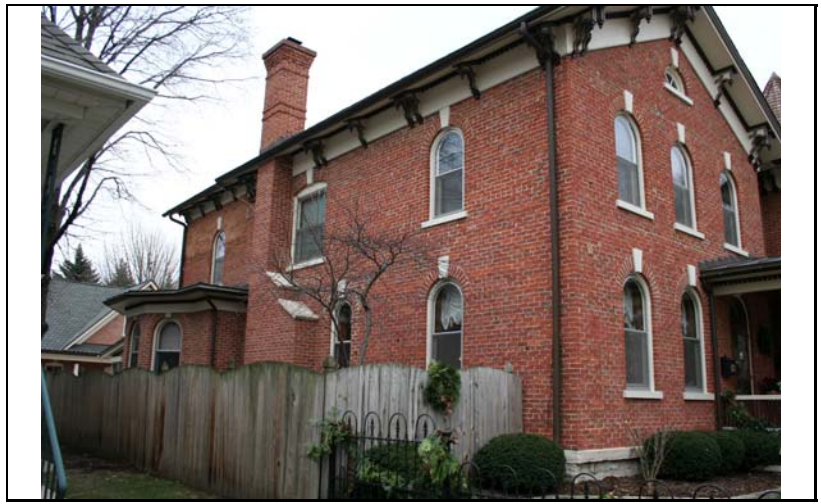
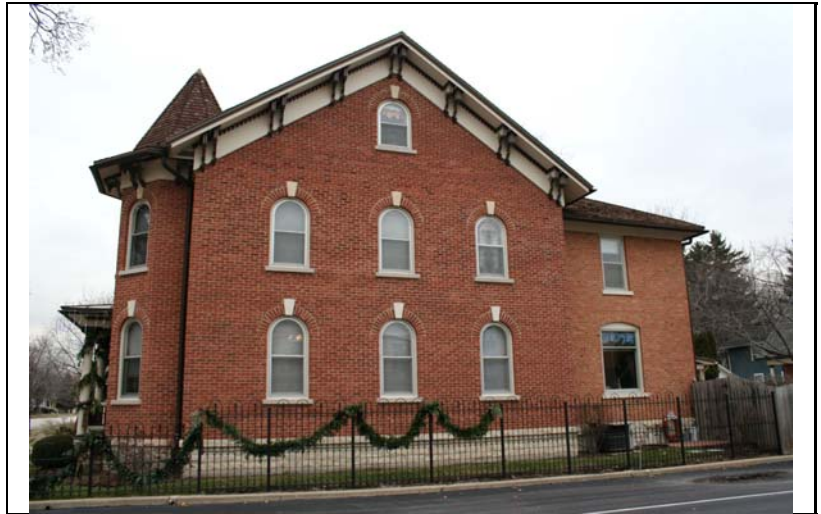
130 N ELLSWORTH

CATEGORY	building	CURRENT FUNCTION	Domestic - single dwelling
CONDITION	excellent	HISTORIC FUNCTION	Domestic - single dwelling
INTEGRITY	major alterations and/or addition(s)	REASON for SIGNIFICANCE	
SECONDARY STRUCTURE	detached garage

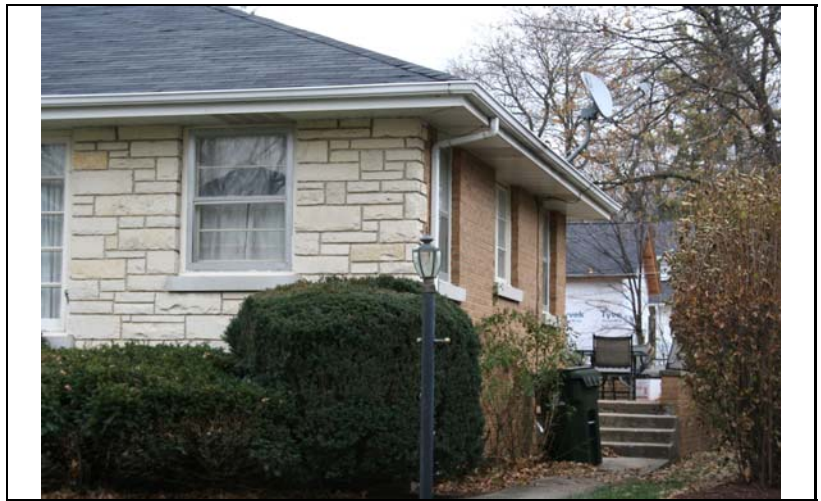
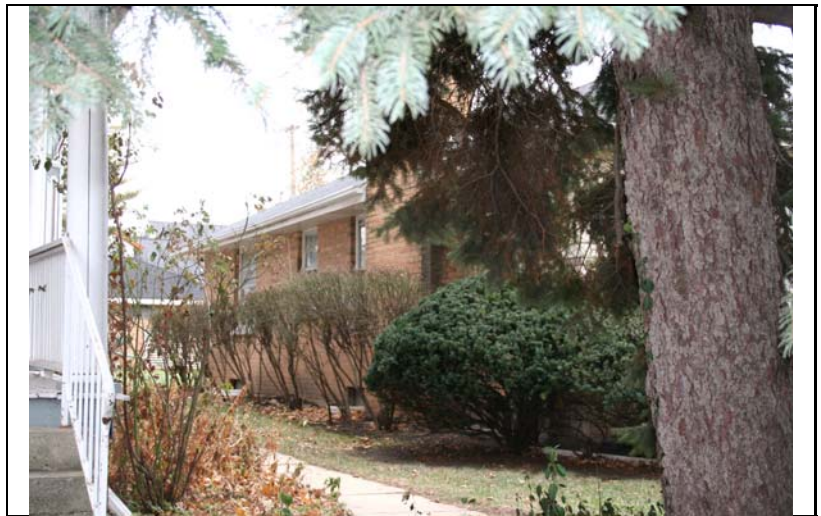
130 S ELLSWORTH

CATEGORY	building	CURRENT FUNCTION	Domestic - single dwelling
CONDITION	good	HISTORIC FUNCTION	Domestic - single dwelling
INTEGRITY	not altered	REASON for SIGNIFICANCE	
SECONDARY STRUCTURE	Detached garage

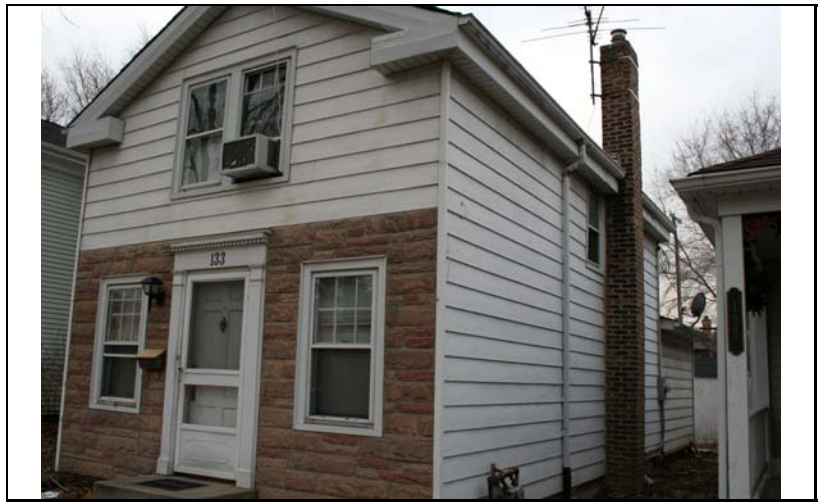
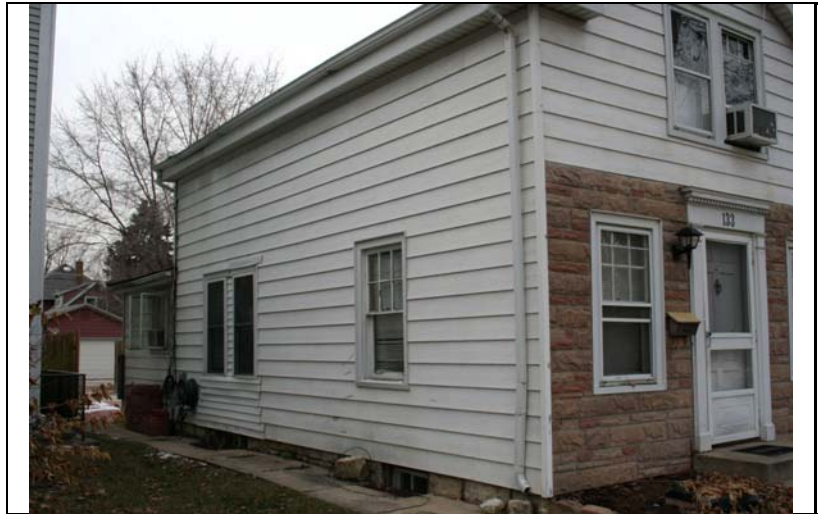
133 N ELLSWORTH

CATEGORY	building	CURRENT FUNCTION	Domestic - single dwelling
CONDITION	good	HISTORIC FUNCTION	Domestic - single dwelling
INTEGRITY	major alterations and/or addition(s)	REASON for SIGNIFICANCE	
SECONDARY STRUCTURE	shed

According to Sanborn Maps, house was originally a one-story structure that has been altered and added to over the years: 1 story south side addition is historic, but south porch appears to have been altered (replacement posts, railing, and steps, Aluminum under eaves); second story addition to original house is historic; first story on north addition was added before 1943, with 2nd story added after; aluminum siding; replacement windows in altered openings (not historic--house originally had a full porch and entry on front façade); multiple rear additions; stone steps to north side entry and stone patio at front of house (not historic)

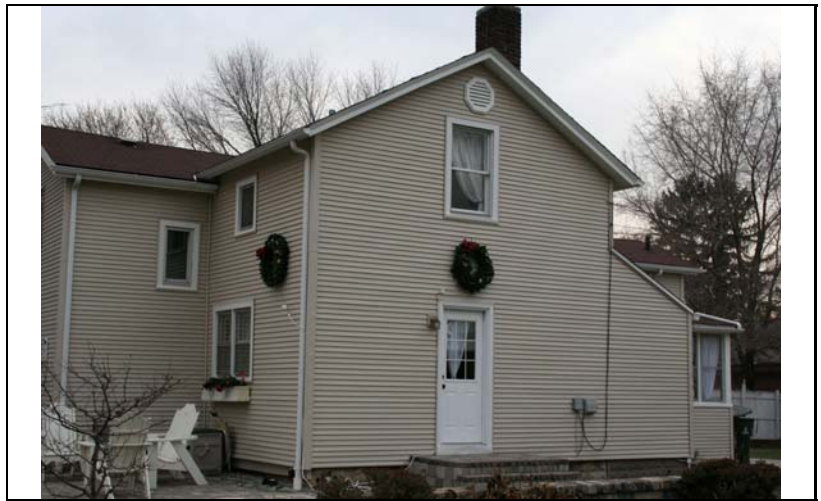
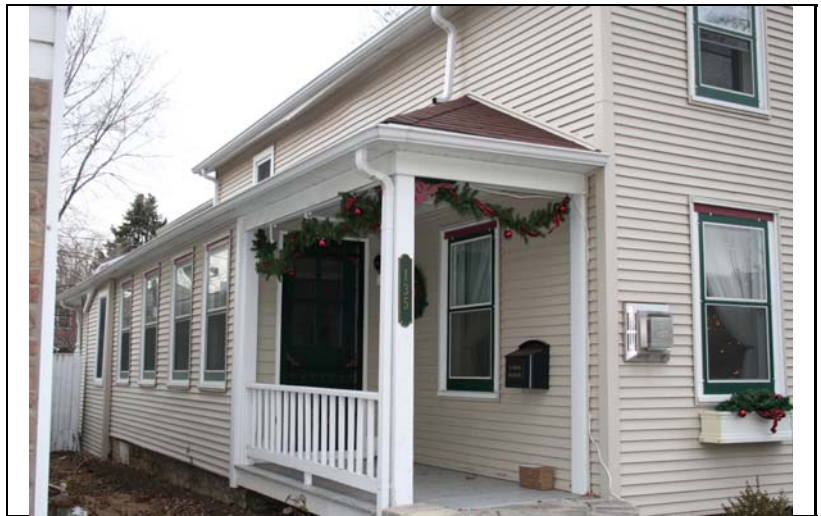
135 N ELLSWORTH

CATEGORY	building	CURRENT FUNCTION	Domestic - single dwelling
CONDITION	good	HISTORIC FUNCTION	Domestic - single dwelling
INTEGRITY	major alterations and/or addition(s)	REASON for SIGNIFICANCE	
SECONDARY STRUCTURE	Detached garage

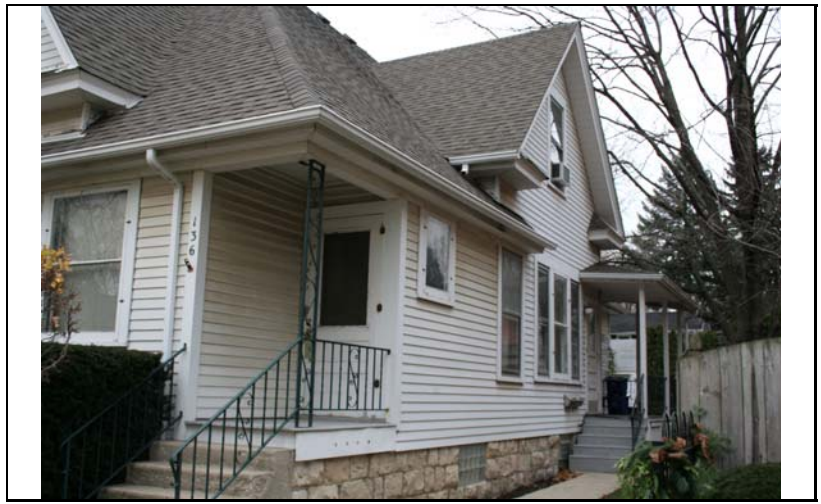
136 N ELLSWORTH

CATEGORY	building	CURRENT FUNCTION	Domestic - single dwelling
CONDITION	good	HISTORIC FUNCTION	Domestic - single dwelling
INTEGRITY	minor alterations and addition(s)	REASON for SIGNIFICANCE	Good local example of early 20th century Queen Anne.
SECONDARY STRUCTURE	detached garage

Replacement siding (not historic); replacement windows in original openings (not-historic); replacement door (not historic); replacement supports/railing on porch (not historic); 3-sided 1st story south window bay addition (not historic); large 2 story rear/south addition (not historic); rear porch addition (not historic)

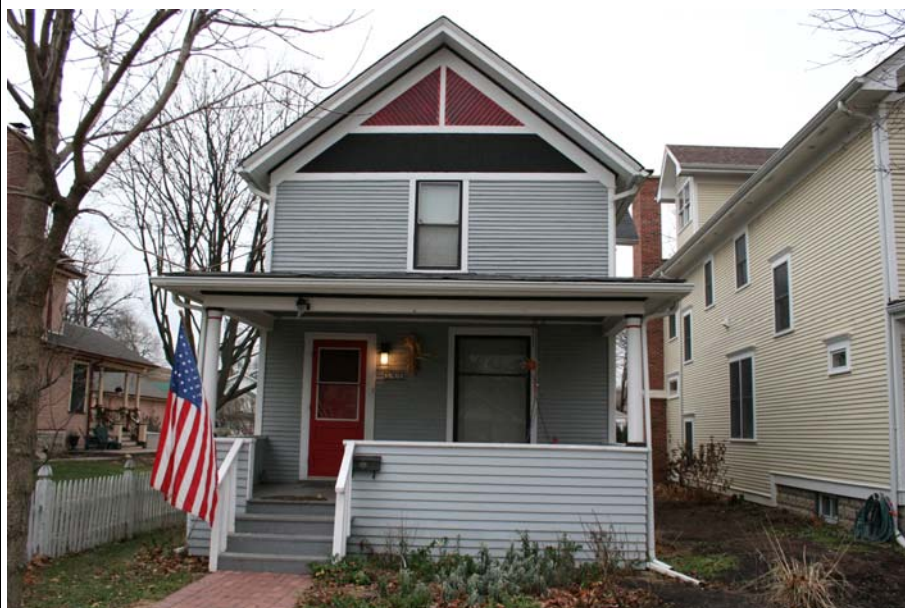
STREET #	144
DIRECTION	N
STREET	ELLSWORTH
SUFFIX	ST
PIN	0818133002
LOCAL SIGNIFICANCE RATING	C
POTENTIAL IND NR? (Y or N)	N
Contributing to a NR DISTRICT?	C
Contributing secondary structure?	-
Listed on existing SURVEY?	Local District; NR District

CATEGORY	building	CURRENT FUNCTION	Domestic - single dwelling
CONDITION	good	HISTORIC FUNCTION	Domestic - single dwelling
INTEGRITY	minor alterations and addition(s)	REASON for SIGNIFICANCE	Solid example of Gable Front vernacular type.
SECONDARY STRUCTURE

ARCHITECTURAL CLASSIFICATION	Gable Front	PLAN	rectangular
DETAILS		NO OF STORIES	2
BEGINYEAR	c. 1880	ROOF TYPE	Front gable
OTHER YEAR		ROOF MATERIAL	Asphalt - shingle
DATESOURCE	surveyor	FOUNDATION	Stone
WALL MATERIAL (current)	Wood	PORCH	Full front
WALL MATERIAL 2 (current)		WINDOW MATERIAL	Wood
WALL MATERIAL (original)	Wood	WINDOW MATERIAL	
WALL MATERIAL 2 (original)		WINDOW TYPE	Double hung/fixed/single h
		WINDOW CONFIG	1/1; 2-light
SIGNIFICANT FEATURES	Front gable roof; 2 story south side gable bay with 1st story cutaway corners; historic 1/1 double and single hung windows; historic porch roof and columns		
ALTERATIONS	Replacement base on porch (historic); replacement siding (historically appropriate); replacement front door (not historic); 2nd story projecting gable addition on north elevation (not historic); two story rear addition (not historic)

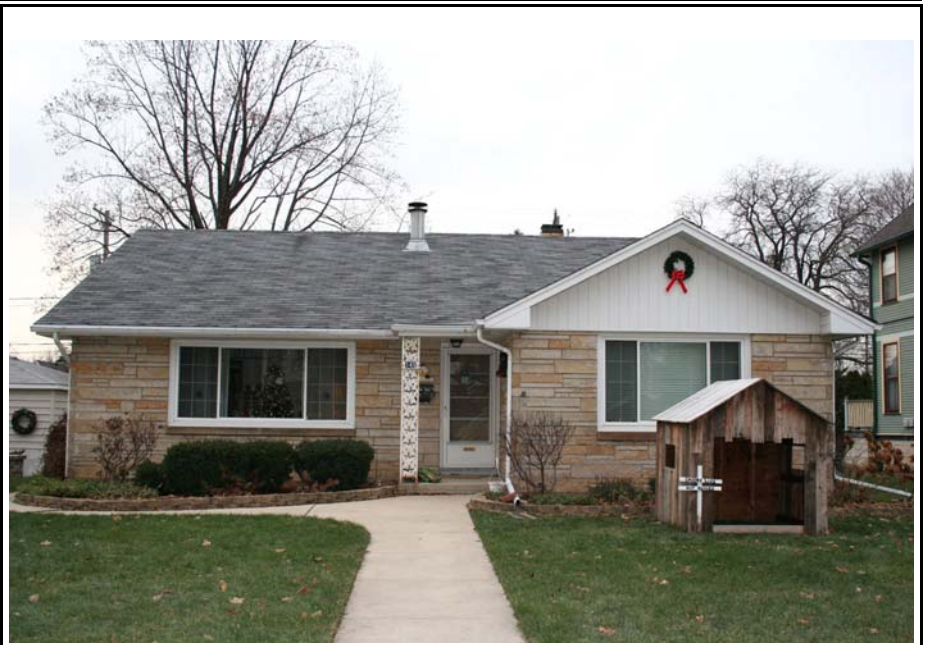
STREET #	145
DIRECTION	N
STREET	ELLSWORTH
SUFFIX	ST
PIN	0818130005
LOCAL SIGNIFICANCE RATING	C
POTENTIAL IND NR? (Y or N)	N
Contributing to a NR DISTRICT?	C
Contributing secondary structure?	-
Listed on existing SURVEY?	Local District; NR District

CATEGORY	building	CURRENT FUNCTION	Domestic - single dwelling
CONDITION	excellent	HISTORIC FUNCTION	Domestic - single dwelling
INTEGRITY	minor alterations	REASON for SIGNIFICANCE	
SECONDARY STRUCTURE

ARCHITECTURAL CLASSIFICATION	Ranch	PLAN	irregular
DETAILS		NO OF STORIES	1
BEGINYEAR	c. 1950	ROOF TYPE	Side gable
OTHER YEAR		ROOF MATERIAL	Asphalt - shingle
DATESOURCE	Surveyor	FOUNDATION	Not visible
WALL MATERIAL (current)	Stone veneer	PORCH	Front entry
WALL MATERIAL 2 (current)	Aluminum	WINDOW MATERIAL	Vinyl
WALL MATERIAL (original)	Stone veneer	WINDOW MATERIAL	
WALL MATERIAL 2 (original)	Wood	WINDOW TYPE	Casement/fixed
		WINDOW CONFIG	Multi-light; 1-light
SIGNIFICANT FEATURES	Side gable roof with lower front gable bay at north end of front façade; stone veneer cladding; front entry porch		
ALTERATIONS	Aluminum awnings; replacement windows in original openings (not historic); aluminum under gables and eaves In kind shingle replacement in areas where small fire occurred (admin. approved COA#18-4656)

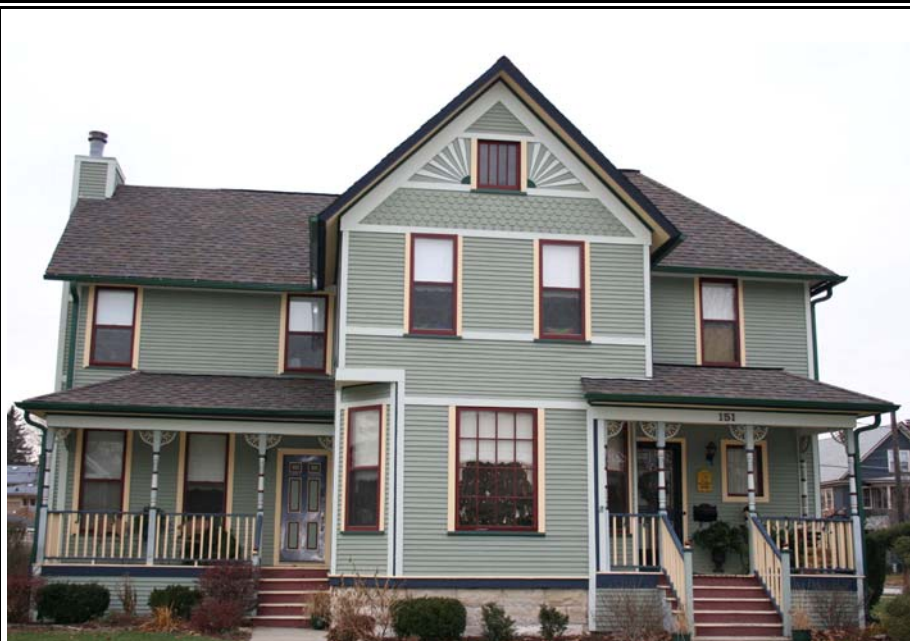
Listed on existing SURVEY? IHSS (O); Local District; NR

CATEGORY	building	CURRENT FUNCTION	Domestic - single dwelling
CONDITION	excellent	HISTORIC FUNCTION	Domestic - single dwelling
INTEGRITY	major alterations and/or addition(s)	REASON for SIGNIFICANCE	Despite alterations, this Queen Anne-style house remains an excellent example of the style within the district.
SECONDARY STRUCTURE	Detached garage

ARCHITECTURAL CLASSIFICATION	Queen Anne	PLAN	irregular
DETAILS		NO OF STORIES	2
BEGINYEAR	1896	ROOF TYPE	Combination
OTHER YEAR		ROOF MATERIAL	Asphalt - shingle
DATESOURCE	Plaque	FOUNDATION	Stone
WALL MATERIAL (current)	Wood	PORCH	Front/side
WALL MATERIAL 2 (current)		WINDOW MATERIAL	Wood
WALL MATERIAL (original)	Wood	WINDOW MATERIAL	
WALL MATERIAL 2 (original)		WINDOW TYPE	double hung/fixed
		WINDOW CONFIG	1/1; multi-light

ALTERATIONS Recent renovation. Appropriate restoration work includes: replacement siding; replacement porch spindles and supports; replacement 1/1 windows; multi-light replacement windows on front bay; north entry porch--SEE CONTINUATION SHEET

Recent renovation. Appropriate restoration work includes: replacement siding; replacement porch spindles and supports; replacement 1/1 windows; multi-light replacement windows on front bay; north entry porch; 1 story rear addition. Inappropriate alterations include glass block basement windows and a large 2-story addition to the south, including entry and porch, which is difficult to distinguish from the original massing of the home.

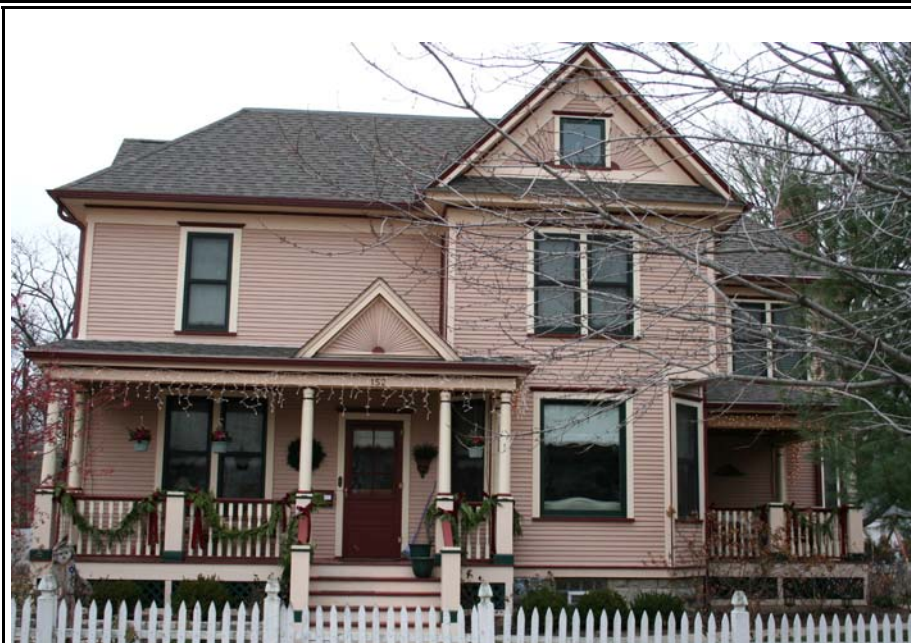
STREET #	152
DIRECTION	N
STREET	ELLSWORTH
SUFFIX	ST
PIN	0818133001
LOCAL SIGNIFICANCE RATING	S
POTENTIAL IND NR? (Y or N)	N
Contributing to a NR DISTRICT?	C
Contributing secondary structure?	NC
Listed on existing SURVEY?	Local District; NR District

CATEGORY	building	CURRENT FUNCTION	Domestic - single dwelling
CONDITION	excellent	HISTORIC FUNCTION	Domestic - single dwelling
INTEGRITY	minor alterations and addition(s)	REASON for SIGNIFICANCE	Despite alterations, this house remains a fine local example of the style.
SECONDARY STRUCTURE	detached garage

ARCHITECTURAL CLASSIFICATION	Queen Anne	PLAN	irregular
DETAILS		NO OF STORIES	2.5
BEGINYEAR	c. 1900	ROOF TYPE	Gable on hip
OTHER YEAR		ROOF MATERIAL	Asphalt - shingle
DATESOURCE	Surveyor	FOUNDATION	Stone
WALL MATERIAL (current)	Wood	PORCH	Full front
WALL MATERIAL 2 (current)		WINDOW MATERIAL	aluminum clad
WALL MATERIAL (original)	Wood	WINDOW MATERIAL	Glass block
WALL MATERIAL 2 (original)		WINDOW TYPE	double hung/fixed
		WINDOW CONFIG	1/1; 1-light
SIGNIFICANT FEATURES	Front gable bay with 1st story cutaway corners; hipped two story north and south (altered) bays; square north window bay; classical wood lintels		
ALTERATIONS	Replacement front porch (appears to be appropriate); replacement windows in original openings (not historic) replacement siding; S. bay extended & S. porch added (not historic); 1 story rear add.; square N window bay add.; north gable window boarded up

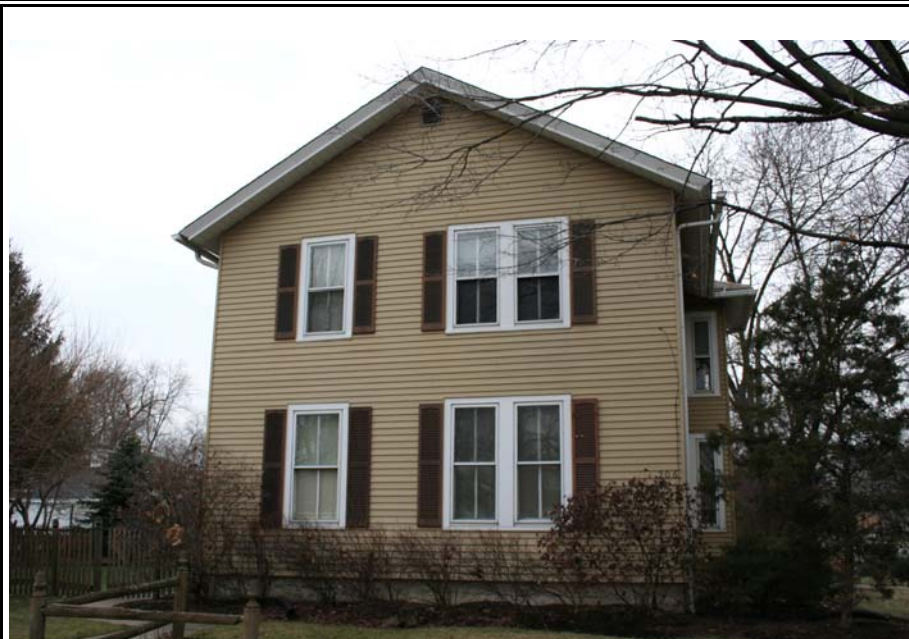
STREET #	206
DIRECTION	N
STREET	ELLSWORTH
SUFFIX	ST
PIN	0818132006
LOCAL SIGNIFICANCE RATING	C
POTENTIAL IND NR? (Y or N)	N
Contributing to a NR DISTRICT?	C
Contributing secondary structure?	-
Listed on existing SURVEY?	Local District; NR District

CATEGORY	building	CURRENT FUNCTION	Domestic - multiple dwelling
CONDITION	Good/fair	HISTORIC FUNCTION	Domestic - single dwelling
INTEGRITY	minor alterations and addition(s)	REASON for SIGNIFICANCE	
SECONDARY STRUCTURE

ARCHITECTURAL CLASSIFICATION	Gable Front	PLAN	irregular
DETAILS	Italianate	NO OF STORIES	2
BEGINYEAR	c. 1870	ROOF TYPE	Front gable
OTHER YEAR		ROOF MATERIAL	Asphalt - shingle
DATESOURCE	Surveyor	FOUNDATION	Stone
WALL MATERIAL (current)	Aluminum	PORCH	Side Entry
WALL MATERIAL 2 (current)		WINDOW MATERIAL	Wood
WALL MATERIAL (original)	Wood	WINDOW MATERIAL	
WALL MATERIAL 2 (original)		WINDOW TYPE	double hung/casement
		WINDOW CONFIG	2/2 vertical; 6-light
SIGNIFICANT FEATURES	Front gable roof; historic 2/2 wood windows; square south two story window bay (early addition); N. side oval window		
ALTERATIONS	Aluminum siding; fixed shutters (not historic); original front entry replaced with window (historic); north entry & porch (not historic); replacement 6-light casement windows (historic)--SEE CONTINUATION SHEET

Aluminum siding; fixed shutters (not historic); original front entry replaced with window (historic); north entry & porch (not historic); replacement 6-light casement windows (historic); 2 story north addition (historic); south side porch extended (historic) & enclosed; 1 story rear addition (historic); rear exterior stair (not historic)

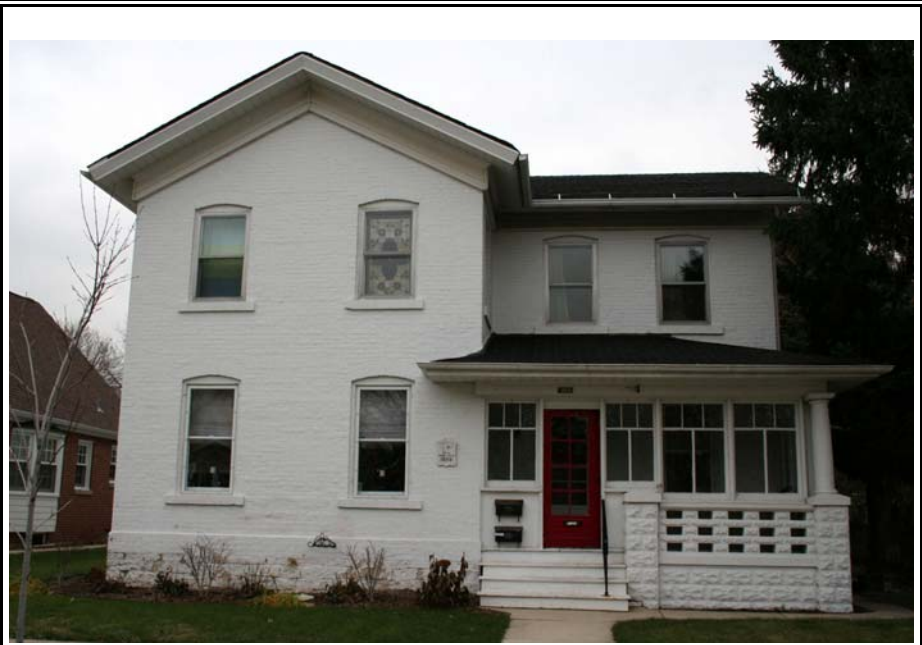
STREET #	214
DIRECTION	N
STREET	ELLSWORTH
SUFFIX	ST
PIN	0818132005
LOCAL SIGNIFICANCE RATING	PS
POTENTIAL IND NR? (Y or N)	N
Contributing to a NR DISTRICT?	C
Contributing secondary structure?	NC
Listed on existing SURVEY?	Local District; NR District

CATEGORY	building	CURRENT FUNCTION	Domestic - multiple dwelling
CONDITION	good	HISTORIC FUNCTION	Domestic - single dwelling
INTEGRITY	minor alterations and addition(s)	REASON for SIGNIFICANCE	Rare brick example of this vernacular type.
SECONDARY STRUCTURE	detached garage

ARCHITECTURAL CLASSIFICATION	L-Form	PLAN	irregular
DETAILS		NO OF STORIES	2
BEGINYEAR	1869	ROOF TYPE	Front gable
OTHER YEAR		ROOF MATERIAL	Asphalt - shingle
DATESOURCE	Plaque	FOUNDATION	Stone
WALL MATERIAL (current)	Brick	PORCH	Front
WALL MATERIAL 2 (current)	aluminum	WINDOW MATERIAL	Vinyl
WALL MATERIAL (original)	Brick	WINDOW MATERIAL	
WALL MATERIAL 2 (original)		WINDOW TYPE	Double hung/storm
		WINDOW CONFIG	1/1; 1-light
SIGNIFICANT FEATURES	Two story front gable bay with south side gable wing; segmental arch window openings with soldier course lintels, wide frieze board, concrete block entry porch addition with hipped roof, concrete block piers & knee walls, wood columns		
ALTERATIONS	Brick painted; two story rear addition; replacement porch (later enclosed--historic); replacement windows in slightly downsized openings (not historic); 1 story rear addition; Aluminum frieze (not historic)

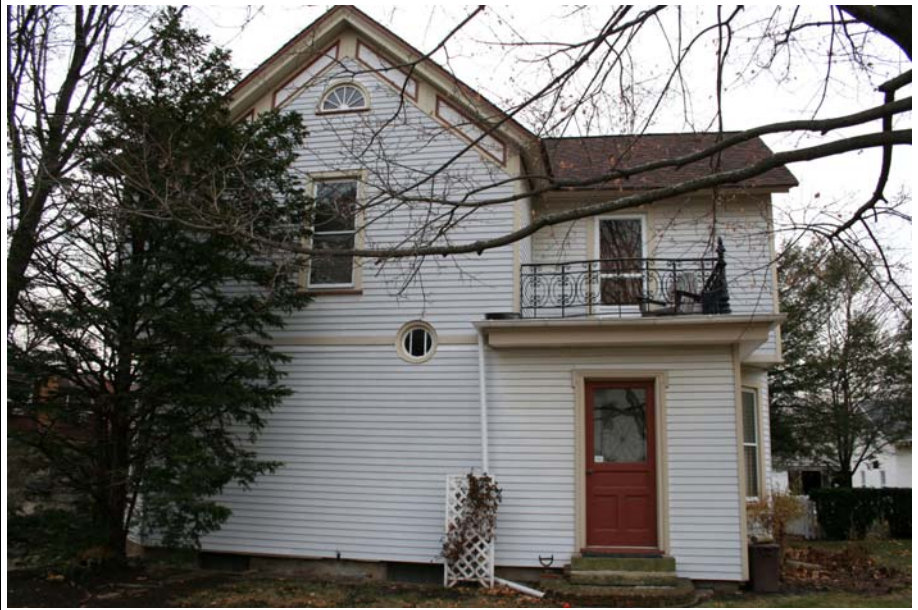
STREET #	215
DIRECTION	N
STREET	ELLSWORTH
SUFFIX	ST
PIN	0818129010
LOCAL SIGNIFICANCE RATING	C
POTENTIAL IND NR? (Y or N)	N
Contributing to a NR DISTRICT?	C
Contributing secondary structure?	NC
Listed on existing SURVEY?	Local District; NR District

CATEGORY	building	CURRENT FUNCTION	Domestic - single dwelling
CONDITION	good	HISTORIC FUNCTION	Domestic - single dwelling
INTEGRITY	major alterations and/or addition(s)	REASON for SIGNIFICANCE	
SECONDARY STRUCTURE	Detached garage

ARCHITECTURAL CLASSIFICATION	Queen Anne (altered)	PLAN	irregular
DETAILS		NO OF STORIES	2
BEGINYEAR	c. 1880	ROOF TYPE	Multi-gable
OTHER YEAR		ROOF MATERIAL	Asphalt - shingle
DATESOURCE	Surveyor	FOUNDATION	Stone
WALL MATERIAL (current)	Aluminum	PORCH	
WALL MATERIAL 2 (current)		WINDOW MATERIAL	Wood
WALL MATERIAL (original)	Wood	WINDOW MATERIAL	
WALL MATERIAL 2 (original)		WINDOW TYPE	double hung/casement
		WINDOW CONFIG	1/1; 1-light
SIGNIFICANT FEATURES	Front gable; south side gable with 1st story cutaway corners; recessed north side 2 story bay w/ 1st story cutaway corners; some historic 1/1 windows on original massing		
ALTERATIONS	Original house obscured by multiple alterations--aluminum siding; 1st story front entry addition (not historic); 2 story rear addition; 1 story south side addition; wrought iron over entry---SEE CONTINUATION SHEET

Original house obscured by multiple alterations--aluminum siding; 1st story front entry addition (not historic); 2 story rear addition (not historic--abuts historic north side bay with 1st story cutaway corners); 1 story south/rear addition (historic-built between 1926 and 1943); wrought iron over entry; round front window (original front 1st story windows covered up); replacement window on 2nd story of north elevation; south side toward rear covered in stone veneer, wrought iron railing and floor-to-ceiling fixed windows & door on 2nd story of south side (toward rear)

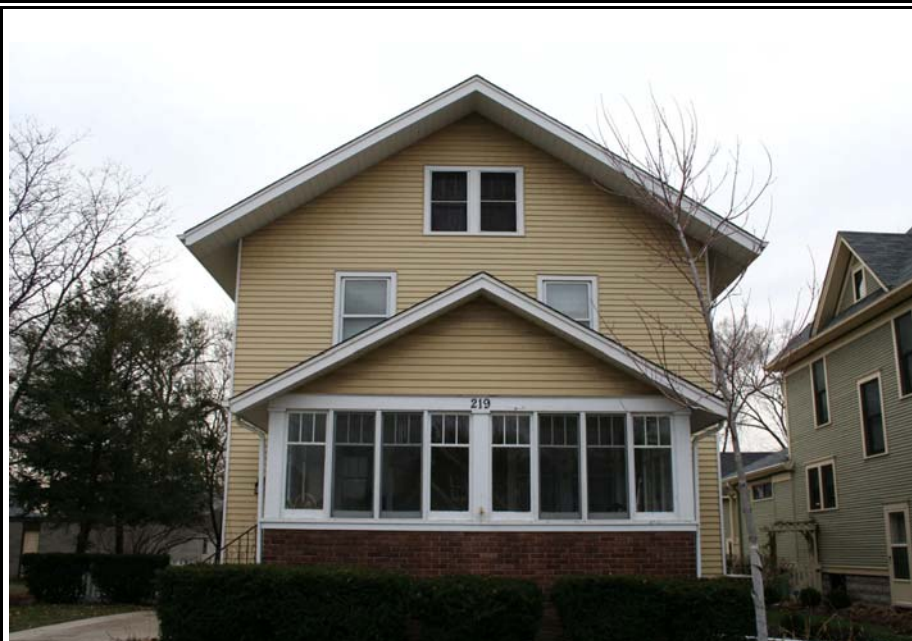
STREET #	219
DIRECTION	N
STREET	ELLSWORTH
SUFFIX	ST
PIN	0818129009
LOCAL SIGNIFICANCE RATING	C
POTENTIAL IND NR? (Y or N)	N
Contributing to a NR DISTRICT?	C
Contributing secondary structure?	C
Listed on existing SURVEY?	Local District; NR District

CATEGORY	building	CURRENT FUNCTION	Domestic - single dwelling
CONDITION	good	HISTORIC FUNCTION	Domestic - single dwelling
INTEGRITY	minor alterations	REASON for SIGNIFICANCE	
SECONDARY STRUCTURE	detached garage

ARCHITECTURAL CLASSIFICATION	Craftsman	PLAN	rectangular
DETAILS		NO OF STORIES	2.5
BEGINYEAR	c. 1915	ROOF TYPE	Front gable
OTHER YEAR		ROOF MATERIAL	Asphalt - shingle
DATESOURCE	Surveyor	FOUNDATION	Concrete
WALL MATERIAL (current)	Aluminum	PORCH	Front
WALL MATERIAL 2 (current)		WINDOW MATERIAL	Wood
WALL MATERIAL (original)	Unknown	WINDOW MATERIAL	
WALL MATERIAL 2 (original)		WINDOW TYPE	double hung/casement/sto
		WINDOW CONFIG	3/1; 1/1; 4-light; 1-light
SIGNIFICANT FEATURES	Broad front gable roof; front gable porch with brick knee walls (enclosed); historic 3/1 wood windows under gable		
ALTERATIONS	Historic 1/1 and 1-light casement window replacements in original openings; Aluminum siding; rear/south entry and porch addition; 2 story rear addition

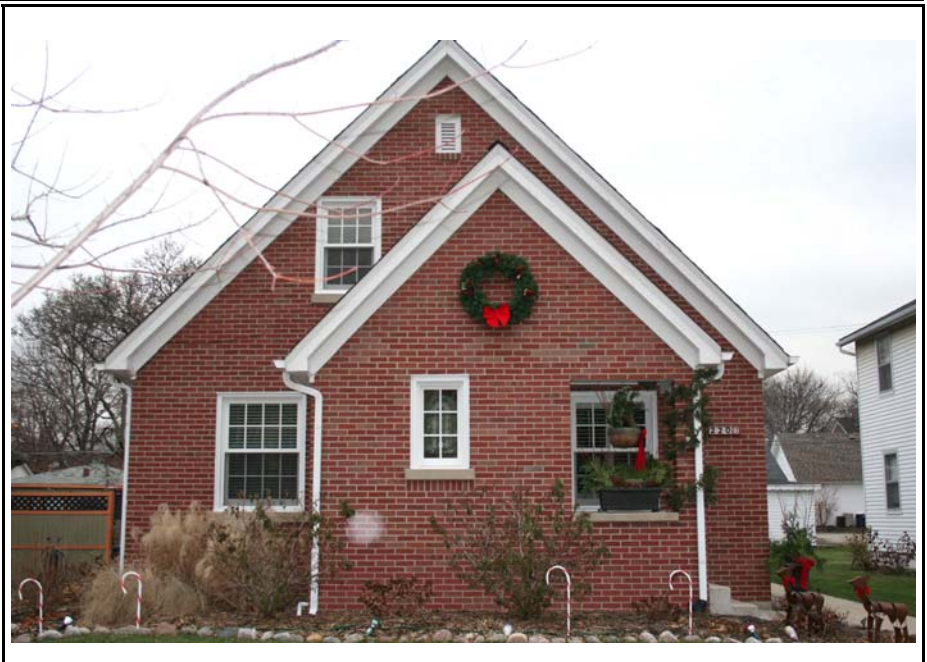
STREET #	220
DIRECTION	N
STREET	ELLSWORTH
SUFFIX	ST
PIN	0818132004
LOCAL SIGNIFICANCE RATING	C
POTENTIAL IND NR? (Y or N)	N
Contributing to a NR DISTRICT?	C
Contributing secondary structure?	NC
Listed on existing SURVEY?	Local District; NR District

CATEGORY	building	CURRENT FUNCTION	Domestic - single dwelling
CONDITION	excellent	HISTORIC FUNCTION	Domestic - single dwelling
INTEGRITY	minor alterations	REASON for SIGNIFICANCE	
SECONDARY STRUCTURE	Detached garage

ARCHITECTURAL CLASSIFICATION	Bungalow	PLAN	rectangular
DETAILS	Tudor Revival	NO OF STORIES	1.5
BEGINYEAR	c. 1930	ROOF TYPE	Front gable
OTHER YEAR		ROOF MATERIAL	Asphalt - shingle
DATESOURCE	surveyor	FOUNDATION	Concrete
WALL MATERIAL (current)	Brick	PORCH	Front entry
WALL MATERIAL 2 (current)		WINDOW MATERIAL	Aluminum clad
WALL MATERIAL (original)	Brick	WINDOW MATERIAL	Glass block
WALL MATERIAL 2 (original)		WINDOW TYPE	double hung/casement
		WINDOW CONFIG	6/6; 8/8; 6-light
SIGNIFICANT FEATURES	Front gable roof with one story front gable bay; inset front entry porch in bay		
ALTERATIONS	Replacement windows in original openings (not historic); 3-sided window bay addition on south side (not historic)

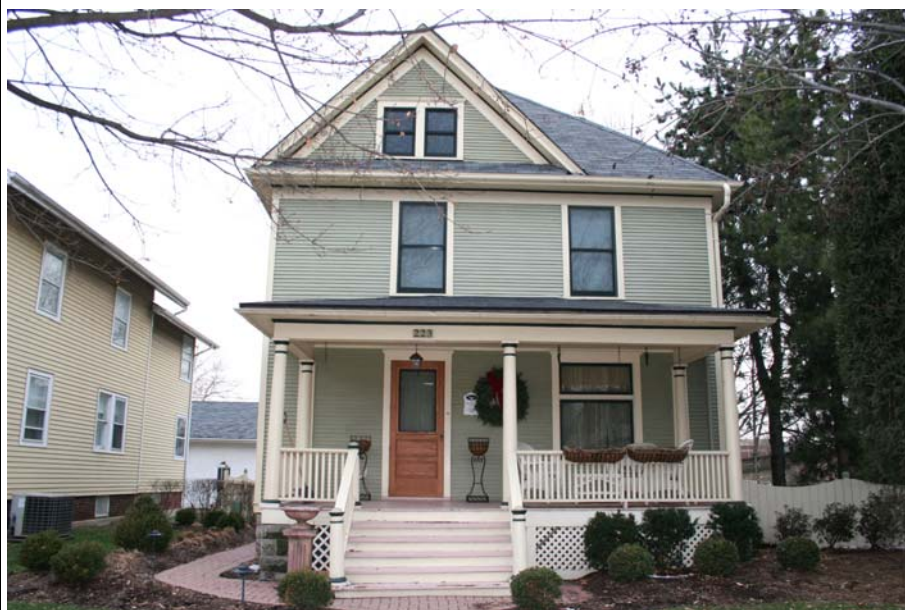
STREET #	223
DIRECTION	N
STREET	ELLSWORTH
SUFFIX	ST
PIN	0818129008
LOCAL SIGNIFICANCE RATING	S
POTENTIAL IND NR? (Y or N)	N
Contributing to a NR DISTRICT?	C
Contributing secondary structure?	C
Listed on existing SURVEY?	Local District; NR District; N

CATEGORY	building	CURRENT FUNCTION	Domestic - single dwelling
CONDITION	excellent	HISTORIC FUNCTION	Domestic - single dwelling
INTEGRITY	minor alterations and addition(s)	REASON for SIGNIFICANCE	Fine, intact example of early 20th-century combination of the American Foursquare and Queen Anne - Free Classic styles.
SECONDARY STRUCTURE	Carriage house

ARCHITECTURAL CLASSIFICATION	American Foursquare	PLAN	rectangular
DETAILS	Queen Anne - Free Classic	NO OF STORIES	2.5
BEGINYEAR	1908	ROOF TYPE	Gable on hip
OTHER YEAR		ROOF MATERIAL	Asphalt - shingle
DATESOURCE	Plaque	FOUNDATION	Concrete - block
WALL MATERIAL (current)	Wood	PORCH	Full front
WALL MATERIAL 2 (current)		WINDOW MATERIAL	Aluminum clad
WALL MATERIAL (original)	Wood	WINDOW MATERIAL	
WALL MATERIAL 2 (original)		WINDOW TYPE	double hung/fixed
		WINDOW CONFIG	1/1; 2-light
SIGNIFICANT FEATURES	Gable on hip roof; full front porch with rounded columns; 2 story north 3-sided bay with pent gable roof; north hipped dormer; historic wood cladding		
ALTERATIONS	Replacement 1/1 windows in original openings (not historic--appropriate configuration); 1 story rear addition (1999)

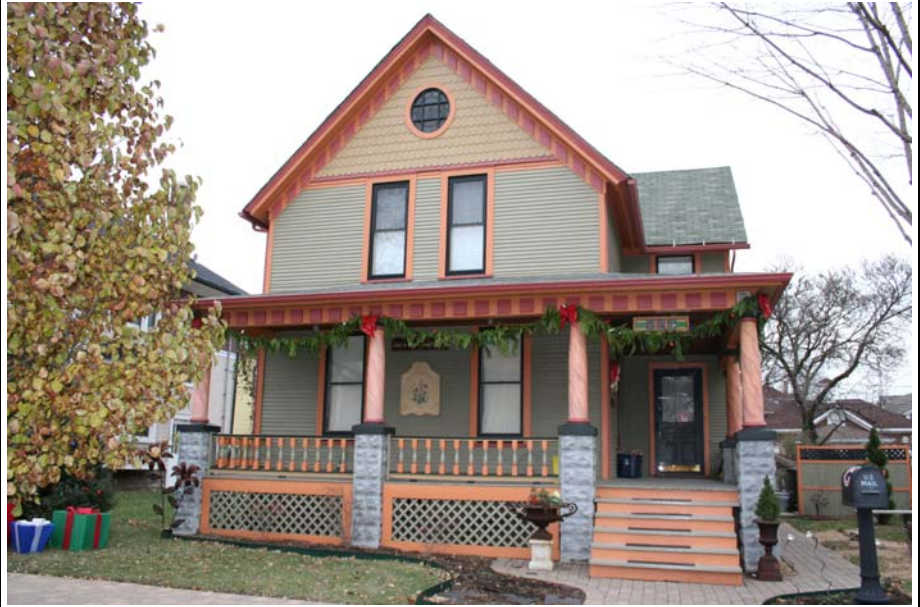
STREET #	224
DIRECTION	N
STREET	ELLSWORTH
SUFFIX	ST
PIN	0818132003
LOCAL SIGNIFICANCE RATING	C
POTENTIAL IND NR? (Y or N)	N
Contributing to a NR DISTRICT?	C
Contributing secondary structure?	C
Listed on existing SURVEY?	Local District; NR District

CATEGORY	building	CURRENT FUNCTION	Domestic - single dwelling
CONDITION	excellent	HISTORIC FUNCTION	Domestic - single dwelling
INTEGRITY	minor alterations and addition(s)	REASON for SIGNIFICANCE	
SECONDARY STRUCTURE	Detached garage

ARCHITECTURAL CLASSIFICATION	Gabled Ell	PLAN	rectangular
DETAILS		NO OF STORIES	2.5
BEGINYEAR	c. 1900	ROOF TYPE	Front gable
OTHER YEAR		ROOF MATERIAL	Asphalt - shingle
DATESOURCE	surveyor	FOUNDATION	Stone
WALL MATERIAL (current)	Wood	PORCH	Wrap around
WALL MATERIAL 2 (current)	Wood - shingle	WINDOW MATERIAL	Wood
WALL MATERIAL (original)	Wood	WINDOW MATERIAL	Vinyl
WALL MATERIAL 2 (original)	Wood - shingle	WINDOW TYPE	double hung
		WINDOW CONFIG	1/1; 9/9
SIGNIFICANT FEATURES	Two story front gable bay and S. side ell; historic 1/1 wood windows on first story		
ALTERATIONS	Wrap around front porch with new concrete blk piers(not historic); replacement windows in original openings on 2nd story (not historic); replacement siding; stained glass replacement window on north side and under front gable; 1 story rear porch addition
