STREET #	619
DIRECTION	E
STREET	FRANKLIN
SUFFIX	AV
PIN	
LOCAL SIGNIFICANCE RATING	PS
POTENTIAL IND NR? (Y or N)	N
Contributing to a NR DISTRICT?	C
Contributing secondary structure?	-
Listed on existing SURVEY?

619 E FRANKLIN

City of NAPERVILLE
ILLINOIS URBAN ARCHITECTURAL AND HISTORICAL SURVEY
CONTINUATION SHEET

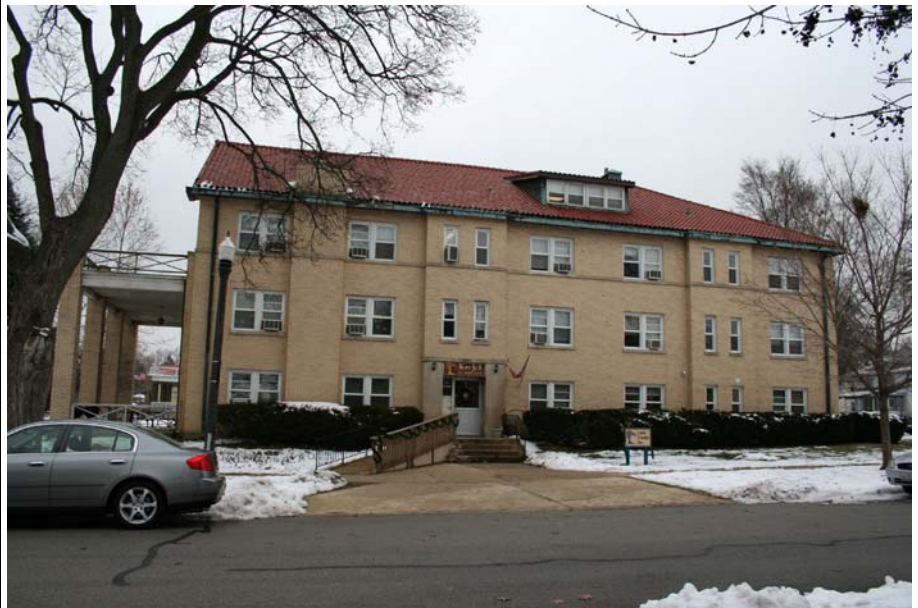
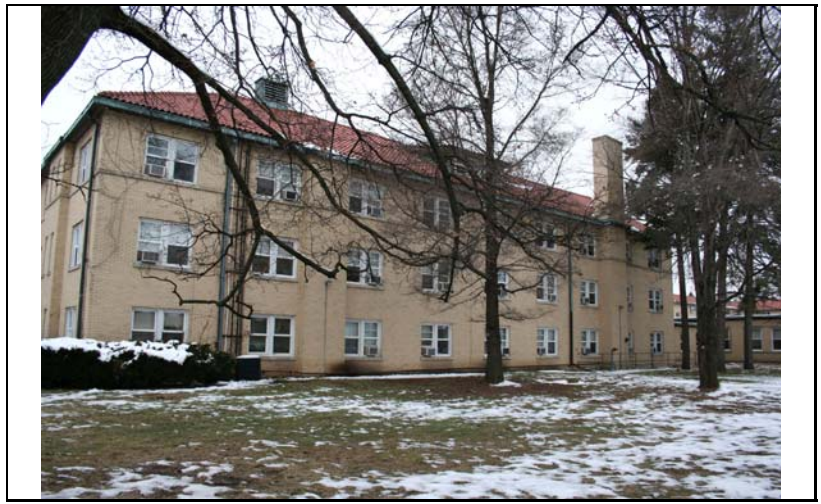
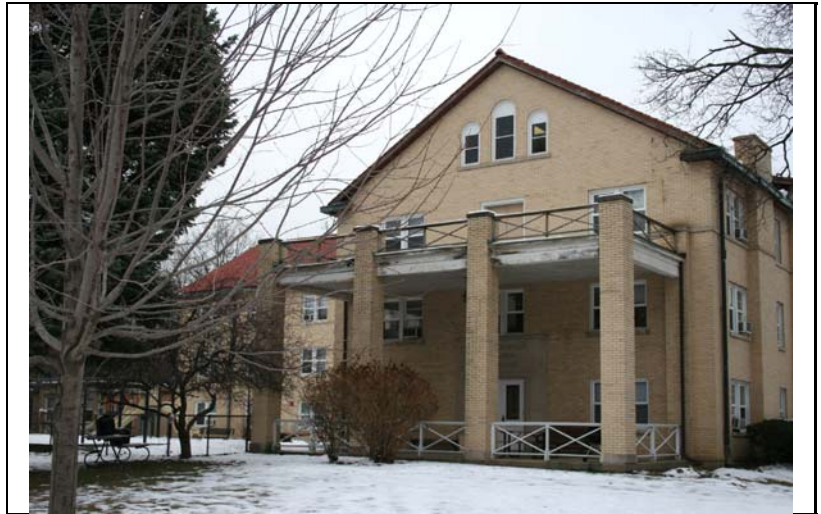
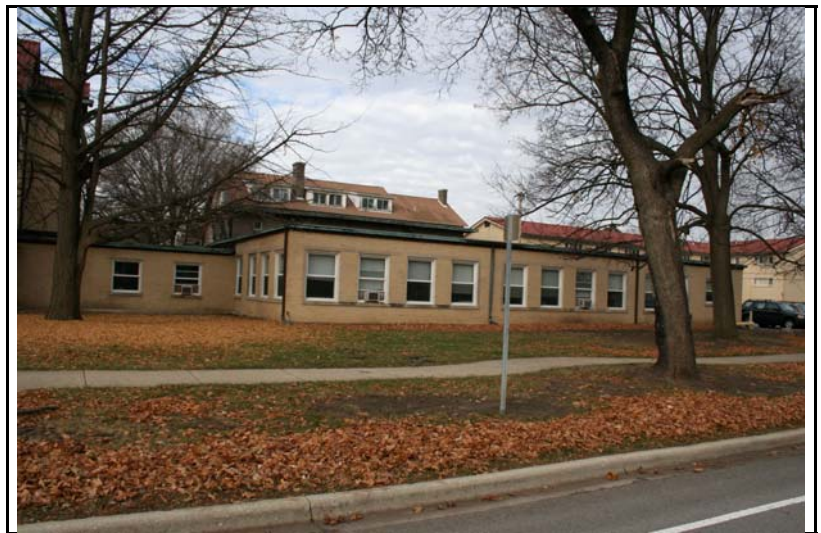
CATEGORY	building	CURRENT FUNCTION	Education - school
CONDITION	good	HISTORIC FUNCTION	Education - education-related
INTEGRITY	minor alterations and addition(s)	REASON for SIGNIFICANCE	This Italian Renaissance Revival building originally served as a dormitory for North Central College.
SECONDARY STRUCTURE

ARCHITECTURAL CLASSIFICATION	Italian Renaissance Revival	PLAN	irregular
DETAILS		NO OF STORIES	3
BEGINYEAR	c. 1930	ROOF TYPE	Combination
OTHER YEAR		ROOF MATERIAL	Ceramic Tile
DATESOURCE	Surveyor/Sanborn	FOUNDATION	Concrete
WALL MATERIAL (current)	Brick	PORCH	West Side
WALL MATERIAL 2 (current)		WINDOW MATERIAL	Vinyl
WALL MATERIAL (original)	Brick	WINDOW MATERIAL	
WALL MATERIAL 2 (original)		WINDOW TYPE	double hung
		WINDOW CONFIG	1/1
SIGNIFICANT FEATURES	Ceramic tile roof with copper gutters; blonde brick exterior with concrete stringcourse at 3rd story sill level; 2-story porch with flat roof and square brick columns; fluted concrete surround at south side entry; shed dormer on south elevation		
ALTERATIONS	Replacement windows in original openings; replacement doors; large 1 story rear addition connected to 26 N. Wright building

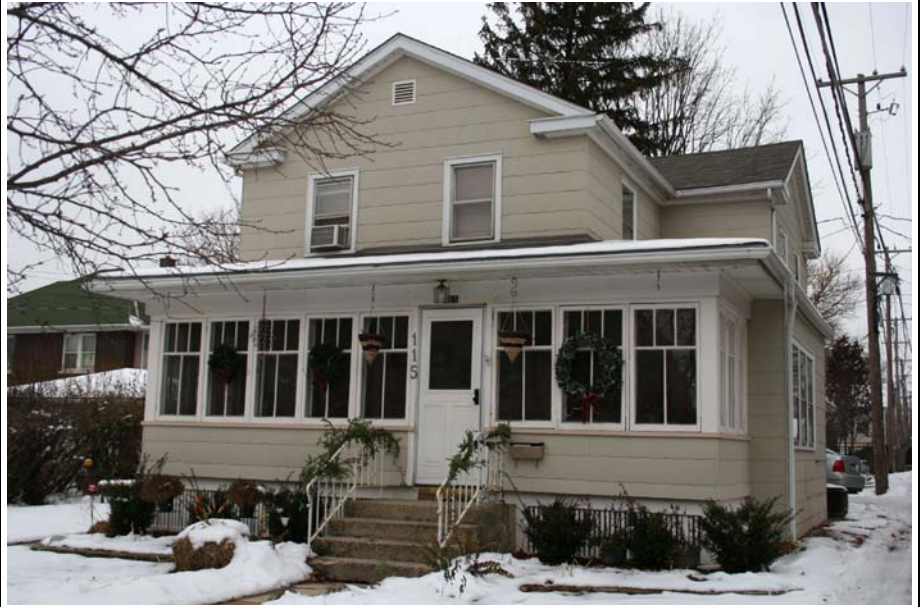
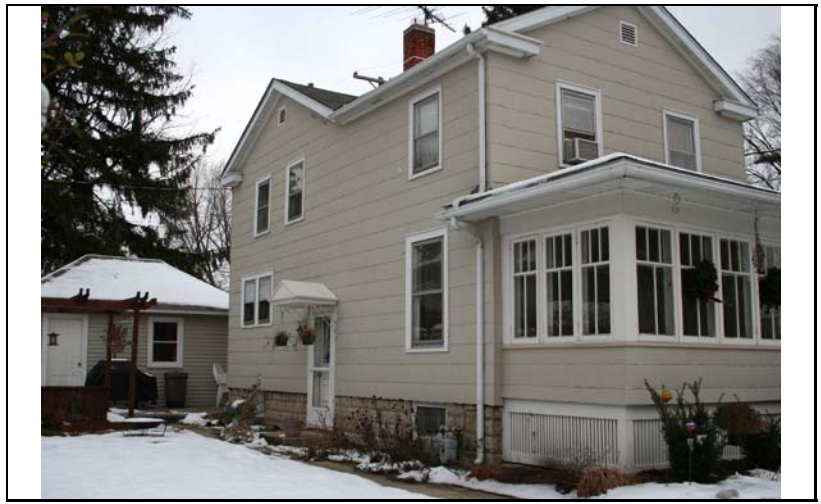
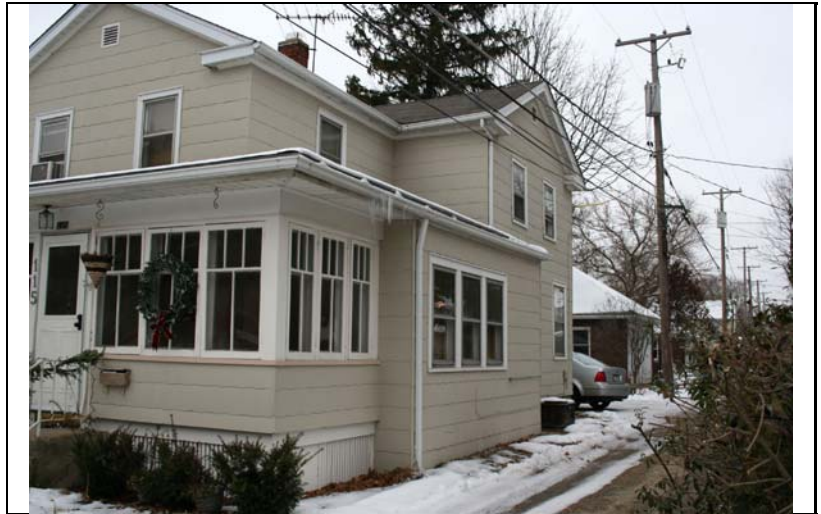
115 E FRANKLIN

CATEGORY	building	CURRENT FUNCTION	Domestic - single dwelling
CONDITION	good	HISTORIC FUNCTION	Domestic - single dwelling
INTEGRITY	minor alterations and addition(s)	REASON for SIGNIFICANCE	
SECONDARY STRUCTURE	Detached garage

ARCHITECTURAL CLASSIFICATION	Gabled Ell	PLAN	L
DETAILS		NO OF STORIES	2
BEGINYEAR	c. 1865	ROOF TYPE	Multi-gable
OTHER YEAR		ROOF MATERIAL	Asphalt - shingle
DATESOURCE	Surveyor	FOUNDATION	Concrete - block
WALL MATERIAL (current)	Asbestos shingle	PORCH	Wrap around
WALL MATERIAL 2 (current)		WINDOW MATERIAL	Wood
WALL MATERIAL (original)	Wood	WINDOW MATERIAL	
WALL MATERIAL 2 (original)		WINDOW TYPE	Double hung/casement/sto
		WINDOW CONFIG	1/1; 2-light; 5-light
SIGNIFICANT FEATURES	Front gable bay; 2 story east side ell with cornice returns		
ALTERATIONS	Replacement siding (1950s); Aluminum under eaves; wraparound front porch enclosed (historic); 1 story east side addition (may be historic); replacement windows in original openings (historic); concrete front steps (not historic)

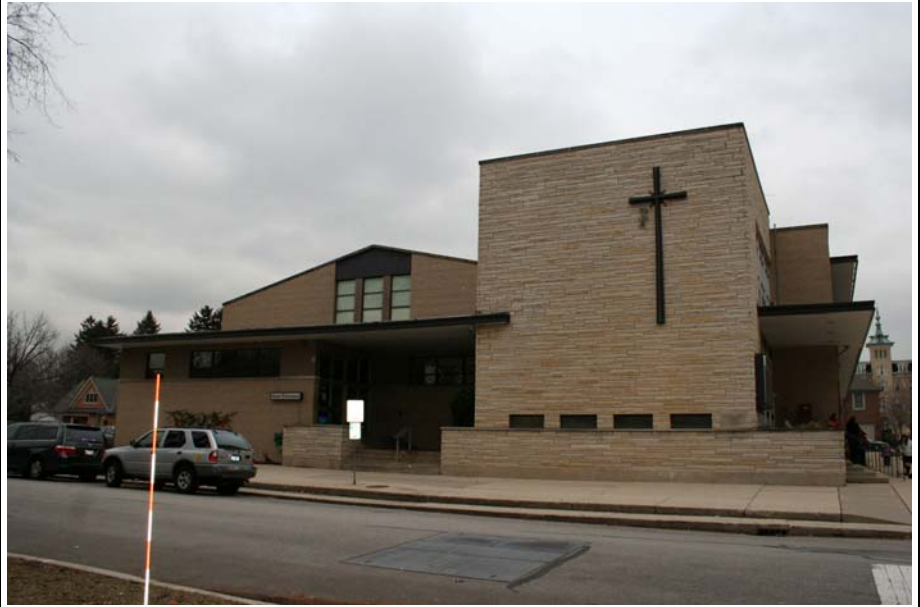
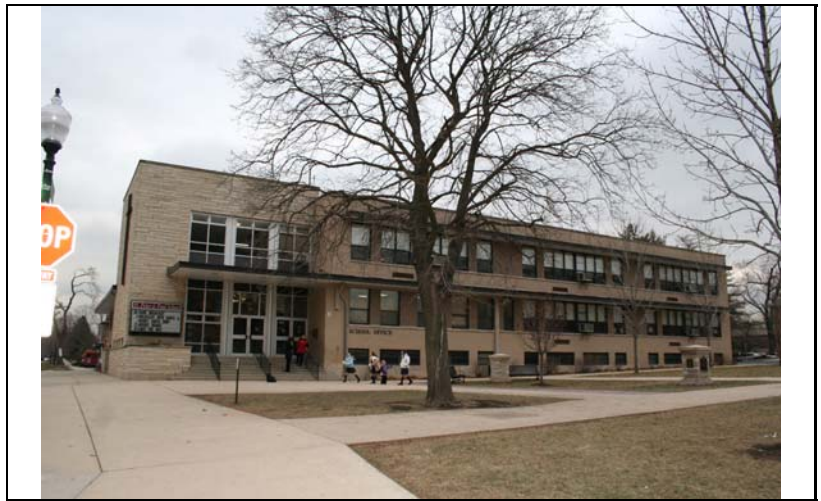
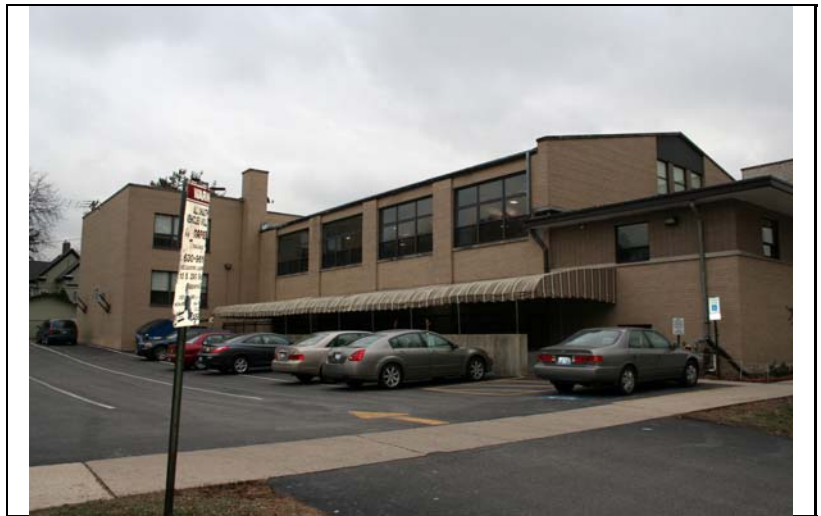
201 E FRANKLIN

CATEGORY	building	CURRENT FUNCTION	Education - school
CONDITION	excellent	HISTORIC FUNCTION	Education - school
INTEGRITY	not altered	REASON for SIGNIFICANCE	
SECONDARY STRUCTURE

ARCHITECTURAL CLASSIFICATION	Contemporary	PLAN	irregular
DETAILS		NO OF STORIES	2
BEGINYEAR	c. 1960	ROOF TYPE	Combination
OTHER YEAR		ROOF MATERIAL	Not visible
DATESOURCE	Surveyor	FOUNDATION	Concrete
WALL MATERIAL (current)	Stone veneer	PORCH	Entry
WALL MATERIAL 2 (current)	Brick	WINDOW MATERIAL	Metal
WALL MATERIAL (original)	Stone veneer	WINDOW MATERIAL	
WALL MATERIAL 2 (original)	Brick	WINDOW TYPE	fixed/hopper
SIGNIFICANT FEATURES			
ALTERATIONS

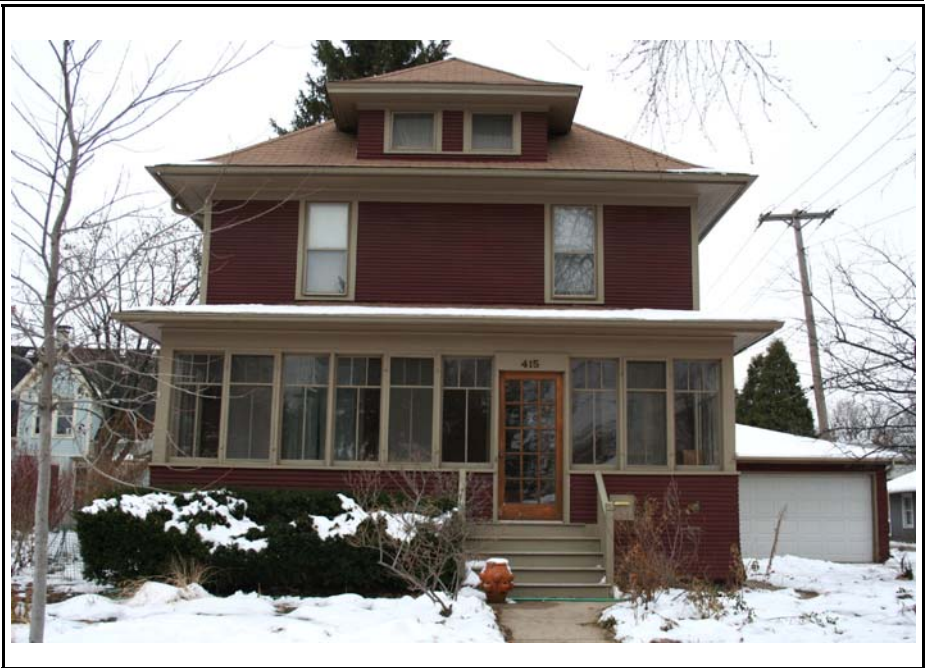
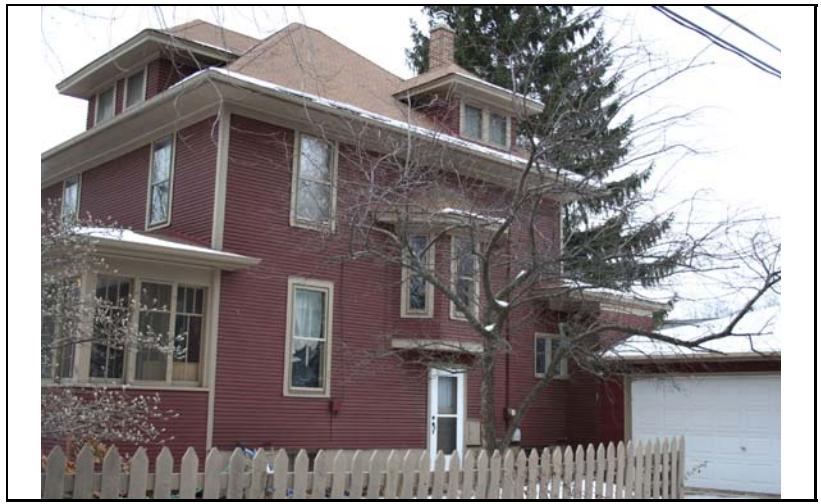
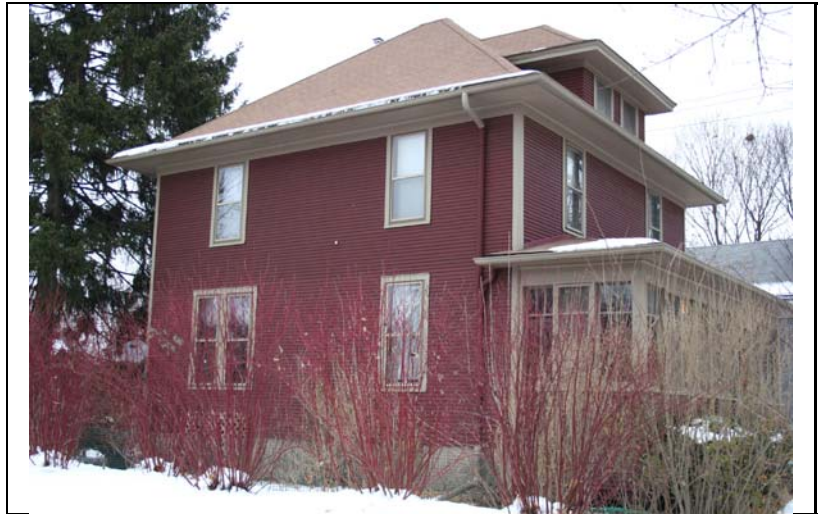
415 E FRANKLIN

CATEGORY	building	CURRENT FUNCTION	Domestic - single dwelling
CONDITION	excellent	HISTORIC FUNCTION	Domestic - single dwelling
INTEGRITY	minor alterations and addition(s)	REASON for SIGNIFICANCE	Good, intact example of American Foursquare type.
SECONDARY STRUCTURE

ARCHITECTURAL CLASSIFICATION	American Foursquare	PLAN	Rectangular
DETAILS		NO OF STORIES	2.5
BEGINYEAR	c. 1915	ROOF TYPE	Hipped
OTHER YEAR		ROOF MATERIAL	Asphalt - shingle
DATESOURCE	Surveyor	FOUNDATION	Concrete - block
WALL MATERIAL (current)	Wood	PORCH	Full front enclosed
WALL MATERIAL 2 (current)		WINDOW MATERIAL	Wood
WALL MATERIAL (original)	Wood	WINDOW MATERIAL	
WALL MATERIAL 2 (original)		WINDOW TYPE	Double & single hung; hop
		WINDOW CONFIG	1/1; 1-light; 5-light
SIGNIFICANT FEATURES	Fared hipped roof with front and east side hipped roof dormers; hipped roof front porch enclosed with historic 5-light casement windows; historic 1/1 and 1-light wood windows		
ALTERATIONS	Replacement front door and steps (not historic); connector addition to rear garage (not historic) Rebuild & change pitch of roof, rebuild existing dormers, creation of new window openings on north, south, & west elevations, replacement of several existing windows and doors, construction of a 2 story addition and a 2nd story addition (HPC approved COA#15-228)

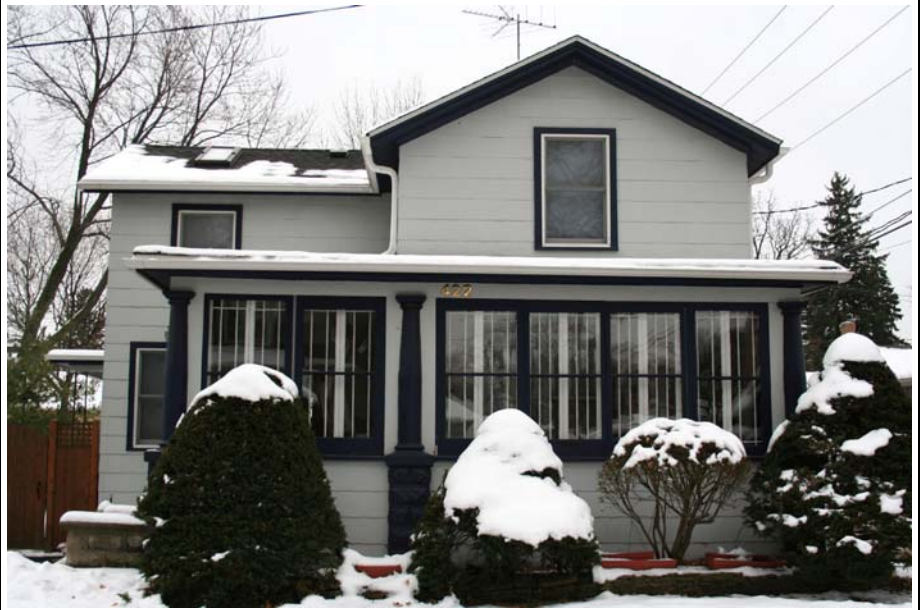
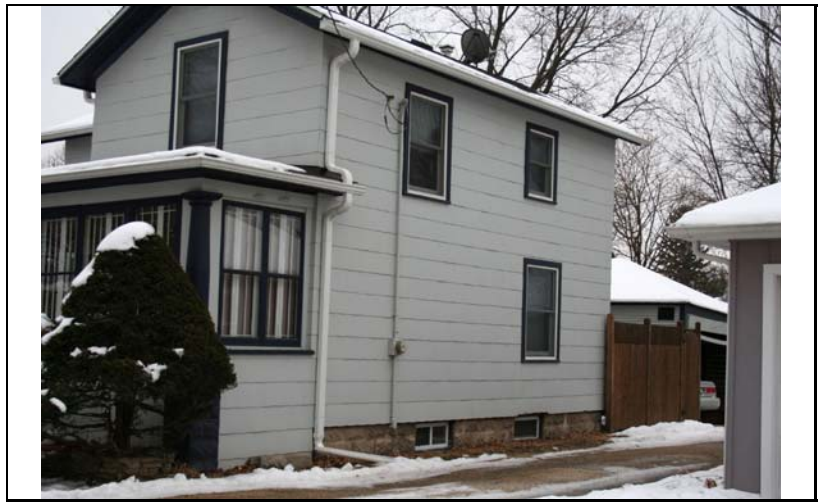
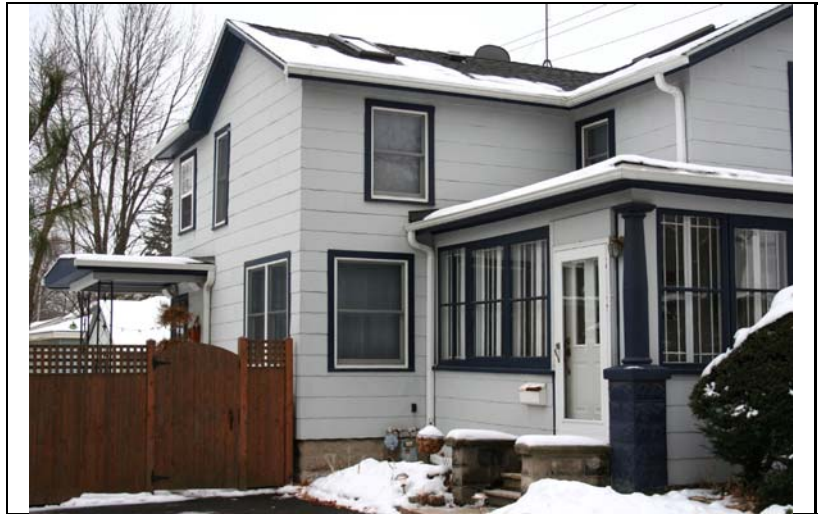
422 E FRANKLIN

Replacement siding (not historic); front porch extended & later enclosed (historic); replacement windows in altered opening on wing (not historic); front porch enclosed with 9-light casement windows (c. 1925); 2 story rear addition; east side entry porch (c. 1950); skylights

CATEGORY	building	CURRENT FUNCTION	Domestic - single dwelling
CONDITION	good	HISTORIC FUNCTION	Domestic - single dwelling
INTEGRITY	minor alterations and addition(s)	REASON for SIGNIFICANCE	
SECONDARY STRUCTURE	Detached garage

ARCHITECTURAL CLASSIFICATION	L-Form	PLAN	L
DETAILS		NO OF STORIES	2
BEGINYEAR	c. 1870	ROOF TYPE	Front gable
OTHER YEAR		ROOF MATERIAL	Asphalt - shingle
DATESOURCE	Surveyor	FOUNDATION	Concrete - block
WALL MATERIAL (current)	Wood - shingle	PORCH	Front
WALL MATERIAL 2 (current)		WINDOW MATERIAL	Vinyl
WALL MATERIAL (original)	Wood	WINDOW MATERIAL	Wood
WALL MATERIAL 2 (original)		WINDOW TYPE	double hung/casement
		WINDOW CONFIG	1/1; 9-light
SIGNIFICANT FEATURES	Front gable west bay with lower side gable wing		
ALTERATIONS	Replacement siding (not historic); front porch extended & later enclosed (historic); replacement windows in altered opening on wing (not historic); front porch enclosed with 9-light casement windows (c. 1925)---SEE CONTINUATION SHEET Variance for detached garage (HPC approved COA#19-29)

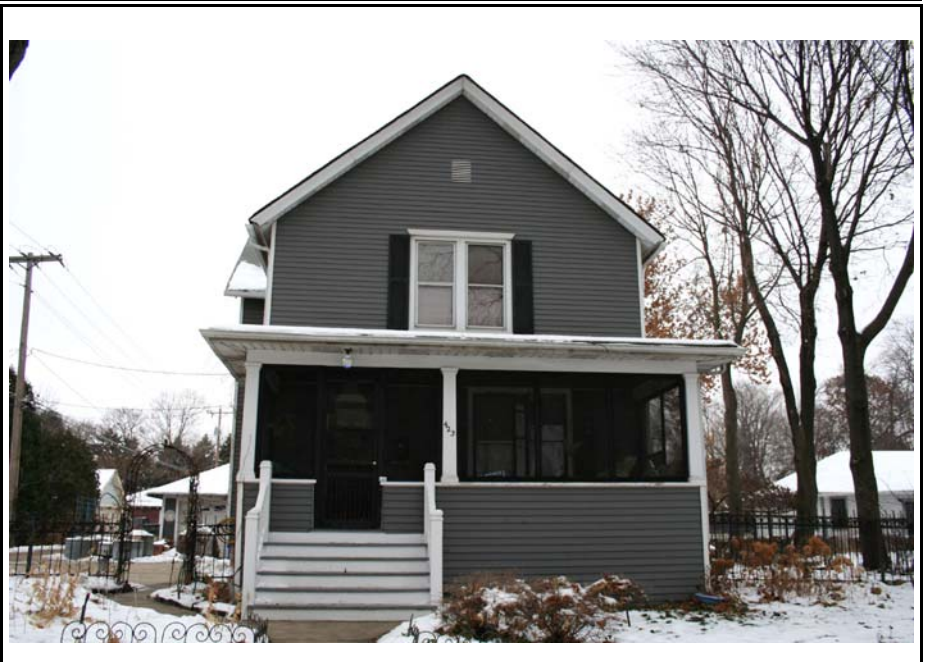
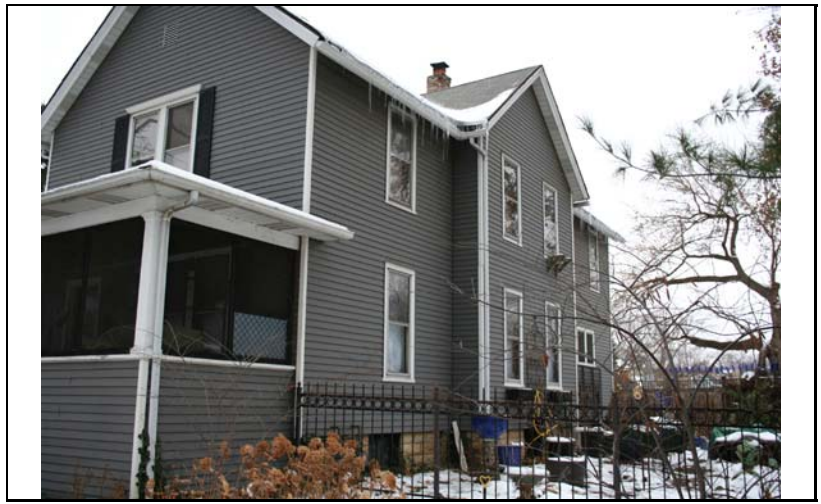
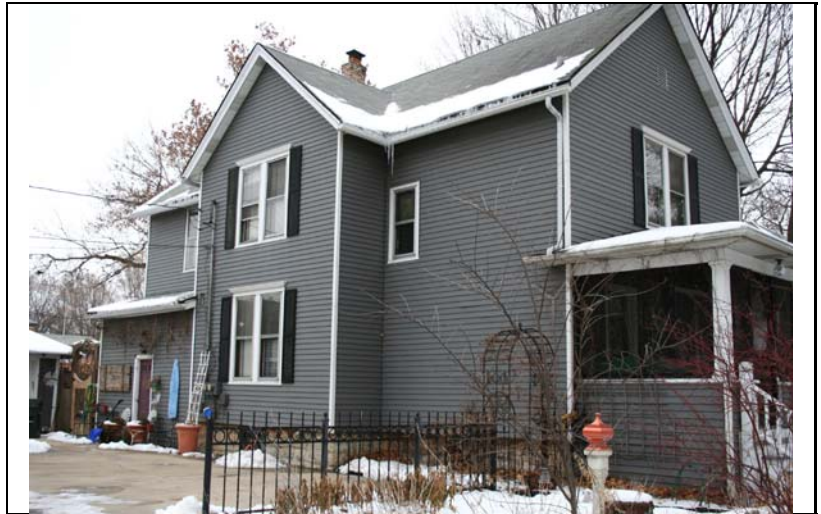
CATEGORY	building	CURRENT FUNCTION	Domestic - single dwelling
CONDITION	good	HISTORIC FUNCTION	Domestic - single dwelling
INTEGRITY	minor alterations and addition(s)	REASON for SIGNIFICANCE	Good turn-of-the-century example of the Gable Front vernacular type.
SECONDARY STRUCTURE	Detached garage

ARCHITECTURAL CLASSIFICATION	Gable Front	PLAN	rectangular
DETAILS		NO OF STORIES	2
BEGINYEAR	c. 1900	ROOF TYPE	Front gable
OTHER YEAR		ROOF MATERIAL	Asphalt - shingle
DATESOURCE	Surveyor	FOUNDATION	Stone
WALL MATERIAL (current)	Vinyl	PORCH	Full front screened
WALL MATERIAL 2 (current)		WINDOW MATERIAL	Wood
WALL MATERIAL (original)	Wood	WINDOW MATERIAL	
WALL MATERIAL 2 (original)		WINDOW TYPE	double hung
		WINDOW CONFIG	1/1
SIGNIFICANT FEATURES	Front gable bay with 2 story side gable bays; classical lintels over paired windows; historic 1/1 wood windows; historic front porch structure with square columns		
ALTERATIONS	Aluminum under eaves; vinyl siding; vinyl on porch base; replacement front steps; screens on porch; 1 story rear addition

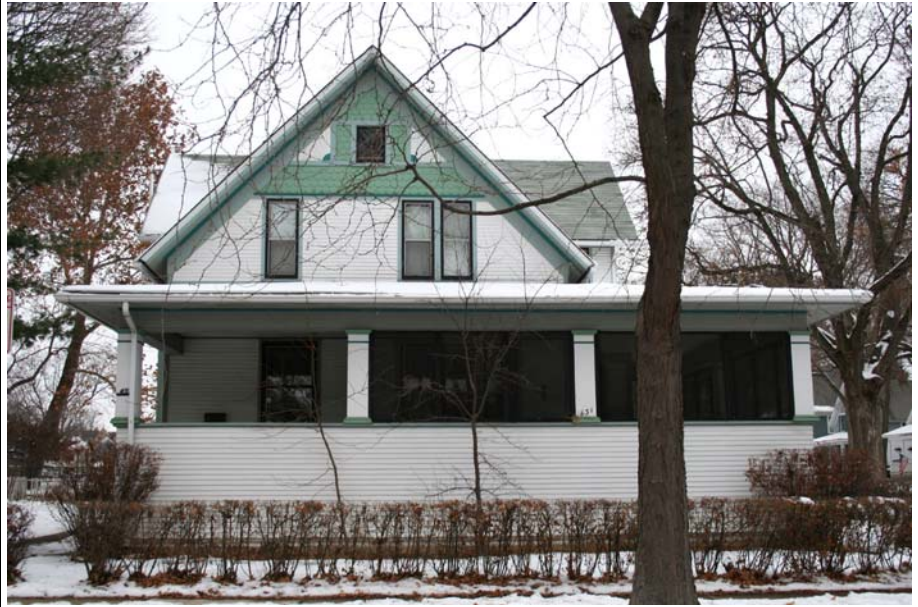
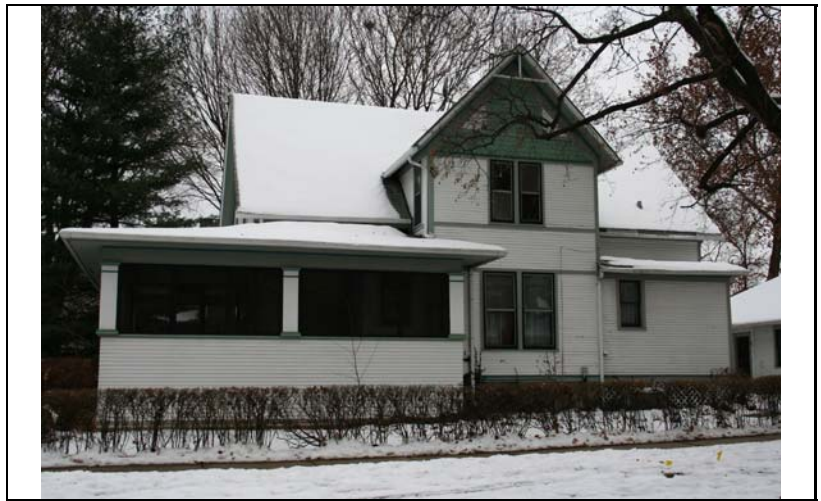
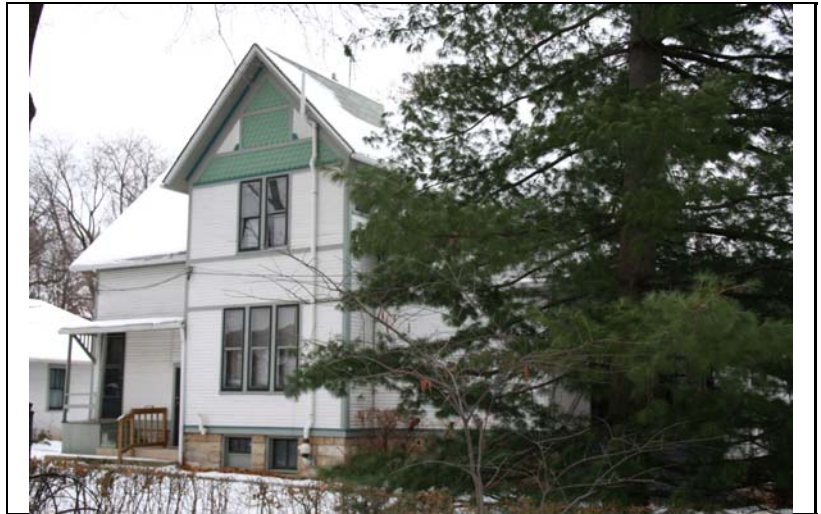
431 E FRANKLIN

CATEGORY	building	CURRENT FUNCTION	Domestic - single dwelling
CONDITION	good	HISTORIC FUNCTION	Domestic - single dwelling
INTEGRITY	minor alterations and addition(s)	REASON for SIGNIFICANCE	
SECONDARY STRUCTURE	Detached garage

ARCHITECTURAL CLASSIFICATION	Queen Anne	PLAN	irregular
DETAILS		NO OF STORIES	2.5
BEGINYEAR	c.1905	ROOF TYPE	Front gable
OTHER YEAR		ROOF MATERIAL	Asphalt - shingle
DATESOURCE	Surveyor	FOUNDATION	Stone/concrete
WALL MATERIAL (current)	Wood	PORCH	Wrap around
WALL MATERIAL 2 (current)	Wood - shingle	WINDOW MATERIAL	Wood
WALL MATERIAL (original)	Wood	WINDOW MATERIAL	
WALL MATERIAL 2 (original)	Wood - shingle	WINDOW TYPE	double hung
		WINDOW CONFIG	1/1
SIGNIFICANT FEATURES	Broad front gable bay with east and west gabled ells; decorative wood shingles in gable; historic 1/1 double hung wood windows (may be historic replacement)		
ALTERATIONS	Replacement front porch (historic--1920s), partially screened; 1 story addition under porch (east side--historic); 1 story rear addition (historic)
