STREET #	208
DIRECTION	N
STREET	LOOMIS
SUFFIX	ST
PIN	0818137004
LOCAL SIGNIFICANCE RATING	S
POTENTIAL IND NR? (Y or N)	N
Contributing to a NR DISTRICT?	C
Contributing secondary structure?	-
Listed on existing SURVEY?	IHSS (O); Local District; NR

PREPARER Lara Ramsey

PREPARER ORGANIZATION GRANACKI HISTORIC CONSULTANTS

SURVEYAREA NAPERVILLE

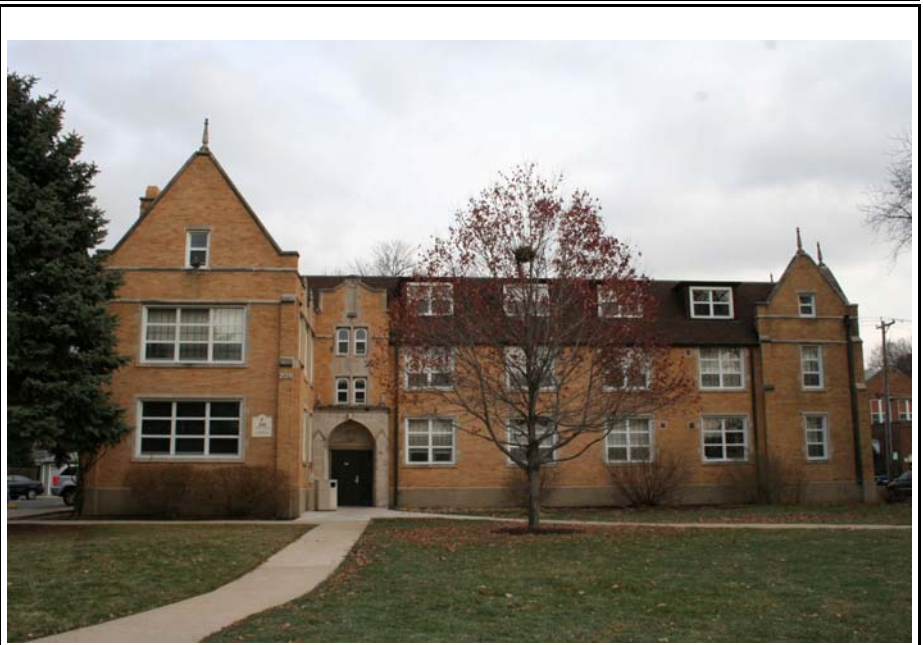
208 N LOOMIS

CATEGORY	building	CURRENT FUNCTION	Education - college
CONDITION	excellent	HISTORIC FUNCTION	Education - college
INTEGRITY	minor alterations	REASON for SIGNIFICANCE	Despite window alterations, this English Gothic dormitory remains a significant structure in the district.
SECONDARY STRUCTURE

ARCHITECTURAL CLASSIFICATION	Gothic Revival	PLAN	L
DETAILS	English	NO OF STORIES	2.5
BEGINYEAR	1928	ROOF TYPE	Multiple gable
OTHER YEAR		ROOF MATERIAL	Asphalt - shingle
DATESOURCE	NCC	FOUNDATION	Concrete
WALL MATERIAL (current)	Brick	PORCH	-
WALL MATERIAL 2 (current)		WINDOW MATERIAL	Vinyl
WALL MATERIAL (original)	Brick	WINDOW MATERIAL	
WALL MATERIAL 2 (original)		WINDOW TYPE	double hung/fixed
		WINDOW CONFIG	8/8; 4-light; 4/4
SIGNIFICANT FEATURES	L-shaped massing; south and west gables and gable parapet walls; shed dormers; stone gothic entries with recessed rounded arches; crenellated parapet walls; stone quoins window surrounds		
ALTERATIONS	replacement windows in original openings (not historic); replacement doors (not historic); glass block replacement windows on north elevation

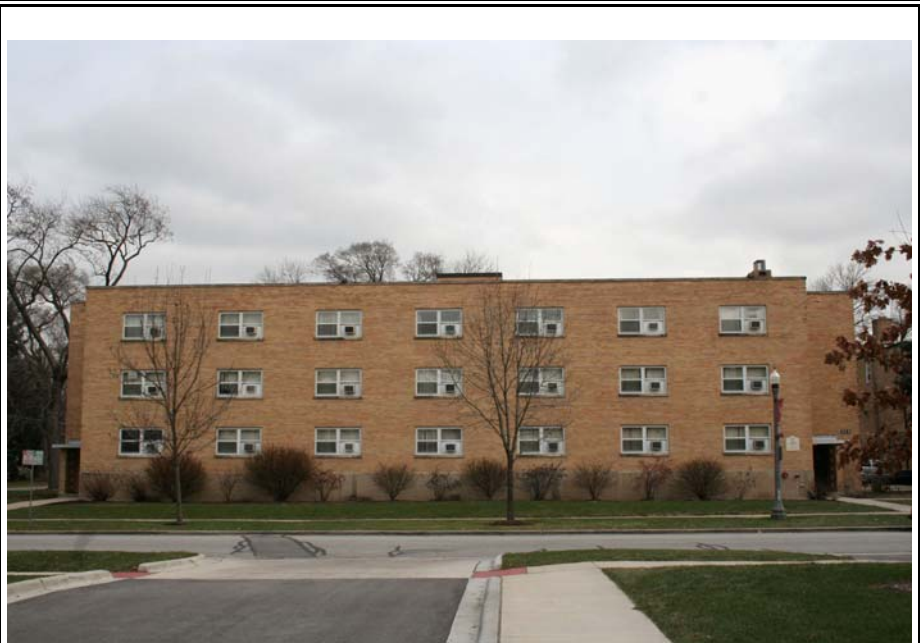
224 N LOOMIS

CATEGORY	building	CURRENT FUNCTION	Education - college (dormitory)
CONDITION	excellent	HISTORIC FUNCTION	Education - college (dormitory)
INTEGRITY	minor alterations	REASON for SIGNIFICANCE	
SECONDARY STRUCTURE

ARCHITECTURAL CLASSIFICATION	Dormitory apartments	PLAN	rectangular
DETAILS		NO OF STORIES	3
BEGINYEAR	1958	ROOF TYPE	Flat
OTHER YEAR		ROOF MATERIAL	Not visible
DATESOURCE	Plaque	FOUNDATION	concrete
WALL MATERIAL (current)	Brick	PORCH	Front entry
WALL MATERIAL 2 (current)		WINDOW MATERIAL	Vinyl
WALL MATERIAL (original)	Brick	WINDOW MATERIAL	
WALL MATERIAL 2 (original)		WINDOW TYPE	double hung
		WINDOW CONFIG	1/1
SIGNIFICANT FEATURES	Rectangular massing and flat roof; north, south, and east entries with flat roof porches		
ALTERATIONS	Replacement windows in original openings; replacement doors

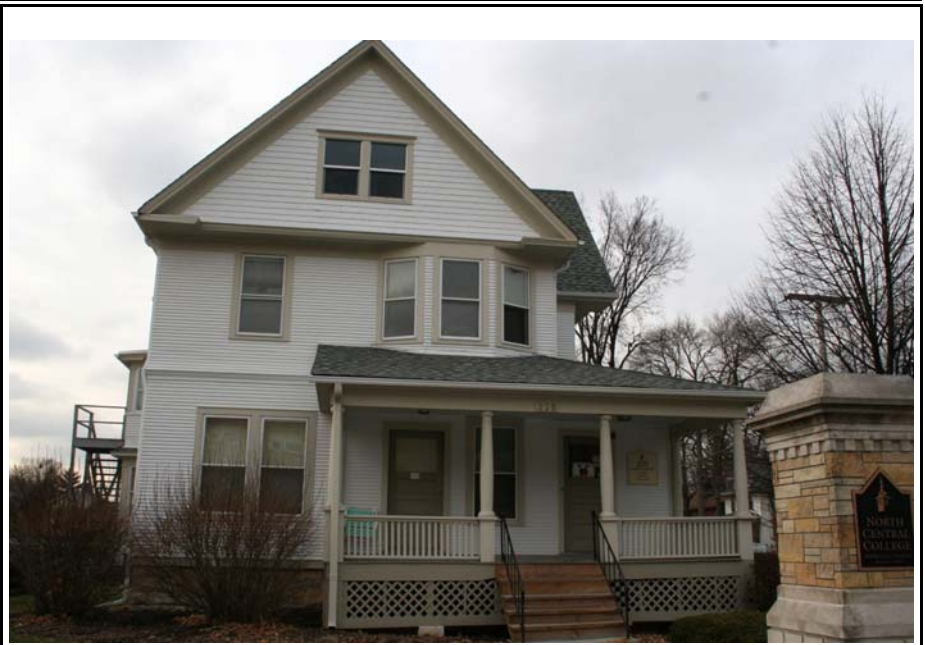
225 N LOOMIS

CATEGORY	building	CURRENT FUNCTION	Education - college
CONDITION	excellent	HISTORIC FUNCTION	Domestic - single dwelling
INTEGRITY	minor alterations and addition(s)	REASON for SIGNIFICANCE	Solid Queen Anne-Free Classic residence with minor alterations.
SECONDARY STRUCTURE	-

ARCHITECTURAL CLASSIFICATION	Queen Anne - Free Classic	PLAN	irregular
DETAILS		NO OF STORIES	2.5
BEGINYEAR	c.1895	ROOF TYPE	Front gable
OTHER YEAR		ROOF MATERIAL	Asphalt - shingle
DATESOURCE	Surveyor	FOUNDATION	Stone
WALL MATERIAL (current)	Wood	PORCH	Front
WALL MATERIAL 2 (current)	Wood - shingle	WINDOW MATERIAL	Wood
WALL MATERIAL (original)	Wood - shingle	WINDOW MATERIAL	
WALL MATERIAL 2 (original)	Wood	WINDOW TYPE	double hung
		WINDOW CONFIG	1/1
SIGNIFICANT FEATURES	Pent front gable bay; two story north side bay with center 3-sided window bay; 2 story south side bay with cutaway corners; shingles under gables; 3-sided 2nd story front window bay		
ALTERATIONS	1/1 windows are historic but not original; 1 story historic north side addition and replacement porch (2nd entry and front window between doors); 2 story rear/south addition w/ exterior stair (historic); basement window boarded

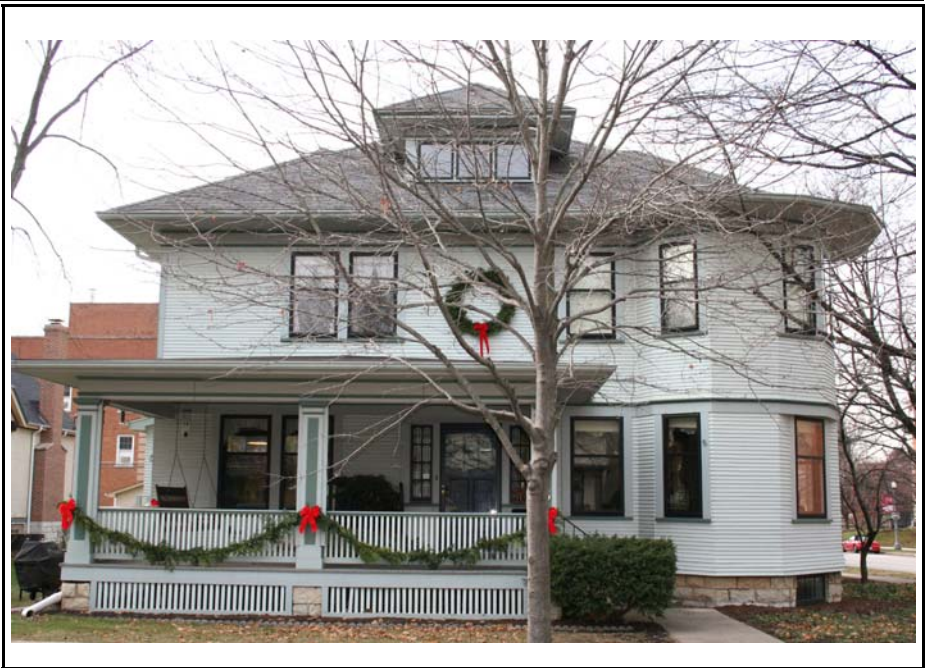
5 S LOOMIS

CATEGORY	<input type="text" value="building"/>	CURRENT FUNCTION	<input type="text" value="Domestic - multiple dwelling"/>
CONDITION	<input type="text" value="good"/>	HISTORIC FUNCTION	<input type="text" value="Religion - religious facility"/>
INTEGRITY	<input type="text" value="major alterations and/or addition(s)"/>	REASON for SIGNIFICANCE	<input type="text" value="Originally a church building that was remodeled in the 1910s to serve as apartments, this Queen Anne residence retains its early 20th century character."/>
SECONDARY STRUCTURE	<input type="text" value="Detached garage"/>

ARCHITECTURAL CLASSIFICATION	<input type="text" value="Queen Anne"/>	PLAN	<input type="text" value="rectangular"/>
DETAILS	<input type="text"/>	NO OF STORIES	<input type="text" value="2.5"/>
BEGINYEAR	<input type="text" value="pre-1886"/>	ROOF TYPE	<input type="text" value="Hipped"/>
OTHER YEAR	<input type="text" value="c. 1910"/>	ROOF MATERIAL	<input type="text" value="Asphalt -shingle"/>
DATESOURCE	<input type="text" value="Surveyor"/>	FOUNDATION	<input type="text" value="Stone"/>
WALL MATERIAL (current)	<input type="text" value="Wood"/>	PORCH	<input type="text" value="Front/side"/>
WALL MATERIAL 2 (current)	<input type="text"/>	WINDOW MATERIAL	<input type="text" value="Wood"/>
WALL MATERIAL (original)	<input type="text" value="Wood"/>	WINDOW MATERIAL	<input type="text" value="Art Glass"/>
WALL MATERIAL 2 (original)	<input type="text"/>	WINDOW TYPE	<input type="text" value="double & single hung/case"/>

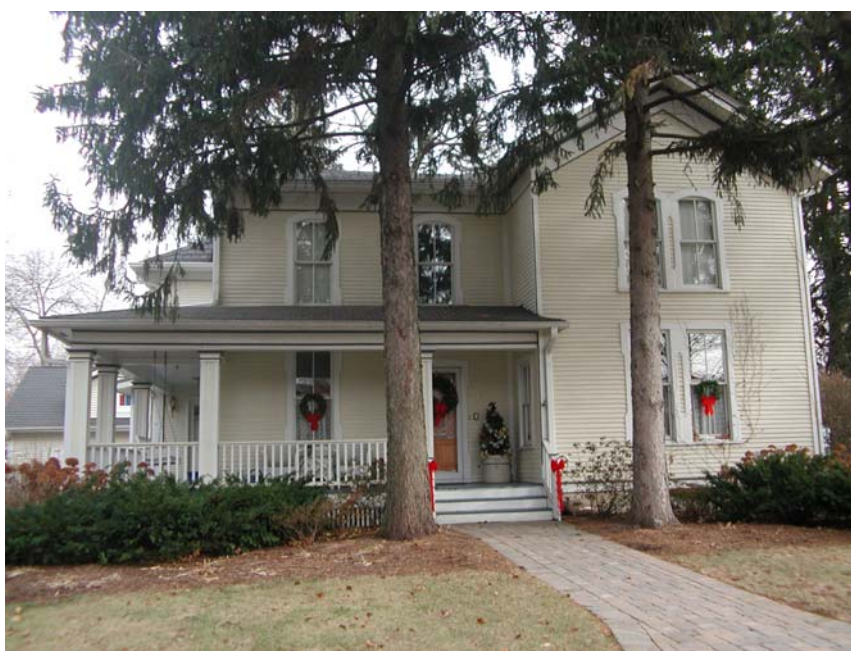
8 N LOOMIS

Aluminum under eaves; wraparound porch (may be extension of historic porch); 2 story rear/N add (not historic); replacement windows in original openings (not historic); replacement door; window on N side of front gable bay looks new; rear deck add. (not historic); side gable N wing extended and roof pitch widened (not historic)

CATEGORY	building	CURRENT FUNCTION	Domestic - single dwelling
CONDITION	excellent	HISTORIC FUNCTION	Domestic - single dwelling
INTEGRITY	major alterations and/or addition(s)	REASON for SIGNIFICANCE	Although altered, this remains a good example of a 19th century L-form, with Italianate detailing.
SECONDARY STRUCTURE	Detached garage

ARCHITECTURAL CLASSIFICATION	L-Form	PLAN	irregular
DETAILS	Italianate	NO OF STORIES	2
BEGINYEAR	c. 1880	ROOF TYPE	Multi-gable
OTHER YEAR		ROOF MATERIAL	Asphalt - shingle
DATESOURCE	Surveyor	FOUNDATION	Stone
WALL MATERIAL (current)	Wood	PORCH	Wrap around
WALL MATERIAL 2 (current)		WINDOW MATERIAL	Aluminum clad
WALL MATERIAL (original)	Wood	WINDOW MATERIAL	
WALL MATERIAL 2 (original)		WINDOW TYPE	double hung
		WINDOW CONFIG	2/2 vertical
SIGNIFICANT FEATURES	Front gable bay with north side recessed side gable wing; wood Italianate label molds; polygonal south side window bay (early alteration--c. 1895)		
ALTERATIONS	Aluminum under eaves; wraparound porch (may be extension of historic porch); 2 story rear/N add.(not historic); replacement windows in original openings; replacement door; window on N side of front gable bay looks new--SEE CONTINUATION SHEET

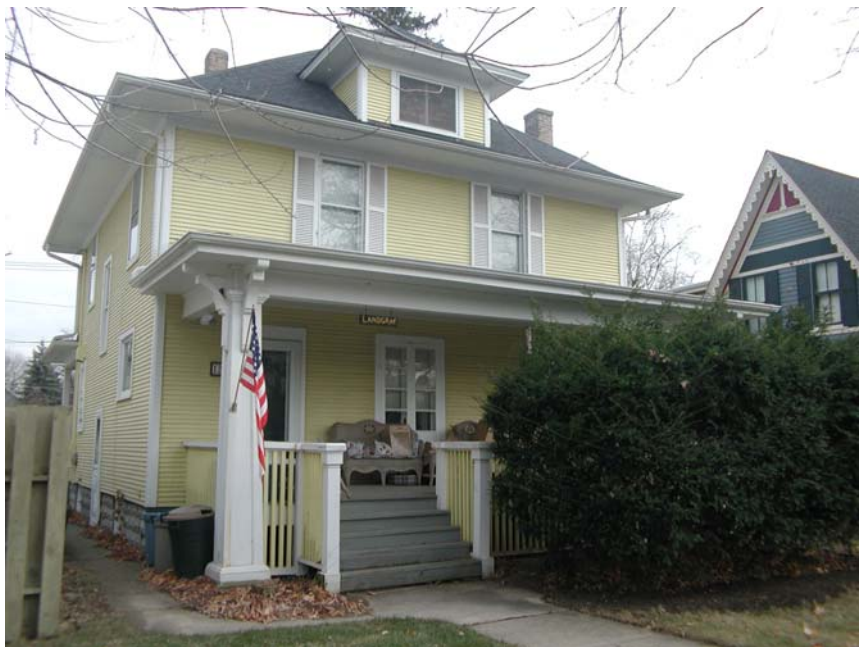
12 S LOOMIS

CATEGORY	building	CURRENT FUNCTION	Domestic - single dwelling
CONDITION	good	HISTORIC FUNCTION	Domestic - single dwelling
INTEGRITY	minor alterations	REASON for SIGNIFICANCE	
SECONDARY STRUCTURE	Detached garage

ARCHITECTURAL CLASSIFICATION	American Foursquare	PLAN	rectangular
DETAILS		NO OF STORIES	2.5
BEGINYEAR	c. 1915	ROOF TYPE	Hipped
OTHER YEAR		ROOF MATERIAL	Asphalt - shingle
DATESOURCE	Surveyor	FOUNDATION	Concrete - block
WALL MATERIAL (current)	Wood	PORCH	Full front
WALL MATERIAL 2 (current)		WINDOW MATERIAL	Wood
WALL MATERIAL (original)	Wood	WINDOW MATERIAL	Leaded glass
WALL MATERIAL 2 (original)		WINDOW TYPE	double hung/casement
		WINDOW CONFIG	1/1; 6/6; 1-light
SIGNIFICANT FEATURES	Hipped roof with overhanging eaves and front hipped dormer; full front porch with battered square columns and knee brackets; historic leaded glass and 1/1 wood windows		
ALTERATIONS	Replacement dormer window (not historic); front double doors (may be historic alteration); replacement 6/6 wood windows in original openings (historic); replacement porch railing

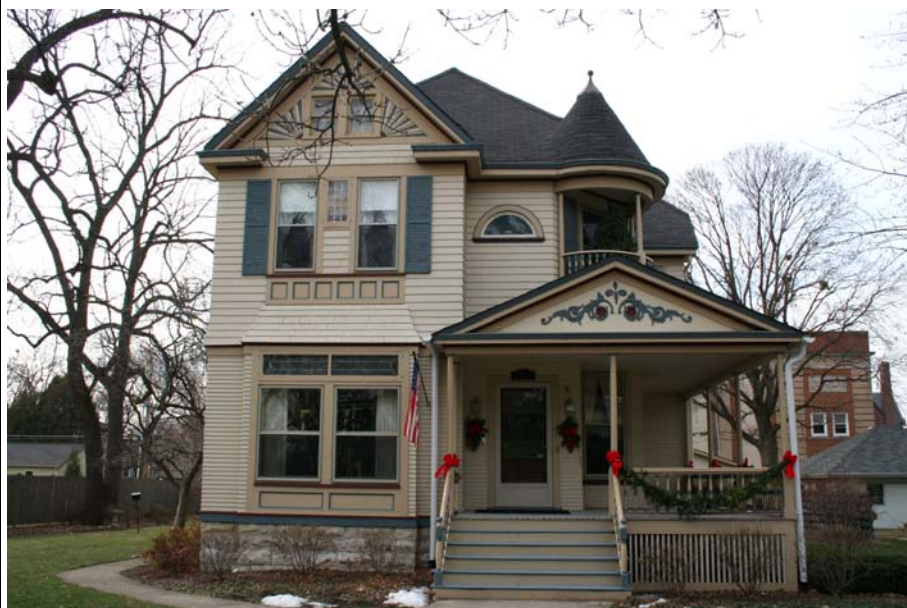
Irregular massing and multiple rooflines; front gable 2 story bay with cornice returns and sunburst motif; northeast 2nd story tower/balcony with conical roof; jerkinhead north side bay; north side pedimented wall dormer; 2 story south 3-sided bay; shingled 2nd story; front wraparound porch structure with pedimented front; stained glass transom on front window bay; multi-light windows under gables; half-round window above porch; leaded glass casement windows on 2nd story of north elevation

CATEGORY	building	CURRENT FUNCTION	Domestic - single dwelling
CONDITION	excellent	HISTORIC FUNCTION	Domestic - single dwelling
INTEGRITY	minor alterations and addition(s)	REASON for SIGNIFICANCE	Picturesque early 1890s Queen Anne residence with corner second story tower and wraparound porch. Listed on IHSS (HD).
SECONDARY STRUCTURE	Detached garage

ARCHITECTURAL CLASSIFICATION	Queen Anne	PLAN	irregular
DETAILS		NO OF STORIES	2.5
BEGINYEAR	1892	ROOF TYPE	Hipped
OTHER YEAR		ROOF MATERIAL	Asphalt - shingle
DATESOURCE	Plaque	FOUNDATION	Stone
WALL MATERIAL (current)	Wood	PORCH	Wrap around
WALL MATERIAL 2 (current)	Wood - shingle	WINDOW MATERIAL	Wood
WALL MATERIAL (original)	Wood	WINDOW MATERIAL	Stained glass
WALL MATERIAL 2 (original)	Wood - shingle	WINDOW TYPE	Double hung/fixed/caseme
		WINDOW CONFIG	1/1; multi-light
SIGNIFICANT FEATURES	Irregular massing and multiple rooflines; front gable 2 story bay with cornice returns and sunburst motif; northeast 2nd story tower/balcony with conical roof; jerkinhead north side bay; north side pedimented wall dormers--SEE CONTINUATION SHEET		
ALTERATIONS	Two story rear addition and south porch addition (not-historic); 1/1 wood windows are historic replacements; replacement columns/railings on front steps (not historic); fixed shutters (not historic) In kind replacement of asphalt shingles (admin. approved COA#17-842)

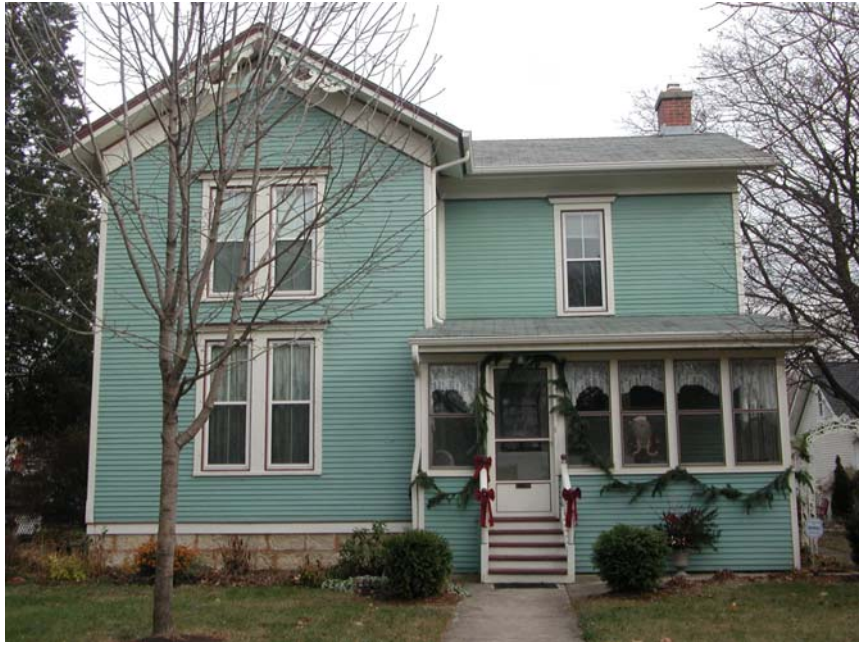
16 N LOOMIS

CATEGORY	building	CURRENT FUNCTION	Domestic - single dwelling
CONDITION	good	HISTORIC FUNCTION	Domestic - single dwelling
INTEGRITY	minor alterations and addition(s)	REASON for SIGNIFICANCE	
SECONDARY STRUCTURE	Detached garage

ARCHITECTURAL CLASSIFICATION	L-Form	PLAN	L
DETAILS		NO OF STORIES	2
BEGINYEAR	1875	ROOF TYPE	Multi-gable
OTHER YEAR		ROOF MATERIAL	Asphalt - shingle
DATESOURCE	Owner	FOUNDATION	Stone
WALL MATERIAL (current)	Wood	PORCH	Front (enclosed)
WALL MATERIAL 2 (current)		WINDOW MATERIAL	Vinyl
WALL MATERIAL (original)	Wood	WINDOW MATERIAL	
WALL MATERIAL 2 (original)		WINDOW TYPE	double hung
		WINDOW CONFIG	2/2 vertical
SIGNIFICANT FEATURES	Front gable bay with south side gable wing; paired window openings on front gable; classical lintels; wide frieze board		
ALTERATIONS	Replacement windows in original openings (not historic); window surrounds possibly restored; shed roof front porch (historic)--porch was enclosed later, with new front steps) verge board under gable (not historic); 2nd story rear addition Siding replacement with fiber cement boards, roofing replacement (admin. approved COA#13-1983)

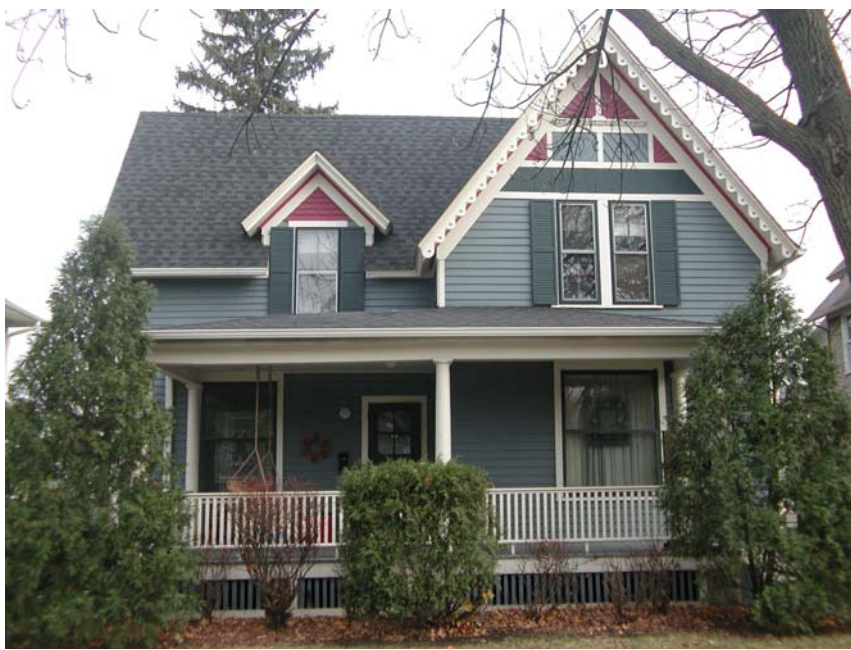
CATEGORY	building	CURRENT FUNCTION	Domestic - single dwelling
CONDITION	good	HISTORIC FUNCTION	Domestic - single dwelling
INTEGRITY	minor alterations and addition(s)	REASON for SIGNIFICANCE	Rare example of Gothic Revival in the district, with historic porch addition.
SECONDARY STRUCTURE	Detached garage Shed (NC)

ARCHITECTURAL CLASSIFICATION	Gothic Revival	PLAN	L
DETAILS		NO OF STORIES	2
BEGINYEAR	1871	ROOF TYPE	Multi-gable
OTHER YEAR		ROOF MATERIAL	Asphalt - shingle
DATESOURCE	Owner	FOUNDATION	Stone
WALL MATERIAL (current)	Wood	PORCH	Front
WALL MATERIAL 2 (current)	Wood - shingle	WINDOW MATERIAL	Wood
WALL MATERIAL (original)	Wood	WINDOW MATERIAL	Glass block/beveled glass
WALL MATERIAL 2 (original)		WINDOW TYPE	double hung/casement
		WINDOW CONFIG	1/1; 2/2 vert.; 2-light
SIGNIFICANT FEATURES	Front gable bay with side gable north wing; 2/2 vertical wood windows; south gabled wall dormers; decorative wood verge board at gables; beveled glass window under porch		
ALTERATIONS	Replacement front porch (historic--1910s); 1 story historic rear addition; 2 story rear add. (not historic); shutters

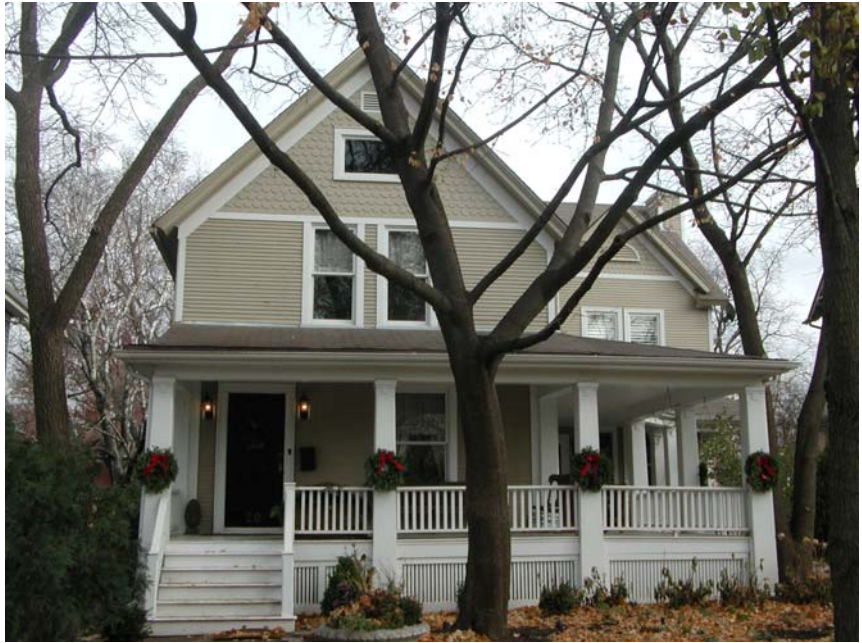
CATEGORY	building	CURRENT FUNCTION	Domestic - single dwelling
CONDITION	excellent	HISTORIC FUNCTION	Domestic - single dwelling
INTEGRITY	major alterations and/or addition(s)	REASON for SIGNIFICANCE	
SECONDARY STRUCTURE	Detached garage

ARCHITECTURAL CLASSIFICATION	Gable Front	PLAN	irregular
DETAILS		NO OF STORIES	2.5
BEGINYEAR	c. 1900	ROOF TYPE	Multi-gable
OTHER YEAR		ROOF MATERIAL	Asphalt - shingle
DATESOURCE	surveyor	FOUNDATION	Stone
WALL MATERIAL (current)	Wood	PORCH	Wrap around
WALL MATERIAL 2 (current)	Wood - shingle	WINDOW MATERIAL	Wood
WALL MATERIAL (original)	Wood	WINDOW MATERIAL	Aluminum clad
WALL MATERIAL 2 (original)	Wood - shingle	WINDOW TYPE	double hung/fixed
		WINDOW CONFIG	1/1; 1-light
SIGNIFICANT FEATURES	Front gable bay of original house; historic front porch structure across original front gable with battered square columns		
ALTERATIONS	Replacement windows in original openings (not historic); front gable rear addition (may be an extension of an original south side ell or window bay); two story rear/south addition; porch extended to south; replacement front door; replacement cladding

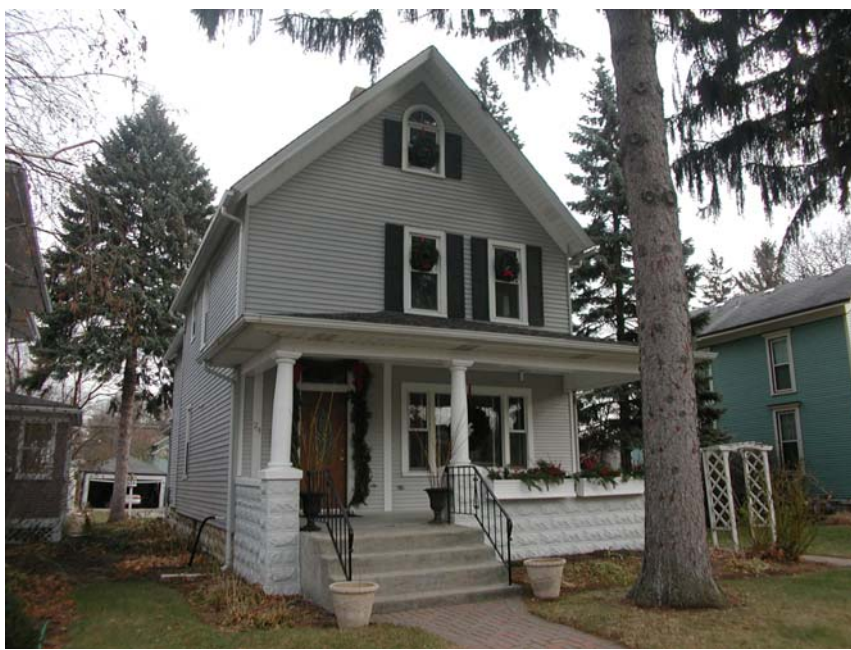
Front porch addition (c. 1910); vinyl siding; replacement windows in enlarged, enclosed & downsized openings on front façade , original openings on side elevations (not historic); fixed shutters (not historic); rear 1 story addition; south deck addition (not historic); replacement front door (not historic)

CATEGORY	building	CURRENT FUNCTION	Domestic - single dwelling
CONDITION	good	HISTORIC FUNCTION	Domestic - single dwelling
INTEGRITY	major alterations and/or addition(s)	REASON for SIGNIFICANCE	
SECONDARY STRUCTURE	Detached garage

ARCHITECTURAL CLASSIFICATION	Gable Front	PLAN	rectangular
DETAILS		NO OF STORIES	2.5
BEGINYEAR	1893	ROOF TYPE	Front gable
OTHER YEAR		ROOF MATERIAL	Asphalt - shingle
DATESOURCE	Owner	FOUNDATION	Stone
WALL MATERIAL (current)	Vinyl	PORCH	Full front
WALL MATERIAL 2 (current)		WINDOW MATERIAL	Vinyl
WALL MATERIAL (original)	Wood	WINDOW MATERIAL	
WALL MATERIAL 2 (original)		WINDOW TYPE	double hung/fixed
		WINDOW CONFIG	1/1; 1-light
SIGNIFICANT FEATURES	Front gable bay; 2 story side gable bay with cutaway corners		
ALTERATIONS	Front porch addition (c. 1910); vinyl siding; replacement windows in enlarged, enclosed & downsized openings on front façade, original openings on side elevations (not historic); fixed shutters (not historic)---SEE CONTINUATION SHEET

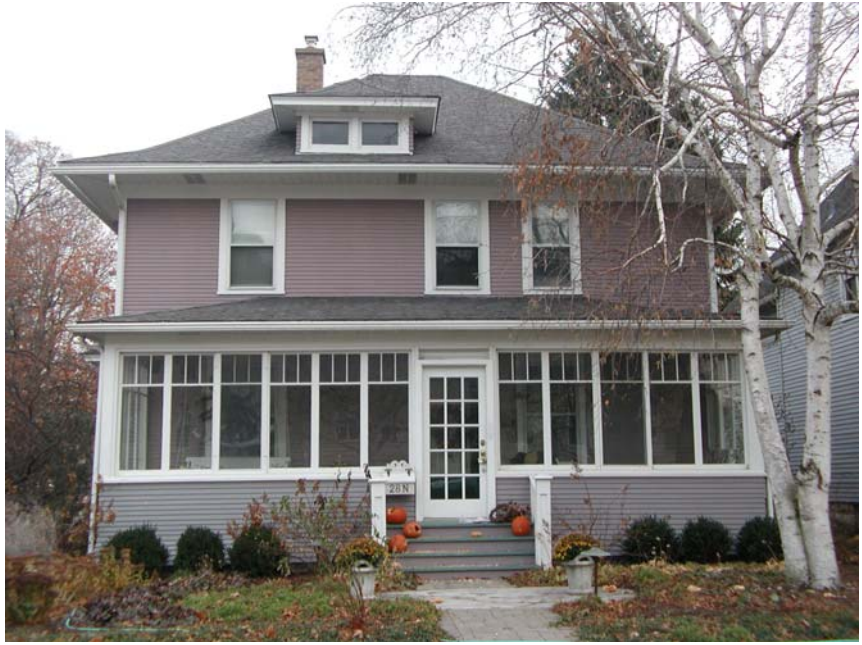
28 N LOOMIS

CATEGORY	building	CURRENT FUNCTION	Domestic - single dwelling
CONDITION	good	HISTORIC FUNCTION	Domestic - single dwelling
INTEGRITY	Minor alterations and addition(s)?	REASON for SIGNIFICANCE	
SECONDARY STRUCTURE	Detached garage

ARCHITECTURAL CLASSIFICATION	American Foursquare	PLAN	rectangular
DETAILS		NO OF STORIES	2.5
BEGINYEAR	c. 1915	ROOF TYPE	Hipped
OTHER YEAR		ROOF MATERIAL	Asphalt - shingle
DATESOURCE	Surveyor	FOUNDATION	Concrete - block
WALL MATERIAL (current)	Wood	PORCH	Full front enclosed
WALL MATERIAL 2 (current)		WINDOW MATERIAL	Wood
WALL MATERIAL (original)	Wood	WINDOW MATERIAL	Glass block
WALL MATERIAL 2 (original)		WINDOW TYPE	Double hung/awning/storm
		WINDOW CONFIG	1/1; 1-light; 4-light
SIGNIFICANT FEATURES	Flared hipped roof with front and north hipped roof dormers; full front porch with hipped roof (enclosed); north square oriel bay with hipped roof; historic 1/1 wood windows		
ALTERATIONS	Two story south addition obscures original symmetry of façade (historic); 1 story rear/south addition; front porch enclosed (historic) Removal one window, addition of 2 new windows (HPC approval COA#16-2711)

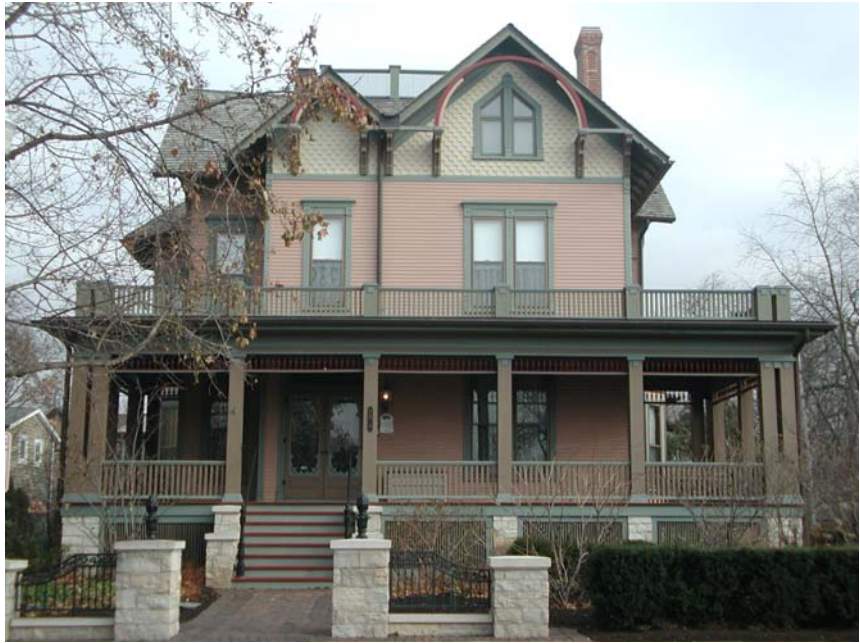
CATEGORY	building	CURRENT FUNCTION	Domestic - single dwelling
CONDITION	excellent	HISTORIC FUNCTION	Domestic - single dwelling
INTEGRITY	minor alterations and addition(s)	REASON for SIGNIFICANCE	This fine Queen Anne was home to Augustine Smith, who served as North Central College's first president from 1861 to 1883. Listed on IHSS (O).
SECONDARY STRUCTURE	Detached garage

ARCHITECTURAL CLASSIFICATION	Queen Anne	PLAN	irregular
DETAILS		NO OF STORIES	2.5
BEGINYEAR	1885	ROOF TYPE	Gable on hip
OTHER YEAR		ROOF MATERIAL	Asphalt - shingle
DATESOURCE	Plaque	FOUNDATION	Stone
WALL MATERIAL (current)	Wood	PORCH	Wrap around/side
WALL MATERIAL 2 (current)	Wood - shingle	WINDOW MATERIAL	Wood
WALL MATERIAL (original)	Wood -	WINDOW MATERIAL	Aluminum clad
WALL MATERIAL 2 (original)	Wood - shingle	WINDOW TYPE	Double hung/fixee
		WINDOW CONFIG	1/1; 1-light
SIGNIFICANT FEATURES	Hipped main roof with two front gable bays; north and south gabled 2-story bays; 3-sided south 1st story window bay; 1/1 wood windows with fluted surrounds, corner bulls eye blocks and classical lintels--SEE CONTINUATION SHEET		
ALTERATIONS	Recent restoration/renovation----wraparound porch (historic add.) has been restored; Aluminum-clad replacement windows under gables; replacement doors and transoms; Eastlake bracing has recently been added (may have been restored)

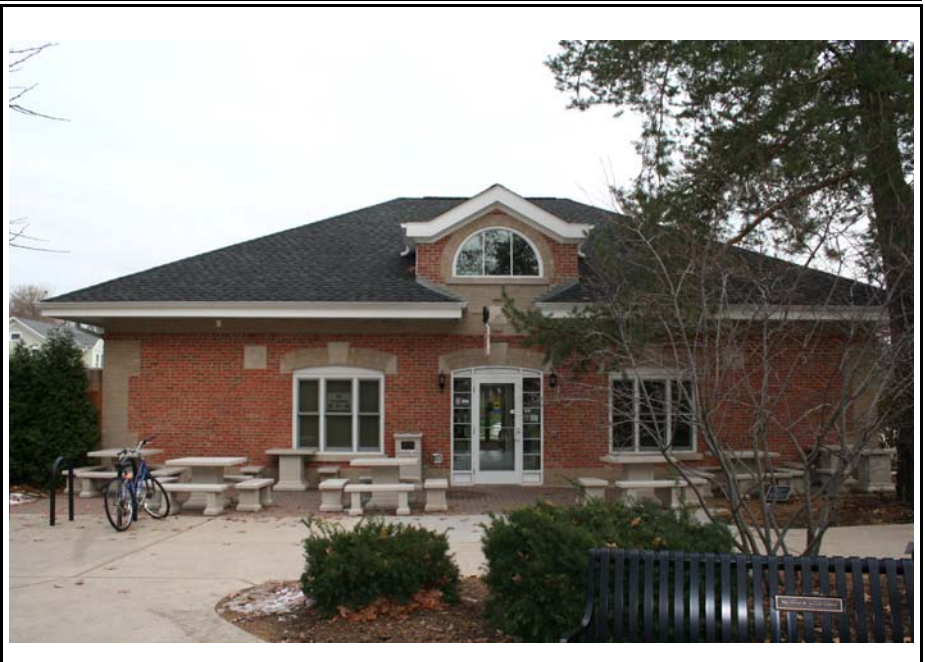
29 N LOOMIS

CATEGORY	building	CURRENT FUNCTION	Commerce/Trade - restaurant
CONDITION	excellent	HISTORIC FUNCTION	Industry/Processing/Extraction
INTEGRITY	minor alterations	REASON for SIGNIFICANCE	
SECONDARY STRUCTURE

ARCHITECTURAL CLASSIFICATION	Industrial Heating Plant	PLAN	Rectangular
DETAILS	Prairie	NO OF STORIES	1.5
BEGINYEAR	1907	ROOF TYPE	Hipped
OTHER YEAR	2004	ROOF MATERIAL	Asphalt - shingle
DATESOURCE	NCC	FOUNDATION	Concrete - poured
WALL MATERIAL (current)	Brick	PORCH	-
WALL MATERIAL 2 (current)		WINDOW MATERIAL	Metal
WALL MATERIAL (original)	Brick	WINDOW MATERIAL	
WALL MATERIAL 2 (original)		WINDOW TYPE	double hung/fixed
		WINDOW CONFIG	1/1; multi-light
SIGNIFICANT FEATURES	Hipped roof with flanged gable wall dormers; segmental arch and round arch window openings with stone lintels		
ALTERATIONS	Replacement windows and doors in original openings; patio addition to east side

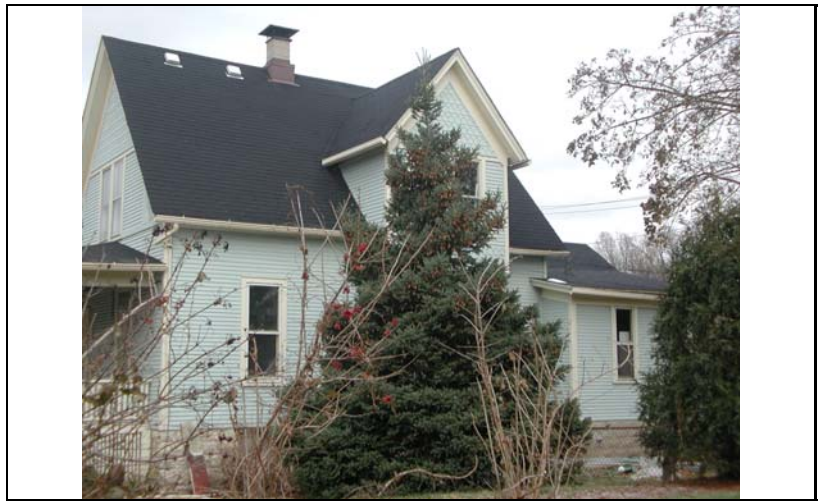
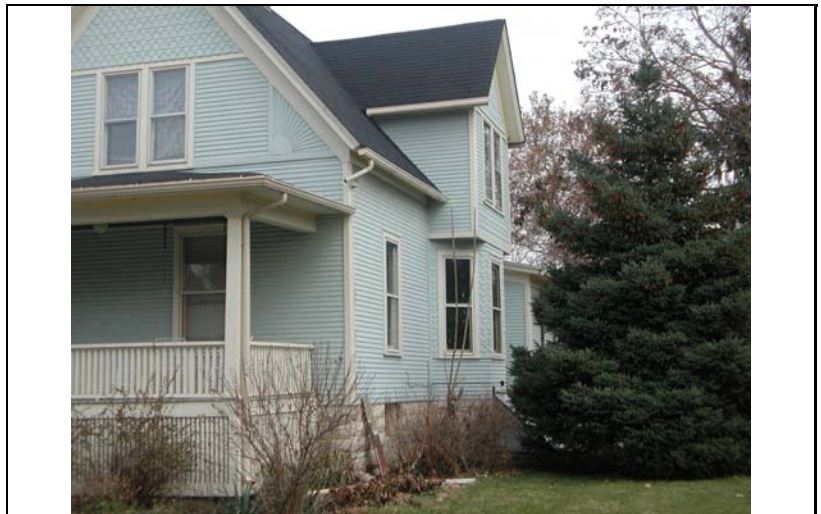
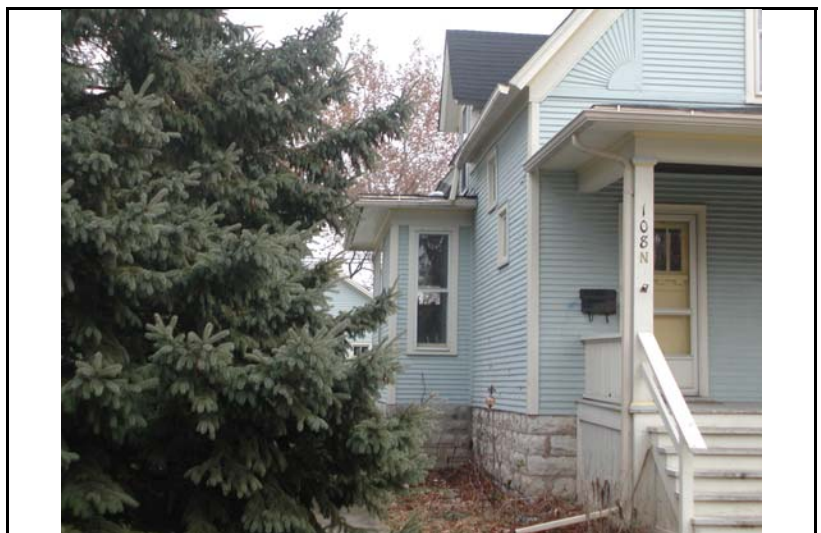
108 N LOOMIS

CATEGORY	building	CURRENT FUNCTION	Domestic - single dwelling
CONDITION	good	HISTORIC FUNCTION	Domestic - single dwelling
INTEGRITY	minor alterations and addition(s)	REASON for SIGNIFICANCE	Charming example of Gable Front Cottage, with some historic alterations.
SECONDARY STRUCTURE	Detached garage Shed (NC)

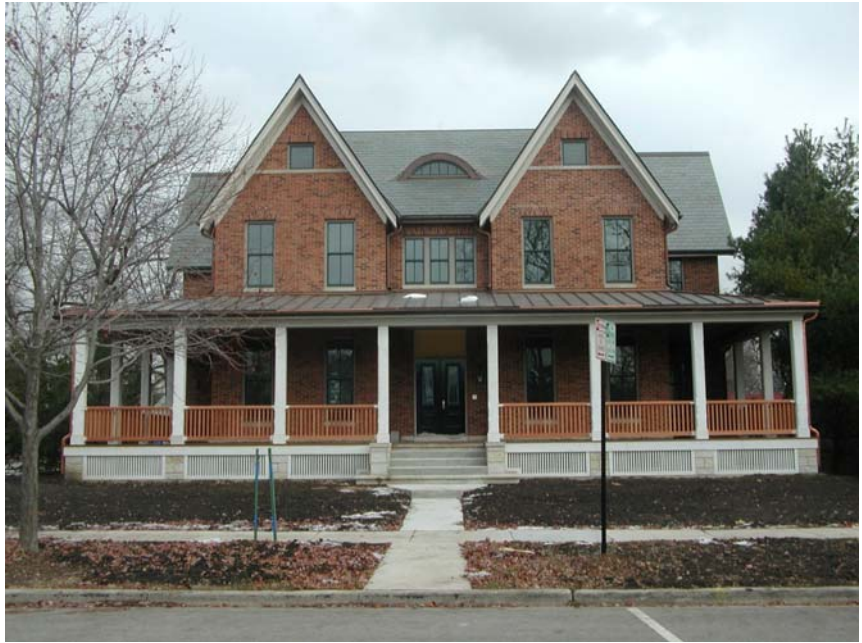
STREET #	110
DIRECTION	S
STREET	LOOMIS
SUFFIX	ST
PIN	0818321001
LOCAL SIGNIFICANCE RATING	NC
POTENTIAL IND NR? (Y or N)	N
Contributing to a NR DISTRICT?	NC
Contributing secondary structure?	-
Listed on existing SURVEY?	Local District; NR District

CATEGORY	building	CURRENT FUNCTION	Domestic - single dwelling
CONDITION	excellent	HISTORIC FUNCTION	Domestic - single dwelling
INTEGRITY	Under construction	REASON for SIGNIFICANCE	
SECONDARY STRUCTURE

ARCHITECTURAL CLASSIFICATION	Neo-Traditional	PLAN	rectangular
DETAILS		NO OF STORIES	2.5
BEGINYEAR	2007	ROOF TYPE	Combination
OTHER YEAR		ROOF MATERIAL	Slate
DATESOURCE	Surveyor	FOUNDATION	Concrete - poured
WALL MATERIAL (current)	Brick veneer	PORCH	Wrap around
WALL MATERIAL 2 (current)		WINDOW MATERIAL	Aluminum clad
WALL MATERIAL (original)	Brick veneer	WINDOW MATERIAL	
WALL MATERIAL 2 (original)		WINDOW TYPE	double hung/fixed
		WINDOW CONFIG	2/2 vert.; 1 & multi-light
SIGNIFICANT FEATURES			
ALTERATIONS

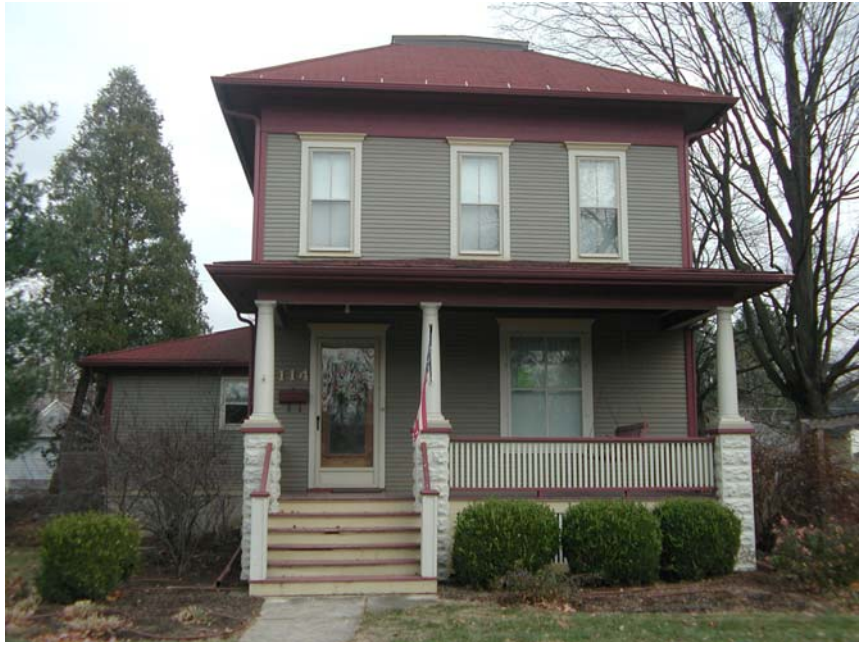
STREET #	114
DIRECTION	S
STREET	LOOMIS
SUFFIX	ST
PIN	0818321002
LOCAL SIGNIFICANCE RATING	S
POTENTIAL IND NR? (Y or N)	N
Contributing to a NR DISTRICT?	C
Contributing secondary structure?	NC
Listed on existing SURVEY?	IHSS (O); Local District; NR

CATEGORY	building	CURRENT FUNCTION	Domestic - single dwelling
CONDITION	excellent	HISTORIC FUNCTION	Domestic - single dwelling
INTEGRITY	minor alterations and addition(s)	REASON for SIGNIFICANCE	Well-proportioned Italianate residence with historic front porch that dates from the 1910s.
SECONDARY STRUCTURE	Detached garage

ARCHITECTURAL CLASSIFICATION	Italianate	PLAN	irregular
DETAILS		NO OF STORIES	2
BEGINYEAR	c. 1880	ROOF TYPE	Hipped
OTHER YEAR		ROOF MATERIAL	Asphalt - shingle
DATESOURCE	Surveyor	FOUNDATION	Stone/concrete block
WALL MATERIAL (current)	Wood	PORCH	Full front
WALL MATERIAL 2 (current)		WINDOW MATERIAL	Wood
WALL MATERIAL (original)	Wood	WINDOW MATERIAL	Leaded/beveled glass
WALL MATERIAL 2 (original)		WINDOW TYPE	Double & single hung/fixed
		WINDOW CONFIG	2/2vert.; 1/1; 1-light
SIGNIFICANT FEATURES	Hipped roof with wide wood frieze; 3-sided south window bay; historic 2/2 vertical wood windows; oval window on north elevation; classical window lintels; leaded glass front and north side windows; historic front door		
ALTERATIONS	Replacement front porch (c. 1915--see 1909 and 1921 Sanborn maps); one story south/rear screened porch addition (not historic); one story north addition (non-historic); from roofline, it appears there was originally a cupola or widow's walk

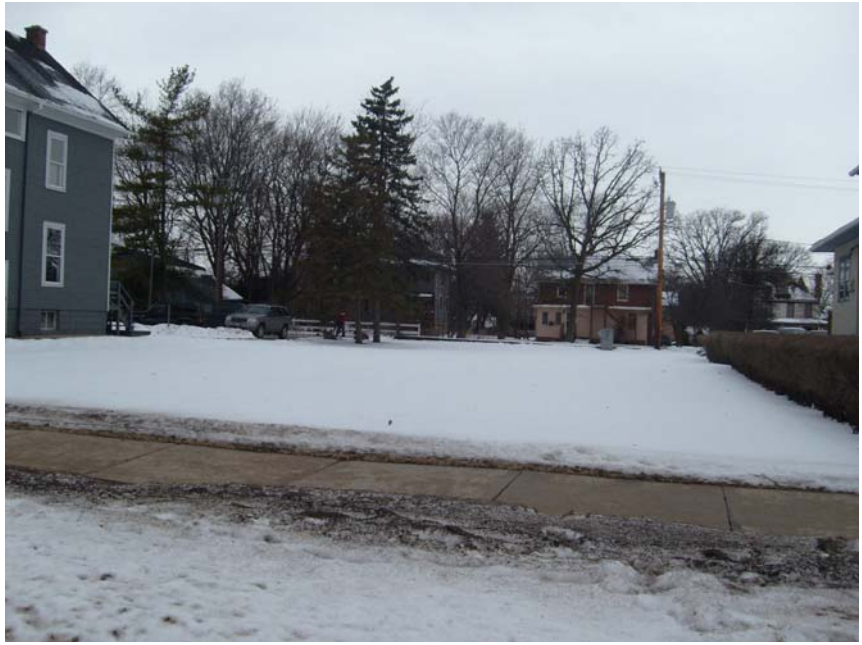
STREET #	115
DIRECTION	S
STREET	LOOMIS
SUFFIX	ST
PIN	0818320008
LOCAL SIGNIFICANCE RATING	NC
POTENTIAL IND NR? (Y or N)	N
Contributing to a NR DISTRICT?	NC
Contributing secondary structure?	-
Listed on existing SURVEY?	Local District; NR District

CATEGORY	site	CURRENT FUNCTION	Landscape - unoccupied land
CONDITION		HISTORIC FUNCTION	
INTEGRITY		REASON for SIGNIFICANCE	
SECONDARY STRUCTURE

ARCHITECTURAL CLASSIFICATION	Vacant Lot	PLAN	
DETAILS		NO OF STORIES	
BEGINYEAR		ROOF TYPE	
OTHER YEAR		ROOF MATERIAL	
DATESOURCE		FOUNDATION	
WALL MATERIAL (current)		PORCH	
WALL MATERIAL 2 (current)		WINDOW MATERIAL	
WALL MATERIAL (original)		WINDOW MATERIAL	
WALL MATERIAL 2 (original)		WINDOW TYPE	
		WINDOW CONFIG	
SIGNIFICANT FEATURES			
ALTERATIONS	Demolition of existing structure (HPC approved revised COA#14-2382)

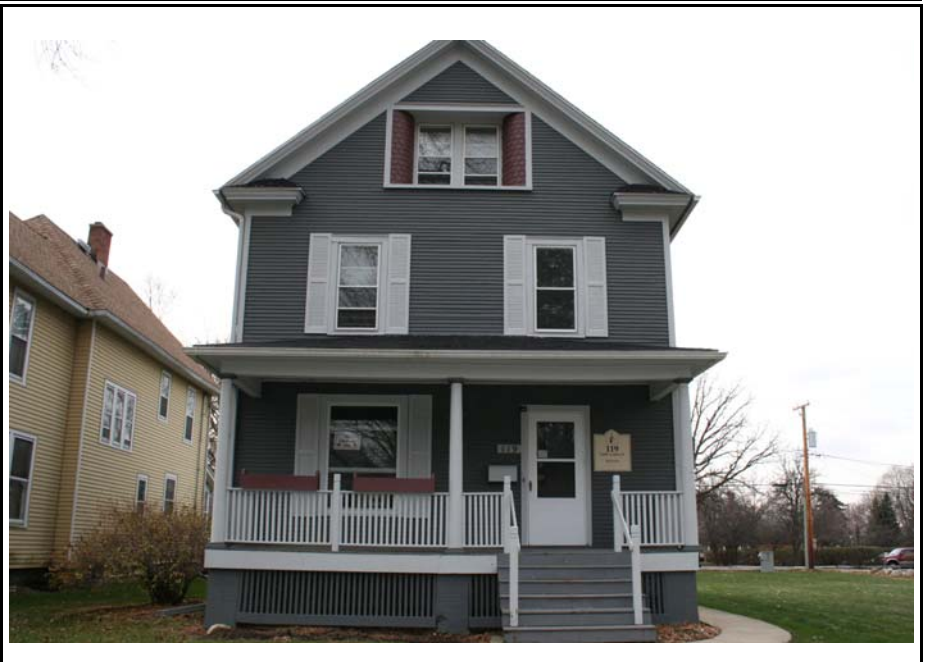
STREET #	119
DIRECTION	S
STREET	LOOMIS
SUFFIX	ST
PIN	0818320009
LOCAL SIGNIFICANCE RATING	S
POTENTIAL IND NR? (Y or N)	N
Contributing to a NR DISTRICT?	C
Contributing secondary structure?	-
Listed on existing SURVEY?	Local District; NR District

CATEGORY	building	CURRENT FUNCTION	Education - college
CONDITION	good	HISTORIC FUNCTION	Domestic - single dwelling
INTEGRITY	minor alterations and addition(s)	REASON for SIGNIFICANCE	The center window under gable with rounded shingle walls is a distinctive feature on this turn-of-the-century Gable Front.
SECONDARY STRUCTURE

ARCHITECTURAL CLASSIFICATION	Gable Front	PLAN	rectangular
DETAILS	Shingle Style/Colonial Revival	NO OF STORIES	2.5
BEGINYEAR	c. 1900	ROOF TYPE	Front gable
OTHER YEAR		ROOF MATERIAL	Asphalt - shingle
DATESOURCE	Surveyor	FOUNDATION	Parged
WALL MATERIAL (current)	Wood	PORCH	Full front
WALL MATERIAL 2 (current)	Wood - shingle	WINDOW MATERIAL	Wood
WALL MATERIAL (original)	Wood	WINDOW MATERIAL	
WALL MATERIAL 2 (original)	Wood - shingle	WINDOW TYPE	double & single hung/fixed
		WINDOW CONFIG	1/1; other
SIGNIFICANT FEATURES	Front gable roof with cornice returns; recessed window under gable with curved shingled sides; 2 story south side bay with 1st story cutaway corners; historic 1/1 double and single hung windows; full front porch with classical columns		
ALTERATIONS	Fixed shutters (not historic); replacement front steps and railing (not historic); alterations to S. dormer (replacement siding, window boarded--dormer itself may not be original); rear exterior stair (not historic); aluminum awning over rear entry Demolition of existing structure (HPC approved revised COA#14-2382)

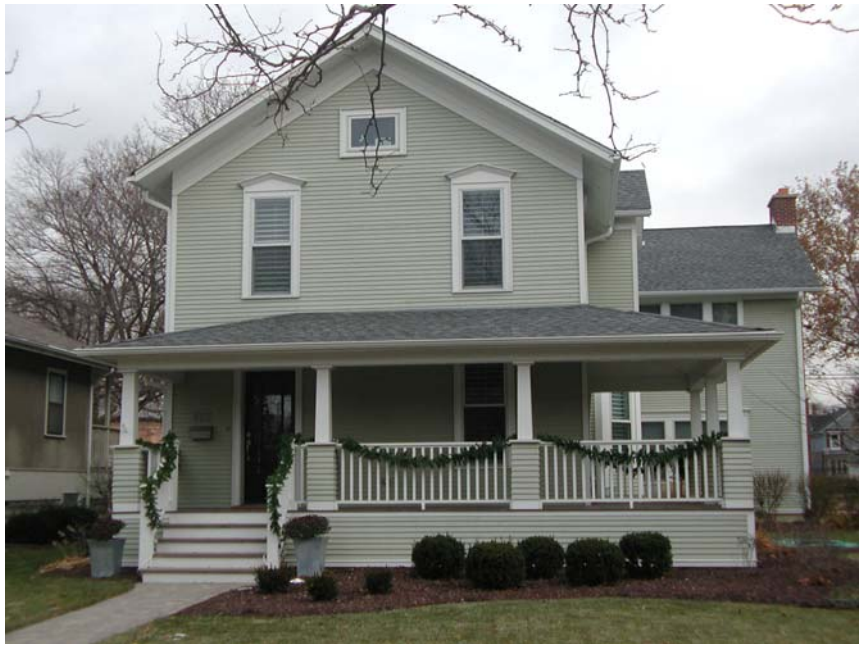
STREET #	122
DIRECTION	N
STREET	LOOMIS
SUFFIX	ST
PIN	0818307006
LOCAL SIGNIFICANCE RATING	C
POTENTIAL IND NR? (Y or N)	N
Contributing to a NR DISTRICT?	C
Contributing secondary structure?	C
Listed on existing SURVEY?	IHSS (O); Local District; NR

CATEGORY	building	CURRENT FUNCTION	Domestic - single dwelling
CONDITION	excellent	HISTORIC FUNCTION	Domestic - single dwelling
INTEGRITY	major alterations and/or addition(s)	REASON for SIGNIFICANCE	
SECONDARY STRUCTURE	Detached garage

ARCHITECTURAL CLASSIFICATION	Gable Front	PLAN	L
DETAILS		NO OF STORIES	2.5
BEGINYEAR	c. 1880	ROOF TYPE	Front gable
OTHER YEAR		ROOF MATERIAL	Asphalt - shingle
DATESOURCE	Surveyor	FOUNDATION	Stone/concrete
WALL MATERIAL (current)	Wood	PORCH	Wrap around
WALL MATERIAL 2 (current)		WINDOW MATERIAL	Vinyl
WALL MATERIAL (original)	Wood	WINDOW MATERIAL	
WALL MATERIAL 2 (original)		WINDOW TYPE	Double hung/awning
		WINDOW CONFIG	1/1; 1-light
SIGNIFICANT FEATURES	Front gable bay; 2 story south side gabled bay with cutaway corners		
ALTERATIONS	Recent renovations--replacement windows in original openings; replacement wraparound front porch; 2 story rear and south side additions; north window bay addition; chimney on north elevation Variance for detached garage (HPC approved COA#18-163)

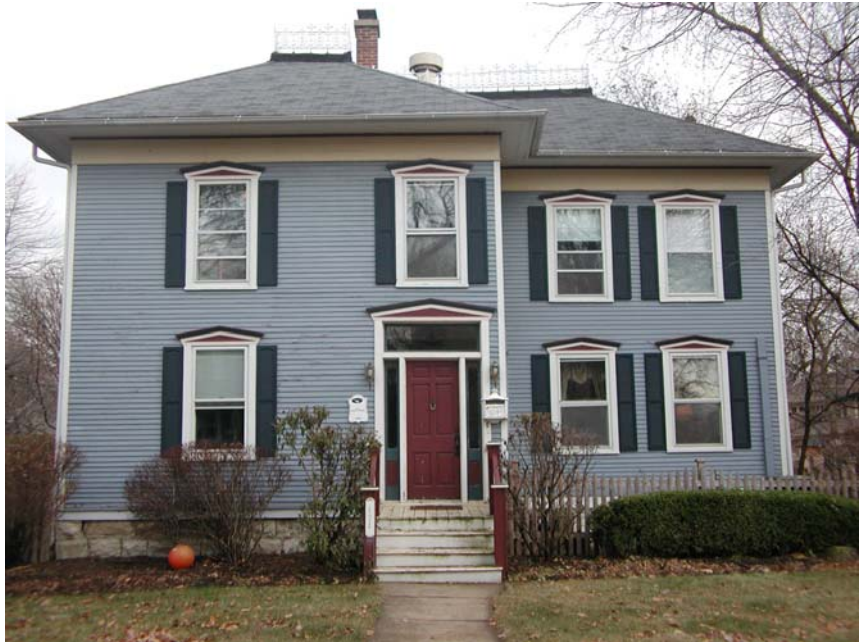
STREET #	124
DIRECTION	S
STREET	LOOMIS
SUFFIX	ST
PIN	0818321003
LOCAL SIGNIFICANCE RATING	PS
POTENTIAL IND NR? (Y or N)	N
Contributing to a NR DISTRICT?	C
Contributing secondary structure?	C
Listed on existing SURVEY?	IHSS (HD); Local District; NR

CATEGORY	building	CURRENT FUNCTION	Domestic - single dwelling
CONDITION	good	HISTORIC FUNCTION	Domestic - single dwelling
INTEGRITY	minor alterations and addition(s)	REASON for SIGNIFICANCE	Even with the enlarged entry surround and removed porch, this remains a good example of the Italianate style in the district. Listed on IHSS (HD).
SECONDARY STRUCTURE	Detached garage

ARCHITECTURAL CLASSIFICATION	Italianate	PLAN	L
DETAILS		NO OF STORIES	2
BEGINYEAR	1870	ROOF TYPE	Hipped
OTHER YEAR		ROOF MATERIAL	Asphalt - shingle
DATESOURCE	Plaque	FOUNDATION	Stone
WALL MATERIAL (current)	Wood	PORCH	-
WALL MATERIAL 2 (current)		WINDOW MATERIAL	Wood
WALL MATERIAL (original)	Wood	WINDOW MATERIAL	
WALL MATERIAL 2 (original)		WINDOW TYPE	double hung
		WINDOW CONFIG	1/1
SIGNIFICANT FEATURES	Hipped roof with wide wood frieze; triangular pediments atop windows		
ALTERATIONS	Porch along recessed south end of front façade removed; alts to front entry surround (not historic); 1 story rear addition and porch; front stoop replaced (not historic); 1/1 wood replacement windows (historic); small shed addition to north elevation

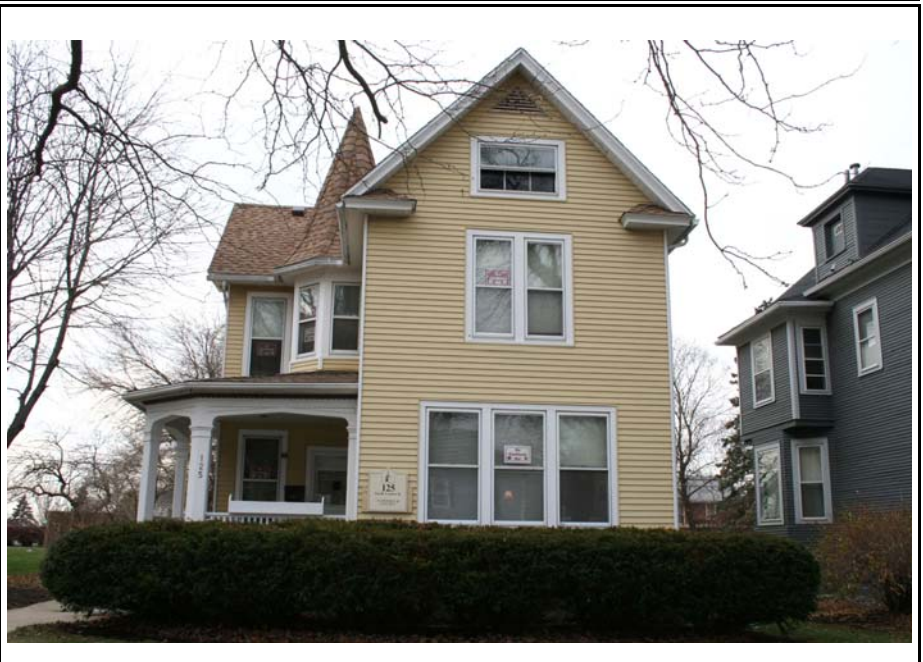
STREET #	125
DIRECTION	S
STREET	LOOMIS
SUFFIX	ST
PIN	0818320010
LOCAL SIGNIFICANCE RATING	S
POTENTIAL IND NR? (Y or N)	N
Contributing to a NR DISTRICT?	C
Contributing secondary structure?	-
Listed on existing SURVEY?	Local District; NR District; IH

CATEGORY	building	CURRENT FUNCTION	Education - college
CONDITION	good	HISTORIC FUNCTION	Domestic - single dwelling
INTEGRITY	minor alterations	REASON for SIGNIFICANCE	The emphasis on the corner of this house, with its polygonal porch and turret, makes it an interesting local example of the Queen Anne style.
SECONDARY STRUCTURE

ARCHITECTURAL CLASSIFICATION	Queen Anne	PLAN	irregular
DETAILS		NO OF STORIES	2.5
BEGINYEAR	1910	ROOF TYPE	Combination
OTHER YEAR		ROOF MATERIAL	Asphalt - shingle
DATESOURCE	NCC	FOUNDATION	Concrete - block
WALL MATERIAL (current)	Aluminum	PORCH	Front entry
WALL MATERIAL 2 (current)		WINDOW MATERIAL	Wood
WALL MATERIAL (original)	Wood	WINDOW MATERIAL	
WALL MATERIAL 2 (original)		WINDOW TYPE	double hung
		WINDOW CONFIG	3/3; 1/1
SIGNIFICANT FEATURES	Front gable bay with cornice returns; two story south side gable wing/bay; corner polygonal 2nd story turret with conical roof; hipped corner porch with flattened pointed arch openings and polygonal columns		
ALTERATIONS	Historic 3/3 and 1/1 wood replacement windows Siding replacement (admin. approved COA#11-1426) Demolition of existing structure (HPC approved revised COA#14-2382)

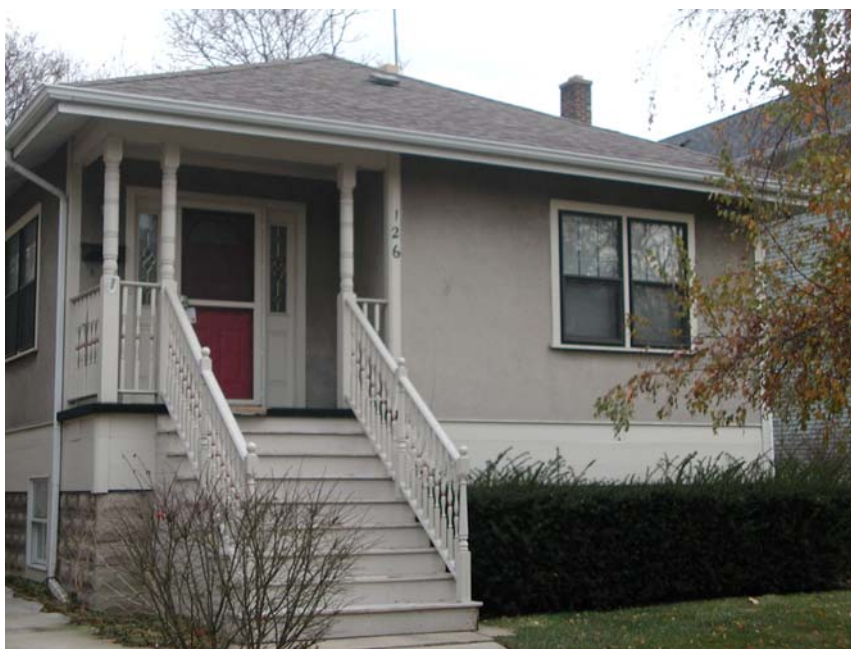
STREET #	126
DIRECTION	N
STREET	LOOMIS
SUFFIX	ST
PIN	0818307005
LOCAL SIGNIFICANCE RATING	C
POTENTIAL IND NR? (Y or N)	N
Contributing to a NR DISTRICT?	C
Contributing secondary structure?	NC
Listed on existing SURVEY?	Local District; NR District

CATEGORY	building	CURRENT FUNCTION	Domestic - single dwelling
CONDITION	good	HISTORIC FUNCTION	Domestic - single dwelling
INTEGRITY	minor alterations	REASON for SIGNIFICANCE	
SECONDARY STRUCTURE	Shed

ARCHITECTURAL CLASSIFICATION	Bungalow	PLAN	rectangular
DETAILS		NO OF STORIES	1
BEGINYEAR	c. 1920	ROOF TYPE	Hipped
OTHER YEAR		ROOF MATERIAL	Asphalt - shingle
DATESOURCE	Surveyor	FOUNDATION	Concrete - block
WALL MATERIAL (current)	Stucco	PORCH	Front entry
WALL MATERIAL 2 (current)		WINDOW MATERIAL	Wood
WALL MATERIAL (original)	Stucco	WINDOW MATERIAL	Vinyl
WALL MATERIAL 2 (original)		WINDOW TYPE	double hung
		WINDOW CONFIG	3/1; 1/1; 6/1
SIGNIFICANT FEATURES	Hipped roof with overhanging eaves; inset front entry porch (altered); historic 3/1 wood windows		
ALTERATIONS	Aluminum under eaves (not historic); replacement front door (not historic); replacement support/railing/steps for porch (not historic); vinyl replacement windows in basement; north side door at grade (not historic)
