STREET #	208
DIRECTION	N
STREET	LOOMIS
SUFFIX	ST
PIN	0818137004
LOCAL SIGNIFICANCE RATING	S
POTENTIAL IND NR? (Y or N)	N
Contributing to a NR DISTRICT?	C
Contributing secondary structure?	-
Listed on existing SURVEY?	IHSS (O); Local District; NR

PREPARER Lara Ramsey

PREPARER ORGANIZATION GRANACKI HISTORIC CONSULTANTS

SURVEYAREA NAPERVILLE

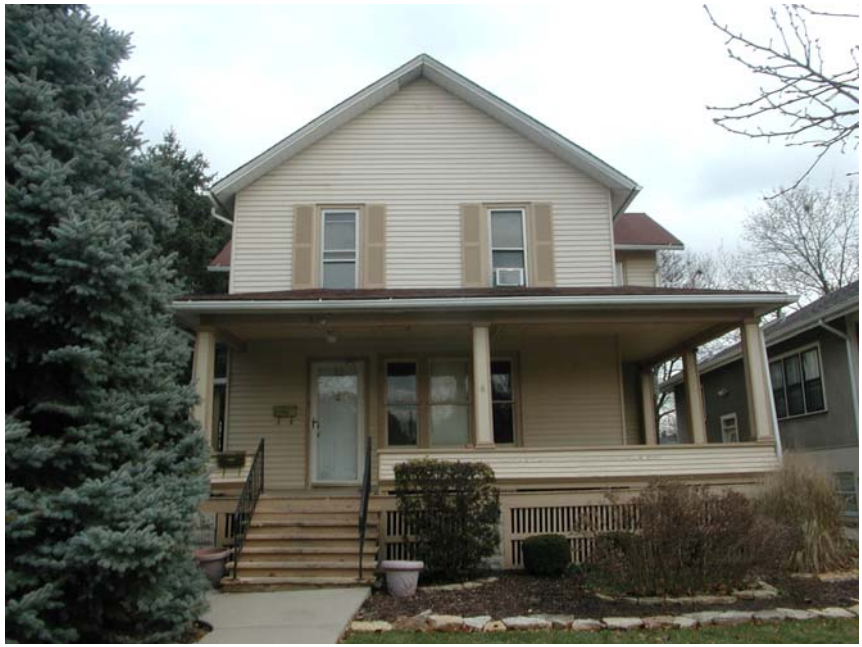
STREET #	130
DIRECTION	N
STREET	LOOMIS
SUFFIX	ST
PIN	0818307004
LOCAL SIGNIFICANCE RATING	C
POTENTIAL IND NR? (Y or N)	N
Contributing to a NR DISTRICT?	C
Contributing secondary structure?	
Listed on existing SURVEY?	Local District; NR District

CATEGORY	building	CURRENT FUNCTION	Domestic - single dwelling
CONDITION	good	HISTORIC FUNCTION	Domestic - single dwelling
INTEGRITY	minor alterations and addition(s)	REASON for SIGNIFICANCE	
SECONDARY STRUCTURE

ARCHITECTURAL CLASSIFICATION	Gabled Ell	PLAN	L
DETAILS		NO OF STORIES	2
BEGINYEAR	c. 1880	ROOF TYPE	Front gable
OTHER YEAR		ROOF MATERIAL	Asphalt - shingle
DATESOURCE	Surveyor	FOUNDATION	Stone
WALL MATERIAL (current)	Aluminum	PORCH	Wrap around
WALL MATERIAL 2 (current)		WINDOW MATERIAL	Wood
WALL MATERIAL (original)	Wood	WINDOW MATERIAL	
WALL MATERIAL 2 (original)		WINDOW TYPE	double hung
		WINDOW CONFIG	1/1
SIGNIFICANT FEATURES	Front gable bay with south side 2 story ell with cutaway corners; 2 story north square bay		
ALTERATIONS	Replacement porch (historic--c. 1915); entry & porch added to N. bay (not-historic); 3-part window under porch (historic); replacement front door; Aluminum siding; fixed shutters; 1 story south side screened porch add.; replacement windows (historic) Change in siding (HPC approved COA#16-4282)

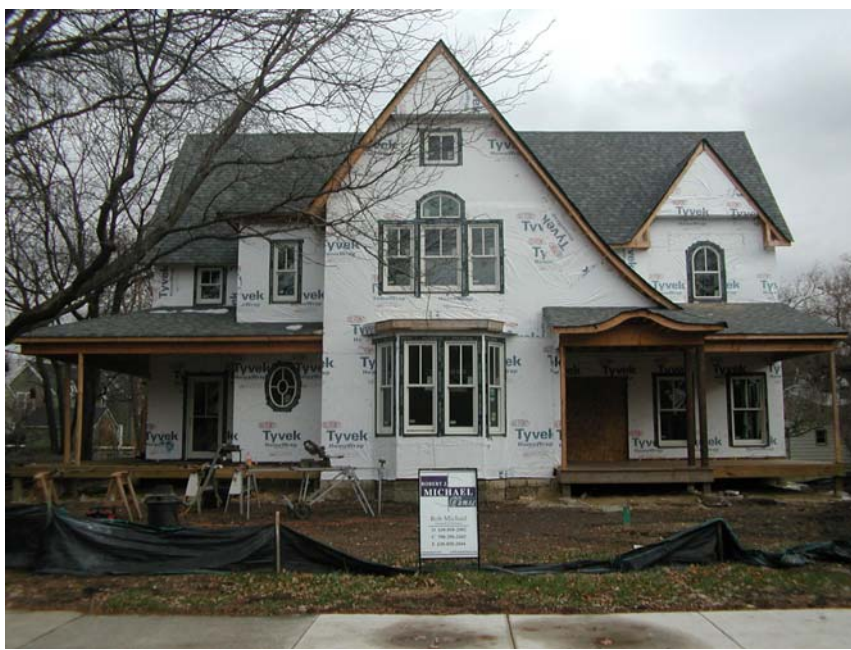
STREET #	132
DIRECTION	S
STREET	LOOMIS
SUFFIX	ST
PIN	0818321004
LOCAL SIGNIFICANCE RATING	NC
POTENTIAL IND NR? (Y or N)	N
Contributing to a NR DISTRICT?	NC
Contributing secondary structure?	-
Listed on existing SURVEY?	Local District; NR District

CATEGORY	building	CURRENT FUNCTION	Domestic - single dwelling
CONDITION	construction	HISTORIC FUNCTION	Domestic - single dwelling
INTEGRITY	major alterations and/or addition(s)	REASON for SIGNIFICANCE	
SECONDARY STRUCTURE

ARCHITECTURAL CLASSIFICATION	No style (altered)	PLAN	irregular
DETAILS		NO OF STORIES	2.5
BEGINYEAR	c. 1880	ROOF TYPE	Multi-gable
OTHER YEAR	2007	ROOF MATERIAL	Asphalt - shingle
DATESOURCE	Surveyor/Title	FOUNDATION	Stone
WALL MATERIAL (current)	Not visible	PORCH	Front/Wraparound
WALL MATERIAL 2 (current)		WINDOW MATERIAL	Aluminum Clad
WALL MATERIAL (original)	Wood	WINDOW MATERIAL	
WALL MATERIAL 2 (original)		WINDOW TYPE	Double hung/awning
SIGNIFICANT FEATURES			
ALTERATIONS	Original house completely obscured by extensive alterations and additions currently underway—roofline raised and altered; front gable bay extended to south, with new south end porch/entry door; gable at south end of façade is new--SEE CONTINUATION SHEET

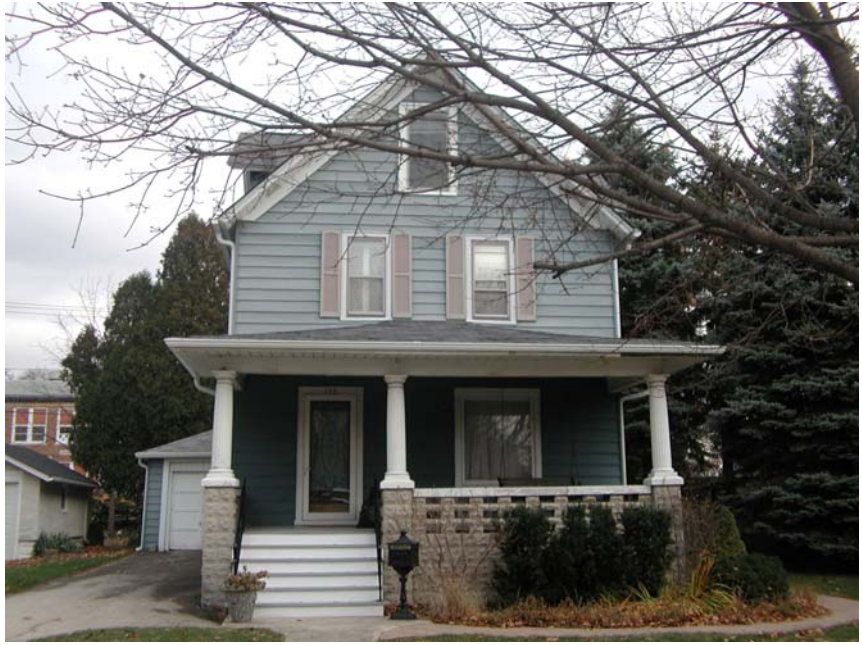
STREET #	136
DIRECTION	N
STREET	LOOMIS
SUFFIX	ST
PIN	0818307003
LOCAL SIGNIFICANCE RATING	PS
POTENTIAL IND NR? (Y or N)	N
Contributing to a NR DISTRICT?	C
Contributing secondary structure?	NC
Listed on existing SURVEY?	Local District; NR District

CATEGORY	building	CURRENT FUNCTION	Domestic - single dwelling
CONDITION	good	HISTORIC FUNCTION	Domestic - single dwelling
INTEGRITY	minor alterations and addition(s)	REASON for SIGNIFICANCE	Good example of Gable Front vernacular type, with minor alterations.
SECONDARY STRUCTURE	Detached garage

ARCHITECTURAL CLASSIFICATION	Gable Front	PLAN	irregular
DETAILS		NO OF STORIES	2.5
BEGINYEAR	c. 1885	ROOF TYPE	Front gable
OTHER YEAR		ROOF MATERIAL	Asphalt - shingle
DATESOURCE	Surveyor	FOUNDATION	Stone
WALL MATERIAL (current)	Aluminum	PORCH	Full front
WALL MATERIAL 2 (current)		WINDOW MATERIAL	Wood
WALL MATERIAL (original)	Wood	WINDOW MATERIAL	Vinyl
WALL MATERIAL 2 (original)		WINDOW TYPE	double hung/fixed
		WINDOW CONFIG	1/1; 1-light
SIGNIFICANT FEATURES	Front gable roof; 2 story south side gable bay with 1st story cutaway corners		
ALTERATIONS	Front porch replaced (1910s); Aluminum siding; N. side dormer add. & window under front gable (non-historic); 2 story rear add. (non-historic); replacement front door; garage addition (1920s); historic replacement windows in original openings; rear deck Siding replacement with cedar (admin. approved COA#13-0043) Addition (HPC approved COA#12-2346)

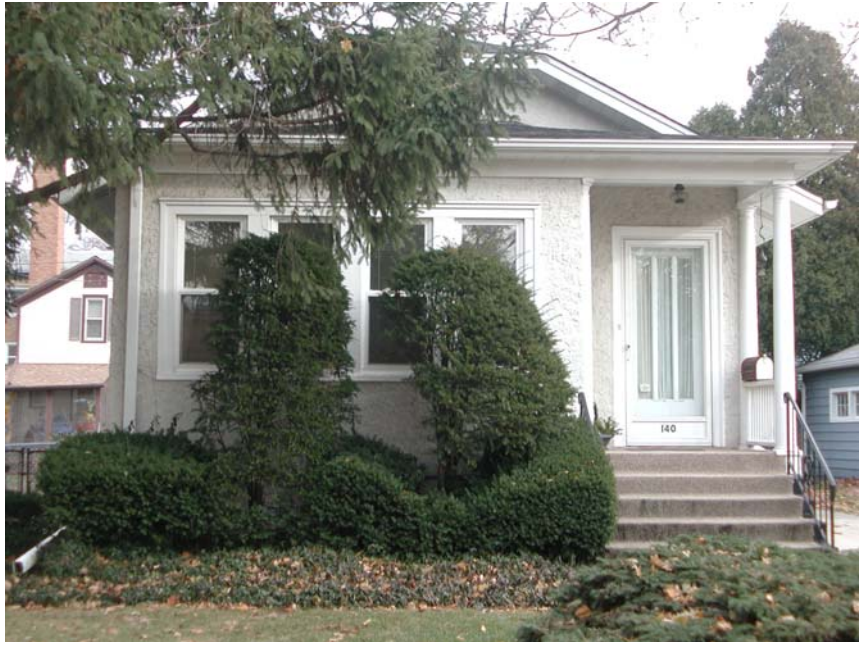
STREET #	140
DIRECTION	N
STREET	LOOMIS
SUFFIX	ST
PIN	0818307002
LOCAL SIGNIFICANCE RATING	C
POTENTIAL IND NR? (Y or N)	N
Contributing to a NR DISTRICT?	C
Contributing secondary structure?	-
Listed on existing SURVEY?	Local District; NR District

CATEGORY	building	CURRENT FUNCTION	Domestic - single dwelling
CONDITION	Good/fair	HISTORIC FUNCTION	Domestic - single dwelling
INTEGRITY	minor alterations	REASON for SIGNIFICANCE	
SECONDARY STRUCTURE

ARCHITECTURAL CLASSIFICATION	Bungalow	PLAN	Rectangular
DETAILS		NO OF STORIES	1
BEGINYEAR	c. 1925	ROOF TYPE	Jerkinhead
OTHER YEAR		ROOF MATERIAL	Asphalt - shingle
DATESOURCE	Surveyor/Sanborn Maps	FOUNDATION	Concrete - block
WALL MATERIAL (current)	Stucco	PORCH	Front entry
WALL MATERIAL 2 (current)		WINDOW MATERIAL	Vinyl
WALL MATERIAL (original)	Stucco	WINDOW MATERIAL	
WALL MATERIAL 2 (original)		WINDOW TYPE	double hung
		WINDOW CONFIG	1/1
SIGNIFICANT FEATURES	Jerkinhead roof; low pitched hipped front bay with corner entry porch (altered)		
ALTERATIONS	Aluminum siding under eaves; front entry bay addition w/ replacement front door (non-historic); replacement front steps and railing (not historic); vinyl replacement windows in original openings

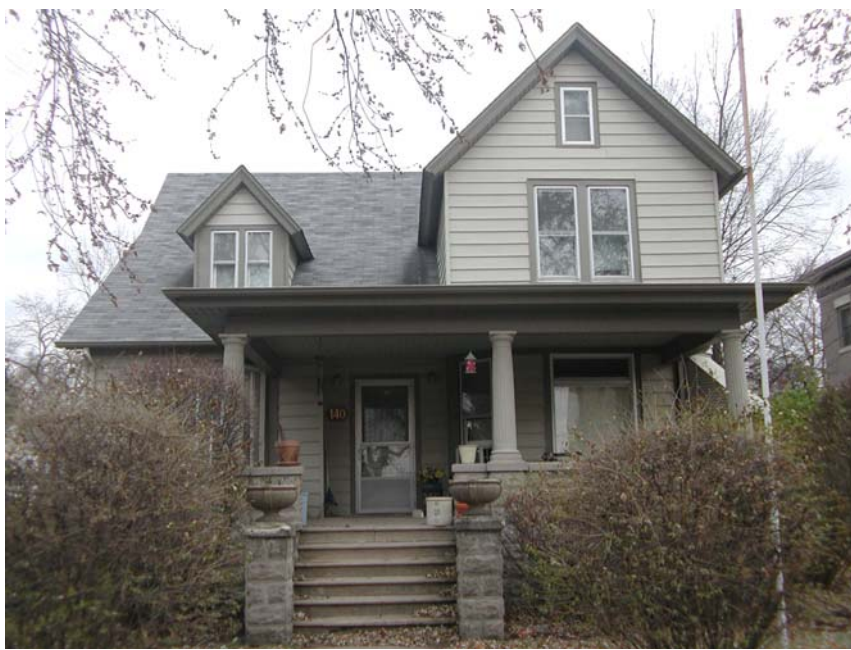
STREET #	140
DIRECTION	S
STREET	LOOMIS
SUFFIX	ST
PIN	0818321006
LOCAL SIGNIFICANCE RATING	C
POTENTIAL IND NR? (Y or N)	N
Contributing to a NR DISTRICT?	C
Contributing secondary structure?	C
Listed on existing SURVEY?	Local District; NR District

Replacement front porch (historic); porch that was recessed in ell of 2 story N side gable bay was enclosed (historic); gable dormer addition (historic); aluminum siding (not historic); front entry addition (historic); 1/1 replacement windows (historic); aluminum awning (not historic); rear porch add.

CATEGORY	building	CURRENT FUNCTION	Domestic - single dwelling
CONDITION	good	HISTORIC FUNCTION	Domestic - single dwelling
INTEGRITY	major alterations and/or addition(s)	REASON for SIGNIFICANCE	
SECONDARY STRUCTURE	Detached garage

ARCHITECTURAL CLASSIFICATION	L-Form	PLAN	Rectangular
DETAILS	Queen Anne	NO OF STORIES	2.5
BEGINYEAR	c. 1900	ROOF TYPE	Multi-gable
OTHER YEAR		ROOF MATERIAL	Asphalt - shingle
DATESOURCE	surveyor	FOUNDATION	Stone
WALL MATERIAL (current)	Aluminum	PORCH	Front
WALL MATERIAL 2 (current)		WINDOW MATERIAL	Wood
WALL MATERIAL (original)	Wood	WINDOW MATERIAL	Beveled glass
WALL MATERIAL 2 (original)		WINDOW TYPE	double hung
		WINDOW CONFIG	1/1
SIGNIFICANT FEATURES	Front gable bay with first story cutaway corners; two story south bay with three-sided two story window bay and gable roof; beveled glass upper sash on first story front windows		
ALTERATIONS	Replacement front porch (historic); porch that was recessed in ell of 2 story N side gable bay was enclosed (historic); gable dormer addition (historic); aluminum siding (not historic)--SEE CONTINUATION SHEET

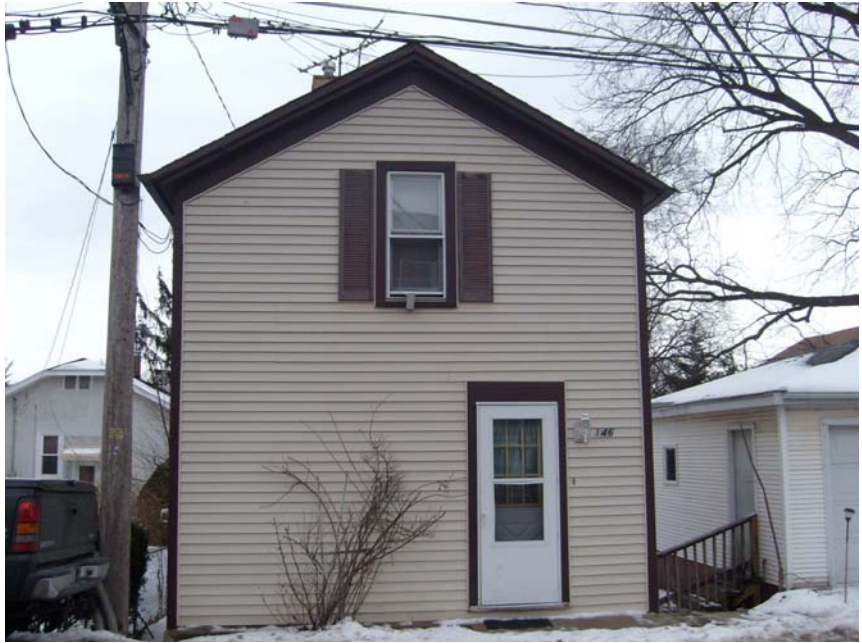
STREET #	146b
DIRECTION	N
STREET	LOOMIS
SUFFIX	ST
PIN	
LOCAL SIGNIFICANCE RATING	C
POTENTIAL IND NR? (Y or N)	N
Contributing to a NR DISTRICT?	C
Contributing secondary structure?	-
Listed on existing SURVEY?

CATEGORY	building	CURRENT FUNCTION	Domestic - secondary structure
CONDITION	good	HISTORIC FUNCTION	Domestic - single dwelling
INTEGRITY	major alterations and/or addition(s)	REASON for SIGNIFICANCE	
SECONDARY STRUCTURE

ARCHITECTURAL CLASSIFICATION	Gable Front	PLAN	rectangular
DETAILS		NO OF STORIES	1.5
BEGINYEAR	c. 1915	ROOF TYPE	Front gable
OTHER YEAR		ROOF MATERIAL	Asphalt - shingle
DATESOURCE	Surveyor	FOUNDATION	Concrete - block
WALL MATERIAL (current)	Vinyl	PORCH	-
WALL MATERIAL 2 (current)		WINDOW MATERIAL	Vinyl
WALL MATERIAL (original)	Wood	WINDOW MATERIAL	
WALL MATERIAL 2 (original)		WINDOW TYPE	double hung
		WINDOW CONFIG	1/1
SIGNIFICANT FEATURES	Front gable roof and rectangular massing		
ALTERATIONS	Vinyl siding; replacement windows in original openings (not historic); first story window on front façade covered; downsized window on S. side (not historic); replacement front door; fixed shutters (not historic); below grade entry added to N. side

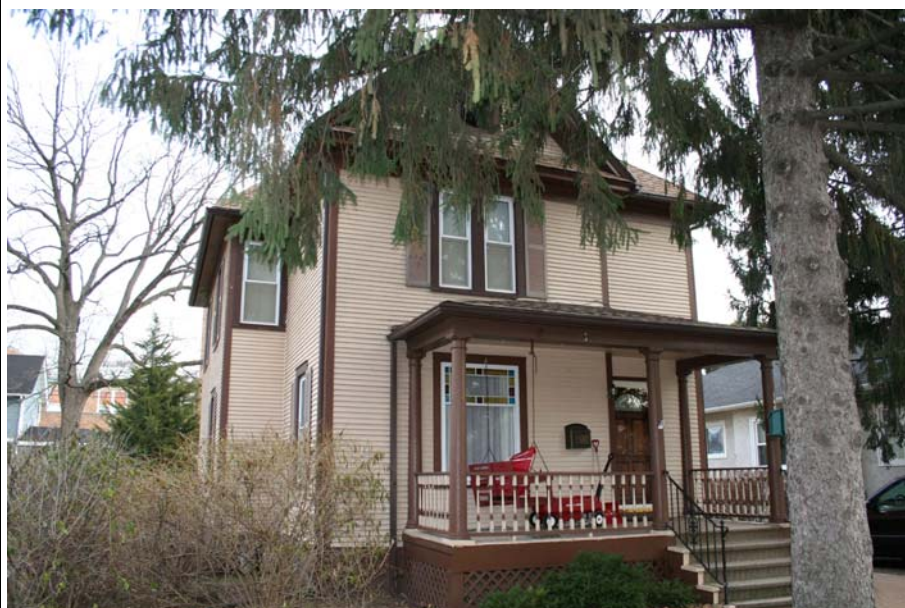
STREET #	146
DIRECTION	N
STREET	LOOMIS
SUFFIX	ST
PIN	0818307001
LOCAL SIGNIFICANCE RATING	C
POTENTIAL IND NR? (Y or N)	N
Contributing to a NR DISTRICT?	C
Contributing secondary structure?	NC
Listed on existing SURVEY?	Local District; NR District

CATEGORY	building	CURRENT FUNCTION	Domestic - single dwelling
CONDITION	good	HISTORIC FUNCTION	Domestic - single dwelling
INTEGRITY	major alterations and/or addition(s)	REASON for SIGNIFICANCE	
SECONDARY STRUCTURE	Detached garage

ARCHITECTURAL CLASSIFICATION	Queen Anne - Free Classic	PLAN	irregular
DETAILS		NO OF STORIES	2.5
BEGINYEAR	c. 1910-15	ROOF TYPE	Gable on hip
OTHER YEAR		ROOF MATERIAL	Asphalt - shingle
DATESOURCE	Surveyor	FOUNDATION	Stone
WALL MATERIAL (current)	Wood	PORCH	Front
WALL MATERIAL 2 (current)		WINDOW MATERIAL	Wood/Vinyl
WALL MATERIAL (original)	Wood	WINDOW MATERIAL	Stained glass
WALL MATERIAL 2 (original)		WINDOW TYPE	Double hung/single hung
		WINDOW CONFIG	1/1; stained glass
SIGNIFICANT FEATURES	Hipped roof with pent gable front bay; gabled south bay with cutaway corners; historic hipped roof front porch with classical wooden columns		
ALTERATIONS	Replacement railings and steps on front porch; vinyl 1/1 replacement windows in original openings; fixed shutters; 2 story rear add. (not-historic); replacement front door In kind replacement of ceiling, deck, steps, roof, and skirting of front porch (admin. approved (COA# 10-2000) Front porch removal (HPC approved COA#10-2215)

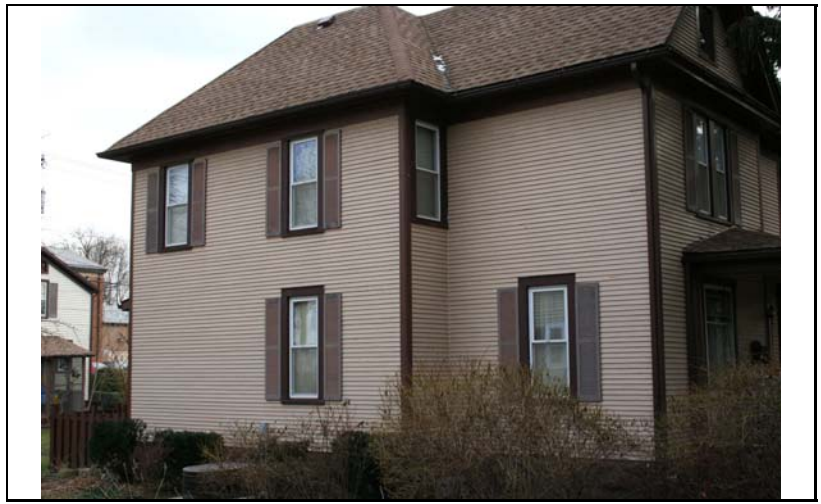
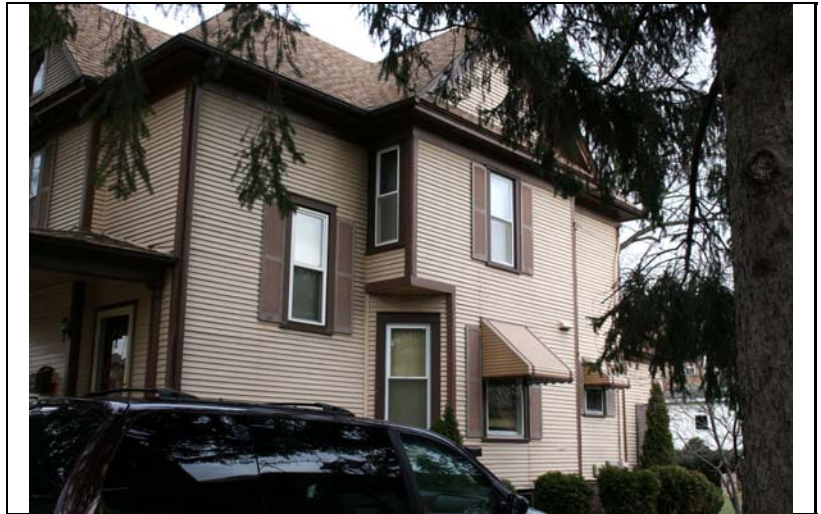
146 N LOOMIS

Aluminum siding; fixed shutters (not historic); replacement windows in original openings; 3-part window on front façade 1st story; multi-light wood window linking two first story windows on S. elevation; 2 story rear addition; 3-light & 2/2 windows on N. elevation (historic—1920s); original front entry at north end of front façade converted to window; rear porch addition (1920s)

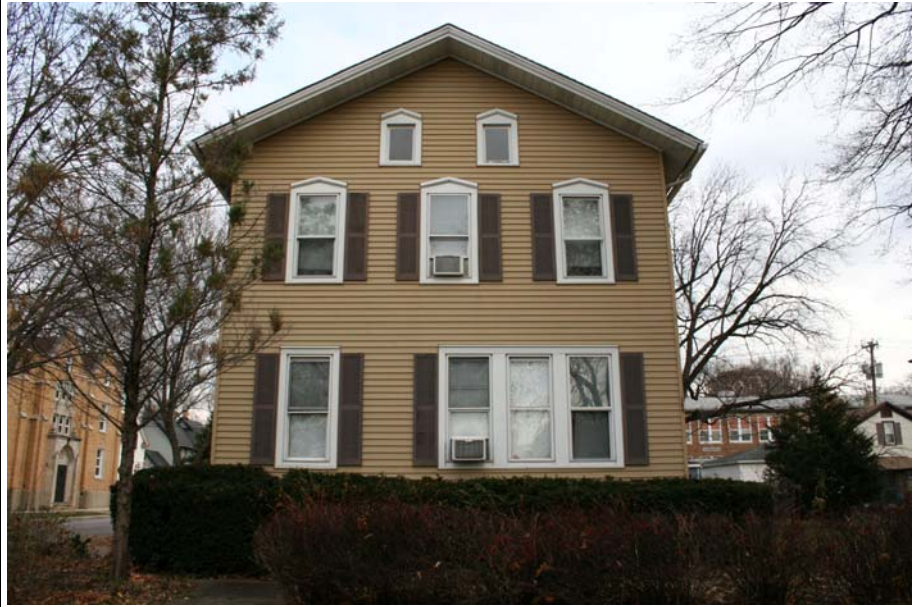
STREET #	154
DIRECTION	N
STREET	LOOMIS
SUFFIX	ST
PIN	0818138001
LOCAL SIGNIFICANCE RATING	C
POTENTIAL IND NR? (Y or N)	N
Contributing to a NR DISTRICT?	C
Contributing secondary structure?	-
Listed on existing SURVEY?	Local District; NR District

CATEGORY	building	CURRENT FUNCTION	Domestic - multiple dwelling
CONDITION	good	HISTORIC FUNCTION	Domestic - single dwelling
INTEGRITY	minor alterations and addition(s)	REASON for SIGNIFICANCE	
SECONDARY STRUCTURE

ARCHITECTURAL CLASSIFICATION	Gable Front	PLAN	rectangular
DETAILS	Italianate	NO OF STORIES	2.5
BEGINYEAR	c. 1875-80	ROOF TYPE	Front gable
OTHER YEAR		ROOF MATERIAL	Asphalt - shingle
DATESOURCE	Surveyor	FOUNDATION	Parged
WALL MATERIAL (current)	Aluminum	PORCH	-
WALL MATERIAL 2 (current)		WINDOW MATERIAL	Wood
WALL MATERIAL (original)	Wood	WINDOW MATERIAL	Vinyl
WALL MATERIAL 2 (original)		WINDOW TYPE	double hung/fixed
		WINDOW CONFIG	1/1; multi-light
SIGNIFICANT FEATURES	Front gable roof and rectangular massing; pedimented lintels		
ALTERATIONS	Aluminum siding; fixed shutters; 1/1 replacement windows in original openings (not historic); 3-part window on front façade 1st story; multi-light wood window linking two first story windows on S. elevation; 2 story rear addition--SEE CONTINUATION SHEET Demolition of existing structure (HPC approval COA#15-961)
