City of NAPERVILLE

| STREET# | 218 | | | | |

| INSTORIC INFORMATION |
|---|
| PREPARER ORGANIZATION GRANACKI HISTORIC CONSULTANTS |
| SURVEYDATE 11/30/2007 |

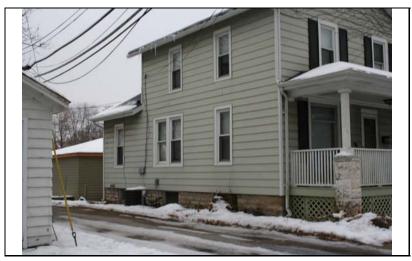
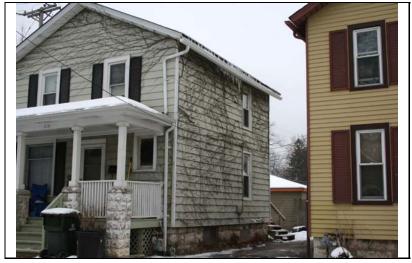
| INSTORIC INFORMATION |
|---|
| 218 NORTH |

| STREET# | 218 | | | | |
|--|---|---|--|--|---|
| CONDITION go | ood | | HISTORIC FUNCTION | ON Domestic - single dwell | ing |
| INTEGRITY m | inor alterations | | REASON for SIGNFICANCE | | |
| | | | | g leaded glass and leaded g d columns on concrete block | lass casement (damaged) |
| Replacement siding (not historic); vinyl replacement windows in original openings; fixed shutters; replacement door (not historic); replacement railings and columns on porch (ca. 1910) | | | | | |

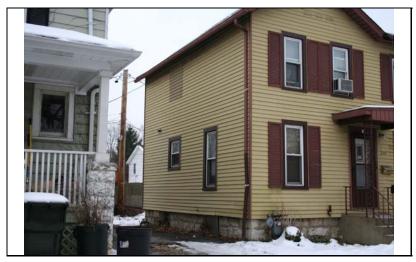
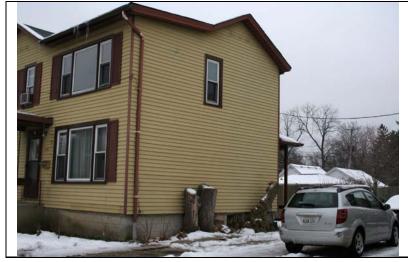
| HISTORIC INFORMATION | | | | |
|---|--|--|--|--|
| 214 NOR | NORTH | | | |

| STREET # | 214 | | | | | | |
|---|---|---|--|---|---|--|--|
| CONDITION fai | ir | | HISTORIC FUNCTI | ON Domestic - single dwe | Domestic - single dwelling | | |
| INTEGRITY ma | ajor alterations | s and/or addition(s) | REASON for SIGNFICANCE | | | | |
| SIGNIFICANT FEATURES | Front gable ba | y and recessed side | le gable wing (now obscur | ed by later addition) | | | |
| c | | | | | n-historic); replacement front utters; rear porch addition (non- | | |
