# ILLINOIS URBAN ARCHITECTURAL AND HISTORICAL SURVEY

COA DATE	
COA DECISION	
PREPARER	Lara Ramsey
PREPARER ORGANIZATION	GRANACKI HISTORIC CONSULTANTS
SURVEYDATE	11/7/2007
SURVEYAREA	NAPERVILLE
226 N WRI	GHT

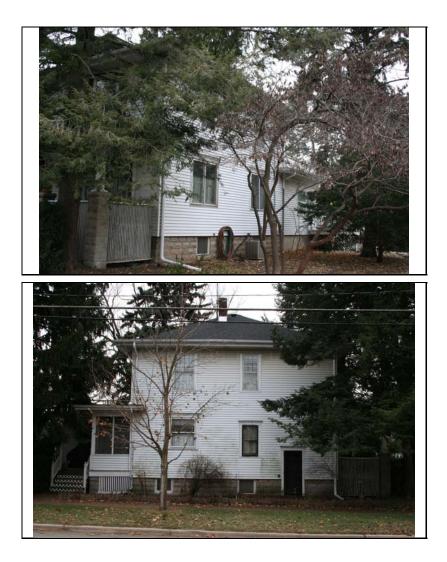
CATEGORY	building	CURRENT FUNCTION	ON Domestic - single dwelling
CONDITION	good	HISTORIC FUNCTI	ON Domestic - single dwelling
INTEGRITY	minor alterations and addition(s)	SIGNFICANCE	Intact early 20th-century Colonial Revival, featuring a broad front porch with classical columns on a concrete block base.
SECONDARY STRUCTURE	Detached garage

ARCHITECTURA	т			
CLASSIFICATIO		Revival	PLAN	rectangular
			NO OF STORIES	2.5
DETAILS			<b>ROOF TYPE</b>	Hipped
BEGINYEAR	1904		<b>ROOF MATERIAL</b>	Asphalt - shingle
OTHER YEAR			FOUNDATION	Concrete - block
DATESOURCE	Owner		FOUNDATION	CONCIERE - DIOCK

-		PORCH	Full front
WALL MATERIA		Aluminum	WINDOW MATERIA	L Wood
WALL MATERIA	L 2 (current)		WINDOW MATERIA	L Leaded glass
WALL MATERIA	L (original)	Wood		L Leaded glass
			WINDOW TYPE	double hung/single hung
WALL MATERIA	L 2 (original)		WINDOW CONFIG	1/1; multi/1
	Hipped roof w/ front hipped dormer; full front porch with classical columns on concrete block piers; 3-sided window bay under porch; historic wood door; historic; multi-light/1; 1/1 and leaded glass windows on front & south elevations			
	Aluminum siding (not historic); 1 story rear add. (1960s); rear deck add. (1987); replacement windows in original openings on S. elevation (not historic); N. side doorway downsized to window, w/ at grade doorway installed (not historic)

HISTORIC NAME	Garment House
COMMON NAME	
COST	
ARCHITECT	
ARCHITECT	2
BUILDER	
ARCHITECT SOURCE	
INFO	See continuation sheet for historic postcard of house and owner information.
PERMITS	
LANDSCAPE	Southeast corner of Wright and North; double lot; front and north sidewalks; similar setbacks; mature trees

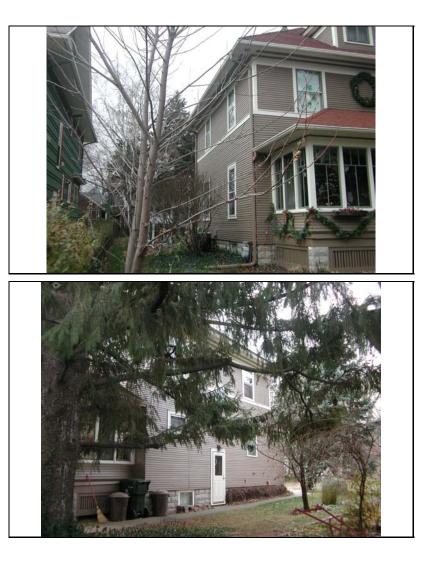
COA DATE	
COA DECISION	
PREPARER	Lara Ramsey
PREPARER ORGANIZATION	GRANACKI HISTORIC CONSULTANTS
SURVEYDATE	11/8/2007
SURVEYAREA	NAPERVILLE
131 N WRI	GHT

STREET #	131		A states		
DIRECTION	Ν				1 and the second
STREET	WRIGHT				A PART AND A
SUFFIX	ST				
PIN	0818308012				1
LOCAL SIGNIFICANCE RATING	С				
POTENTIAL IND NR? (Y or N)	Ν				
Contributing to a NR DISTRICT?	С				
Contributing second	dary structure	? C	the state of the s		
Listed on existing SURVEY?	Local District;	NR District			
			GENERAL INFO	RMATION	
CATEGORY bu	iilding		CURRENT FUNCTION	DN Domestic - single dwell	ing
CONDITION ex	cellent		HISTORIC FUNCTION	ON Domestic - single dwell	ing
INTEGRITY minor alterations and addition(s) REASON for SIGNFICANCE					
SECONDARY STRUCTURE	Detached gar	age			
			ARCHITECTURAI	L DESCRIPTION	
ARCHITECTURA CLASSIFICATION		Foursquare		PLAN	rectangular
	, incritati	rouioquaio		NO OF STORIES	2.5
DETAILS	c. 1915			ROOF TYPE	Hipped
BEGINYEAR	C. 1915			<b>ROOF MATERIAL</b>	Asphalt - shingle
OTHER YEAR	Survoyor			FOUNDATION	Concrete - block
DATESOURCE	Surveyor	Wood		PORCH	Full front

WALL MATERIA		vvoou		WINDOW MATERIA	L Wood
WALL MATERIA		Wood		WINDOW MATERIA	L Stained glass
WALL MATERIA		WOOU		WINDOW TYPE	Double & single hung/case
WALL MATERIA	u 2 (original)			WINDOW CONFIG	1/1; 1-light
	Hipped roof wit double hung wi		s under eaves and front hip	ped dormer; curved knee w	all of front porch; historic 1/1
			n windows (historic alteratio behind porch; wrought iron		have been raised (not

2
Midblock on west side of residential street; front sidewalk; rear alley; similar setbacks; mature trees

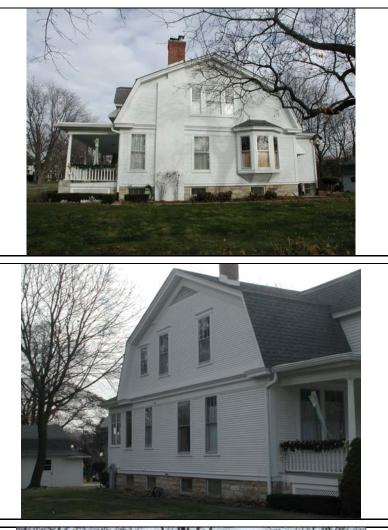
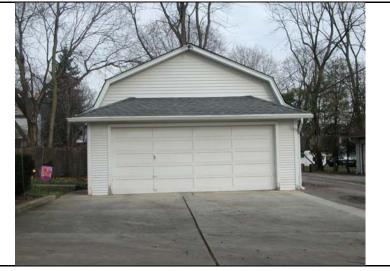
132 S WRIGHT

STREET #	132		-	· F		~	Propagat 1
DIRECTION	S						1
STREET	WRIGHT				iii./		S THE
SUFFIX	ST			A REAL PROPERTY AND			
PIN	0818323004		100	17		TRACK CANON	
LOCAL SIGNIFICANCE RATING	S			been state			
POTENTIAL IND NR? (Y or N)	Ν						
Contributing to a NR DISTRICT? Contributing secon	C dary structure	? C					
Listed on existing SURVEY?	IHSS (O); Lo	cal District; NR		R		, i	
GENERAL INFORMATION							
CATEGORY bu	uilding			CURRENT FUNCT	ION	Domestic - single dwelli	ng
CONDITION ex	cellent			HISTORIC FUNCT	ION	Domestic - single dwelli	ng
INTEGRITY minor alterations REASON for SIGNFICANCE SIGNFICANCE Unusual, early example of Dutch Colonial Revival architecture, with broad side-gambrel roof and classical front porch.							
SECONDARY STRUCTURE	Detached ga	rage					
			AR	CHITECTURA	LD	ESCRIPTION	
ARCHITECTURA CLASSIFICATION		Ionial Revival				PLAN	rectangular
						NO OF STORIES	2
DETAILS	- 1005					<b>ROOF TYPE</b>	Side gambrel

BEGINYEAR	c. 1905					<b>ROOF MATERIAL</b>	Asphalt - shingle
OTHER YEAR						FOUNDATION	Stone
DATESOURCE	NHS add					PORCH	Full front
WALL MATERIA		Wood				WINDOW MATERIA	
WALL MATERIA	L 2 (current)	aluminum				WINDOW MATERIA	
WALL MATERIA	L (original)	Wood				WINDOW TYPE	Double hung/single hung
WALL MATERIA	L 2 (original)					WINDOW CONFIG	3/1; 1/1

Broad side gambrel roof with cornice returns; front gambrel centered along front façade; 3-sided south side window bay with leaded glass windows
Replacement 3/1 wood windows in original openings (historic1920s); replacement front porch (historic); Aluminum awning on front 2nd story window (not historic)

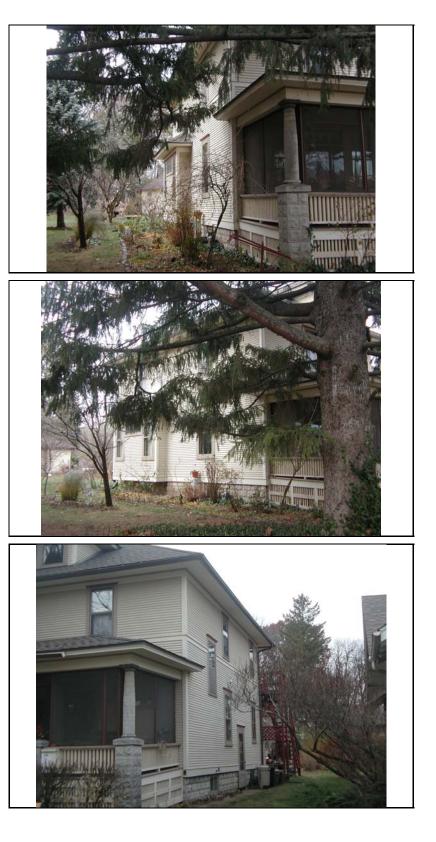
STREET #	135						
DIRECTION	Ν		14.1		5 6	alt	2
STREET	WRIGHT		The second				
SUFFIX	ST		14				
PIN	0818308011		2				
LOCAL SIGNIFICANCE RATING	С			Contraction of the second	1500	a .	
POTENTIAL IND NR? (Y or N)	Ν			STREET,		135	
Contributing to a NR DISTRICT?	С			erai			
Contributing secon	dary structure	? C					
Listed on existing SURVEY?	Local District;	NR District		Contractor			
GENERAL INFORMATION							
CATEGORY bu	uilding			CURRENT FUNCTION	ON	Domestic - single dwelli	ng
CONDITION ex	kcellent			HISTORIC FUNCTION	ON	Domestic - single dwelli	ng
INTEGRITY m	inor alterations	and addition(s)		REASON for SIGNFICANCE			
SECONDARY STRUCTURE	Detached gar	age					
			AR	CHITECTURAI	L DI	ESCRIPTION	
ARCHITECTURA CLASSIFICATION		Foursquare				PLAN	rectangular
DETAILS		•				NO OF STORIES	2.5
BEGINYEAR	c. 1910					<b>ROOF TYPE</b>	Hipped
OTHER YEAR	0. 1910					<b>ROOF MATERIAL</b>	Asphalt - shingle
DATESOURCE	Surveyor					FOUNDATION	Concrete - block

ALTERATIONS Porch columns/piers on porch appear to be replacement (not historic); porch screened in (not historic); replacement windows in dormer (enlarge openings, not historic); north exterior stair addition (not historic); one story rear addition

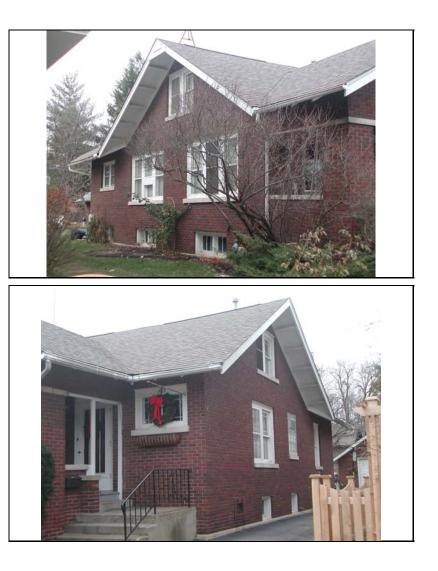
COA DATE	
COA DECISION	
PREPARER	Lara Ramsey
PREPARER ORGANIZATION	GRANACKI HISTORIC CONSULTANTS
SURVEYDATE	11/8/2007
SURVEYAREA	NAPERVILLE
139 N WRI	GHT

STREET #	139				
DIRECTION	N				
STREET	WRIGHT				
SUFFIX	ST				
PIN	0818308010			NEW .	
LOCAL SIGNIFICANCE RATING POTENTIAL IND NR? (Y or N)	C				
Contributing to a NR DISTRICT? Contributing second Listed on existing SURVEY?	C dary structure Local District;				
			GENERAL INFO	<b>RMATION</b>	
CATEGORY bu	ilding		CURRENT FUNCTIO	N Domestic - single dwel	ling
CONDITION ex	cellent		HISTORIC FUNCTIO	N Domestic - single dwel	ling
INTEGRITY       minor alterations       REASON for SIGNFICANCE       Fine example of Craftsman Bungalow, with broad eaves and a front gable porch with stout columns on solid knee walls.         SECONDARY STRUCTURE       Detached garage       Detached garage					
				DESCRIPTION	
ARCHITECTURA			ARCHITECTURAL	<u>DESCRIPTION</u> → PLAN	rectangular
CLASSIFICATION	Craftsmar	n Bungalow		NO OF STORIES	1.5
DETAILS				ROOF TYPE	Side gable
BEGINYEAR	c. 1925			ROOF MATERIAL	Asphalt - shingle
OTHER YEAR				FOUNDATION	concrete

DATESOURCE	Surveyor			PORCH	Front
WALL MATERIA	L (current)	Brick		WINDOW MATERIA	
WALL MATERIA	L 2 (current)			WINDOW MATERIA	
WALL MATERIA	L (original)	Brick		WINDOW TYPE	Double hung/awning
WALL MATERIA	L 2 (original)			WINDOW CONFIG	91/ geometric; 9-light geo
		f with overhanging toric 9/1 and 9-ligh	eaves and exposed rafter ta t wood windows		
ALTERATIONS North side window filled with glass block (not historic); framing for door at porch entry (not historic); replacement porch steps and railing

HISTORIC NAME	
COMMON NAME	
COST	
ARCHITECT	
ARCHITECT2	
BUILDER	
ARCHITECT SOURCE	
HISTORIC INFO	
PERMITS	
	Midblock on west side of residential street; side driveway; similar setbacks; mature trees

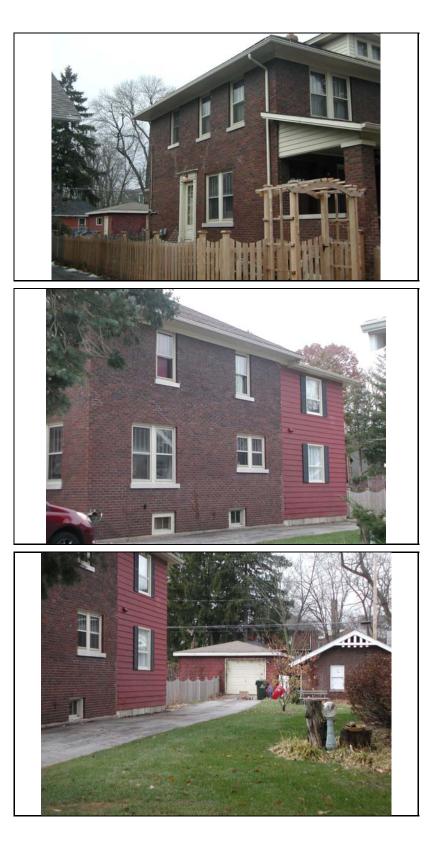
143 N WRIGHT

STREET #	143			- All
DIRECTION	Ν			and the second s
STREET	WRIGHT			A A A
SUFFIX	ST			
PIN	0818308009			
LOCAL SIGNIFICANCE RATING	C		1	
POTENTIAL IND NR? (Y or N)	Ν			
			e c	
Contributing to a NR DISTRICT?	C			****
Contributing second	lary structure? C	A COLOR	The state of the state of	
Listed on existing SURVEY?	Local District; NR District			
GENERAL INFORMATION				
		GENERAL INFUR		
CATEGORY bu	ilding	CURRENT FUNCTION	Domestic - single dwel	ling
	ilding od			-
CONDITION go		CURRENT FUNCTION HISTORIC FUNCTION REASON for	Domestic - single dwel	-
CONDITION go INTEGRITY mi	od	CURRENT FUNCTION	Domestic - single dwel	-
CONDITION gc INTEGRITY mi SECONDARY	od	CURRENT FUNCTION HISTORIC FUNCTION REASON for	Domestic - single dwel	-
CONDITION go INTEGRITY mi	od nor alterations and addition(s)	CURRENT FUNCTION HISTORIC FUNCTION REASON for SIGNFICANCE	Domestic - single dwel	-
CONDITION gc INTEGRITY mi SECONDARY	od nor alterations and addition(s) Detached garage	CURRENT FUNCTION HISTORIC FUNCTION REASON for	Domestic - single dwel Domestic - single dwel Domestic - single dwel	ling

WALL MATERIA	T (	Brick	IORCII	Tom
WALL MATERIAL (current)		DIICK	WINDOW MATERIAL	Wood
WALL MATERIAL 2 (current)		vinyl		Weed
			WINDOW MATERIAL	
WALL MATERIAL (original)		Brick		
WALL MATERIAL 2 (original)		Wood	WINDOW TYPE	double hung/casement
		Wood	WINDOW CONFIG	4/1; 1-light
	Hipped roof wit classical surrou	h overhanging eaves and hipped dormer; historio	c 4/1 and 1-light wood win	dows; south side entry with

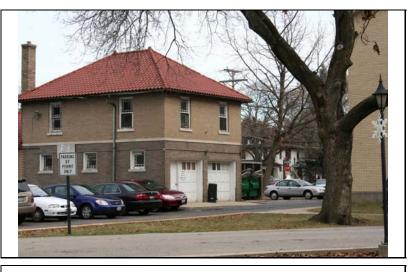
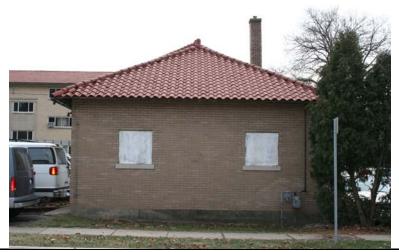
COA DATE	
COA DECISION	
PREPARER	Lara Ramsey
PREPARER ORGANIZATION	GRANACKI HISTORIC CONSULTANTS
SURVEYDATE	11/7/2007
SURVEYAREA	NAPERVILLE
148 N WRI	ЭНТ

ARCHITECTURAL					r٩	ctangular
CLASSIFICATION	Garage			I LAN	10	etaligulai
				NO OF STORIES	2	
DETAILS				ROOF TYPE	Hi	pped
BEGINYEAR	c. 1910					FF
OTHER YEAR				<b>ROOF MATERIAL</b>	Ce	eramic Tile
UTHER TEAR				FOUNDATION	C	oncrete
DATESOURCE	Surveyor			DODGH		
WALL MATERIAL (c	urrent)	Brick		PORCH		
	,			WINDOW MATERIA	L	Wood
WALL MATERIAL 2	(current)			WINDOW MATERIA	T	
WALL MATERIAL (o	riginal)	Brick				
,	0 /			WINDOW TYPE		double hung/awning
WALL MATERIAL 2	(original)			WINDOW CONFIG		multi-light
				WINDOW CONFIG		mun-ngm
SIGNIELCANT Hipp	od roof wi	th coromic tilo	- historia multi light double hung	and awaing windows: two	h-214	aarago doors

SIGNIFICANT FEATURES	Hipped roof with ceramic tile; historic multi-light double hung and awning windows; two-bay garage doors
ALTERATIONS	Replacement garage doors; one story north addition (historic)windows in addition boarded up

HISTORIC NAME	Kroehler, P.E., Carriage House
COMMON NAME	
COST	
ARCHITECT	
ARCHITECT2	
BUILDER	
ARCHITECT SOURCE	
	/as originally carriage house for the . E. Kroehler House
PERMITS	
	Midblock on south side of residential street; parking lot to east; mature trees

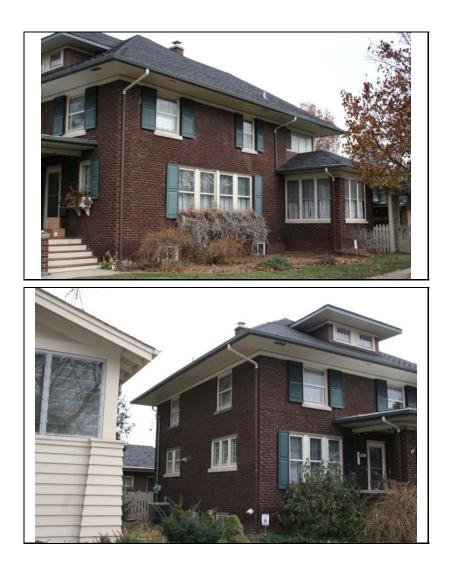
COA DATE	
COA DECISION	
PREPARER	Lara Ramsey
PREPARER ORGANIZATION	GRANACKI HISTORIC CONSULTANTS
SURVEYDATE	11/7/2007
SURVEYAREA	NAPERVILLE
204 N WRI	GHT

STREET #	204	
DIRECTION	Ν	
STREET	WRIGHT	
SUFFIX	ST	
PIN	0818143005	
LOCAL SIGNIFICANCE RATING	S	
POTENTIAL IND NR? (Y or N)	Ν	
Contributing to a NR DISTRICT?	C	
Contributing second	lary structure? C	
Listed on existing SURVEY?	Local District; NR District	
		GENERAL INFORMATION
CATEGORY bu	lding	CURRENT FUNCTION Domestic - single dwelling
CONDITION ex	cellent	HISTORIC FUNCTION Domestic - single dwelling
INTEGRITY Ad	dition(s)	REASON for         Fine local example of Prairie Style with some Colonial details.
SECONDARY STRUCTURE	Detached garage Det. Gar. (NC)	
		ARCHITECTURAL DESCRIPTION
ARCHITECTURAI CLASSIFICATION		PLAN rectangular
DETAILS		NO OF STORIES 2.5
DETAILS	Colonial Revival

ALTERATIONS Two story rear addition Demolition of a chimney & in kind replacement (admin. approved COA#13-4149)

HISTORIC NAME	
COMMON NAME	
COST	
ARCHITECT	
ARCHITECT	2
BUILDER	
ARCHITECT SOURCE	
HISTORIC INFO	
PERMITS	
LANDSCAPE	Northeast corner of Wright and School; front and south sidewalks; rear driveway; rear picket fence; similar setbacks; mature trees

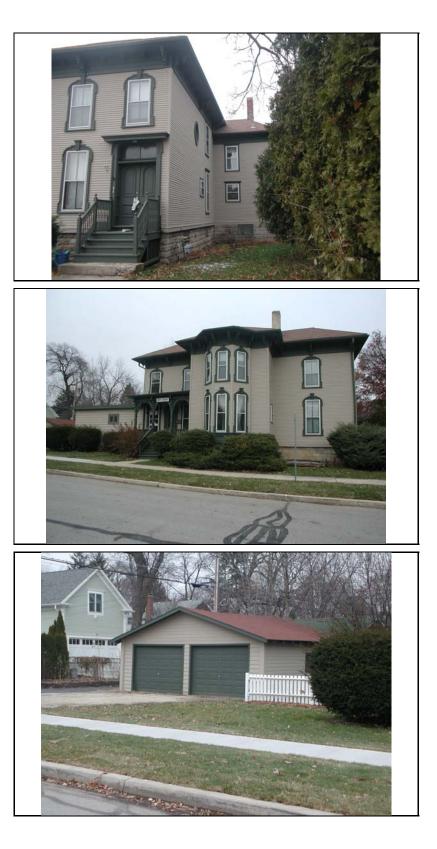
205 N WRIGHT

STREET #	205				
DIRECTION	Ν				
STREET	WRIGHT		South		
SUFFIX	ST			A A	
PIN	0818140010				- ANCASA
LOCAL SIGNIFICANCE RATING POTENTIAL IND NR? (Y or N) Contributing to a NR DISTRICT? Contributing secon Listed on existing SURVEY?	-	P C			
			GENERAL INFO	DRMATION	
CATEGORY bu	uilding		CURRENT FUNCTION	ON Domestic - single dwel	ling
CONDITION ex	cellent		HISTORIC FUNCTION	ON Domestic - single dwel	ling
INTEGRITY m SECONDARY STRUCTURE	inor alterations	and addition(s) age	SIGNFICANCE	Elegant Italianate residence window surrounds and corr and pendants. Listed on IH	nice with carved wood brackets
			ARCHITECTURA	LDESCRIPTION	
ARCHITECTURA CLASSIFICATION			<u>ARCHITECTORN</u>	PLAN	irregular
				NO OF STORIES	2
DETAILS BEGINYEAR	c. 1880			ROOF TYPE	Hipped
OTHER YEAR	C. 1000			<b>ROOF MATERIAL</b>	Asphalt - shingle
DATESOURCE		hure (East)		FOUNDATION	Concrete - block
WALL MATERIA		Wood		PORCH	Side
WALL MATERIA		11000		WINDOW MATERIA	AL Wood

WALL MATERIA		Wood		WINDOW MATERIA	
	-	11000		WINDOW TYPE	double hung
WALL MATERIA	L 2 (original)			WINDOW CONFIG	1/1; 2/2 vertical
FEATURES	story south win		try with double wood panel	pendants) under eaves; pa ed doors, segmental arch tr	neled wood frieze; 3-sided 2- ansom, and incised wood
				historic); 1/1 replacement v nent front stoop (not historic	vindow on east side of south c)

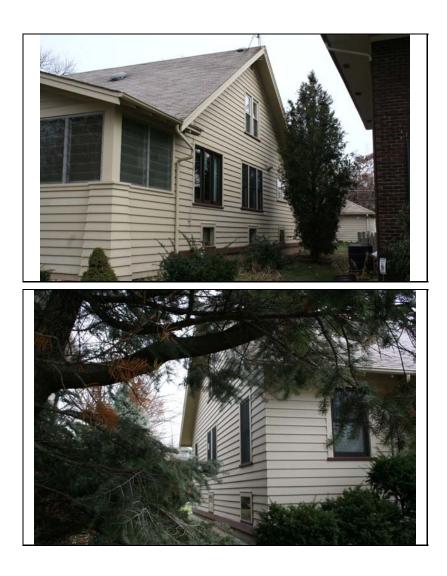
STREET #	210				+ /1
DIRECTION	Ν	1			No Di
STREET	WRIGHT		CARL CONTRACTOR		
SUFFIX	ST				
PIN	0818143004			-	
LOCAL SIGNIFICANCE RATING	С				
POTENTIAL IND NR? (Y or N)	Ν				
Contributing to a NR DISTRICT?	С				
Contributing second	dary structure?	С			
Listed on existing SURVEY?	Local District; N	NR District	and the second		·
			GENERAL INFO	RMATION	
CATEGORY bu	ilding		CURRENT FUNCTION	ON Domestic - single dwell	ing
CONDITION ex	cellent		HISTORIC FUNCTION	ON Domestic - single dwell	ing
<b>INTEGRITY</b> mi	nor alterations		REASON for SIGNFICANCE		
SECONDARY	Detached garage	ae			
STRUCTURE	_ chaoned gand,	30			
		<u>A</u>	RCHITECTURAI	L DESCRIPTION	
ARCHITECTURA CLASSIFICATION				PLAN	rectangular
DETAILS				NO OF STORIES	1.5
BEGINYEAR	1923			ROOF TYPE	Side gable
OTHER YEAR	1920			<b>ROOF MATERIAL</b>	Asphalt - shingle
DATESOURCE	NCC			FOUNDATION	Concrete - block
WALL MATERIA		Wood		PORCH	Front
	· · L	wood		WINDOW MATERIA	L Wood

WALL MATERIA		Wood		WINDOW MATERIA	L Metal
WALL MATERIAL		wood		WINDOW TYPE	double hung/jalousie/casm
WALL MATERIA	L 2 (original)			WINDOW CONFIG	1/1; multi-light; 1-light
SIGNIFICANT FEATURES	Side gable roof v	with exposed rafter	tails; front gable porch w	vith battered piers	
			vs; replacement windows (admin. approved COA

HISTORIC NAME	Kolthoff, Clyde P. & Ruth House
COMMON NAME	
COST	
ARCHITECT	
ARCHITECT2	
BUILDER	
ARCHITECT SOURCE	
HISTORIC INFO	
PERMITS	
	Midblock on east side of residential street; front sidewalk; rear alley; similar setbacks; mature trees

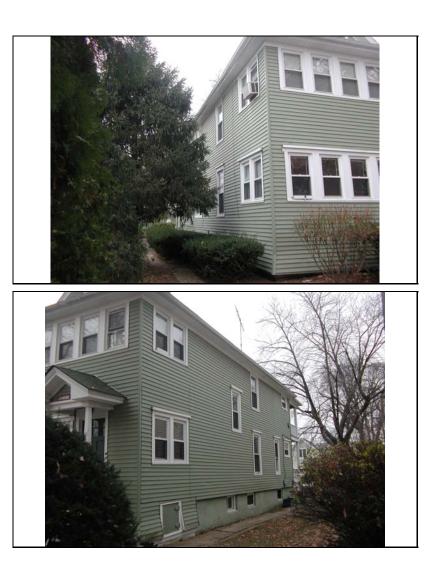
COA DATE	
COA DECISION	
PREPARER	Lara Ramsey
PREPARER ORGANIZATION	GRANACKI HISTORIC CONSULTANTS
SURVEYDATE	11/12/2007
SURVEYAREA	NAPERVILLE
211 N WRI	ЭНТ

STREET # DIRECTION STREET SUFFIX PIN LOCAL SIGNIFICANCE RATING POTENTIAL IND NR? (Y or N) Contributing to a NR DISTRICT? Contributing secon Listed on existing SURVEY?	211 N WRIGHT ST 0818140009 NC N NC dary structure:				
			<b>GENERAL INFO</b>	<b>RMATION</b>	
CATEGORY bu	uilding		CURRENT FUNCTIO	N Domestic - multiple dwe	elling
CONDITION G	ood/Fair		HISTORIC FUNCTIO	N Domestic - single dwelli	ng
INTEGRITY m	ajor alterations	and/or addition(s)	REASON for SIGNFICANCE		
SECONDARY STRUCTURE	SECONDARY Detached garage STRUCTURE				
ARCHITECTURA			ARCHITECTURAL	<u> DESCRIPTION</u>	rectangular
CLASSIFICATION	N No Style				2.5
DETAILS				NO OF STORIES	
BEGINYEAR	c. 1900			<b>ROOF TYPE</b>	Front gable
OTHER YEAR				ROOF MATERIAL	Asphalt - shingle
DATESOURCE	surveyor			FOUNDATION	Parged/concrete
WALL MATERIA	L (current)	Vinyl		PORCH	Front entry
WALL MATERIA	L 2 (current)			WINDOW MATERIA	,
WALL MATERIA	L (original)	Wood		WINDOW MATERIA

WALL MATERIA	-			WINDOW TYPE	double hung
SIGNIFICANT FEATURES ALTERATIONS	Original house		ry front addition (my have o ndows in original opening or		1/1 addition that was enclosed);
	viriyi siairig; rep	nacement vinyi wir	loows in original opening of	in side elevations

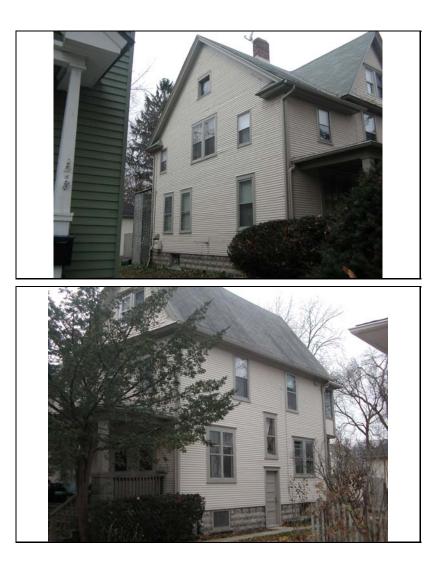
COA DATE	
COA DECISION	
PREPARER	Lara Ramsey
PREPARER ORGANIZATION	GRANACKI HISTORIC CONSULTANTS
SURVEYDATE	11/12/2007
SURVEYAREA	NAPERVILLE
215 N WRI	ЭНТ

STREET #	215				
DIRECTION	Ν				
STREET	WRIGHT				A NO TO TO
SUFFIX	ST				States And
PIN	0818143008		AT THE REAL PROPERTY AND A PROPERTY		
LOCAL SIGNIFICANCE RATING	С				
POTENTIAL IND NR? (Y or N)	<b>N</b>				
Contributing to a NR DISTRICT?	C	? C			
Contributing secon Listed on existing SURVEY?	Local District				
			<b>GENERAL INFO</b>	<b>RMATION</b>	
CATEGORY b	ouilding		CURRENT FUNCTIO	N Domestic - multiple dw	relling
CONDITION	jood		HISTORIC FUNCTIO	N Domestic - single dwel	ling
INTEGRITY	ninor alterations	and addition(s)	REASON for		
			SIGNFICANCE		
SECONDARY Detached garage					
				DECONDITION	
ARCHITECTUR			ARCHITECTURAL	$\rightarrow$ PLAN	rectangular
CLASSIFICATIO	N Queen Ar	nne		NO OF STORIES	2.5
DETAILS				ROOF TYPE	Side gable
BEGINYEAR	c. 1905			ROOF MATERIAL	Asphalt - shingle
OTHER YEAR				FOUNDATION	Concrete - block
DATESOURCE	Surveyor			PORCH	Full front
WALL MATERIA	AL (current)	Wood		WINDOW MATERIA

WALL MATERIA	AL 2 (current)	Wood - shingle		WINDOW MATERIA	
WALL MATERIA	AL (original)	Wood		WINDOW TYPE	Double hung/single hung
WALL MATERIA	AL 2 (original)	Wood - shingle		WINDOW CONFIG	1/1
SIGNIFICANT FEATURES	Side gable roo historic 1/1 woo		able; cornice returns; front p		
ALTERATIONS			not historic); rear porch addi ersion); replacement porch fl		under gable (not historic); 2 historic)

HISTORIC NAME	
COMMON NAME	
COST	
ARCHITECT	
ARCHITECT2	
BUILDER	
ARCHITECT SOURCE	
HISTORIC INFO	
PERMITS	
LANDSCAPE	Midblock on west side of residential street; front sidewalk; rear alley; similar setbacks; mature trees

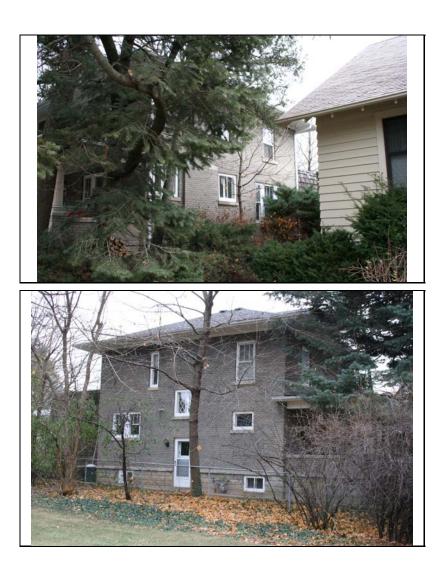
COA DATE	
COA DECISION	
PREPARER	Lara Ramsey
PREPARER ORGANIZATION	GRANACKI HISTORIC CONSULTANTS
SURVEYDATE	11/7/2007
SURVEYAREA	NAPERVILLE
216 N WRI	GHT

STREET #	216			
DIRECTION	Ν			
STREET	WRIGHT			
SUFFIX	ST		AND THE REAL PROPERTY	
PIN	0818140003			
LOCAL SIGNIFICANCE RATING	S			
POTENTIAL IND NR? (Y or N)	Ν			
Contributing to a NR DISTRICT? Contributing second Listed on existing				
SURVEY?	Local District; NR District			
SURVEY?	Local District; NR District	GENERAL INFOR	RMATION	
	ILOCAI District; NR District	GENERAL INFOR		ling
CATEGORY bu			N Domestic - single dwel	•
CATEGORY bu CONDITION ex	ilding	CURRENT FUNCTION HISTORIC FUNCTION REASON for Th	N Domestic - single dwel	ing Foursquare with distinctive
CATEGORY bu CONDITION ex	ilding	CURRENT FUNCTION HISTORIC FUNCTION REASON for Th	N Domestic - single dwel N Domestic - single dwel	ing Foursquare with distinctive
CATEGORY bu CONDITION ex INTEGRITY ac SECONDARY STRUCTURE	ilding cellent ldition(s) Detached garage	CURRENT FUNCTION HISTORIC FUNCTION REASON for Th	Domestic - single dwel Domestic - single dwel nis handsome American F ont porch is almost comple	ing Foursquare with distinctive

HISTORIC NAME	
COMMON NAME	
COST	
ARCHITECT	
ARCHITECT	2
BUILDER	
ARCHITECT SOURCE	
HISTORIC INFO	
PERMITS	
LANDSCAPE	Midblock on east side of residential street; front sidewalk; rear alley; similar setbacks; mature trees

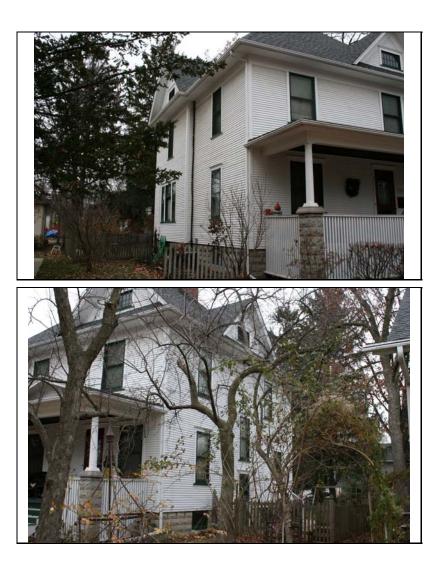
COA DATE	
COA DECISION	
PREPARER	Lara Ramsey
PREPARER ORGANIZATION	GRANACKI HISTORIC CONSULTANTS
SURVEYDATE	11/12/2007
SURVEYAREA	NAPERVILLE
219 N WRI	GHT

STREET #	219	1	NAME TO DE L
DIRECTION	N		
STREET	WRIGHT		
SUFFIX	ST	William Contraction	
PIN	0818140007	Ville V	
LOCAL SIGNIFICANCE			
RATING	S		
POTENTIAL IND NR? (Y or N)	N		
		I BOL	
Contributing to a NR DISTRICT?	С		
Contributing second	dary structure? C		
Listed on existing SURVEY?	Local District; NR District		
		GENERAL INFO	DRMATION
CATEGORY bu	ilding	CURRENT FUNCTION	ON Domestic - single dwelling
CONDITION go	od	HISTORIC FUNCTI	ON Domestic - single dwelling
<b>INTEGRITY</b> mi	nor alterations		Fine, intact example of the American Foursquare type, with Queen Anne - Free Classic details.
SECONDARY STRUCTURE	Barn	_

ARCHITECTURA	-	_		- PLAN	rea	ctangular
CLASSIFICATIO	N American	Foursquare				
DETAILS	Queen An	ne - Free Cla		NO OF STORIES	2.5	5
DETAILS			3510	<b>ROOF TYPE</b>	Ga	able on hip
BEGINYEAR	1909			<b>ROOF MATERIAL</b>	Δ.c	phalt chingle
OTHER YEAR				KOUF MATERIAL	AS	phalt - shingle
				FOUNDATION	Сс	oncrete - block
DATESOURCE	Owner			PORCH	Fu	III front
WALL MATERIA	L (current)	Wood				
WALL MATERIA	L 2 (current)			WINDOW MATERIA	L	Wood
				WINDOW MATERIA	L	
WALL MATERIA	L (original)	Wood		WINDOW TYPE		
WALL MATERIA	L 2 (original)					Double hung/awning
				WINDOW CONFIG		1/1; multi-light
			de gables; hipped roof front porch 1/1 double hung and multi-light a			
ALTERATIONS	Replacement ra	ailings on por	ch (not historic); rear deck additior	n (not historic)

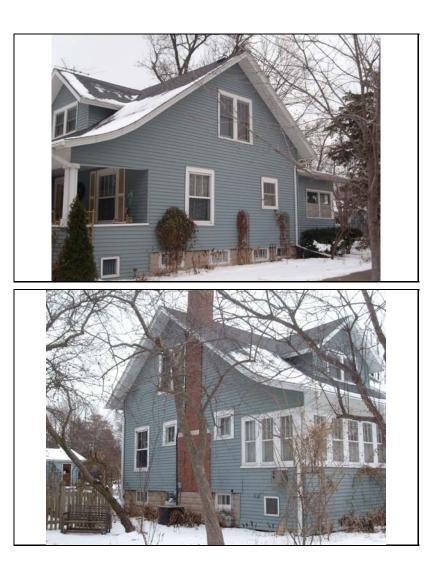
COA DATE	
COA DECISION	
PREPARER	Lara Ramsey
PREPARER ORGANIZATION	GRANACKI HISTORIC CONSULTANTS
SURVEYDATE	11/12/2007
SURVEYAREA	NAPERVILLE
225 N WRI	GHT

-	dary structure	? NC			
Listed on existing SURVEY?	Local District; NR District				
GENERAL INFORMATION					
CATEGORY bu	uilding		CURRENT FUNCTIO	Domestic - single dwe	lling
CONDITION go	bod		HISTORIC FUNCTION	Domestic - single dwe	lling
INTEGRITY	inor alterations	3	REASON for SIGNFICANCE		
SECONDARY	Deteched				
STRUCTURE	Detached ga	rage			
			ARCHITECTURAI	DESCRIPTION	
ARCHITECTURA CLASSIFICATION				PLAN	rectangular
	Bullgalov	V		NO OF STORIES	1.5
DETAILS				ROOF TYPE	Side gable
BEGINYEAR	c. 1920			<b>ROOF MATERIAL</b>	Asphalt - shingle
OTHER YEAR				<b>FOUNDATION</b>	Concrete - block
DATESOURCE	Surveyor			PORCH	Full front
WALL MATERIA		Aluminum		WINDOW MATERL	AL Wood
WALL MATERIAL 2 (current)		WINDOW MATERIAL Vinyl		AL Vinvl	
				WINDOW MATERI	
WALL MATERIA		Wood			
WALL MATERIA WALL MATERIA	L (original)	Wood		WINDOW TYPE	double hung
WALL MATERIA	L (original) L 2 (original) Side gable roo	f with front facing	gable dormer; integrated op all; historic 3/1 and 4/1 wood	WINDOW TYPE WINDOW CONFIG en front porch with south e	double hung           3/1; 4/1; 1/1

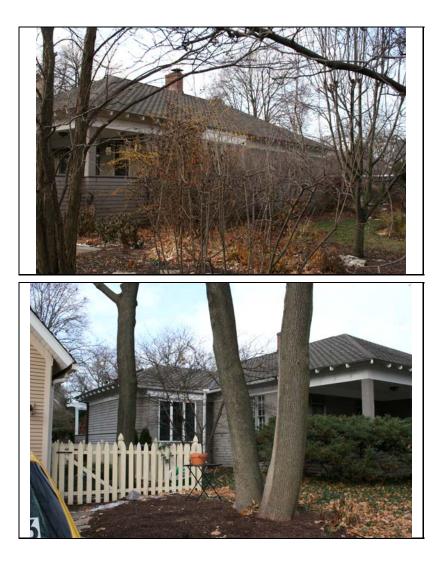
COA DATE	
COA DECISION	
PREPARER	Lara Ramsey
PREPARER ORGANIZATION	GRANACKI HISTORIC CONSULTANTS
SURVEYDATE	11/8/2007
SURVEYAREA	NAPERVILLE
127 S WRI	GHT

STREET #	127				
DIRECTION	S			HAC	4.4
STREET	WRIGHT	- A Far		ALC:	74
SUFFIX	ST		SAN MARK		Nel mar
PIN	0818322014				
LOCAL SIGNIFICANCE RATING	S				
POTENTIAL IND NR? (Y or N)	Ν				
Contributing to a NR DISTRICT?	С				
Contributing secon	ndary structure	? NC			
Listed on existing SURVEY?	IHSS (O); Lo	cal District; NR			
GENERAL INFORMATION					
CATEGORY b	uilding		CURRENT FUNCTION	DN Domestic - single dwell	ing
<b>CONDITION</b> g	ood		HISTORIC FUNCTION	ON Domestic - single dwell	ing
INTEGRITY	ddition(s)				man Bungalow includes fine
SECONDARY       Detached garage         STRUCTURE       Detached garage					
			ARCHITECTURAI	L DESCRIPTION	
ARCHITECTURA CLASSIFICATIO		n Bungalow		PLAN	L
		T Burigalow		NO OF STORIES	1
DETAILS	c. 1920			ROOF TYPE	Hipped
BEGINYEAR	C. 1920			<b>ROOF MATERIAL</b>	Asphalt shingle
OTHER YEAR DATESOURCE	Surveyor			FOUNDATION	Concrete - poured
WALL MATERIA		Stucco		PORCH	Full front
WALL MATERIA		Wood - shingle		WINDOW MATERIA	L Wood/Leaded glass

WALL MATERIA		Stucco		WINDOW MATERIA	L Vinyl
WALL MATERIA				WINDOW TYPE	Casement/fixed
	()B)	L		WINDOW CONFIG	1-light; multi-light
			ils; leaded glass windows; window bay; square projec	inset front porch structure ting north window bay	with stucco square piers on
ALTERATIONS	1-story south/re	ear addition

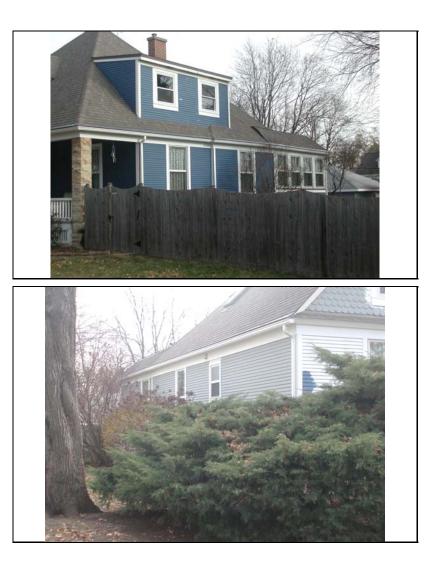
COA DATE	
COA DECISION	
PREPARER	Lara Ramsey
PREPARER ORGANIZATION	GRANACKI HISTORIC CONSULTANTS
SURVEYDATE	11/7/2007
SURVEYAREA	NAPERVILLE
122 S WRI	GHT

WALL MATERIAL (original) Wood			WINDO	WINDOW TYPE double hung/casement				
WALL MATERIAL 2 (original)				WINDO	W CONFIG	1/1; 1-light		
SIGNIFICANT FEATURES Hipped roof with front gable north bay; inset front porch (altered); historic 1/1 and 1-light wood windows								
ALTERATIONS	concroto block	niara an frant nara	h (may ba historia altoratia	n), chod roof	auth darmar	addition; front hipped dormer

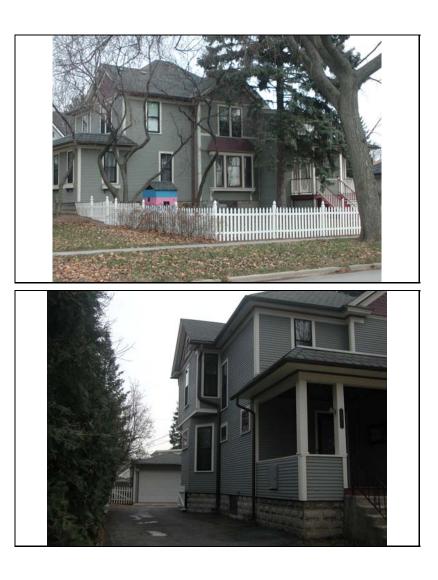
COA DATE	
COA DECISION	
PREPARER	Lara Ramsey
PREPARER ORGANIZATION	GRANACKI HISTORIC CONSULTANTS
SURVEYDATE	11/7/2007
SURVEYAREA	NAPERVILLE
6 N WRI	GHT

STREET #	6				
DIRECTION	Ν				
STREET	WRIGHT				
SUFFIX	ST				
PIN	0818312004				
CONDITION ex	Local District; iilding	NR District			<u> </u>
INTEGRITY	inor alterations	and addition(s)	REASON for SIGNFICANCE		
SECONDARY STRUCTURE	Detached gar	age			
	T		ARCHITECTURAL	DESCRIPTION	
ARCHITECTURA CLASSIFICATION		ine		PLAN	rectangular
DETAILS				NO OF STORIES	2
BEGINYEAR	c. 1900			ROOF TYPE	Hipped
OTHER YEAR				<b>ROOF MATERIAL</b>	Asphalt - shingle
DATESOURCE	surveyor			FOUNDATION	Concrete - block
WALL MATERIA		Wood		PORCH	-
WALL MATERIA		Wood - shingle		WINDOW MATERIA	AL Wood
WALL MATERIA	L (original)	Wood		WINDOW MATERIA	
WALL MATERIAL 2 (original) Wood - shingle			WINDOW TYPE	double hung

-				WINDOW CONFIG	1/1
FEATURES	1/1 wood windo	ows; 1st story south	side window bay		ory gabled south bay; historic
N	window on sou	th first story (histori	enclosed with 3/1 windows c); replacement siding (app and creation of a new 2 sto	propriate)	uth addition; replacement 3/1

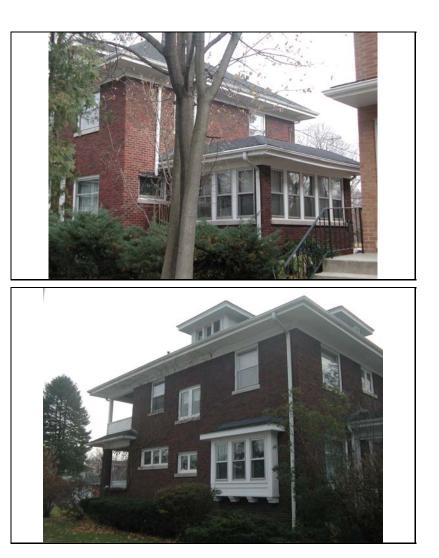
COA DATE	
COA DECISION	
PREPARER	Lara Ramsey
PREPARER ORGANIZATION	GRANACKI HISTORIC CONSULTANTS
SURVEYDATE	11/7/2007
SURVEYAREA	NAPERVILLE
6 S WRIC	GHT

NO OF STORIES	2.5	
DETAILS	Prairie					ROOF TYPE	Hip	ped
BEGINYEAR	c. 1925					<b>ROOF MATERIAL</b>	As	ohalt - shingle
OTHER YEAR						FOUNDATION	cor	ncrete
DATESOURCE	surveyor	Deiste				PORCH	Frc	ont entry
WALL MATERIA		Brick			]	WINDOW MATERIA	L	wood
WALL MATERIA		wood			]	WINDOW MATERIAL		
WALL MATERIAL (original) Brick WALL MATERIAL 2 (original) Wood				WINDOW TYPE	[	single & double hung/case		
WALL MATERIA	AL 2 (original)	Wood				WINDOW CONFIG		1/1; 1-light
SIGNIFICANT FEATURES		sed brick entry b				ners; hipped front entry ghts; 3-sided square nor		ch w/ grouped classical /indow bay; historic wood
ALTERATIONS	Second story re	ear porch additic	on (post-	1943)

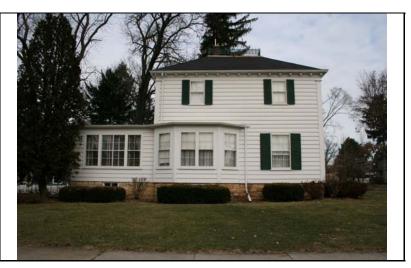
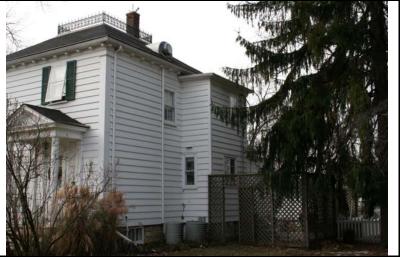
COA DATE	
COA DECISION	
PREPARER	Lara Ramsey
PREPARER ORGANIZATION	GRANACKI HISTORIC CONSULTANTS
SURVEYDATE	11/8/2007
SURVEYAREA	NAPERVILLE
7 N WRI	GHT

STREET #	7					1. 1. 1. 1. 1. 1. 1. 1. 1. 1. 1. 1. 1. 1	14	
DIRECTION	Ν		ý.				N.	A TAV
STREET	WRIGHT							
SUFFIX	ST							
PIN	0818311008							
LOCAL SIGNIFICANCE RATING POTENTIAL IND NR? (Y or N) Contributing to a NR DISTRICT? Contributing secon	C N C dary structure?	P NC						
Listed on existing SURVEY?	_	cal District; NR		an a				ALL STREET
			(	GENERAL INFO	)RN	MATION		
CATEGORY bu	uilding			CURRENT FUNCTION	ON	Domestic - single dwell	ing	
CONDITION         excellent         HISTORIC FUNCTION         Domestic - single dwelling								
<b>INTEGRITY</b> M	inor alterations			REASON for SIGNFICANCE				
SECONDARY STRUCTURE	Detached gar Greenhouse (	-		SIGNFICANCE				
			AR	<b>CHITECTURA</b>	L D	ESCRIPTION		
ARCHITECTURA CLASSIFICATION						PLAN	rec	ctangular
DETAILS	Colonial F	Pevival				NO OF STORIES	2	
BEGINYEAR	c. 1870					<b>ROOF TYPE</b>	Hip	oped
OTHER YEAR	0. 1070					<b>ROOF MATERIAL</b>	As	phalt - shingle

DATESOURCE	Surveyor					FOUNDATION	Sto	one
WALL MATERIA		Wood				PORCH		ont entry
WALL MATERIA						WINDOW MATERIA	L	Wood
WALL MATERIA	L (original)	Wood				WINDOW MATERIA	L	
WALL MATERIA	L 2 (original)					WINDOW TYPE		double hung
						WINDOW CONFIG		2/2; 4/4; 6/6
				dillions; pedimented fr bay; classical corner p		entry porch with classica ters	ıl co	lumns; historic double
(	historic), and f		ded; 2r	nd story north addition		eplacement front entry po t historic)	orcł	n (historic), wood siding

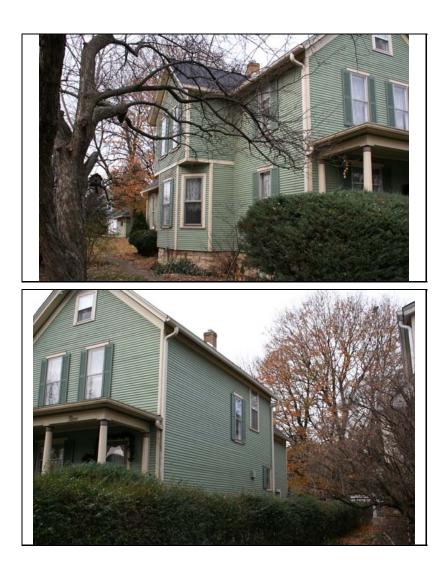
COA DATE	
COA DECISION	
PREPARER	Lara Ramsey
PREPARER ORGANIZATION	GRANACKI HISTORIC CONSULTANTS
SURVEYDATE	11/8/2007
SURVEYAREA	NAPERVILLE
9 S WRIG	GHT

CATEGORY	building	CURRENT FUNCTION	ON Domestic - single dwelling
CONDITION	good	HISTORIC FUNCTION	ON Domestic - single dwelling
INTEGRITY	minor alterations		Fine, well-preserved example of early 20th-century Queen Anne.
SECONDARY STRUCTURE	Detached garage

ARCHITECTURA				<b>¬ PLAN</b>	irre	egular
CLASSIFICATIO	N Queen A	nne - Free Clas	sic	LAN	inc	,90101
				NO OF STORIES	2	
DETAILS				<b>ROOF TYPE</b>	Fro	ont gable
BEGINYEAR	c. 1900					
OTHER YEAR				ROOF MATERIAL	As	phalt - shingle
-				FOUNDATION	Sto	one
DATESOURCE	surveyor			PORCH	Fro	ont
WALL MATERIA	L (current)	Wood				
				WINDOW MATERIA	L	Wood
WALL MATERIA	L 2 (current)			WINDOW MATERIA	r	
WALL MATERIA	L (original)	Wood			L	
		mood		WINDOW TYPE	ļ	Double hung/single hung
WALL MATERIA	L 2 (original)					
				→ WINDOW CONFIG		1/1
SIGNIFICANT	Front gable ba	v with full heigh	t south bay with cutaway corners;	full front porch with class	sica	l columns and square
FEATURES		wood windows	t bouth buy with butaway comore,		100	
ALTERATIONS	Fixed shutters	(not historic); p	ossible 2nd story rear addition; re	placement front steps an	d ra	ailings (not historic)

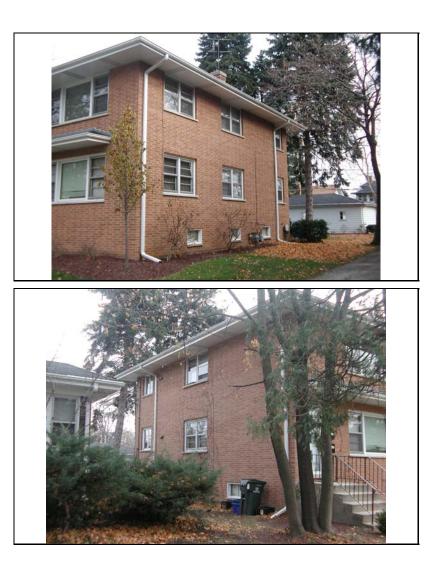
COA DATE	
COA DECISION	
PREPARER	Lara Ramsey
PREPARER ORGANIZATION	GRANACKI HISTORIC CONSULTANTS
SURVEYDATE	11/7/2007
SURVEYAREA	NAPERVILLE
10 S WRI	CHT

STREET #	10		1		A.L.		ŧ	
DIRECTION	S		N)	TI-X			-	it.
STREET	WRIGHT				and a	11 II		and the second second
SUFFIX	ST			and a				1 State
PIN	0818318002							
LOCAL SIGNIFICANCE RATING POTENTIAL IND NR? (Y or N) Contributing to a NR DISTRICT? Contributing secon Listed on existing SURVEY?	C N C dary structure: Local District;							
_				ENERAL INFO	_			
	uilding			CURRENT FUNCTION		Domestic - multiple dwe		
CONDITION go	bod			HISTORIC FUNCTIO	ON [	Domestic - multiple dwe	ellin	g
<b>INTEGRITY</b> m	inor alterations	3		REASON for SIGNFICANCE				
SECONDARY STRUCTURE	Detached gar	age						
			AR	CHITECTURAI	L DF	ESCRIPTION		
ARCHITECTURA CLASSIFICATION						PLAN	rec	tangular
						NO OF STORIES	2	
DETAILS	a 1055					<b>ROOF TYPE</b>	Hip	pped
BEGINYEAR	c. 1955					<b>ROOF MATERIAL</b>	As	phalt - shingle
OTHER YEAR	curvovor					FOUNDATION	No	t visible
DATESOURCE	surveyor	Brick				PORCH	-	
WALL MATERIA		DIICK				WINDOW MATERIA	L	Wood

WALL MATERIA		Brick				WINDOW MATERIA	L	
WALL MATERIA	-	DIICK				WINDOW TYPE		Double hung/fixed
WALL MATERIA	L 2 (original)					WINDOW CONFIG		2/1; 1-light
SIGNIFICANT FEATURES	Hipped roof wit	h overhanging ea	aves; h	ipped canopy over en	ntry ai	nd first story windows		
ALTERATIONS	Aluminum sidin	ng under eaves

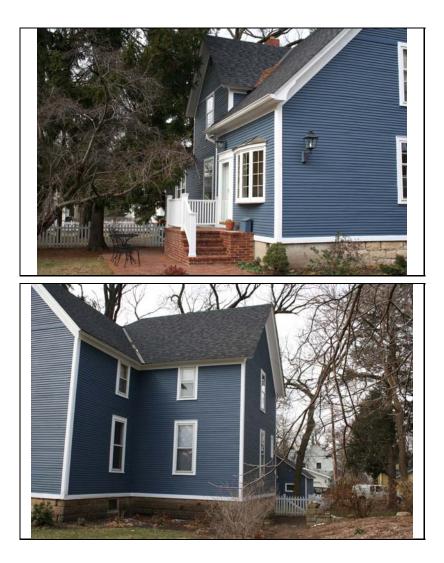
COA DATE	
COA DECISION	
PREPARER	Lara Ramsey
PREPARER ORGANIZATION	GRANACKI HISTORIC CONSULTANTS
SURVEYDATE	11/8/2007
SURVEYAREA	NAPERVILLE
13 N WRI	GHT

ALTERATIONS South extension of roofline on front gable bay with new south side entry and stoop (post-1943); 2 story north side addition (historic); 1 story rear addition

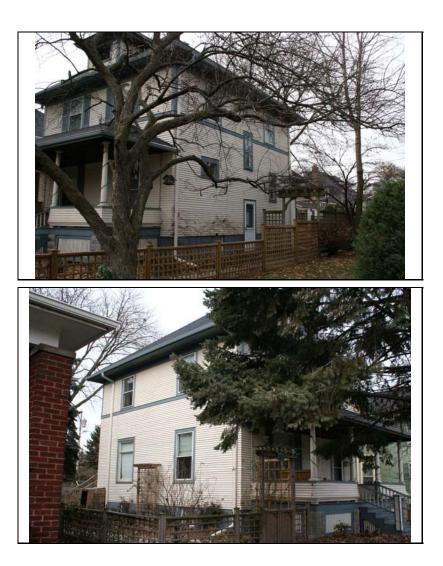
COA DATE	
COA DECISION	
PREPARER	Lara Ramsey
PREPARER ORGANIZATION	GRANACKI HISTORIC CONSULTANTS
SURVEYDATE	11/8/2007
SURVEYAREA	NAPERVILLE
15 S WRI	GHT

ALTERATIONS Door replaced; fixed shutters

historic 1/1 wood windows

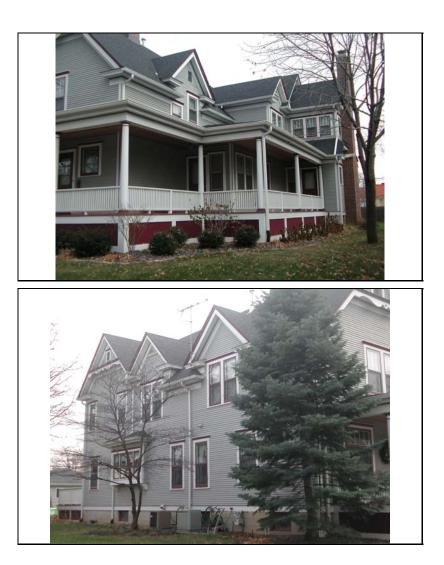
COA DATE	
COA DECISION	
PREPARER	Lara Ramsey
PREPARER ORGANIZATION	GRANACKI HISTORIC CONSULTANTS
SURVEYDATE	11/7/2007
SURVEYAREA	NAPERVILLE
16 N WRI	GHT

Replacement siding & verge board (not historic); wraparound front porch w/ 1 story entry add. on S. side (not ALTERATIONS historic); large 2-story rear (south) addition (not historic); replacement windows in original openings on original house (may be historic)

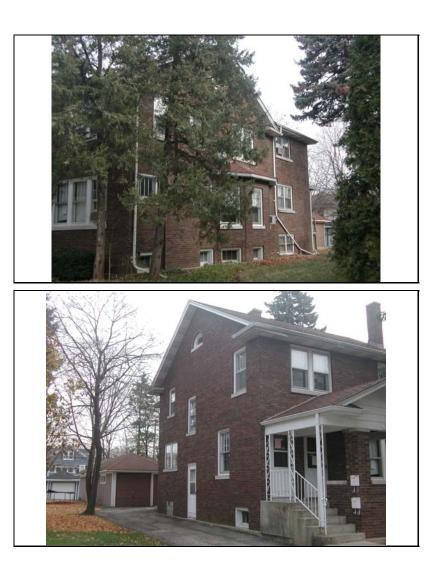
COA DATE	
COA DECISION	
PREPARER	Lara Ramsey
PREPARER ORGANIZATION	GRANACKI HISTORIC CONSULTANTS
SURVEYDATE	11/7/2007
SURVEYAREA	NAPERVILLE
16 S WRIG	GHT

WALL MATERIA		Brick		PORCH	Front entry
WALL MATERIA		DIICK		WINDOW MATERI	AL Wood
WALL MATERIA		Brick		WINDOW MATERL	AL
WALL MATERIA		DIICK		WINDOW TYPE	double hung/fixed
WALL MATERIA	IL 2 (01 Igilial)			WINDOW CONFIG	4/1; 1-light
			rns; front gable entry porch ung windows & half circle w		uare brick columns on solid
	Front porch ex story rear addit		n steps, wrought iron suppo	rts and porch railing; 2nd e	ntry added under porch; 2

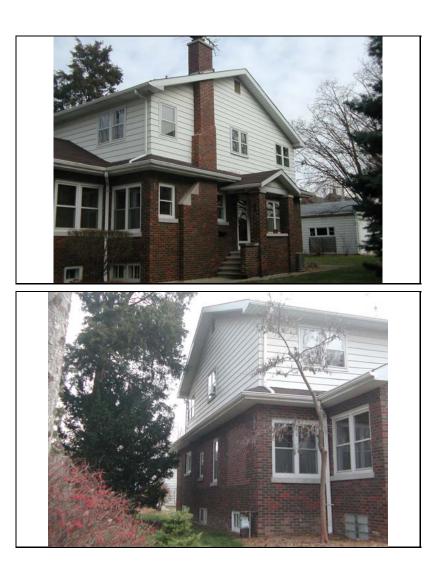
COA DATE	
COA DECISION	
PREPARER	Lara Ramsey
PREPARER ORGANIZATION	GRANACKI HISTORIC CONSULTANTS
SURVEYDATE	11/7/2007
SURVEYAREA	NAPERVILLE
20 N WRI	ЭНТ

ALTERATIONS Original house obscured by alterations and additions--replacement windows in altered openings on north side, original openings on rest of house; 2nd story addition (not historic); aluminum under eaves Replacement of existing siding with fiber cement board, replacement of soffit and fascia (admin. approved COA#15-2805)

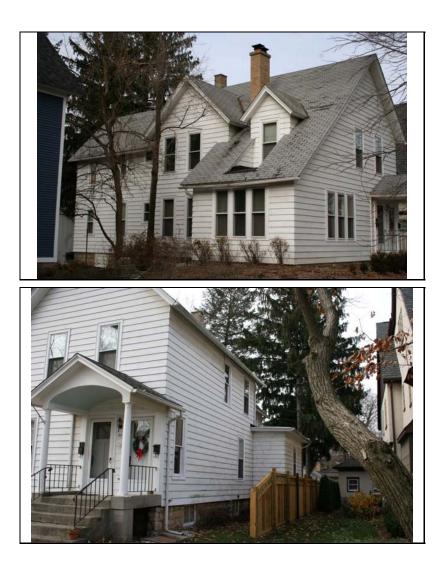
COA DATE	
COA DECISION	
PREPARER	Lara Ramsey
PREPARER ORGANIZATION	GRANACKI HISTORIC CONSULTANTS
SURVEYDATE	11/8/2007
SURVEYAREA	NAPERVILLE
21 N WRI	GHT

DATESOURCE	Surveyor					FOUNDATION		ont entry
WALL MATERIA	L (current)	Aluminum				WINDOW MATERIA		Wood
WALL MATERIA	L 2 (current)					WINDOW MATERIA		
WALL MATERIA	L (original)	Wood				WINDOW MATERIA WINDOW TYPE		double hung
WALL MATERIA	L 2 (original)					WINDOW CONFIG		1/1
SIGNIFICANT FEATURES	House was orig	jinally gabled ell, w	vith f	ront gable and south s	side (			
	2 story rear add		h ado	dition; window appear		porch with 2 entry doors historic wood replacem		onversion to multi-family); t windows

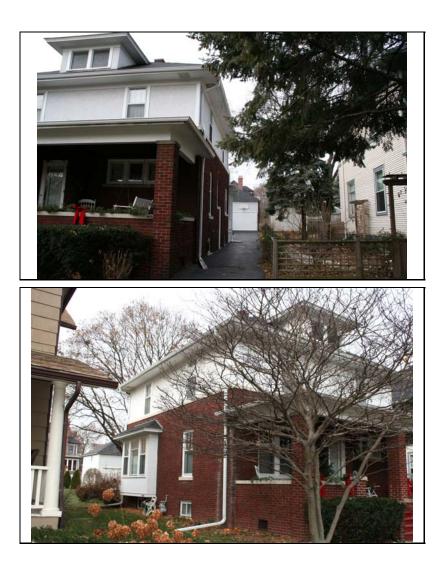
COA DATE	
COA DECISION	
PREPARER	Lara Ramsey
PREPARER ORGANIZATION	GRANACKI HISTORIC CONSULTANTS
SURVEYDATE	11/8/2007
SURVEYAREA	NAPERVILLE
21 S WRI	ЭНТ

ALTERATIONS Replacement dormer windows; replacement door; rear porch enclosed

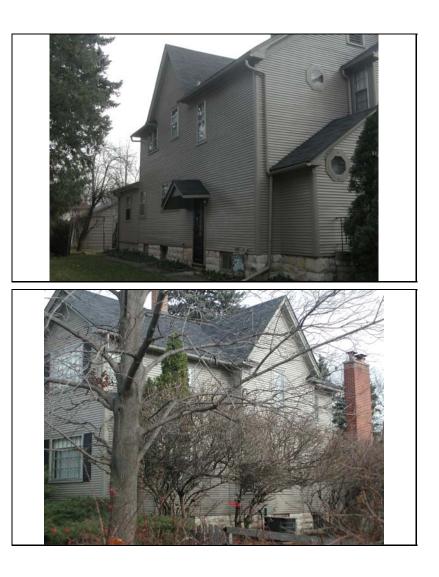
DIGITAL	\
PHOTO ID	2
DIGITAL	\I
PHOTO ID2	2

WALL MATERIA	L (current)	Wood				PORCH	- L Wood
WALL MATERIA	L 2 (current)					WINDOW MATERIA	
WALL MATERIA	L (original)	Wood				WINDOW MATERIA	
WALL MATERIA	L 2 (original)					WINDOW TYPE WINDOW CONFIG	double hung/fixed multi-light
SIGNIFICANT FEATURES	Front gable roc	of; 2 story gable s	outh	side bay with 1st story	cuta		man-ngnt
				; one story front entry b al window on front faça			lacement windows in original

HISTORIC NAME	
COMMON NAME	
COST	
ARCHITECT	
ARCHITECT2	
BUILDER	
ARCHITECT SOURCE	
HISTORIC INFO	
PERMITS	
LANDSCAPE	Midblock on east side of residential street; front sidewalk; rear alley; similar setbacks; mature trees

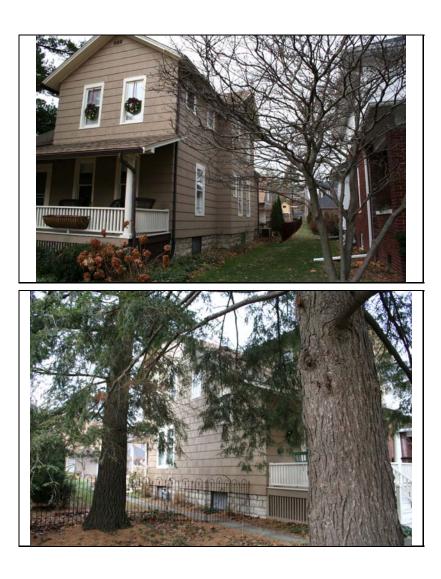
DIGITAL	\Images\wr
PHOTO ID	5s.jpg
DIGITAL	\Images\wr
PHOTO ID2	5s(2).jpg

STREET #	25				
DIRECTION	S				
STREET	WRIGHT				
SUFFIX	ST				
PIN	0818317012			TET	
LOCAL SIGNIFICANCE RATING POTENTIAL IND	PS				
NR? (Y or N)	Ν				
Contributing to a NR DISTRICT?	С			25	
Contributing second	lary structure:	P NC			
Listed on existing SURVEY?	Local District;	NR District	All the second second		
			GENERAL INFO	<b>DRMATION</b>	
CATEGORY bu	ilding		CURRENT FUNCTION	ON Domestic - single dwel	ling
CONDITION go	od		HISTORIC FUNCTION	ON Domestic - single dwel	ling
INTEGRITY mi	nor alterations	and addition(s)			ence from the turn of the 20th
	SIGNFICANCE century.				
SECONDARY STRUCTURE	Detached gar	age			
ARCHITECTURA	L		ARCHITECTURA	L DESCRIPTION PLAN	rectangular
CLASSIFICATION	No Style				
DETAILS				NO OF STORIES	2
BEGINYEAR	c. 1905			ROOF TYPE	Multi-gable
OTHER YEAR				ROOF MATERIAL	Asphalt - shingle
DATESOURCE	Surveyor			FOUNDATION	Stone
WALL MATERIAI	L (current)	Wood - shingle		PORCH	Full front

WALL MATERIAI	L 2 (current)			WINDOW MATERIA	
WALL MATERIAI	L (original)	Wood - shingle		WINDOW MATERIA	
WALL MATERIAI	L 2 (original)	Wood		WINDOW TYPE	double hung
	_	L		WINDOW CONFIG	1/1
			outh side gables; shed roof double hung windows on no		olumns; stained glass window
ALTERATIONS F	Replacement 1	/1 double hung wi	indows on front and north e	levations (historic); 1 story	rear porch addition

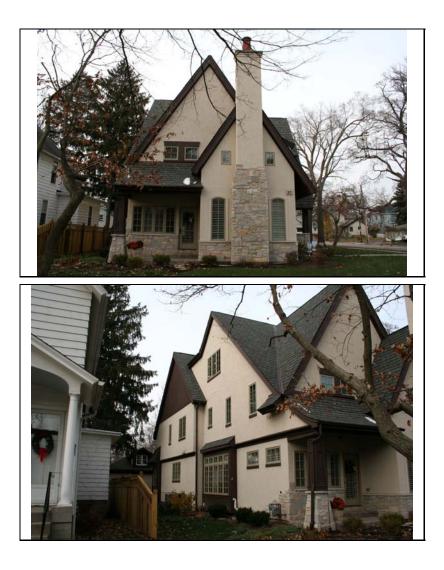
DIGITAL	\lm
PHOTO ID	7n.
DIGITAL	∖lm
PHOTO ID2	7n(

STREET #	27	Les 17		ally in the case					
DIRECTION	Ν	X A		Sty JE					
STREET	WRIGHT	AT Via							
SUFFIX	ST								
PIN	0818311005	XIX							
LOCAL SIGNIFICANCE RATING	NC								
POTENTIAL IND NR? (Y or N)	Ν								
Contributing to a NR DISTRICT? Contributing secon	NC dary structure? NC								
Listed on existing SURVEY?	Local District; NR District			Listed on existing					
	· · · · ·	GENERAL INFOR	MATION						
CATEGORY bu	uilding	GENERAL INFOR		ling					
	uilding		Domestic - single dwel						
CONDITION ex		CURRENT FUNCTION	Domestic - single dwel						
CONDITION ex	cellent	CURRENT FUNCTION HISTORIC FUNCTION REASON for	Domestic - single dwel						
CONDITION (ex) INTEGRITY (not SECONDARY STRUCTURE	Detached garage	CURRENT FUNCTION HISTORIC FUNCTION REASON for	Domestic - single dwel						
CONDITION (e) INTEGRITY (no SECONDARY STRUCTURE ARCHITECTURA	L	CURRENT FUNCTION HISTORIC FUNCTION REASON for SIGNFICANCE	Domestic - single dwel

HISTORIC NAME	
COMMON NAME	
COST	
ARCHITECT	
ARCHITECT	2
BUILDER	
ARCHITECT SOURCE	
HISTORIC INFO	
PERMITS	
LANDSCAPE	Southwest corner of Franklin and Wright; front and north sidewalks; rear alley; similar setbacks; mature trees

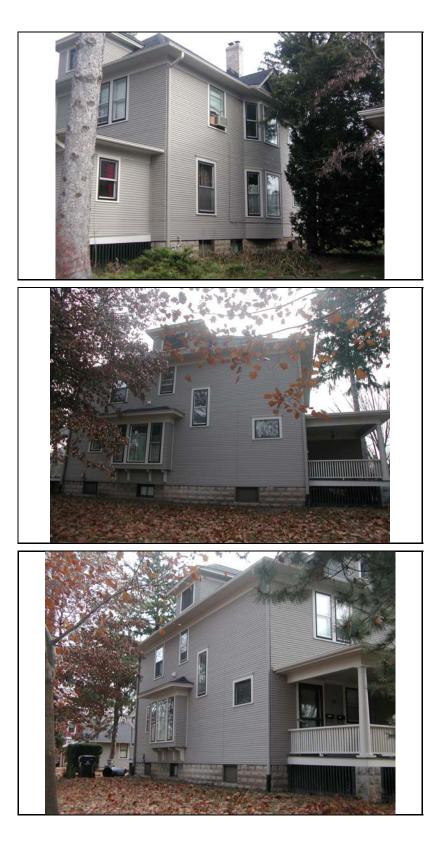
DIGITAL	\Images\wright02	DIGITAL	\Images\wright028n(3
PHOTO ID	8n.jpg	PHOTO ID3	).jpg
DIGITAL	\Images\wright02	DIGITAL	\Images\wright028n(4
PHOTO ID2	8n(2).jpg	PHOTOID4	).jpg

STREET #	28	the second of the		
DIRECTION	Ν	W.	A	A
STREET	WRIGHT	1		
SUFFIX	ST			
PIN	0818312001			
LOCAL SIGNIFICANCE RATING	С			
POTENTIAL IND NR? (Y or N)	Ν			
Contributing to a NR DISTRICT? Contributing second	C dary structure? C			
Listed on existing				
SURVEY?	Local District; NR District	and the second	and i growth	
		<b>GENERAL INFO</b>	RMATION	
CATEGORY bu	ilding	CURRENT FUNCTIO	N Domestic - multiple dw	relling
CONDITION ex	cellent	HISTORIC FUNCTIO	N Domestic - single dwel	ling
<b>INTEGRITY</b> mi	nor alterations	REASON for SIGNFICANCE		
SECONDARY STRUCTURE	Detached garage			
		ARCHITECTURAL	<b>DESCRIPTION</b>	
ARCHITECTURA CLASSIFICATION	r			
			PLAN	Rectangular
	American Foursquare	lassia	PLAN NO OF STORIES	Rectangular 2.5
DETAILS	American Foursquare Queen Anne - Free Cl	lassic		
DETAILS BEGINYEAR	American Foursquare	lassic	NO OF STORIES	2.5
DETAILS BEGINYEAR OTHER YEAR	American Foursquare Queen Anne - Free Cl c. 1905	lassic	NO OF STORIES ROOF TYPE	2.5 Hipped

HISTORIC NAME	
COMMON NAME	
COST	
ARCHITECT	
ARCHITECT2	
BUILDER	
ARCHITECT SOURCE	
HISTORIC INFO	
PERMITS	
Fra	utheast corner of Wright and anklin; front sidewalk; rear /eway; similar setbacks; mature es
COA DATE	
COA DECISION	
PREPARER	Lara Ramsey
PREPARER ORGANIZATION	GRANACKI HISTORIC CONSULTANTS
SURVEYDATE	11/7/2007
SURVEYAREA	NAPERVILLE

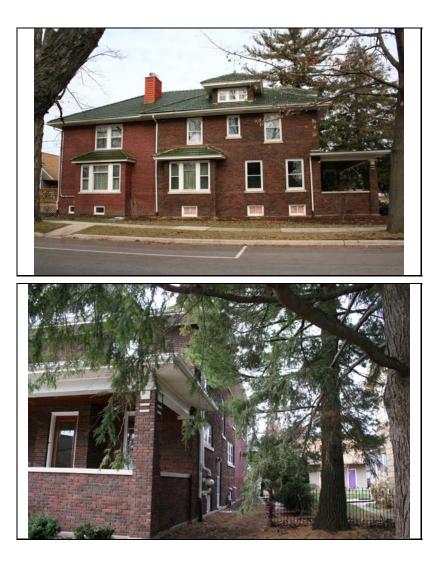
DIGITAL	\Images
PHOTO ID	1s.jpg
DIGITAL	\Images
PHOTO ID2	1s(2).jp

STREET #	31	S		
DIRECTION	S			
STREET	WRIGHT	12		
SUFFIX	ST			
PIN	0818317013			
LOCAL SIGNIFICANCE RATING	S		n	
POTENTIAL IND NR? (Y or N)	Ν			
Contributing to a NR DISTRICT? Contributing secon	C dary structure? NC			
Listed on existing SURVEY?	Local District; NR District	same and		
GENERAL INFORMATION				
CATEGORY bu	uilding	CURRENT FUNCTION	ON Domestic - single dwelling	
CONDITION ex	kcellent	HISTORIC FUNCTION	ON Domestic - single dwelling	
INTEGRITY a	ddition(s)	REASON for	The ceramic tile roof and Prairie detailing on the porch

ARCHITECTURA CLASSIFICATIO			PLAN	rectangular	
CLASSIFICATIO	American	rouisquale		NO OF STORIES	2.5
DETAILS	Prairie			Llippod	
BEGINYEAR	c. 1910			ROOF TYPE	Hipped
				<b>ROOF MATERIAL</b>	Ceramic Tile
OTHER YEAR				FOUNDATION	Concrete
DATESOURCE	Surveyor			PORCH	Full front
WALL MATERIAL (current) Brick				WINDOW MATERIA	L Wood/beveled glass
WALL MATERIAL 2 (current)				T Al	
WALL MATERIAL (original)		Brick		WINDOW MATERIA	L Aluminum
				WINDOW TYPE	double hung/single hung
WALL MATERIAL 2 (original)			WINDOW CONFIG	1/1	
FEATURES	Hipped roof with overhanging eaves; front and side hipped dormers; broad massing; full porch with brick columns & knee walls; historic wood windows on main house; beveled glass windows; first story square window bay on south elevation				
ALTERATIONS	Two story rear addition; replacement windows (not historic) in dormers

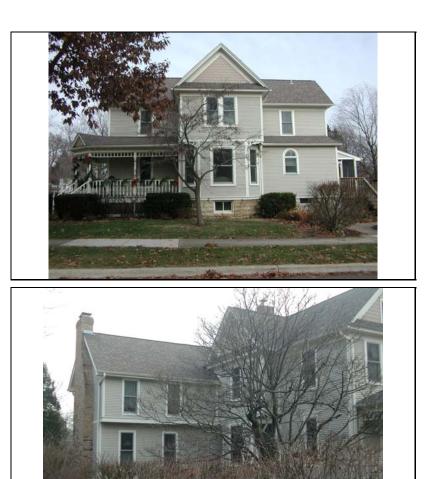
DIGITAL	∖In
PHOTO ID	2s
DIGITAL	\In
PHOTO ID2	2s

STREET #	32				
DIRECTION	S		U.X MAL		
STREET	WRIGHT		Ker Kert		
SUFFIX	ST		VER HEAL		
PIN	0818318005		VIL WILL		
LOCAL SIGNIFICANCE RATING	С		A AND		
POTENTIAL IND NR? (Y or N)	Ν				
Contributing to a NR DISTRICT? Contributing second	C				
Listed on existing SURVEY?	Local District; NR D	Pistrict		Mar Min S	
			GENERAL INFO	RMATION	
CATEGORY bu	ilding		CURRENT FUNCTION	DN Domestic - single dwell	ling
CONDITION ex	cellent		HISTORIC FUNCTION	ON Domestic - single dwell	ling
INTEGRITY ma	ajor alterations and/c	or addition(s)	REASON for SIGNFICANCE		
SECONDARY STRUCTURE	Detached garage				
		AI	RCHITECTURAI	L DESCRIPTION	
ARCHITECTURA CLASSIFICATION				PLAN	irregular
DETAILS				NO OF STORIES	2
BEGINYEAR	c.1900			ROOF TYPE	Multi-gable
OTHER YEAR	0.1300			<b>ROOF MATERIAL</b>	Asphalt - shingle
DATESOURCE	Surveyor			FOUNDATION	Stone
WALL MATERIAI		4		PORCH	Wrap around
WALL MATERIA		d - shingle		WINDOW MATERIA	L Wood
WALL MATERIA	`´´	0		WINDOW MATERIA

WALL MATERIA	-	d - shingle		WINDOW TYPE	Double hung/single hung
		a shingle		WINDOW CONFIG	1/1
SIGNIFICANT FEATURES	Front gable bay with	pent enclosure;	2 story side gable north	n and south bays with 1st st	ory cutaway corners
c	ppenings (historic); 1 instillation of stone v	story south side	addition (not historic); ation of the addition to r	nt porch (not historic); replace rear deck and screen porch match original foundation (a val COA#14-4087) Addition	n addition (not historic) dmin. approved COA#10-1640)
(	HPC approval COA	416-942) Additio		lows, new porch ráils & spir	ndles, alteration to style of existing

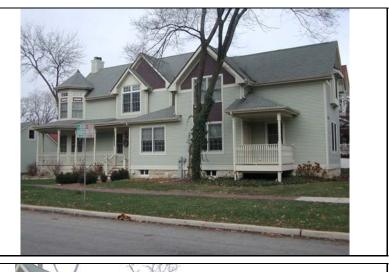
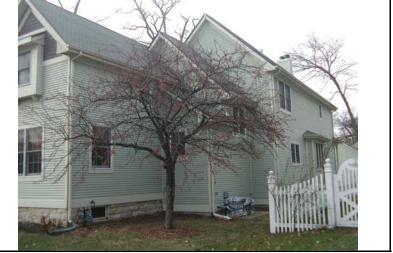
DIGITAL	∖lr
PHOTO ID	3r
DIGITAL	∖Ir
PHOTO ID2	3r

STREET #	103		1				
DIRECTION	Ν				Y		AR
STREET	WRIGHT		X	N A A A	X		
SUFFIX	ST		1	ANKAN	e		N MA
PIN	0818308017		in the second se		V.		A think of
LOCAL SIGNIFICANCE RATING	С						
POTENTIAL IND NR? (Y or N)	Ν						
Contributing to a NR DISTRICT?	С		W				
Contributing secon	dary structure	? NC		- Annald State		a los la	
Listed on existing SURVEY?	Local District	; NR District					
			<u>(</u>	GENERAL INFO	ORN	<b>IATION</b>	
CATEGORY bu	uilding			CURRENT FUNCTION	ON	Domestic - single dwelli	ng
CONDITION ex	cellent			HISTORIC FUNCTION	ON	Domestic - single dwelli	ng
INTEGRITY major alterations and/or addition(s) REASON for SIGNFICANCE							
SECONDARY STRUCTURE	Detached ga	rage					
	_		AR	RCHITECTURAI	L D	ESCRIPTION	
ARCHITECTURA CLASSIFICATION		II (altered)				PLAN	irregular
DETAILS	Queen A					NO OF STORIES	2
BEGINYEAR	c. 1885					<b>ROOF TYPE</b>	Multi-gable
OTHER YEAR						<b>ROOF MATERIAL</b>	Asphalt - shingle

DATESOURCE	Surveyor					FOUNDATION	Stone/concrete
WALL MATERIA		Wood				PORCH	Front entry
WALL MATERIAL 2 (current) Wood - shingle					WINDOW MATERIA	L Vinyl	
WALL MATERIAL (original) Wood					WINDOW MATERIA		
WALL MATERIAL 2 (original)					WINDOW TYPE	double hung	
······································					WINDOW CONFIG	6/6	
SIGNIFICANT FEATURES

ALTERATIONS House has been recently renovated---replacement front porch & door; large 2 story rear/south add.; 2 story north add.; 1 story extension of original south side bay; replacement siding; replacement windows; 2nd story bay window on front gable
