# ILLINOIS URBAN ARCHITECTURAL AND HISTORICAL SURVEY

COA DATE	
COA DECISION	
PREPARER	Lara Ramsey
PREPARER ORGANIZATION	GRANACKI HISTORIC CONSULTANTS
SURVEYDATE	11/7/2007
SURVEYAREA	NAPERVILLE
226 N WRI	GHT

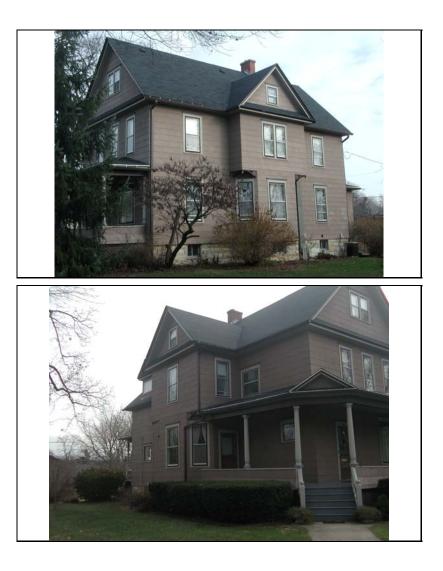
DIGITAL	\Images\wright	
PHOTO ID	4s.jpg	
DIGITAL	\Images\wright	
PHOTO ID2	4s(2).jpg

-				A State of the second second	
Listed on existing SURVEY?	Local District; NR District	a state a printing the state		Sector Contraction Contraction	
		<b>GENERAL INFORM</b>	MATION		
CATEGORY bu	ilding	CURRENT FUNCTION	Domestic - single dwel	ling	
CONDITION go	ood	HISTORIC FUNCTION	Domestic - single dwelling		
INTEGRITY	SIGNFICANCE cha			estantial Free-Classic Queen Anne residence, with racteristic pent gable roof and classically ornamented	
SECONDARY STRUCTURE	Detached garage	por			
ARCHITECTURAL DESCRIPTION					
ARCHITECTURA CLASSIFICATION			PLAN	rectangular	
			NO OF STORIES	2.5	
DETAILS			<b>ROOF TYPE</b>	Front gable	
BEGINYEAR	c. 1900		<b>ROOF MATERIAL</b>	Asphalt - shingle	
OTHER YEAR			- FOUNDATION	Stone	
DATESOURCE	surveyor L (current) Wood - shingle		PORCH	Wrap around

ALTERATIONS Replacement wood shingle siding (not historic); 1 story rear porch addition Replacement of siding with cement boards replacement of windows with aluminum clad windows, restore original balusters on front porch (admin. approval COA#13-2034) In kind shingle replacement (admin. approval COA#18-3267) In kind porch replacement (admin. approval COA#19-926) Second story addition to rear (HPC approval COA#18-2255)

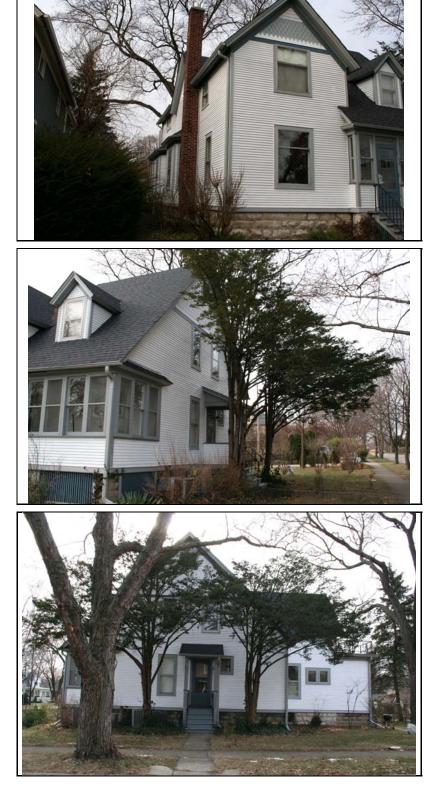
DIGITAL \\mages\wright10		DIGITAL	\Images\wright105s(3		
PHOTO ID 5s.jpg		PHOTO ID3	).jpg		
DIGITAL	\Images\wright10	DIGITAL	\Images\wright105s(4		
PHOTO ID2	5s(2).jpg	PHOTOID4	).jpg

STREET #	105				
DIRECTION	S		AV.	A MAN	
STREET	WRIGHT		A COL		I and I
SUFFIX	ST				
PIN	0818322009				
LOCAL SIGNIFICANCE RATING POTENTIAL IND NP2 (V or N)	C				
NR? (Y or N) Contributing to a NR DISTRICT? Contributing second Listed on existing SURVEY?	С				
			GENERAL INFO	<u>DRMATION</u>	
CATEGORY bu	iilding		CURRENT FUNCTION	ON Domestic - single dwel	ling
CONDITION go	ood		HISTORIC FUNCTION	ON Domestic - single dwel	ling
<b>INTEGRITY</b> ma	ajor alterations	and/or addition(s)	REASON for SIGNFICANCE		
SECONDARY STRUCTURE	Detached gar	age	]		
		A	RCHITECTURA	L DESCRIPTION	
ARCHITECTURA CLASSIFICATION				PLAN	irregular
DETAILS				NO OF STORIES	2
BEGINYEAR	c. 1880			<b>ROOF TYPE</b>	Multi-gable
OTHER YEAR	c. 1900-10	0		<b>ROOF MATERIAL</b>	Asphalt - shingle
DATESOURCE	Surveyor	<u> </u>		FOUNDATION	Stone/concrete block
WALL MATERIA		Wood		PORCH	Front (enclosed)
WALL MATERIA		Wood - shingle		WINDOW MATERIA	AL Wood

WALL MATERIAL (original) Wood - shingle		WINDOW MATERIA			
WALL MATERIA	L 2 (original)	Wood		WINDOW TYPE	Double hung/single hung
SIGNIFICANT FEATURES	Front gable bay	y; south cross gable;	3-sided window bay	WINDOW CONFIG	1/1
			storicroofline altered/ra rear addition; north entr	aised); dormer addition; inse y addition (not historic)	et porch (historiclater

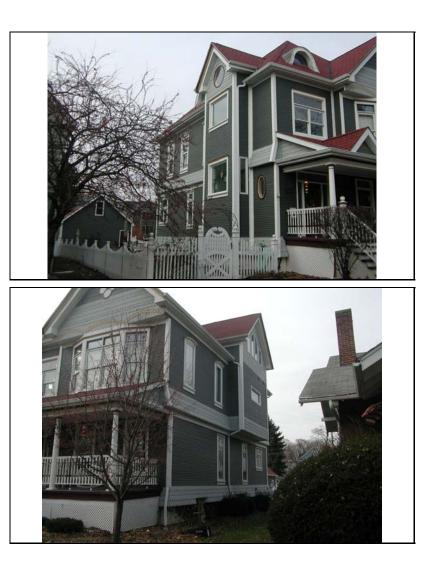
DIGITAL	∖lma(
PHOTO ID	7n.jp
DIGITAL	\lmag
PHOTO ID2	7n(2)

STREET #	107					
DIRECTION	Ν					
STREET	WRIGHT					
SUFFIX	ST					
PIN	0818308016					
LOCAL SIGNIFICANCE RATING	NC					
POTENTIAL IND NR? (Y or N)	Ν				BINH	
Contributing to a NR DISTRICT?	NC	? NC				
Contributing second	dary structure					
Listed on existing SURVEY?	Local District	NR District				
			GENERAL INFO	<b>RMATION</b>		
CATEGORY bu	uilding		CURRENT FUNCTIO	N Domestic - single dwell	ing	
CONDITION excellent			HISTORIC FUNCTIO	ON Domestic - single dwelling		
INTEGRITY not altered REASON for SIGNFICANCE						
SECONDARY STRUCTURE	Detached gar	age				
	_		ARCHITECTURAL	DESCRIPTION		
ARCHITECTURA CLASSIFICATION		itional		PLAN	rectangular	
DETAILS				NO OF STORIES	2.5	
BEGINYEAR	c. 2000			ROOF TYPE	Hipped	
OTHER YEAR	0. 2000			<b>ROOF MATERIAL</b>	Asphalt - shingle	
DATESOURCE	Surveyor			FOUNDATION	Stone	
WALL MATERIA		Wood		PORCH	Full front	
WALL MATERIA		Wood - shingle		WINDOW MATERIA	L vinyl	
		Wood		WINDOW MATERIA	L Wood/Beveled glass

HISTORIC NAME	
COMMON NAME	
COST	
ARCHITECT	
ARCHITECT2	2
BUILDER	
ARCHITECT SOURCE	
HISTORIC INFO	
PERMITS	
LANDSCAPE	Midblock on west side of residential street; front sidewalk; rear alley; similar setbacks; mature trees; rear fencing

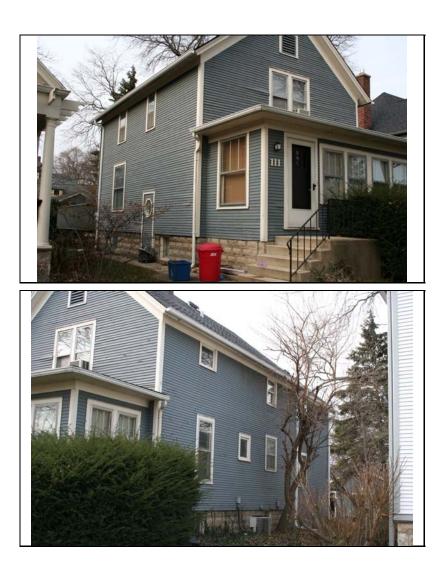
DIGITAL	\
PHOTO ID	1
DIGITAL	\
PHOTO ID2	1

STREET #	111		<b>N</b> 11		851		19007	
DIRECTION	S		AY	NAME			依	THE PARTY OF
STREET	WRIGHT		XIX	XE			R	WY IT
SUFFIX	ST		W				L.	
PIN	0818322010			16	/			WYY =
LOCAL SIGNIFICANCE RATING	C							KV/
POTENTIAL IND NR? (Y or N)	Ν							
Contributing to a NR DISTRICT?	С							CHAR CONT
Contributing second	ndary structure	? C		and the second				
Listed on existing SURVEY?	Local District	NR District					-	
			G	ENERAL INFO	)RN	IATION		
CATEGORY b	uilding			CURRENT FUNCTIO	ON [	Domestic - single dwelli	ng	
<b>CONDITION</b> g	ood		]	HISTORIC FUNCTION	ON	Domestic - single dwelli	ng	
INTEGRITY	ninor alterations	and addition(s)		REASON for SIGNFICANCE				
SECONDARY STRUCTURE	Detached gar	age						
			AR	CHITECTURAI	L DI	ESCRIPTION		
ARCHITECTURA CLASSIFICATIO		ont				PLAN	Re	ctangular
DETAILS						NO OF STORIES	2	
BEGINYEAR	c. 1905					<b>ROOF TYPE</b>	Fro	ont gable
OTHER YEAR	0. 1000					<b>ROOF MATERIAL</b>	As	phalt - shingle

DATESOURCE	Surveyor					FOUNDATION	Co	ncrete - block
WALL MATERIA		Wood				PORCH	Fu	Il front
WALL MATERIA						WINDOW MATERIA	L	Wood
WALL MATERIA		Wood				WINDOW MATERIA	L	
WALL MATERIA	-					WINDOW TYPE		double hung
		L			]	WINDOW CONFIG		1/1; 3/1
SIGNIFICANT FEATURES	Front gable roc	of with wood frieze	e; histo	ric 1/1 wood windows	S			
ALTERATIONS	Front porch en	closed (c. 1920);	two sto	ory rear addition; doo	r add	ed (now enclosed) to so	outh	side; rear deck addition

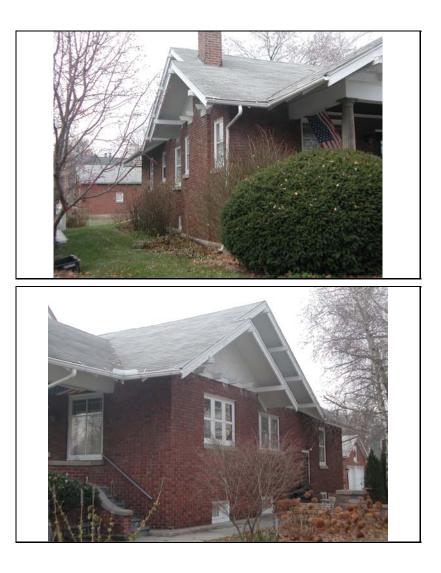
DIGITAL	\lı
PHOTO ID	5ı
DIGITAL	\lı
PHOTO ID2	5ı

WALL MATERIA	L 2 (original)	01000		WINDOW CONFIG	1/1; 9/1; multi-light
SIGNIFICANT FEATURESBroad side gable roof with overhanging eaves & exposed rafter tails; front gable porch w/ brick knee wall; historic 9/1 single hung wood windows under porch & 1/1 wood windows on side elevations; historic wood door; nested side gable bay on north side					
ALTERATIONS	front window u	Inder porch gable p	painted roof replacement (a	dmin. approval COA#11-33	371)

HISTORIC NAME	
COMMON NAME	
COST	
ARCHITECT	
ARCHITECT2	
BUILDER	
ARCHITECT SOURCE	
HISTORIC INFO	
PERMITS	
street	lock on west side of residential t; front sidewalk; rear alley; ar setbacks; mature trees

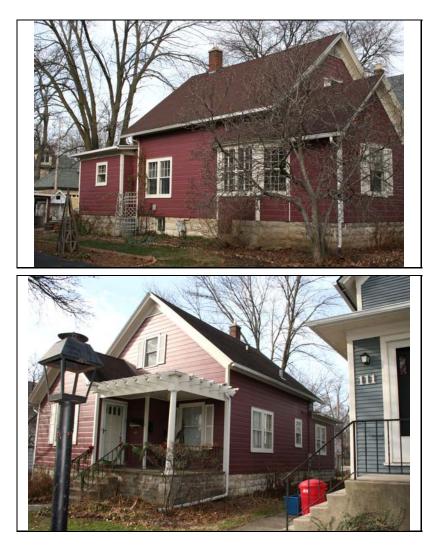
\lma 5s.jp
\lma 5s(2

STREET #	115			Section 199	111		et al la la	
DIRECTION	S			All I	J.	NA MA	X	Te y
STREET	WRIGHT		J. Sala	A Company	1	Mar - Cost	L JETTY	
SUFFIX	ST		S.V.C		A			ALA TO
PIN	0818322011				1			VE //
LOCAL SIGNIFICANCE RATING	С							
POTENTIAL IND NR? (Y or N)	Ν							
Contributing to a NR DISTRICT?	С		1.		ī.			
Contributing secon	dary structure	? NC			in in Salare		- Lake	S MA HE
Listed on existing SURVEY?	Local District	; NR District						August & Mar & Market
			GEN	NERAL INFO	)RM	ATION		
CATEGORY bu	uilding		CUI	RRENT FUNCTI	ON [	Domestic - single dwell	ng	
CONDITION go	bod		HIS	TORIC FUNCTI	ON [	Domestic - single dwell	ng	
INTEGRITY m	inor alterations	3		ASON for NFICANCE				
SECONDARY STRUCTURE	Detached gai Shed (NC)	rage						
	_		ARCH	ITECTURA	L DI	<b>ESCRIPTION</b>		
ARCHITECTURA CLASSIFICATION		ont Cottage				PLAN	rectangular	
DETAILS						NO OF STORIES	1.5	
BEGINYEAR	c. 1900					<b>ROOF TYPE</b>	Front gable

OTHER YEAR	c. 1920					<b>ROOF MATERIAL</b>	Asphalt - sh	ingle
DATESOURCE	Surveyor					FOUNDATION	Concrete - t	block
WALL MATERIA		Wood				PORCH	Front	
WALL MATERIA		11000				WINDOW MATERIA	L Wood	
WALL MATERIA		Wood				WINDOW MATERIA	L Aluminur	n
WALL MATERIA	-	WOOd				WINDOW TYPE	double h	ung
WALL WATCHA	L 2 (UI Igilial)					WINDOW CONFIG	8/1;6/1;	4/1
SIGNIFICANT FEATURES	Front gable roo	of; historic 6/1; 8	/1; and 4/1	wood windows

ALTERATIONS Replacement siding (historic); wrought iron railing and concrete steps (not historic); fixed shutters (not historic); replacement 1/1 aluminum windows under gable (not historic); 3-sided south bay addition (historic)---SEE CONTINUATION SHEET

Replacement siding (historic); wrought iron railing and concrete steps (not historic); fixed shutters (not historic); replacement 1/1 aluminum windows under gable (not historic); 3-sided south bay addition (historic); 1 story rear addition; replacement windows in original openings (historic); one story front bay and porch additions (not historic)

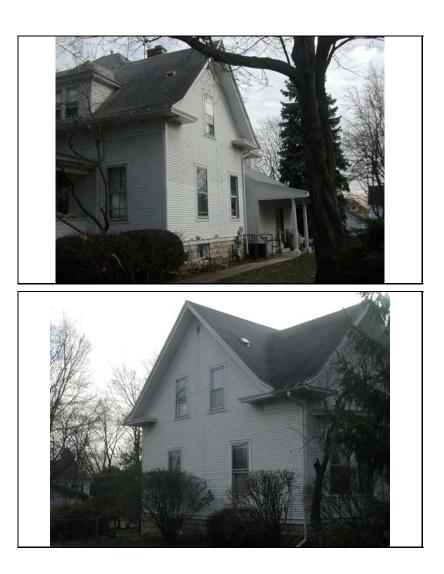
DIGITAL	\Image
PHOTO ID	6s.jpg
DIGITAL	\Image
PHOTO ID2	6s(2).j

STREET #	116		21		KI CAY
DIRECTION	S				1 AL
STREET	WRIGHT		Star the		
SUFFIX	ST		A AF		
PIN	0818323002				
LOCAL SIGNIFICANCE RATING	S				
POTENTIAL IND NR? (Y or N)	Ν				
Contributing to a NR DISTRICT?	С				
Contributing secon Listed on existing SURVEY?		? C	Ser Contraction		
			GENERAL INFO	DRMATION	
CATEGORY b	uilding		CURRENT FUNCTION	ON Domestic - single dwel	ling
CONDITION g	ood		HISTORIC FUNCTION	ON Domestic - single dwel	ling
INTEGRITY m	INTEGRITY minor alterations and addition(s) REASON for Early, transitional Colonial Revival residence with Queen				
SECONDARY STRUCTURE	Detaolieu galage				
			ARCHITECTURA	L DESCRIPTION	
ARCHITECTURA CLASSIFICATIO		Revival		PLAN	Т
				NO OF STORIES	1.5
DETAILS	Queen Ar	ine		ROOF TYPE	Multi-gable
BEGINYEAR	c. 1900			<b>ROOF MATERIAL</b>	Asphalt - shingle
OTHER YEAR	Surveyor			FOUNDATION	Stone
DATESOURCE WALL MATERIA		Wood		PORCH	Front
WALL MATERIA		wood		WINDOW MATERIA	AL Wood

WALL MATERIA		Wood		WINDOW MATERIA	
WALL MATERIA		wood		WINDOW TYPE	double hung
WALL MAIERIA	IL 2 (original)			WINDOW CONFIG	1/1
FEATURES		toric 1/1 wood wi	and cornice returns; rounden ndows; front porch with rour		ay; Palladian window under d knee wall (may be historic,
ALTERATIONS		ont porch (historio may be historic)	c); new entry in front gable b	oay (historic); 3-part front wir	ndow added to front façade

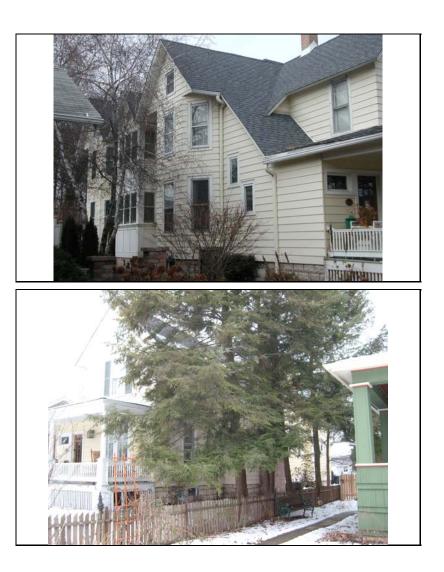
DIGITAL	\Ir
PHOTO ID	9r
DIGITAL	\lr
PHOTO ID2	9r

STREET #	119		I I WE Y	Self [	PUNECK	ţ1]	
DIRECTION	Ν		the state	校旗			
STREET	WRIGHT			A XP			and the second second
SUFFIX	ST			XX		_	at Page to the
PIN	0818308014						
LOCAL SIGNIFICANCE RATING	С		AXAT	2		-	
POTENTIAL IND NR? (Y or N)	Ν			- 10			
Contributing to a NR DISTRICT? Contributing secon	C	С					
Listed on existing SURVEY?	Local District; N						
			GENERAL INF	ORMA	Γ <b>ΙΟΝ</b>		
CATEGORY bu	uilding		CURRENT FUNCT	ION Dom	nestic - single dwell	ing	
CONDITION go							
<b>INTEGRITY</b> m	inor alterations a	and addition(s)	REASON for				
			SIGNFICANCE				
SECONDARY STRUCTURE	Detached garage	ge					
ARCHITECTURA			ARCHITECTURA			rec	tangular
CLASSIFICATION	N Gabled Ell			PLAN rectangul NO OF STORIES 2.5			
DETAILS	Queen Ann	е					
BEGINYEAR	c. 1890				ROOF TYPE Multi-gable		phalt - shingle
OTHER YEAR					OOF MATERIAL		<u> </u>
DATESOURCE	DATESOURCE Surveyor				OUNDATION	Stone/concrete block Full front

WALL MATERIA	L (current)	Nood			ORCH	L	
WALL MATERIA	L 2 (current)	Aluminum			INDOW MATERIA	L	Wood
WALL MATERIA	L (original)	Wood			INDOW MATERIA	L	Leaded glass
WALL MATERIA	L 2 (original)				INDOW TYPE	L	double hung/fixed
SIGNIFICANT FEATURES	Front gable and	side gable ell wi	th cutaway corners; histor		INDOW CONFIG		1/1; 2/2 ade of front gable bay
\$	ALTERATIONS S. side addition between bays with interior stair & new entry (may be historic); replacement front porch (historic); 2 story rear addition; replacement windows on south gable and on 3rd floor under front gable (not historic)SEE CONTINUATION SHEET

S. side addition between bays with interior stair & new entry (may be historic); replacement front porch (historic); 2 story rear addition; replacement windows on south gable and on 3rd floor under front gable (not historic); aluminum siding on 1st story and on rear addition (not historic); fixed shutters (not historic)

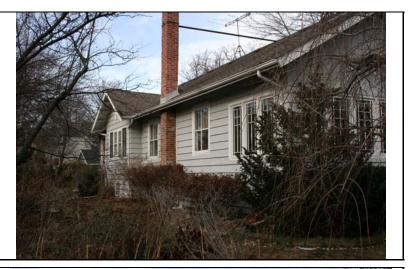
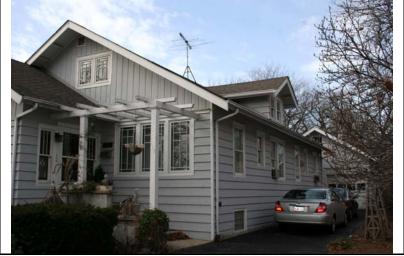
DIGITAL PHOTO ID	ļ
DIGITAL	Ì
PHOTO ID2	9

STREET #	119				THE TANK
DIRECTION	S			1	
STREET	WRIGHT				LANCE
SUFFIX	ST				1 AM
PIN	0818322012				
LOCAL SIGNIFICANCE RATING POTENTIAL IND NR? (Y or N)	C N				
Contributing to a NR DISTRICT? Contributing secon Listed on existing SURVEY?	C dary structure Local District;				
			<u>GENERAL INFO</u>	DRMATION	
CATEGORY bu	uilding		CURRENT FUNCTION	ON Domestic - single dwe	lling
CONDITION go	bod		HISTORIC FUNCTI	ON Domestic - single dwe	lling
<b>INTEGRITY</b> m	inor alterations	and addition(s)	REASON for SIGNFICANCE		
SECONDARY STRUCTURE	Detached gar	rage			
			ARCHITECTURA	L DESCRIPTION	
ARCHITECTURA CLASSIFICATION		1		PLAN	irregular
				NO OF STORIES	1.5
DETAILS	1922			<b>ROOF TYPE</b>	Front gable
BEGINYEAR	1922			<b>ROOF MATERIAL</b>	Asphalt - shingle
OTHER YEAR	Owner			FOUNDATION	Concrete
DATESOURCE WALL MATERIA		Wood		PORCH	-
WALL MATERIA		Wood - vertical b	oard	WINDOW MATERIA	AL Wood
WALL MATERIA		Stucco		WINDOW MATERIA	AL Vinyl/glass block

WALL MATERIA				WINDOW TYPE	double hung/casement
	L 2 (original)			WINDOW CONFIG	3/1; 2/1; 4/1
	Front gable roc side dormer	of with overhangin	g eaves; front gable bay; h	istoric 4/1, 3/1, & 2/1 windov	ws on side elevations; north
				was originally stuccoed); re asement windows; rear dec	placement windows on front k addition (1990s)

HISTORIC NAME	Hedinger, John House
COMMON NAME	
COST	
ARCHITECT	
ARCHITECT	2
BUILDER	
ARCHITECT SOURCE	
INFO	According to owner, John Hedinger first came to Naperville in 1914 and worked as a cement layer.
PERMITS	
LANDSCAPE	Midblock on west side of residential street; front sidewalk; side driveway; similar setbacks; mature trees

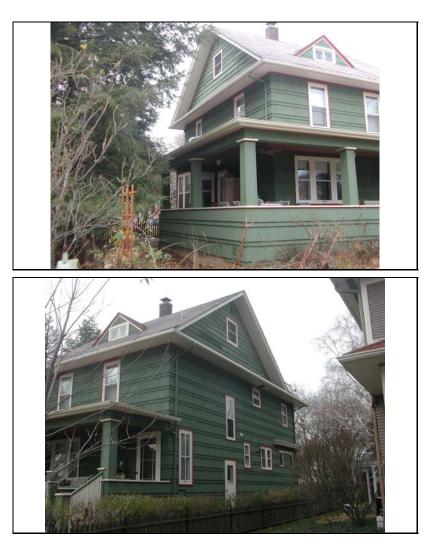
DIGITAL	\I
PHOTO ID	5
DIGITAL	\I
PHOTO ID2	5

STREET #	125			CANT	
DIRECTION	N				X
STREET	WRIGHT		and when the state		1 . 1
SUFFIX	ST				the second secon
PIN	0818308013		12		And Constants
LOCAL SIGNIFICANCE RATING POTENTIAL IND NR? (Y or N) Contributing to a NR DISTRICT? Contributing second Listed on existing					
SURVEY?	IHSS (O); Lo	cal District; NR			
			<u>GENERAL INFO</u>	<b>DRMATION</b>	
CATEGORY bu	ilding		CURRENT FUNCTION	ON Domestic - single dwel	ling
CONDITION ex	cellent		HISTORIC FUNCTION	ON Domestic - single dwel	ling
INTEGRITY no	t altered		REASON for SIGNFICANCE		
SECONDARY STRUCTURE	Detached gar Shed(NC)	rage			
	r		ARCHITECTURA	L DESCRIPTION	
ARCHITECTURAL CLASSIFICATION				PLAN	rectangular
DETAILS				NO OF STORIES	2.5
BEGINYEAR	1906			ROOF TYPE	Side gable
OTHER YEAR	c. 1930			<b>ROOF MATERIAL</b>	Asphalt - shingle
DATESOURCE	Owner			FOUNDATION	concrete
WALL MATERIAI	L (current)	Wood		PORCH	Wrap around
WALL MATERIAI		wood - shingle		WINDOW MATERIA

WALL MATERIAI	L (original)	Wood		WINDOW MATERIA	
WALL MATERIAI	L 2 (original)	Wood - shingle		WINDOW TYPE	Double hung/awning
FEATURES	ladding (histo	ric alt); 1 story, 3-s	sided south bay; historic fro		1/1; 1-light
ALTERATIONS V	vrap around po	orch (not historic2	2000)

HISTORIC NAME		
COMMON NAME		
COST		
ARCHITEC		
ARCHITEC	2	
BUILDER		
ARCHITEC SOURCE		
HISTORIC INFO	According to the owners, Mrs. Lillian Priem, who lived in the house from 19222 to 1960, was the first female chemistry professor at NCC.	
PERMITS	See continuation sheet for photograph of historic front entry. According to owners, the roof was originally hipped, & reconfigured in the 1930s during a 2- flat conversion. The cedar siding also dates from that time.	
LANDSCAP	E Midblock on west side of residential street; front sidewalk; rear alley; similar setbacks; mature trees

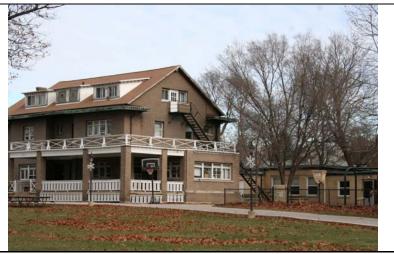
STREET #	126			2
DIRECTION	Ν			a de
STREET	WRIGHT			19
SUFFIX	ST		14	1
PIN	0818309002			
LOCAL SIGNIFICANCE RATING POTENTIAL IND NR? (Y or N) Contributing to a NR DISTRICT? Contributing secon Listed on existing SURVEY?	S N C dary structure? - IHSS (O); Local District; NR			
		GENERAL INFO	DIMATION	
	uilding	CURRENT FUNCTION		
CONDITION go	bod	HISTORIC FUNCTI	ON Domestic - single dwelli	ng
INTEGRITY	inor alterations and addition(s)	REASON for SIGNFICANCE	Despite alterations, this impr house remains a significant	
SECONDARY STRUCTURE				
	_	ARCHITECTURA	L DESCRIPTION	
ARCHITECTURA CLASSIFICATION			PLAN	irregular
DETAILS			NO OF STORIES	2.5

ALTERATIONS Replacement windows in dormers; glass block in center dormer; exterior stair on south side; one story rear addition on north side connected with 140 N. Wright.

HISTORIC NAME	Kroehler, P. E. House
COMMON NAME	
COST	
ARCHITECT	
ARCHITECT2	2
BUILDER	
ARCHITECT SOURCE	
INFO L	NR]P. E. Kroehler was Naperville ounge Factory Co.'s president beginning in 1903.
PERMITS	
LANDSCAPE	Midblock on east side of residential street; house set far back on lot, almost in center of block; curving front driveway; mature trees

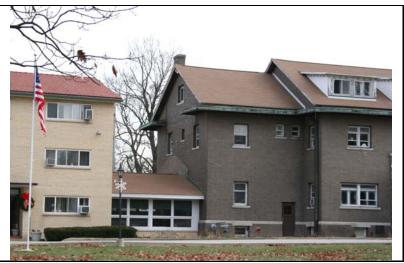
DIGITAL	\Images\wright12	DIGITAL
PHOTO ID	6n.jpg	PHOTO ID3
DIGITAL	\Images\wright12	DIGITAL
PHOTO ID2	6n(2).jpg	PHOTOID4

c. 1915		ROOF TYPE	Side gable
BEGINYEAR OTHER YEAR	C. 1915		<b>ROOF MATERIAL</b>	Asphalt - shingle
	Surveyor		FOUNDATION	Not visible
DATESOURCE	-		PORCH	Wrap around
WALL MATERIA			WINDOW MATERIA	L Wood
			WINDOW MATERIA	L Glass block
WALL MATERIA	-		WINDOW TYPE	casement/double hung/fixe
WALL MATERIA			WINDOW CONFIG	1/1; 1-light
	Side gable roof with shed dormowindows	ers and copper gutters; wrap	paround porch with square br	ick piers; historic 1/1 wood
