PREPARER	Lara Ramsey	SURVEYDATE	10/29/2025
ORGANIZATION	RAMSEY HISTORIC CONSULTANTS	SURVEYAREA	NAPERVILLE SURVEY UPDATE

City of NAPERVILLE
2025 HISTORIC RESOURCES SURVEY UPDATE
CONTINUATION SHEET

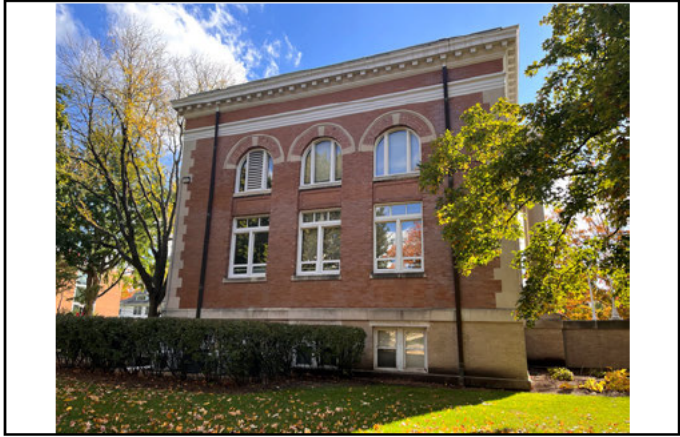
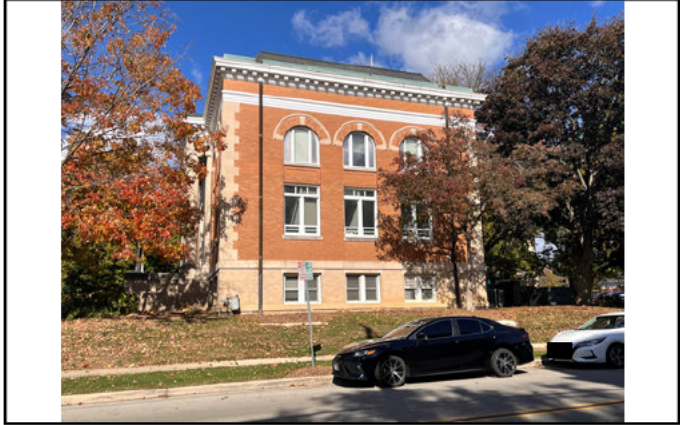
HISTORIC NAME	Carnegie Library
COMMON NAME	Carnegie Hall
ARCHITECT	
BUILDER	
ARCHITECT SOURCE	
HISTORIC INFO	**GUIDE TO CHICAGO'S HISTORIC SUBURBS, P. 408**. After being vacant for many years, the building was rehabbed and re-opened in 1986 (NHS file)
PERMITS	
LANDSCAPE	Northeast corner of Brainard and Benton; at southwest corner of main campus block of North Central College; front, side, and rear sidewalks; building on slight rise; mature trees
COA DATES	
COA DECISION	
COA Compliance Notes	
COA Work Not Completed	
Work Not Requiring COA

“This relatively small but quite massive structure shows that, at North Central College, the library was a serious place. It has pairs of Ionic columns flanking the doorway and supporting the pediment which is made of sheet metal, as is the cornice. In the block to which that frontispiece is attached are pairs of arched windows with the extrados of the arch traced in limestone, corresponding to the frontispiece and to the quoins and mud sill of the brick structure.”

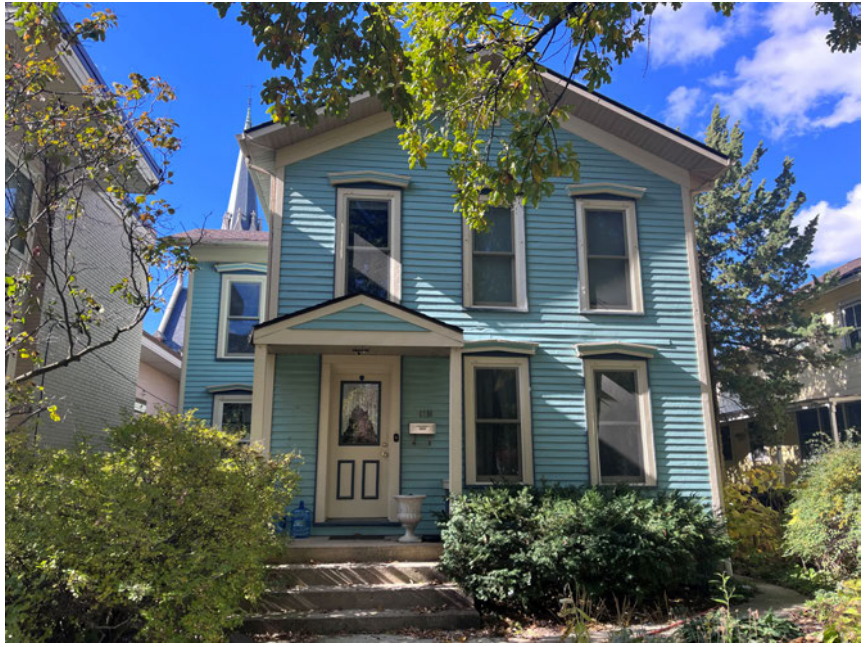
HISTORIC NAME	
COMMON NAME	
ARCHITECT	
BUILDER	
ARCHITECT SOURCE	
HISTORIC INFO	Sanborn maps show house with full-front porch through 1954.
PERMITS	
LANDSCAPE	Midblock on west side of residential street; front sidewalk; rear alley; similar setbacks; mature trees; rear fencing
COA DATES	
COA DECISION	
COA Compliance Notes	
COA Work Not Completed	
Work Not Requiring COA	Replacement windows on secondary north and south elevations.

Replacement windows on front façade – 2007 survey photographs show 1/1 wood windows throughout, with historic wood storms on first story and aluminum storms on second story.

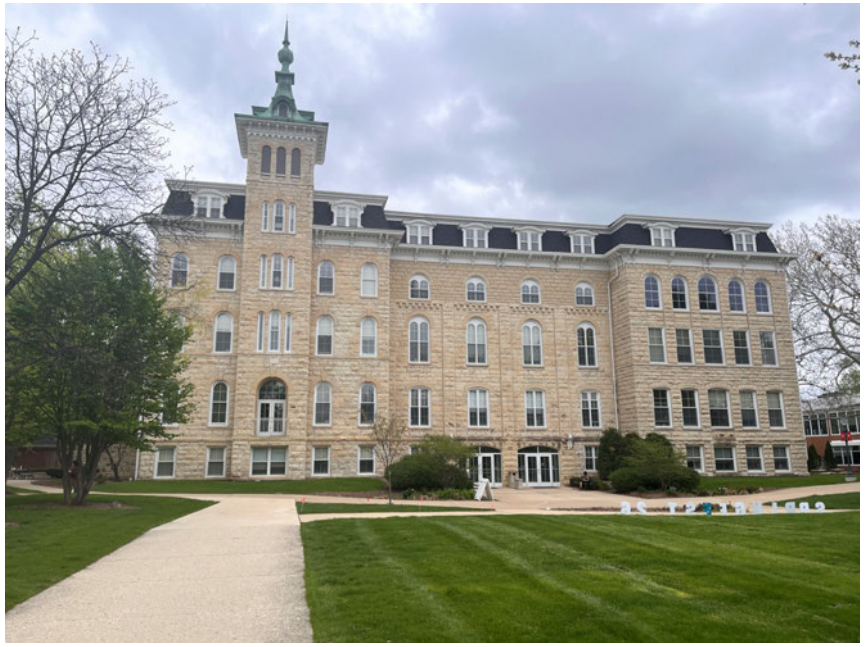
North section is original building, middle section is either original or very early addition (but has been recently altered and added to), south section is historic (1891) addition; mansard roof with modillion cornice and paired scrolled brackets on original, north section; projecting square bay in center of original building (north section) with copper pinnacle on roof; rusticated limestone exterior; round arch and segmental arch window openings; flat arch lintels on first story, flanged segmental arch dormers

Original raised front entry was in center of north section—steps to entry have been removed, and entry has been closed with balcony; entry on south (1891) addition was also raised, but has been filled in with ground level window (not historic); top two stories (including mansard roof) of center section are addition from 1998 renovation; south section originally had hipped roof—mansard is an historic alteration; vinyl replacement windows in original openings; replacement entry doors in middle section (probably in altered openings); below grade entry doors on east elevation; elevated patio addition to north elevation.

Louvers installed at upper section of first-story window opening on west elevation (2017, COA approved)

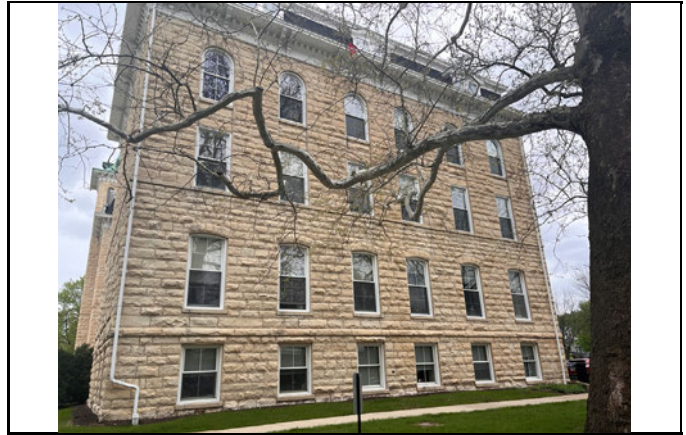
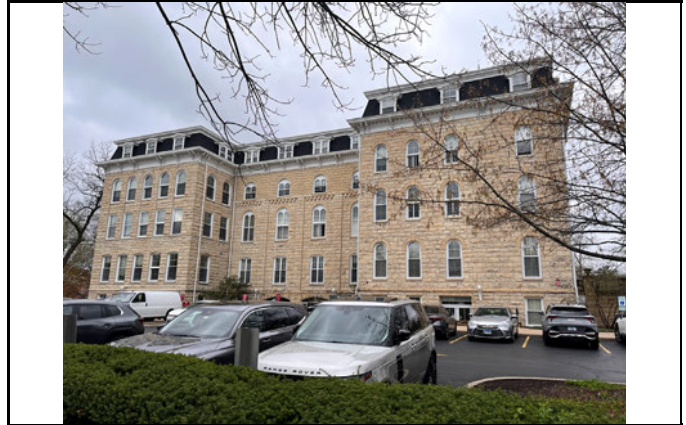
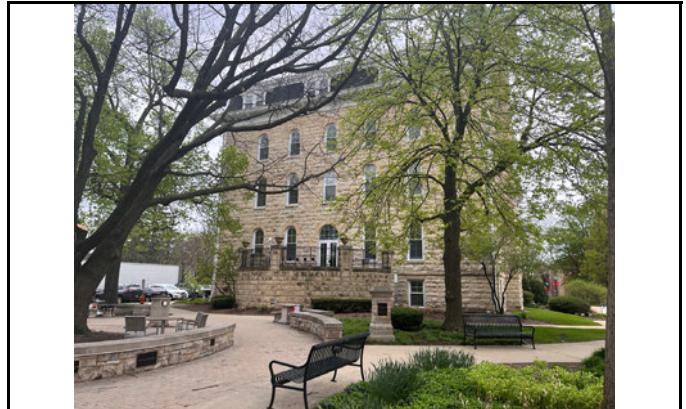
HISTORIC NAME	Old Main
COMMON NAME	
ARCHITECT	
BUILDER	
ARCHITECT SOURCE	
HISTORIC INFO	Cornerstone dated May 17, 1870--See continuation sheet.
PERMITS	
LANDSCAPE	In center of main campus block for North Central College; building faces west; concrete walkways on all sides; mature trees
COA DATES	1/24/2017
COA DECISION	COA #17-179 - Removing portion of window for air supply (approved 1/25/2017)
COA Compliance Notes	
COA Work Not Completed	
Work Not Requiring COA

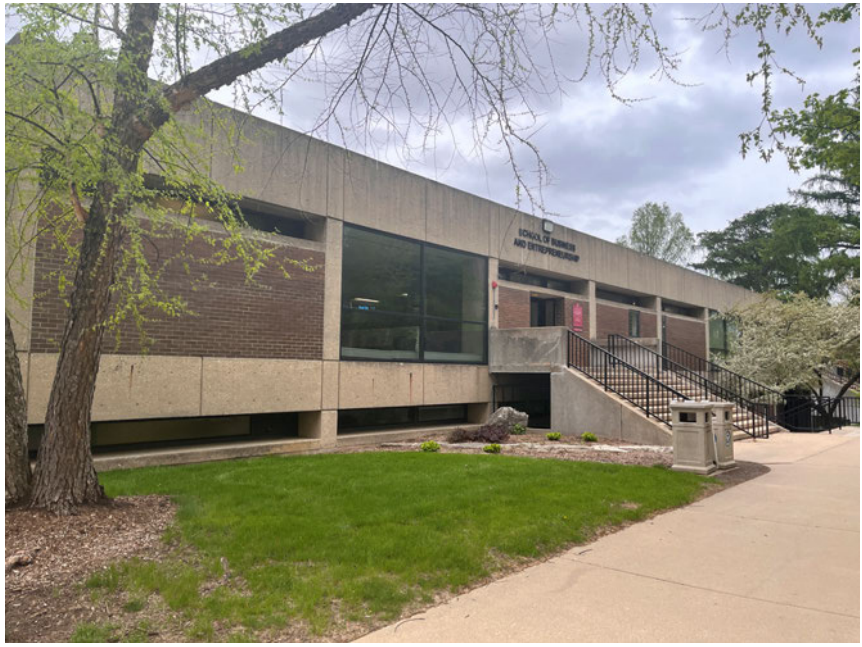
SIGNIFICANT FEATURES Rectangular massing and flat roof; concrete structural fram exposed on exterior; deeply recessed windows at raised basement level and above first story; main (first) story infilled with brick, with vertical and square windows; basement level exposed on primary east elevation; main entrances located at north and south ends of east elevation and accessed via concrete steps

ALTERATIONS Post-2007 -- new fixed windows at south end of west elevation and near center of west elevation

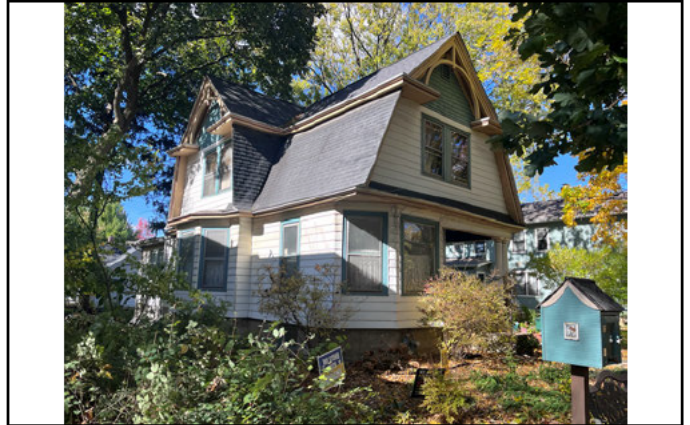
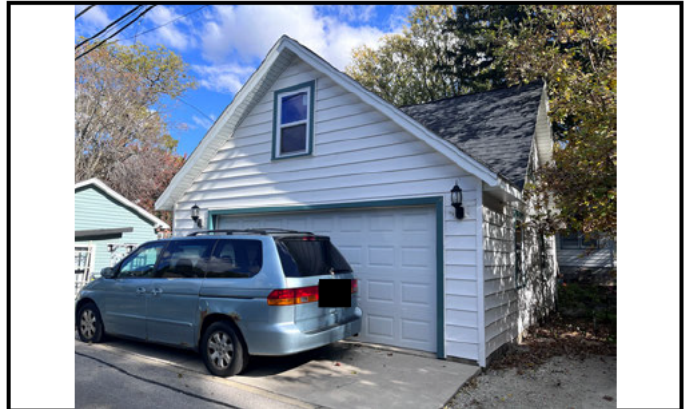
HISTORIC NAME	
COMMON NAME	
ARCHITECT	
BUILDER	
ARCHITECT SOURCE	
HISTORIC INFO	
PERMITS	
LANDSCAPE	Midblock on west side of residential street; rear driveway; front sidewalk; similar setbacks; mature trees
COA DATES	
COA DECISION	
COA Compliance Notes	
COA Work Not Completed	
Work Not Requiring COA	Detached garage replaced

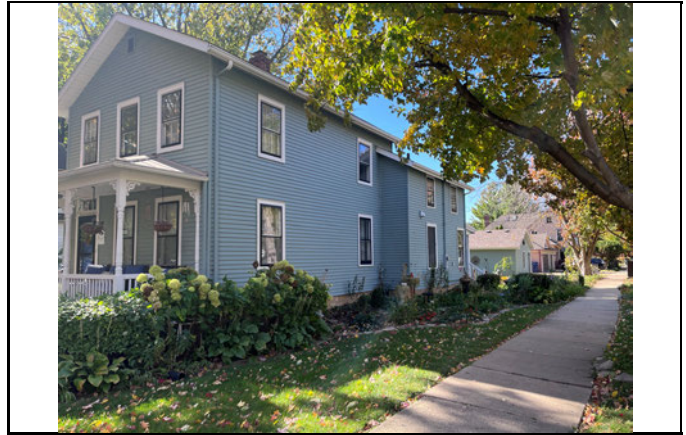
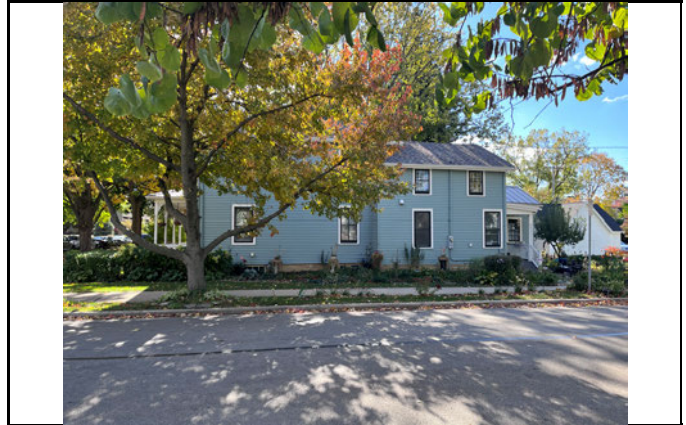
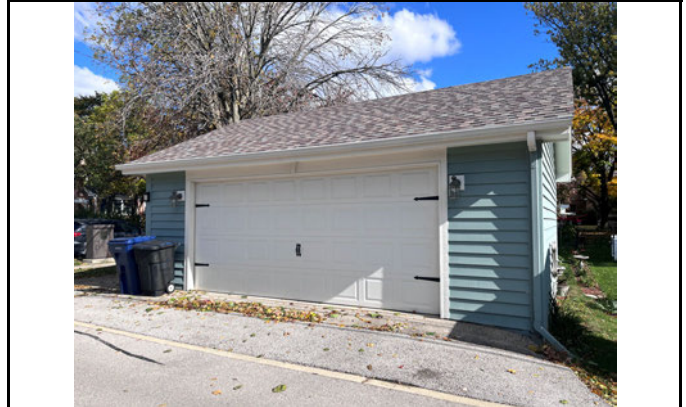
HISTORIC NAME	Leffler, Jeremiah House
COMMON NAME	
ARCHITECT	
BUILDER	
ARCHITECT SOURCE	
HISTORIC INFO	
PERMITS	
LANDSCAPE	Southwest corner of School and Brainard; front and north sidewalks; rear alley; similar setbacks; mature trees
COA DATES	5/25/2023
COA DECISION	COA #23-1617 - In-kind roof replacement (approved 5/26/2023)
COA Compliance Notes	
COA Work Not Completed	
Work Not Requiring COA	Repainting

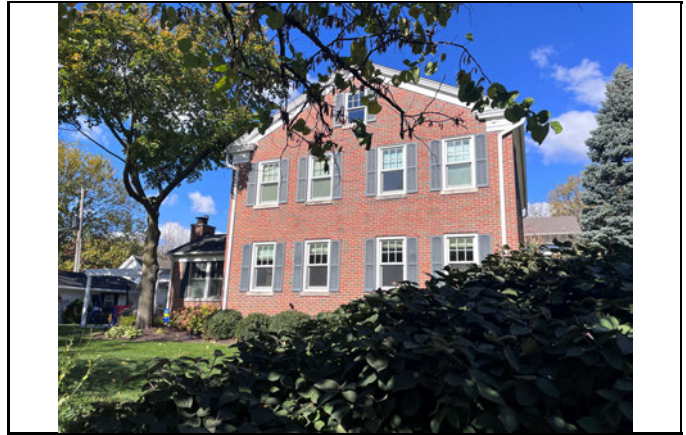
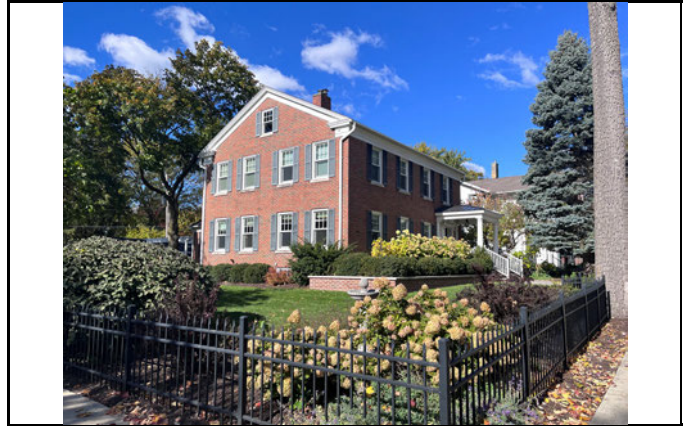
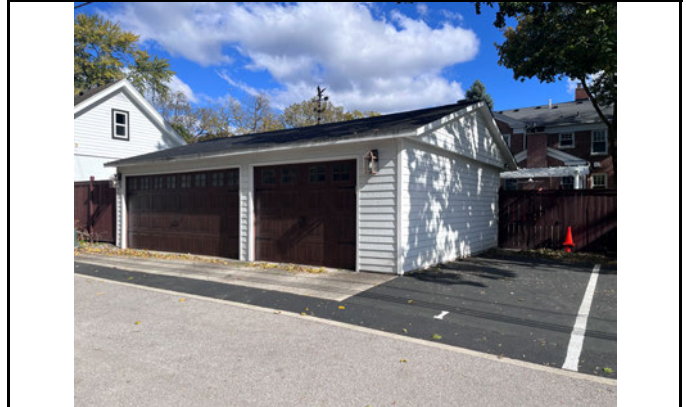
HISTORIC NAME	
COMMON NAME	
ARCHITECT	
BUILDER	
ARCHITECT SOURCE	
HISTORIC INFO	Historic photograph of house included with house history questionnaire returned by owner. The house was occupied by G. B. Kimmel through the 1930s -- Kimmel served as president of the theological seminary associated with North Central College.
PERMITS	
LANDSCAPE	Northwest corner of Brainard and School; front and south sidewalks; oversized lot; wrought iron fence; rear alley; mature trees
COA DATES	10/6/2010; 10/28/2011; 5/28/2020
COA DECISION	COA #10-2893 - Window replacement (approved 10/8/2010); COA #11-3735 - Window Replacement (approved 11/1/2011); COA #20-987 - Expand front porch, new sunroom window replacement from two separated windows to three windows next to each other (approved by HPC 5/28/20); COA #20-1569 - Add outdoor chimney to primary façade (approved by HPC 6/25/20)
COA Compliance Notes	
COA Work Not Completed	Chimney addition to primary façade (COA #20-1569)

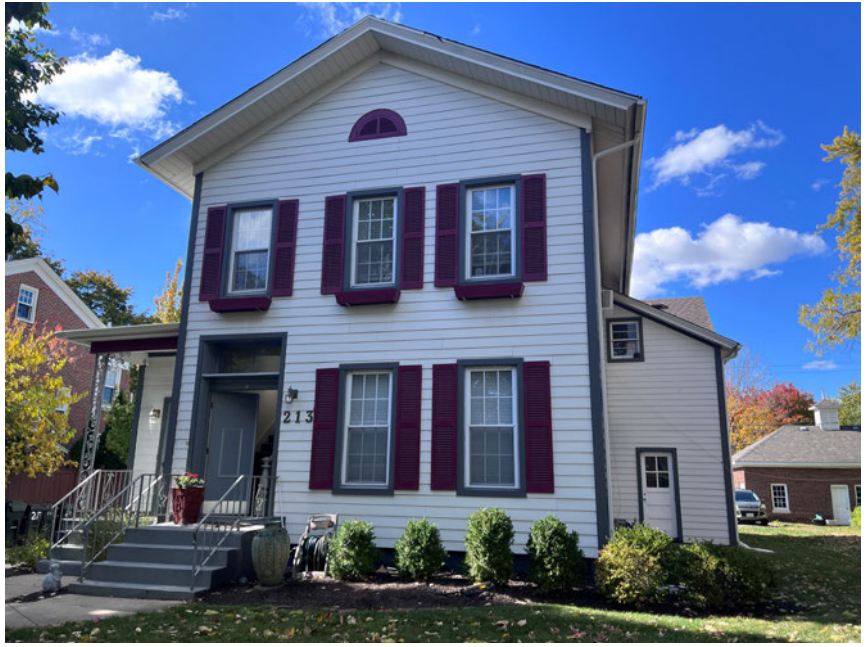
Replacement windows in original openings on front façade; replacement front entry doors.

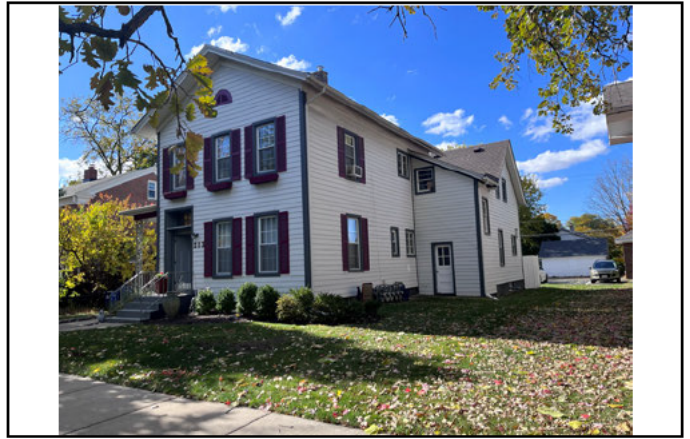
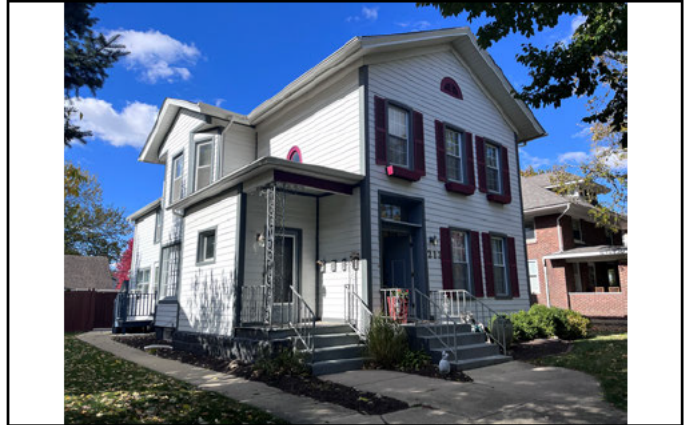
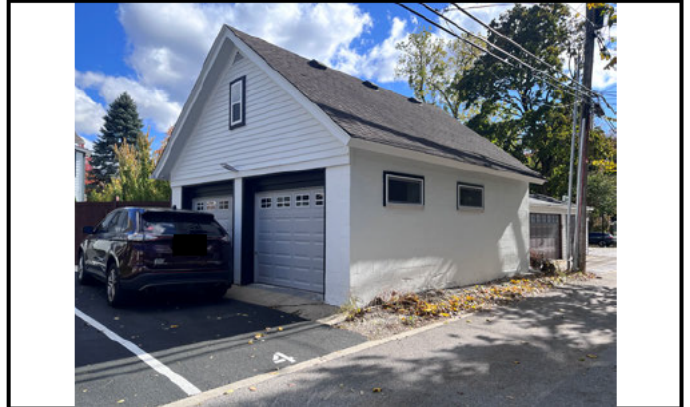
HISTORIC NAME	
COMMON NAME	
ARCHITECT	
BUILDER	
ARCHITECT SOURCE	
HISTORIC INFO	
PERMITS	
LANDSCAPE	Midblock on west side of residential street; front sidewalk; large lot; mature trees; rear alley
COA DATES	12/11/2015
COA DECISION	COA #15-4313 - In-kind replacement of siding and window trim (approved 12/14/2015)
COA Compliance Notes	
COA Work Not Completed	
Work Not Requiring COA

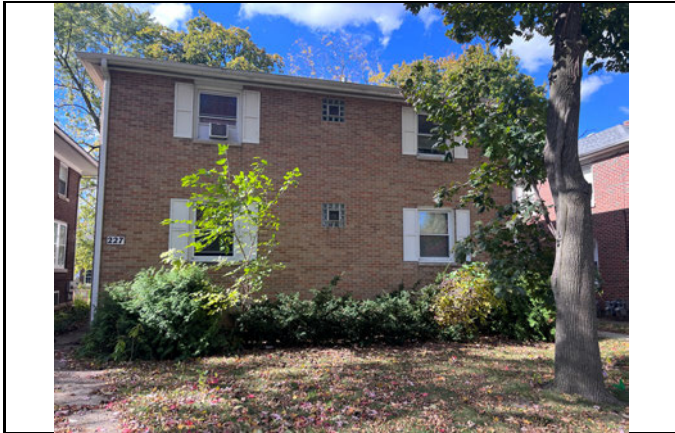
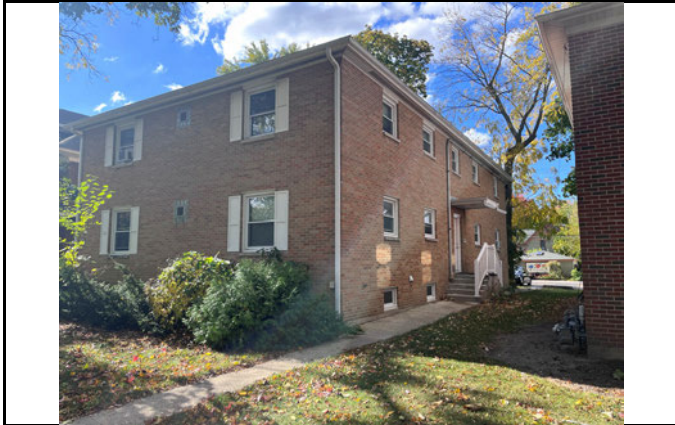
Work Not Requiring COA Replacement windows on secondary north and south elevations; replacement of railings at entrance steps on secondary north and south elevations.

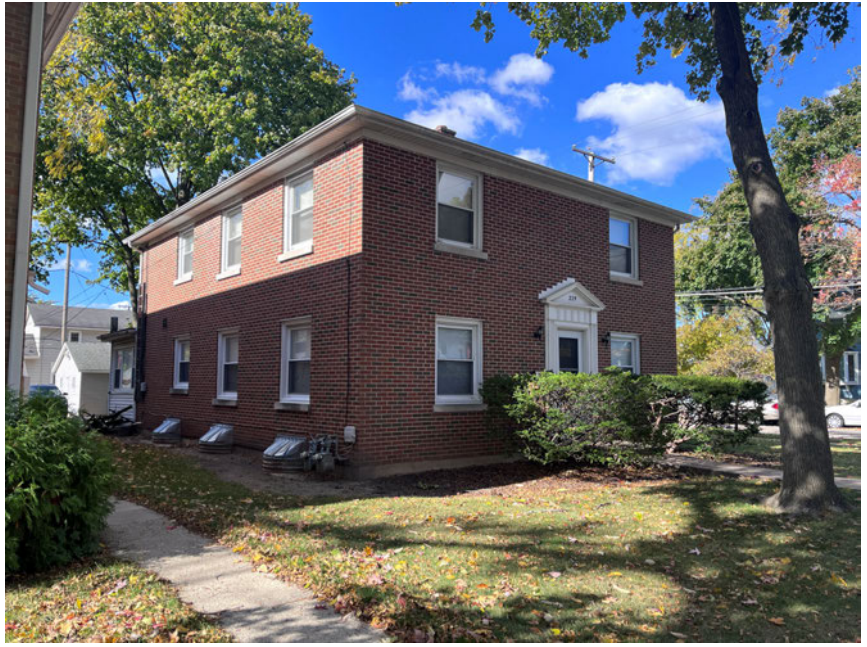
Work Not Requiring COA Replacement windows on secondary elevations.

Replacement windows on front façade.

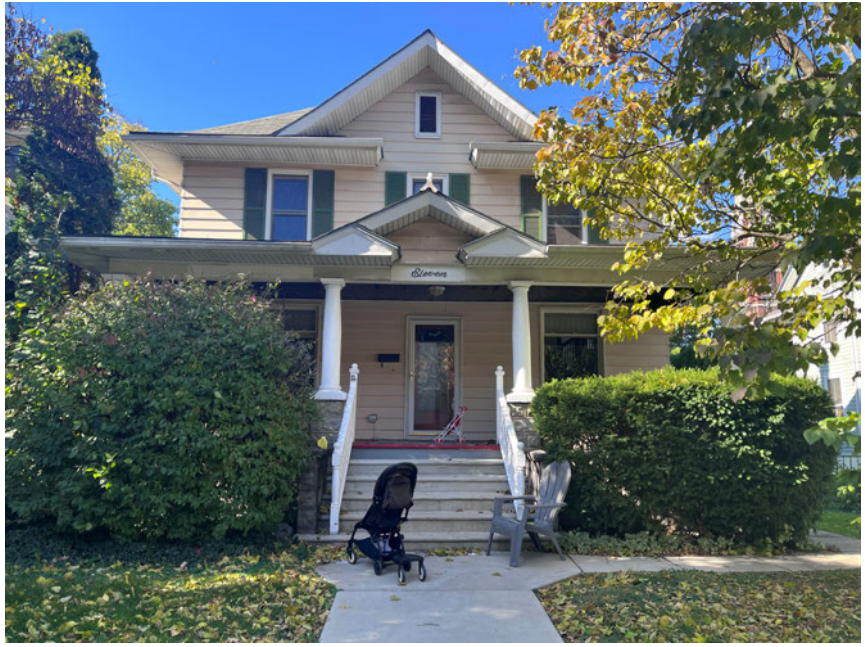
ALTERATIONS Aluminum siding (not historic); replacement 1/1 windows in original openings (not historic); fixed shutters (not historic); 1 story rear addition; 8/8 wood windows on south elevation (historic). Post-2007 -- in-kind replacement of front steps (2020)

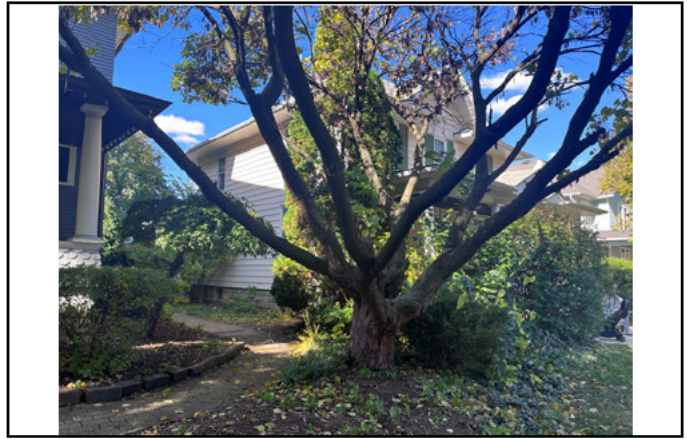
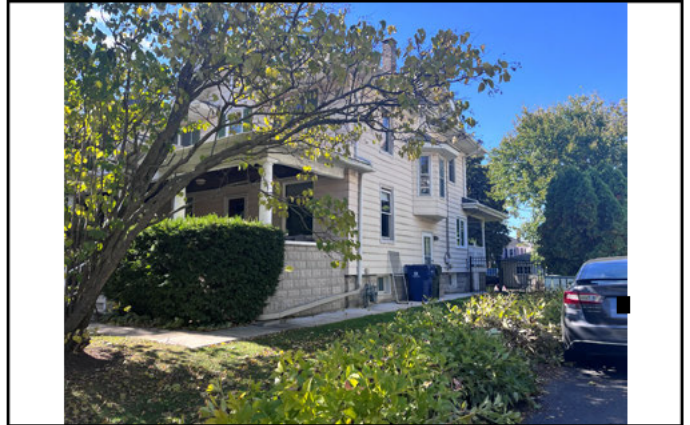
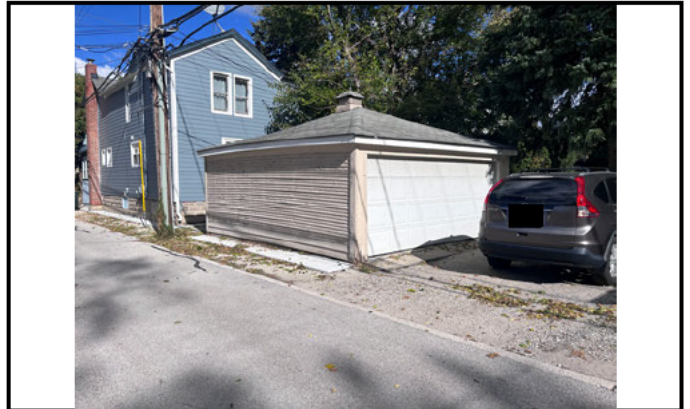
HISTORIC NAME	
COMMON NAME	
ARCHITECT	
BUILDER	
ARCHITECT SOURCE	
HISTORIC INFO	
PERMITS	
LANDSCAPE	Midblock on west side of residential street; front sidewalk; rear alley; similar setbacks; mature trees
COA DATES	8/4/2020
COA DECISION	COA #20-2688 - In-kind front porch stair replacement (approved 8/6/2020)
COA Compliance Notes	
COA Work Not Completed	
Work Not Requiring COA

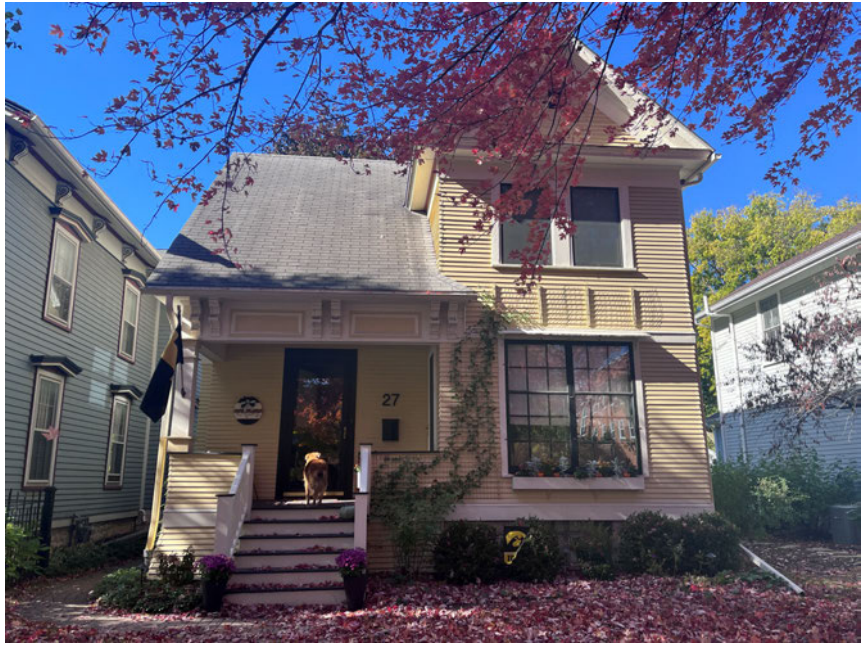
ALTERATIONS 1 story rear addition; replacement 3/1 windows in original openings (historic); replacement multi-light windows in altered openings on first floor (historic); panels & brackets appear to be new/salvaged. Post-2007 -- no changes.
