STREET # 415  
 DIRECTION E  
 STREET FRANKLIN  
 SUFFIX AV  
 PIN 0818307010  
 LOCAL SIGNIFICANCE RATING PS  
 POTENTIAL IND NR? (Y or N) N  
 Contributing to a NR DISTRICT? C  
 Contributing secondary structure? -  
 Listed on existing SURVEY? Local District; NR District

**City of NAPERVILLE**  
ILLINOIS URBAN ARCHITECTURAL AND HISTORICAL SURVEY  
CONTINUATION SHEET

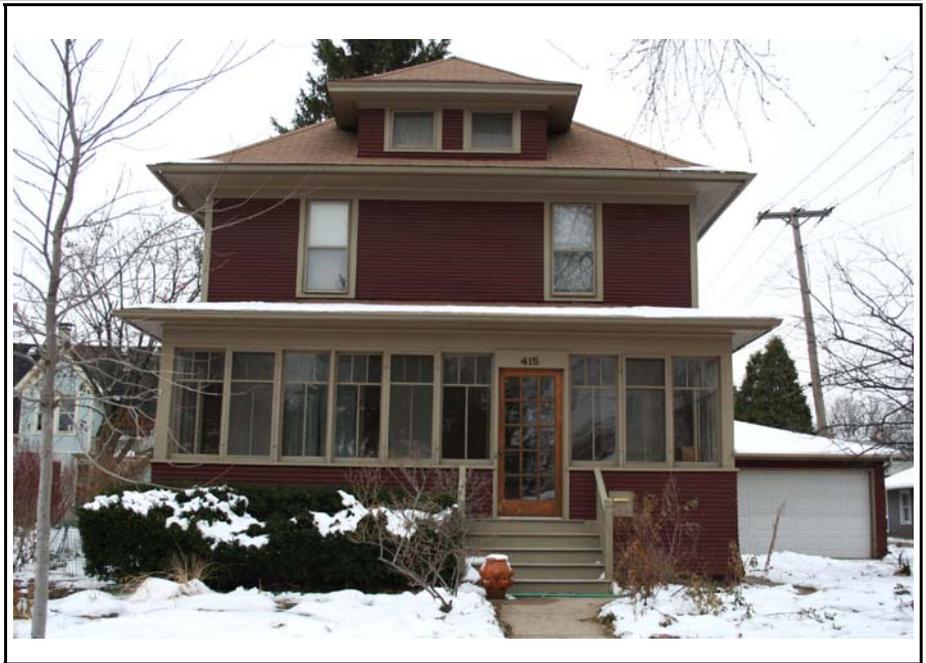
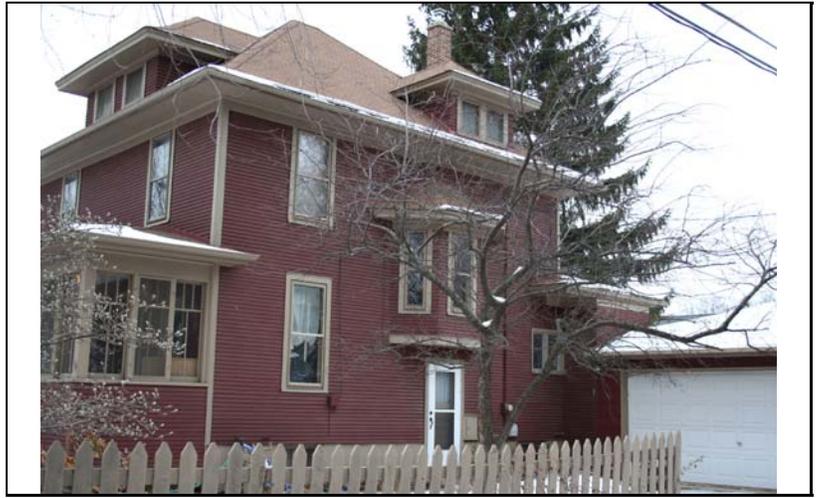
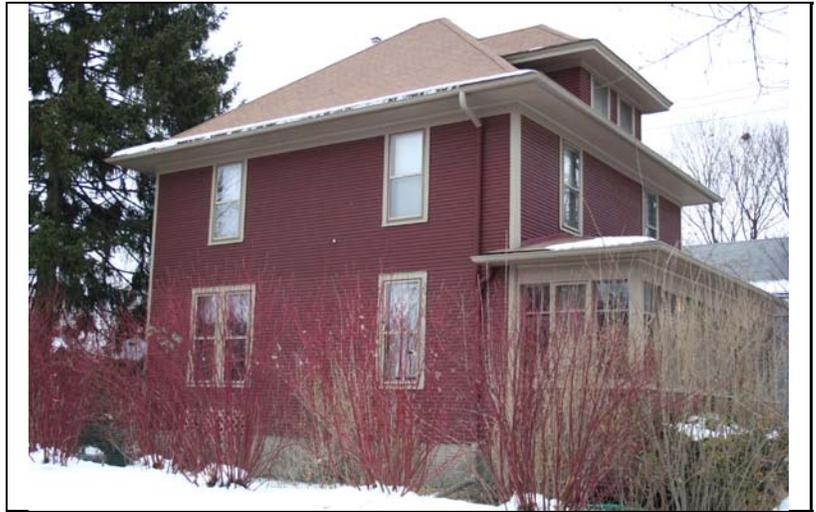
CATEGORY building CURRENT FUNCTION Domestic - single dwelling  
 CONDITION excellent HISTORIC FUNCTION Domestic - single dwelling  
 INTEGRITY minor alterations and addition(s) REASON for SIGNIFICANCE Good, intact example of American Foursquare type.  
 SECONDARY STRUCTURE

ARCHITECTURAL CLASSIFICATION American Foursquare PLAN Rectangular  
 DETAILS NO OF STORIES 2.5  
 BEGINYEAR c. 1915 ROOF TYPE Hipped  
 OTHER YEAR ROOF MATERIAL Asphalt - shingle  
 DATESOURCE Surveyor FOUNDATION Concrete - block  
 WALL MATERIAL (current) Wood PORCH Full front enclosed  
 WALL MATERIAL 2 (current) WINDOW MATERIAL Wood  
 WALL MATERIAL (original) Wood WINDOW MATERIAL  
 WALL MATERIAL 2 (original) WINDOW TYPE Double & single hung; hop  
 WINDOW CONFIG 1/1; 1-light; 5-light  
 SIGNIFICANT FEATURES Fared hipped roof with front and east side hipped roof dormers; hipped roof front porch enclosed with historic 5-light casement windows; historic 1/1 and 1-light wood windows  
 ALTERATIONS Replacement front door and steps (not historic); connector addition to rear garage (not historic)
