PREPARER	Lara Ramsey
ORGANIZATION	RAMSEY HISTORIC CONSULTANTS

SURVEYDATE	11/20/2025
SURVEYAREA	NAPERVILLE SURVEY UPDATE

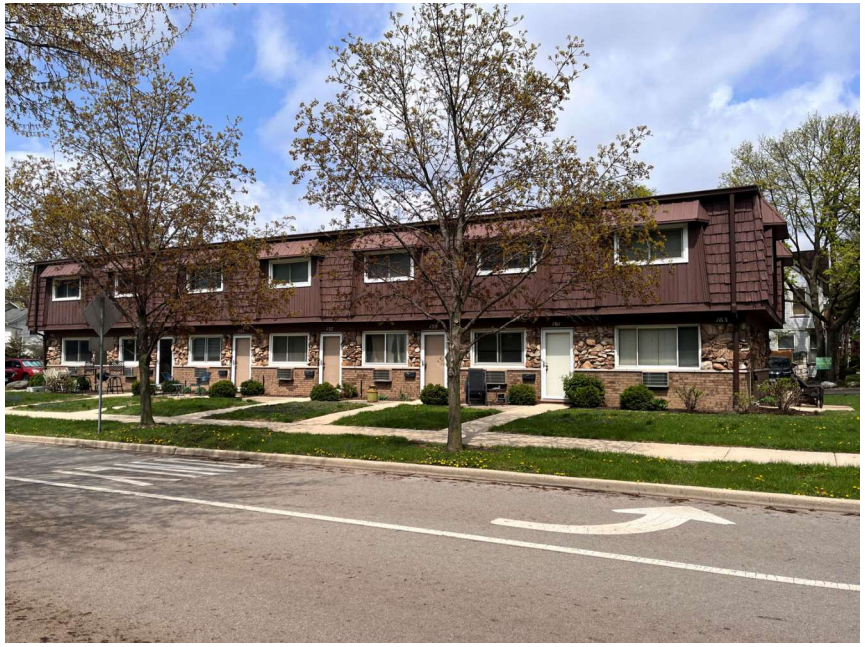
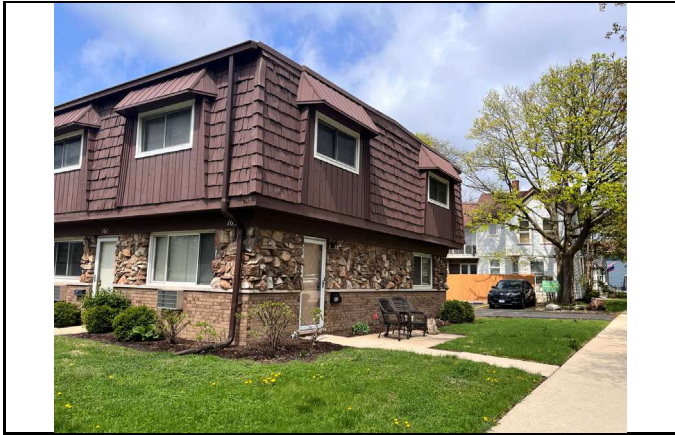
HISTORIC INFO  
Historic aerial maps show that the building was constructed sometime between 1974 and 1978.

LANDSCAPE  
Northwest corner of School and Ellsworth; front and east sidewalks; rear parking lot; similar setbacks; mature trees; west alley

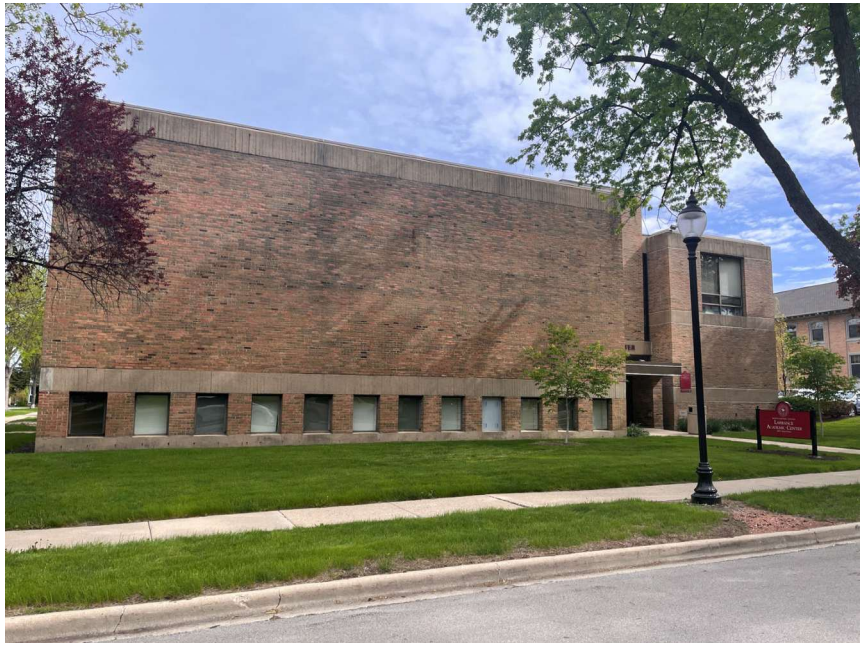
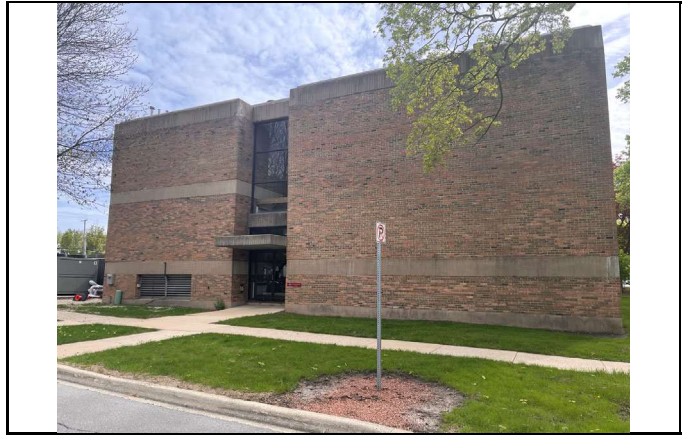
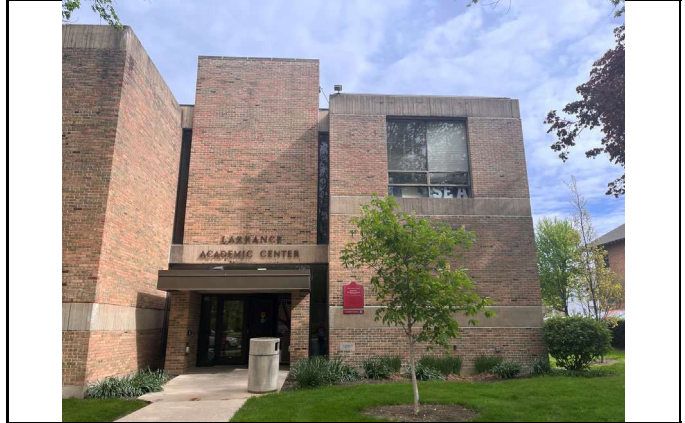
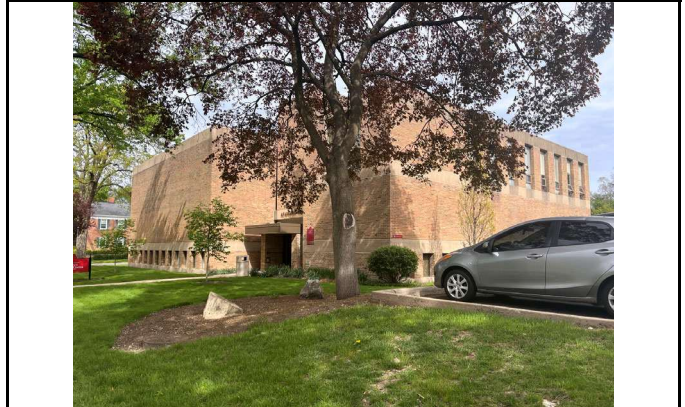
**SIGNIFICANT FEATURES** Flat roof with concrete parapet (formwork on concrete is visible); multi-tonal red brick exterior walls with concrete horizontal banding; large west volume with no fenestration above raised basement level; slight taller entry bay on south elevation with cantilevered canopy over entry doors; two-story east volume with multi-light window at 2nd story; unfenestated west elevation (facing Brainard St) divided by recessed entry bay with cantilevered canopy over doors and glazing above

**ALTERATIONS** Basement window boarded up on south elevation.

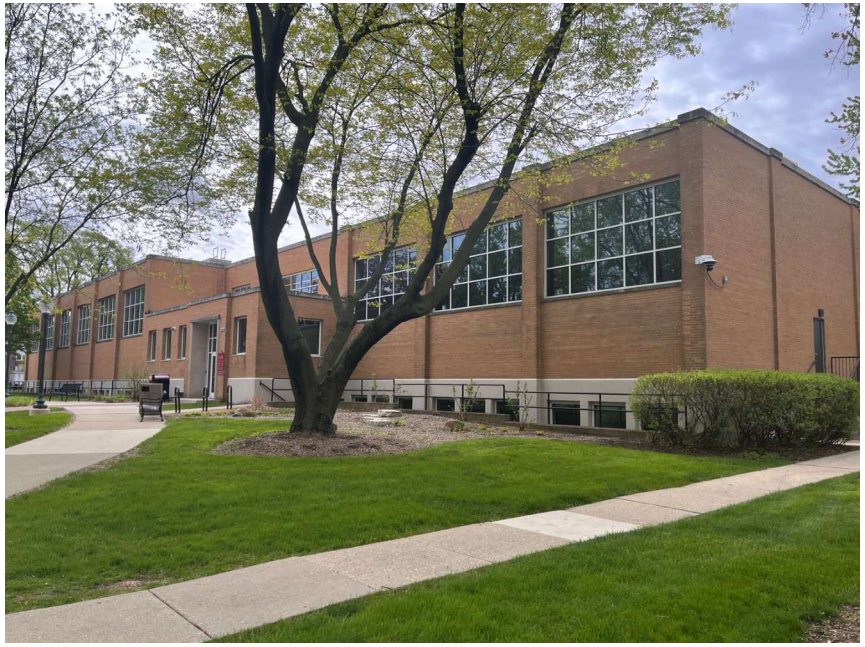
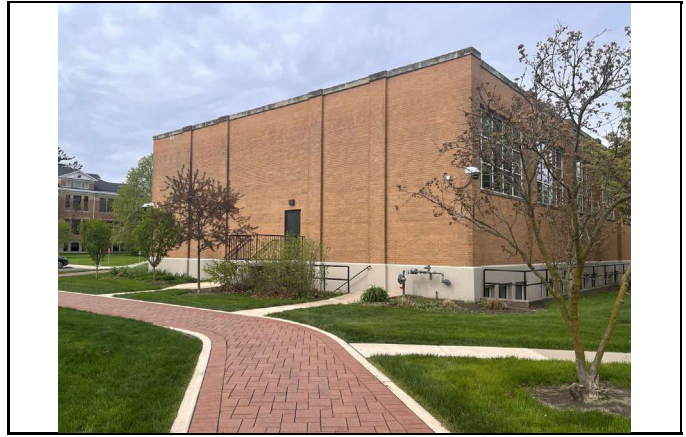
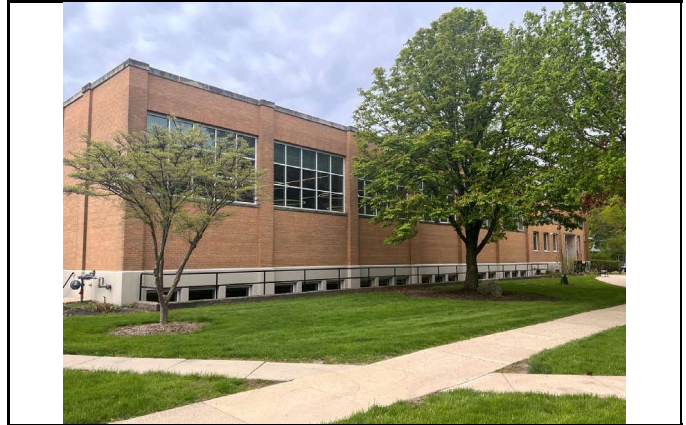
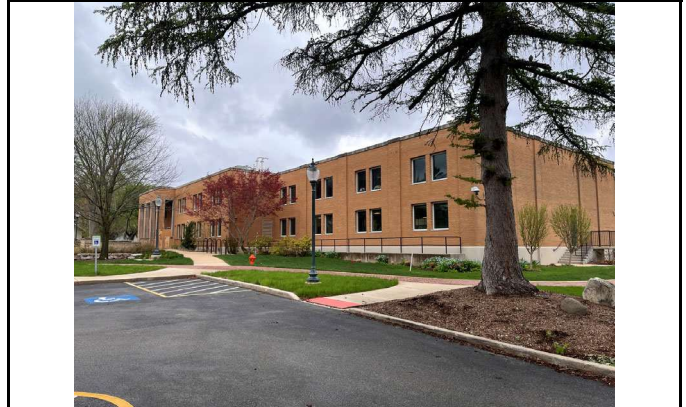
<b>HISTORIC NAME</b>	Library - North Central College and Evangelical Theological Seminary
<b>COMMON NAME</b>	Oesterle Library & Learning Commons
<b>ARCHITECT</b>	Fugard, Burt, Wilkinson & Orth
<b>BUILDER</b>	
<b>ARCHITECT SOURCE</b>	Naperville Preservation Inc
<b>HISTORIC INFO</b>	Gustave Orth of Fugard, Burt, Wilkinson & Orth was lead designer for the building.
<b>PERMITS</b>	
<b>LANDSCAPE</b>	Southeast corner of School and Brainard; front and west sidewalks; building is at north end of main campus block; mature trees
<b>COA DATES</b>	7/9/2018
<b>COA DECISION</b>	COA #18-2731 - In-kind replacement of doors and windows - windows will be divided (approved 7/13/2018)
<b>COA Compliance Notes</b>	
<b>COA Work Not Completed</b>	
<b>Work Not Requiring COA</b>	
<b>PREPARER</b>	Lara Ramsey
<b>ORGANIZATION</b>	RAMSEY HISTORIC CONSULTANTS
<b>SURVEYDATE</b>	11/20/2025
<b>SURVEYAREA</b>	NAPERVILLE SURVEY UPDATE

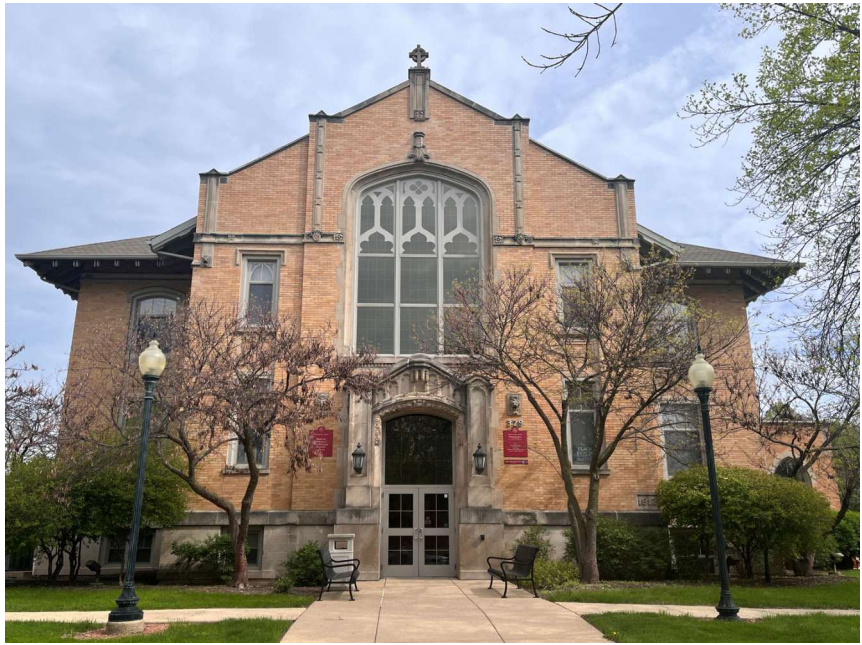
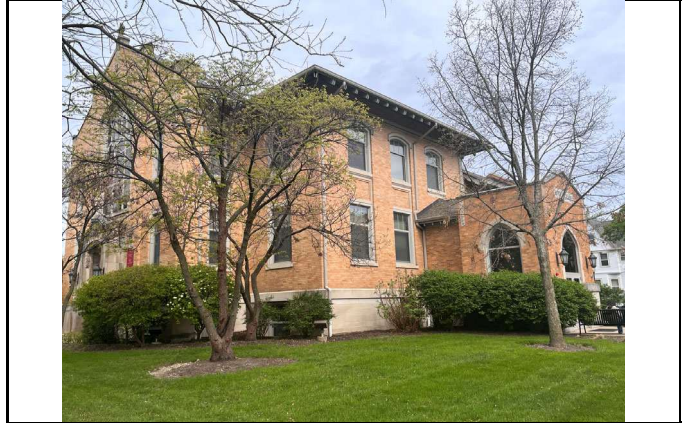
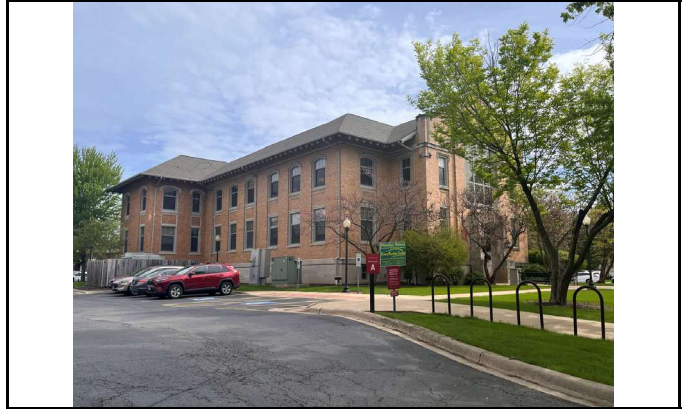
HISTORIC NAME	Kiekhofler Hall
COMMON NAME	
ARCHITECT	
BUILDER	
ARCHITECT SOURCE	
HISTORIC INFO	Building featured in Naperville Heritage Housewalk brochure.
PERMITS	
LANDSCAPE	Northwest corner of Loomis and School; front and east sidewalks; west side parking lot
COA DATES	
COA DECISION	
COA Compliance Notes	
COA Work Not Completed	
Work Not Requiring COA

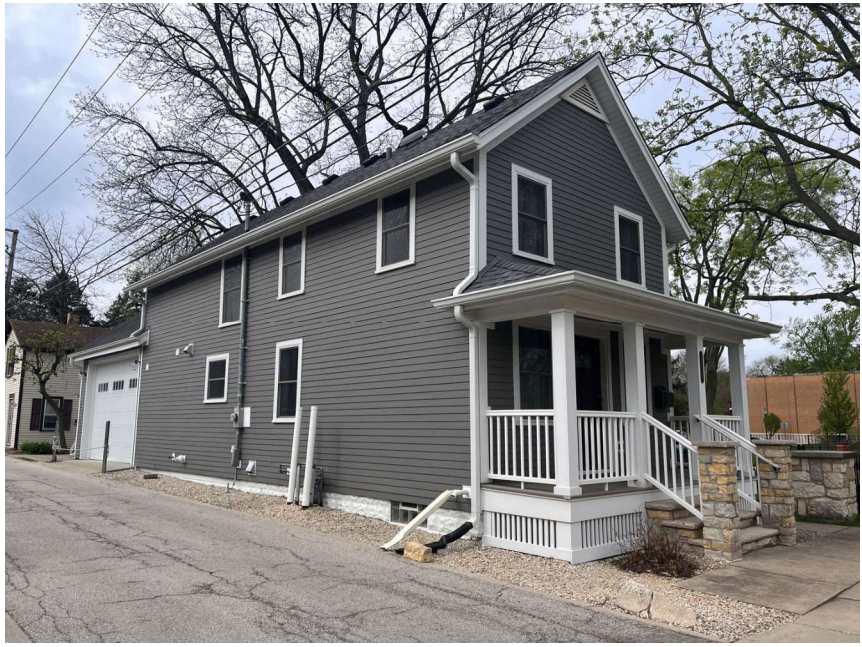
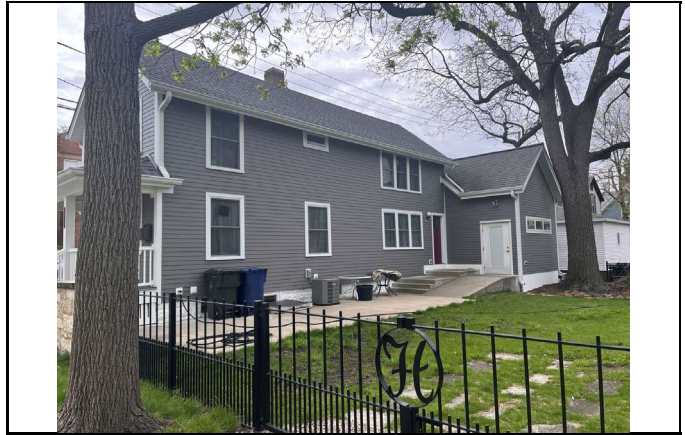
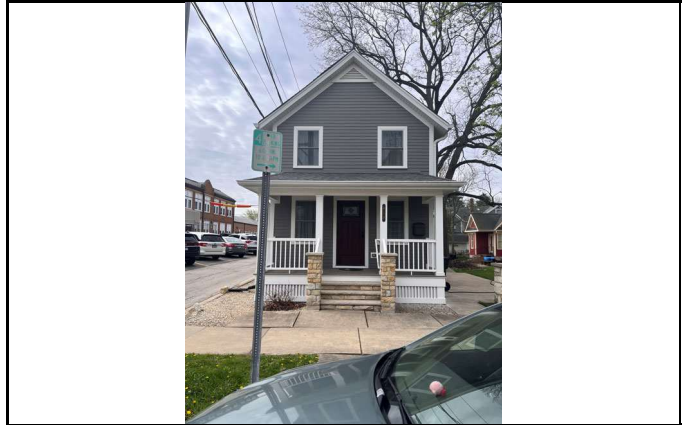
**COA DECISION** COA #15-2157 - Renovation of and addition to attached garage (approved by HPC 9/24/2015); COA #19-3978 - In-kind door, siding, shingle replacement. Removal of chimney and shutters (approved 10/18/2019); COA #19-3978 - field change for a patio, ramp, and sidewalk changes (approved 4/17/2020)

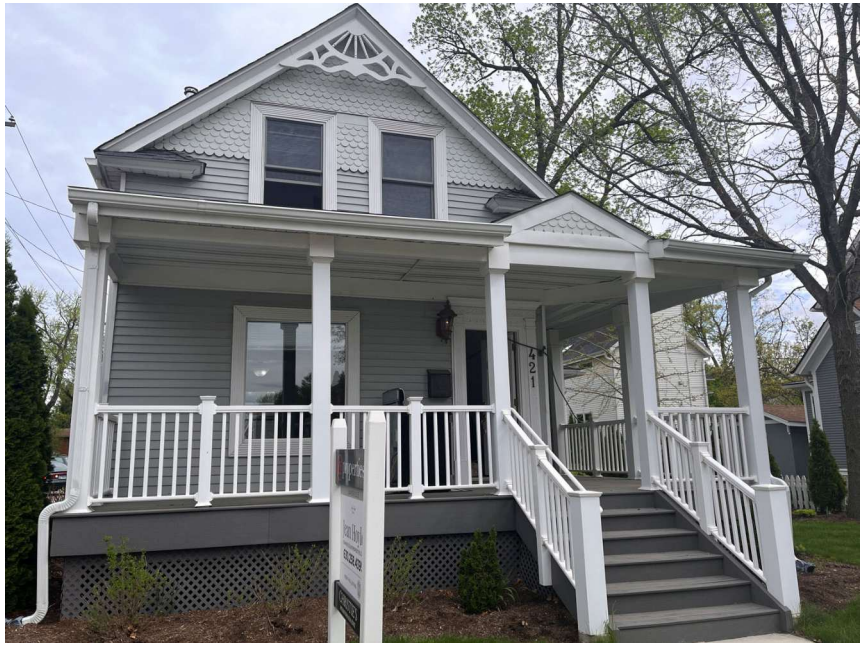
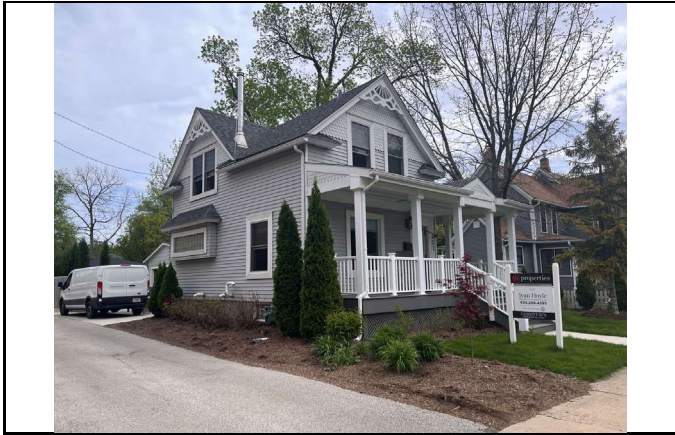
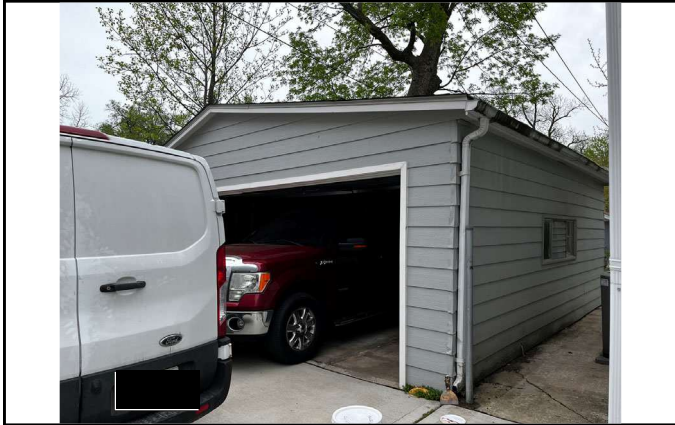
**HISTORIC INFO** Sanborn maps from the early 20th century show that the house originally featured a wraparound front porch that was removed sometime after 1954.

**COA DECISION** Application for COA dated 8/5/2019 for new wraparound front porch with hip/shed roof, triangular pediment at entrance, square columns and open railings. Drawings show porch with decorative corner detailing at columns, which were not included when built.

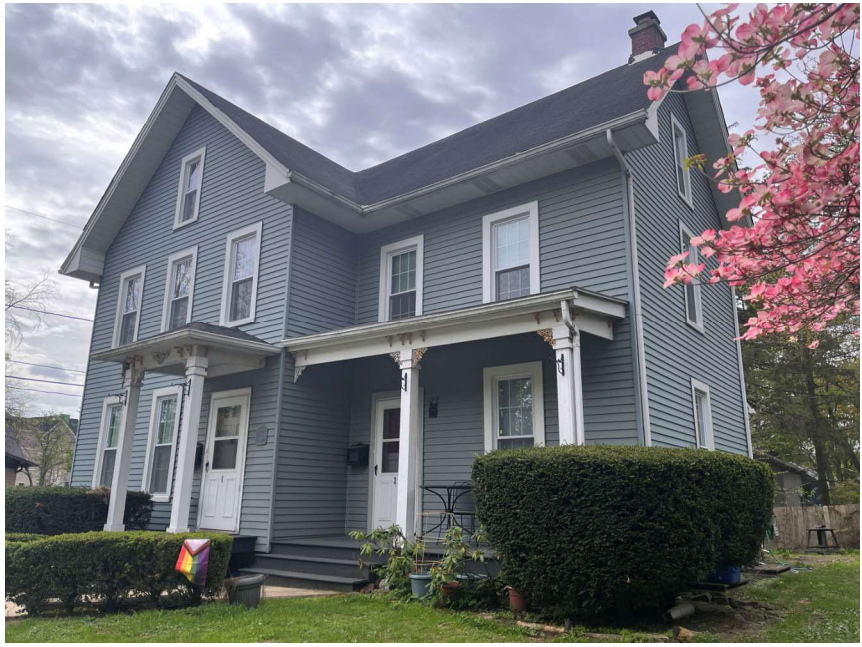
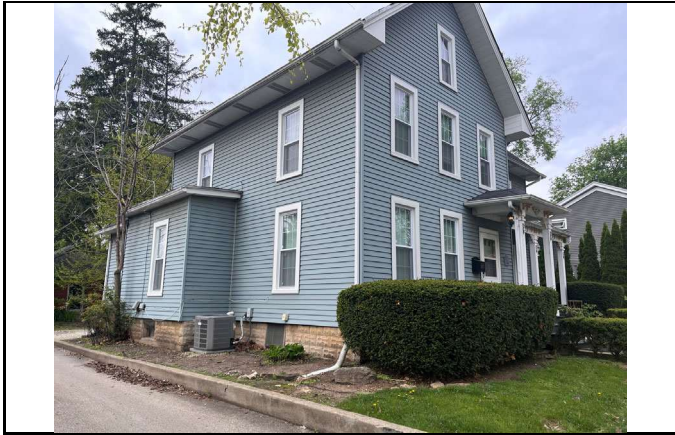
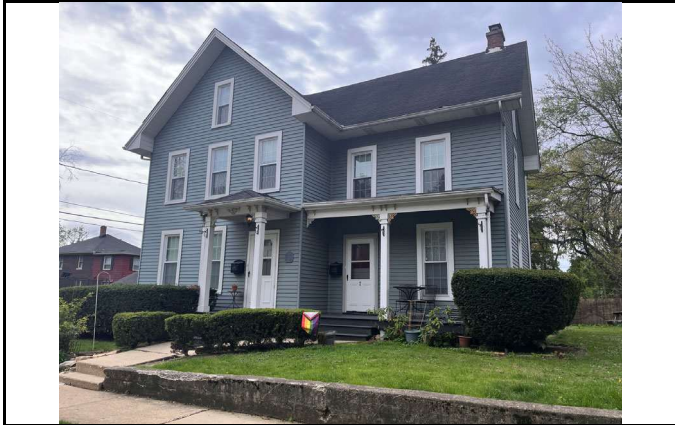
HISTORIC INFO Building does not appear on Sanborn maps at this location until 1949, but massing, roofline, and fenestration patterns are consistent with late 19th century residence, suggesting that the building may have been moved from another location. IHSS photo from the 1970s shows the house with Italianate-style window hoods.

Historic 4/4 wood windows replaced with 6/6 replacement windows in existing openings.

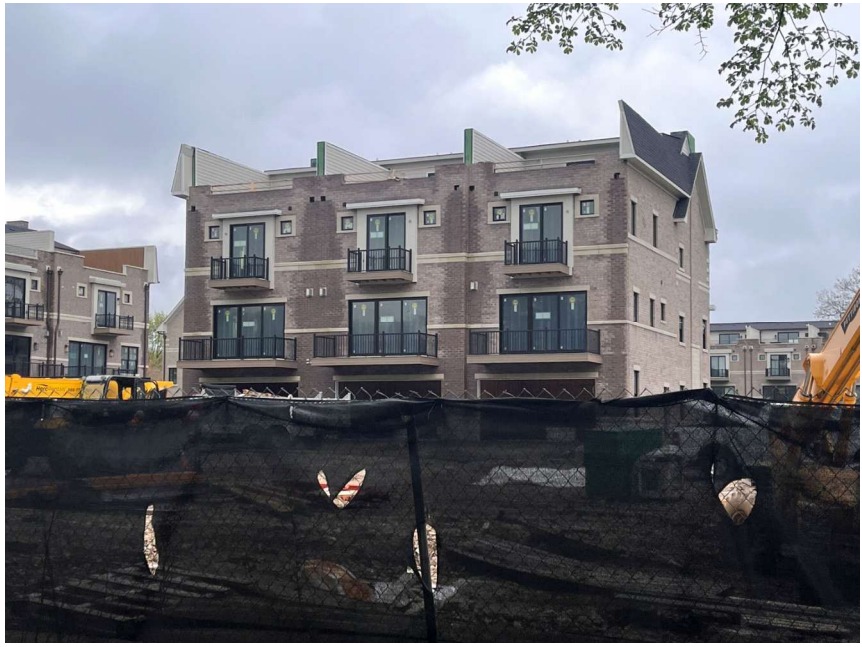
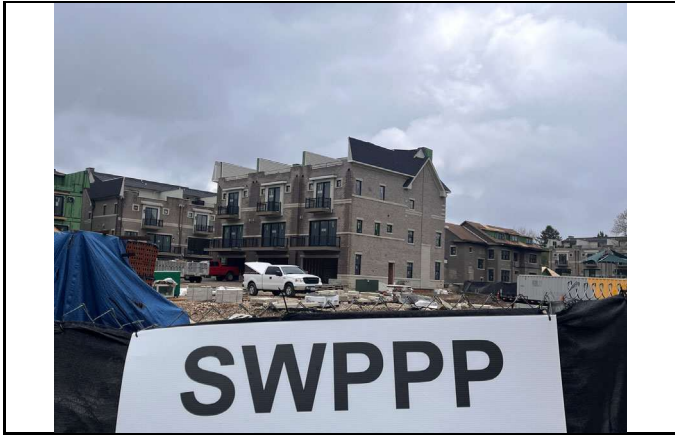
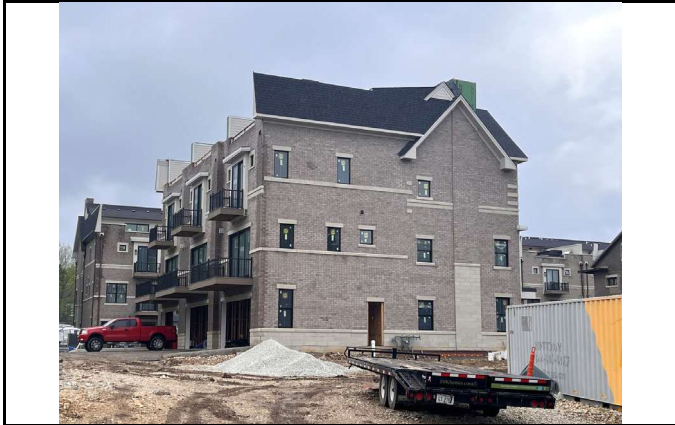
HISTORIC INFO Former site of post-WWII building that housed Little Friends, Inc. Building was originally connected to the P. E. Kroehler House at 126 N. Wright Street. Building was demolished to make way for Heritage Place Development -- a new grouping of three row houses (Building 3 on the development's site plan) is currently under construction.

COA Compliance Notes Under construction.
