**ADDENDUM NO. 1 (DRAFT)**  
**Naperville Riverwalk**  
**Moser Tower Structural Assessment**  
**September 2018**

### CORROSION AND MATERIAL DURABILITY ANALYSIS

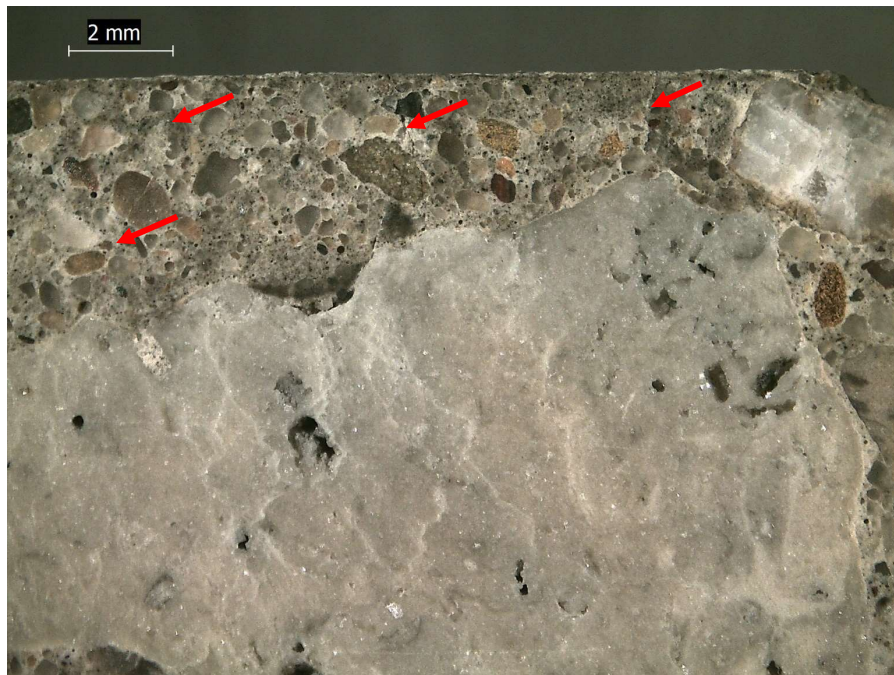
Figure 29. Column (3150054). Stereo-optical micrograph of the polished slab showing perpendicular microcracks consistent with drying shrinkage up to 3/16" deep.

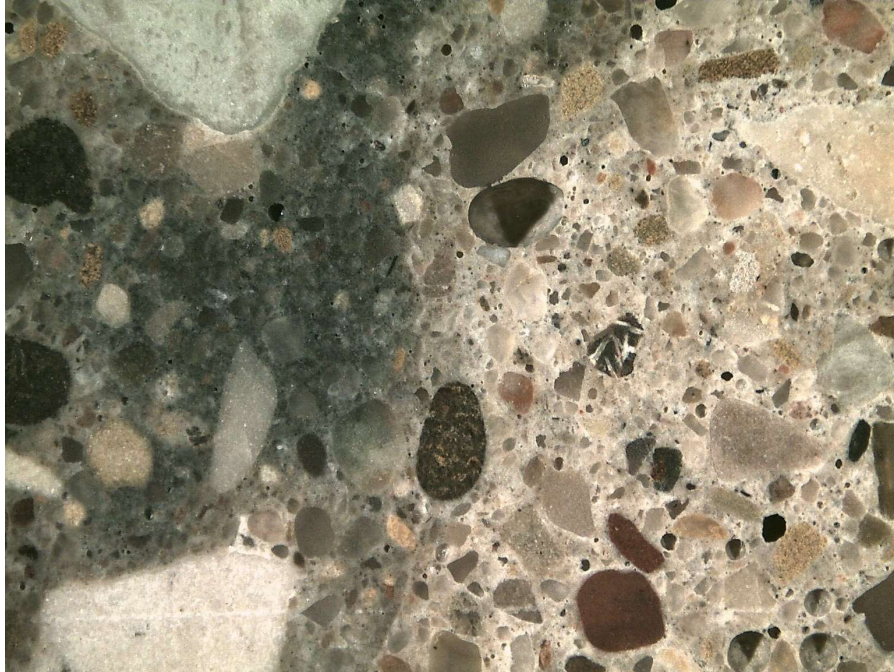
Figure 39. Entrance Wall (3150055). Stereo-optical micrograph showing the interface between concrete pours.

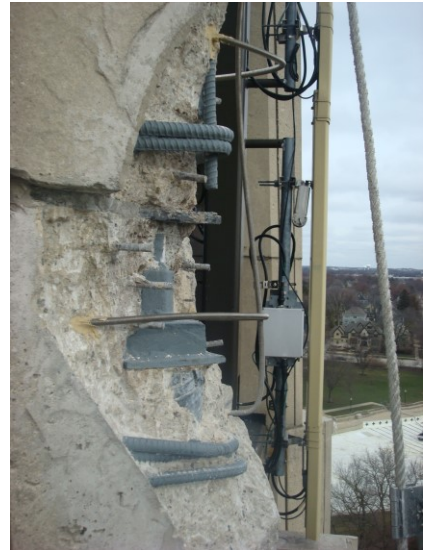
*Failed patch with post-tension dead end with anchor stressing assembly. Note new stainless-steel patch reinforcing.*

Based on the architectural survey of the pattern of deterioration at this specific elevation, it is our opinion that the concrete failure is primarily of a structural nature to be addressed by ERA. The repairs should address structural issues in conjunction with the durability and aesthetic considerations. We noted that the post tensioned dead-end assembly does not match the shop drawings which may have a bearing on the failure. Additionally, the reinforcing configuration and quantity around the PT dead-end should be reviewed for common practice standards.

Any patches whether they are load bearing or not, must match the host material in color, texture and form as determined through test mock-ups and color sample development. Tertiary issues include proximity of the PT dead-end to the surface of the concrete. Expansion and contraction of the embedded steel should be addressed during patching. All patch material should be colored and textured to match the color of the cleaned parent material. The areas to be patched should be sawcut at right angles with the appropriate depth and surface texture for the required bond.

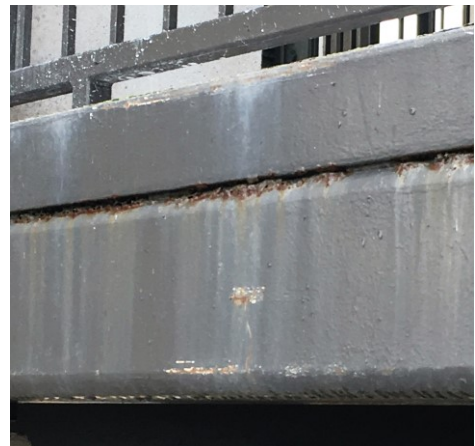
*The typical corrosion buildup between ring beam and deck edge. Note vertical streaks from water runoff.*

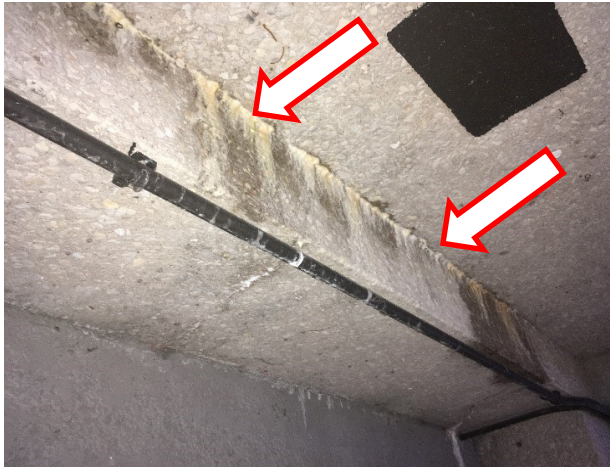
13. A close-up view of concrete cracks and water infiltration below front door.

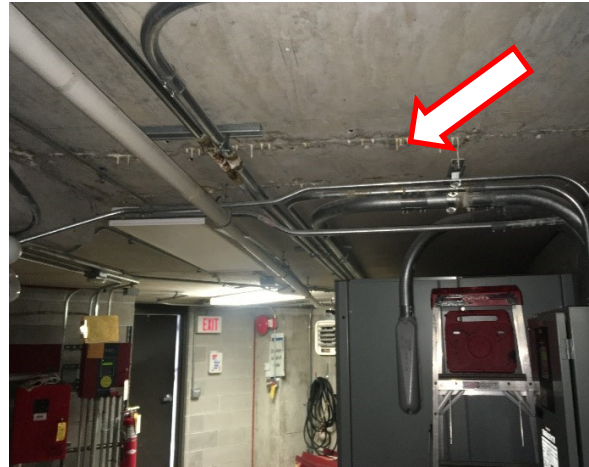
14. A view of concrete cracks and water infiltration in mechanical room below plaza.

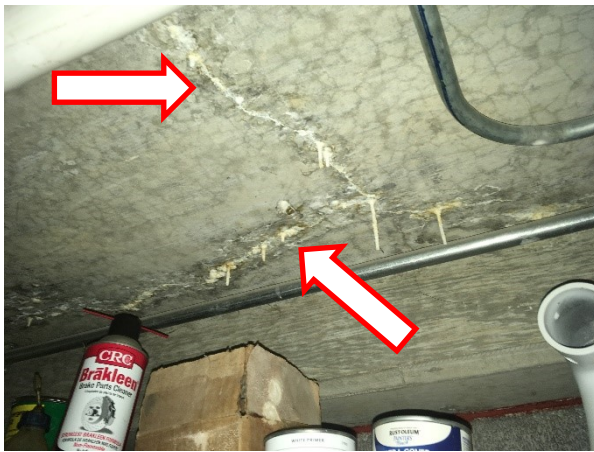
15. A view of concrete cracks and mineral leaching in mechanical room below plaza.

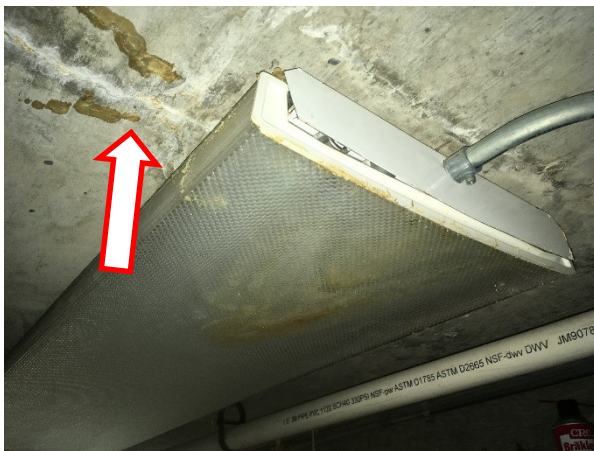
17. A view of concrete cracks and water infiltration in mechanical room below plaza.

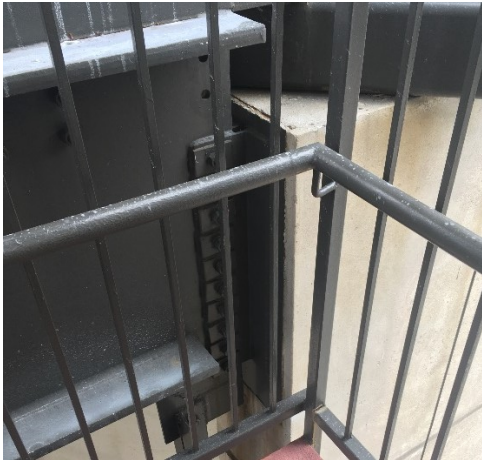
19. Wide flange beam connected to precast at the Gallery level.

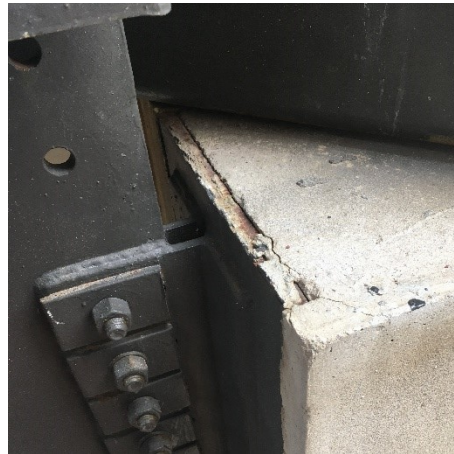
20. A close-up view of the exposed top of the steel embed at the Gallery level beam.

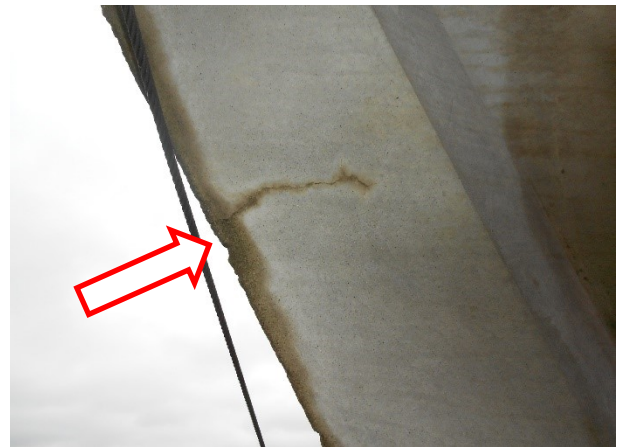
28. A close-up view of the knife edge of the roof panel with crack and water saturation.

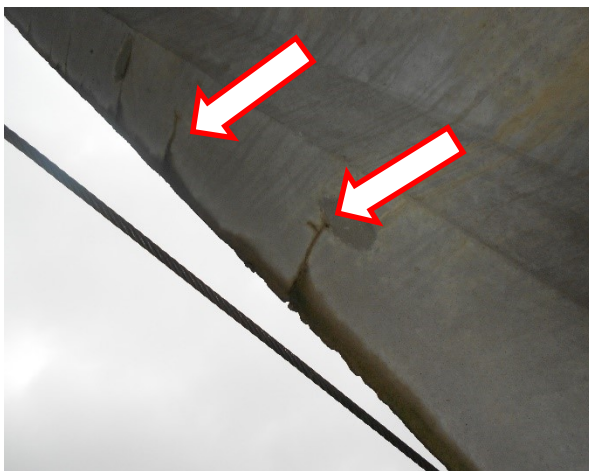
29. A close-up view of the knife edge of the roof panel with cracks and water saturation.

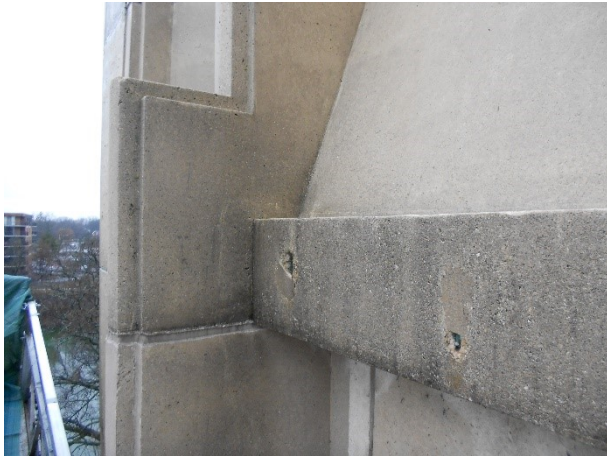
31. A close-up view of small rebar spalls

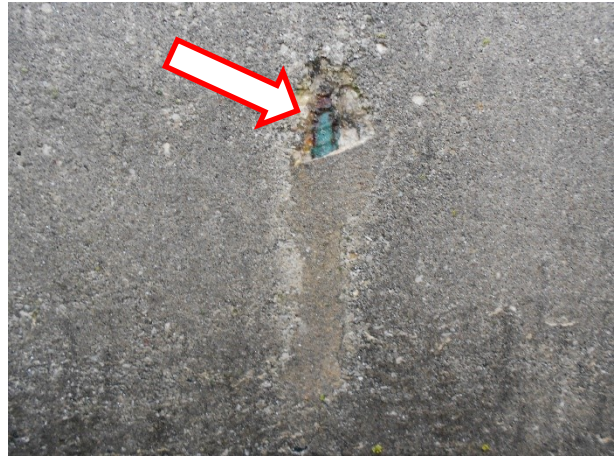
32. A close-up view of a small rebar spall. Note the previous patch.

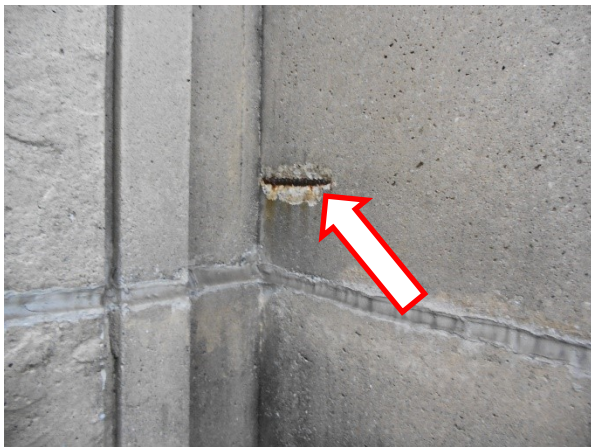
33. A close-up view of small rebar spalls

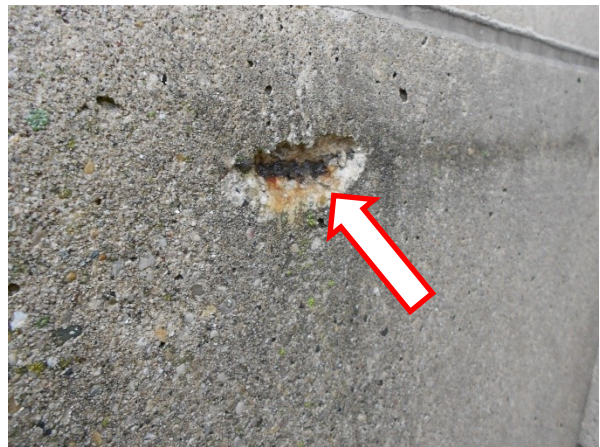
34. A close-up view of small rebar spalls

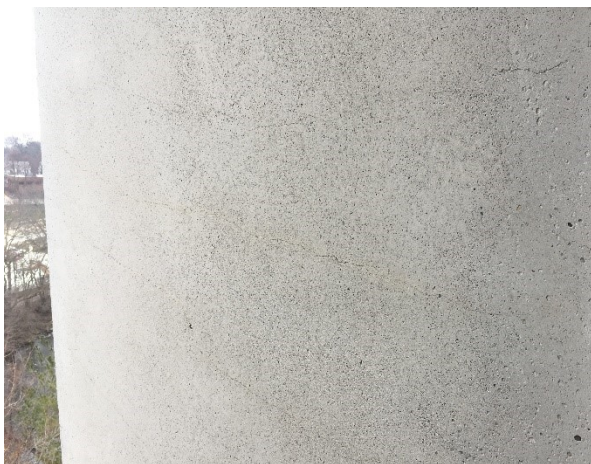
35. A close-up of a precast fin panel with several diagonal hairline cracks.

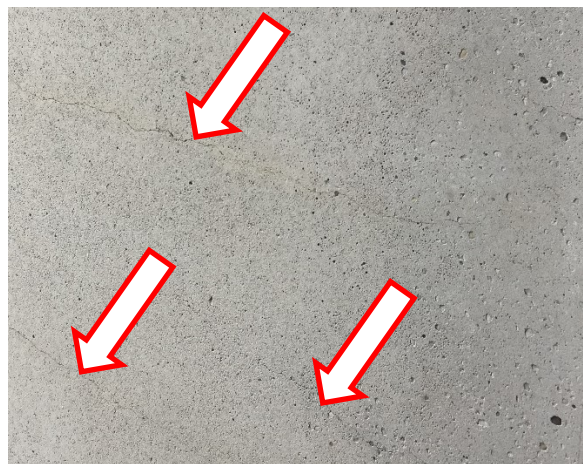
36. A close-up of precast fin panel with several diagonal hairline cracks

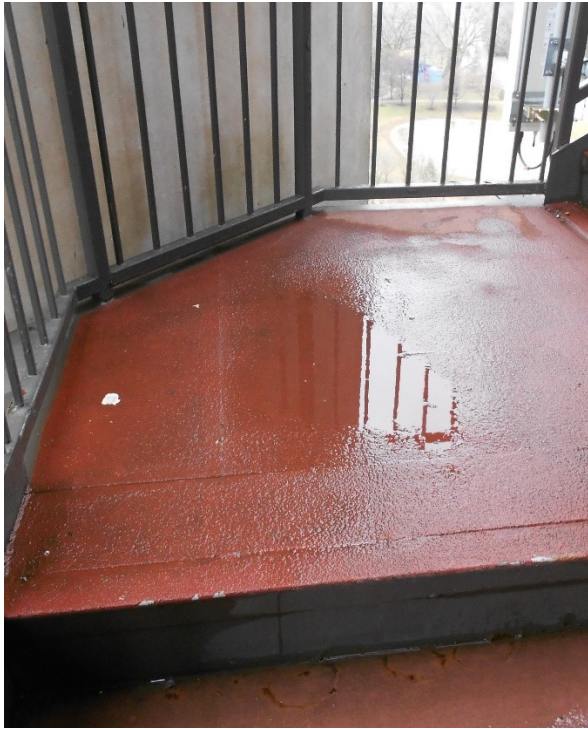
37. Standing water on stair landing.

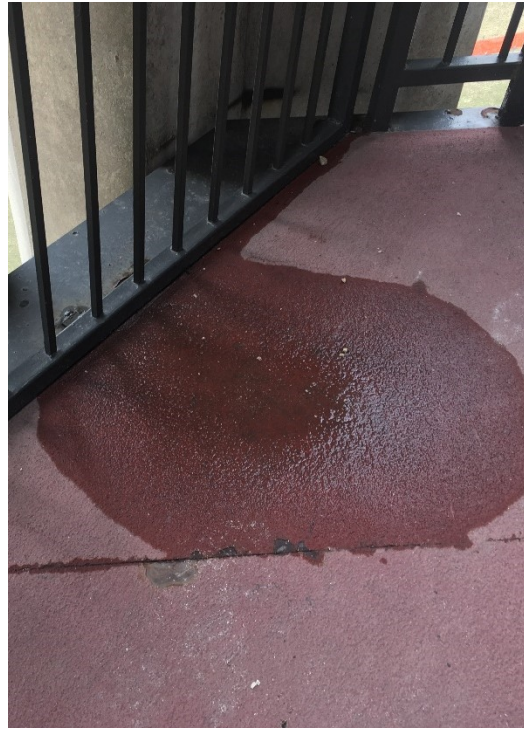
38. Standing water on stair landing.

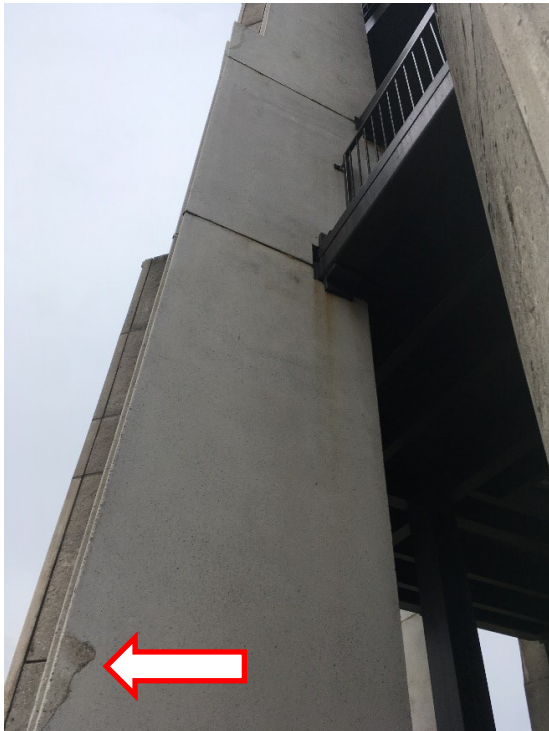
39. A view of a precast fin. Note patch at outer edge at left.

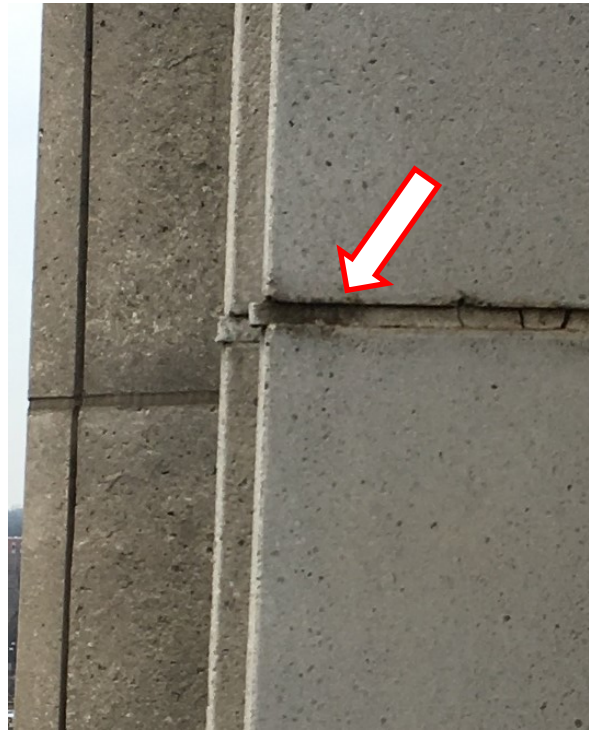
40. A close-up of view of a precast fin joint. Note loose grout in joint.

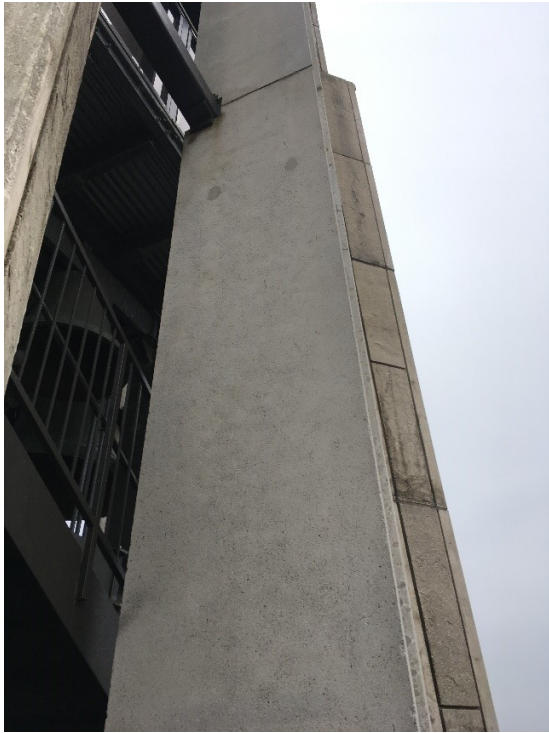
41. A view of a precast fin. Note small lift point patches.

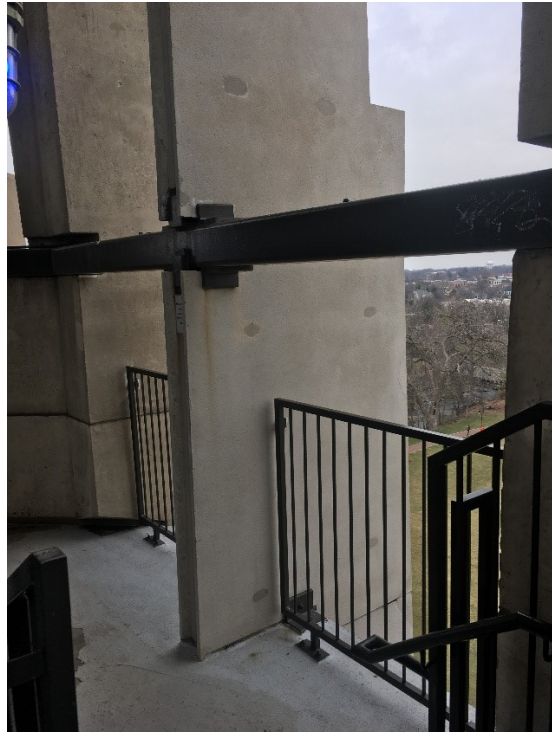
42. A view of a precast fin connection. Note small lift point patches.

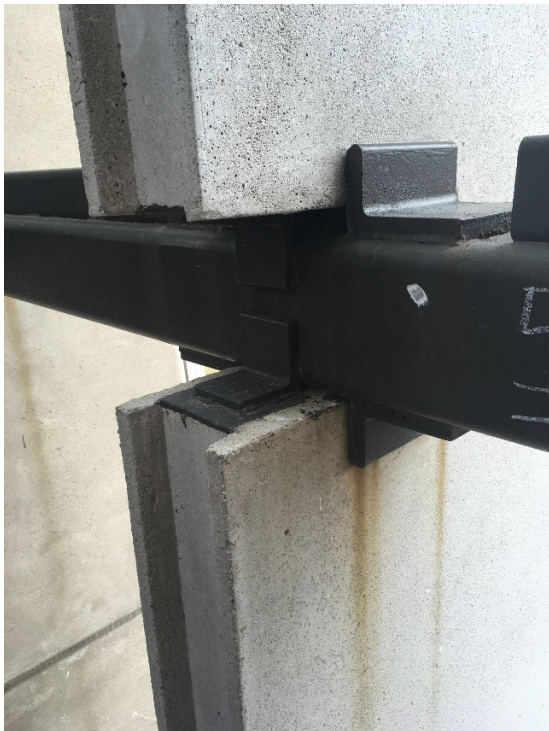
43. A detail view of the precast fin connection. Note corrosion staining.

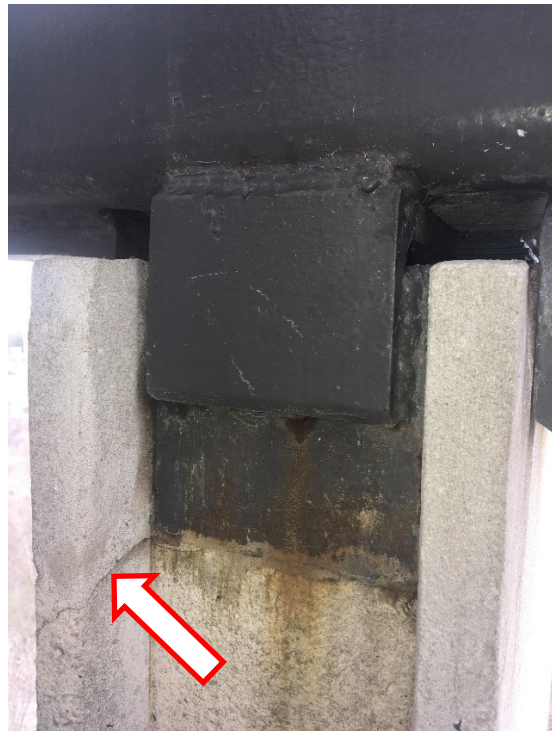
44. A close-up view of the precast fin weld connection. Note concrete crack at corner of steel embed

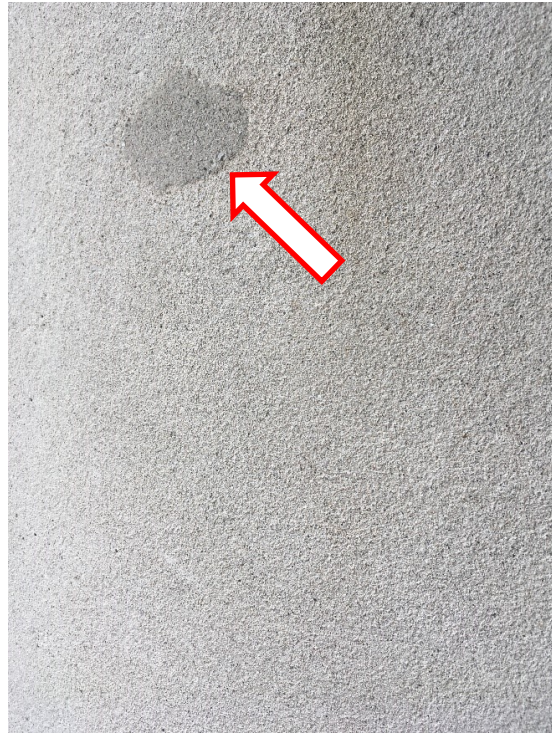
46. close-up of the precast fin showing surface finish. Note typical lift point patch.

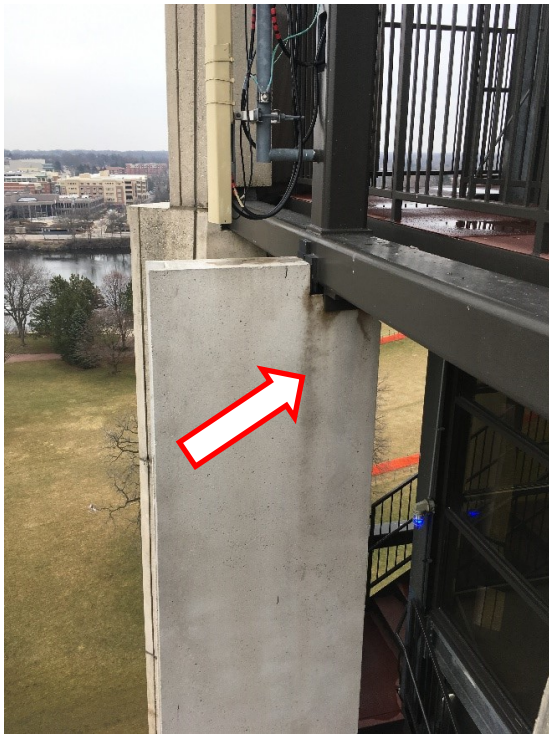
47. A view of the top of a precast fin. Note corrosion and runoff stains.

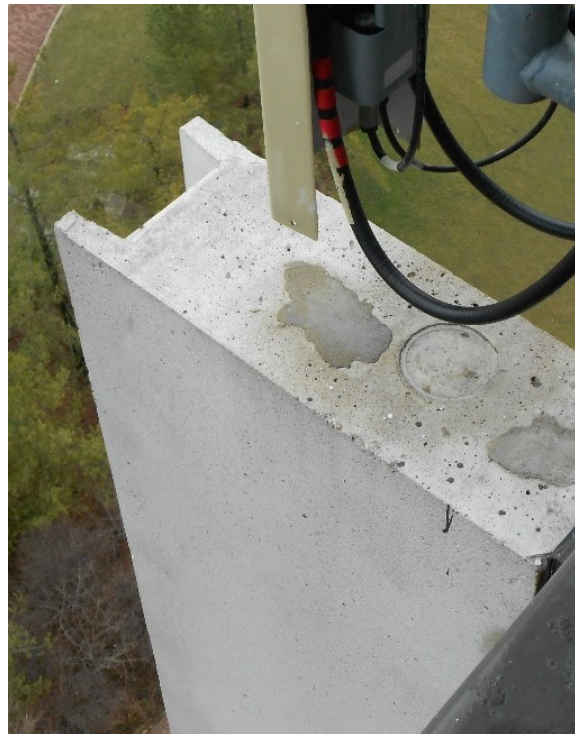
48. A view of the top of a precast fin. Note tensioning rod patches.

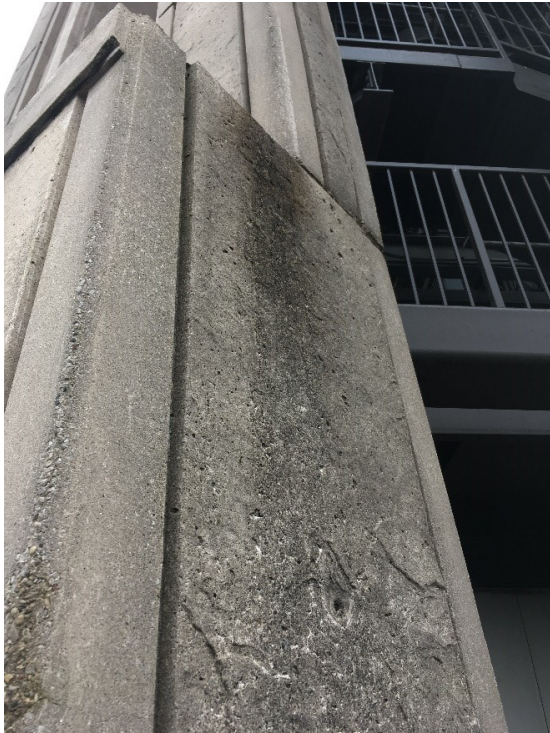
49. An example of surface discoloration from runoff.

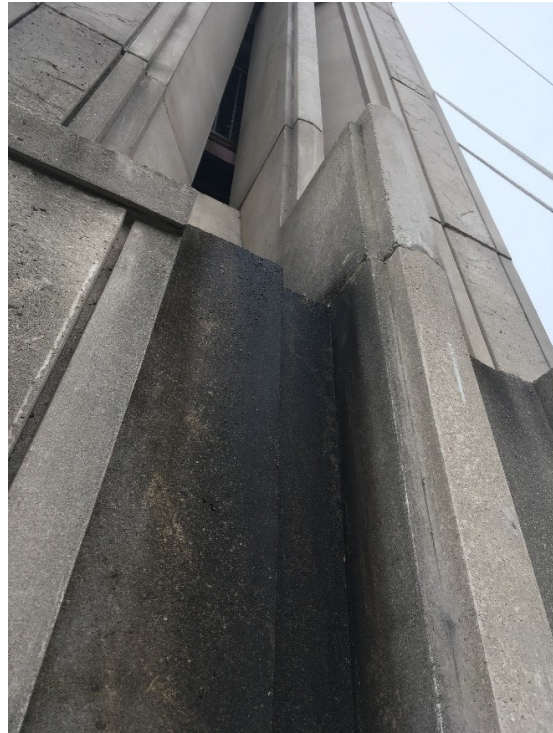
50. An example of surface discoloration from runoff.

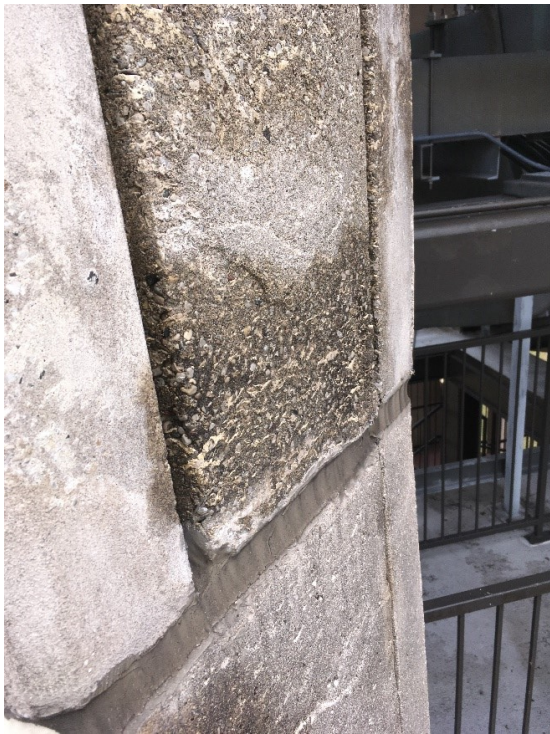
51. An example of surface discoloration from poor concrete consolidation.

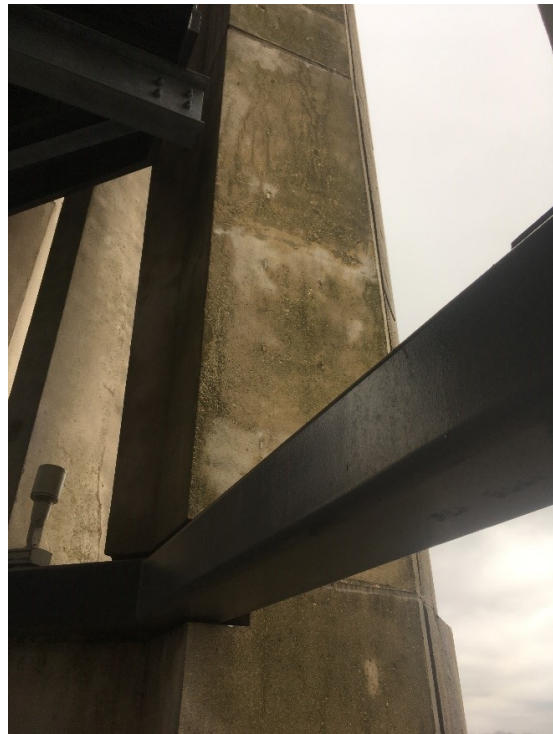
52. An example of surface discoloration from biological growth.

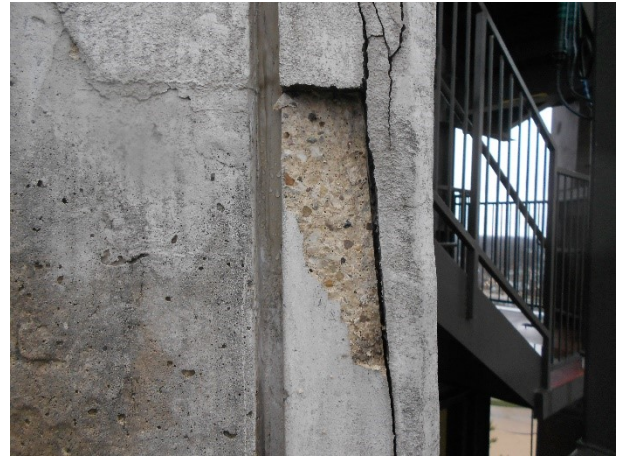
54. A close-up view of failed patch at El. 116'-8" prior to repatching. .

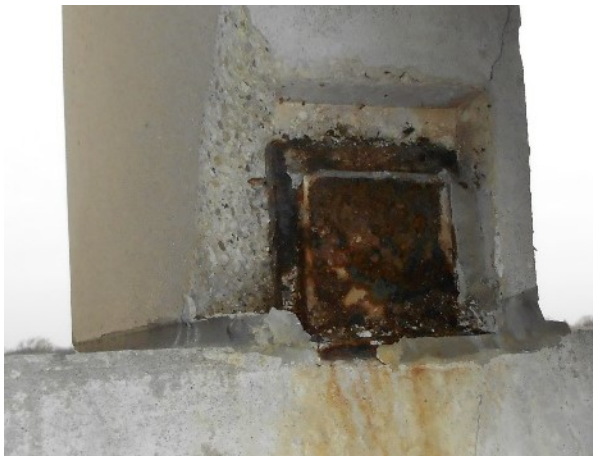
57. A close-up of failed embed patch at small precast fin in pier.

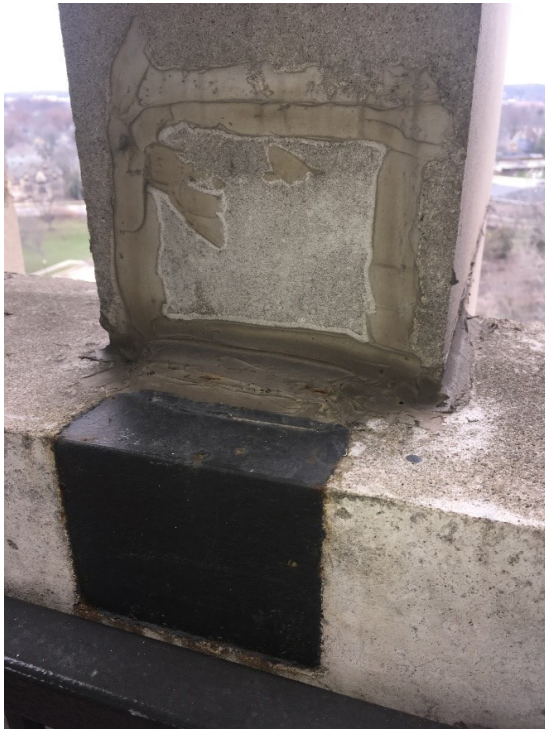
58. A close-up of an intact embed patch.

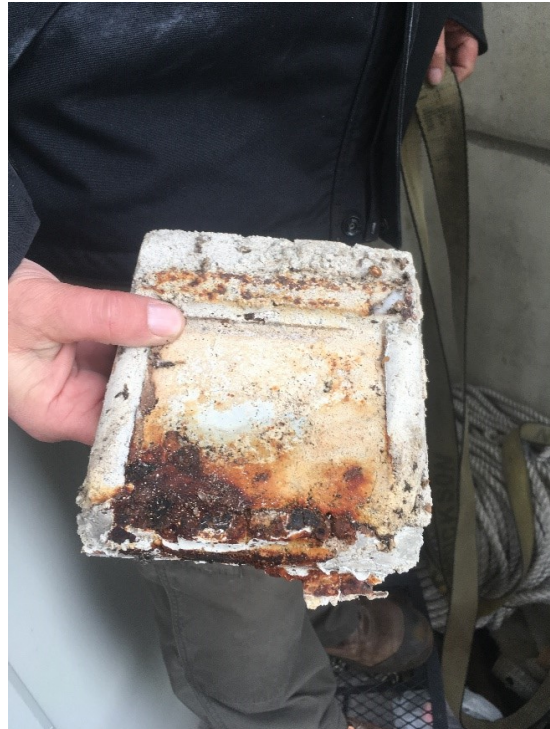
59. A close-up of an embed patch with sealant.

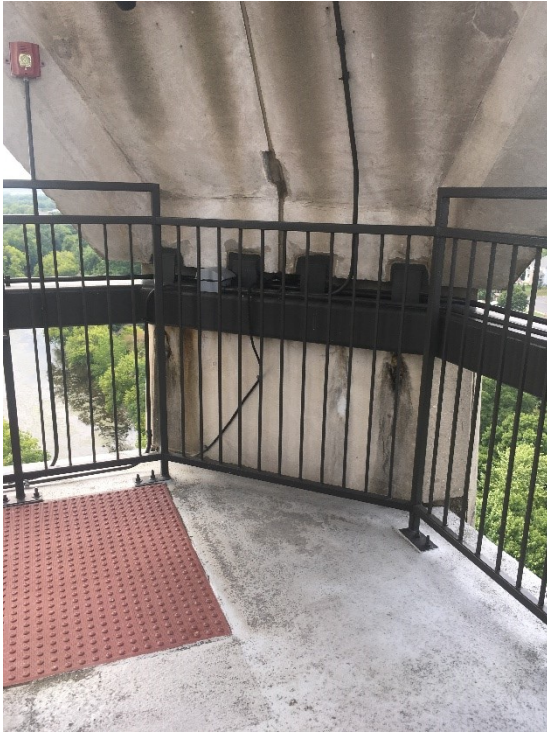
62. A view of the repaired patch on the SE pier made during the investigation. Photo by Golf Construction.

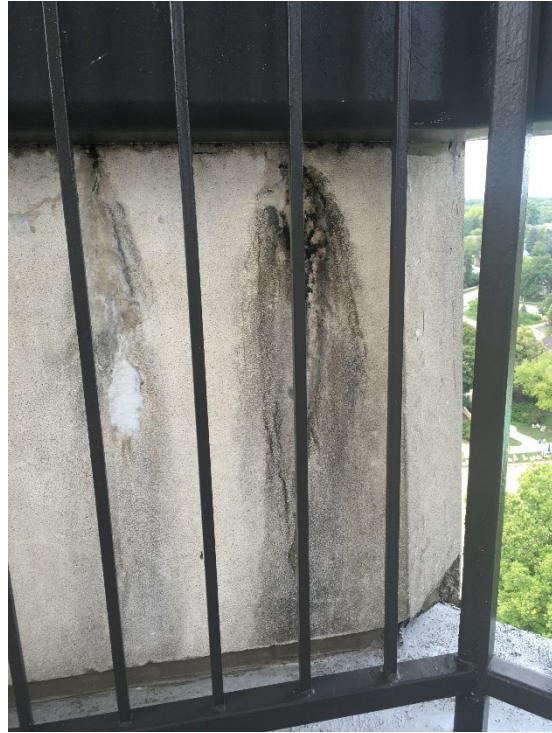
63. A view of the NW pier at the Observation deck. Note corrosion staining below the ring beam.

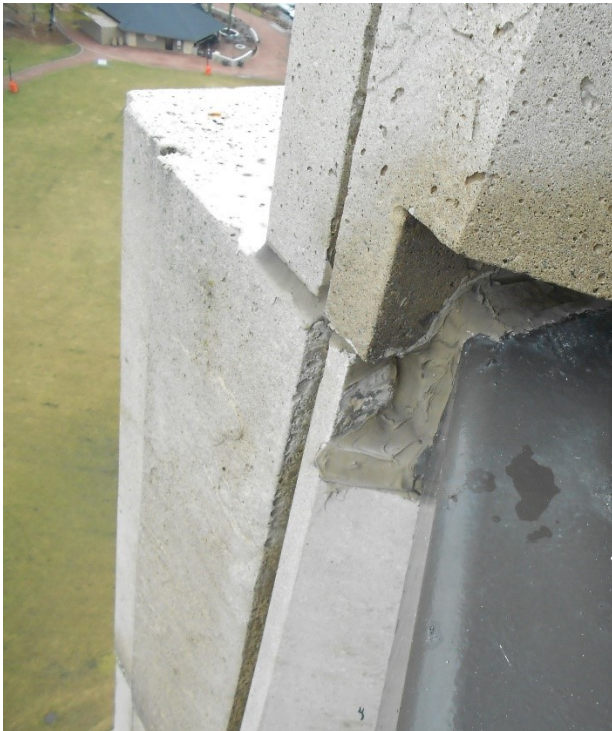
64. A close-up of corrosion and leak patterns at the NW pier below the ring beam.

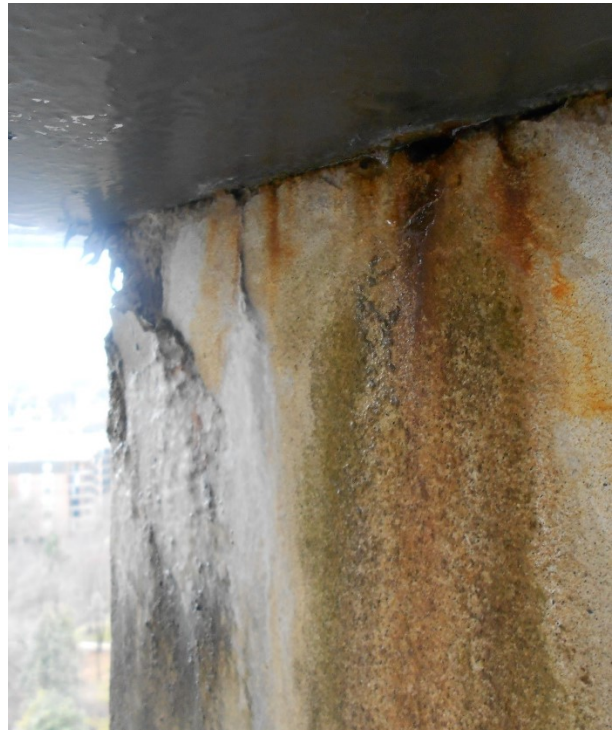
65. A close-up of ledge adjacent to the interior leaks at the Observation deck.

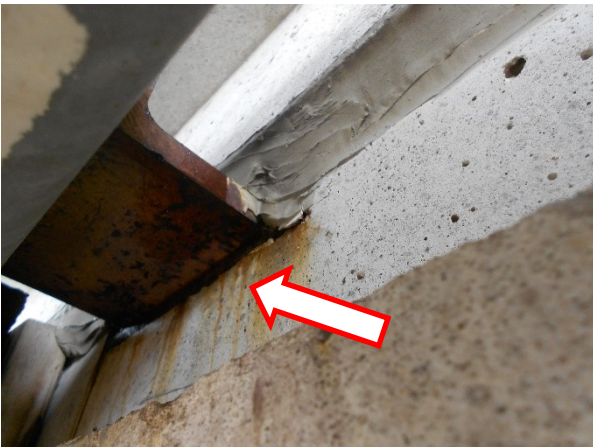
71. A close-up view of clip angle in precast concrete joint from below. Note corrosion staining from runoff.

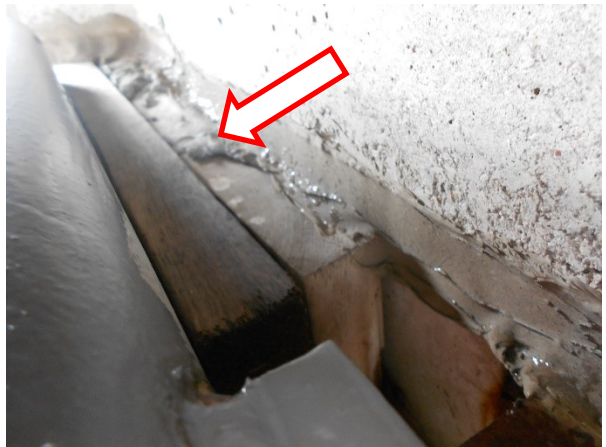
72. A close-up view of leftover wood blocking at ring beam connection.

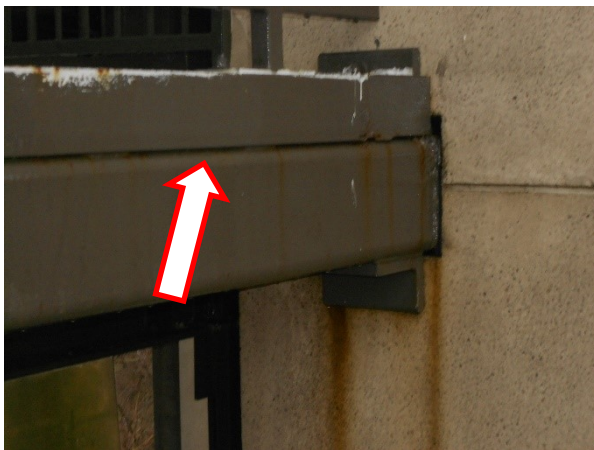
77. A view of typical corrosion at non-galvanized deck edge and ring beam. Note corrosion staining on precast fin.

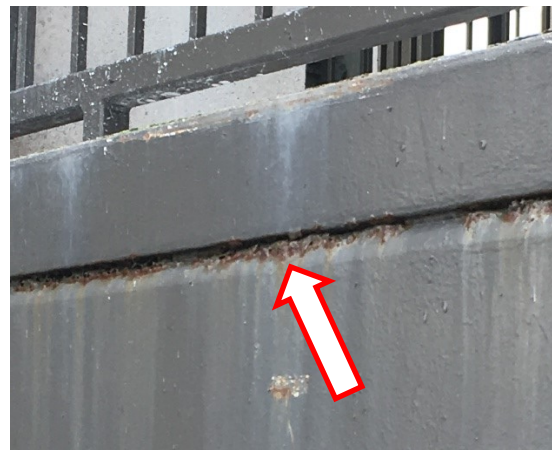
78. A view of typical corrosion at non-galvanized deck edge and ring beam.

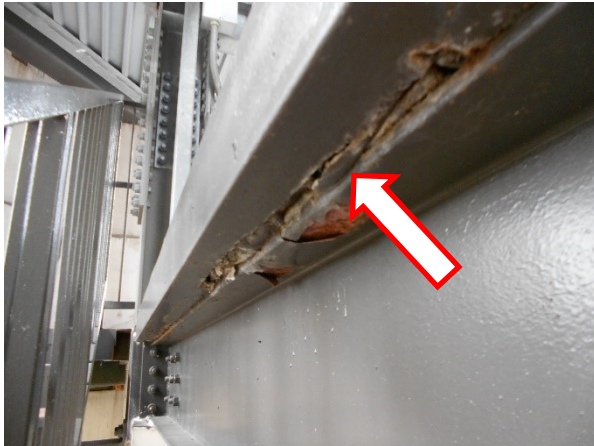
79. A close-up of corroded deck angle and Belfry level.

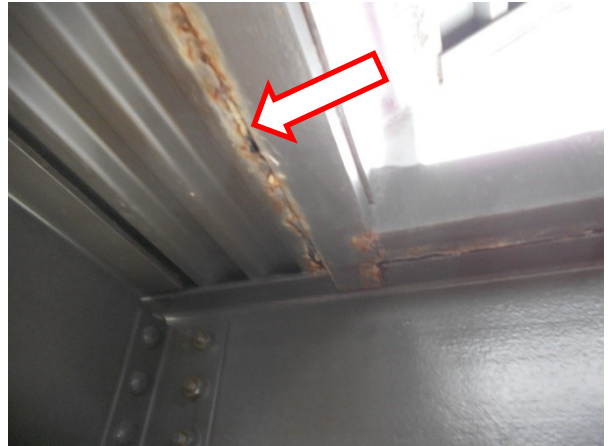
80. A close-up of corroded deck angle and Belfry level.

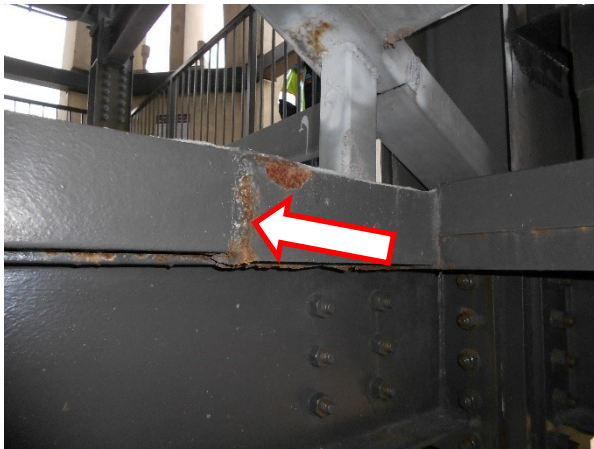
81. A close-up of corroded deck angle at the Belfry level.

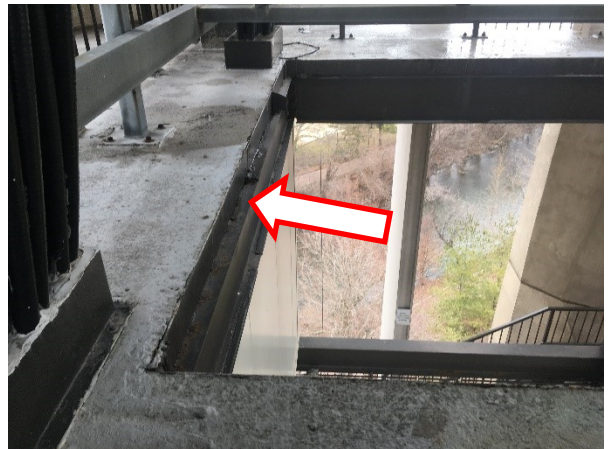
82. A view of the corroded deck edge at elevator shaft at the Belfry level.

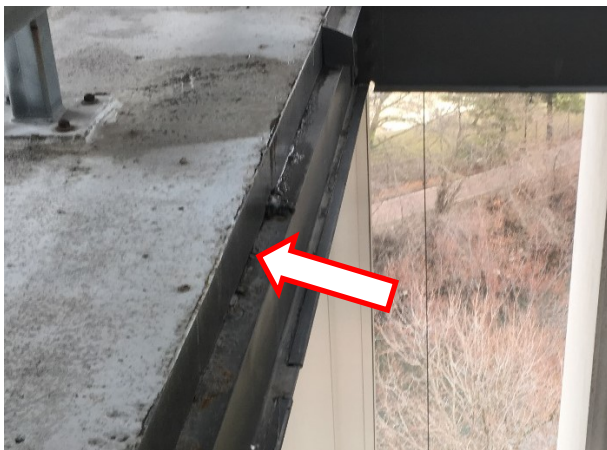
83. A close-up view of the corroded deck edge at elevator shaft at the Belfry level.

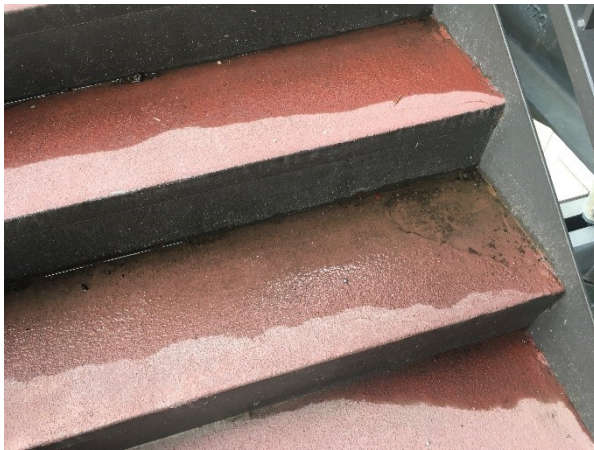
87. A close-up of steel stair with standing water and corrosion.

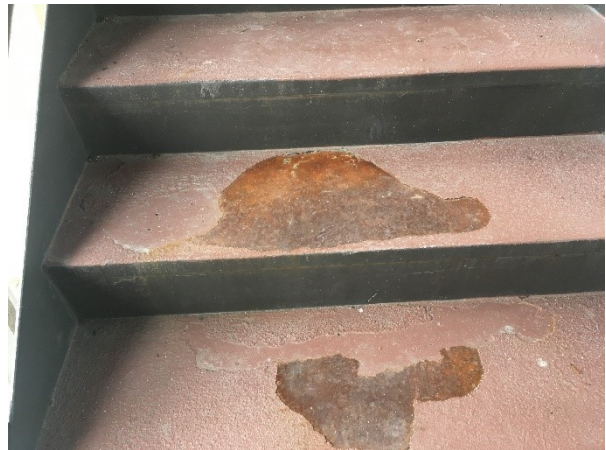
88. A close-up of steel stair with delamination of traffic coating and corrosion.

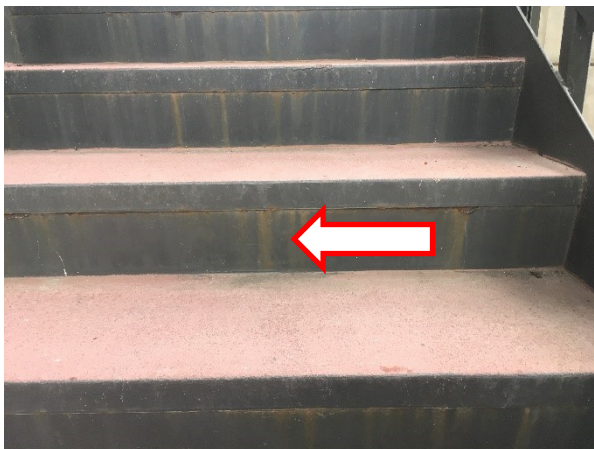
89. A close-up of steel stair with corrosion runoff stains from uncoated metal to metal contact.

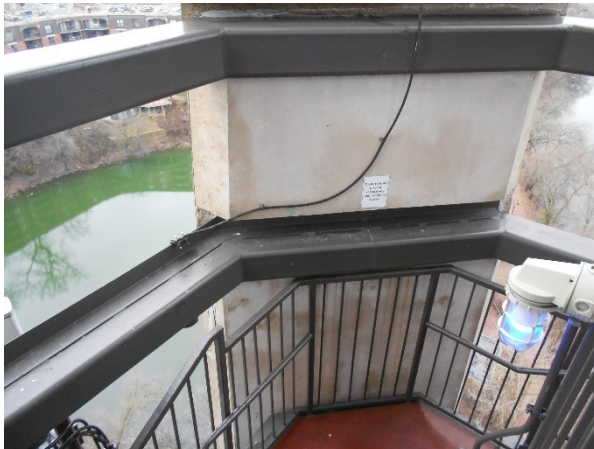
93. A view of abandoned deck support at the Gallery level.

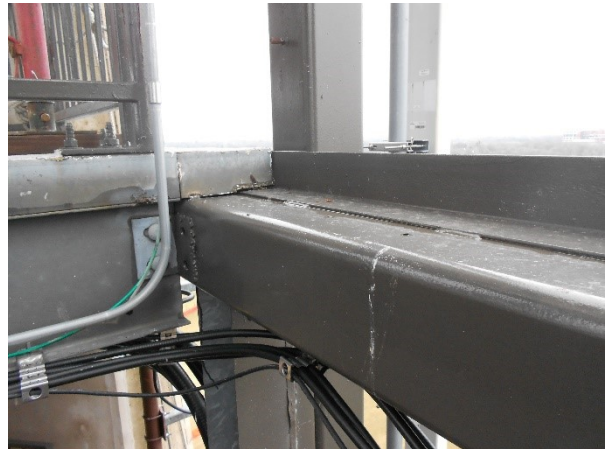
94. A view of abandoned deck support at the Gallery level.

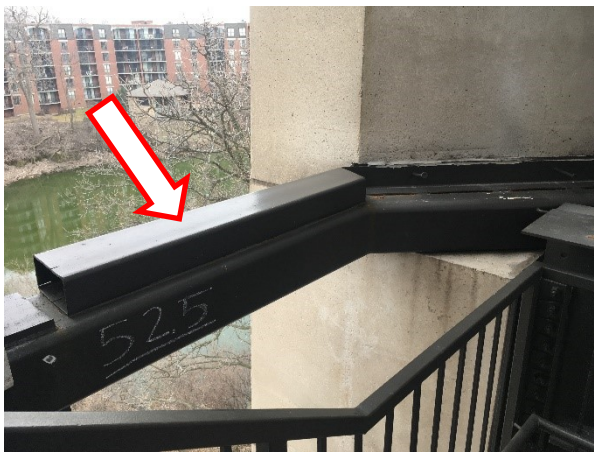
95. A view of abandoned deck support at the Gallery level.

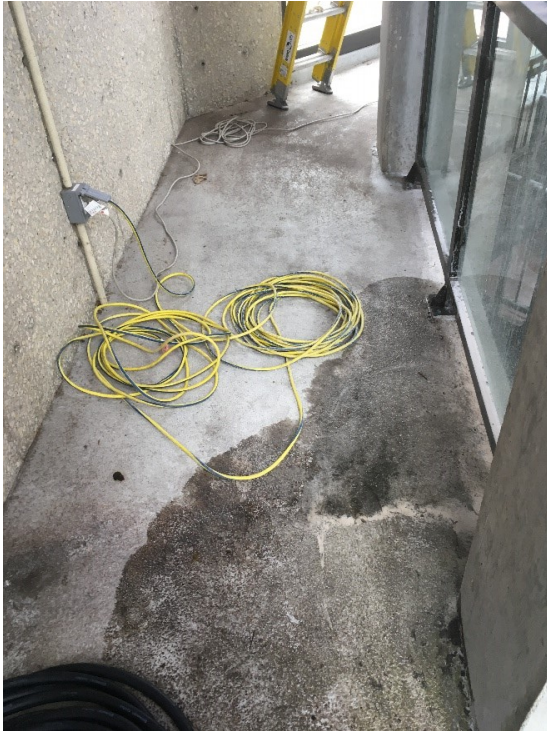
97. A view of the ground floor failed traffic coating with standing water.

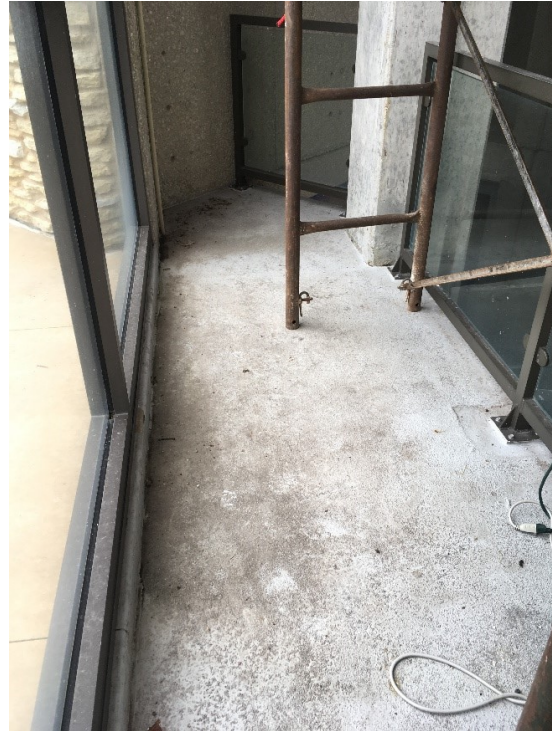
98. A view of the ground floor damaged traffic coating.

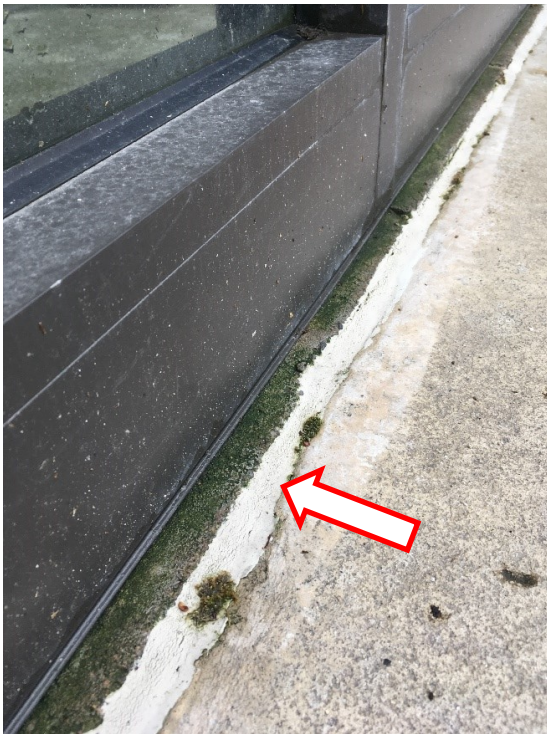
99. A close-up view of the base of glazing walls. Note failed sealant and biological growth.

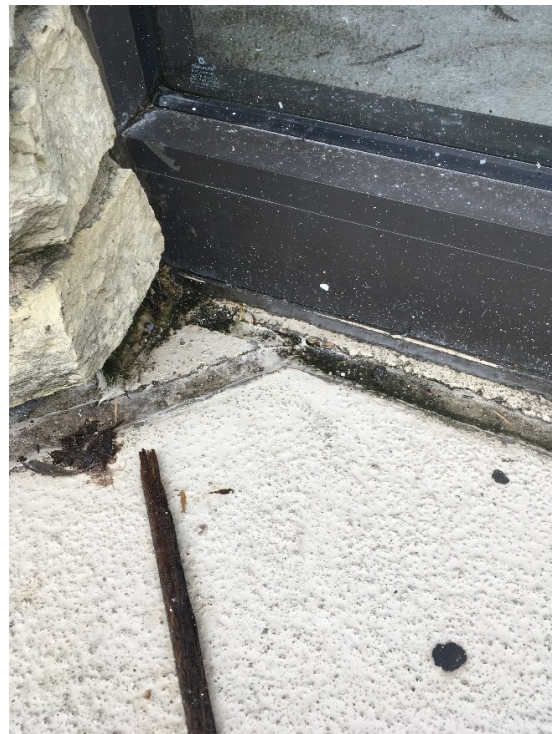
100. A close-up view of the base of glazing walls. Note failed sealant and biological growth.

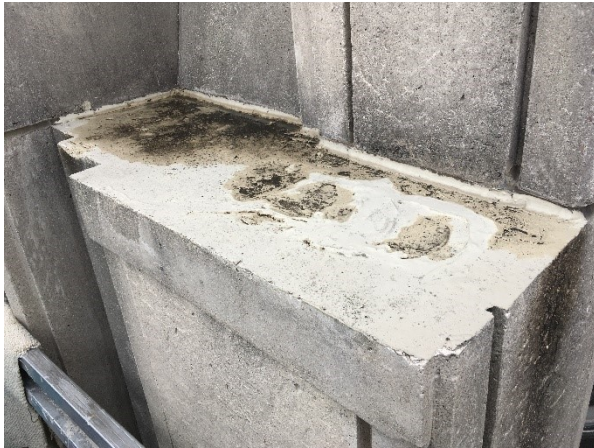
101. A close-up of precast ledge with traffic coating and standing water.

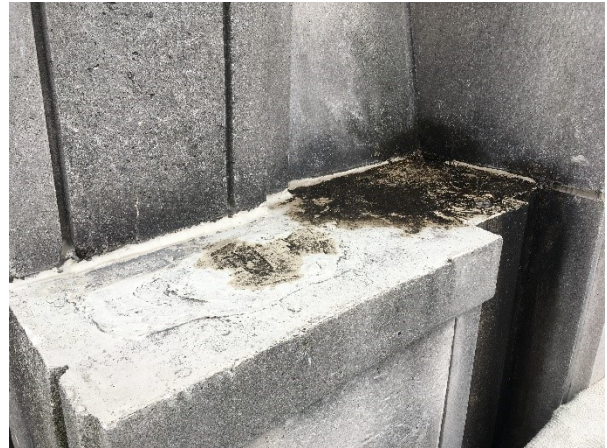
102. A close-up of precast ledge with traffic coating and standing water.

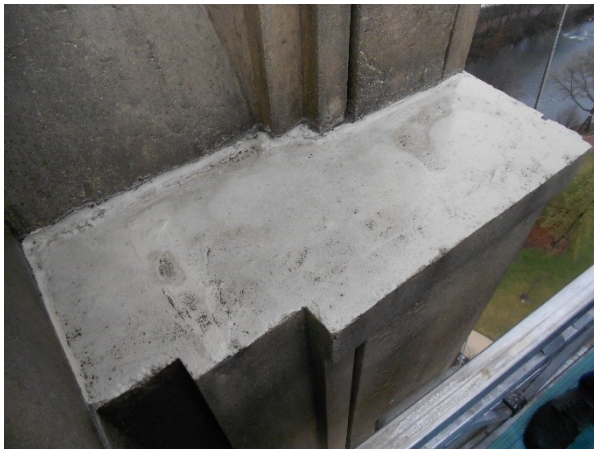
103. A close-up of precast ledge with intact traffic coating.

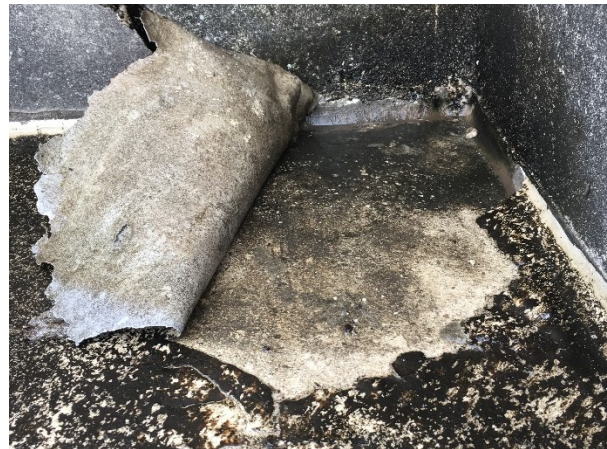
104. A close-up of precast ledge with failed waterproofing and standing water.

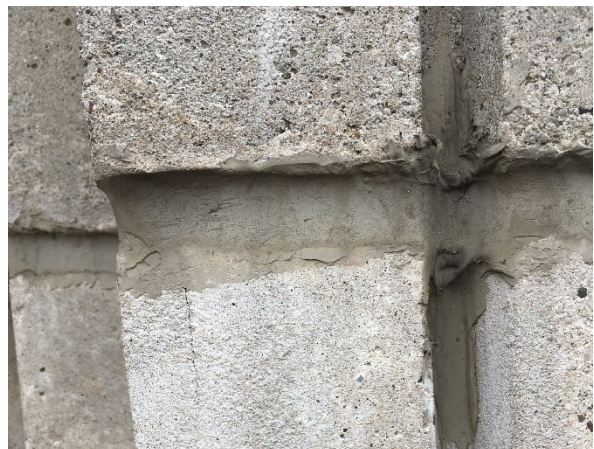
106. A close-up of typical precast sealant joint.
