**ADDENDUM NO. 1 (DRAFT)**  
**Naperville Riverwalk**  
**Moser Tower Structural Assessment**  
**September 2018**

### CORROSION AND MATERIAL DURABILITY ANALYSIS

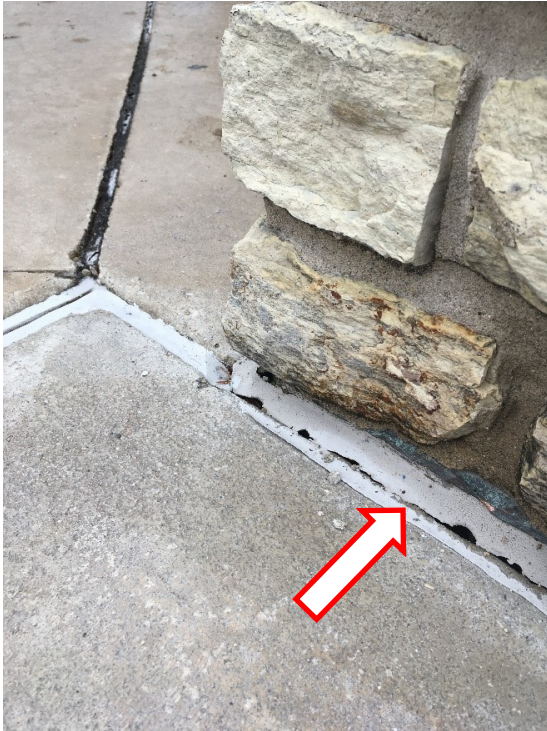
107. A close-up of the failed sealant and flashing at the stone veneer and plaza.

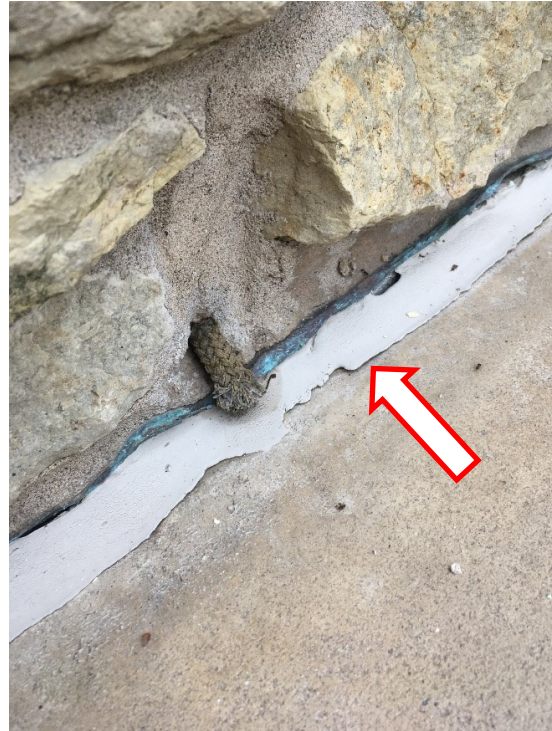
108. A close-up of the failed sealant and damaged flashing at the stone veneer and plaza.

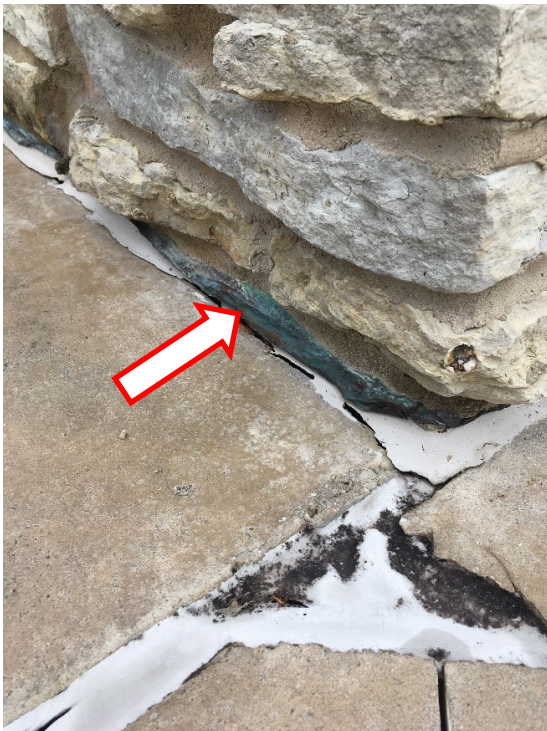
109. A close-up of the failed sealant and damaged flashing at the stone veneer and plaza.

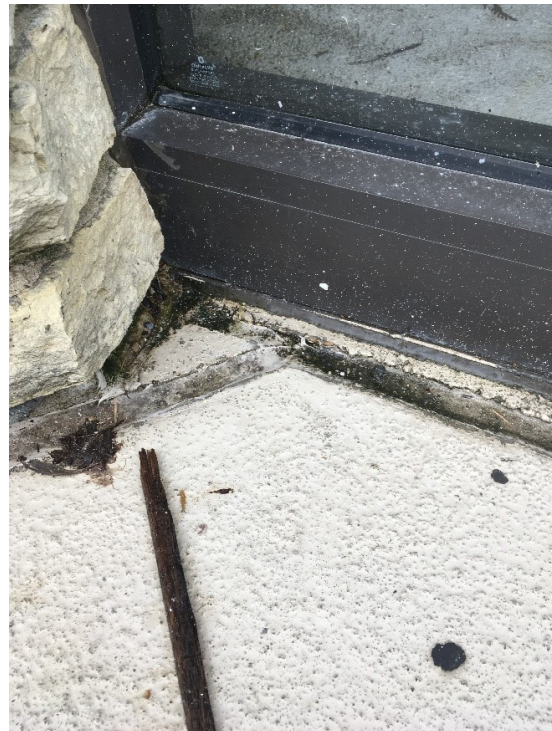
110. A close-up of the failed sealant and flashing at the stone veneer and plaza.

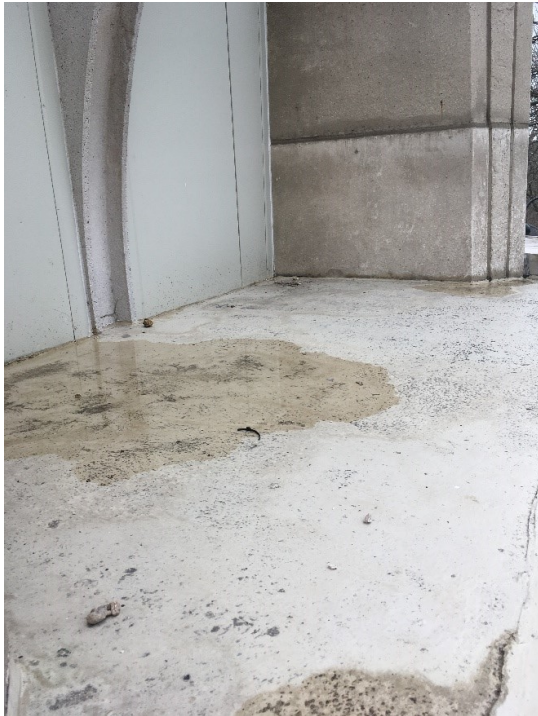
111. A close-up of the small roof at ground floor. Note standing water.

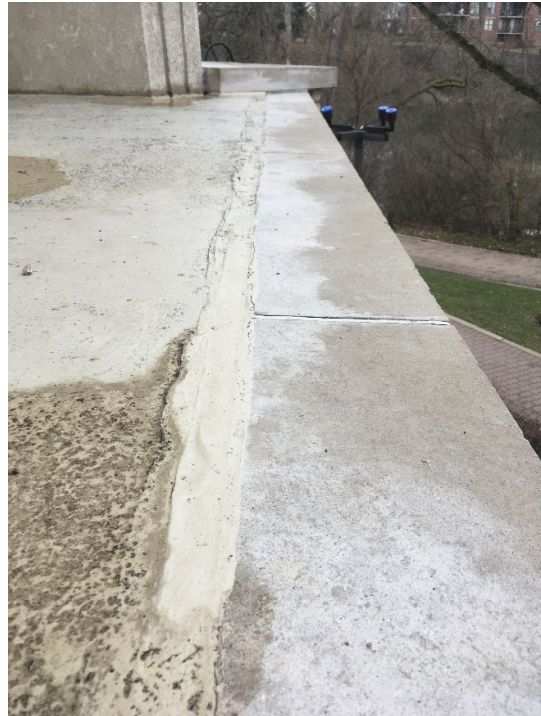
112. A close-up of the failed sealant at the West side of ground floor coping.

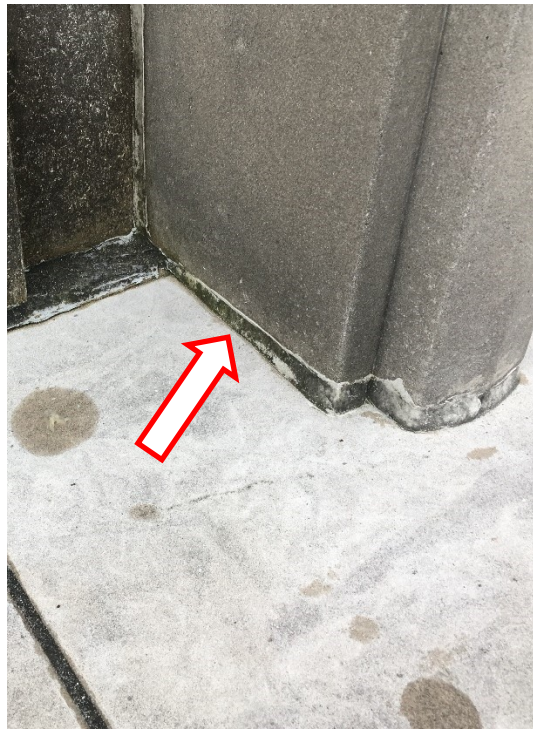
114. A close-up of a precast fin intersecting the Northwest base coping. Note failed sealant.
