<b>HISTORIC NAME</b>	Geiger, C. H. House
<b>COMMON NAME</b>	
<b>ARCHITECT</b>	
<b>BUILDER</b>	
<b>ARCHITECT SOURCE</b>	
<b>HISTORIC INFO</b>	Geiger was president of North Central College from 1946-1960. House was featured in Naperville Heritage Housewalk Brochure.
<b>PERMITS</b>	Certificate of Rehabilitation issued January 2007.
<b>LANDSCAPE</b>	Northwest corner of Columbia and Benton; front and south sidewalks; side driveway; similar setbacks; mature trees; rear wood fence
<b>COA DATES</b>	1/4/2017; 5/19/2017
<b>COA DECISION</b>	COA #17-36 - In-kind window and siding replacement (approved 1/5/2017); COA #17-1941 - in-kind replacement of asphalt shingles (approved 5/23/2017)
<b>COA Compliance Notes</b>	COA-approved work does not appear to have been completed.
<b>COA Work Not Completed</b>	
<b>Work Not Requiring COA</b>

<b>PREPARER</b>	Lara Ramsey	<b>SURVEYDATE</b>	11/13/2025
<b>ORGANIZATION</b>	RAMSEY HISTORIC CONSULTANTS	<b>SURVEYAREA</b>	NAPERVILLE SURVEY UPDATE

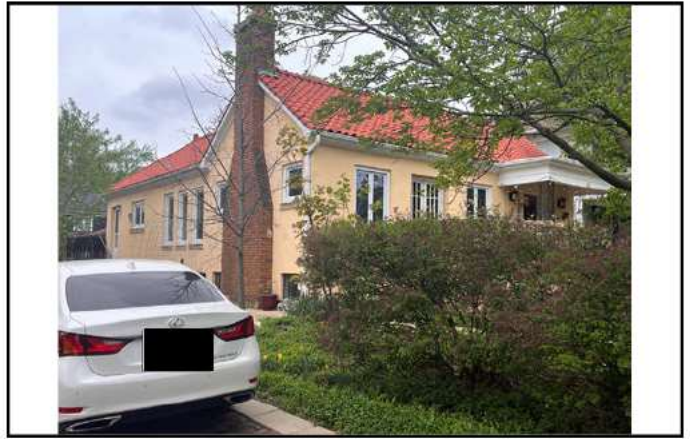
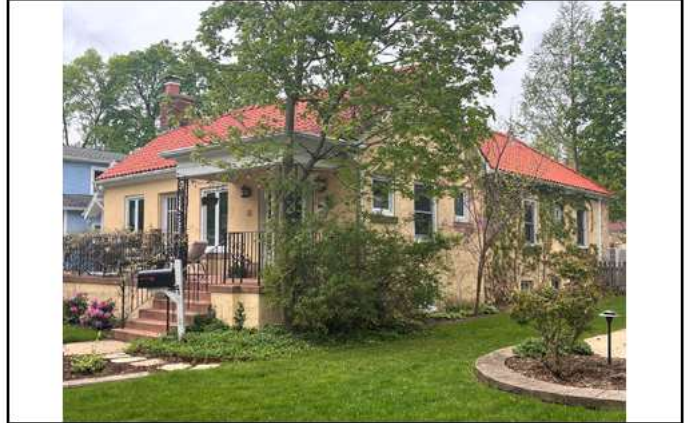
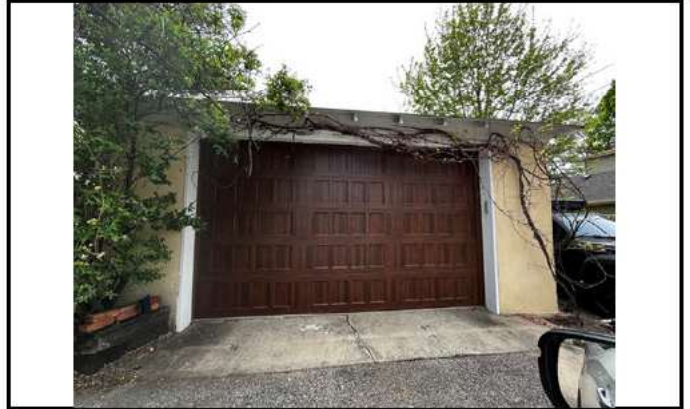
HISTORIC NAME	Houghton, Walter E. House
COMMON NAME	
ARCHITECT	
BUILDER	
ARCHITECT SOURCE	
HISTORIC INFO	
PERMITS	
LANDSCAPE	Midblock on west side of residential street; front sidewalk; rear alley; similar setbacks; mature trees
COA DATES	
COA DECISION	
COA Compliance Notes	
COA Work Not Completed	
Work Not Requiring COA	Folding doors replaced with overhead door on detached garage.

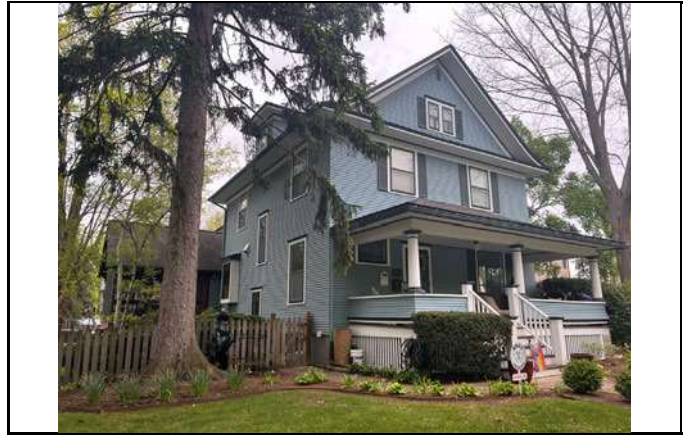
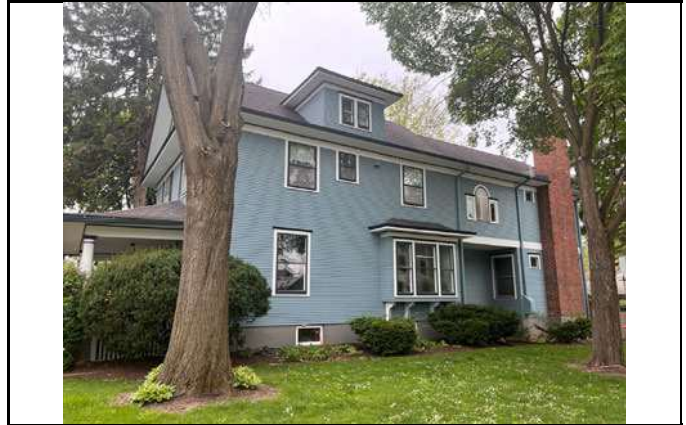
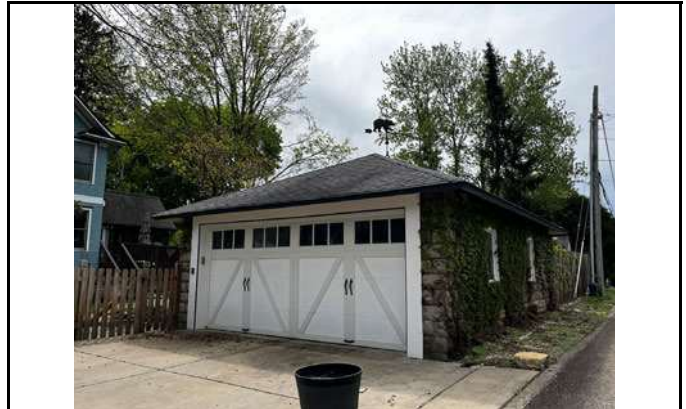
HISTORIC NAME	Goehring, Louis and Verena House
COMMON NAME	
ARCHITECT	
BUILDER	
ARCHITECT SOURCE	
HISTORIC INFO	
PERMITS	
LANDSCAPE	Southwest corner of Franklin and Columbia; front and north sidewalks; rear driveway; similar setbacks; mature trees; rear & south picket fence
COA DATES	
COA DECISION	
COA Compliance Notes	
COA Work Not Completed	
Work Not Requiring COA	Square oriel bay addition on first story of secondary south elevation.

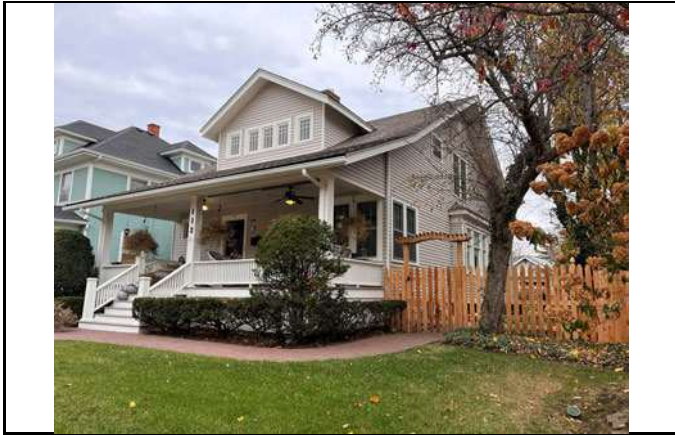
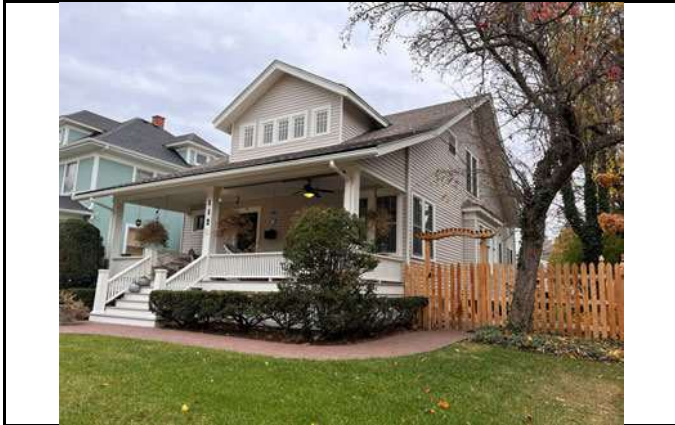
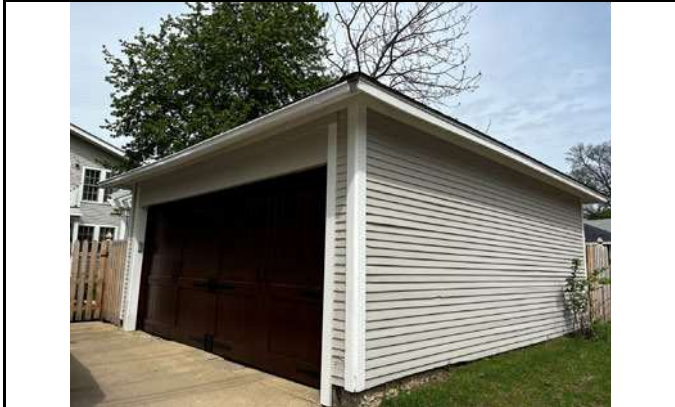
Work Not Requiring COA Aluminum double-hung replacement windows on first story on secondary north and south side elevations.

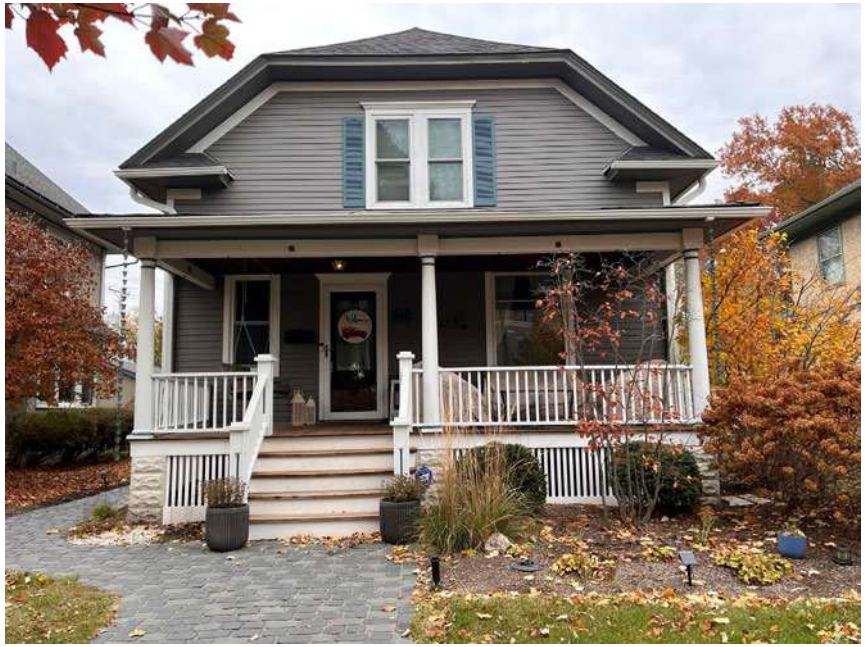
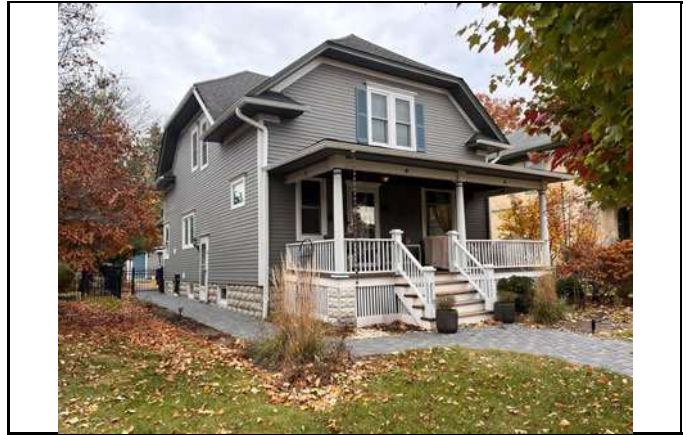
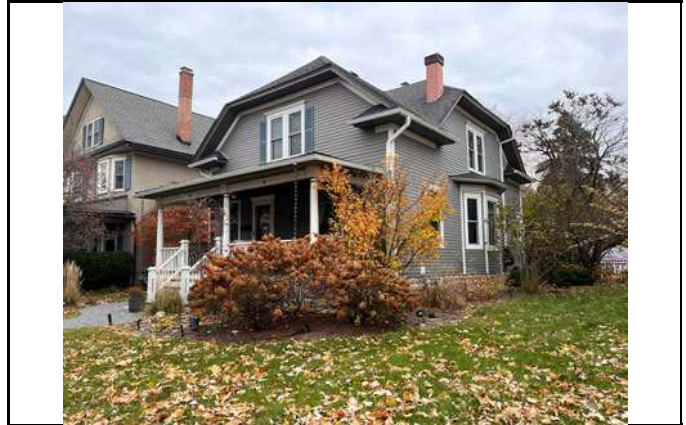
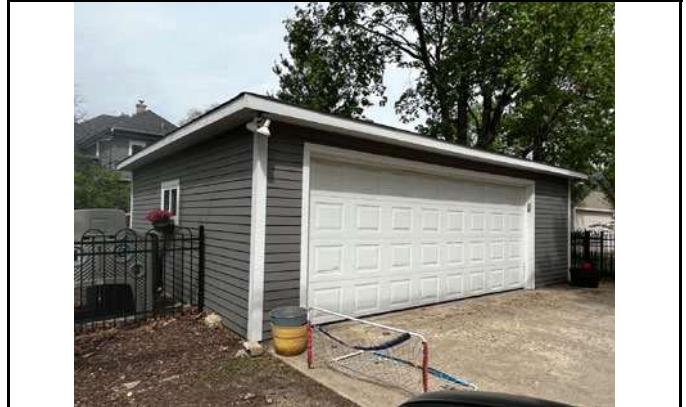
**ALTERATIONS** Post-2007 -- Aluminum siding replaced with fiber-cement board siding; solid knee walls on porch replaced with wood railings; replacement siding; Aluminum replacement windows in original openings.

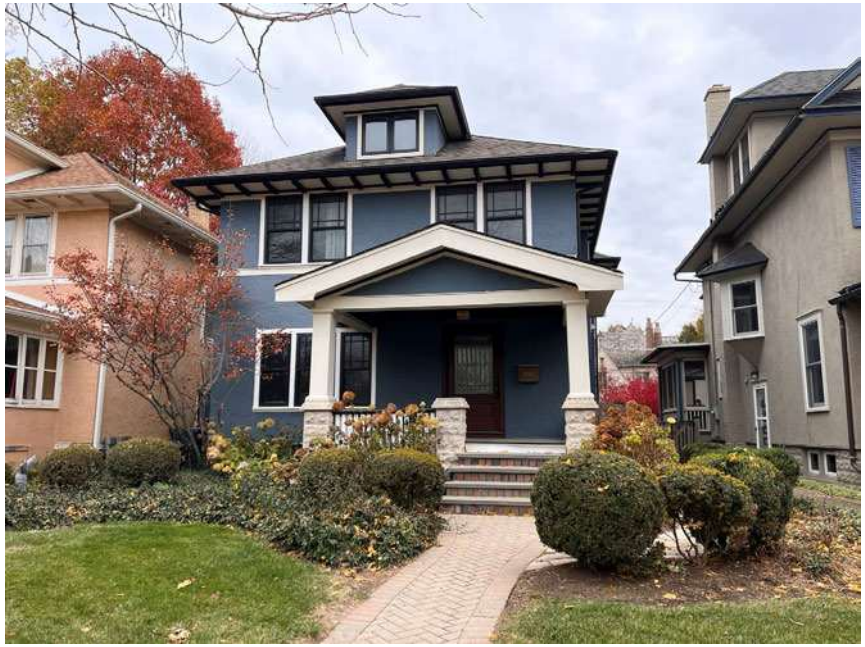
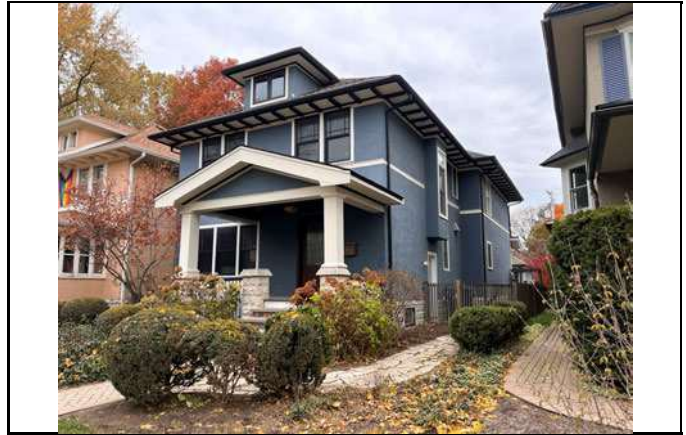
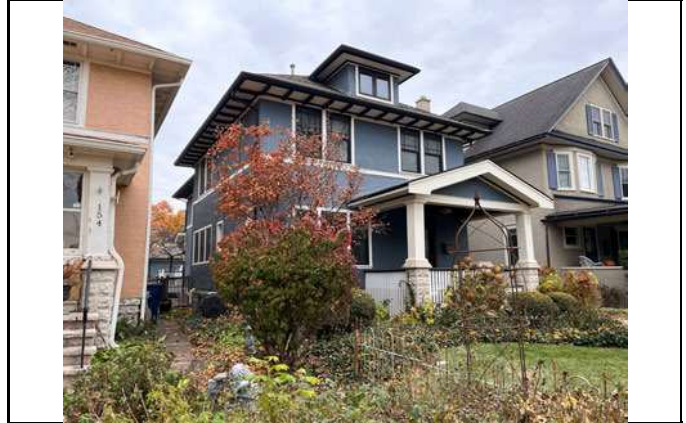
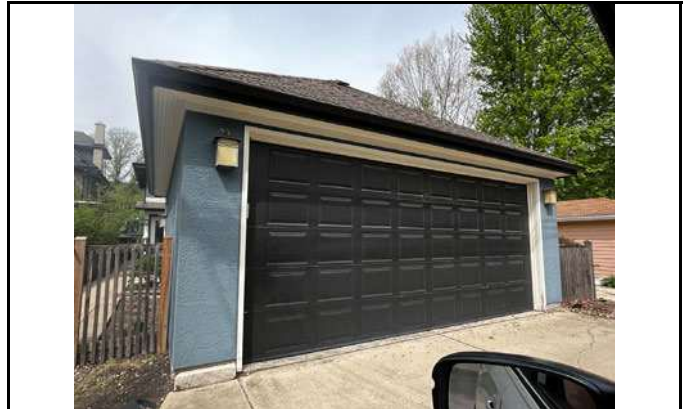
SIGNIFICANT FEATURES	<input type="text" value="Hipped roof with overhanging eaves and exposed rafter tails; front gable porch with square wood columns on concrete block piers; front hipped dormer"/>		
ALTERATIONS	<input type="text" value="Replacement windows in original openings (not historic); replacement front door (not historic); two story rear addition; replacement railing and steps on front porch (not historic). Post-2007 -- no changes."/>

HISTORIC NAME	
COMMON NAME	
ARCHITECT	
BUILDER	
ARCHITECT SOURCE	
HISTORIC INFO	
PERMITS	
LANDSCAPE	Midblock on east side of residential street; front sidewalk; rear alley; rear wood fencing; similar setbacks; mature trees
COA DATES	12/12/2011
COA DECISION	COA #11-4105 - Add railing for front porch stairs (approved 12/15/2011)
COA Compliance Notes	
COA Work Not Completed	Work approved by COA (COA #11-4105) appears to have not been undertaken.
Work Not Requiring COA

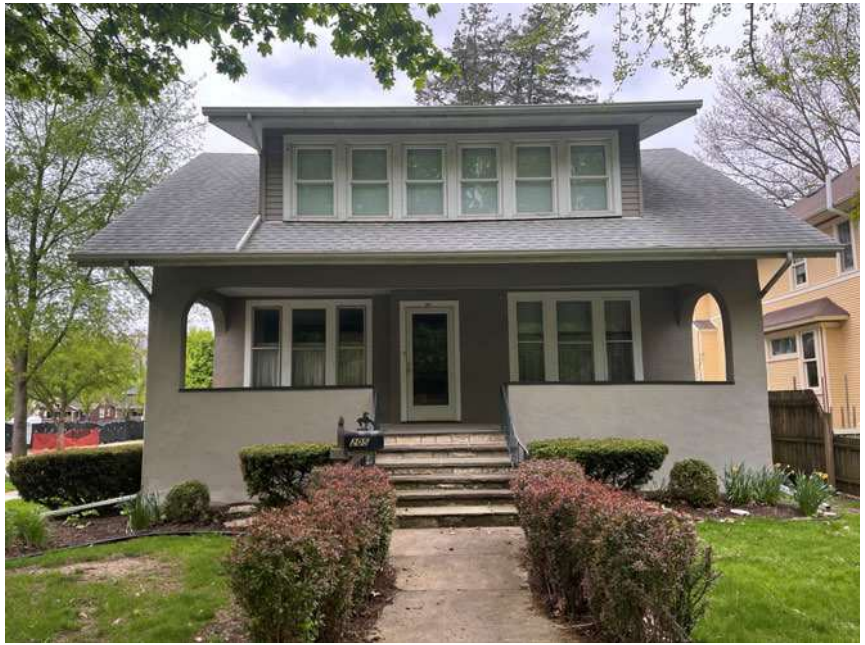
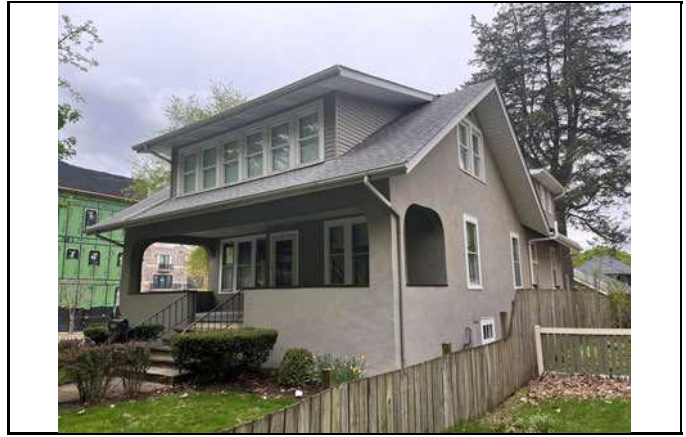
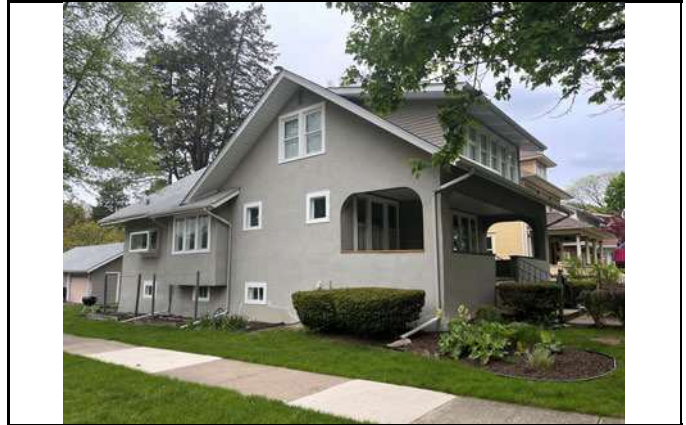
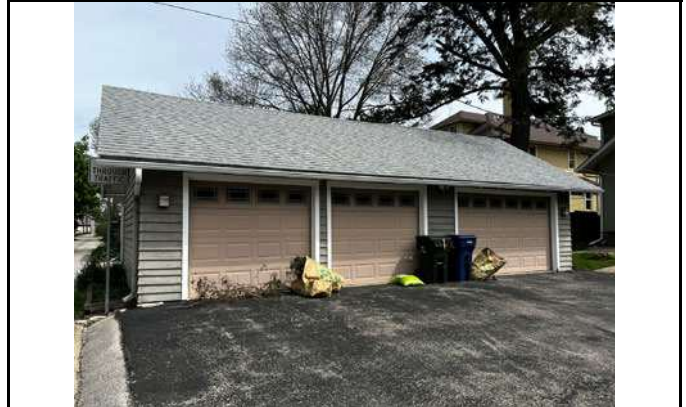
HISTORIC NAME	
COMMON NAME	
ARCHITECT	
BUILDER	
ARCHITECT SOURCE	
HISTORIC INFO	
PERMITS	
LANDSCAPE	Northwest corner of Columbia and School; front and south sidewalks; rear driveway; rear fencing; similar setbacks; mature trees
COA DATES	5/26/2011
COA DECISION	COA #11-1157 - demolition of an existing staircase, awning and bracket to accommodate a new building addition, including enclosed porch on the rear (west) side of the home (approved by HPC 5/26/2011)
COA Compliance Notes	
COA Work Not Completed	Work approved by COA appears to have not been undertaken.
Work Not Requiring COA

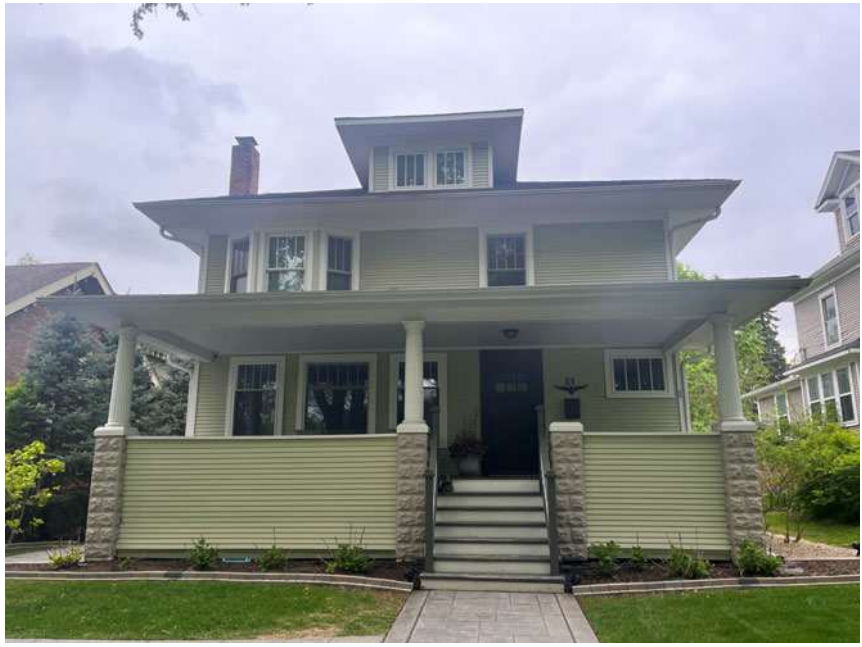
Replacement railings at porch steps.

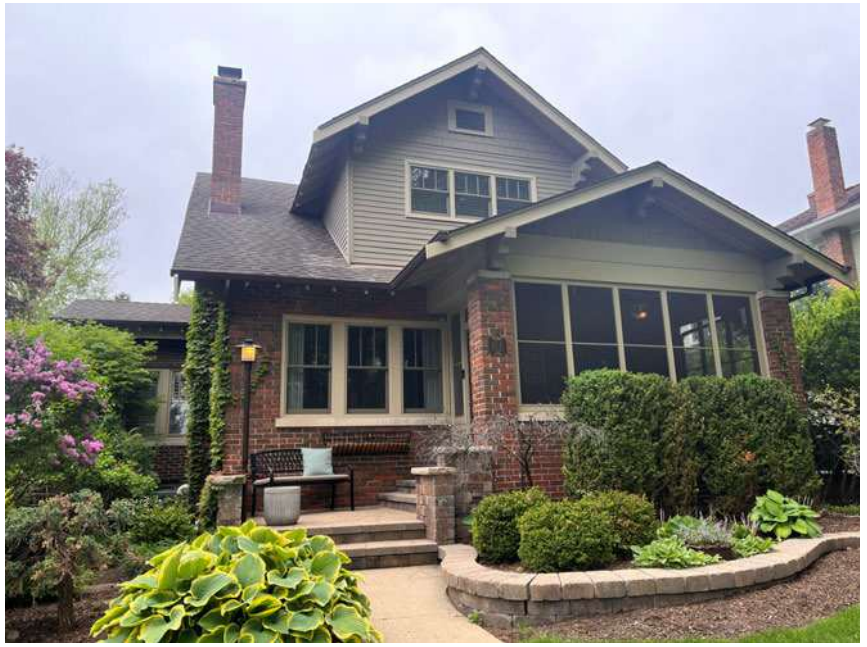
3/1 Aluminum replacement windows on front elevation (do not match original 4/1 configuration, but are historically compatible)

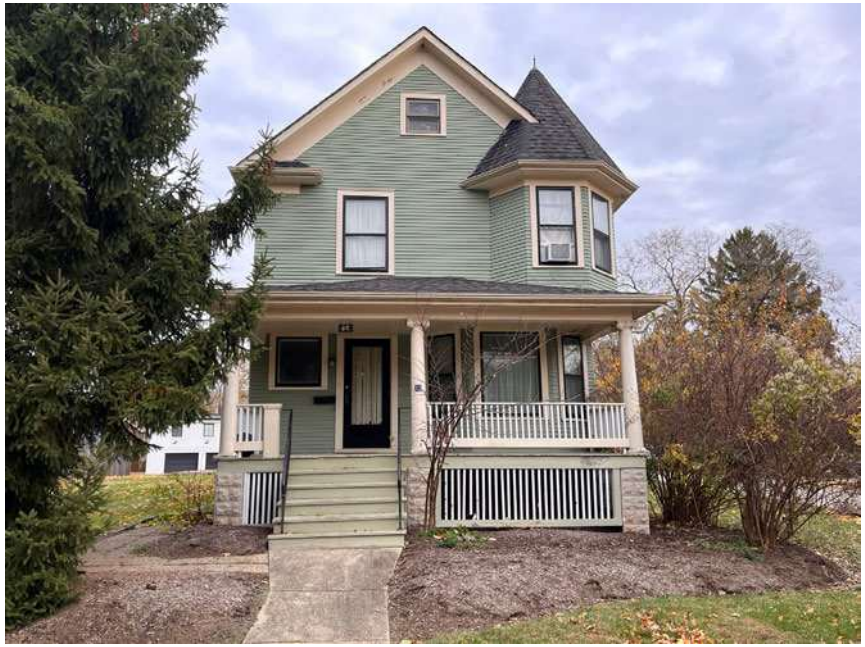
Wood railing replaced with historically compatible new wood railing at front porch.

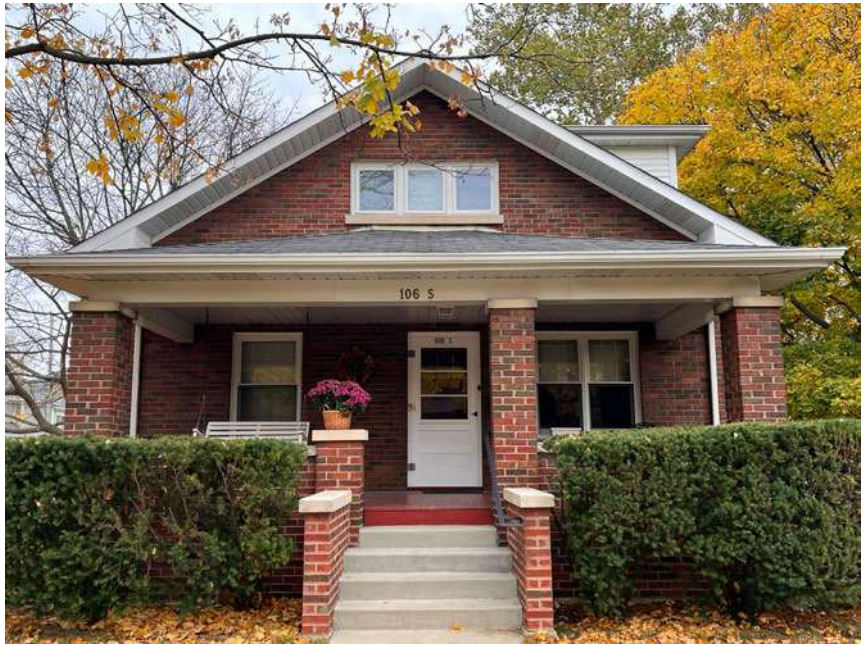
Aluminum replacement windows at east and west ends of north elevation (facing Van Buren Avenue)
