NAPERVILLE SURVEY UPDATE

City of NAPERVILLE

ILLINOIS URBAN ARCHITECTURAL AND HISTORICAL SURVEY CONTINUATION SHEET

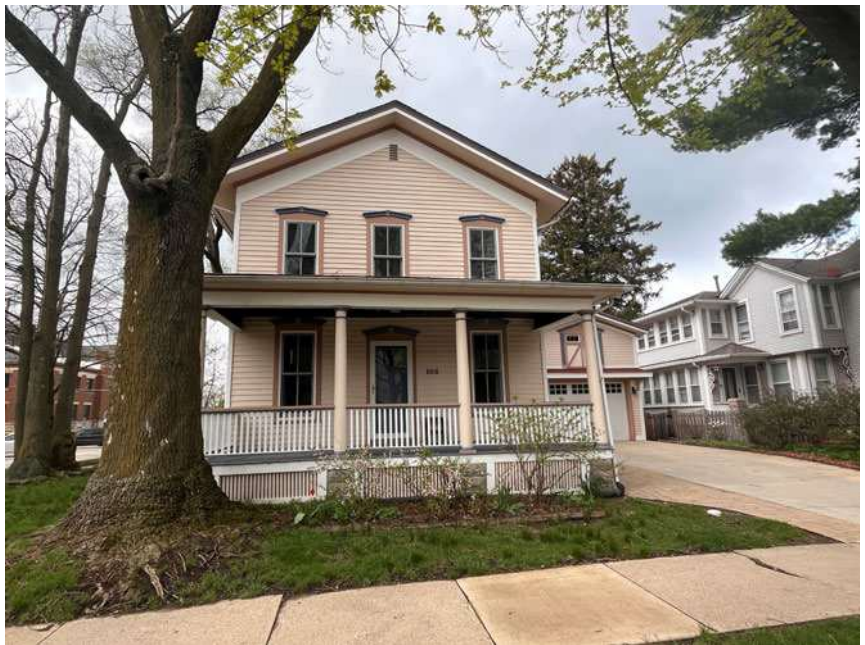
2/2 double-hung replacement windows on front (east) façade and south elevation (facing Franklin Avenue) -- historically compatible type and configuration

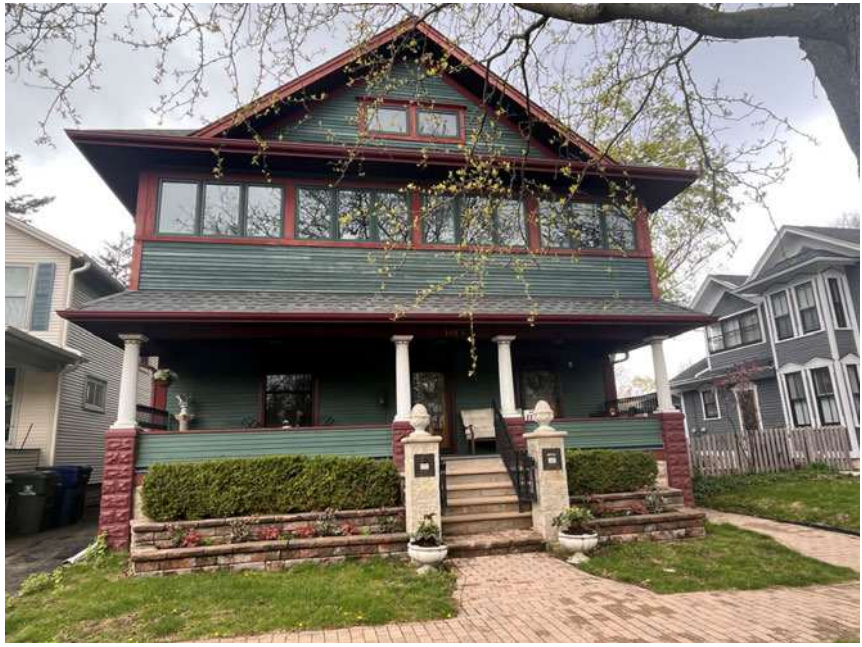
Replacement windows on front façade; north end enclosure of front porch evident in 2007 survey removed; cast-stone steps to front porch; wrought iron railings added above north and south knee walls at front porch.

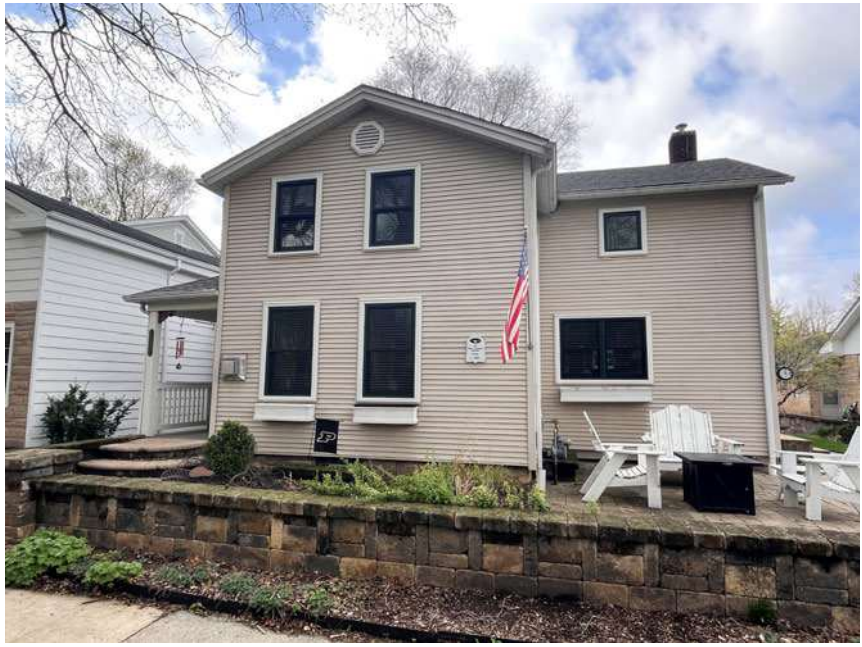
Replacement windows on front façade.

According to Sanborn Maps, house was originally a one-story structure that has been altered and added to over the years: 1 story south side addition is historic, but south porch appears to have been altered (replacement posts, railing, and steps, Aluminum under eaves); second story addition to original house is historic; first story on north addition was added sometime between 1926 and 1949, with 2nd story added after; aluminum siding; replacement windows in altered openings (not historic--house originally had a full porch and entry on front façade); multiple rear additions; stone steps to north side entry and stone patio at front of house (not historic)

Windows on front façade appear to be newer 1/1 aluminum replacement windows; porch railing replaced.

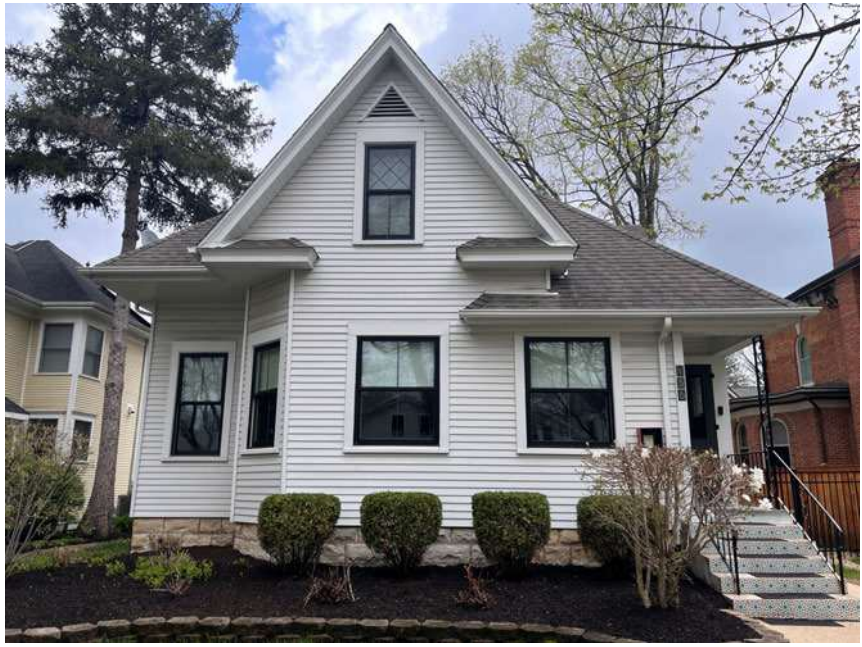
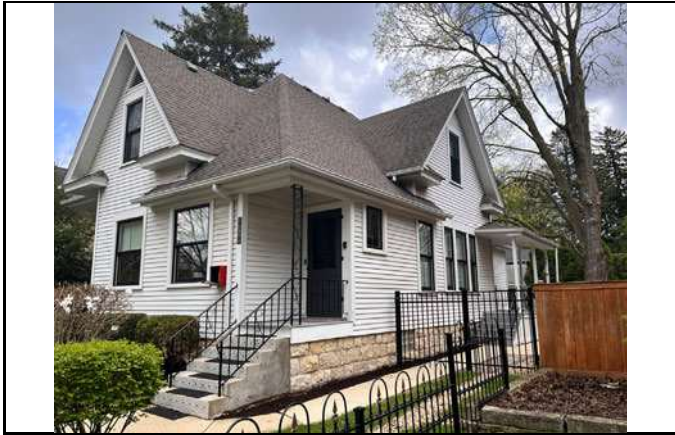
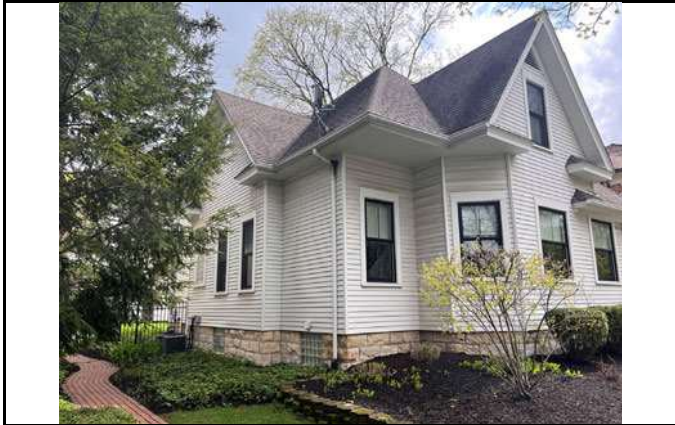
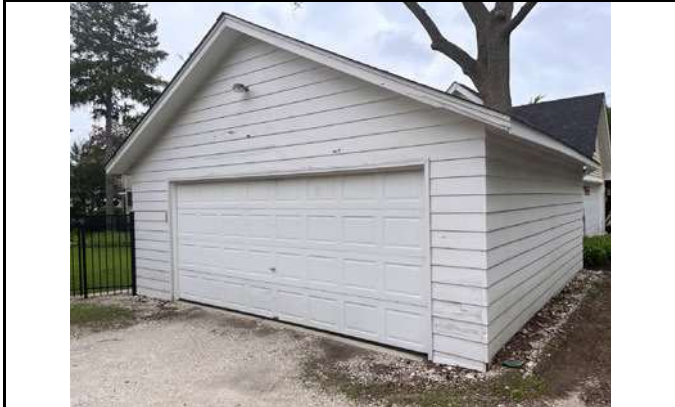
COA Compliance Notes 2007 survey photos show 1/1 double-hung windows on front and side elevations -- replacement windows are 2/2.

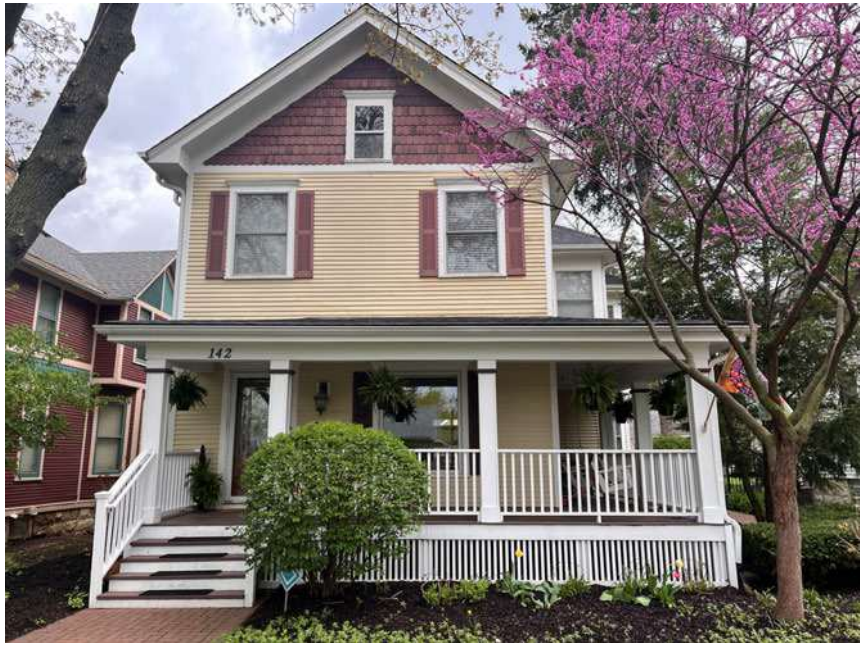
Solar panels on roof--may have been present in 2007 and not noted on survey. 2007 survey photographs do not show slope of roof where panels are located.

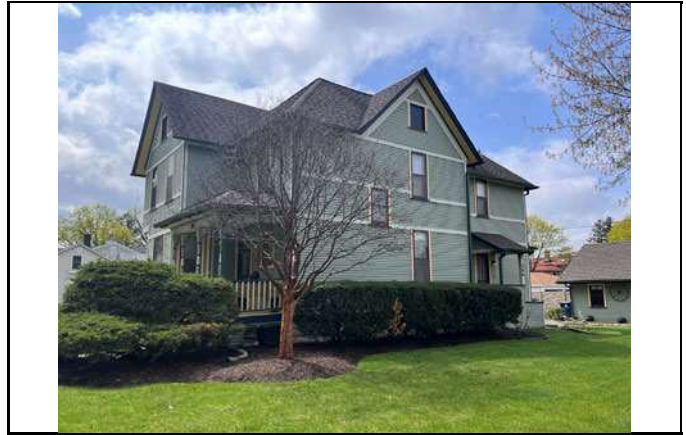
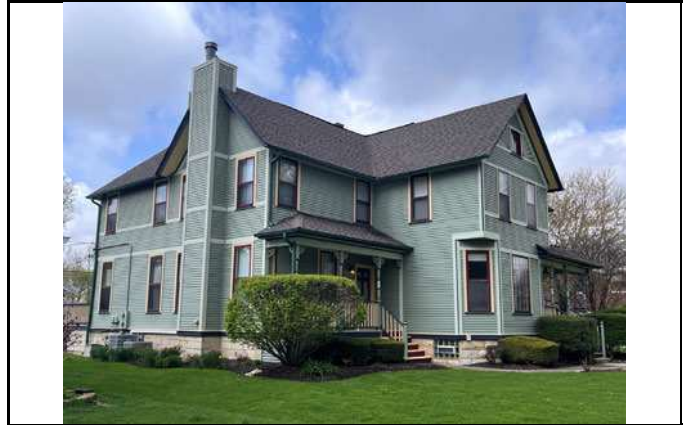
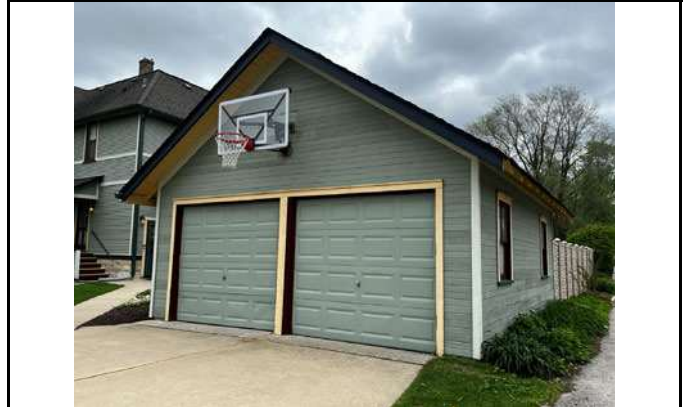
Recent renovation. Appropriate restoration work includes: replacement siding; replacement porch spindles and supports; replacement 1/1 windows; multi-light replacement windows on front bay; north entry porch; 1 story rear addition. Inappropriate alterations include glass block basement windows and a large 2-story addition to the south, including entry and porch, which is difficult to distinguish from the original massing of the home.

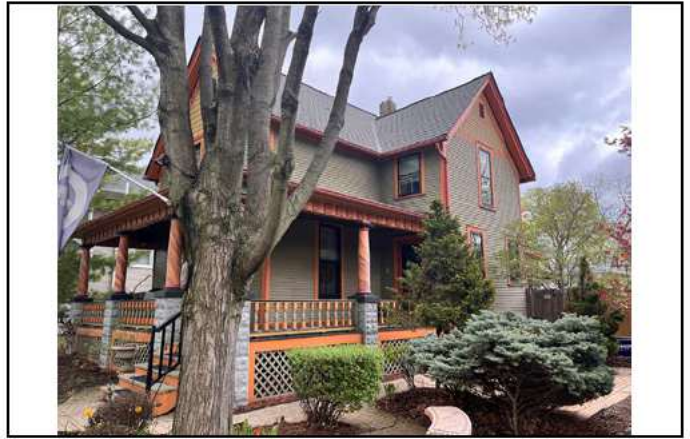
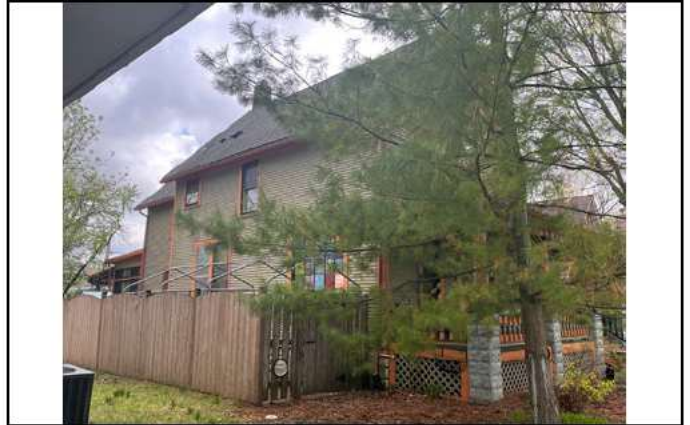
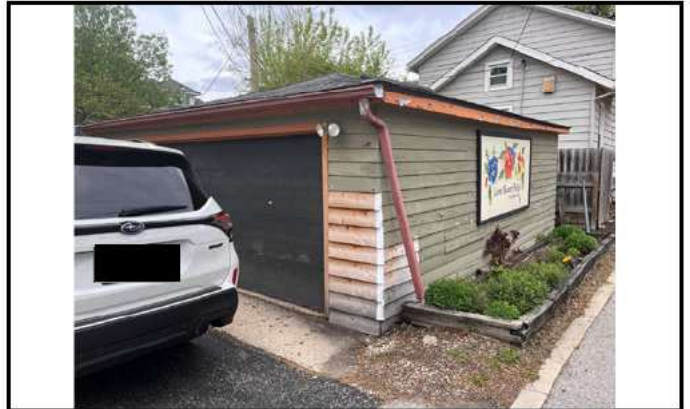
Work Completed Without COA	Metal handrail added to steps on front porch
----------------------------	--

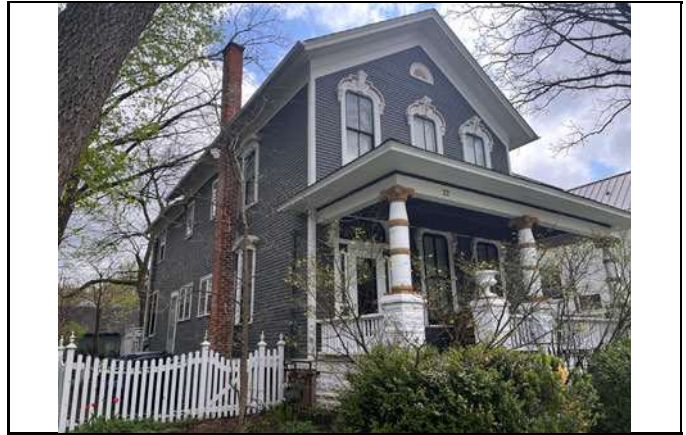
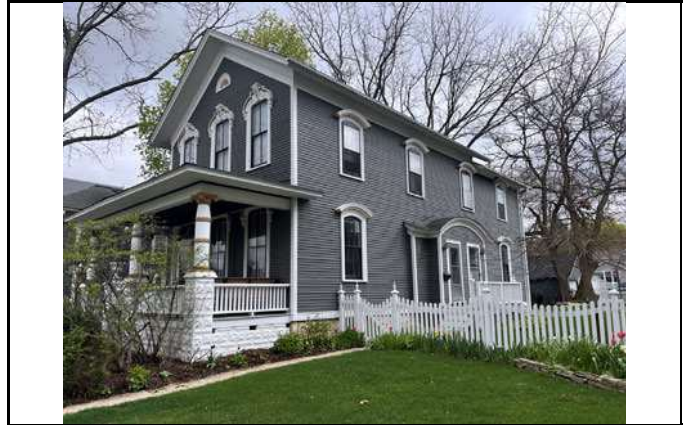
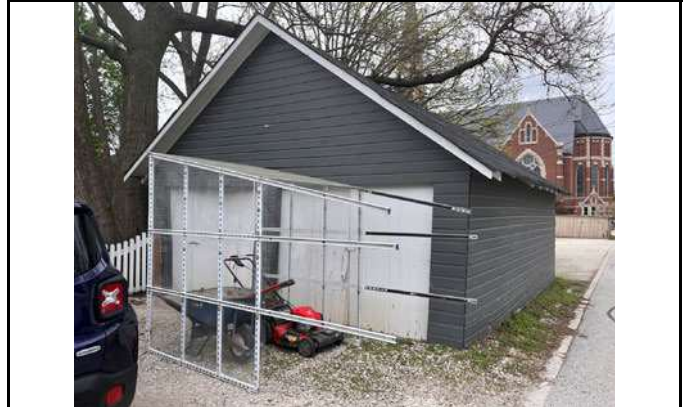
HISTORIC NAME	Metz, Adam House
COMMON NAME	
ARCHITECT	
BUILDER	
ARCHITECT SOURCE	
HISTORIC INFO	Chain of title indicates Metz purchased property from Alvin Scott in 1874 for \$440. Inventory of Metz estate date 1878 makes mention of house.
PERMITS	
LANDSCAPE	Midblock on east side of residential street; front sidewalk; rear alley; rear and side picket fence; large south side yard; mature trees
COA DATES	
COA DECISION	
COA Compliance Notes	
COA Work Not Completed	
Work Not Requiring COA

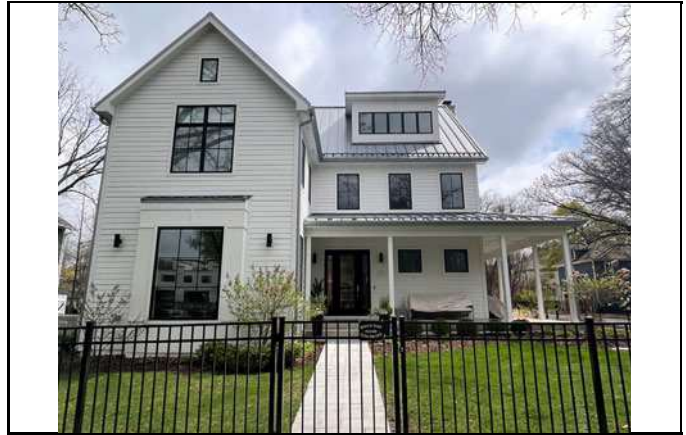
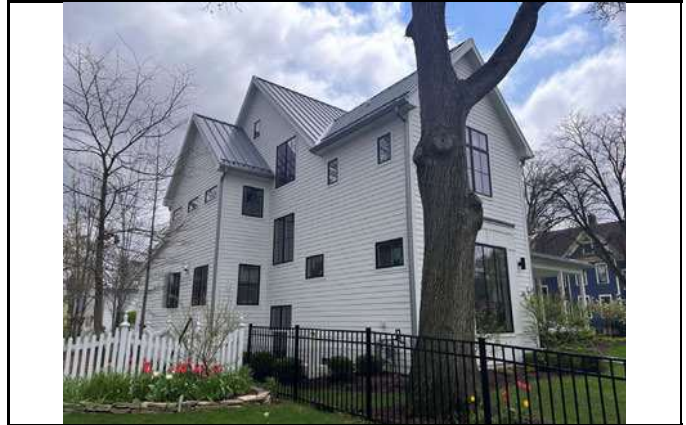
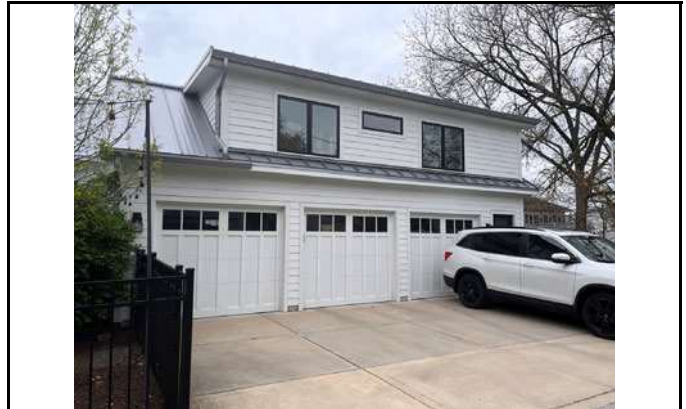
HISTORIC NAME	
COMMON NAME	
ARCHITECT	
BUILDER	
ARCHITECT SOURCE	
HISTORIC INFO	Former site of late 19th century Greek Revival residence rated "C" in 2007 survey. Historic maps indicate that the building was likely constructed early 1870s.
PERMITS	
LANDSCAPE	Northeast corner of S. Ellsworth and Van Buren; front and south sidewalks; rear/south picket fence; rear alley; oversized lot; mature trees
COA DATES	5/6/2016; 1/26/2012
COA DECISION	COA #15-3111 - Addition of 2 upper story windows, modifying screen porch to windows (approved 3/28/2016); COA #11-2993 - demolition of the existing structure and new construction (approved by HPC 1/26/2012); COA #13-3320 - Modifications to the site plan and Building Elevations approved through COA #11-2293 (approved by HPC 9/26/2013); COA #15-3111 - construction of new residence (tabled by HPC 9/24/2015, approved 10/29/2015)
COA Compliance Notes	
COA Work Not Completed

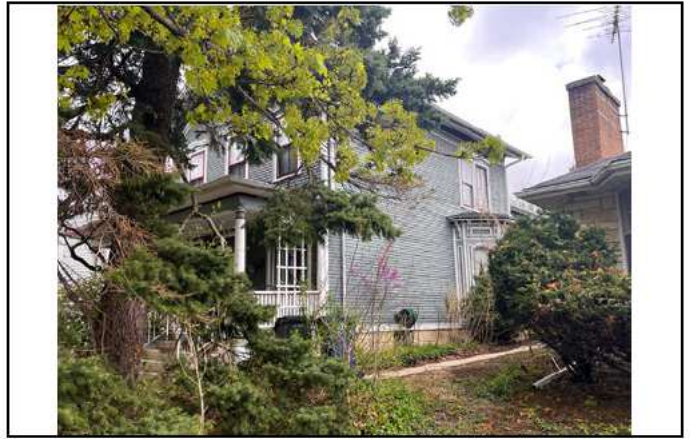
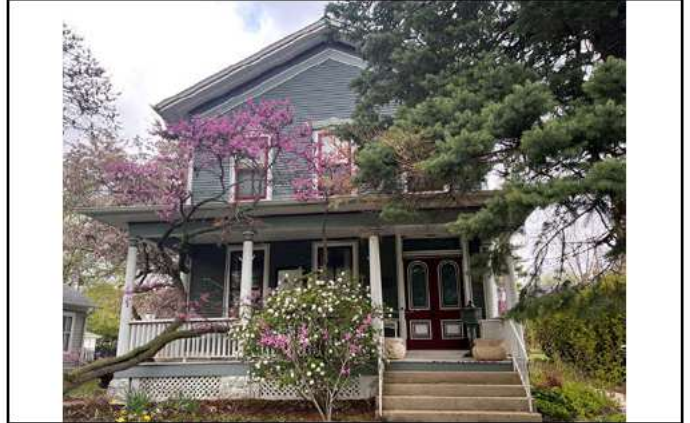
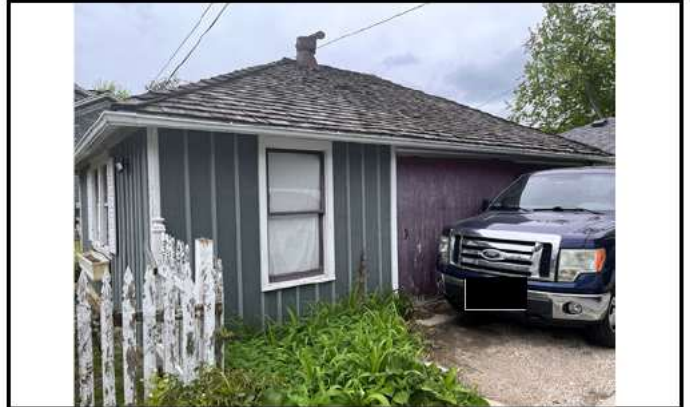
ALTERATIONS Solid arched glass panes in front doors were probably originally wood (not historic); replacement front and south/rear porches (historic); concrete front steps with wrought iron railing; 1 story north/rear addition (historic). Post-2007 -- replacement asphalt-shingle roof.
