The City of Naperville's Department of Public Utilities-Water (DPU-Water) is now in the ninth year of a comprehensive sewer rehabilitation program. The goal of this program is to eliminate sewer backups by finding and fixing defects that allow rainwater and groundwater into the system.

Sanitary Sewer Service Line Rehabilitation-East Highlands

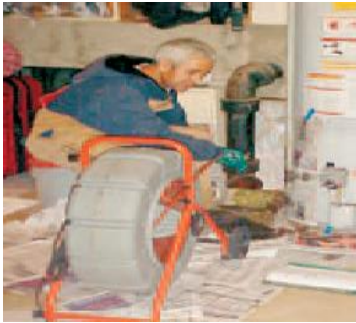
Locating the pipe

The first step in service lateral rehabilitation is locating and inspecting the pipeline. The City uses video technology to inspect the pipe. Naperville's sewer inspection truck is

capable of launching a small camera up the service line from the city main. This method, which does not require entry into the residence, is successful in most cases. However, service lines with a series of sharp bends, tree root obstructions, or other defects require the service lateral to be inspected from inside the house.

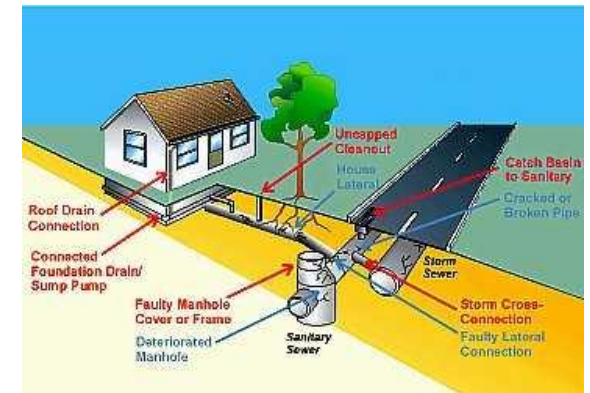
The final step in service lateral rehabilitation is the installation of the liner. Prior to lining, the contractor will thoroughly clean the lateral pipeline to remove all tree roots and other obstructions. The contractor returns later to install the lining tube, which is launched from inside the city main. To ensure a perfect fit, the contractor uses video technology to monitor the installation. When the process is complete, the resident has a leak free service line that is virtually maintenance free, from the end of the liner to the city main.
