**ADDENDUM NO. 1 (DRAFT)**  
**Naperville Riverwalk**  
**Moser Tower Structural Assessment**  
**September 2018**

### CORROSION AND MATERIAL DURABILITY ANALYSIS

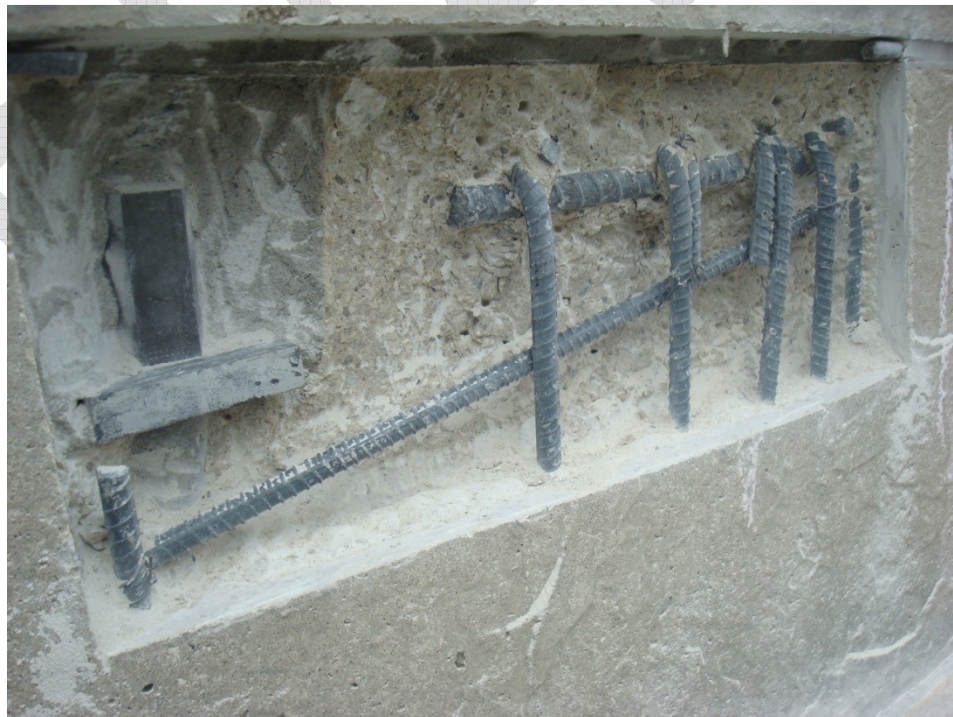
**Photograph #3: Exposed end of PT rod and reinforcement bars at right opening**

As can be clearly seen in Photographs #2, #3, and #4, the post-tensioned rod, reaction plate, and adjacent reinforcement bars are in good condition. There is no sign of corrosion that would cause deterioration of the rods, plates, or bars. These removals also confirmed that the rods have been encased in grouted sleeves, as called out on the precast shop drawings, providing additional protection to these rods from corrosion due to water infiltration.

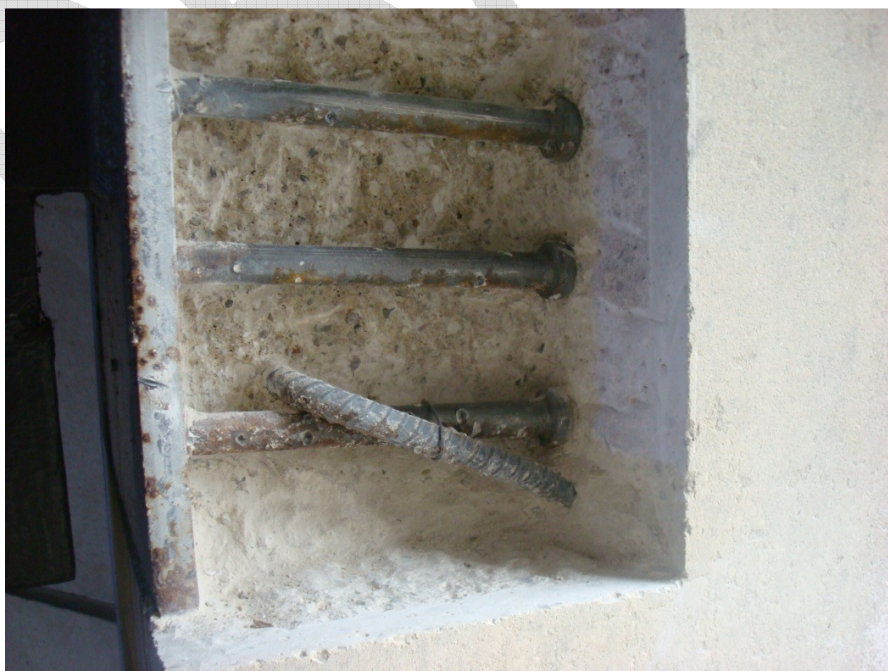
**Photograph #7: Exposed connection plate and embedded studs at northwest side of Elev. 52.5.**

As can be clearly seen in Photographs #5, #6, and #7, the embedded parts of these connections that are exposed are in good condition. There is evidence of minor surface corrosion on a portion of the embedded steel studs, along with the backside and edges of the plate, but no evidence of significant deterioration of these members. These removals confirm that the installation conforms to the girder support detail C4 shown on C1.1 of the Charles Vincent George drawings.

Weather intrusion through concrete cracks and spalled aggregates propagate corrosion on the backside of the connection plate, resulting in corrosion product flow down the face of the concrete. These plates are anchored to the concrete with steel studs, subject to corrosion deterioration. **The weather intrusion and corrosion propagation in these connections must be abated.**

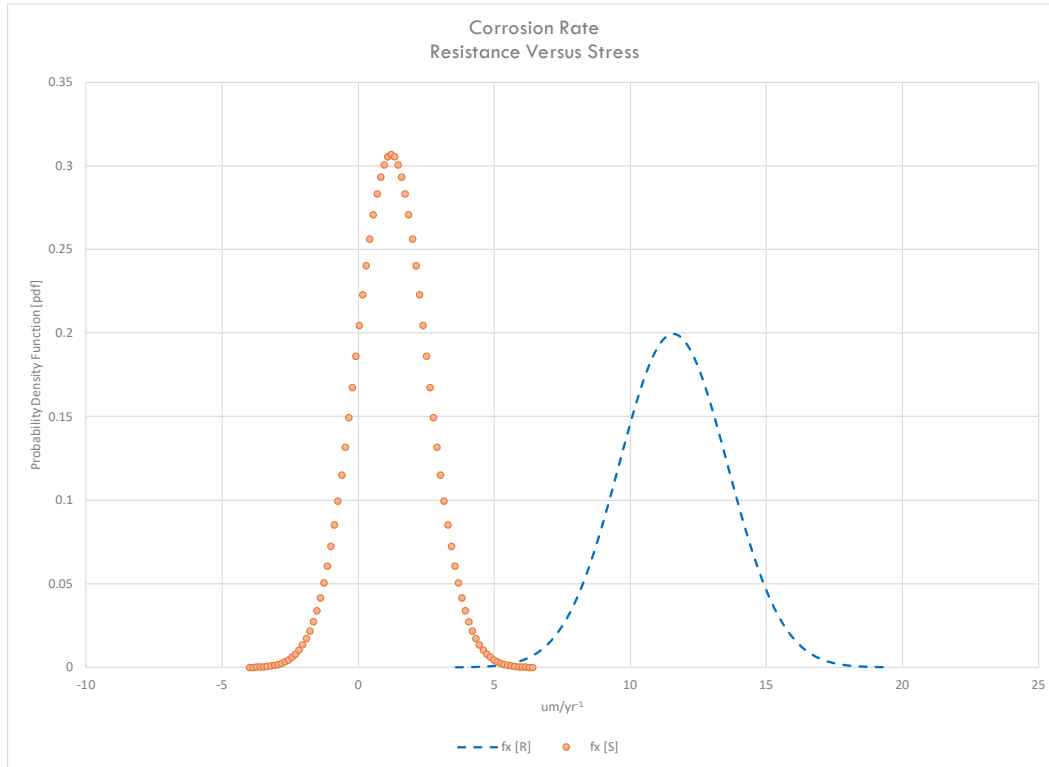
Table 32, can be summarized by stating that 62% of the readings recorded on the pre-cast panels are at condition state 4 Low to medium corrosion activity. It should be noted that at the high end of this condition state a corrosion rate of  $1.16\mu\text{m}/\text{yr}^{-1}$  would take 100 years to lose 0.1 mm section loss, however the corrosion product would produce a volume six times this which inevitably would crack the concrete increasing this corrosion rate to much higher levels. This has to be taken into consideration when reviewing the long-term performance model.

At condition state 3 we have a further 33% making a total of 95% at condition state three and four which has a deterioration prediction of between 10 to 25 years before corrosion distress is caused. The remaining 5% of the readings belongs to condition state 2 having a medium-high corrosion rate which is expected to show failure within 10 years. No visual distress was noticed during the field work which confirms the majority of the readings fall within condition state 4 as tested.

FIGURE 10 CORROSION LEVELS PRECAST RESISTANCE V STRESS

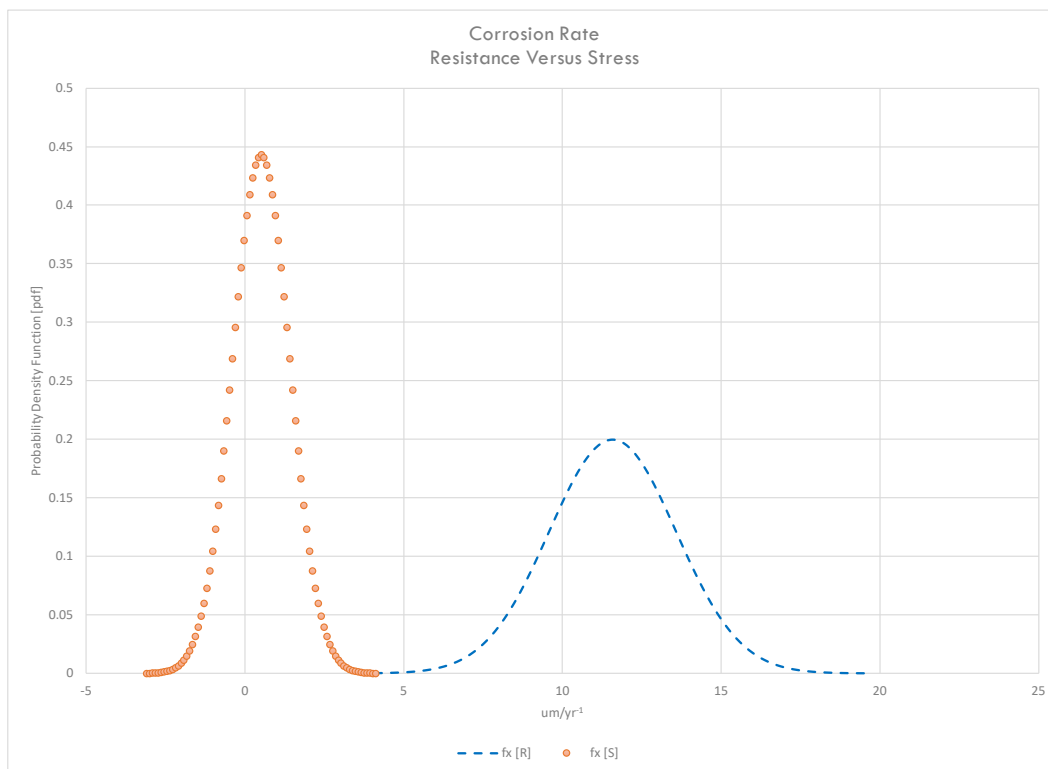
The remaining 11% of the readings belongs to condition state 2 having a medium-high corrosion rate which is expected to show failure within 10 years. No visual distress was noticed during the field work which confirms the majority of the readings fall within condition state 4 as tested.

It was visually noted by the team that water splashes onto these areas causing an excessive amount of moisture. This was confirmed by the temperature and humidity measurements taking from site.

FIGURE 11 CORROSION LEVELS BEAM RESISTANCE V STRESS

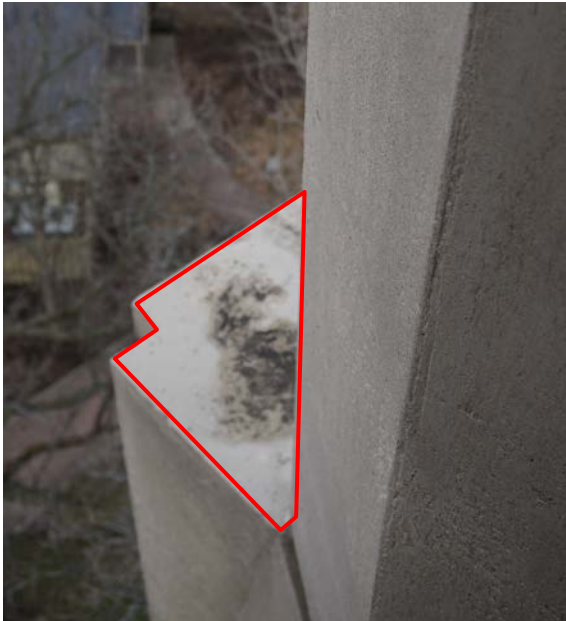
During the field work, it was observed that several of the pre-cast panels and the reinforced concrete beams are directly exposed to the environment with no presence of any flashing and minimal waterproofing membrane as shown in Figure 21 and Figure 22.

FIGURE 21 STANDING WATER ON TOP OF A PRE-CAST PANEL

[NO PRESENCE OF ANY FLASHING]

The absence of waterproofing membrane and flashing details will potentially aggravate the corrosion condition by allowing water ingress into the structural elements as the tower is open to the environment. The “stepping” configuration of the pre-cast panels displayed on all four elevations allows for water and snow accumulation as shown in Figure 21 and Figure 24. In addition, the connection detail from each compressive ring to the pre-cast panels are not protected as shown in Figure 23. In conclusion, a water-management plan should be implemented as part of the rehabilitation project, however caution should be noted in reducing moisture levels at certain locations as this will increase oxygen and could exasperate corrosion if not fully understood.

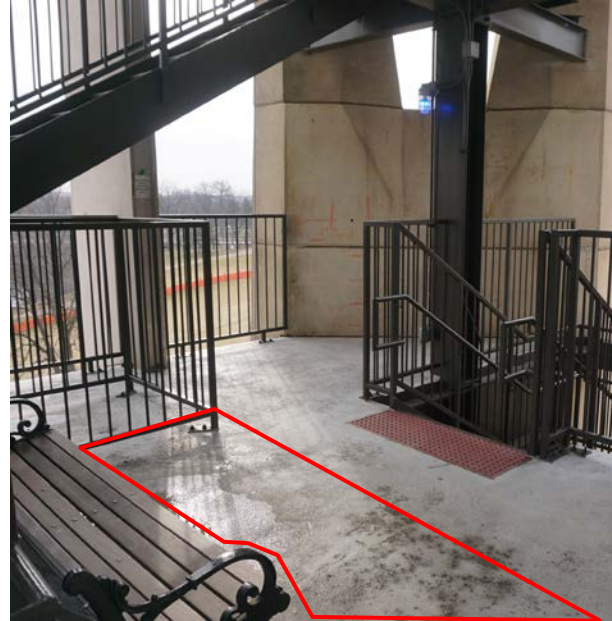
FIGURE 22 STANDING WATER ON LEVEL +52.5.

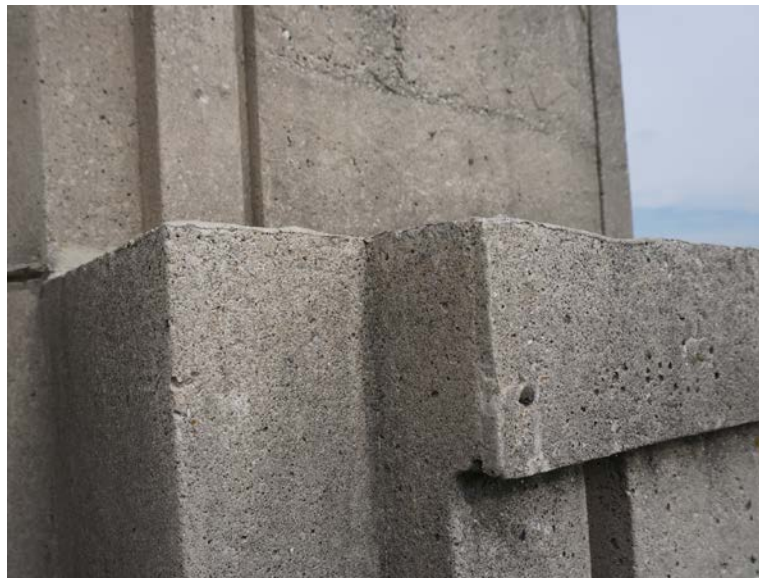
FIGURE 24 STEPPING CONFIGURATION OF THE PRE-CAST PANEL ON THE ELEVATION

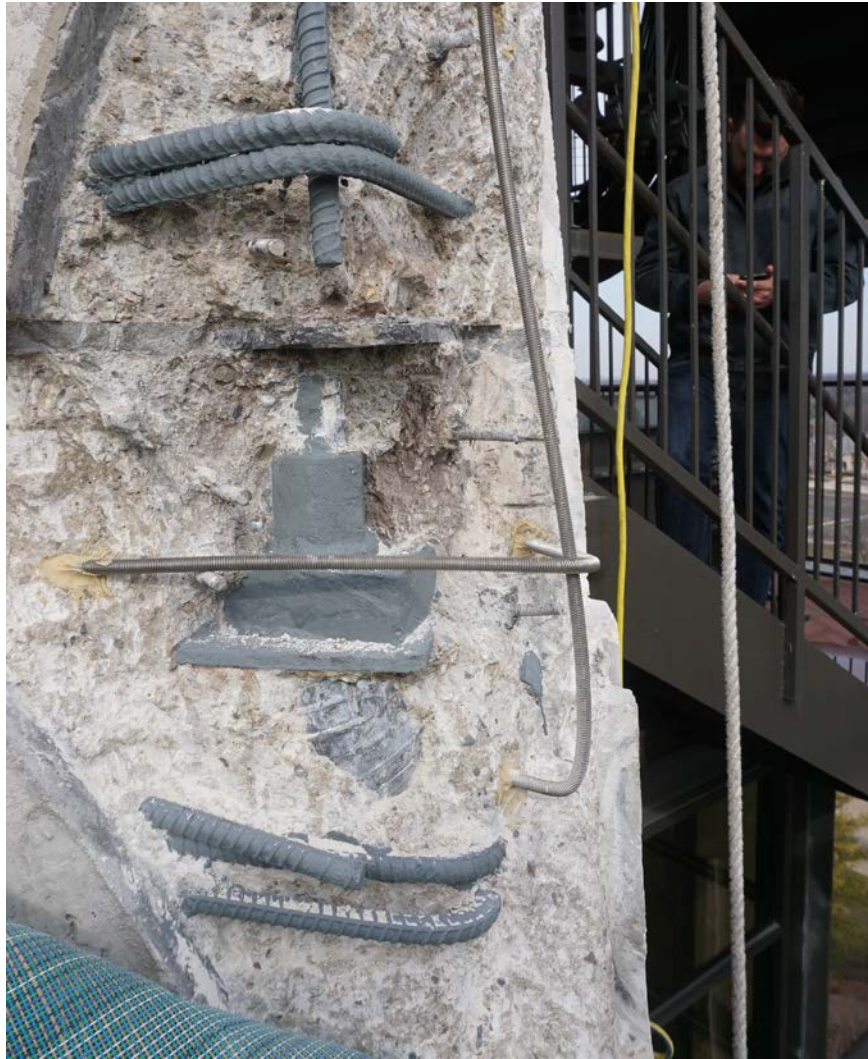
Precast post-tensioned panels made up the elevations of the tower located at four corners as shown in Figure 25. The post-tensioning rod was identified through a probe opening that was completed by Golf Construction during the Field Work as shown in Figure 28 and Figure 29. The SPR was not able to clearly detect the location of the post-tension rod due to the presence of the reinforcement in front.

FIGURE 28 PROBE OPENING ON THE NORTH ELEVATION

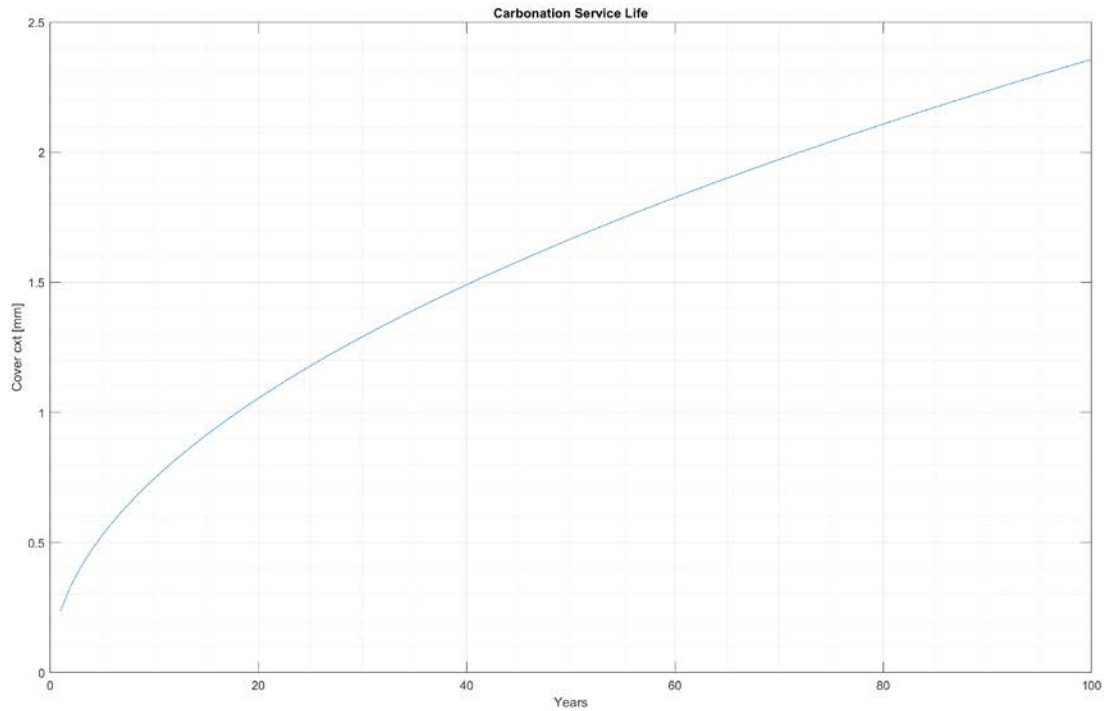
FIGURE 38 SERVICE LIFE CARBONATION PENETRATION

The above model shows that only a minimal carbonation front in the concrete is expected in the next 100 years, primarily due to concrete quality and moisture levels that currently exist. It should be noted that this is not uncommon on this type of exposed structure, however this model becomes invalid when cracks exist where carbon dioxide can migrate into the concrete effortlessly to the depth of the reinforcing steel.

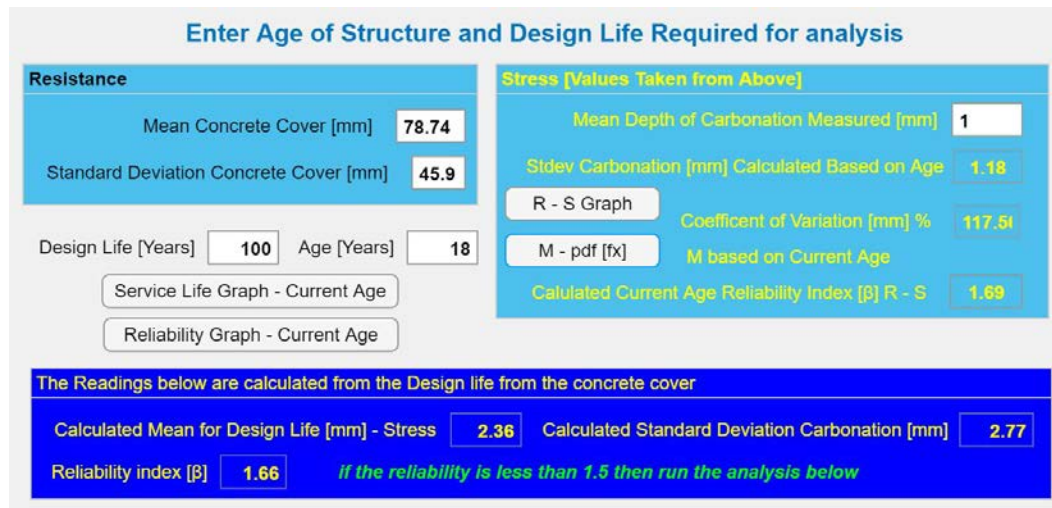
FIGURE 43 SERVICE LIFE RELIABILITY [β] PREDICTION FOR 100 YEAR DESIGN LIFE CARBONATION PRECAST

The above models clearly show slow migration of carbonation over time and shows that ultimately the structure will not be compromised with carbonation in 100 Years based on a reliability index of 1.56 for the cast in place and 1.66 for the precast.

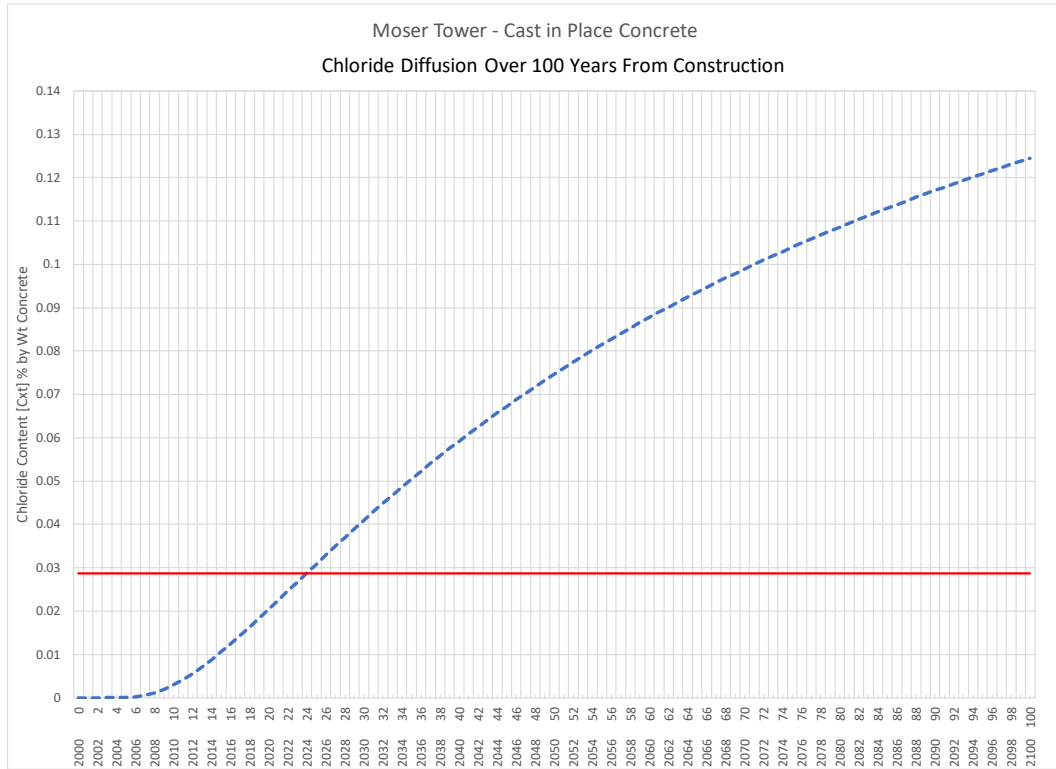
FIGURE 47 SERVICE LIFE CHLORIDE DIFFUSION CAST IN PLACE CONCRETE

The above models clearly show the affects on low cover concrete seen in the cast in place beams as the theoretical ACI model shows a time period of 56 Years compared to that of the precast of over 100 years. These models are built on environmental condition and concrete properties.

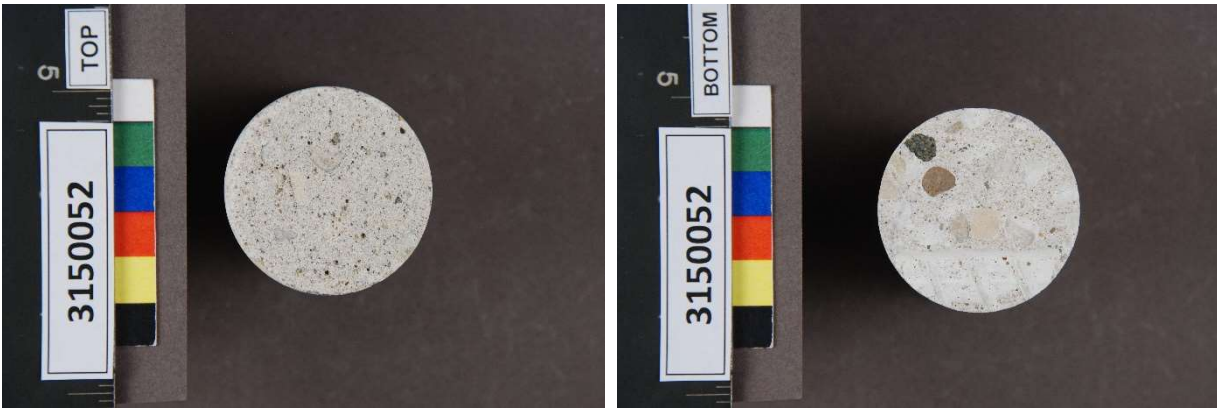
Figure 1. Fin (3150052). Photographs of core in as-received condition.

Overall Condition	Estimated Air (%)	Estimated Paste (%)	Estimated w/c ratio	Cement Type & Hydration	Reinforcement Cover
Good	2-3	27	0.55 ± 0.05	Well hydrated Portland cement	Imprint of ½" Ø steel bar observed on bottom of core

- The top surface was lightly scaled with exposed sand and a few coarse aggregate exposed less than 1 mm.
- The bottom was snapped with an impression of a steel bar.
- Innocuous alkali silica reaction (ASR) of micro-crystalline quartz within a chert fine aggregate was detected. No cracking in the aggregate or into the paste had occurred.
- Variable porosity and abundant calcium hydroxide in the paste throughout the thin section.
- Minor-trace amounts of secondary ettringite formation within the paste and former cement grains was present in thin section.
- The cement grains appear to have two-toned relic structure indicative of the potential for high temperatures during curing which could lead to delayed ettringite formation (DEF). No evidence of DEF was detected.

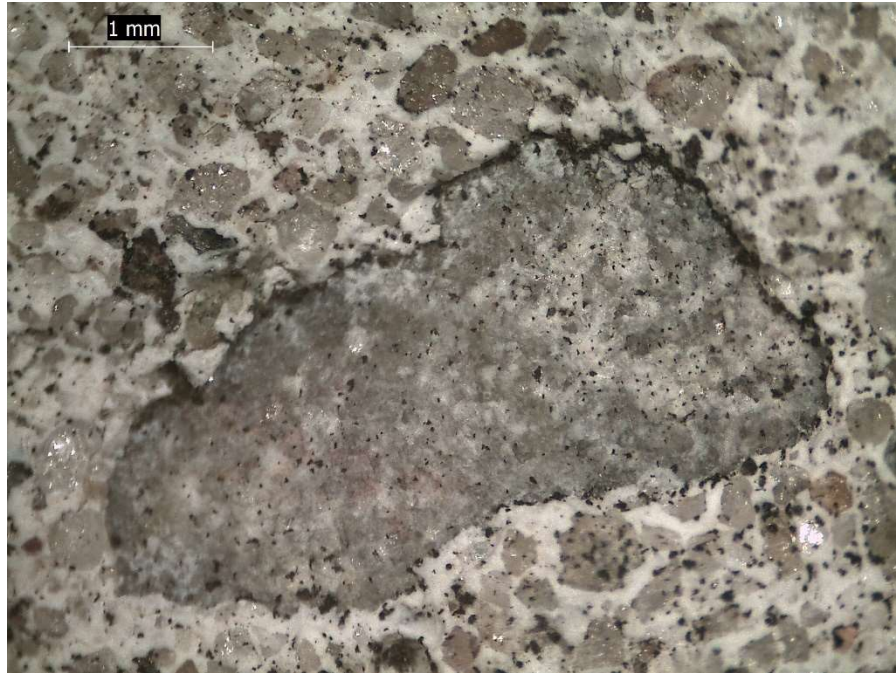
**Figure 2. Fin (3150052). Stereo-optical micrograph showing exposed coarse and fine aggregates on the surface.**

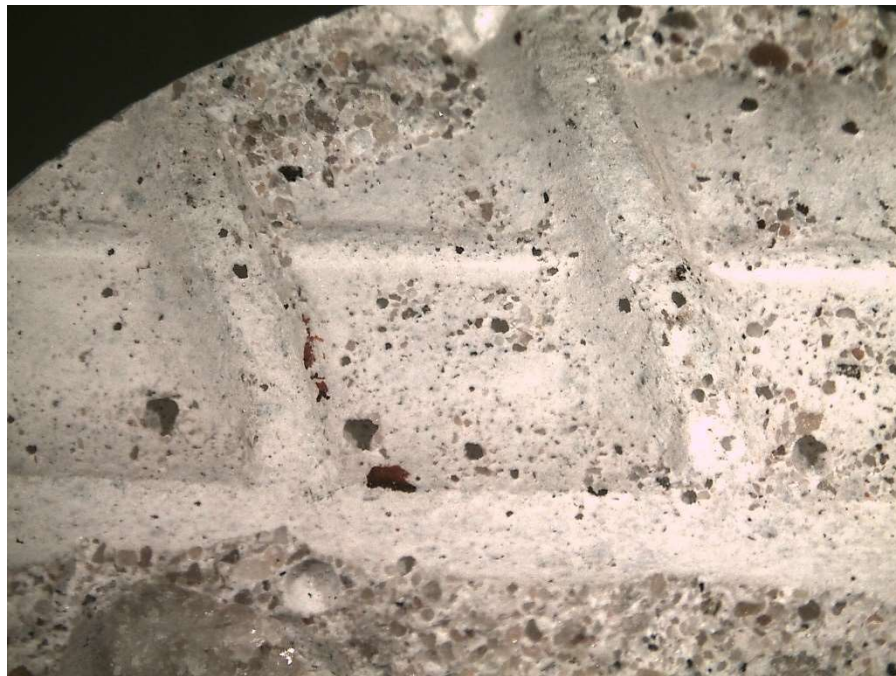
**Figure 3. Fin (3150052). Stereo-optical micrograph showing the impression of the steel bar on the bottom of the core.**

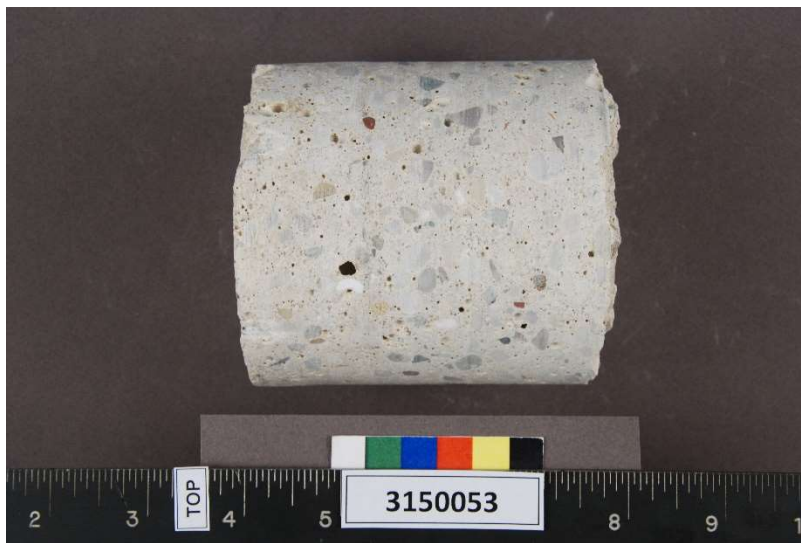
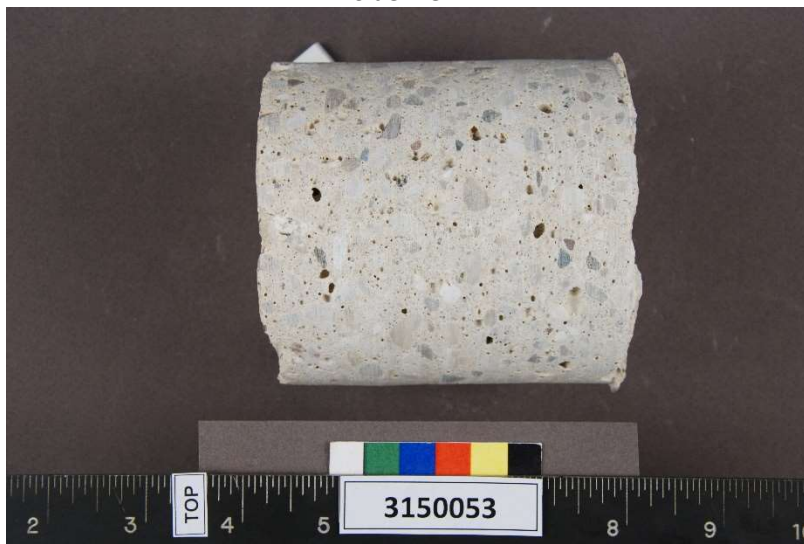
- The top surface was a smooth cast surface with small air voids. Trace amount of map microcracking was present on the painted surface, but did not extend into the concrete.
- The bottom was snapped through and around aggregates.
- Minor amount of very fine water channels or gaps along paste aggregate interface in top 1/8".
- Variable porosity and abundant calcium hydroxide in the paste.
- The cement grains appear to have two-toned relic structure indicative of the potential for high temperatures during curing which could lead to delayed ettringite formation (DEF). No evidence of DEF or any appreciable amount of secondary ettringite was detected.

Figure 14. Pre-Cast Panel (3150053). Photographs of core in as-received condition.

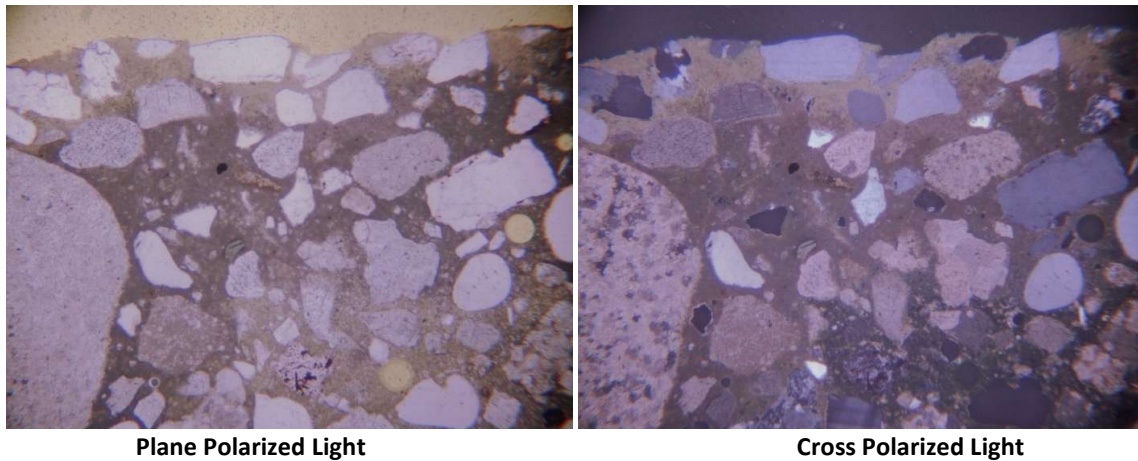
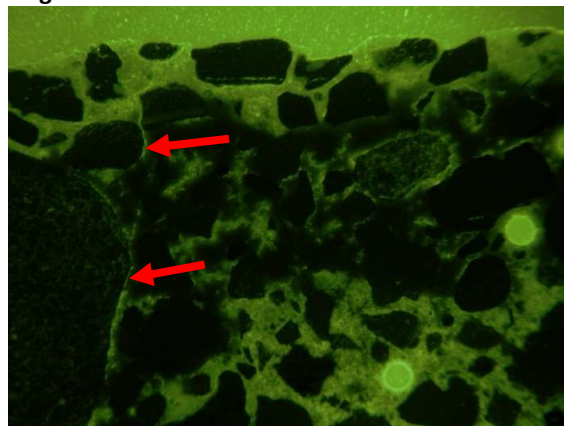
Figure 20. Pre-Cast Panel (3150053). Optical micro-graph in different light modes showing carbonated paste and a water channel along aggregate (highlighted by red arrows). Field of view 2.6 mm wide.

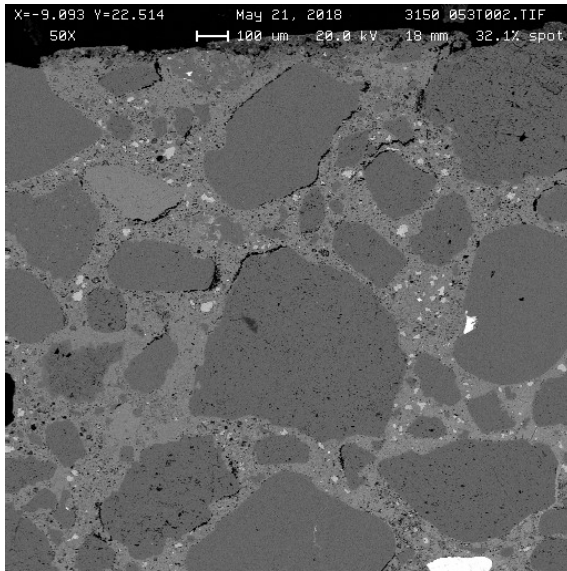
Figure 21. Pre-Cast Panel (3150053). BSE image of water channels or gaps along aggregate in the top 1/8".

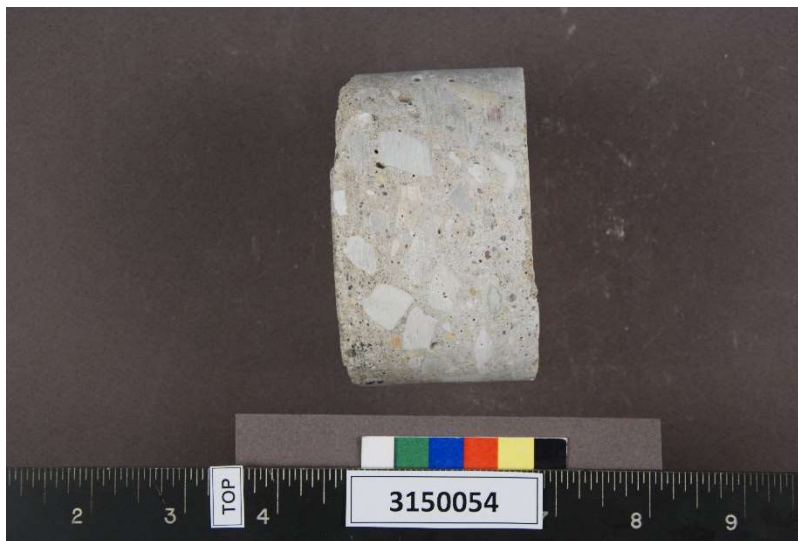
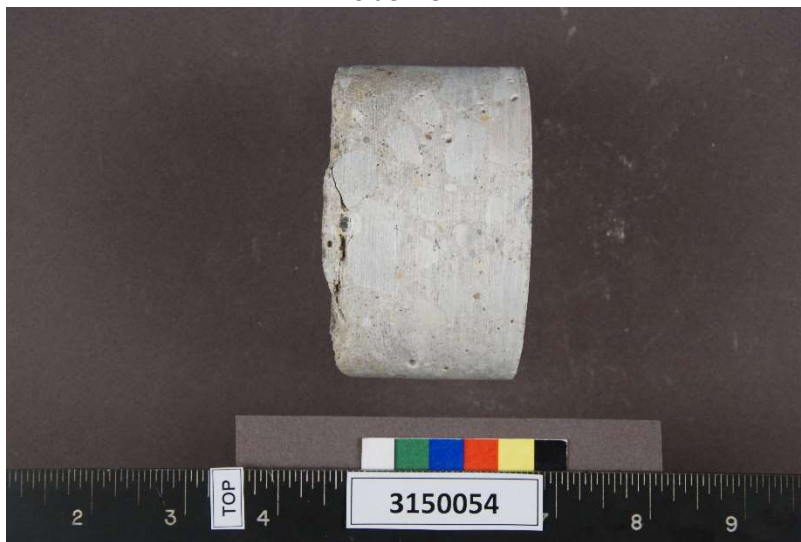
Observations
<ul style="list-style-type: none"> <li>The top surface was a smooth finished surface with chipping around the edges.</li> <li>The bottom surface was cut.</li> </ul>
<ul style="list-style-type: none"> <li>Few localized gaps at paste/aggregate interfaces consistent with trapped bleed water or poor compaction.</li> </ul>
<ul style="list-style-type: none"> <li>Trace to minor amount of fine calcium hydroxide in the paste.</li> </ul>
<ul style="list-style-type: none"> <li>Trace amounts of monosulfate and ettringite deposits in the paste.</li> </ul>

Figure 25. Column (3150054). Photographs of core in as-received condition.

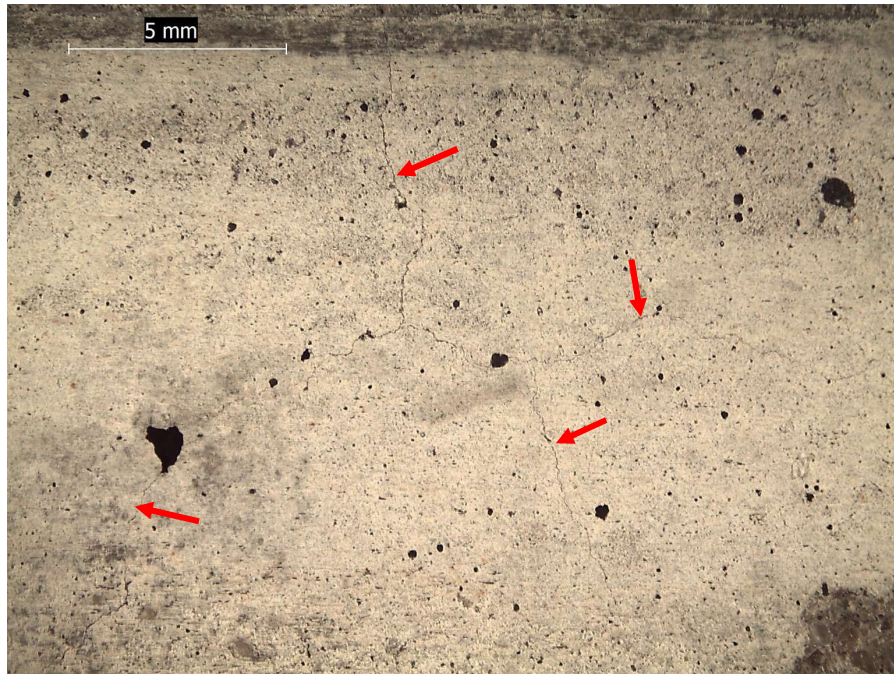
Figure 27. Column (3150054). Stereo-optical micrograph of the core side showing microcracks up to  $\frac{13}{16}$ " deep.

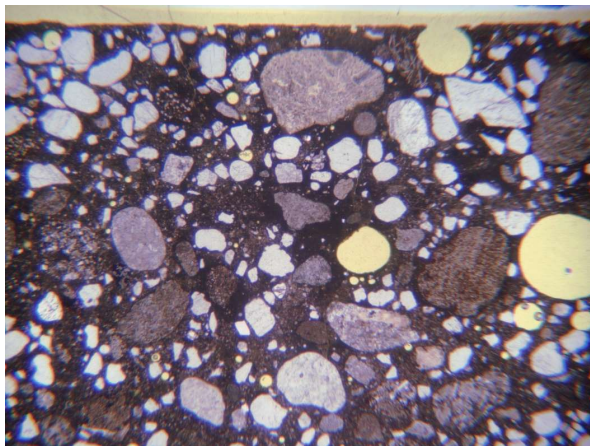
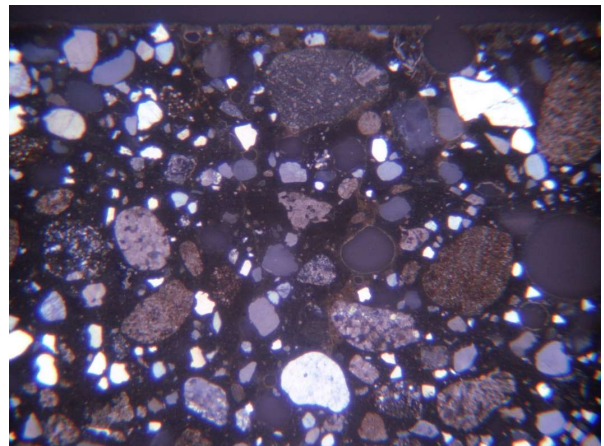
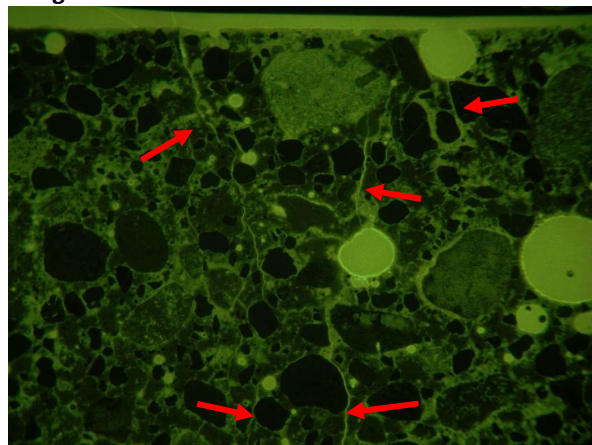
Figure 31. Column (3150054). Optical micro-graphs in different light modes showing drying shrinkage micro cracks (highlighted by arrows) from the surface. Field of view 10.0 mm wide.

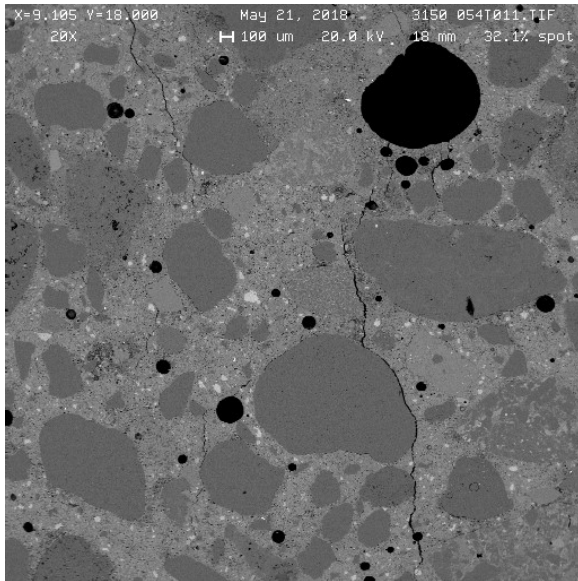
**Figure 32. Column (3150054). BSE image of discontinuous microcracks near surface.**

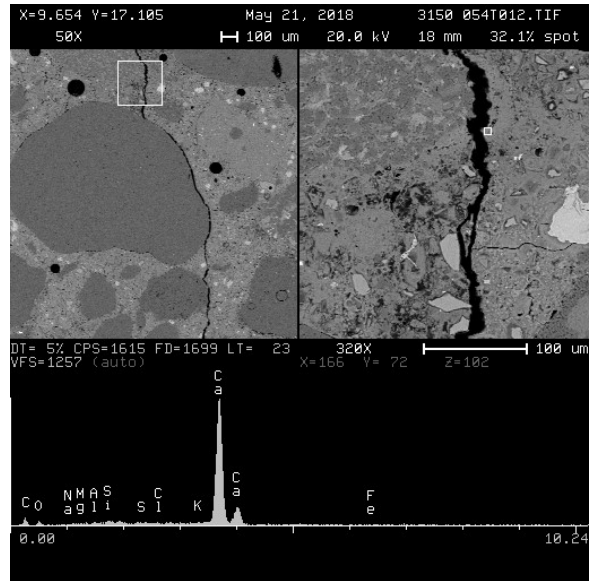
**Figure 33. Column (3150054). BSE images with EDS spectrum of carbonated paste along the crack face to 3/16".**

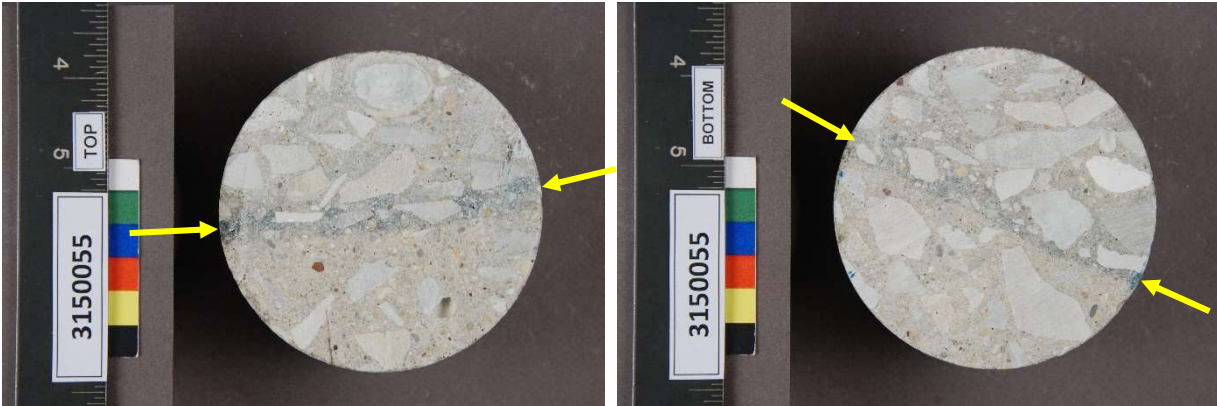
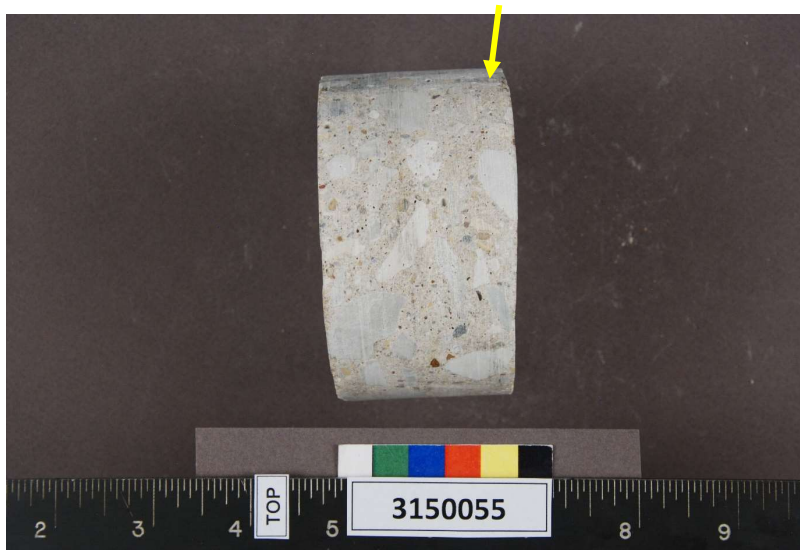
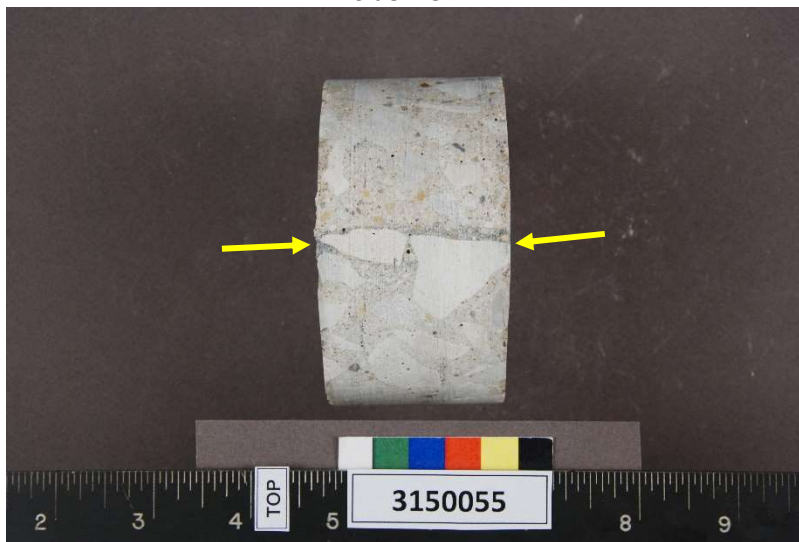
Observations
<ul style="list-style-type: none"> <li>Top and bottom of the core were cut.</li> <li>A cold joint was indicated bisecting the core. A narrow band of medium grey paste was present which was correlated with decreased hydration along the edge.               <ul style="list-style-type: none"> <li>The medium gray paste belongs to a slighter denser paste with slightly reduced air content as compared to the concrete on the other side of it.</li> <li>Slight retardation of hydration within medium gray paste approximately 1/16" wide.</li> </ul> </li> <li>Trace calcium hydroxide observed throughout section.</li> <li>Innocuous alkali silica reaction (ASR) within rim of a chert fine aggregate, but no cracking within the aggregate or into the paste.</li> </ul>

Figure 36. Entrance Wall (3150055). Photographs of core in as-received condition. A band of blue-gray paste (indicated by arrows) bisects the core.

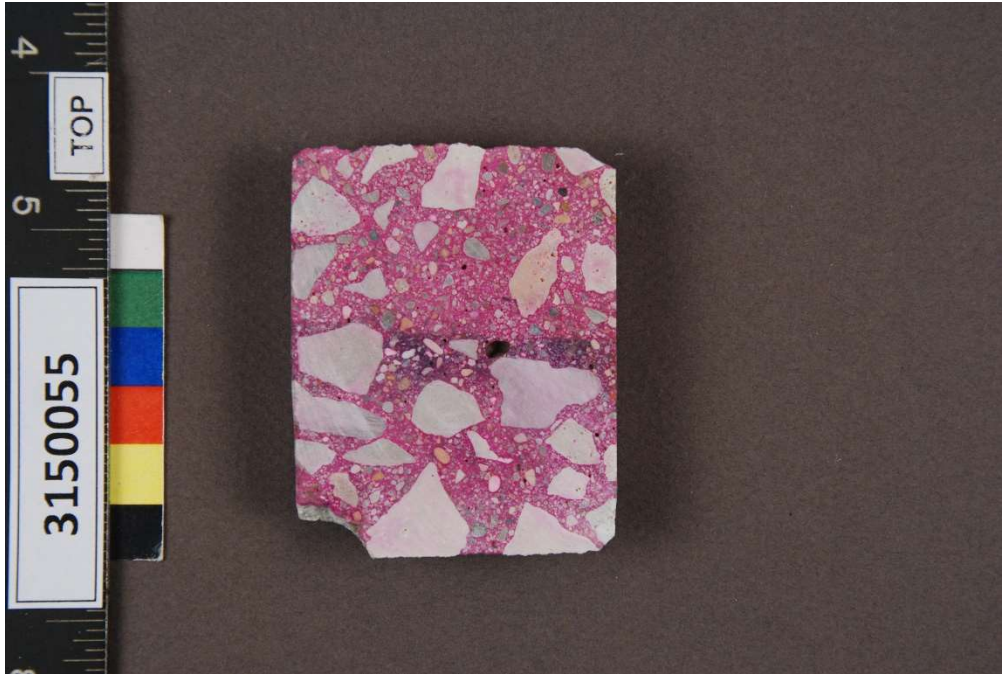
Figure 37. Entrance Wall (3150055). Photograph of freshly cut surface with phenolphthalein indicator applied.

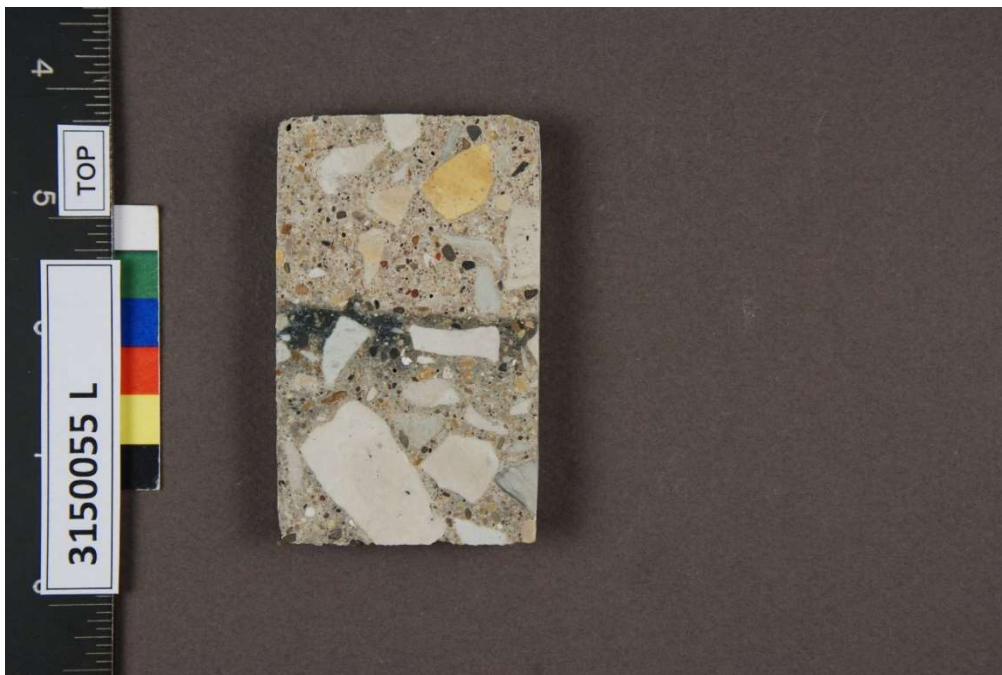
Figure 38. Entrance Wall (3150055). Photograph of polished cross sectioned slab.

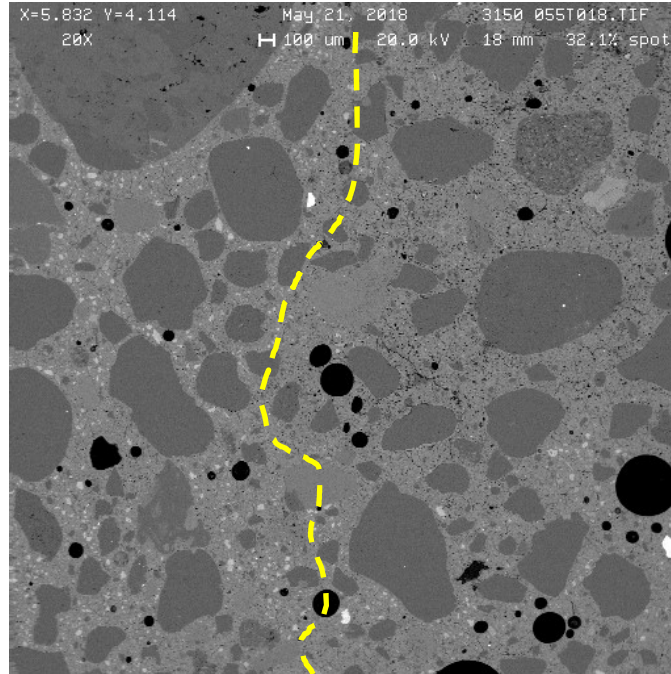
Figure 41. Entrance Wall (3150055). BSE image of the interface between the concrete pours.

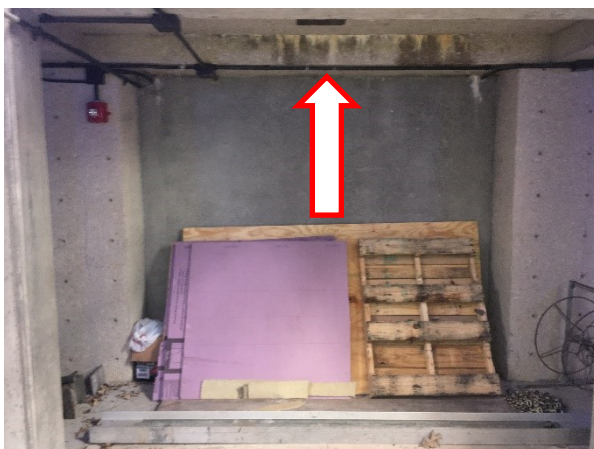
11. A close-up view of concrete cracks and water infiltration below front door.

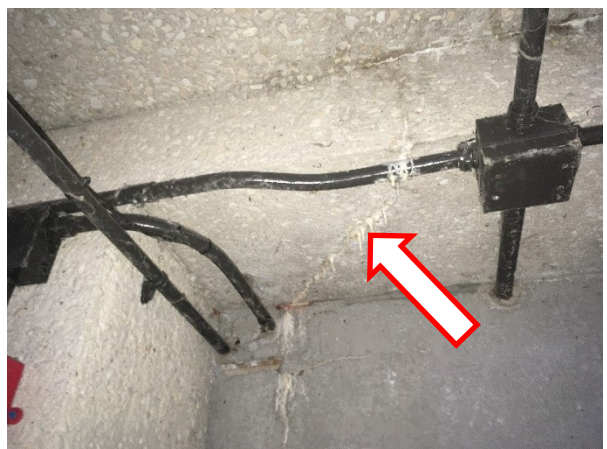
12. A close-up view of concrete cracks and water infiltration below front door.

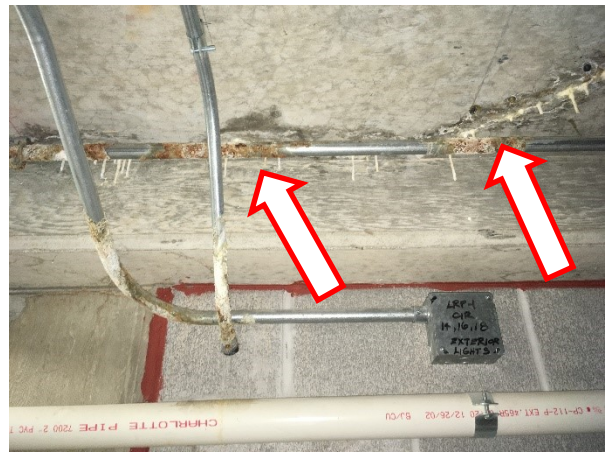
16. A view of concrete cracks and mineral leaching in the mechanical room below plaza.

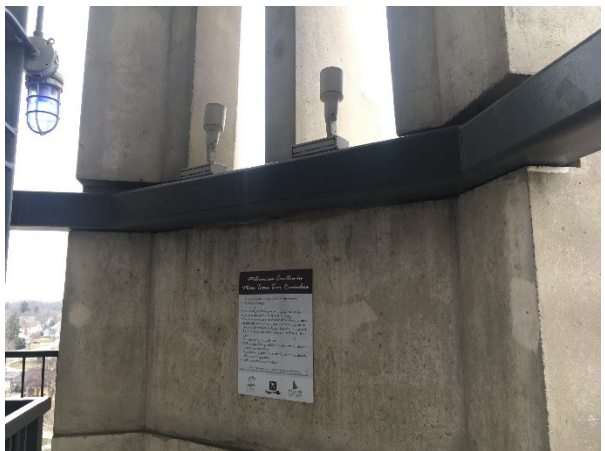
18. A view of one ring beam connection to the precast. The configuration of ring level connection varies.

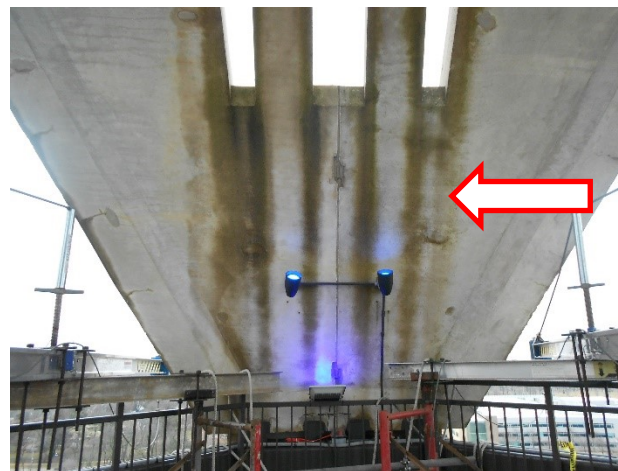
30. A view of the roof panel with knife edge both sides and water staining from runoff.

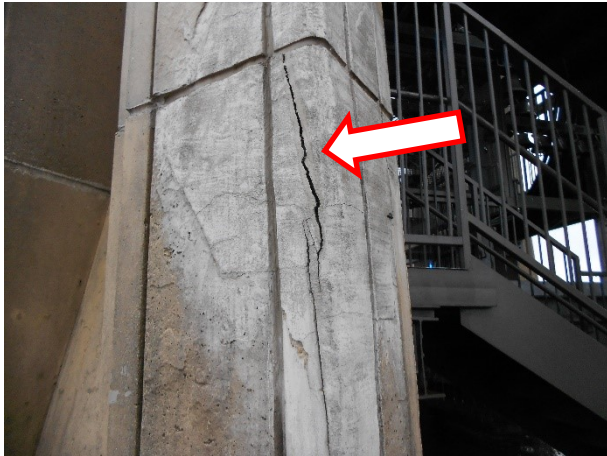
53. A close-up view of failed patch at El. 116'-8" prior to repatching. .

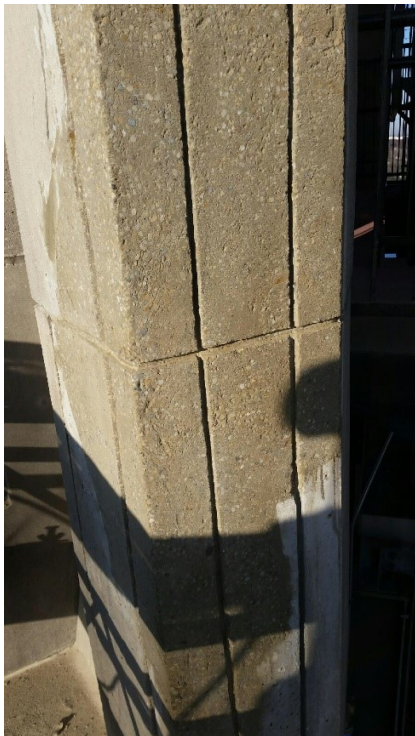
60. A failed embed patch removed during inspection.

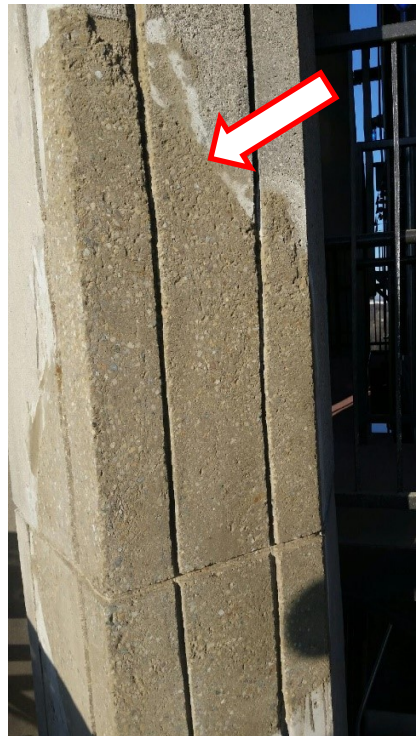
61. A view of the repaired patch on the SE pier made during the investigation. Photo by Golf Construction.

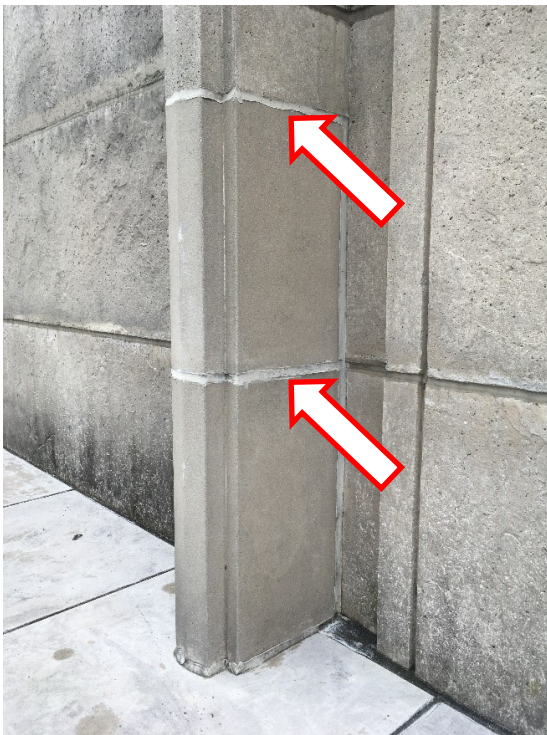
113. A view of a precast fin intersecting the Northwest base coping. Note failed sealant between sections.
