**ADDENDUM NO. 1 (DRAFT)**  
**Naperville Riverwalk**  
**Moser Tower Structural Assessment**  
**September 2018**

### CORROSION AND MATERIAL DURABILITY ANALYSIS

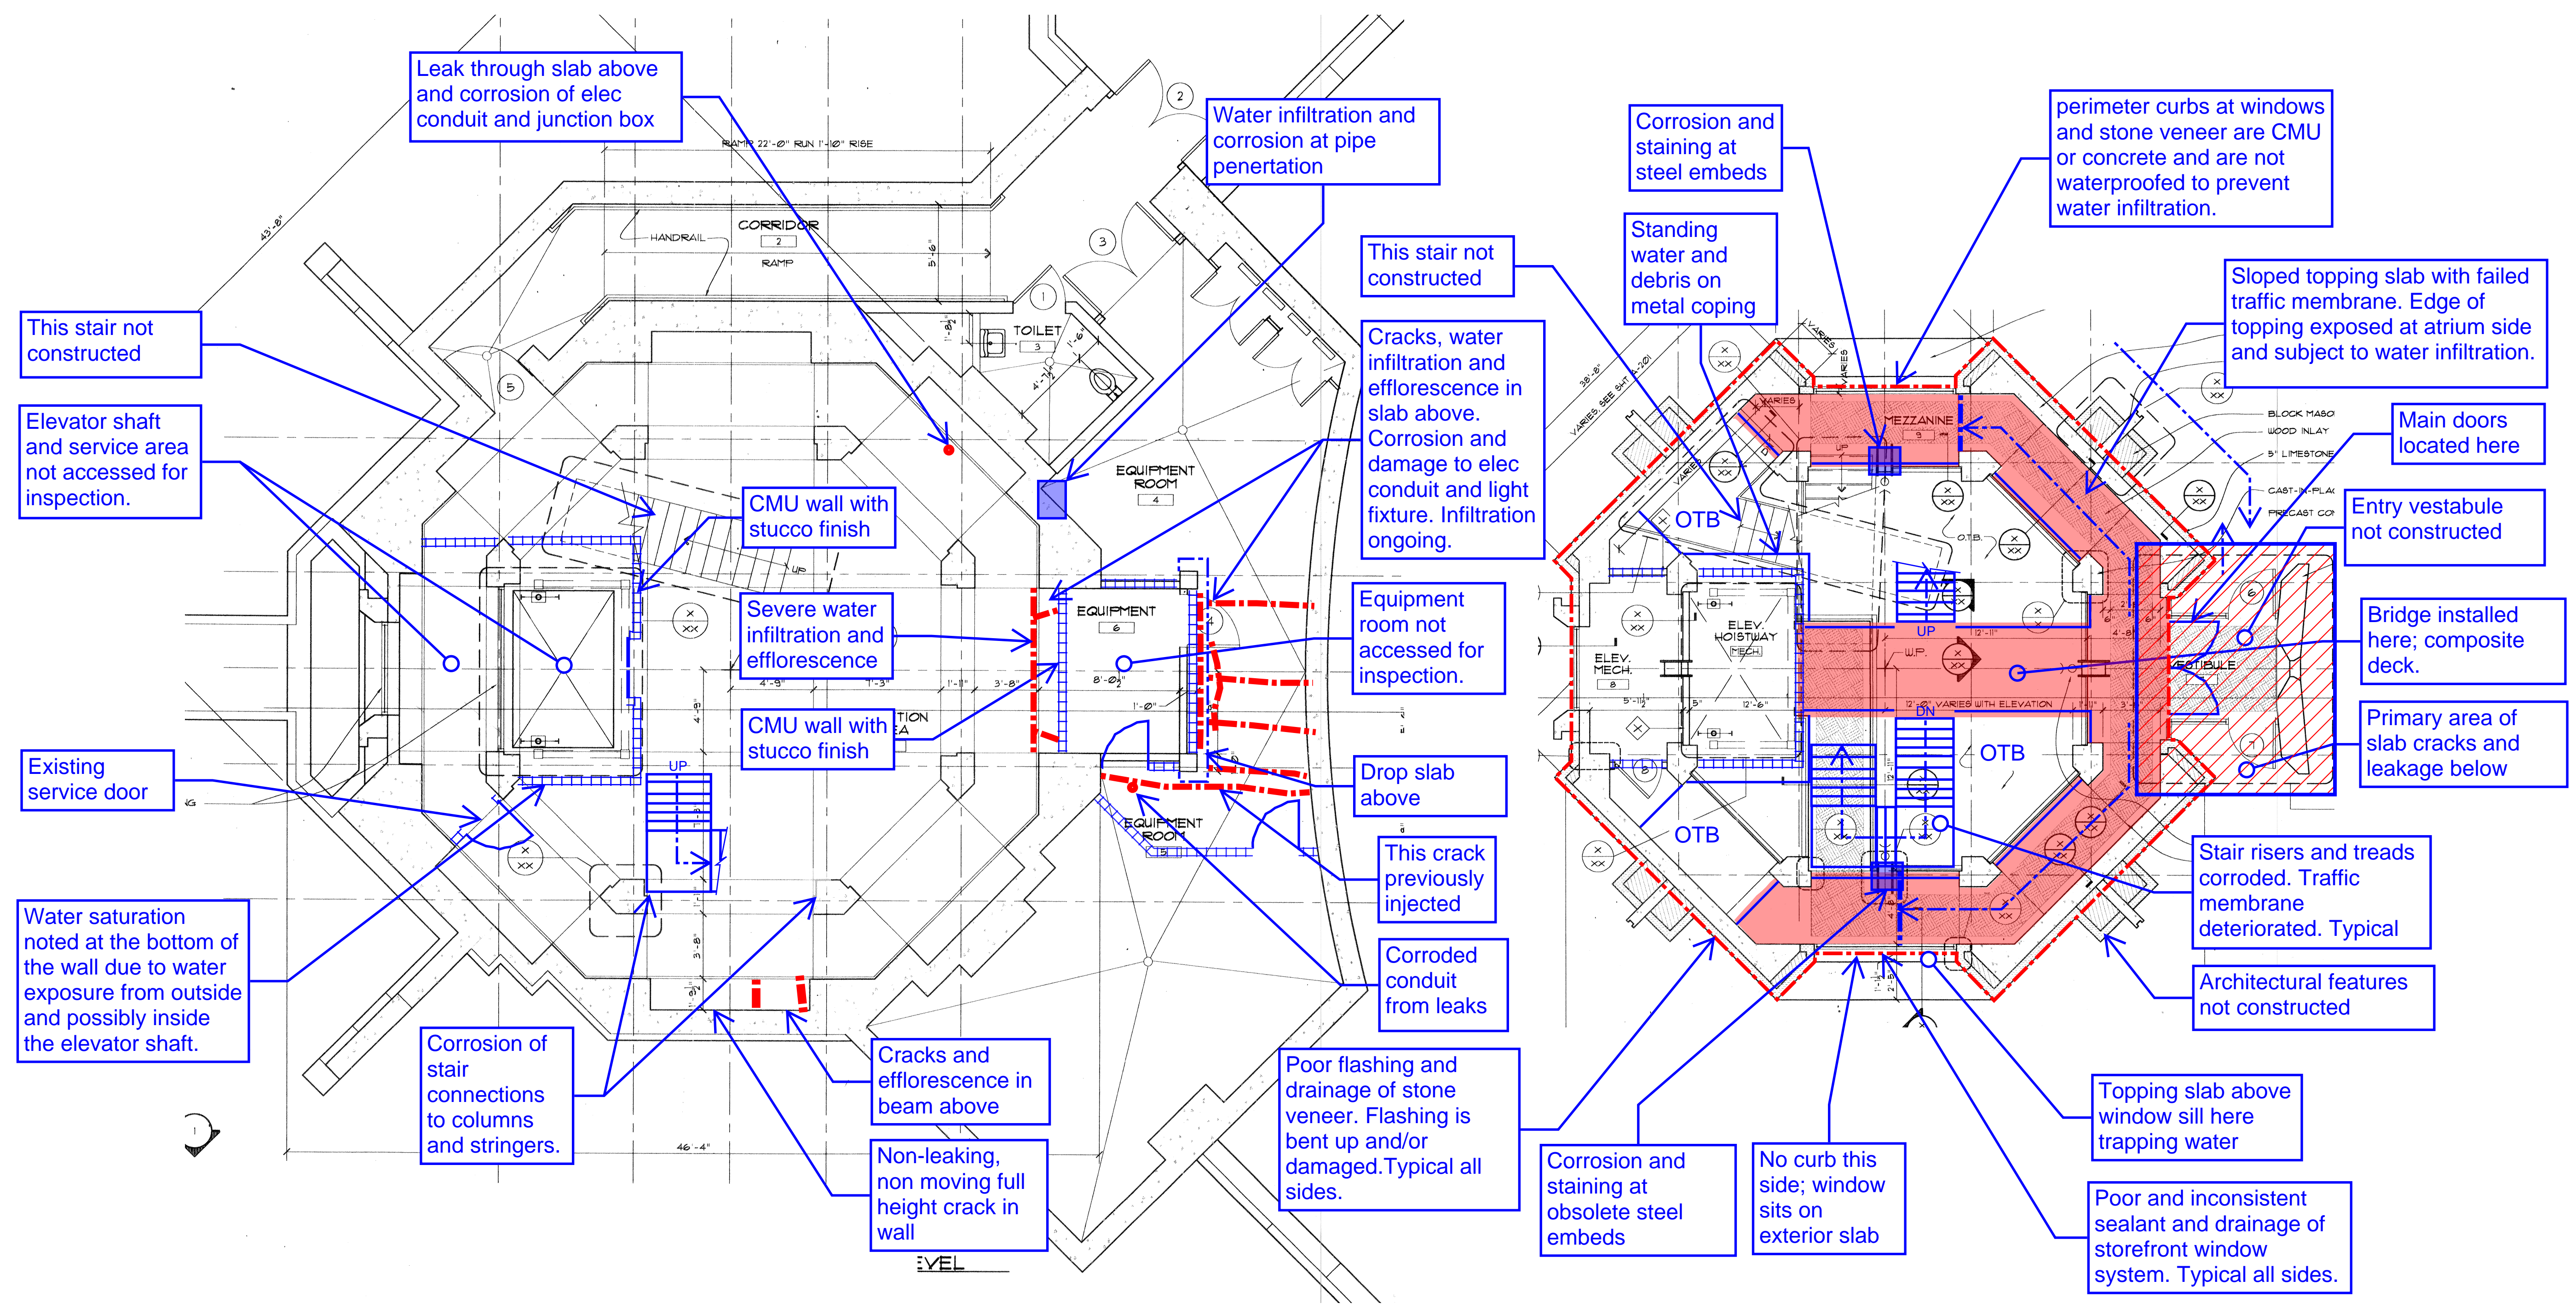
Entry Level Plan

Note: The elevation of the surrounding topping slab is too high, preventing proper drainage of window systems and masonry veneer flashing.
