| ORGANIZATION | RAMSEY HISTORIC CONSULTANTS |

| SURVEYAREA | NAPERVILLE SURVEY UPDATE |

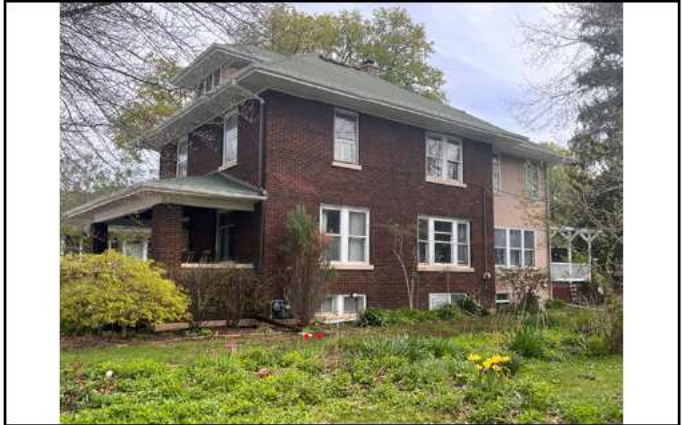
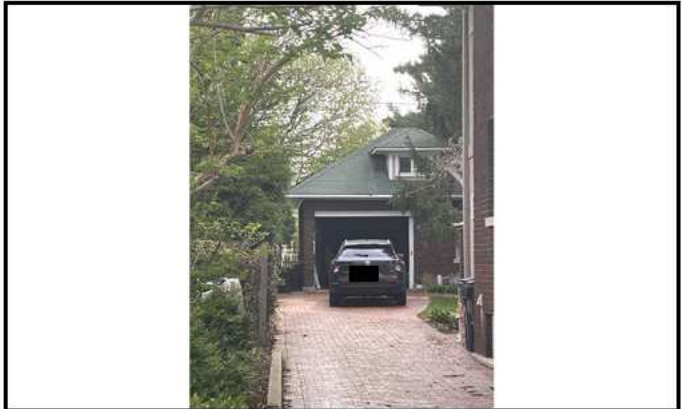
Aluminum siding installed under eaves

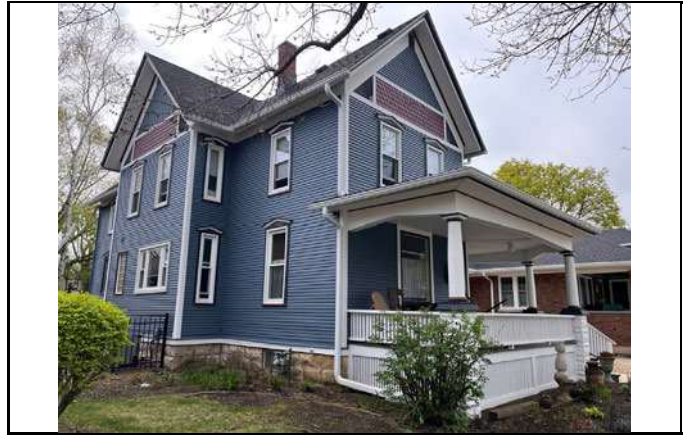
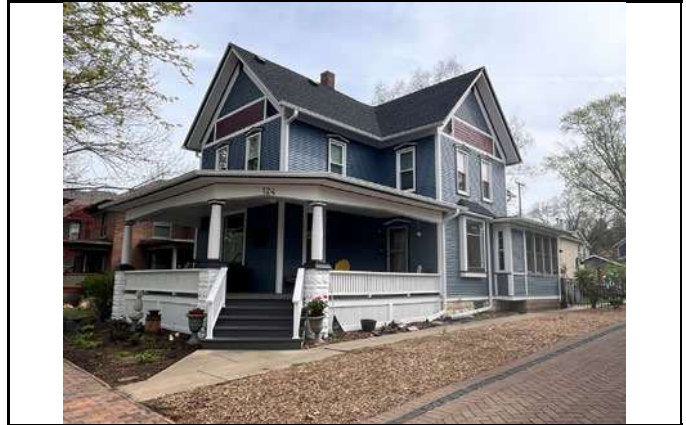
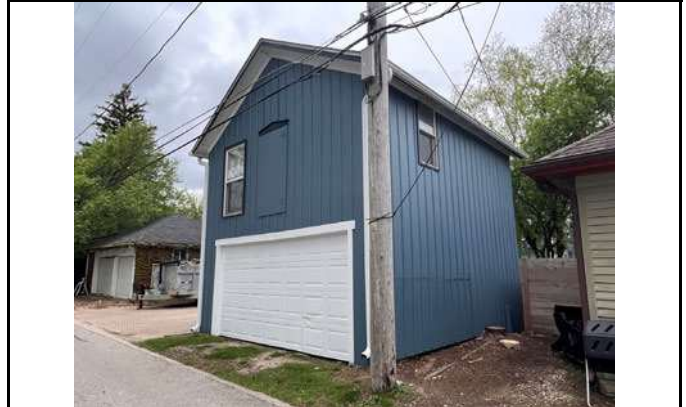
| Work Not Requiring COA | Exterior repainting; select replacement windows on secondary north and south elevations. |

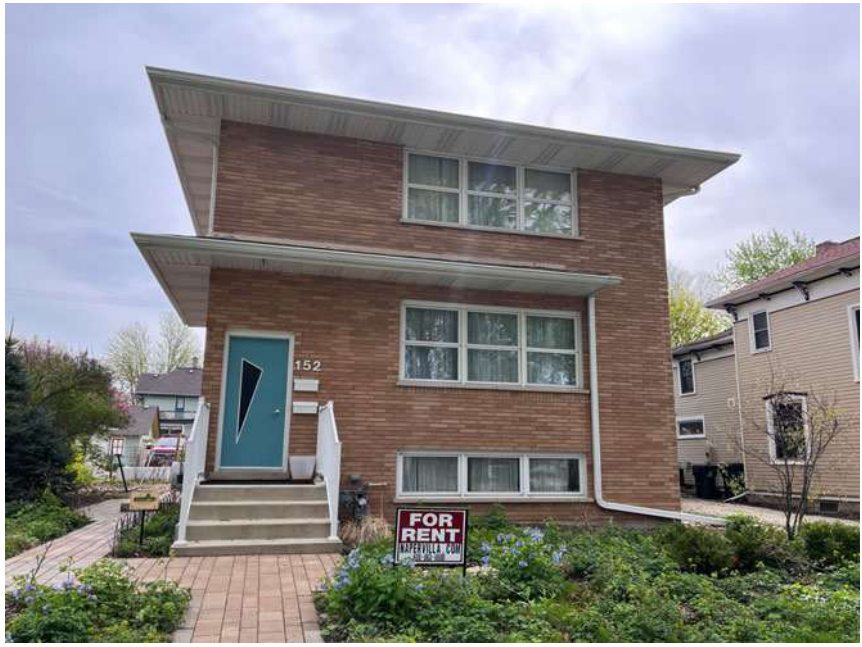
Metal railing at front steps; replacement front door (historically compatible).

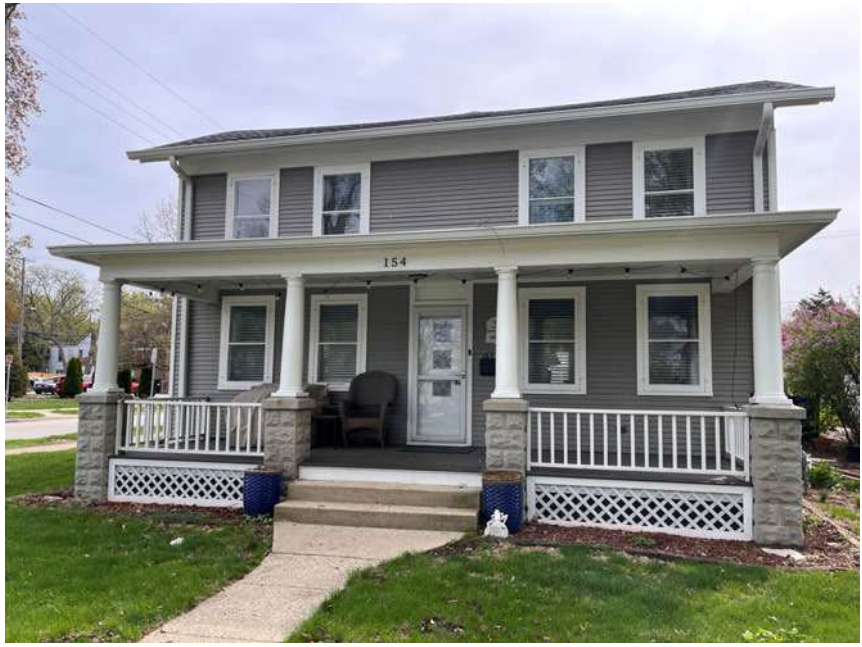
| COA Compliance Notes | Replacement material for front porch roof not visible from public way. |

Replacement windows on street-facing north elevation (historically compatible); replacement door and stoop at north entrance.

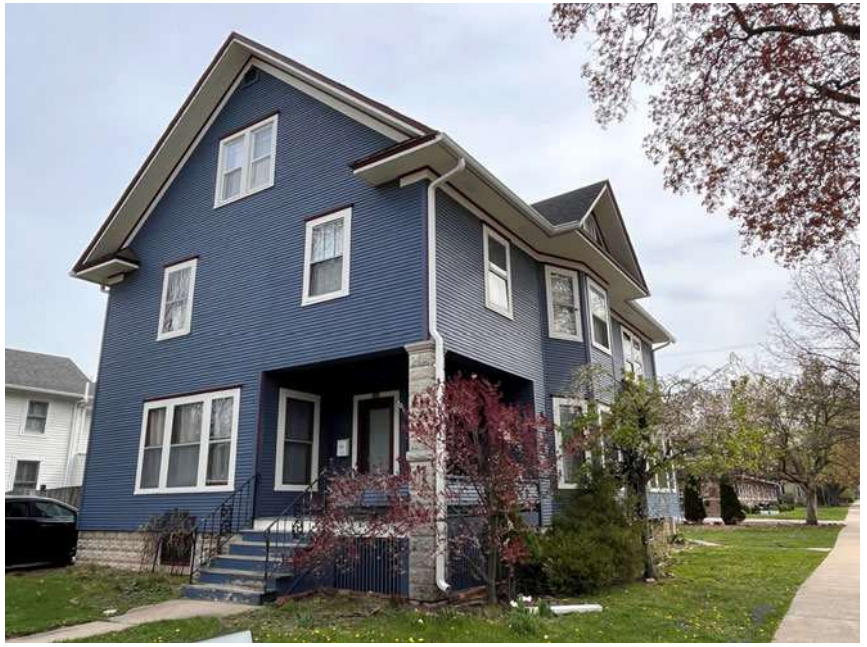
ALTERATIONS 3/1 wood replacement windows in original openings (historic); 2 story enclosed rear porch (historic); metal seam roofing on front cornice returns and south window bay (not historic). Post-2007 -- no changes.

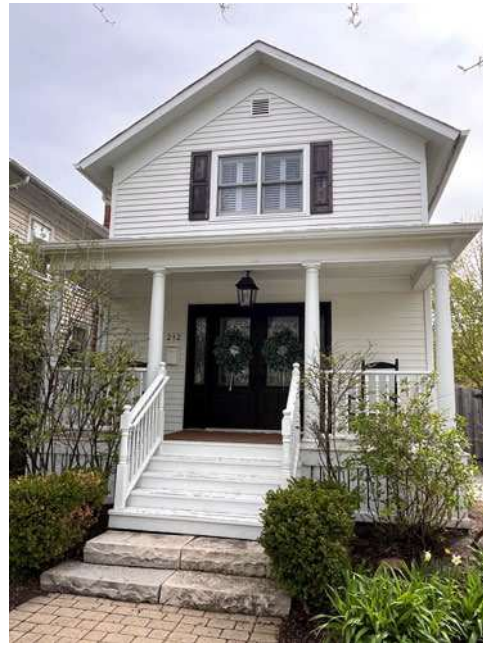
Solid porch knee wall replaced with turned wood railing; front door removed and center window under porch converted to main entrance and fitted with double-leaf door and sidelights; decorative shutters added to 2nd-story window opening on front façade

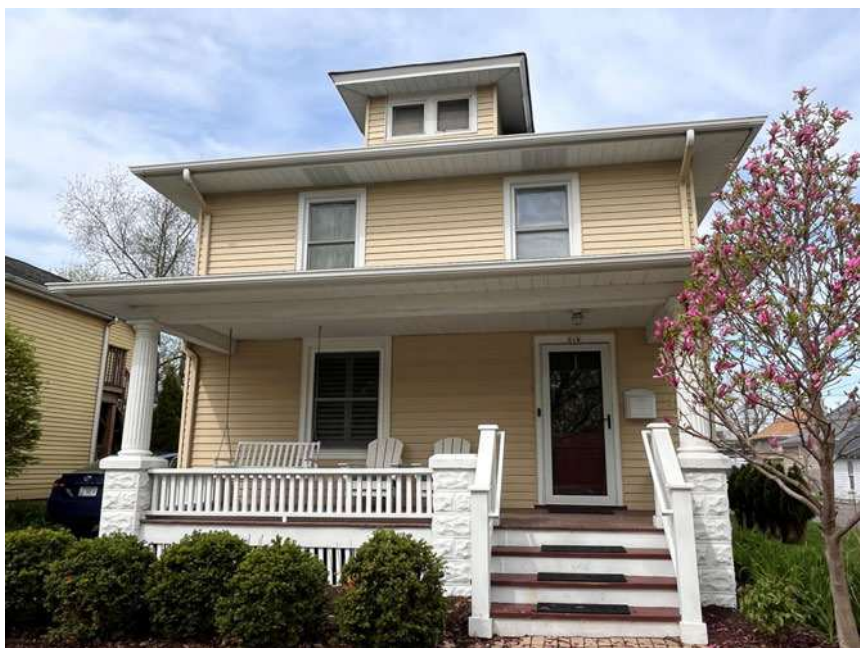
Work Completed Without COA 2nd-story replacement windows in original openings; railing replacement at porch steps

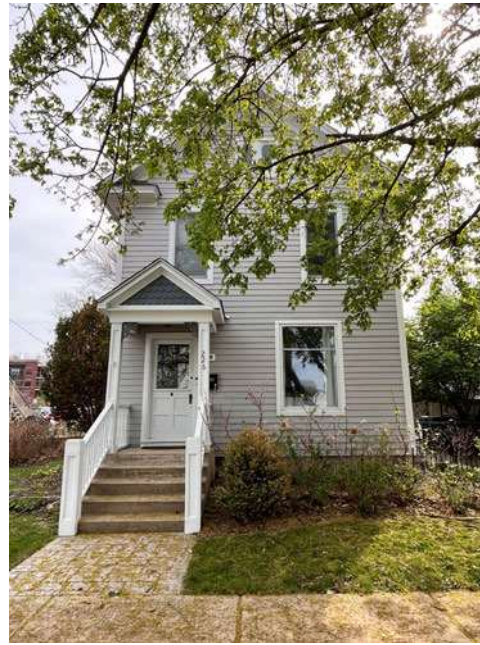
ALTERATIONS Front entry porch (post-1954); replacement concrete steps, possibly supports & railings, on south/rear porch (not historic). Post-2007 -- 1/1 replacement windows on second story of front façade and on side elevations; 2nd-story window at west end of north elevation appears to be in a downsized opening; wood siding replaced with fiber cement (wider width than previous wood siding); painted railing added to front steps; one-story bump-out constructed on south wall of three-sided first-story bay on south elevation

COA Compliance Notes Board width of replacement siding does not match historic wood siding.

Second-story replacement windows and new step railings on front façade

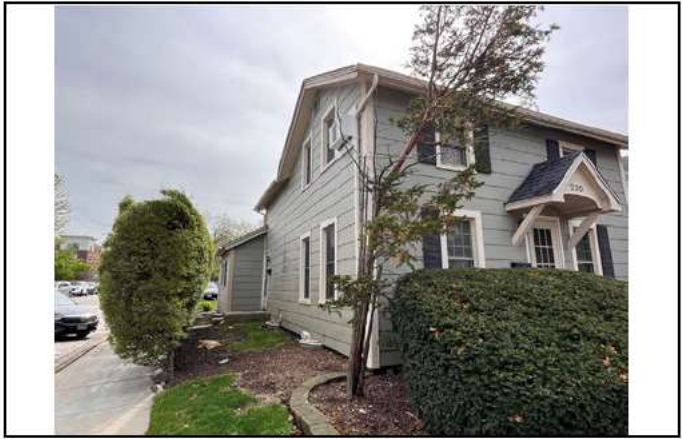
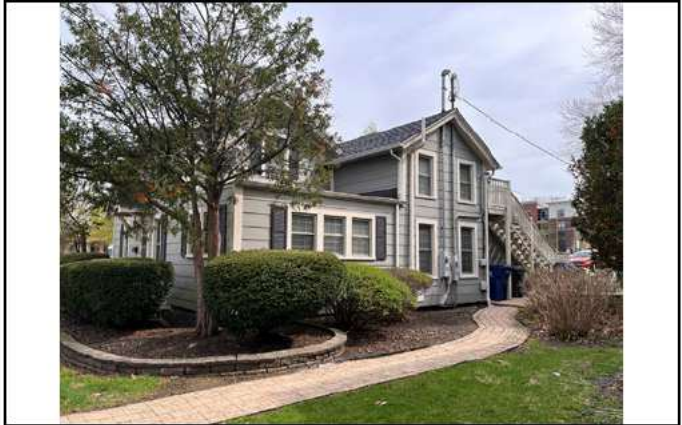
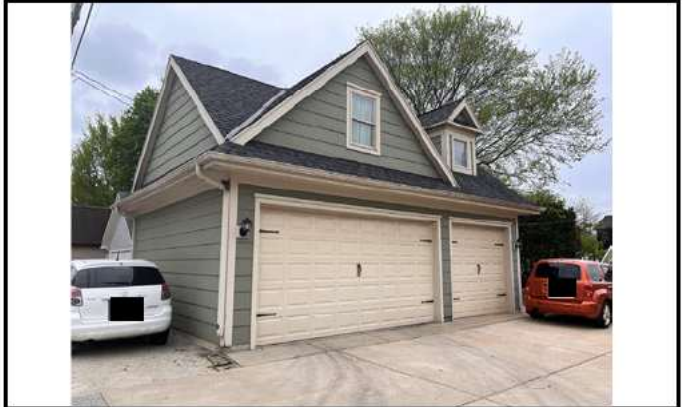
| COA DECISION | COA #10-2176 - Siding replacement (approved by HPC 8/26/2010) |

Work Completed Without COA
