DOCUMENT REFERENCE RE-E17258-IM-REV 1.0

MOSER TOWER

CORROSION AND MATERIAL DURABILITY ANALYSIS

ECHEM CONSULTANTS LLC 4 JEFFERSON PLAZA SUITE 500 POUGHKEEPSIE, NY 12601

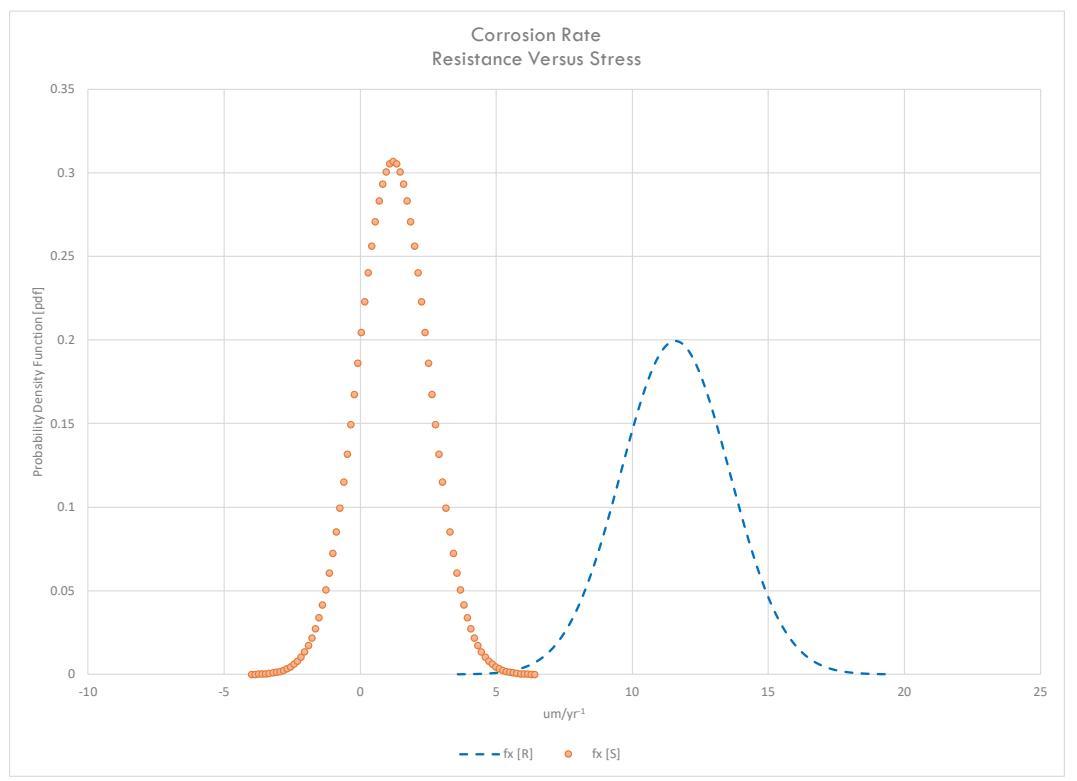
FIGURE 10 CORROSION LEVELS PRECAST RESISTANCE V STRESS

At condition state 3 we have a further 33% making a total of 95% at condition state three and four which has a deterioration prediction of between 10 to 25 years before corrosion distress is caused. The remaining 5% of the readings belongs to condition state 2 having a medium-high corrosion rate which is expected to show failure within 10 years. No visual distress was noticed during the field work which confirms the majority of the readings fall within condition state 4 as tested.

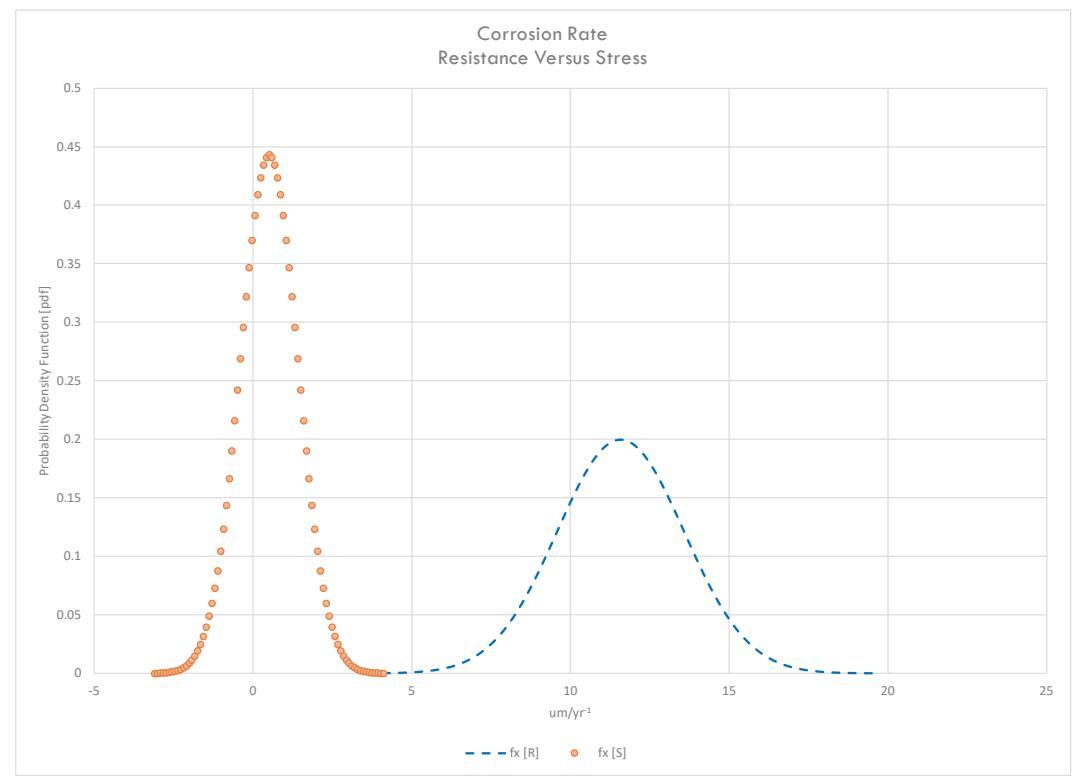
FIGURE 11 CORROSION LEVELS BEAM RESISTANCE V STRESS

It was visually noted by the team that water splashes onto these areas causing an excessive amount of moisture. This was confirmed by the temperature and humidity measurements taking from site.

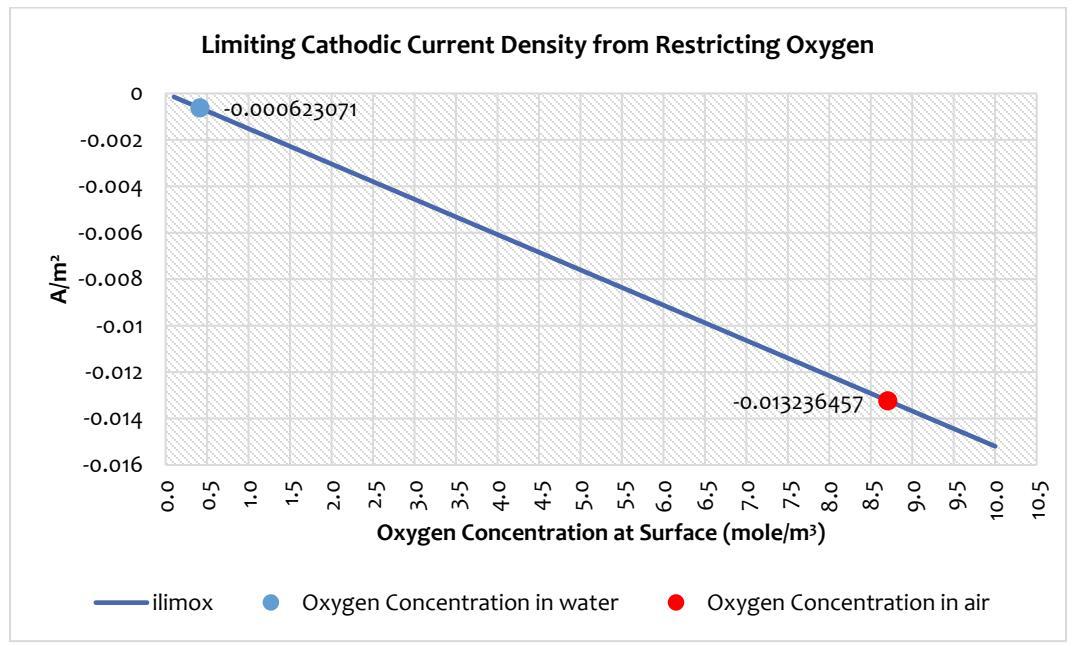
FIGURE 18 CATHODIC CURRENT DENSITY WITH OXYGEN AVAILABILITY IN CONCRETE

The figure above shows how large the reduction of current is when restricting oxygen availability in the corrosion reaction. The amount of current available when saturated is negligible and hence why reinforcing steel when saturated corrodes very slowly (0.72µm/yr⁻¹). At this corrosion rate in one hundred years you would have less than 0.1 mm section loss.

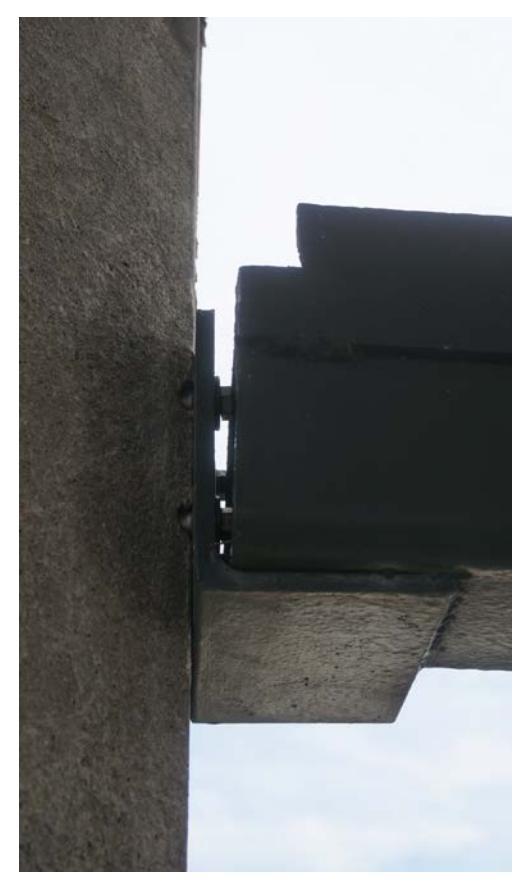
FIGURE 23 DETAIL OF CONNECTION BETWEEN COMPRESSIVE RING AND THE PRE-CAST PANEL

chlorides and carbonation profiles were identified. The absence of waterproofing membrane and flashing details will potentially aggravate the corrosion condition by allowing water ingress into the structural elements as the tower is open to the environment. The "stepping" configuration of the pre-cast panels displayed on all four elevations allows for water and snow accumulation as shown in Figure 21 and Figure 24. In addition, the connection detail from each compressive ring to the pre-cast panels are not protected as shown in Figure 23. In conclusion, a water-management plan should be implemented as part of the rehabilitation project, however caution should be noted in reducing moisture levels at certain locations as this will increase oxygen and could exasperate corrosion if not fully understood.

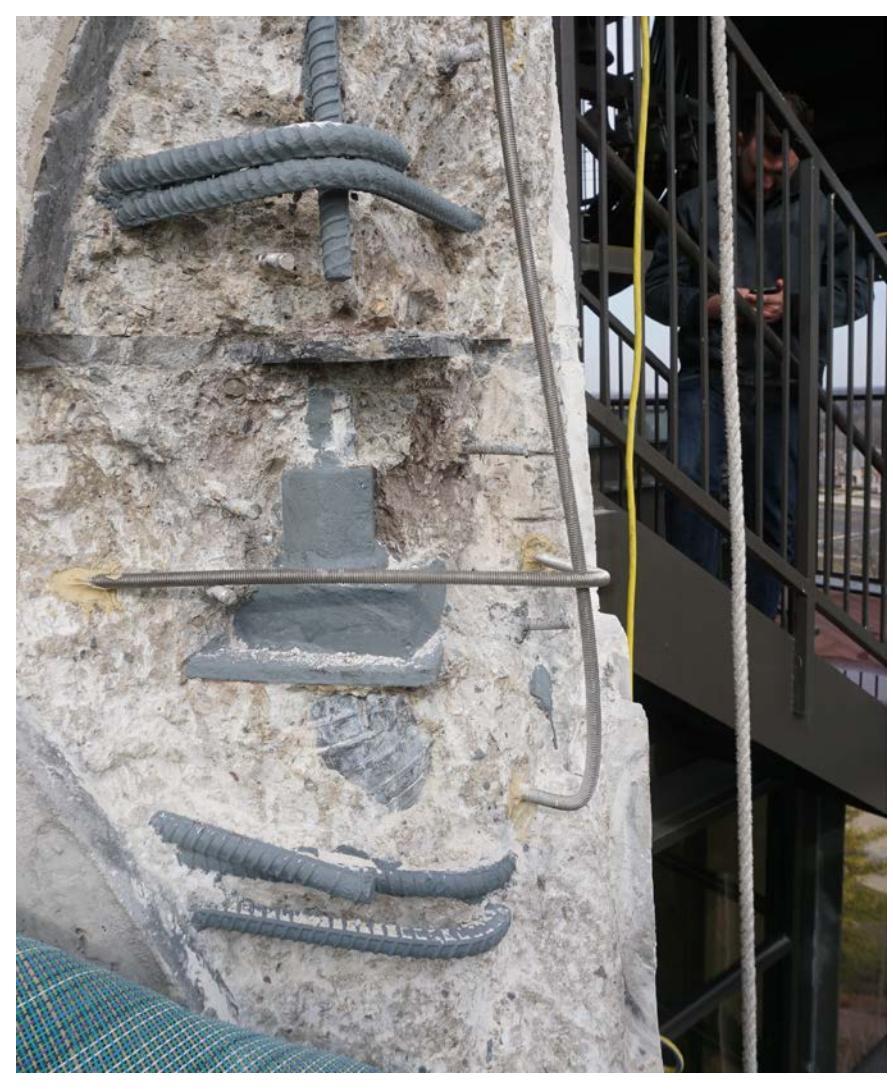
FIGURE 28 PROBE OPENING ON THE NORTH ELEVATION

Precast post-tensioned panels made up the elevations of the tower located at four corners as shown in Figure 25. The post-tensioning rod was identified through a probe opening that was completed by Golf Construction during the Field Work as shown in Figure 28 and Figure 29. The SPR was not able to clearly detect the location of the post-tension rod due to the presence of the reinforcement in front.

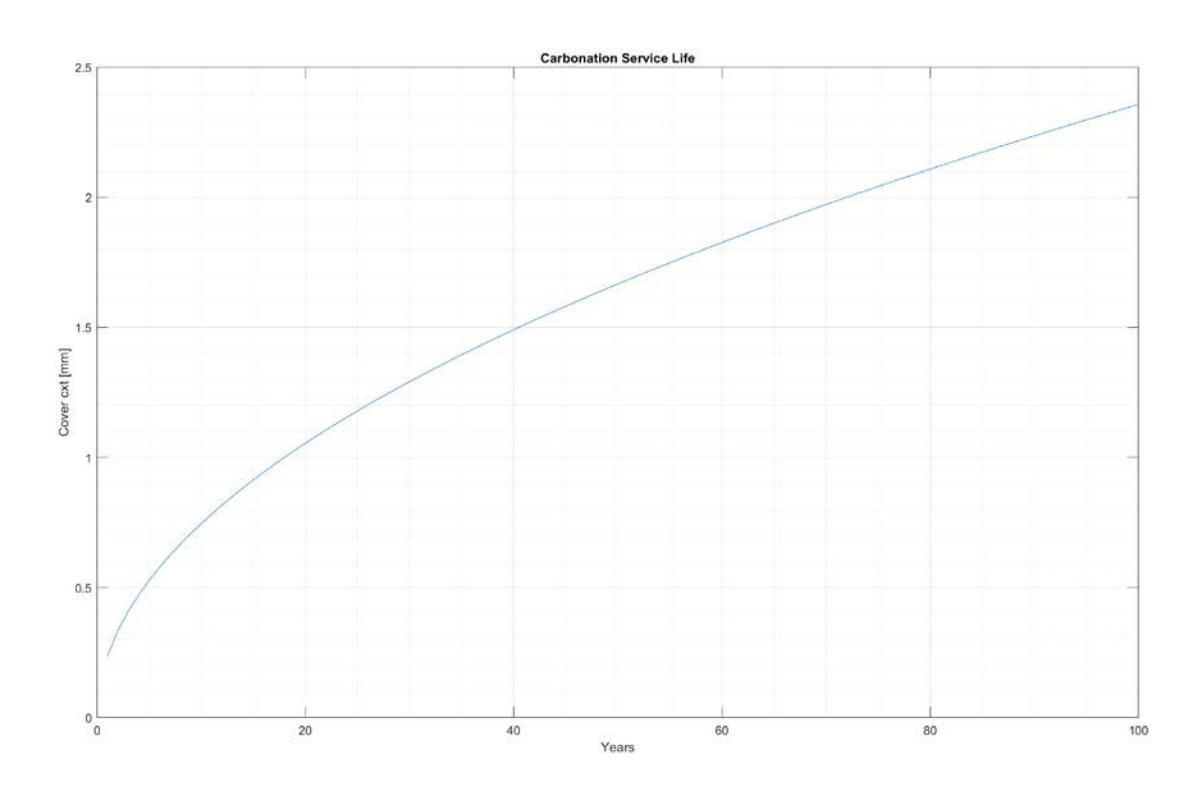
FIGURE 38 SERVICE LIFE CARBONATION PENETRATION

The above model shows that only a minimal carbonation front in the concrete is expected in the next 100 years, primarily due to concrete quality and moisture levels that currently exist. It should be noted that this is not uncommon on this type of exposed structure, however this model becomes invalid when cracks exist where carbon dioxide can migrate into the concrete effortlessly to the depth of the reinforcing steel.

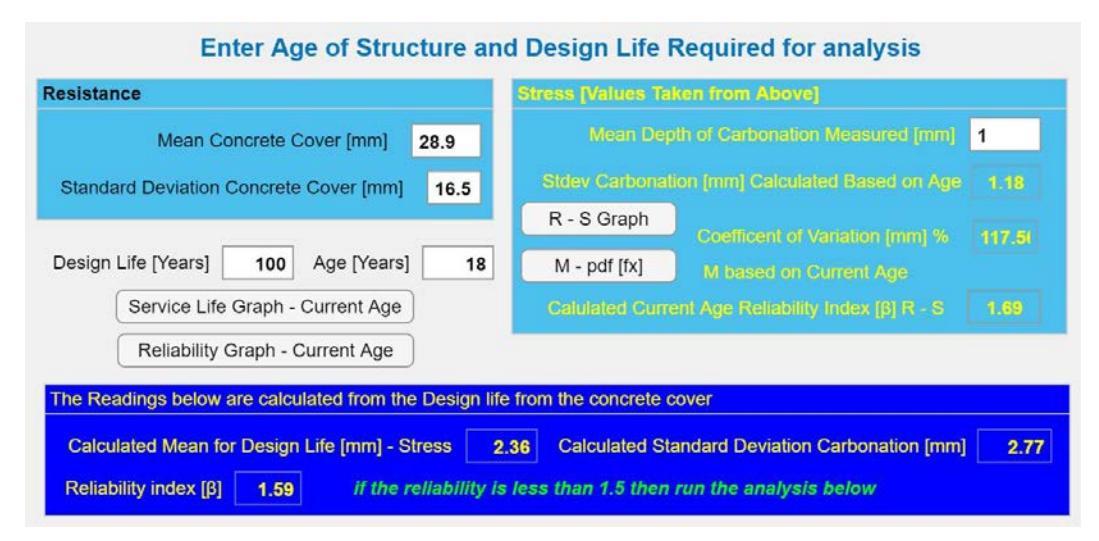
Figure 44 Service Life Reliability $[\beta]$ Prediction for 100 Year Design Life Carbonation Cast in Place

The above models clearly show slow migration of carbonation over time and shows that ultimately the structure will not be compromised with carbonation in 100 Years based on a reliability index of 1.56 for the cast in place and 1.66 for the precast.

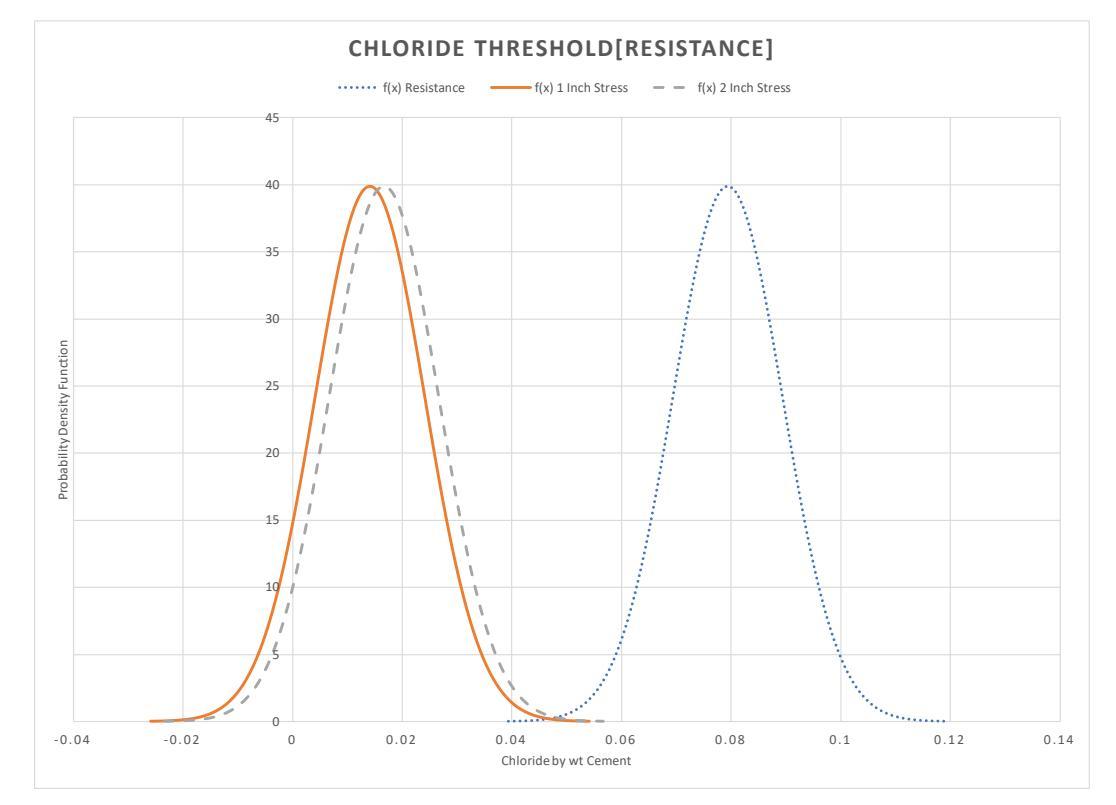
FIGURE 49 RESISTANCE VERSUS STRESS SOUTH BEAM CHLORIDES

Qcr	34.57	Service Life Calculation
q1	0.26579432	
q2	2.507184893	
q3	1.089405389	
q	0.611705717	
ti	56.52	Years

The above models clearly show the affects on low cover concrete seen in the cast in place beams as the theoretical ACI model shows a time period of 56 Years compared to that of the precast of over 100 years. These models are built on environmental condition and concrete properties.

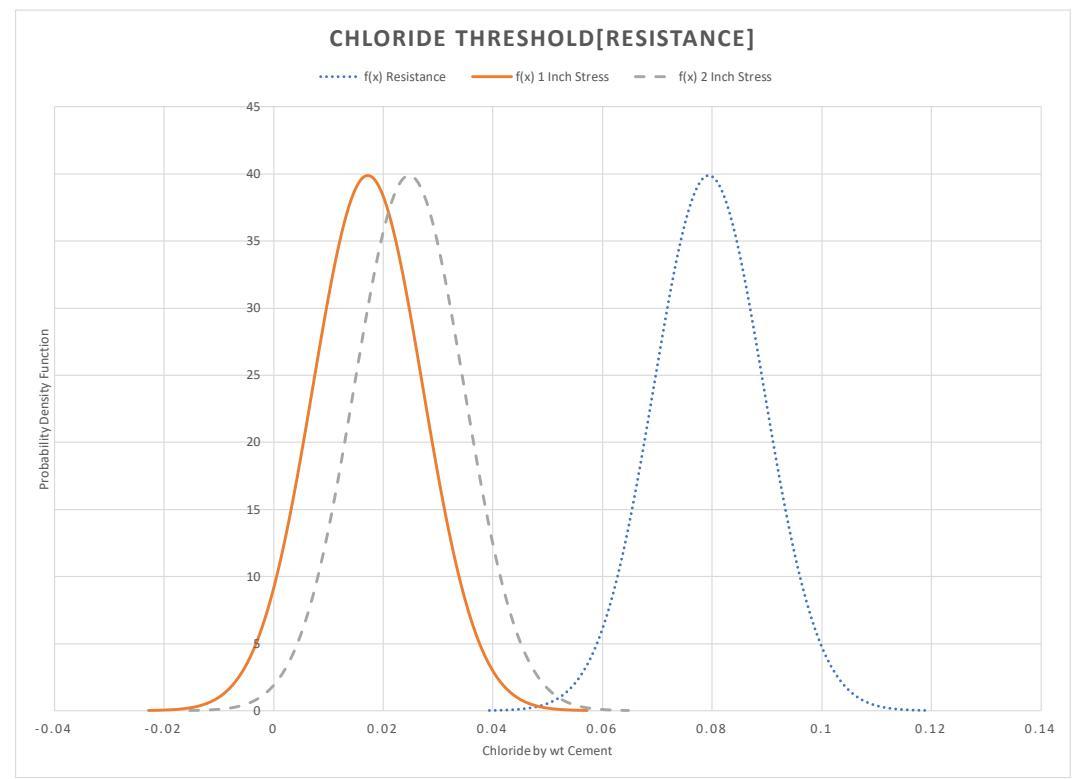
FIGURE 50 RESISTANCE VERSUS STRESS PRECAST PANEL CHLORIDES

Qcr	81.83	Service Life Calculation
q1	0.02841027	nel joj
q2	2.867508195	
q3	1.345719348	
q	0.060537646	
ti	>100	Years

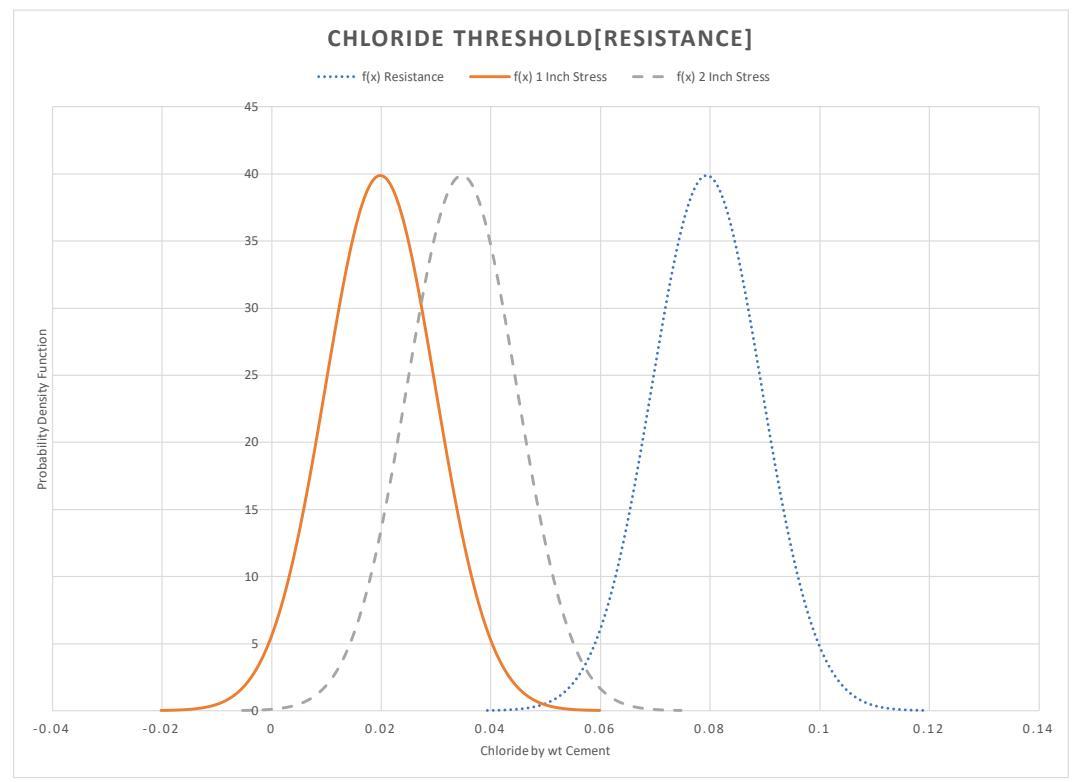
FIGURE 51 RESISTANCE VERSUS STRESS PRECAST FINS CHLORIDES

Qcr	60.81	Service Life Calculation
q1	0.06961803	ACI 305
q2	3.317912323	
q3	1.666111797	
q	0.138638067	
ti	>100	Years

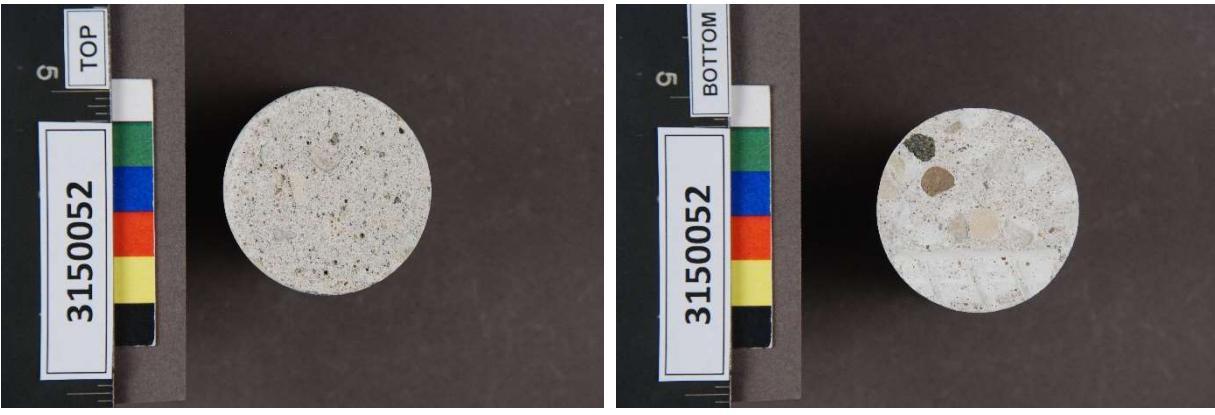
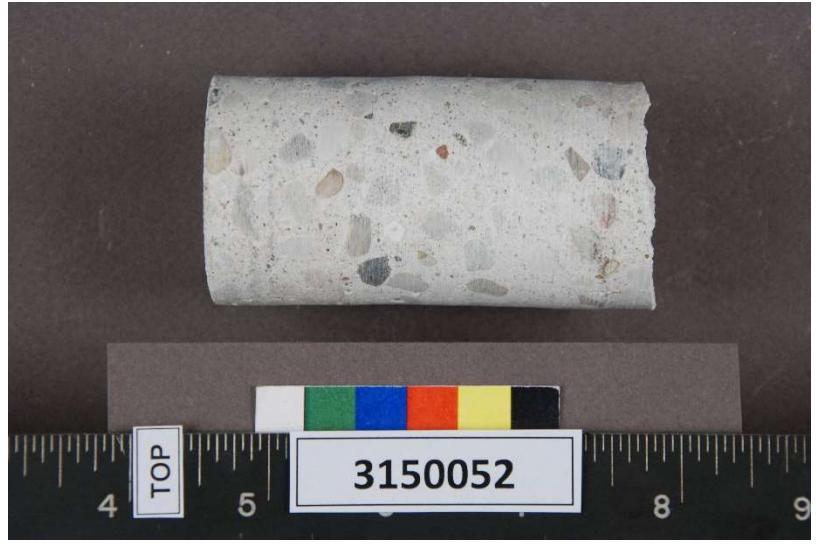
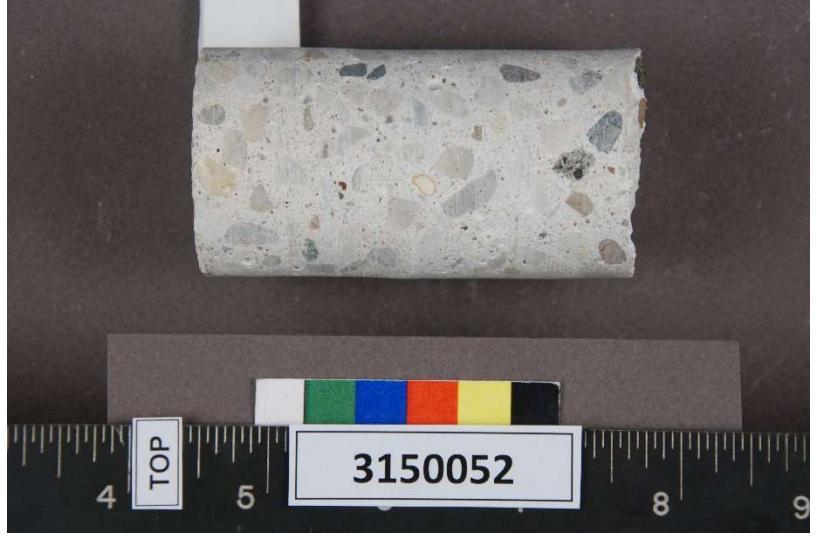
The pre-cast concrete was comprised of well hydrated Portland cement with natural gravel dolomitic limestone and natural siliceous and calcareous sand. The cores were generally in good condition. The Fin sample showed some light scaling and the Panel exhibited entrapped water channels at the paste aggregate interface. The samples did not appear to be adequately air entrained for freeze thaw resistance although no evidence of freeze thaw damage was observed.

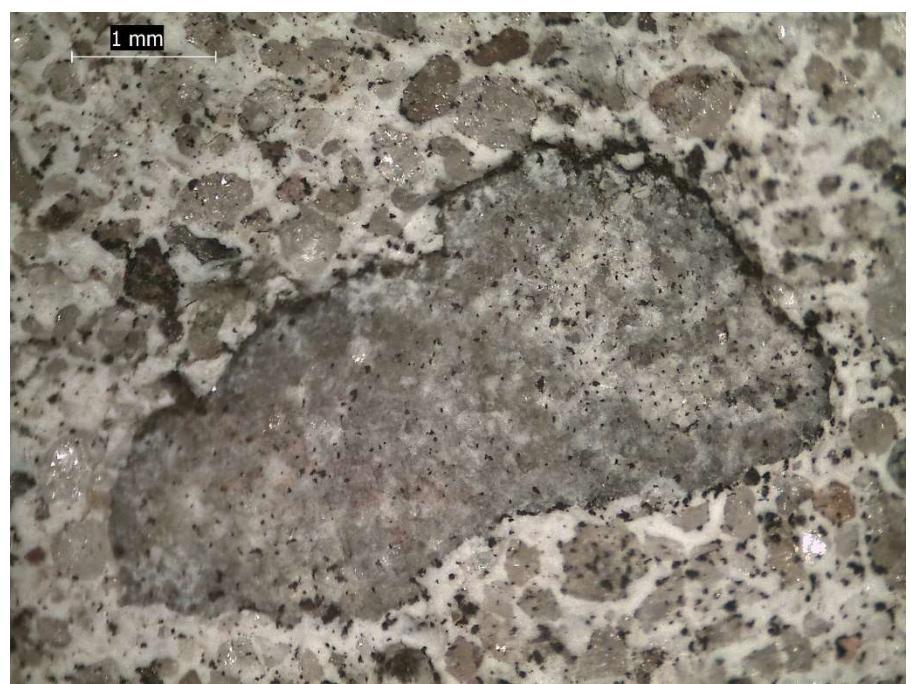
Figure 2. Fin (3150052). Stereo-optical micrograph showing exposed coarse and fine aggregates on the surface.

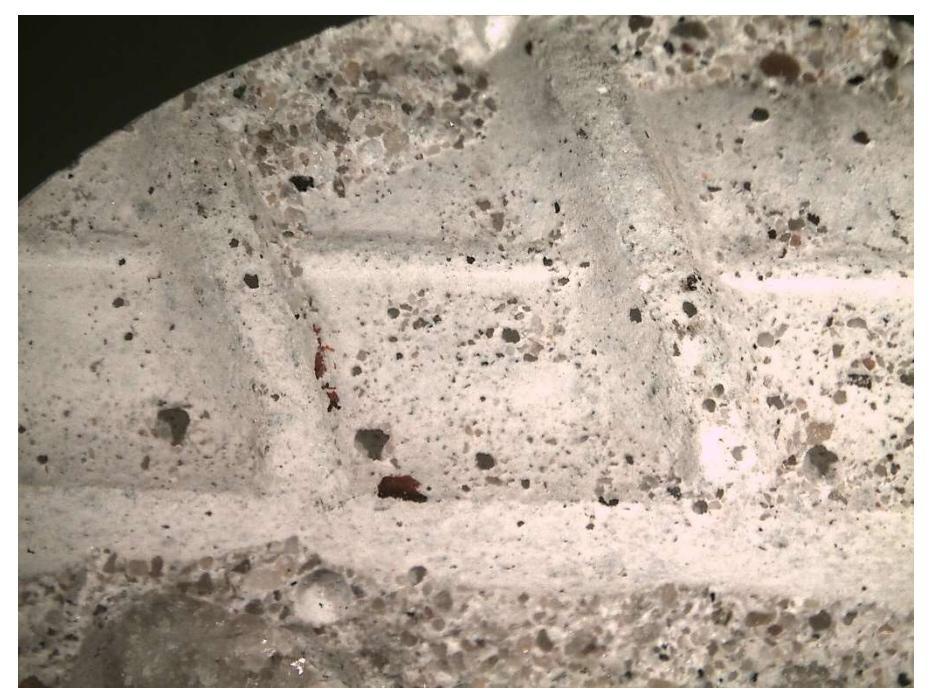
Figure 3. Fin (3150052). Stereo-optical micrograph showing the impression of the steel bar on the bottom of the core.

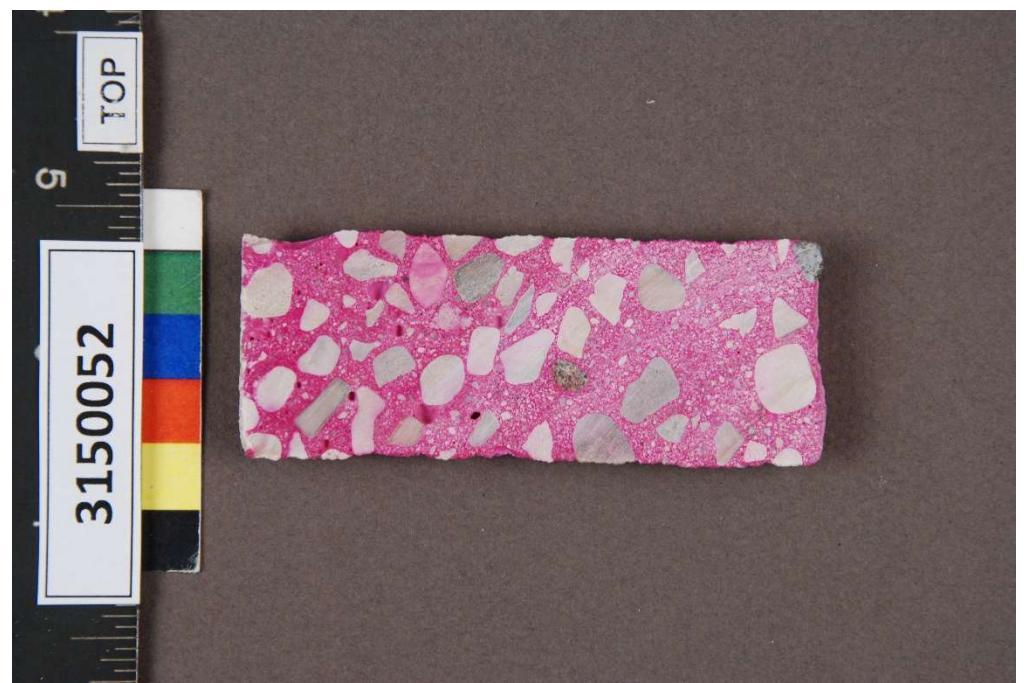
Figure 4. Fin (3150052). Photograph of freshly cut surface with phenolphthalein indicator applied.

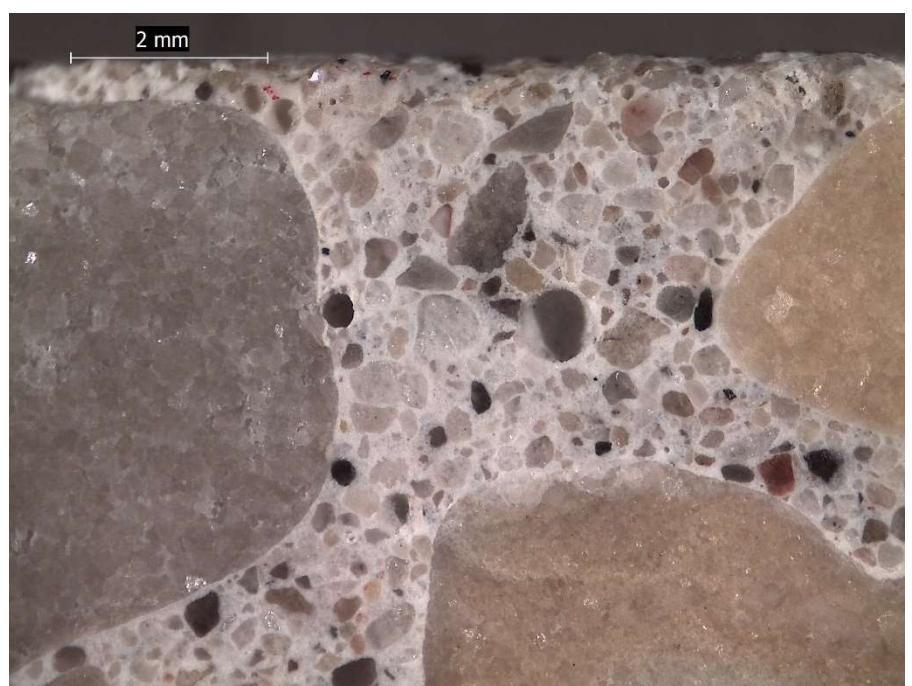
Figure 6. Fin (3150052). Stereo-optical micrograph showing exposed coarse and fine aggregates on the surface.

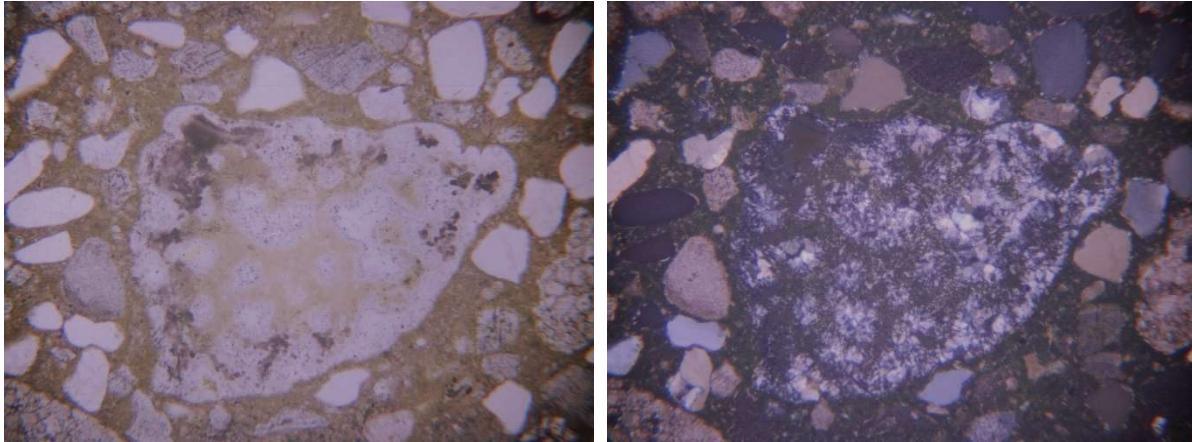
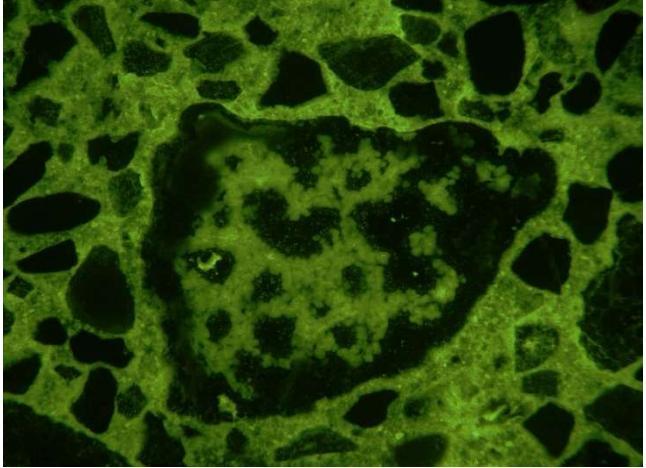
Figure 8. Fin (3150052). Optical micro-graph in different light modes showing a fine aggregate that is reactive rim, but no cracking in the aggregate or into the paste. Field of view 2.6 mm wide.

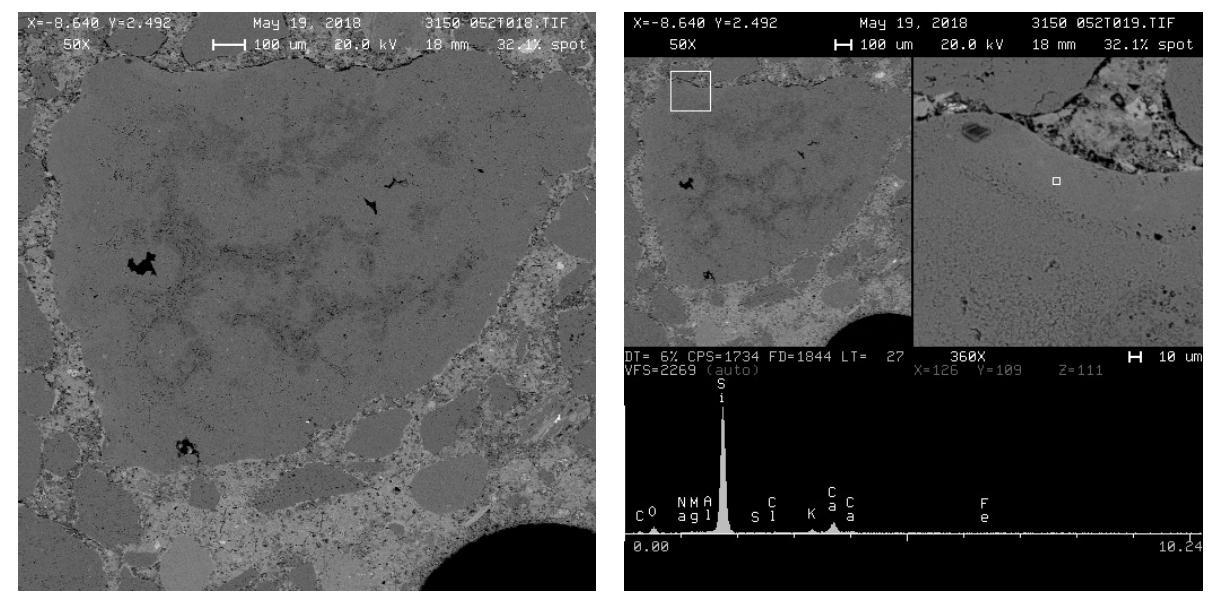
Figure 9. Fin (3150052). Backscattered electron (BSE) images with EDS spectrum showing the reactive rim on the fine aggregate and the ASR gel with traces of calcium and alkali (K).

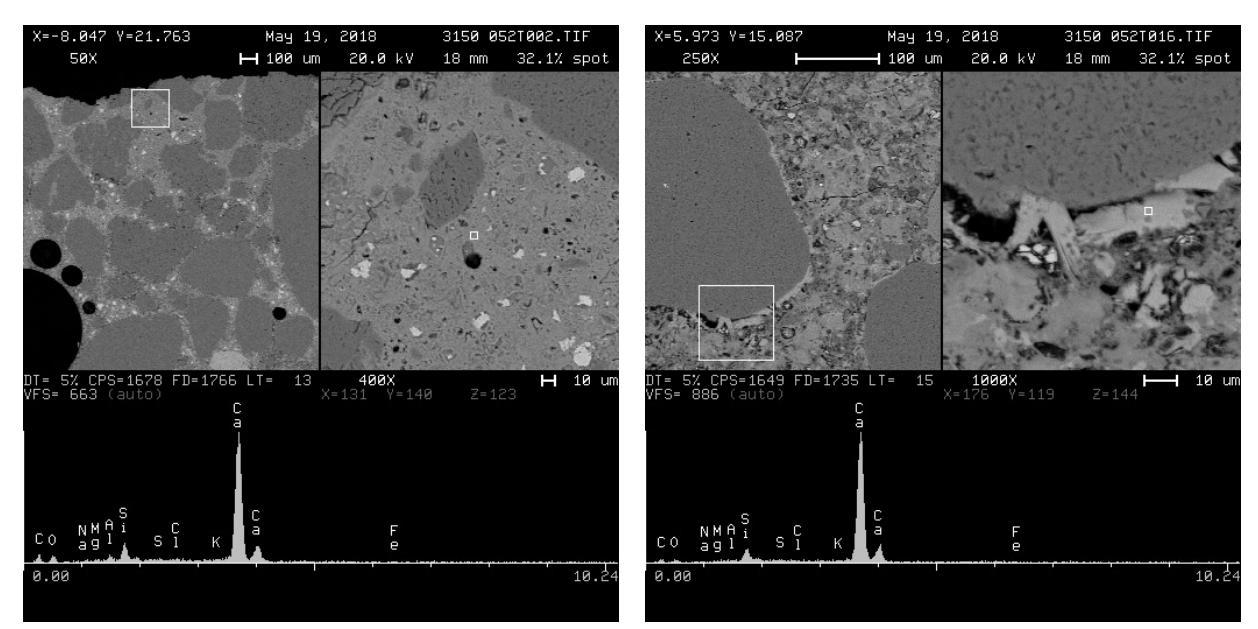
Figure 10. Fin (3150052). BSE images with EDS spectrum of carbonated paste.

Figure 11. Fin (3150052). BSE images with EDS spectrum of calcium hydroxide along the paste/aggregate interface.

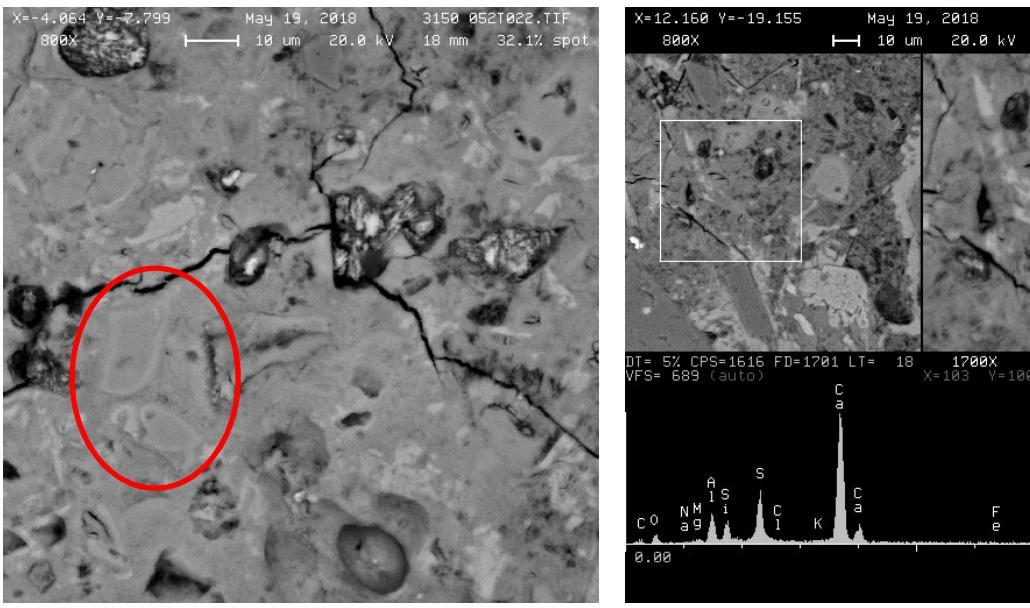
Figure 12. Fin (3150052). BSE image showing two toned rims of hydrated Portland cement grains.

Figure 13. Fin (3150052). BSE images with EDS spectrum of ettringite in the porous paste.

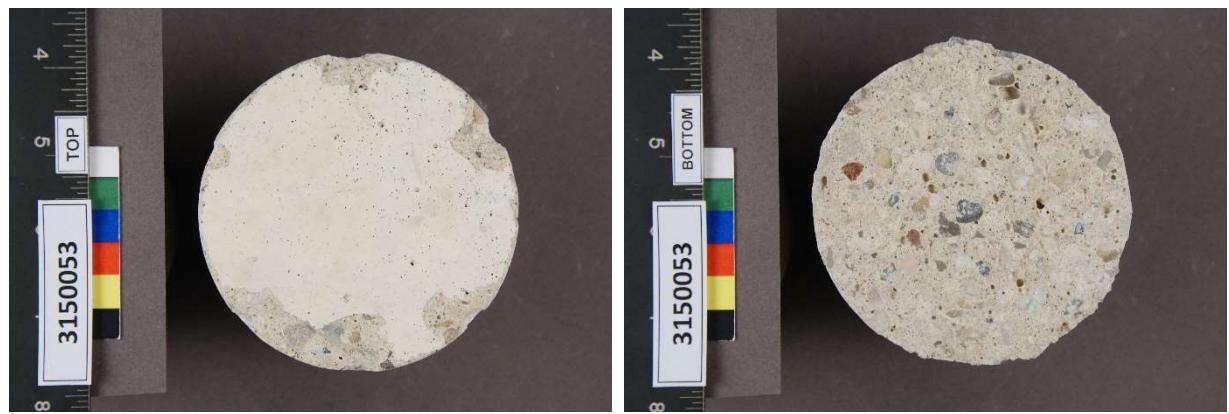
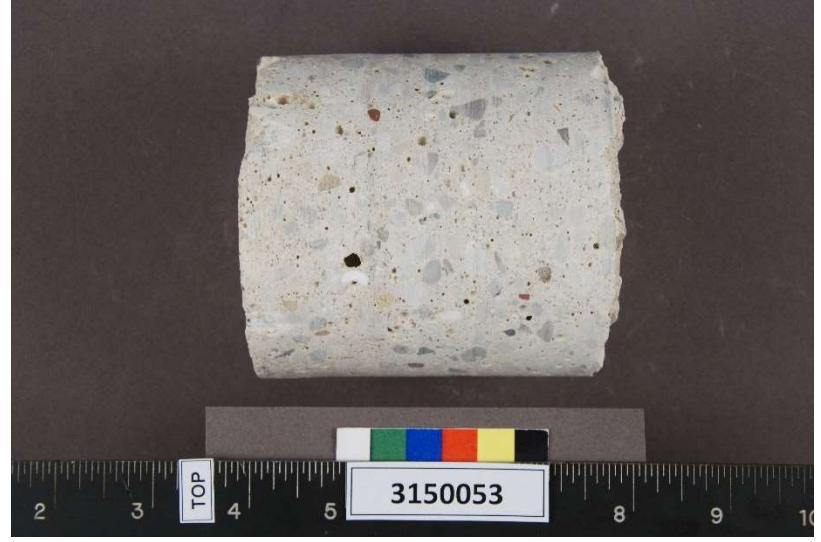
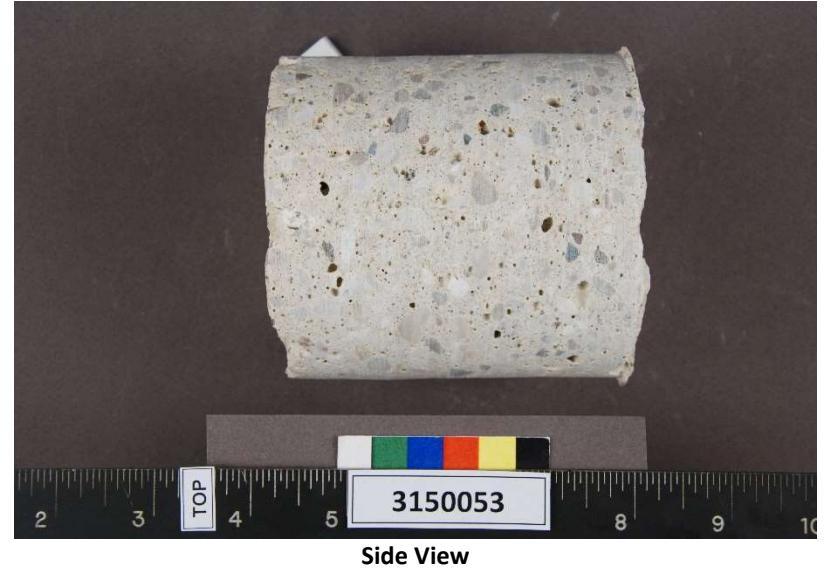
- The top surface was a smooth cast surface with small air voids. Trace amount of map microcracking was present on the painted surface, but did not extend into the concrete.
- The bottom was snapped through and around aggregates.
- Minor amount of very fine water channels or gaps along paste aggregate interface in top 1/8".
- Variable porosity and abundant calcium hydroxide in the paste.
- The cement grains appear to have two-toned relic structure indicative of the potential for high temperatures during curing which could lead to delayed ettringite formation (DEF). No evidence of DEF or any appreciable amount of secondary ettringite was detected.

Figure 14. Pre-Cast Panel (3150053). Photographs of core in as-received condition.

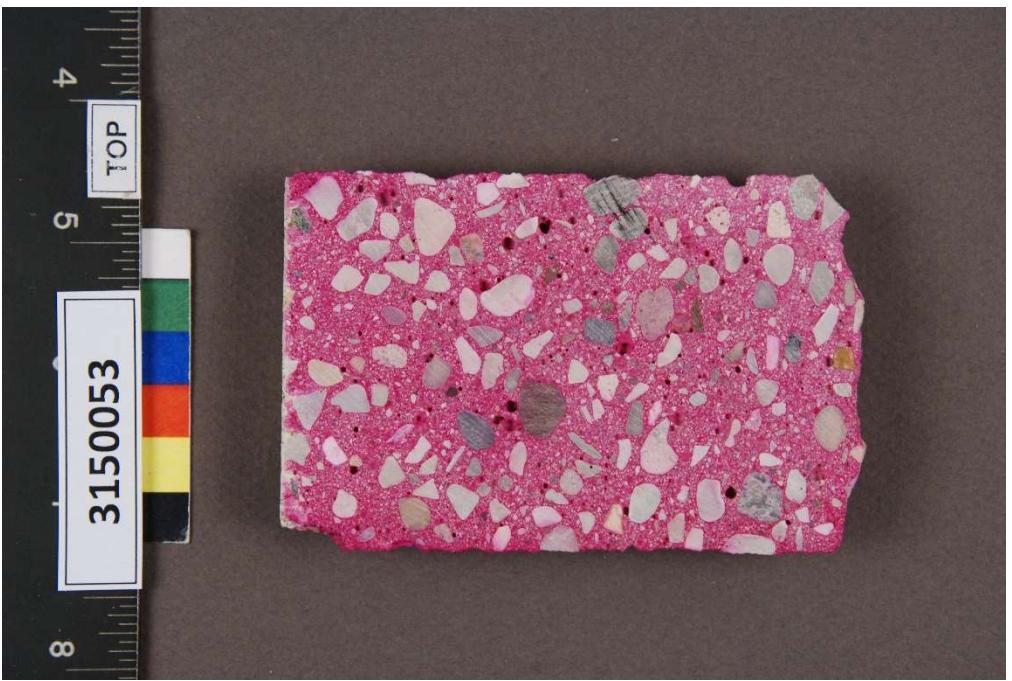
Figure 16. Pre-Cast Panel (3150053). Photograph of freshly cut surface with phenolphthalein indicator applied.

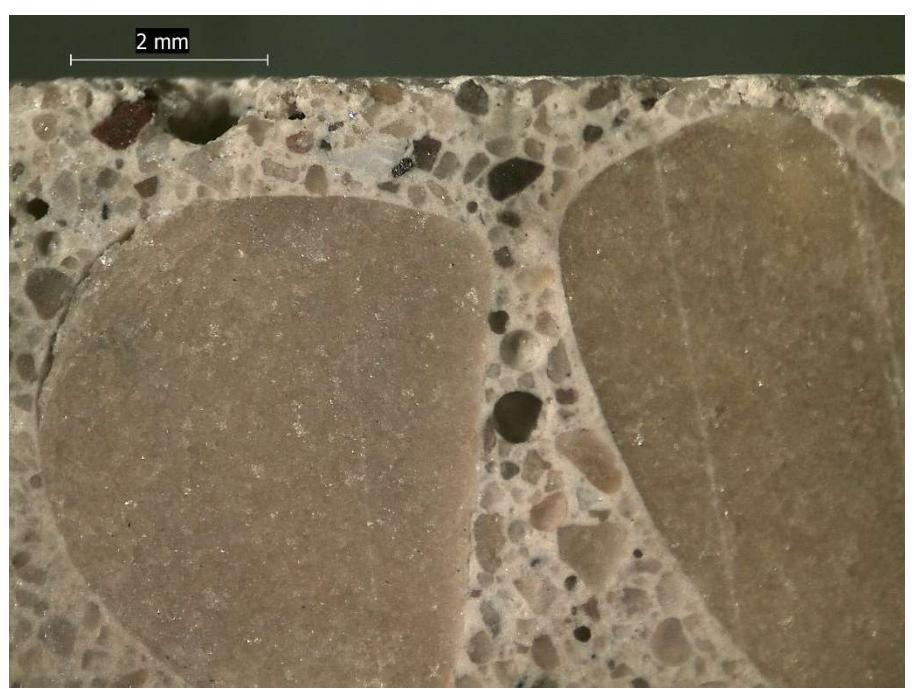
Figure 18. Pre-Cast Panel (3150053). Stereo-optical micrograph of the polished cross sectioned slab showing the top surface.

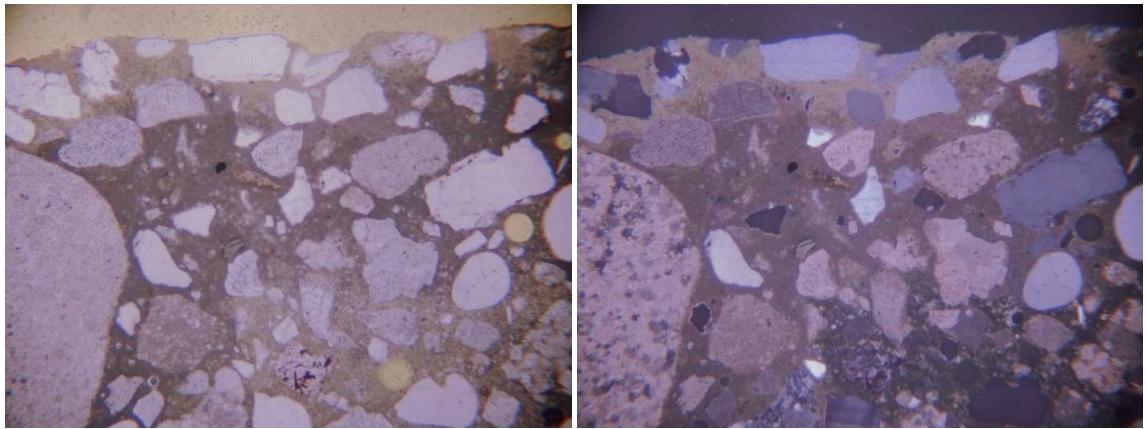
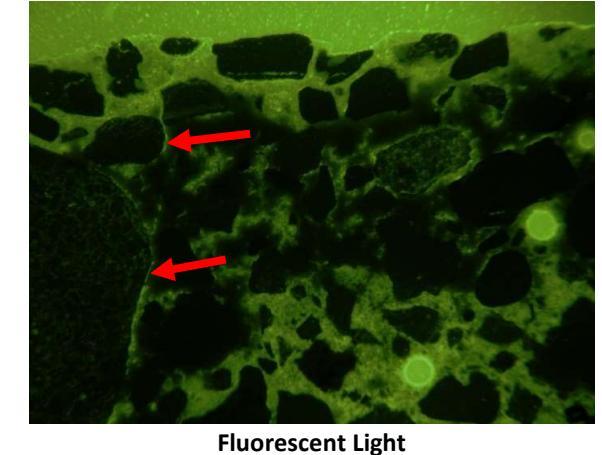
Figure 20. Pre-Cast Panel (3150053). Optical micro-graph in different light modes showing carbonated paste and a water channel along aggregate (highlighted by red arrows). Field of view 2.6 mm wide.

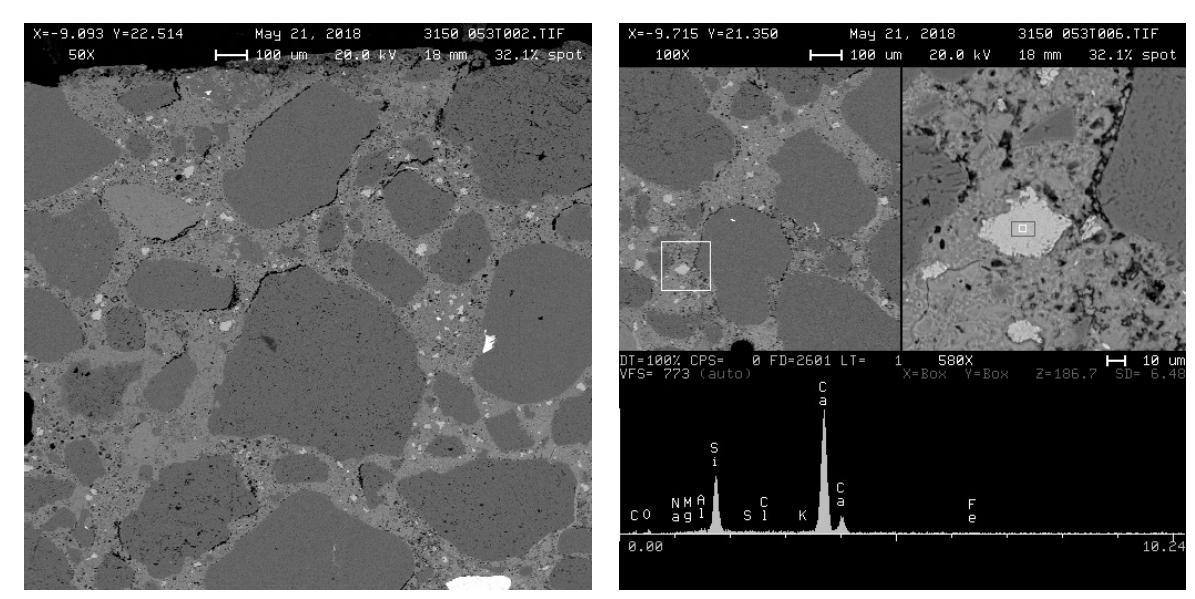
Figure 21. Pre-Cast Panel (3150053). BSE image of water channels or gaps along aggregate in the top $\frac{1}{8}$ ".

Figure 22. Pre-Cast Panel (3150053). BSE images with EDS spectrum of partially hydrated cement grain.

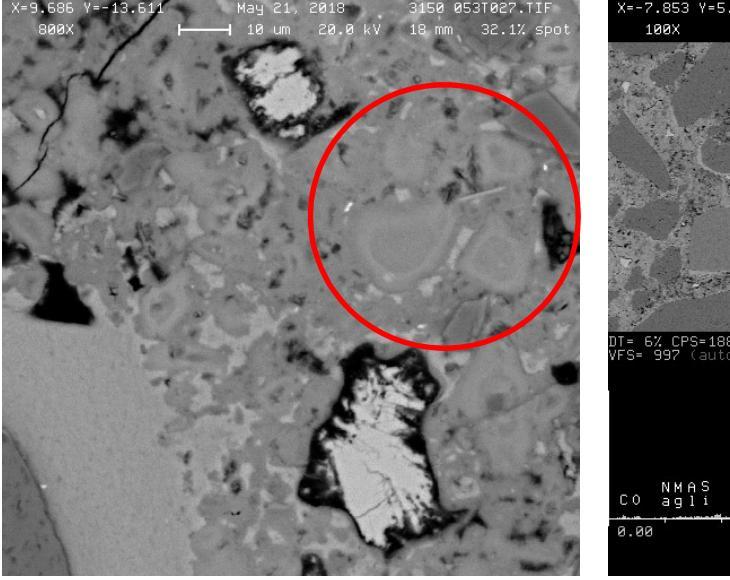
Figure 23. Pre-Cast Panel (3150053). BSE image showing two toned rims of hydrated Portland cement grains.

Figure 24. Pre-Cast Panel (3150053). BSE images with EDS spectrum of calcium hydroxide along the paste/aggregate interface.

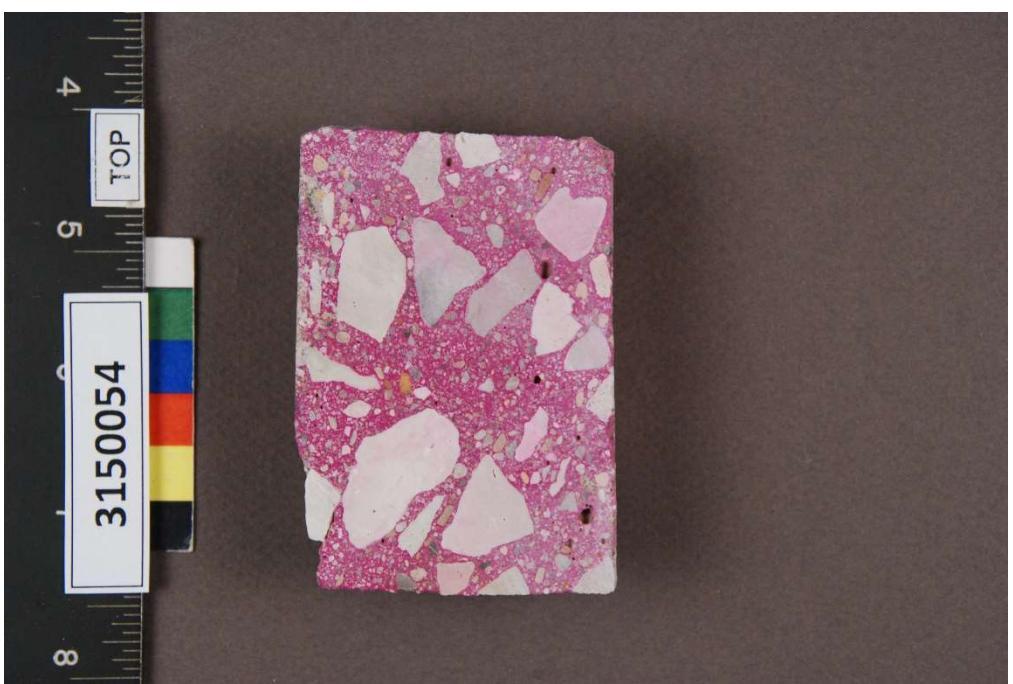
Figure 26. Column (3150054). Photograph of freshly cut surface with phenolphthalein indicator applied.

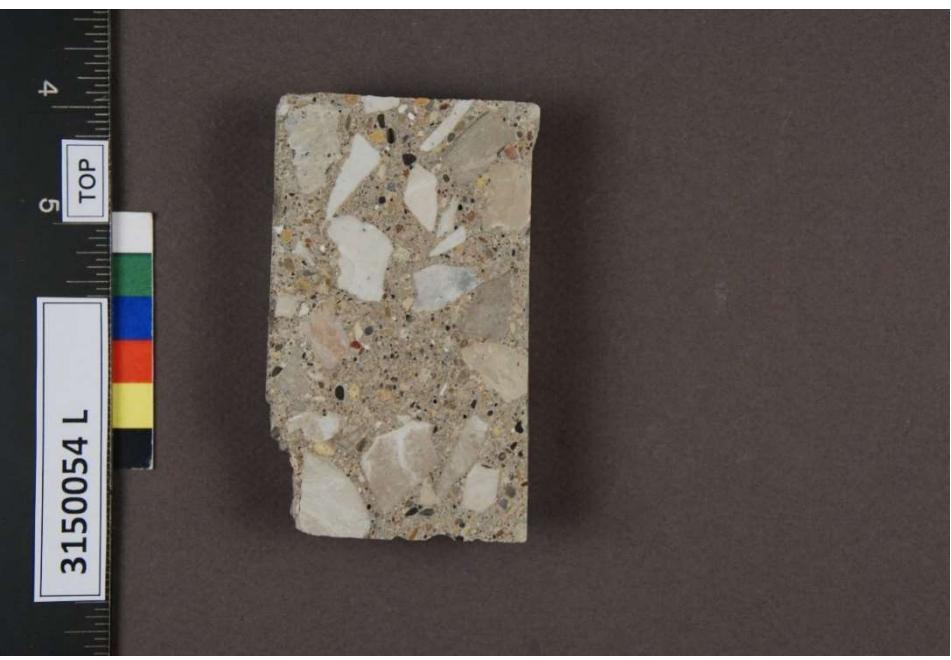
Figure 27. Column (3150054). Stereo-optical micrograph of the core side showing microcracks up to $^{13}/_{16}$ " deep.
