DOCUMENT REFERENCE RE-E17258-IM-REV 1.0

MOSER TOWER

CORROSION AND MATERIAL DURABILITY ANALYSIS

ECHEM CONSULTANTS LLC 4 JEFFERSON PLAZA SUITE 500 POUGHKEEPSIE, NY 12601

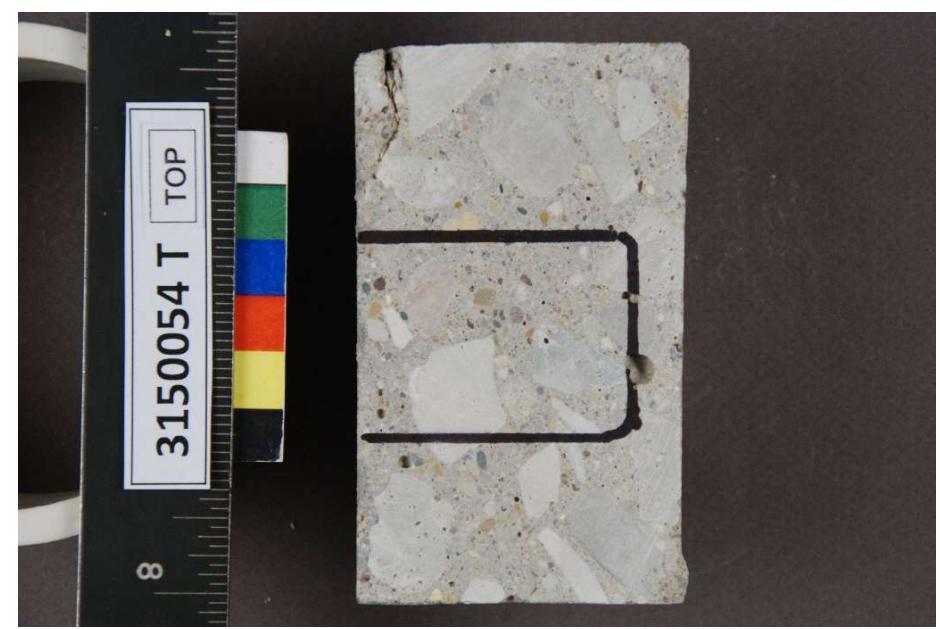
Figure 29. Column (3150054). Stereo-optical micrograph of the polished slab showing perpedicular microcracks consistent with drying shrinkage up to 3/16" deep.

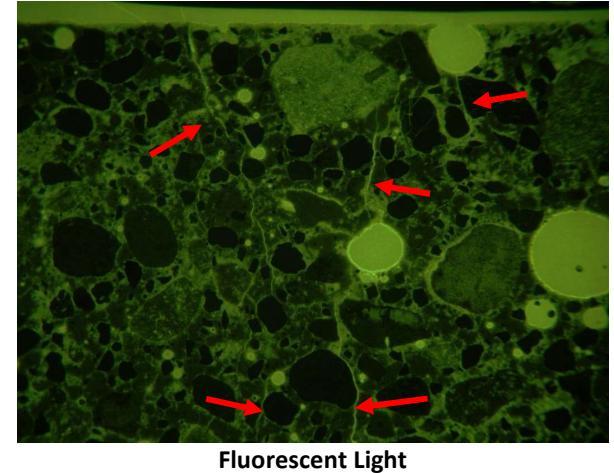
Figure 31. Column (3150054). Optical micro-graphs in different light modes showing drying shrinkage micro cracks (highlighted by arrows) from the surface. Field of view 10.0 mm wide.

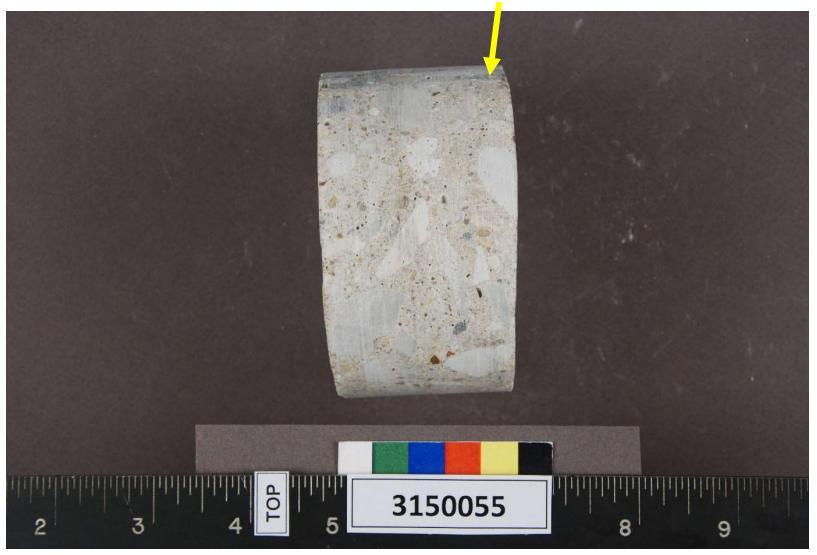
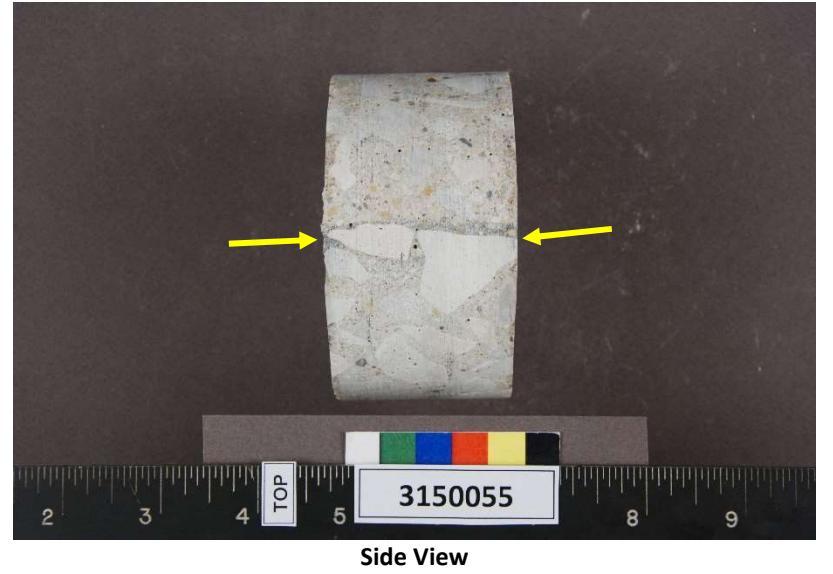
Figure 36. Entrance Wall (3150055). Photographs of core in as-received condition. A band of blue-gray paste (indicated by arrows) bisects the core.

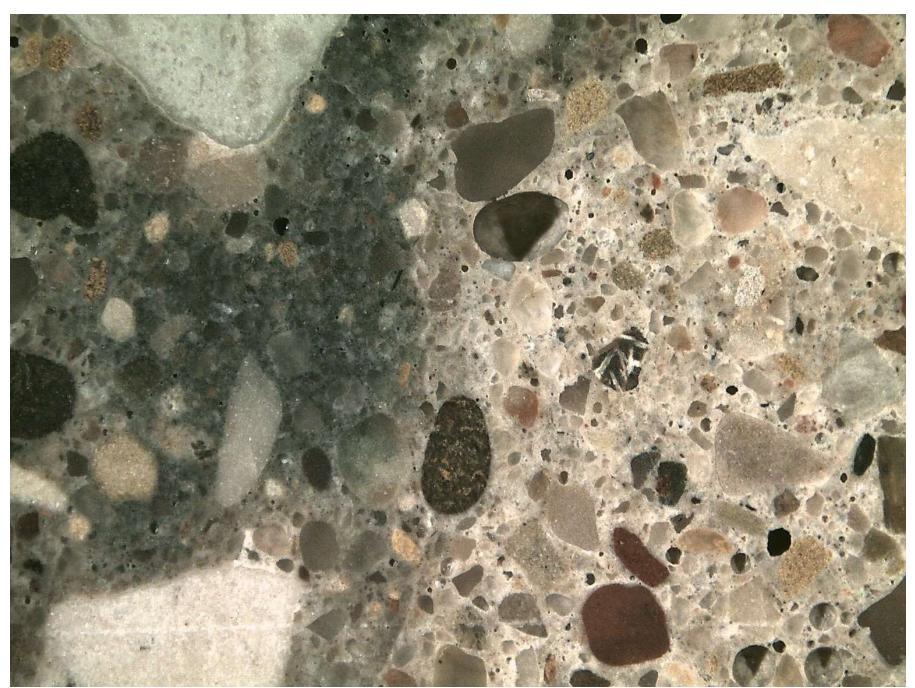
Figure 39. Entrance Wall (3150055). Stereo-optical micrograph showing the interface between concrete pours.

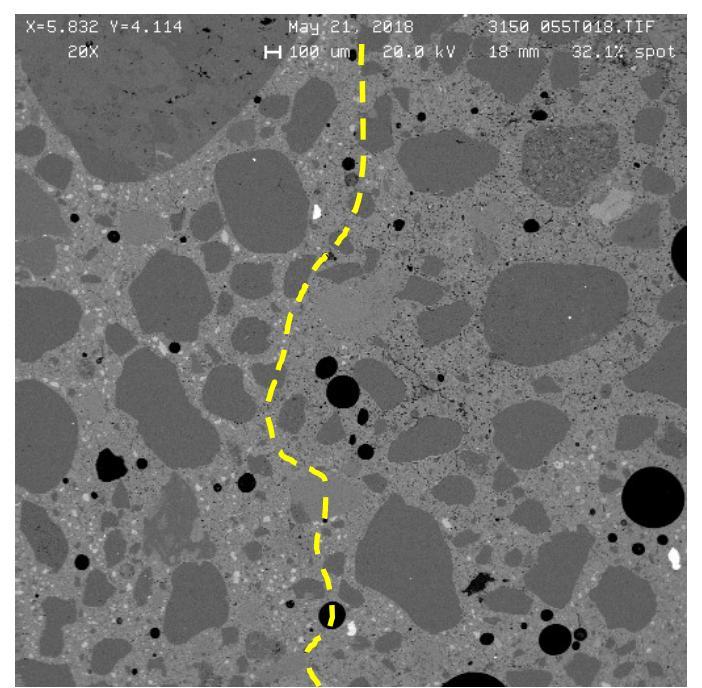
Figure 41. Entrance Wall (3150055). BSE image of the interface between the concrete pours.

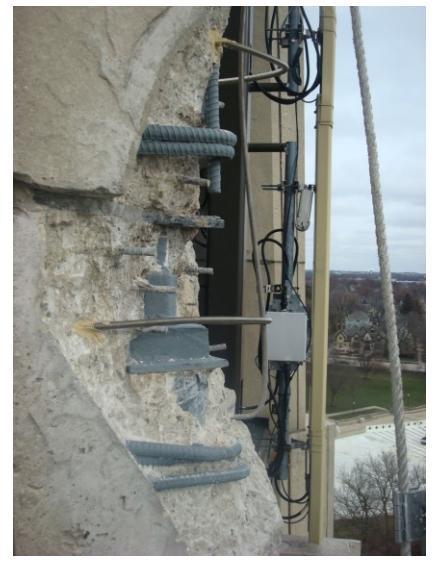
Based on the architectural survey of the pattern of deterioration at this specific elevation, it is our opinion that the concrete failure is primarily of a structural nature to be addressed by ERA. The repairs should address structural issues in conjunction with the durability and aesthetic considerations. We noted that the post tensioned dead-end assembly does not match the shop drawings which may have a bearing on the failure. Additionally, the reinforcing configuration and quantity around the PT dead-end should be reviewed for common practice standards.

Failed patch with post-tension dead end with anchor stressing assembly. Note new stainless-steel patch reinforcing.

Any patches whether they are load bearing or not, must match the host material in color, texture and form as determined through test mock-ups and color sample development. Tertiary issues include proximity of the PT

dead-end to the surface of the concrete. Expansion and contraction of the embedded steel should be addressed during patching. All patch material should be colored and textured to match the color of the cleaned parent material. The areas to be patched should be sawcut at right angles with the appropriate depth and surface texture for the required bond.

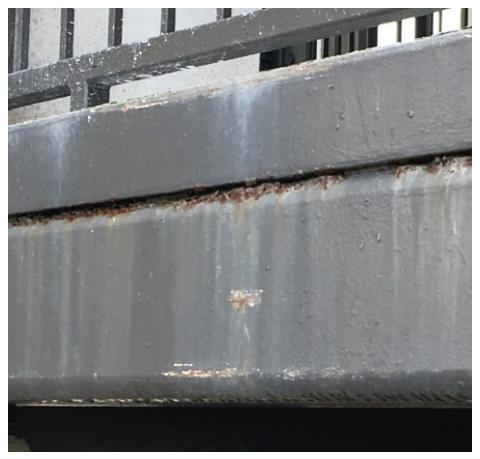
The typical corrosion buildup between ring beam and deck edge. Note vertical streaks from water runoff.

with the edge of the ring beam. The Observation deck edge angle and decking appear to be galvanized, consistent with its original design, but the lower decks are coated steel. Significant corrosion was observed between the rings and the deck angle (**Photos 77-78**). Based upon our observations the corrosion of the steel decking varies from severe to isolated areas of corrosion. The most severe corrosion of the decking was observed at the Belfry level where corrosion has led to 100% section loss of isolated areas of the corrugated decking and approximately 5% at some perimeter angles (**Photos 79-81**). This deck was intended to be the "roof" level with a skylight opening in the center and covering the elevator shaft. The surface of the concrete is uneven and rough at this level. The roofing and skylight were not installed which creates unintended and vulnerable deck edge

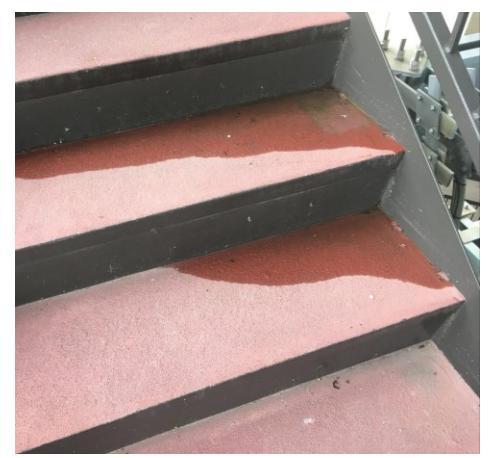
We observed widespread, minor surface corrosion of the stair treads, risers, landings and supporting clip angles **(Photos 87-89).** Without repair and a robust waterproofing of the treads, continued corrosion will require ongoing maintenance and could create hazardous conditions. The treads overlap the risers by about 1/2'' making direct contact. These

The typical corrosion buildup between ring beam and deck edge. Note vertical streaks

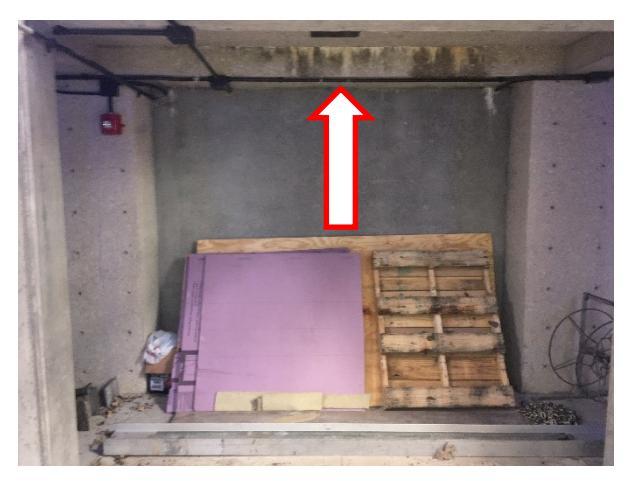
11. A close-up view of concrete cracks and water infiltration below front door.

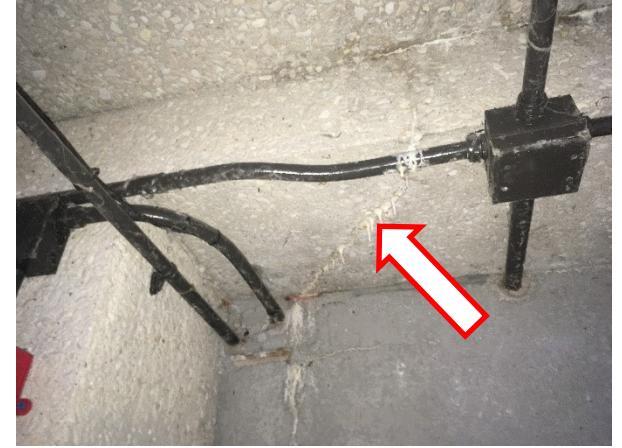
12. A close-up view of concrete cracks and water infiltration below front door.

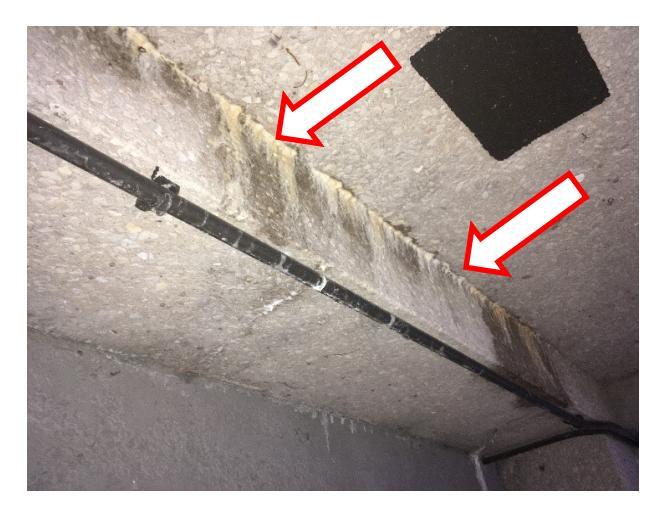
13. A close-up view of concrete cracks and water infiltration below front door.

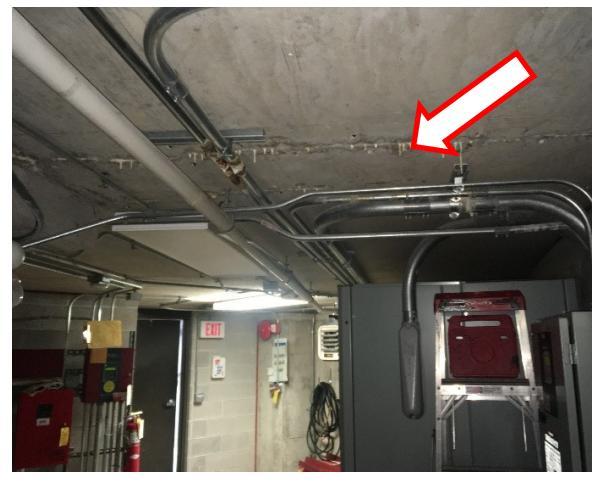
14. A view of concrete cracks and water infiltration in mechanical room below plaza.

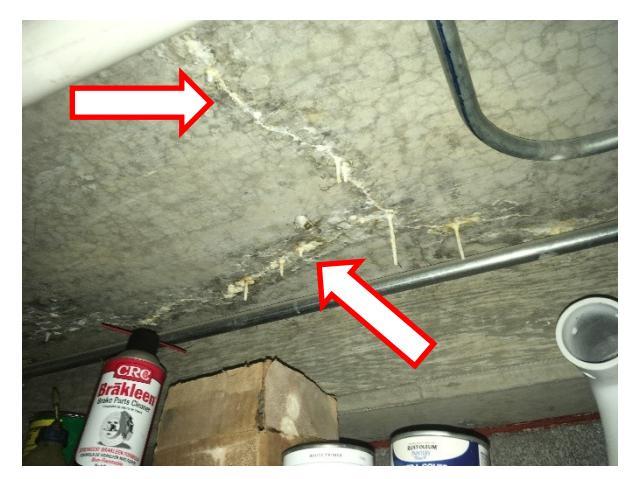
15. A view of concrete cracks and mineral leaching in mechanical room below plaza.

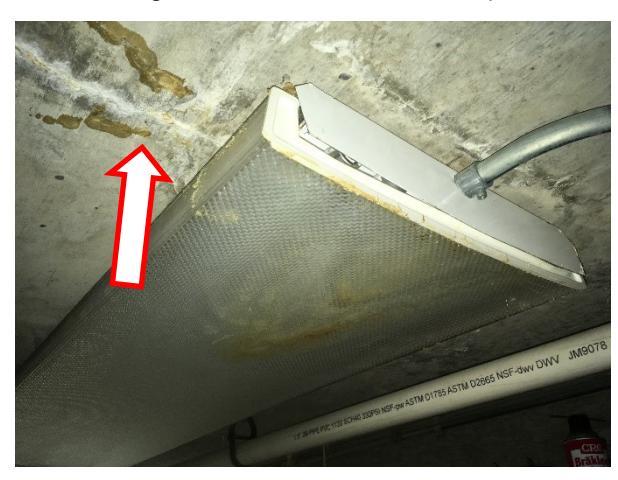
17. A view of concrete cracks and water infiltration in mechanical room below plaza.

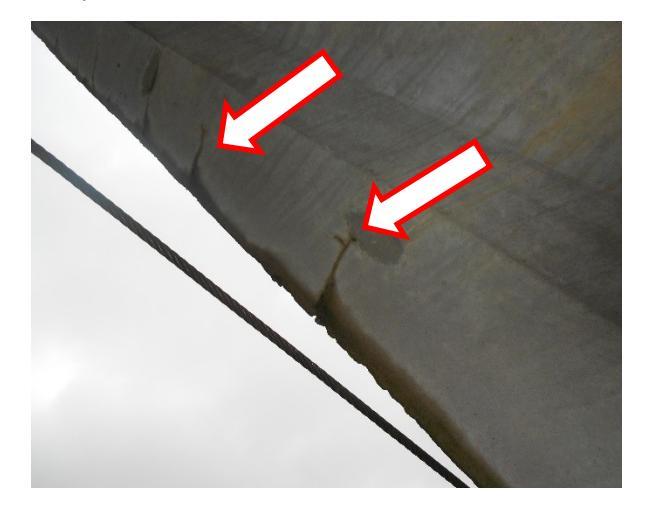
29. A close-up view of the knife edge of the roof panel with cracks and water saturation.

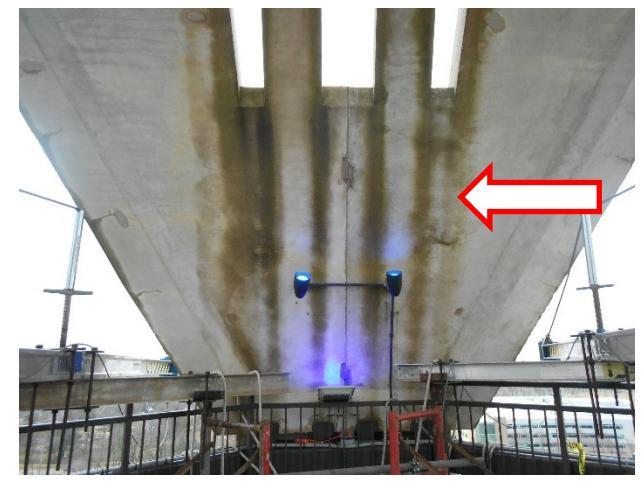
30. A view of the roof panel with knife edge both sides and water staining from runoff.

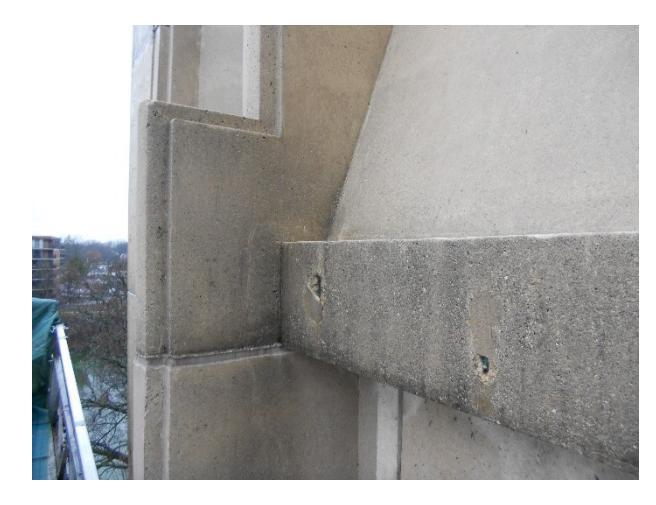
31. A close-up view of small rebar spalls

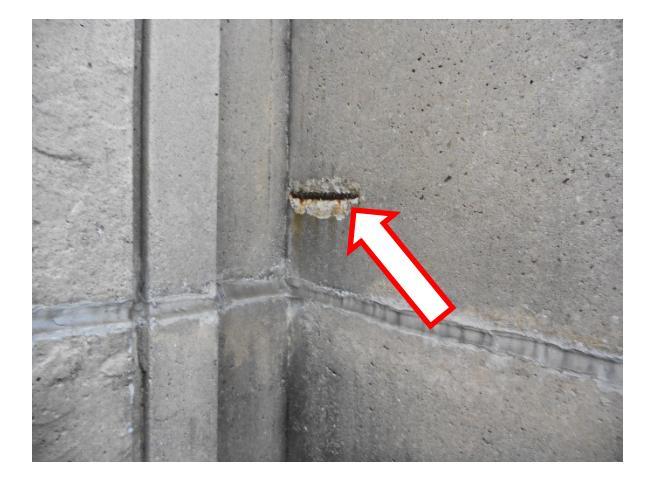
33. A close-up view of small rebar spalls

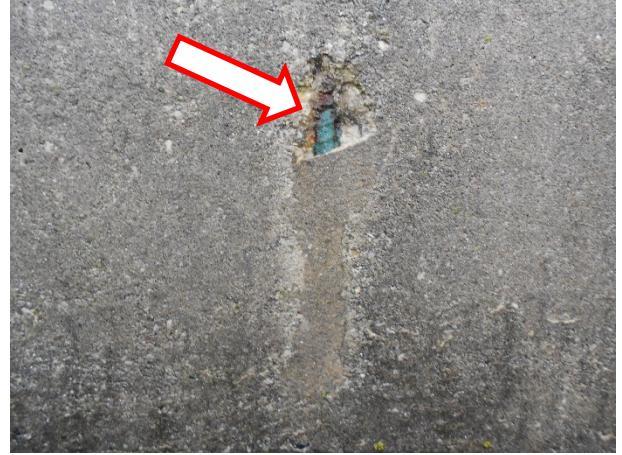
32. A close-up view of a small rebar spall. Note the previous patch.

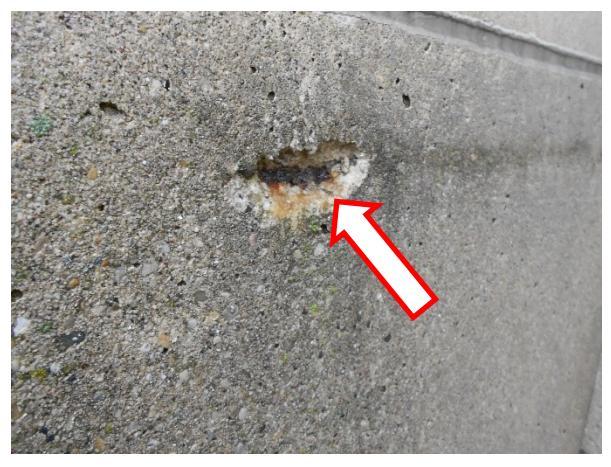
34. A close-up view of small rebar spalls

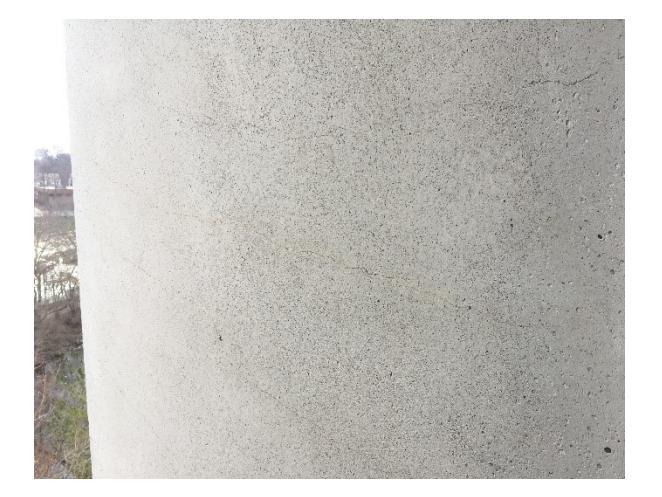
35. A close-up of a precast fin panel with several diagonal hairline cracks.

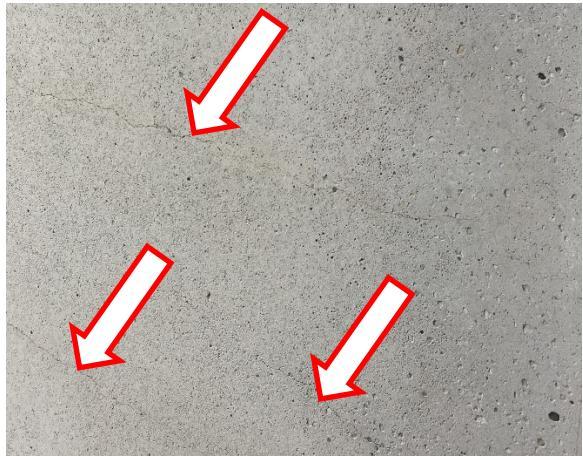
36. A close-up of precast fin panel with several diagonal hairline cracks

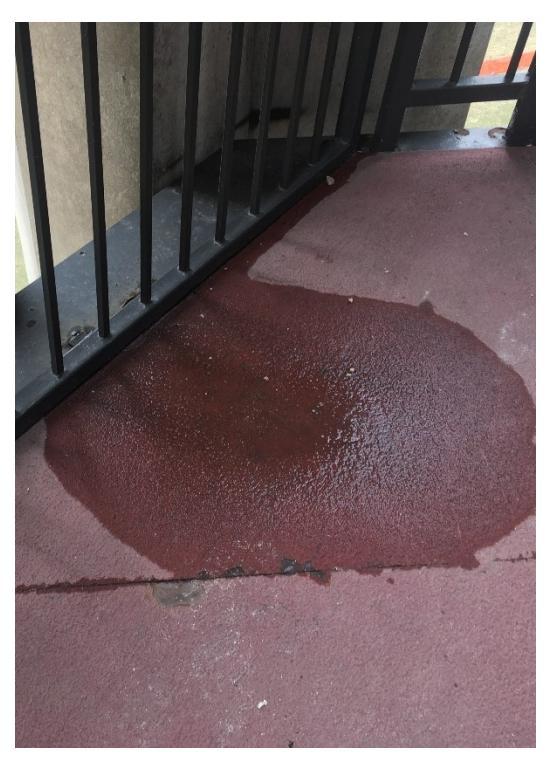
38. Standing water on stair landing.

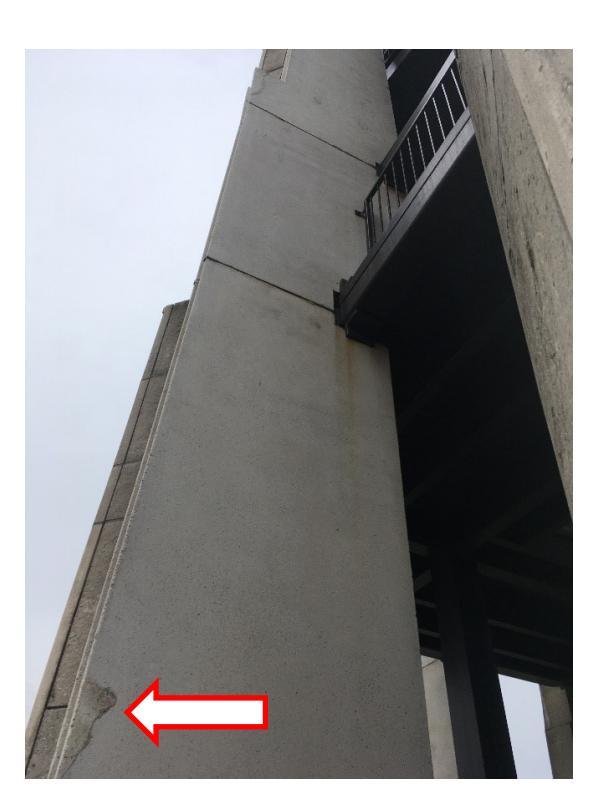
39. A view of a precast fin. Note patch at outer edge at left.

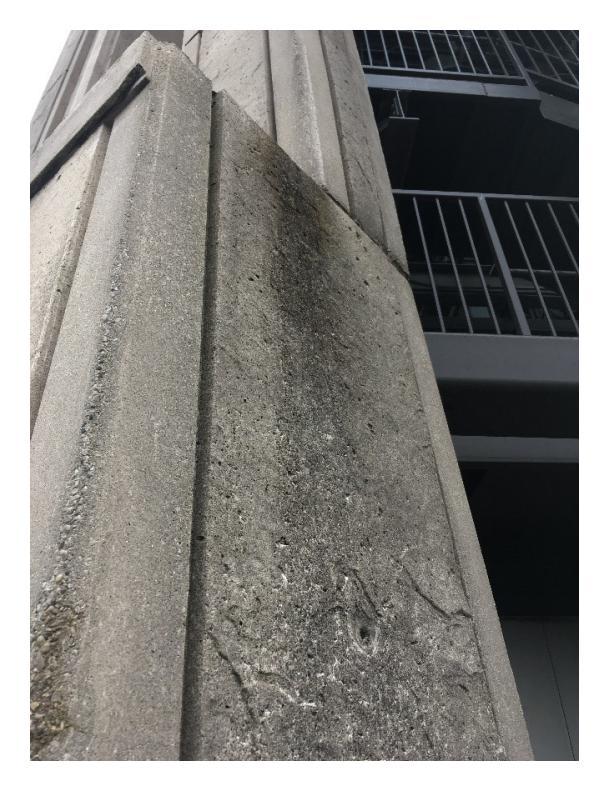
The concrete is discolored primarily with a biologic growth coincident to the high moisture content of the concrete. Naturally this is concentrated on the north sides of the concrete units which receive less solar driven evaporation. However, much of the interior is also discolored with the greenish dark brownish hues of biologic discoloration (**Photos 49-52**).

49. An example of surface discoloration from runoff.

The building is designed to be a sieve to the elements. So, it will naturally remain a moist and humid environment. A large-scale cleaning with biocide options is a consideration with a regular interval for future cleanings. The chemical composition of the biocide must be researched for its long-term impact both on the concrete as well as the natural environment beyond the tower.

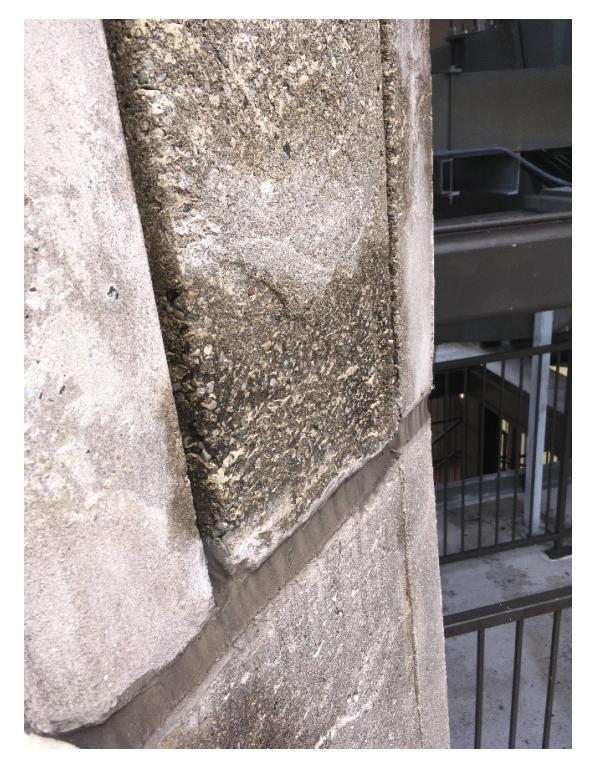
51. An example of surface discoloration from poor concrete consolidation.

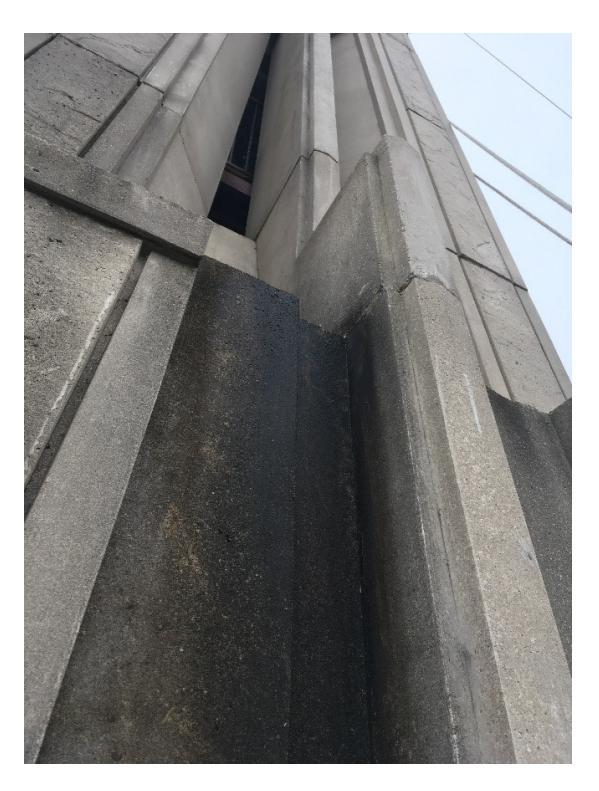
50. An example of surface discoloration from runoff.

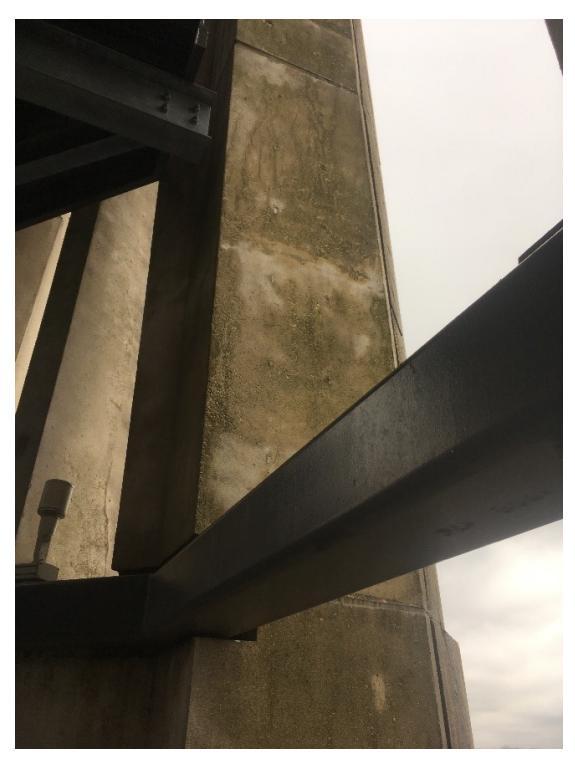
52. An example of surface discoloration from biological growth.

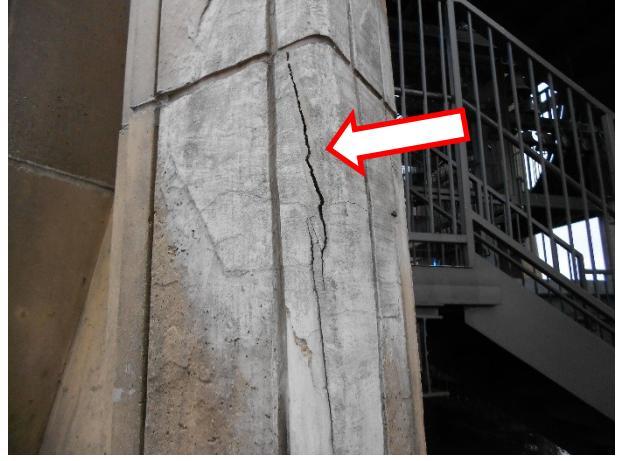
53. A close-up view of failed patch at El. 116'-8" prior to repatching. .

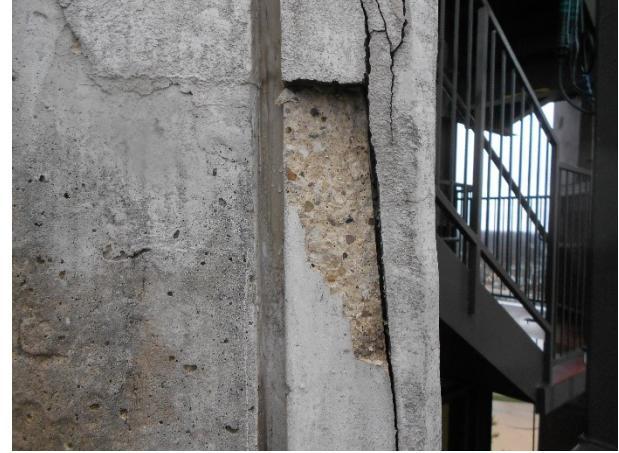
54. A close-up view of failed patch at El. 116'-8" prior to repatching.

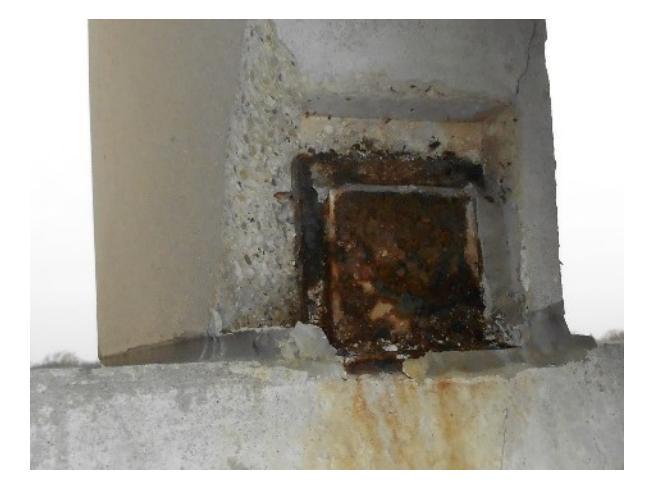
57. A close-up of failed embed patch at small precast fin in pier.

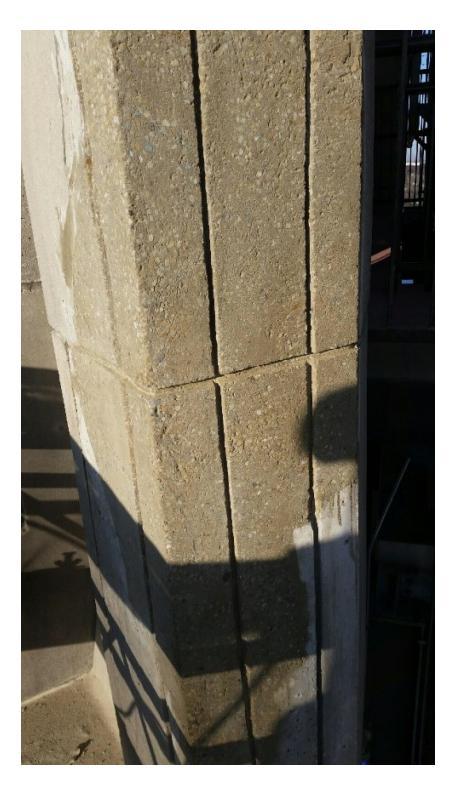
61. A view of the repaired patch on the SE pier made during the investigation. Photo by Golf Construction.

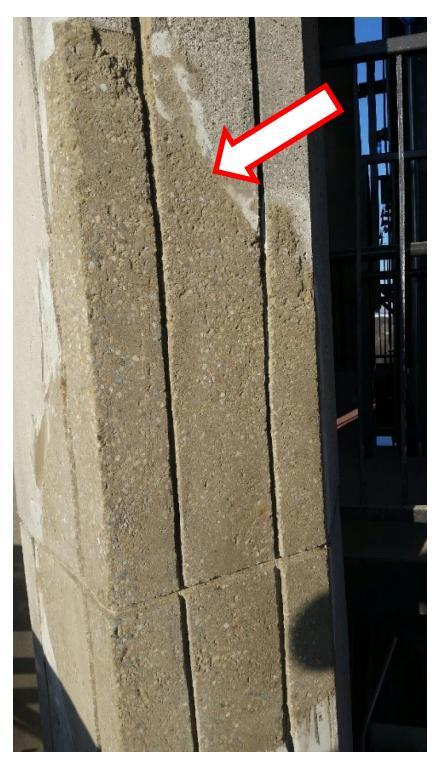
62. A view of the repaired patch on the SE pier made during the investigation. Photo by Golf Construction.

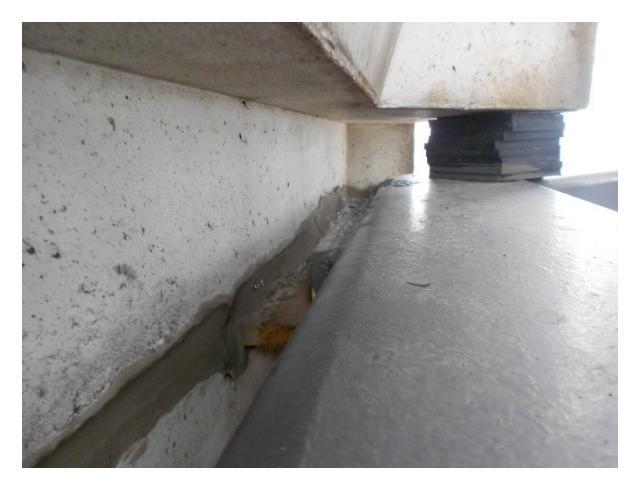
70. A close-up view of clip angle in precast concrete joint from above.

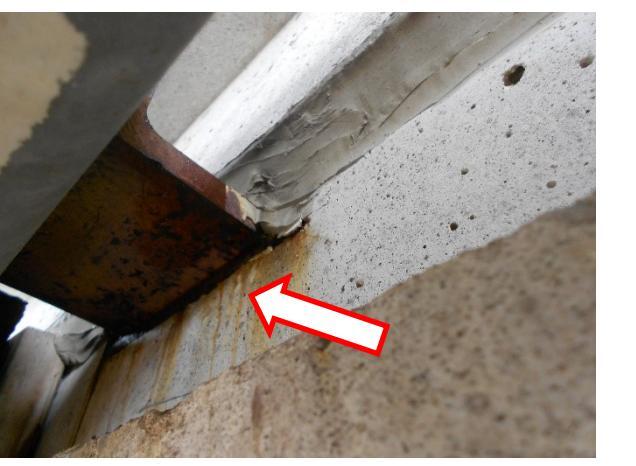
71. A close-up view of clip angle in precast concrete joint from below. Note corrosion staining from runoff.

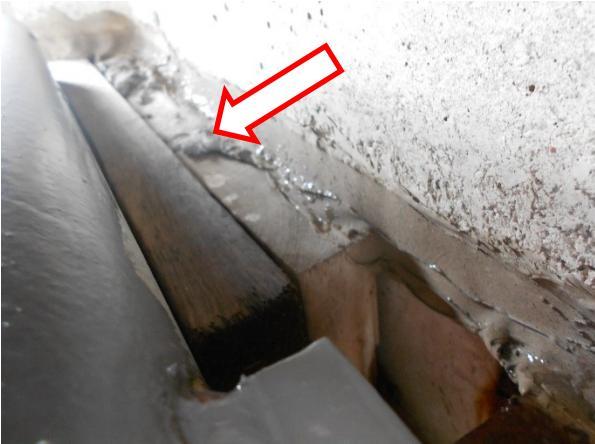
72. A close-up view of leftover wood blocking at ring beam connection.

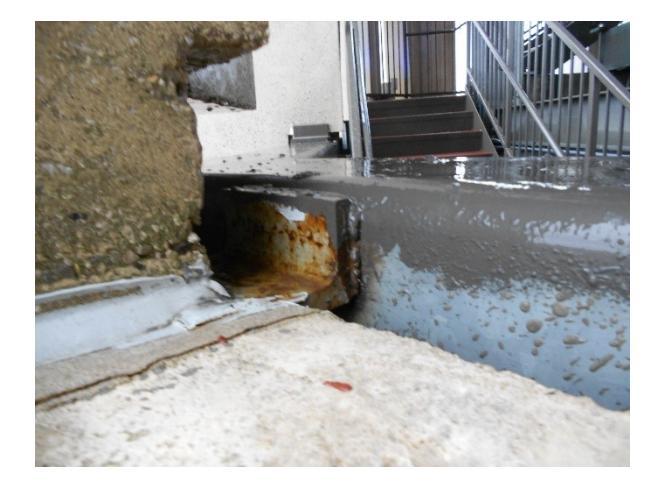
73. A view of a precast clip angle exposed at horizontal surface.

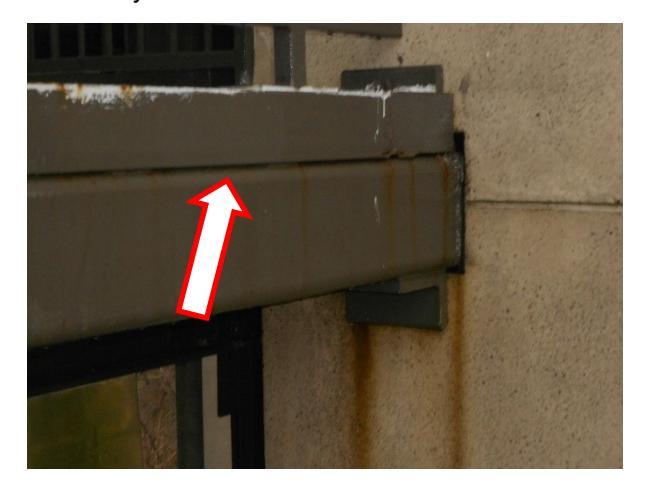
77. A view of typical corrosion at nongalvanized deck edge and ring beam. Note corrosion staining on precast fin.

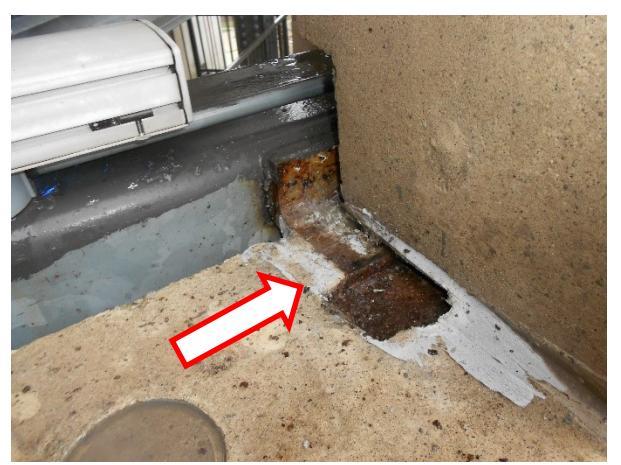
74. A view of a precast clip angle exposed at horizontal surface.

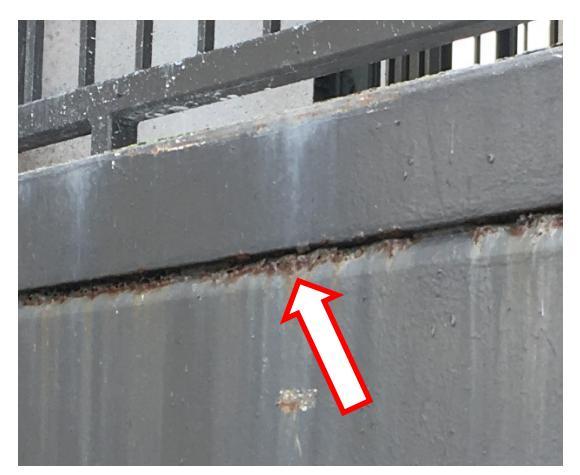
78. A view of typical corrosion at non-galvanized deck edge and ring beam.

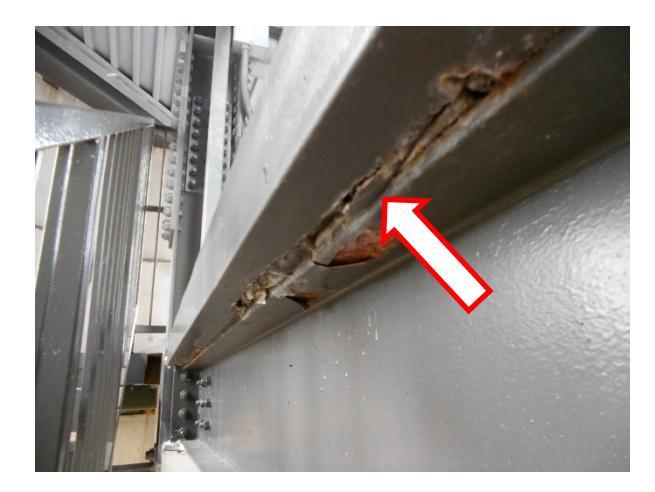
79. A close-up of corroded deck angle and Belfry level.

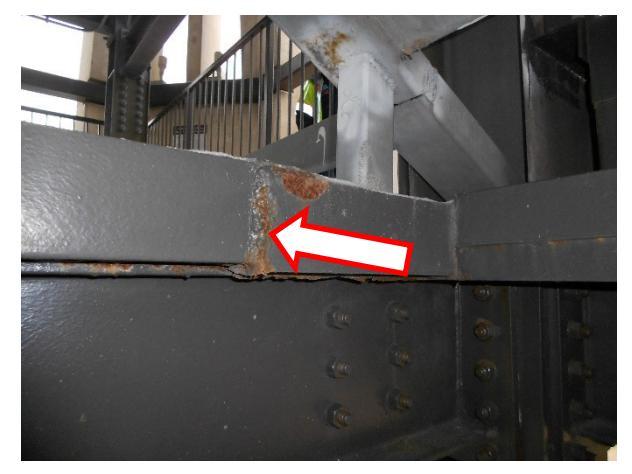
81. A close-up of corroded deck angle at the Belfry level.

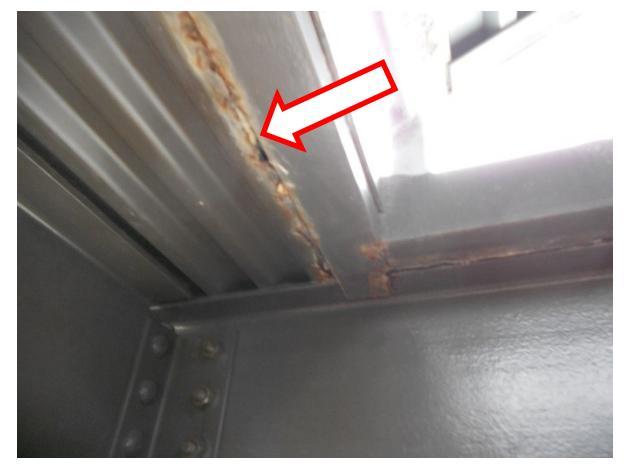
80. A close-up of corroded deck angle and Belfry level.

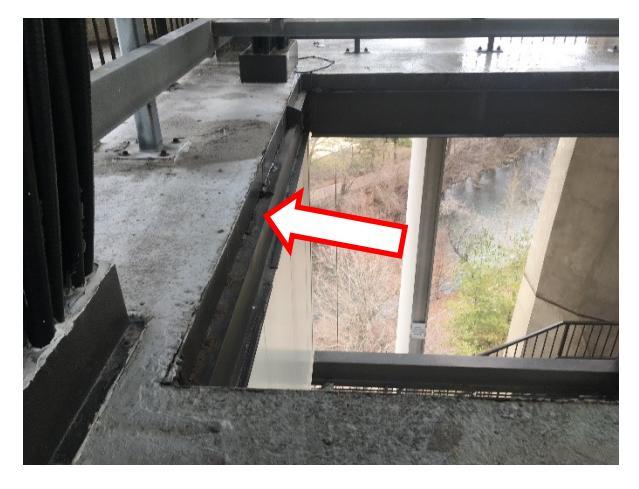
82. A view of the corroded deck edge at elevator shaft at the Belfry level.

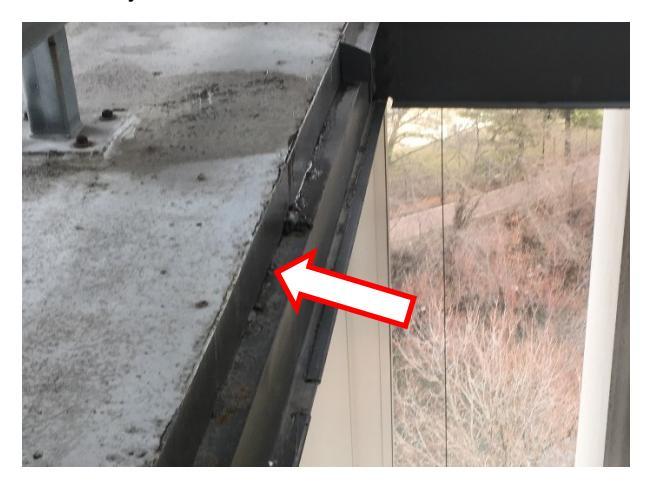
83. A close-up view of the corroded deck edge at elevator shaft at the Belfry level.

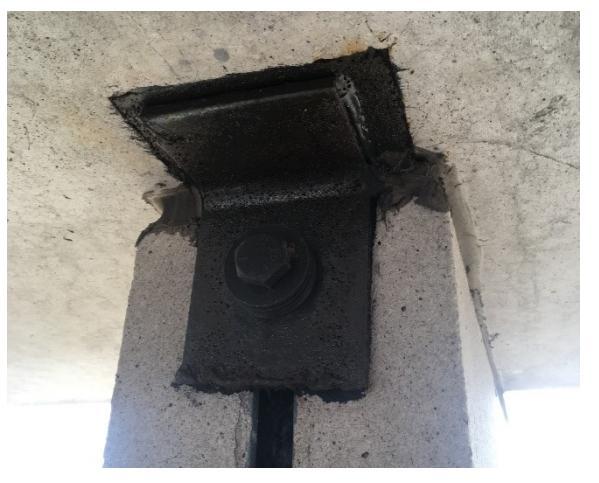
86. A close-up of fin connection in main piers.

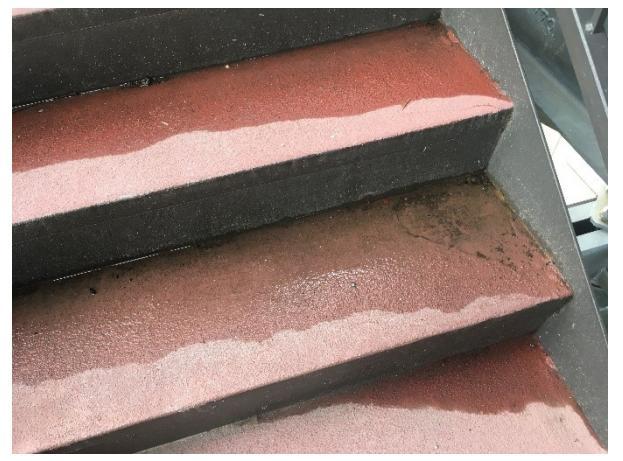
87. A close-up of steel stair with standing water and corrosion.

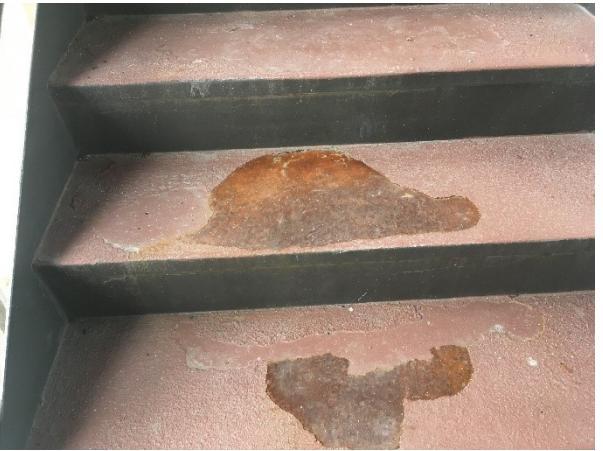
88. A close-up of steel stair with delamination of traffic coating and corrosion.

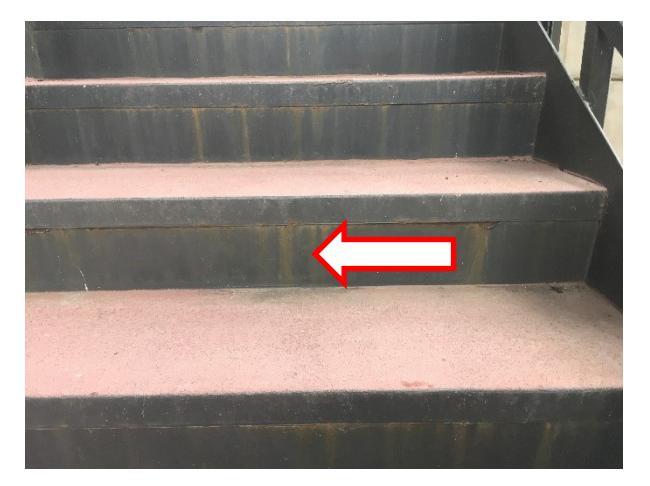
89. A close-up of steel stair with corrosion runoff stains from uncoated metal to metal contact.

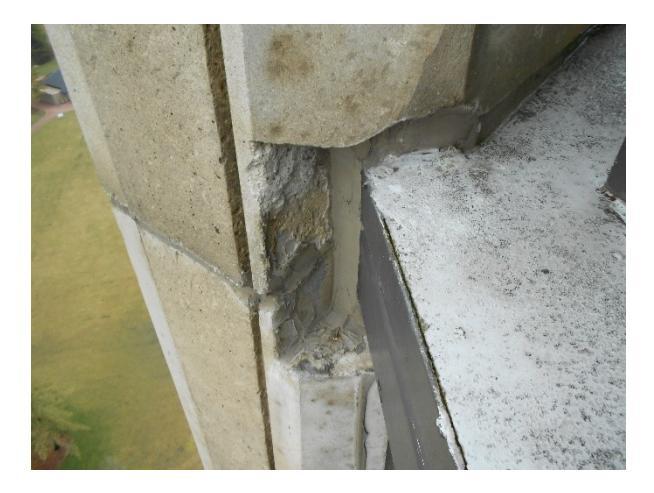
91. A close-up of open deck angle and traffic coating at the Observation deck level. .

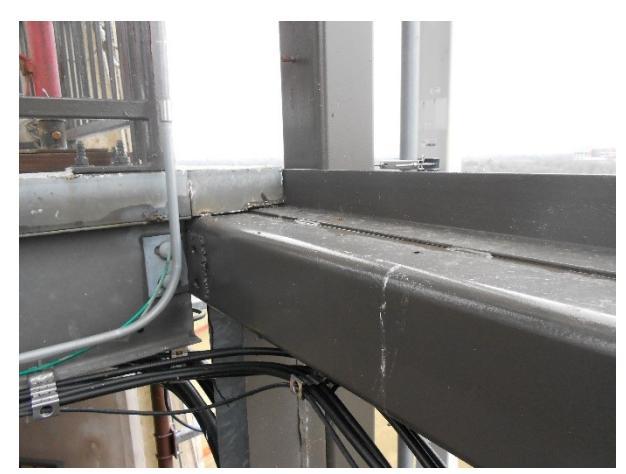
94. A view of abandoned deck support at the Gallery level.

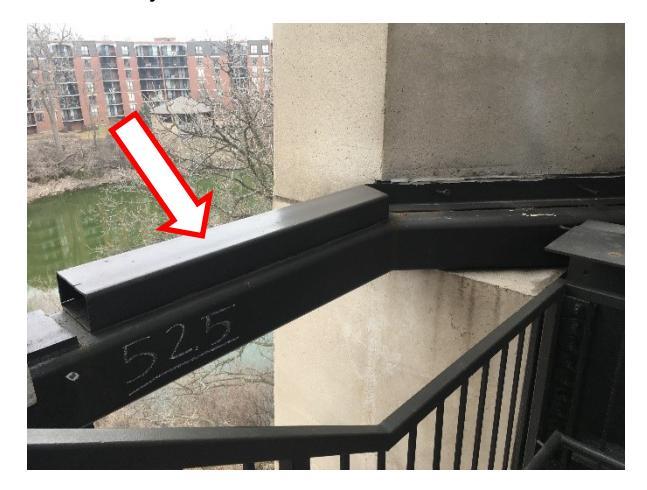
95. A view of abandoned deck support at the Gallery level.

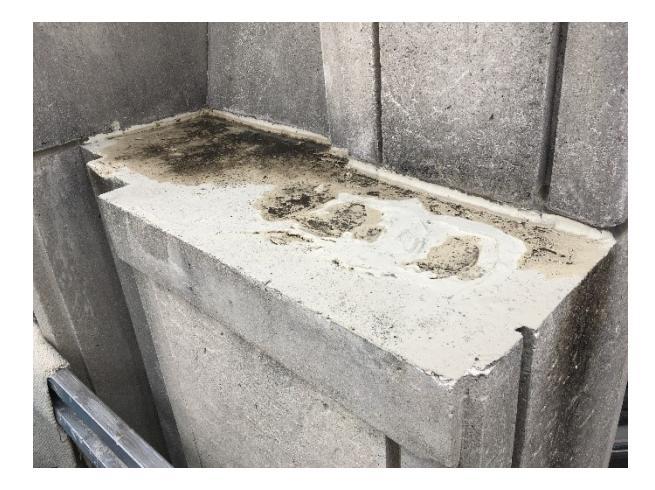
101. A close-up of precast ledge with traffic coating and standing water.

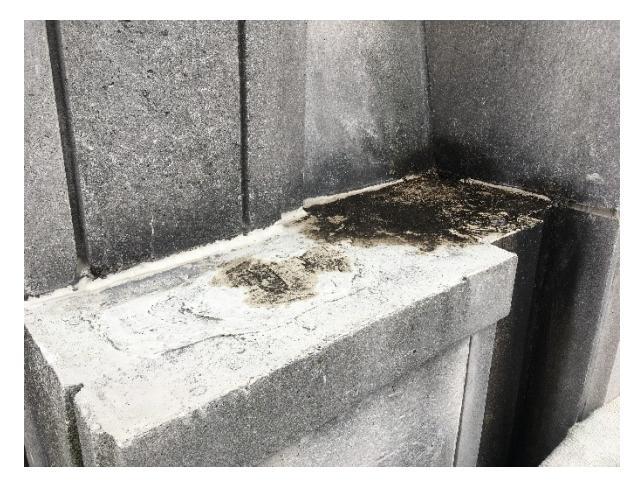
102. A close-up of precast ledge with traffic coating and standing water.

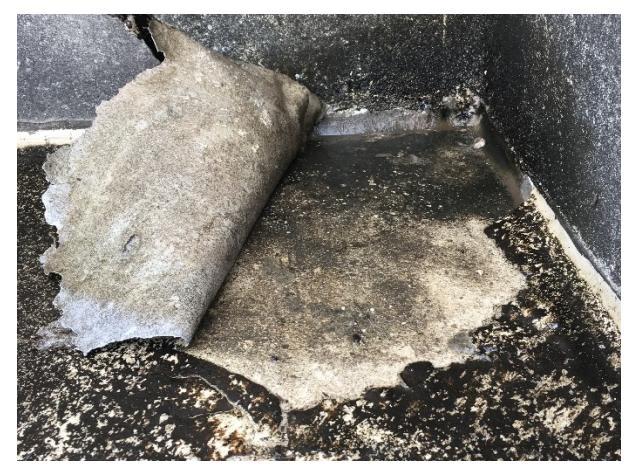
104. A close-up of precast ledge with failed waterproofing and standing water.

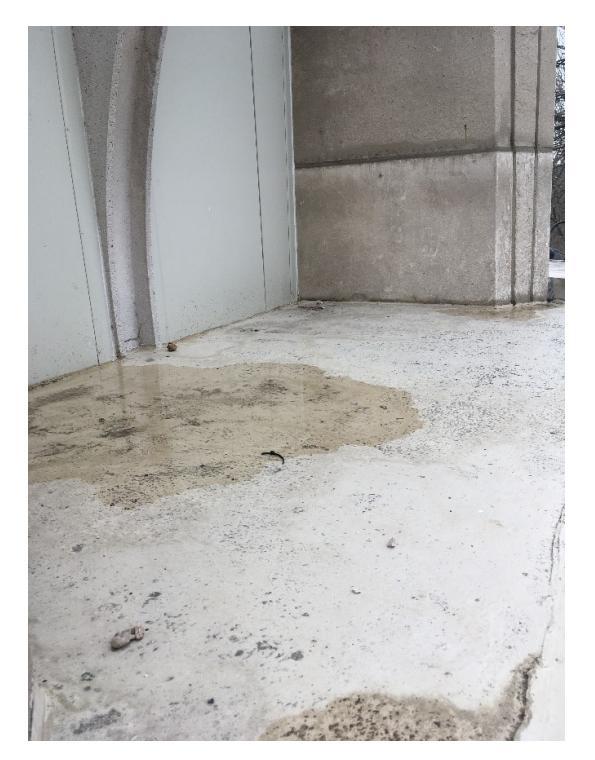
111. A close-up of the small roof at ground floor. Note standing water.
